18TH CENTURY MILITARY ROAD AT LOCH ARKLET

Archaeological Evaluation

for Forestry Commission, Scotland

September 2011

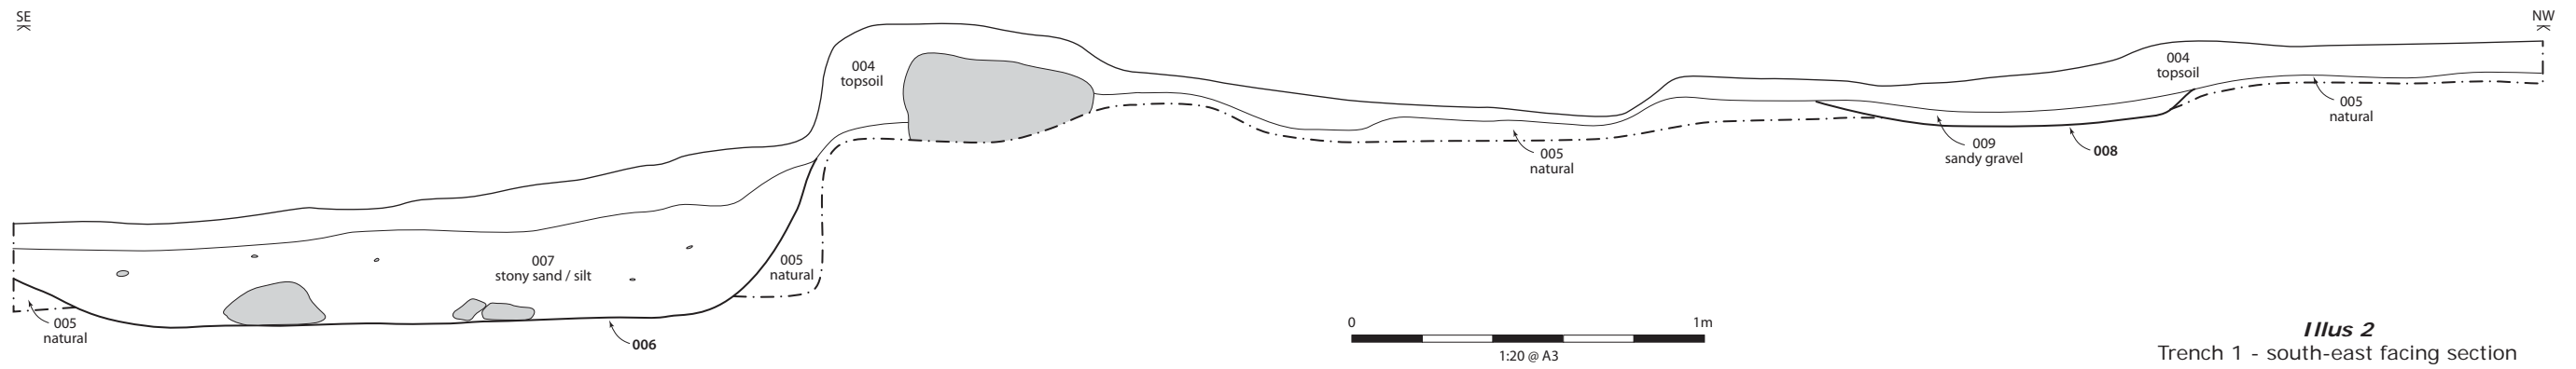
Illus 2
Trench 1 - south-east facing section

Trench 1 (Illus 2) was aligned north-south and measured approximately 7 x 1m (Illus 3). The trench was located 3m west of a possible blocked culvert or ford (Illus 1). The trench was located across the line of the pre-1718, and 18th century military roads, both clearly visible. Excavation revealed orange/brown natural [005] at a depth of 0.3m sealed by a layer of dark brown topsoil [004].

At the northern extent of the trench the cut for the 18th Century Military Road was identified ([008] cut into the natural [005]). The cut was approximately 1.6m wide and

0.15m deep, and contained a thin basal layer of compact mid grey sandy gravel [009], overlain by topsoil [004]. Basal deposit [009] likely represents the remains of the road surface.

At the southern end of trench 1 the cut of the pre-1718 road was identified [006] cut into the natural. This was 2.2m wide, 0.45m deep, and filled with a greyish brown sand/silt material [007], overlain by topsoil [004]. The deposit [007] contained abundant small and medium stone inclusions with larger stones set into the natural at the base of the cut.

The 18th century military road was successfully identified in each of the four trenches. In Trench 1, two phases of road construction were recorded; one was a shallow cut filled with compact sandy gravel, while the second lay further down the slope as a narrow terrace, also overlain by a stony deposit. Although no direct stratigraphic relationship could be identified between the two at that point, it is likely that the lower route represents the earlier alignment of the road. The higher line is more direct and firmer ground – it is also likely that the

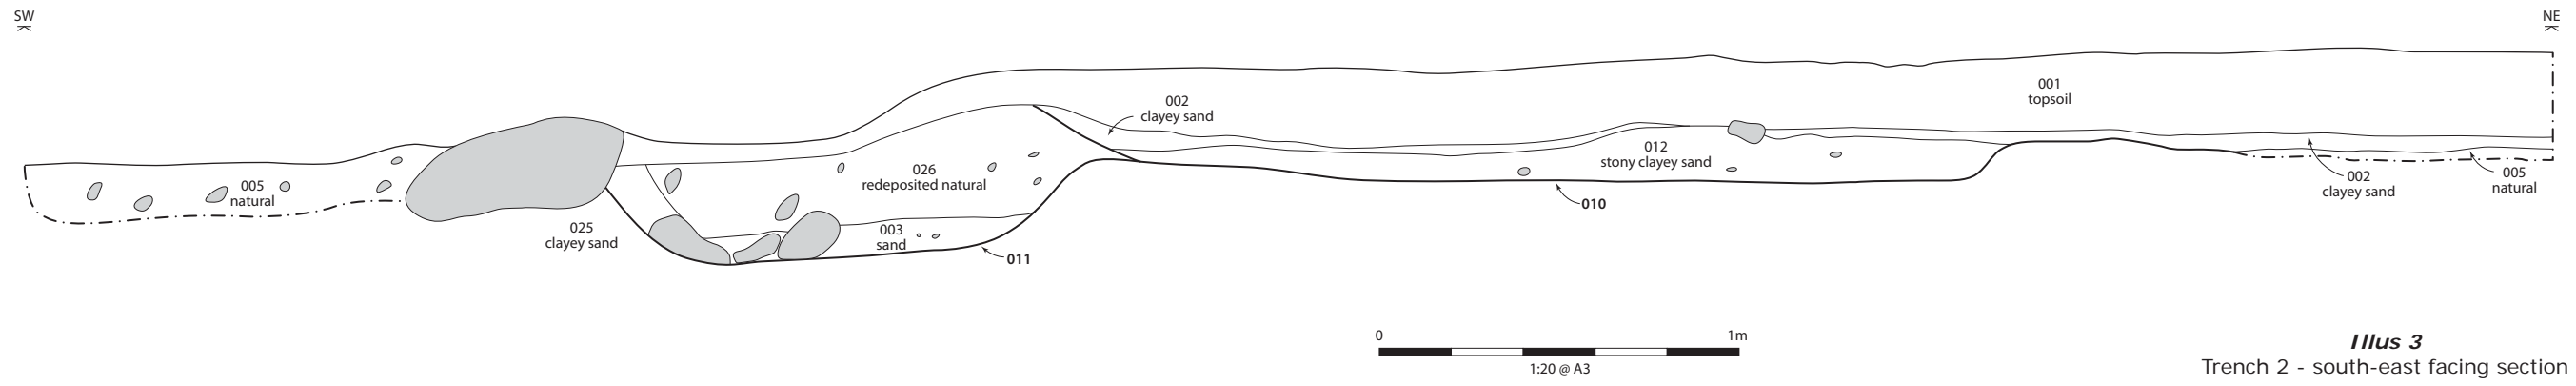
Illus 3
Trench 2 - south-east facing section

Trench 2 (Illus 4) was also aligned north-east to south-west and measured approximately 7m x 1m (Illus 5). The trench was located at a point where both roads converge, approximately 60m east of Trench 1. Excavation revealed an orange/brown natural [005] at a depth of 0.35m. At the south-western end of Trench 2, cut into the natural, the cut of the pre-1718 road was identified [011]. On a north-west to south-east alignment it measured 0.95m wide and 0.35m deep. Filling the base of the cut was a layer of stones sitting on and compressed into the natural this deposit likely represents the remains of the road surface. Overlaying this was a mid grey sand deposit [003], and a natural build up of light grey clay sand [025]. Above this was a layer of light orange re-deposited natural [026].

At the northern extent of Trench 2, the cut of the military road [010] was identified cut into deposit [026] and natural [005]. The exposed section measured 2.2m wide and 0.2m deep. The cut contained a basal deposit of compact orange grey clayey sand with sub-angular stone inclusions [012], overlain by a compact grey clayey sand [002], which extended beyond the cut of the road. Sealing both deposits was topsoil [001]. It is possible that deposit [002] is the road surface, placed directly upon the hard natural, with the road cut [010] and deposit [012] providing levelling and foundation where the ground may have been uneven or less stable. The re-deposited natural [026] found within trench [011] may have been placed there during this process.

In Trench 2, the relationship between the two phases of the road could be demonstrated stratigraphically. The earlier (lower) line exists as a clear cut into the natural, with some large stones and a thin deposit of sand at the base. The road cut has been filled with redeposited natural sand – whether this is the result of natural erosion or deliberate levelling related to the construction of the Military road is unclear. It is likely that the full width of the road was not seen, with a possible levelling deposit continuing under a slumped bank to the north.

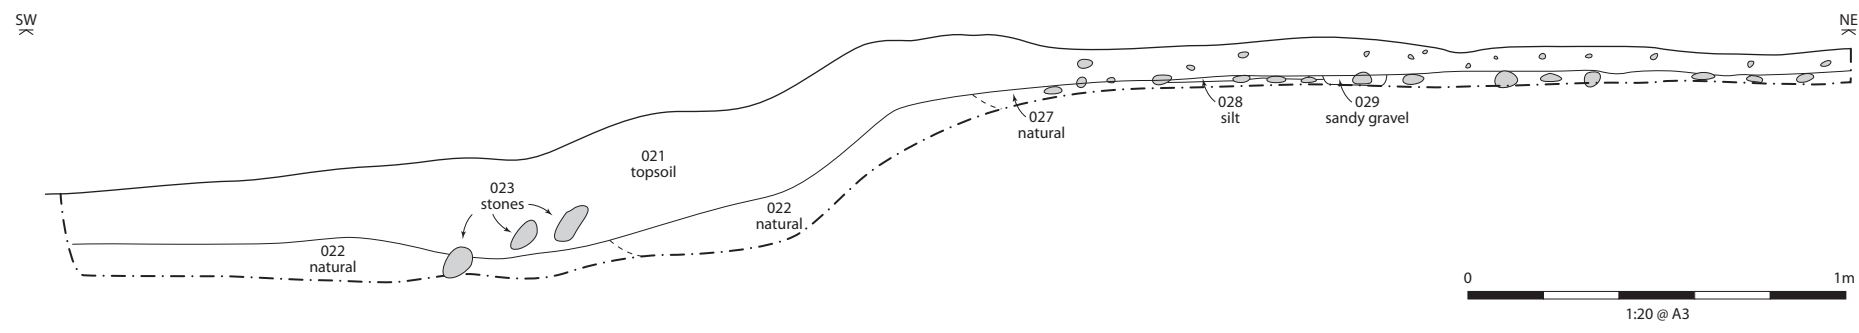
Illus 4
Trench 4 - south-east facing section

Trench 4 (Illus 5) was on a north-east to south-west alignment located approximately 150m north-east of Trench 3 (Illus 11). Measuring 5m by 1m it was located to target the intersection of the two roads Natural yellow silty sand [022] was located at a depth of 0.1 to 0.25m. This was sealed by a thick layer of dark brown topsoil [004]. Although in the correct location, there was no definite sign of the earlier pre-1718 road. But, several stones [023] set into the natural could represent a revetment or kerb marking its north eastern extent. At the north-eastern extent of the trench, the natural was compacted, reddish orange gravel [027] with abundant small stone inclusions. This was sealed by a thin dark brown silt deposit [028] with occasional patches of grey sand/gravel [029] interpreted as the military road surface, and dark brown topsoil [004].

In Trench 4, the old road barely survives – a slight terrace with a few small to medium stones set into the natural. During construction of the military road further upslope, the topsoil was cleared and the stony natural used as a surface, possibly levelled with a sandy gravel infill.

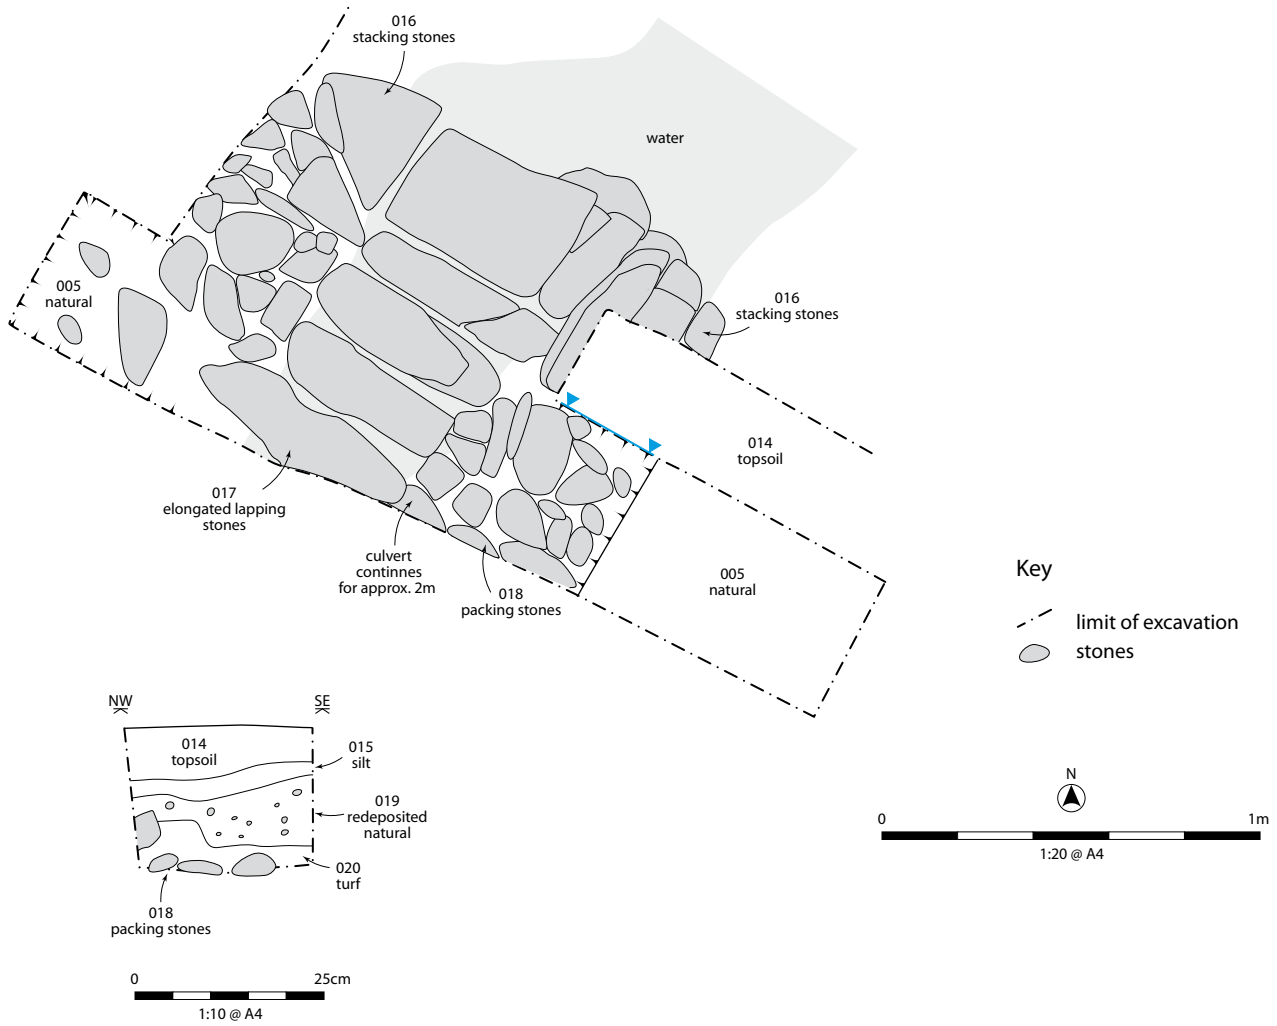
Illus 5

Trench 3 – plan and south-west facing section through collapse

The sides of culvert [016] were constructed of three to five courses of angular to sub-angular stones ranging in size from 0.2m x 0.18m x 0.1m to 0.4m x 0.3m x 0.4m. Overlaying the sides of the culvert were angular to sub-angular capping stones [017] ranging in size from 1m x 0.8m x 0.1m to 1m x 0.4m x 0.08m. Between the gaps

Natural orange/brown clay sand natural [005] was identified at a depth of 0.25m to either side of the structure. This was overlain by compacted light grey silt [015], and a dark brown topsoil [014]. On the western extent of the culvert there had been minor collapse of the structure where lower courses of the sides of the culvert had subsided. Attempts at repair have clearly been made as the subsided stones [018] were sealed by dark brown turf [020], a layer of re-deposited natural [019], a compact light grey silt road surface [015], overlain by dark brown topsoil.

Trench 3 exposed part of a substantial stone culvert. An area of collapse on the western side of the culvert had been repaired with turf and a compact silt that may represent levelling material from the road as it approached the culvert. No evidence for any surfacing or levelling material was used over the culvert itself.

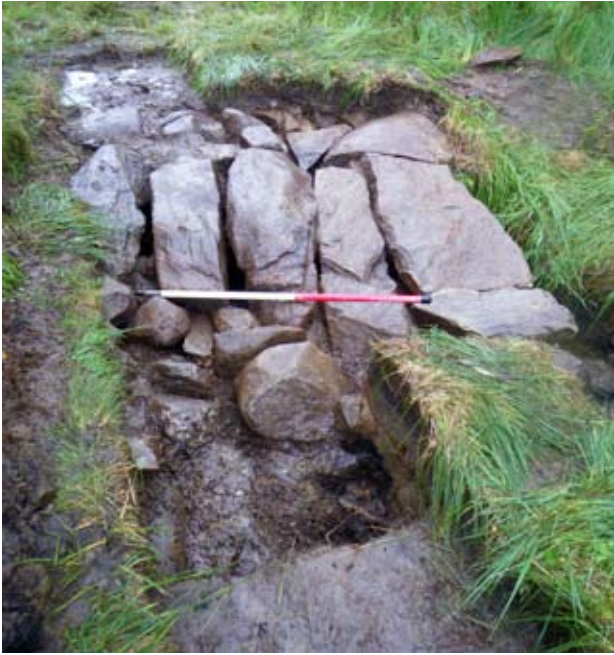
Illus 8

Trench 3, facing north-west and showing collapse in foreground

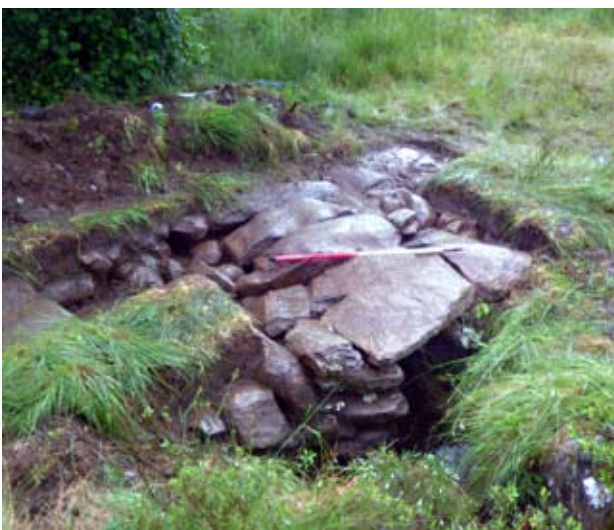
Illus 9

created by the capping stones there was an abundance of smaller capping stones up to 0.12 x 0.12 x 0.07m in size.

Trench 3, facing south-west, showing elevation of culvert

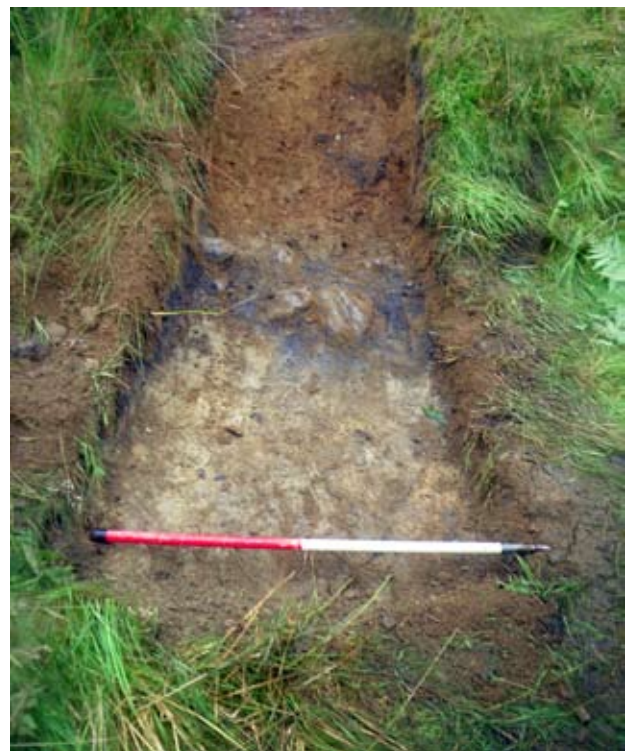
Illus 10

Trench 4, facing north-east
