**Geotechnical Site Investigation Works
Port Dundas Canal Basin
Forth and Clyde Canal
Glasgow
Archaeological Watching Brief**

Report No. 3397

Authors	Magnus Kirby MA FSA Scot ACIfA
Illustrator	Shelly Werner BA MPhil PhD MCIfA
Editor	Bruce Glendinning MA PgDip MCIfA
Commissioned by	Waterman Structures Ltd
Date issued	February 2016
Version	1
Grid Ref	NS 5946 6660

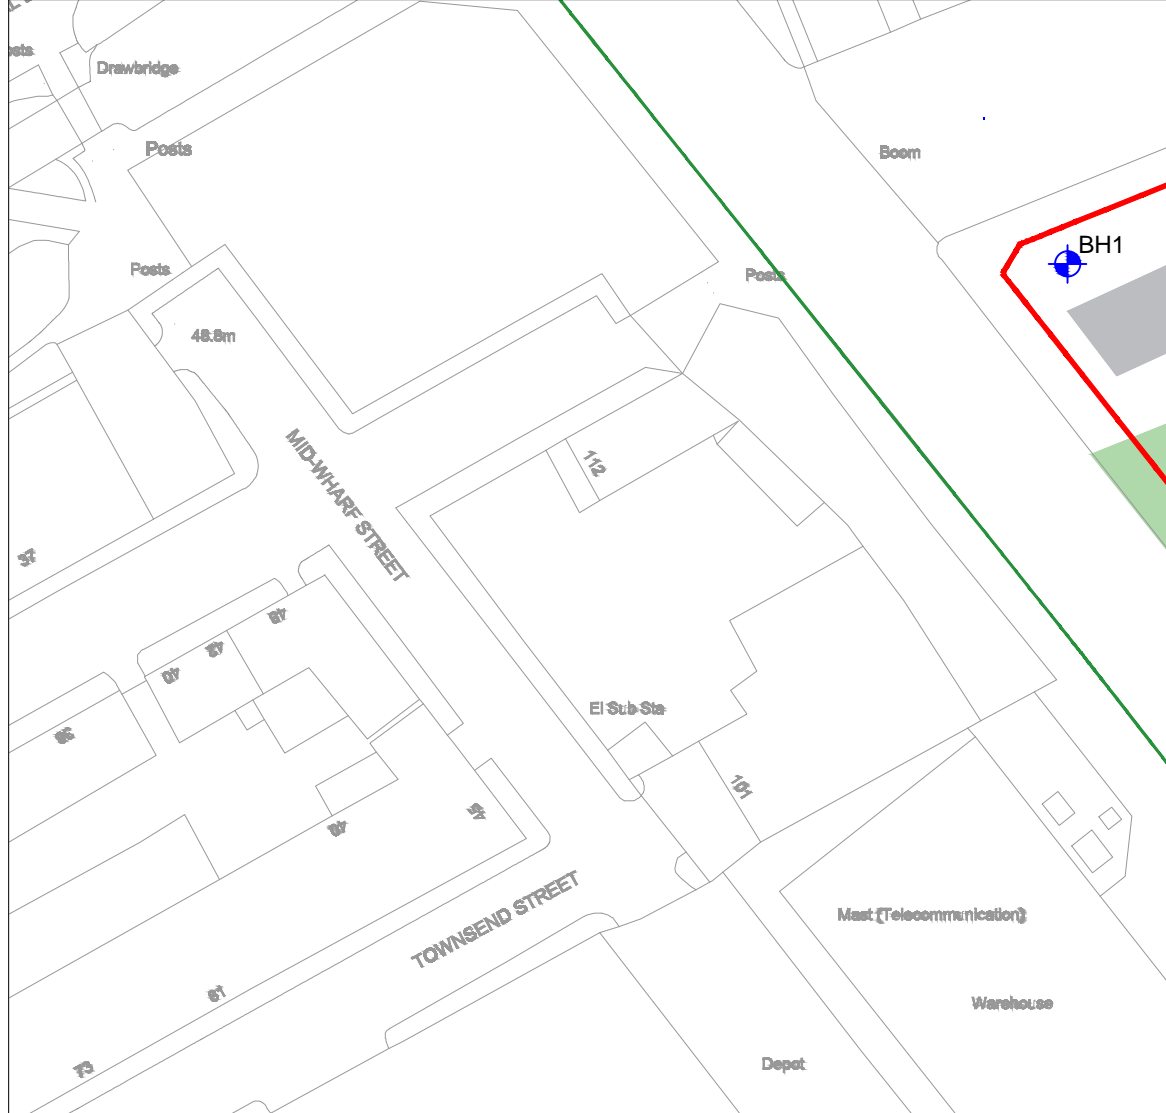
- Key:**
- Site Boundary
 - Scheduled Monument
 - Former Timber Basin Location
 - Approximate Location of Former Cooling Tower
 - Approximate Alternative Location of Former Cooling tower Location
 - Former Coke Kilns
 - Former Boat Building and Repairing Yard
 - Trial Trench
 - Trial Pit
 - Borehole
 - ⊕ Concrete Core

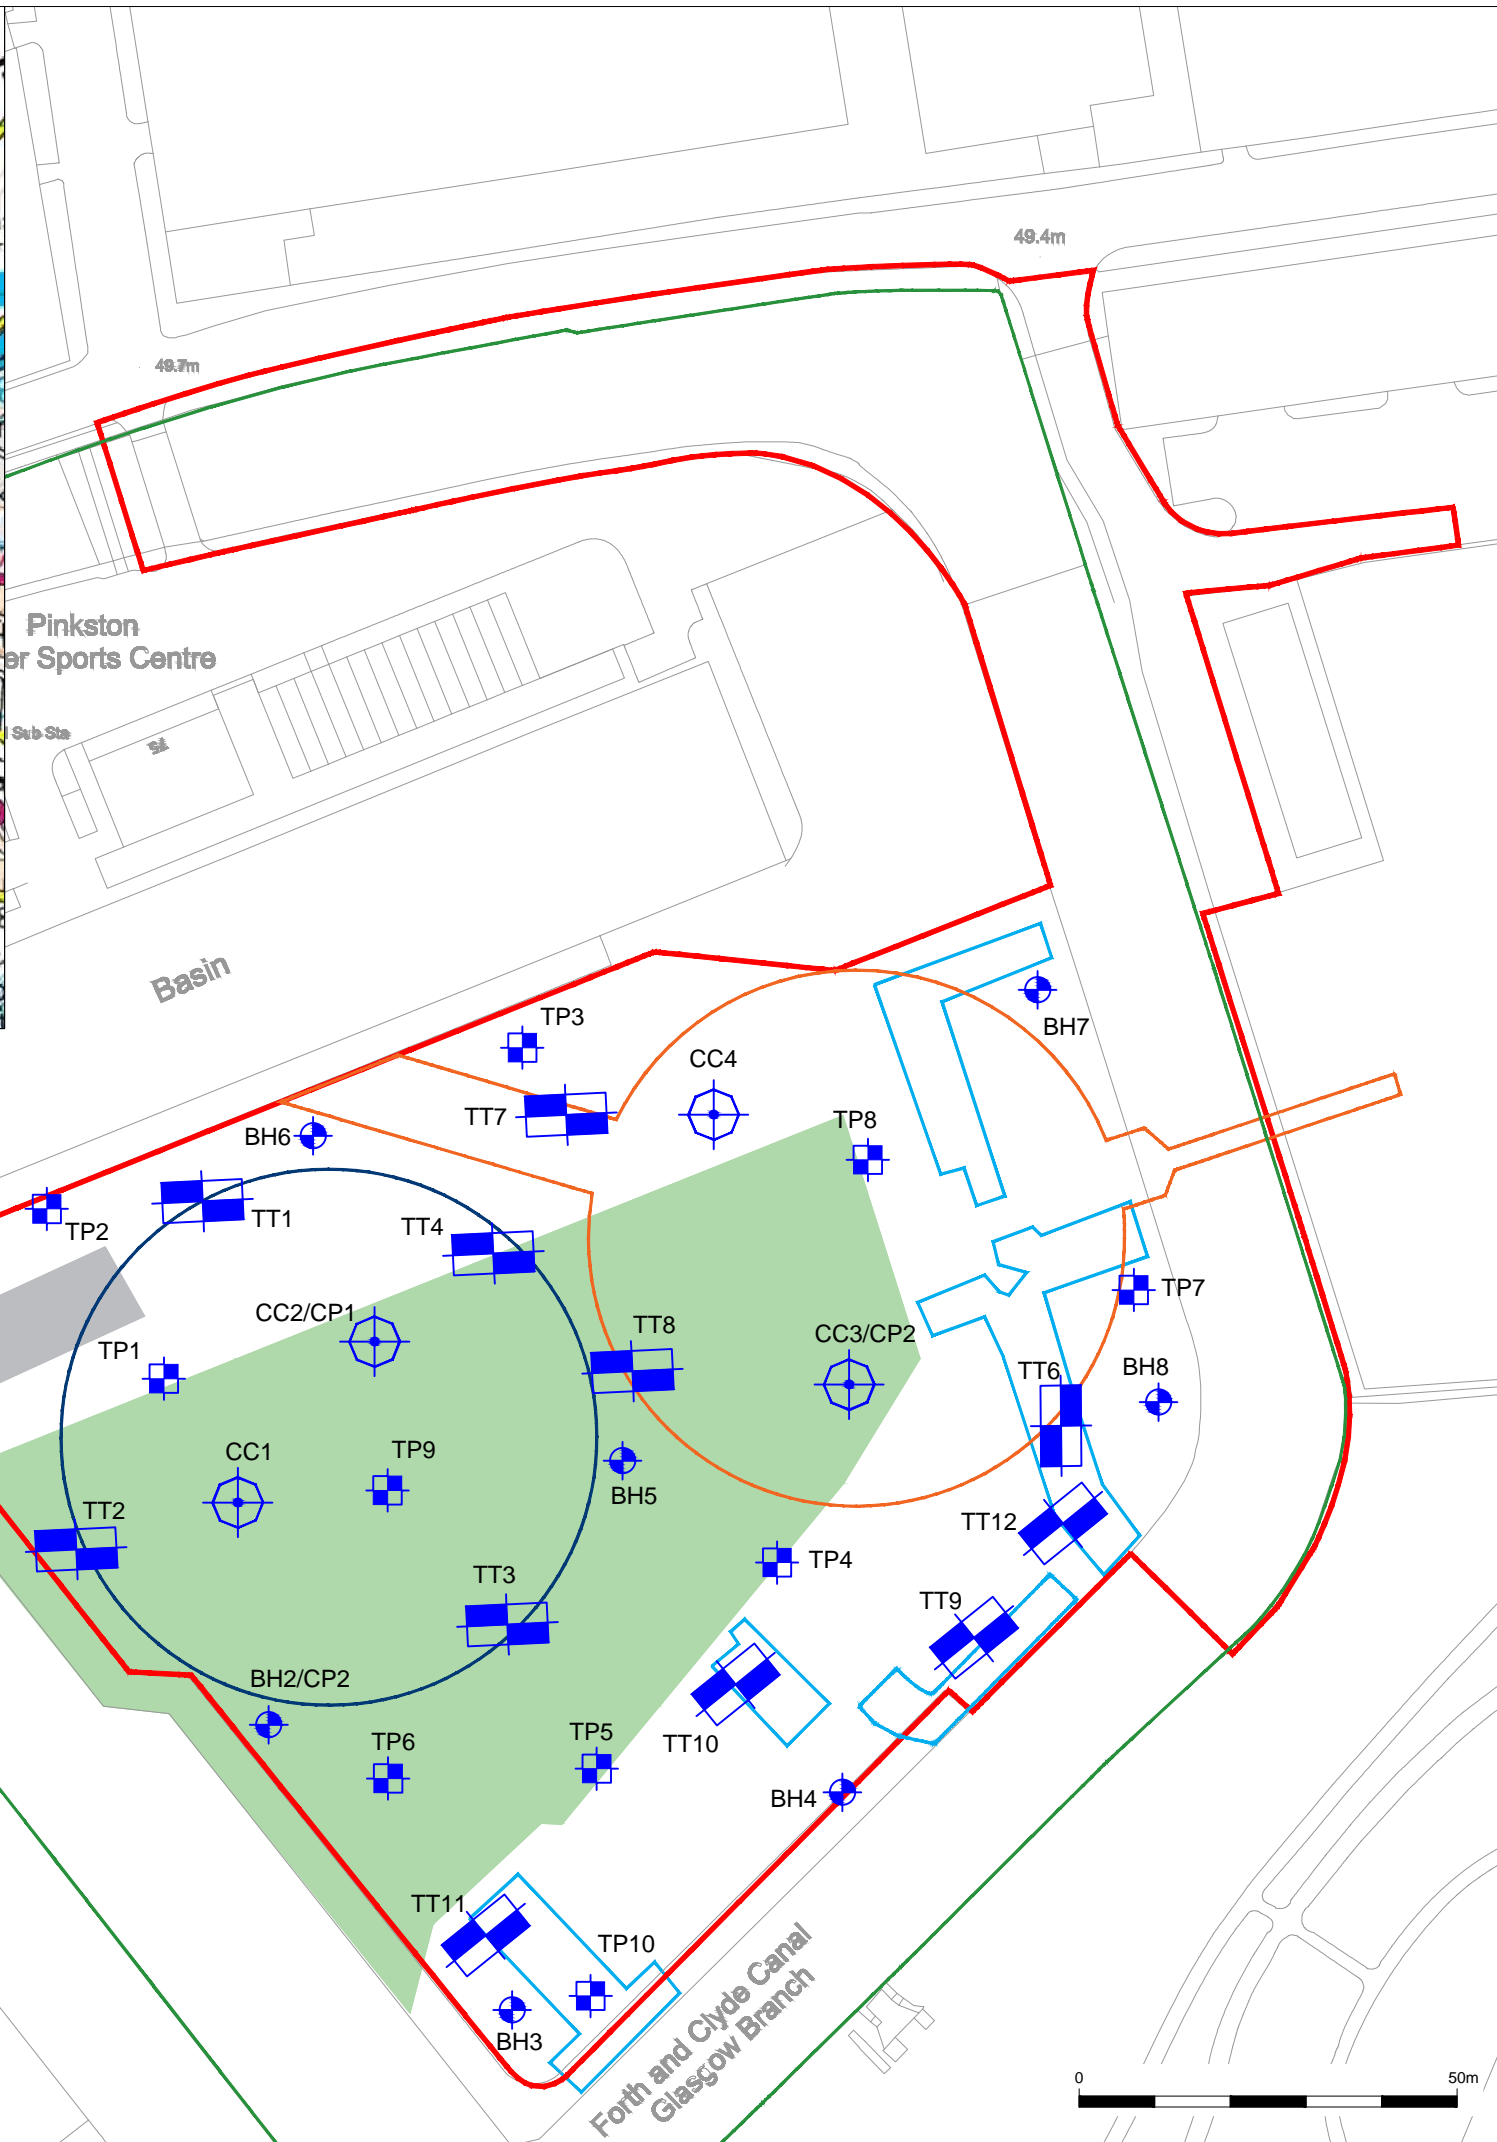
Title:
Location map and site plan

The watching brief monitored the excavation of ten test pits (TP1-TP10), eleven trial trenches (TT1-TT4 and TT6-TT12), and twelve hand-dug starter pits (BH1, BH2/CP2, BH3, BH4, BH5, BH6, BH7, BH8, CC1, CC2/CP1, CC3/CP2 and CC4) (Fig.1). Details of the test-pits/trial trenches/starter-pits containing notable features are contained within the following paragraphs and a summary of all the test-pits/trial trenches is given in Appendix 1.

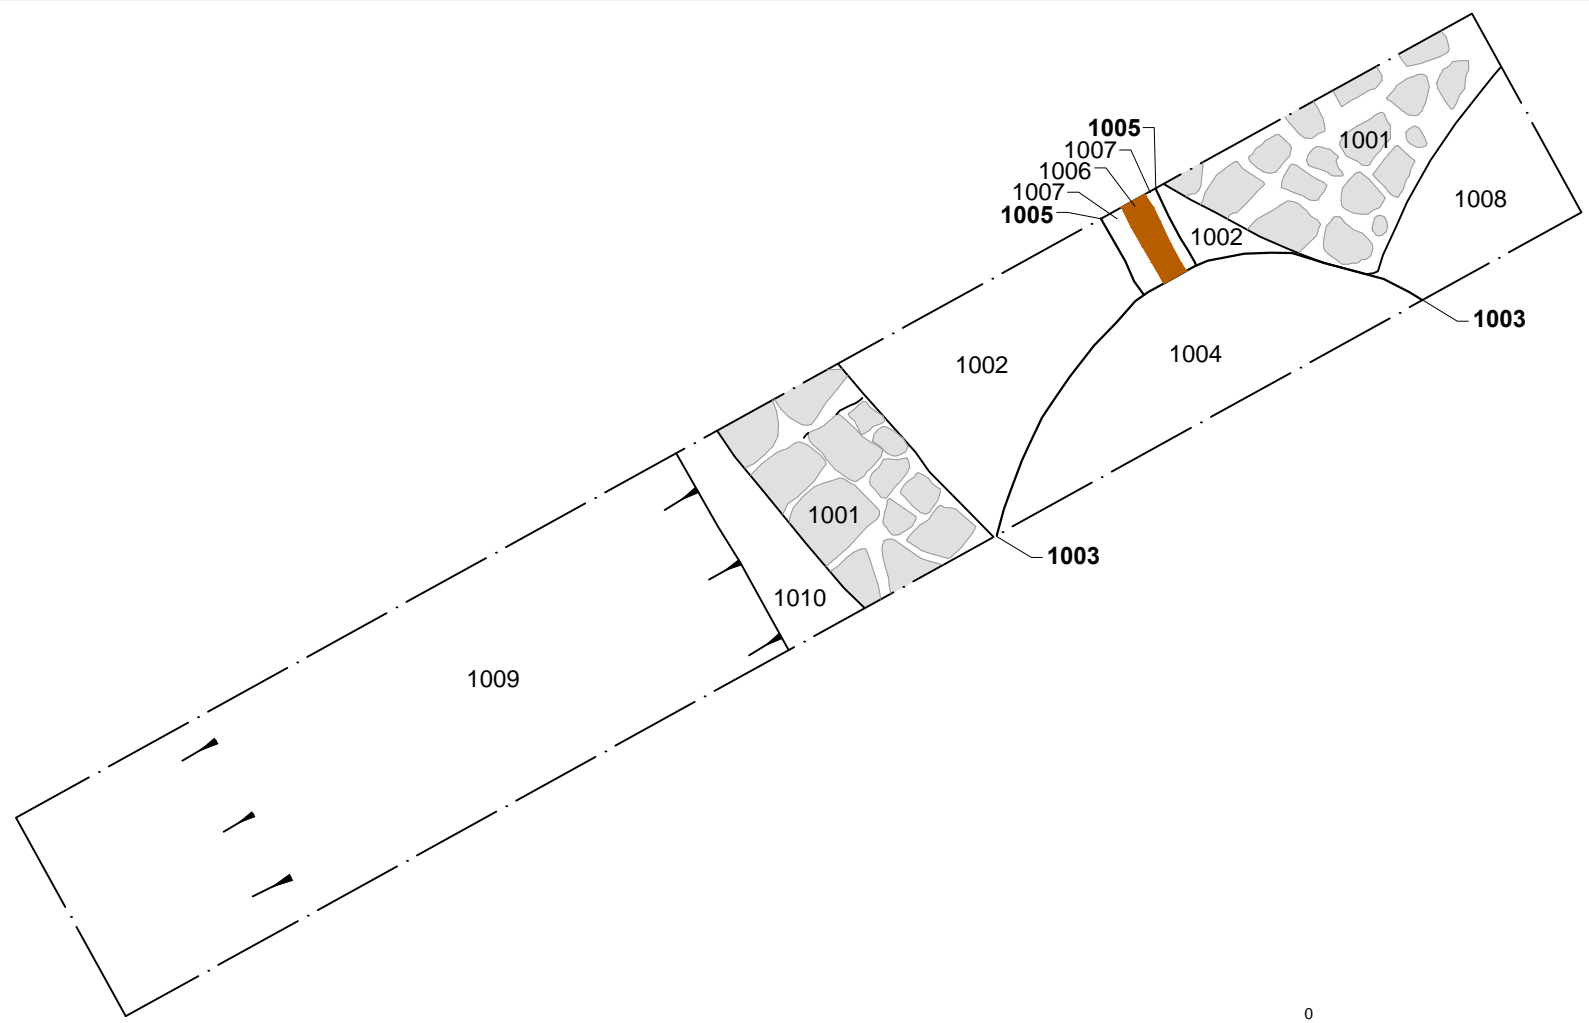
Fig. 2 - Plan of TT10

TT10 measured 11m by 1.5m and was aligned ENE to WSW. At the ENE end of the trench, the deposits consisted of 0.2m of topsoil (**1011**) and 0.2m of grey clay (**1012**) overlying two areas of heat-affected sandstone paving (**1001**) and an area of shattered sandstone deposits (**1002**) (Figs. 2 & 11). A linear gully (**1005**) containing a length of wooden log (**1006**) had been cut into the sandstone deposit **1002**. The gully in turn had been partially truncated by a modern cut feature (**1004**). Underlying the paving/sandstone deposits was a mixed ash deposit (**1009**) with a depth of at least 1m. At the ENE end, the trench was terminated at a depth of 0.4m so that the sandstone

paving surface could be preserved in situ, but was excavated to a maximum depth of 1.4m in the rest of the trench where the paving was not present. The remains in this trench are considered to be the remains of a coke kiln, which was depicted on the 1895 Ordnance Survey map edition.

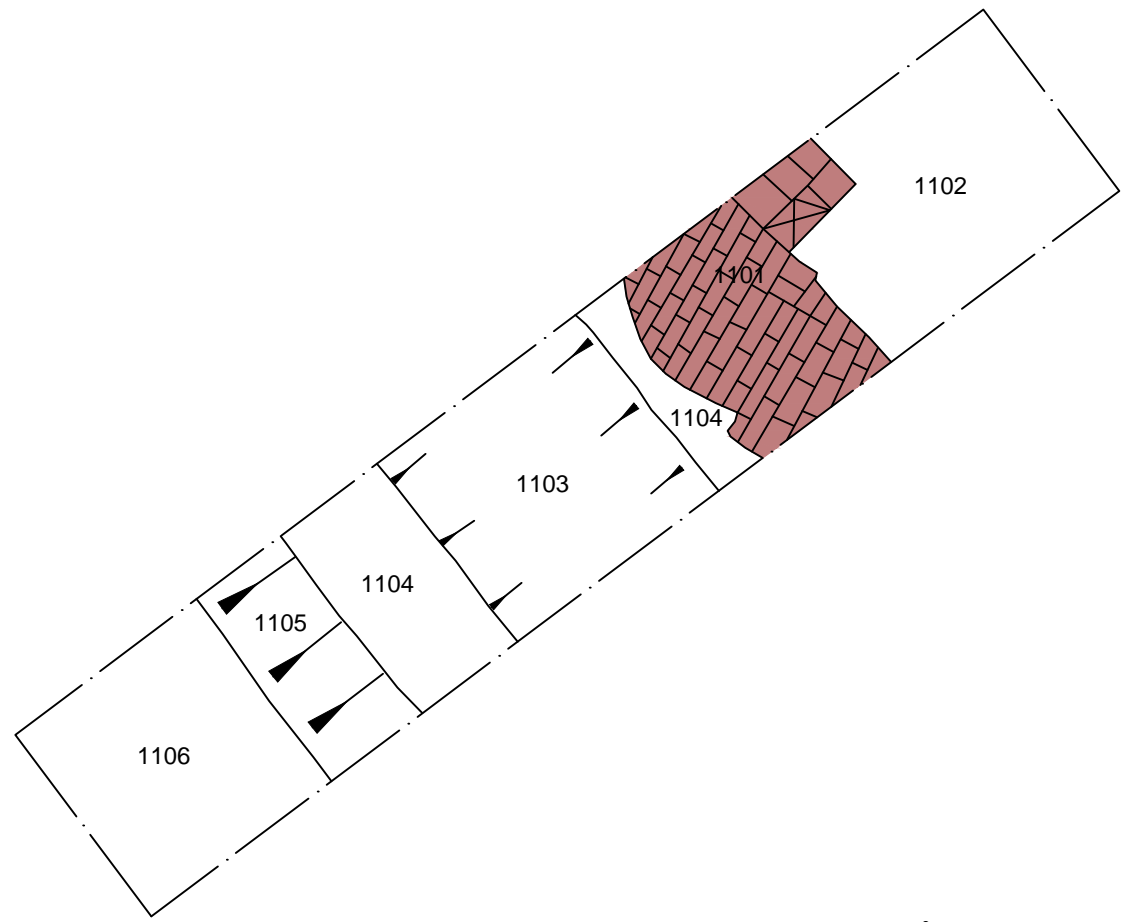
Fig. 3 - Plan of TT11

TT11 measured 8m by 1.5m and was aligned NE to SW. The deposits within this trench from the top downwards consisted of rooty topsoil (1110), a mixed deposit of ash, clay, soil and stones (1109), a lens of creamy lime mortar and brick fragments (1107), a series of lenses of ash, grit and coal (1108), a compacted layer of clay, ash and broken brick (1106), and a layer of very compact coal dust (1105). These overlay a brick surface (1101) at a depth of c.0.8m below the current ground surface (Figs. 3 & 12). The brick surface was constructed from bricks of many different types, which may have been reused from elsewhere. They overlay a mixed ash deposit (1103) with a depth of 0.3m. This feature coincides with the location of a T-shaped structure, which is first depicted on the 1861 Ordnance Survey map edition. On the subsequent 1895 edition, this building is labelled as a coke kiln. The brick surface was preserved in situ.

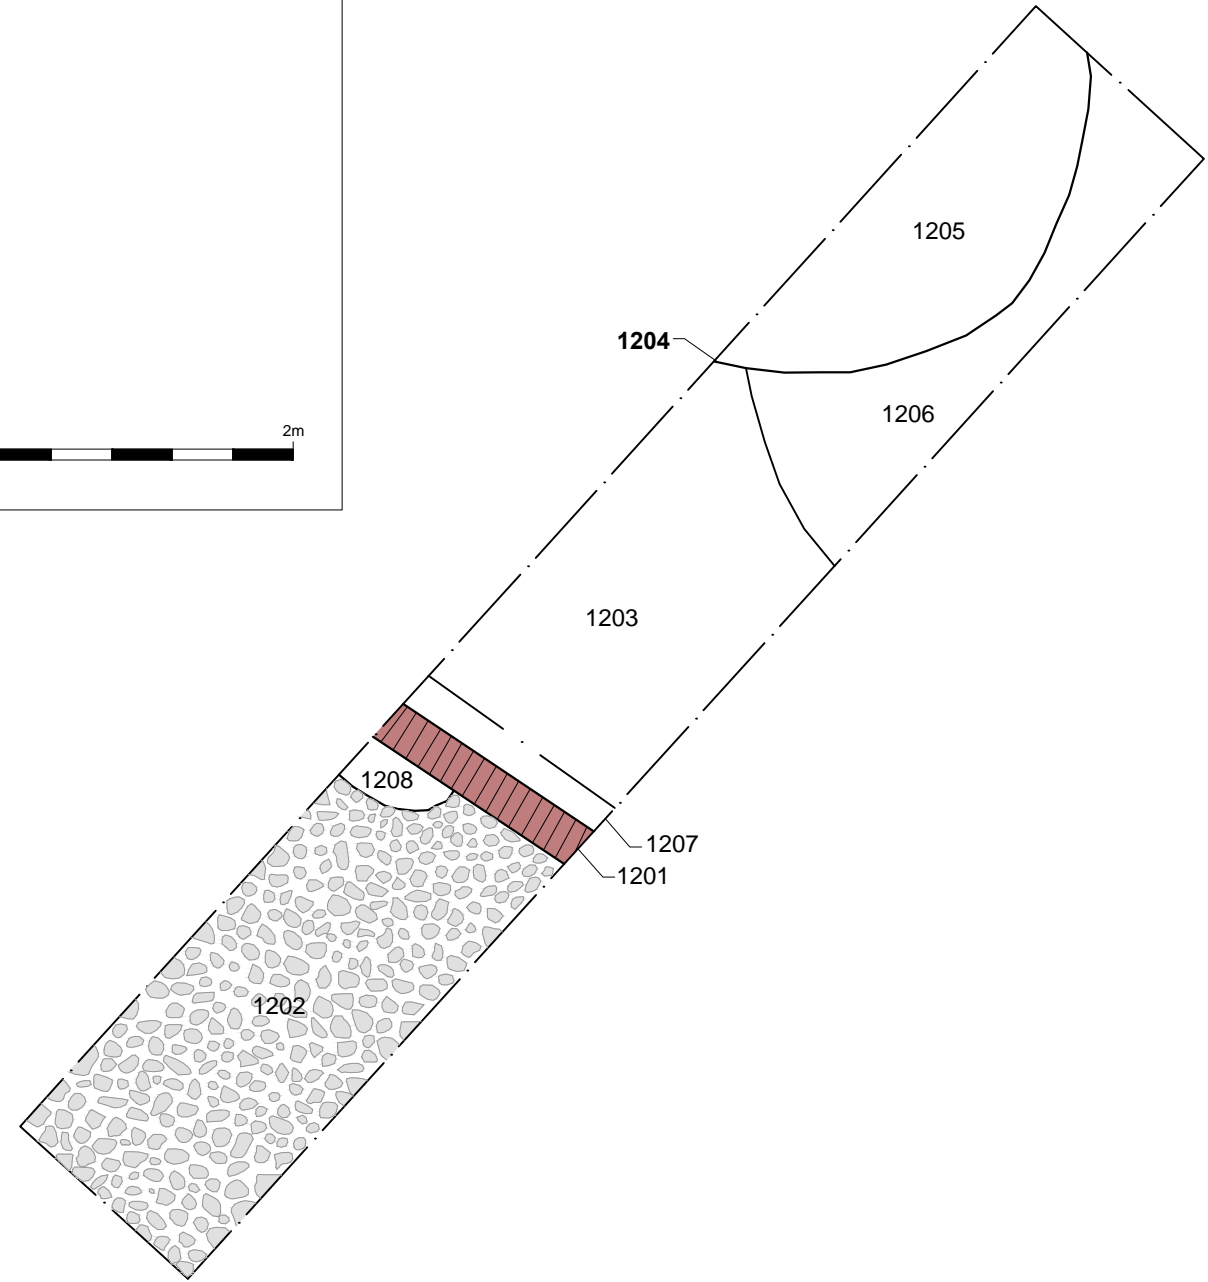
Fig. 4 - Plan of TT12

TT12 measured 10m by 1.5m and was aligned NE-SW. Beneath the topsoil (1210) and a layer of gravel containing off cuts of metal rebar (1203) was a line of edge-set bricks (1201) and a cobbled surface (1202) at a depth of 0.55m below the current ground surface (Figs. 4 & 13). The cobbles overlay made ground deposits (1207/1208), and to the NE of the edge set bricks (1201) there were further made ground deposits (1203/1206) with a modern feature (1204/1205) cut into them. The features within this trench are considered to be the remains of a coke kiln first depicted on the 1861 Ordnance Survey map. They were preserved in situ.

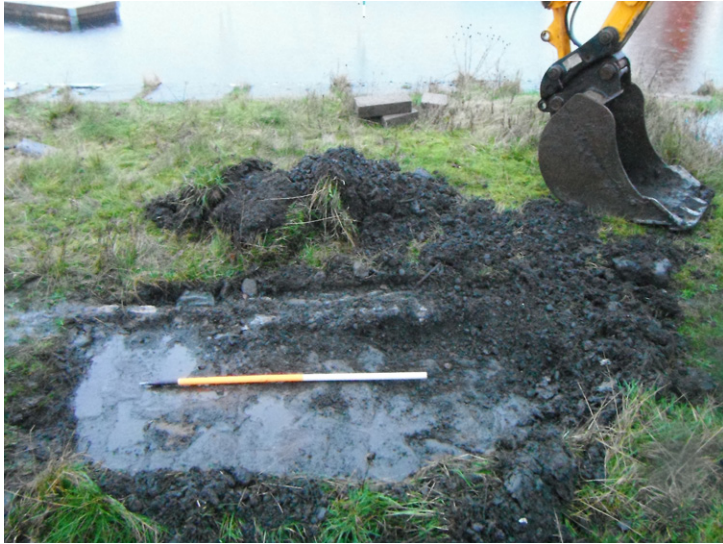
Fig. 5 - TP2 from south

TP2 measured 2m by 1m and was aligned ENE to WSW. The deposits within this test-pit from the top downwards consisted of 0.15m of soil and gravel (**005**), which overlay a cobbled surface (**006**) with a raised concrete kerb (**007**) (Fig. 5). Information from the 1895 Ordnance Survey map edition suggested that this area of cobbles was the surface for one of the wharfs adjacent to the canal basin. This cobble surface was preserved in situ.

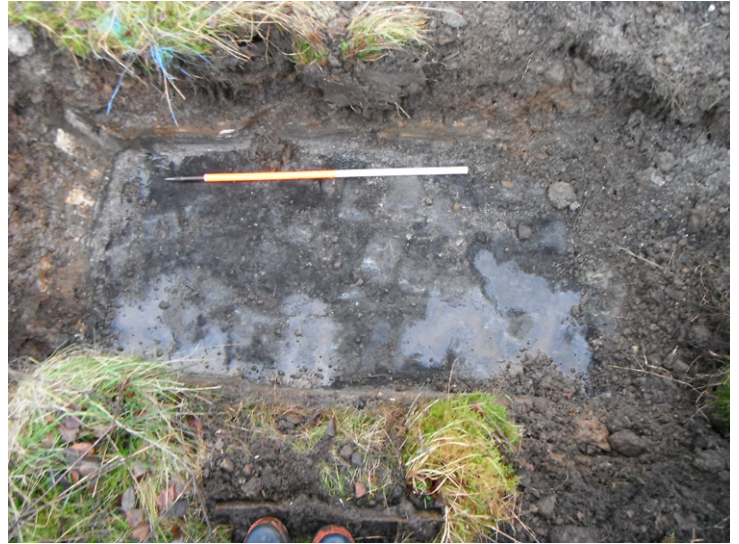
Fig. 6 - TP3 from south

TP3 measured 2.2m by 1m and was aligned ENE to WSW. The deposits within this test-pit from the top downwards consisted of 0.1m of soil and concrete (**008**), 0.2m of concrete (**009**), 0.3m mixed rubble (**010**), and 0.05m of grey-black ash (**011**) overlying a cobbled surface (**012**) (0.65m below current ground surface) (Fig. 6). Information from the 1895 Ordnance Survey map edition suggested that this area of cobbles was the surface for one of the wharfs adjacent to the canal basin. This cobble surface was preserved in situ.

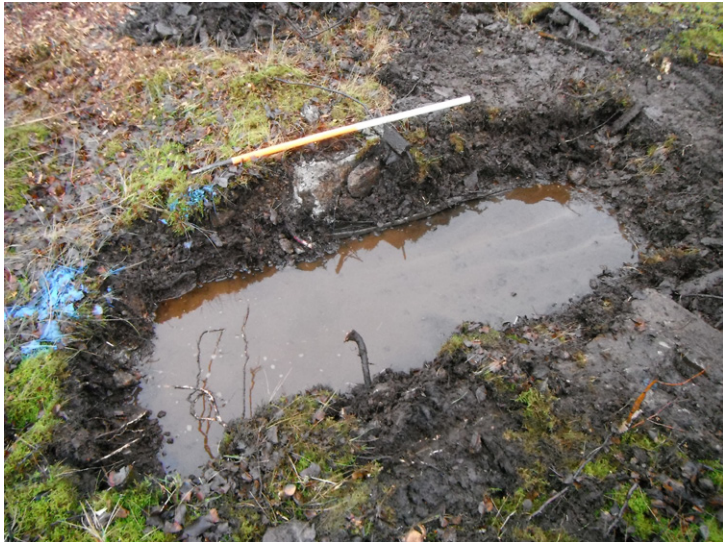
Fig. 7 - TP8 from SSW

TP8 measured 2m by 0.8m and was aligned ENE to WSW. The deposits within this test-pit from the top downwards consisted of 0.25m of mixed made-ground (**030**) overlying a flat concrete surface (**031**). This test-pit rapidly filled with water covering the concrete surface (Fig. 7). The concrete surface is considered likely to relate to the cooling tower depicted on the 1960 Ordnance Survey map and was preserved in situ.

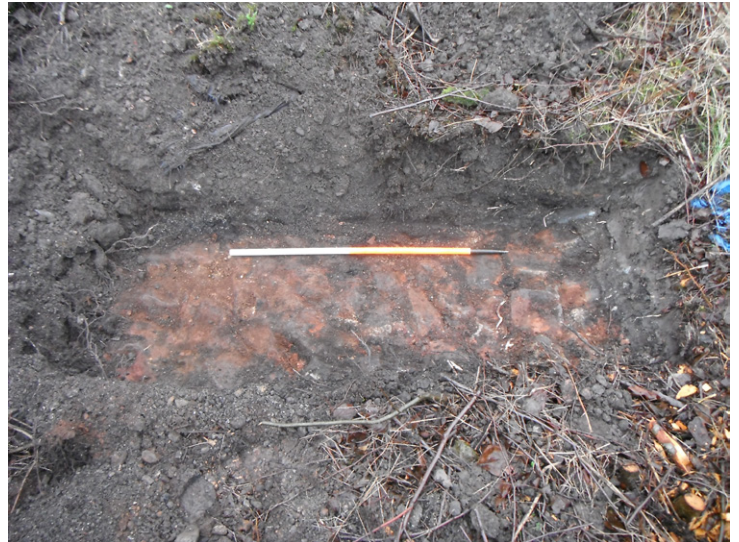
Fig. 8 - TP10 from north

TP10 measured 2m by 0.8m and was aligned east to west. The deposits within this test-pit from the top downwards consisted of 0.2m of topsoil and roots (**036**) overlying a thin lens of ash and grit (**037**). This overlay a cobbled surface (**038**) (Fig. 8). Information from the 1861 Ordnance Survey map edition suggested that this area of cobbles lay within a T-shaped structure, which is labelled as a coke kiln on the later 1895 Ordnance Survey map. The cobbled surface was preserved in situ.

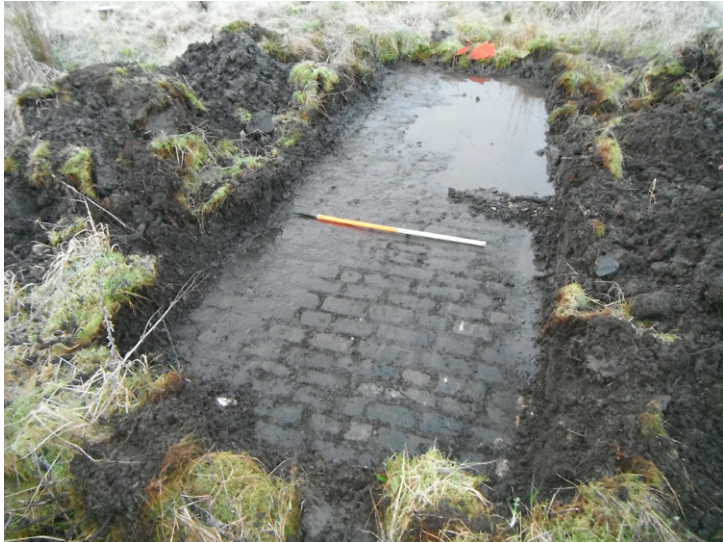
Fig. 9 - TT1 from east

TT1 measured 5m by 1.75m and was aligned east to west. The deposits within this trench from the top downwards consisted of 0.25m of topsoil containing modern debris (**039**) overlying well laid setts/cobbles (**040**) (Fig. 9). Information from the 1895 Ordnance Survey map edition suggested that this area of cobbles was the surface for one of the wharfs adjacent to the canal basin. The cobbles were preserved in situ.

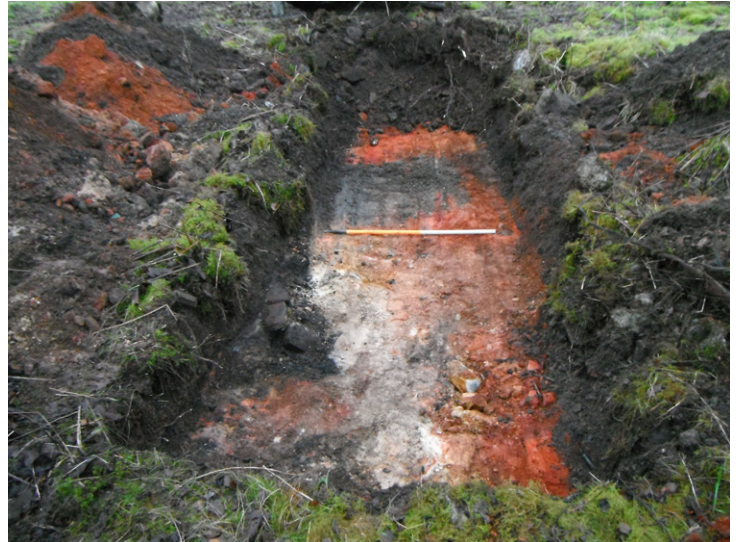
Fig. 10 - TT6 from north

TT6 measured 5m by 1.9m and was aligned north to south. The deposits within this trench from the top downwards consisted of 0.35m to 0.55m of stony topsoil (**051**) overlying coarse bright red (heat affected sand) sand (**052**) (Fig. 10). Apparently cutting through the red sand there was a linear strip of white sand (**053**), which was 0.3m wide and may mark the robbed out remains of the former wall line of the coke kiln that was mapped in this location on the the 1861 Ordnance Survey map. The white sand bordered an area of cobbles (**054**) and an area of mixed red/white sand (**055**). The cobbles may have represented the warf surface outside of the coke kiln. A modern feature (**056**) filled with grey gravel/sand (**057**) had been cut into the base of this trench. Excavation ceased at this depth and the features were preserved in situ.

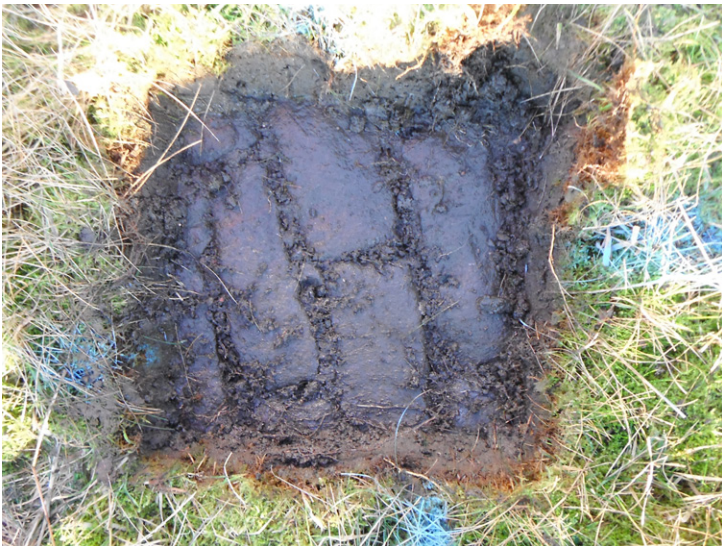
Fig. 14 - BH1 from west

The BH1 starter-pit measured 0.5m by 0.5m and was excavated to a depth of 1.2m. A cobbled surface (066) 0.2m thick was exposed c. 0.1m below the current ground surface (065) (Fig. 14). The deposits beneath the cobbles consisted of 0.5m of brownish gravel (067) and >0.4m of grey-black clay-silt (068), which continued below the base of the pit. Information from the 1895 Ordnance Survey map edition suggests that this area of cobbles was the surface for one of the wharfs adjacent to the canal basin.

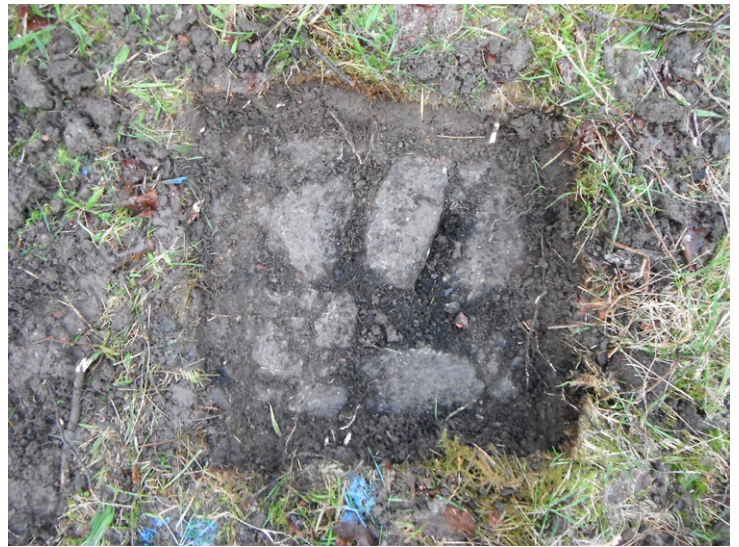
Fig. 15 - BH3 from east

The BH3 starter-pit measured 0.5m by 0.5m and was excavated to a depth of 1.1m. A cobbled surface (070) 0.2m thick was exposed c. 0.1m below the current ground surface (069) (Fig. 15). The deposits beneath the cobbles consisted of 0.1m of ash (071), 0.2m of sand and >0.5m of mixed clay/ash/stones (072), which continued below the base of the pit. Information from the 1895 Ordnance Survey map edition

suggests that this area of cobbles was the surface for one of the wharfs adjacent to the canal basin.
