# SCAPAMAP2

Marine Heritage Monitoring with High-Resolution Survey Tools:

Scapa Flow 2001-2006

Final Report

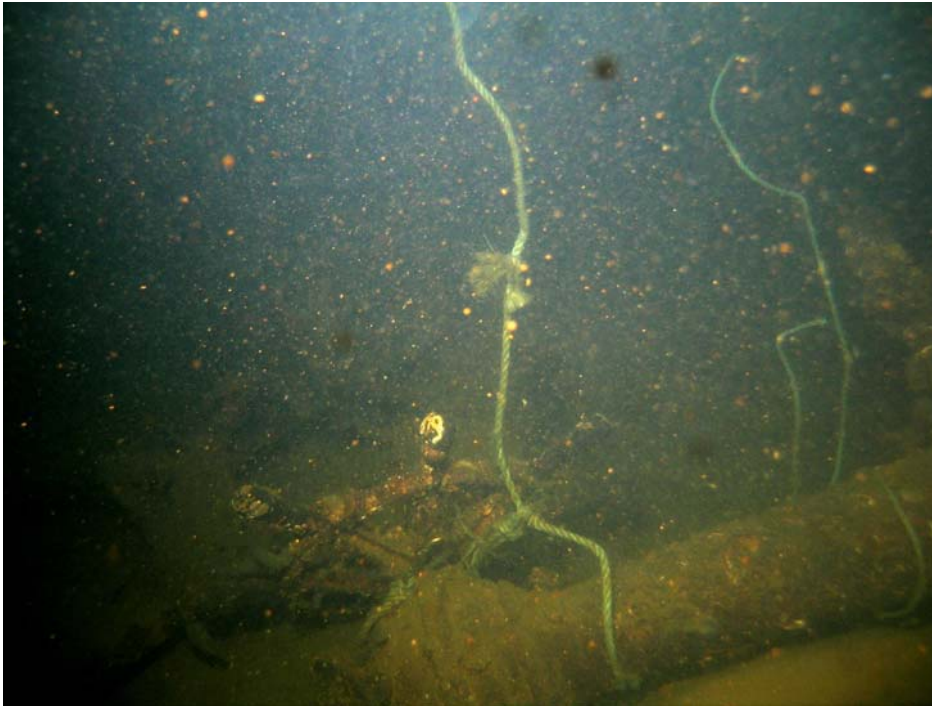
On the 29 July 2005 a recreational diver reported seeing lifting bags attached to the auxiliary rudder steering mechanism during a dive on the SMS Markgraf. On the 2 August 2005 this was investigated. No evidence of lifting bags was found, however, ropes were attached to the mechanism in preparation for recovery (Figure 2.2).

**Figure 2.1:** Auxiliary steering mechanism in the SMS Markgraf with ropes and karabiners attached.

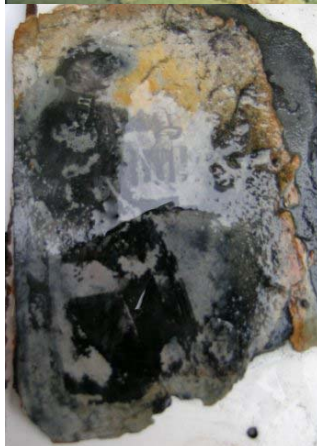
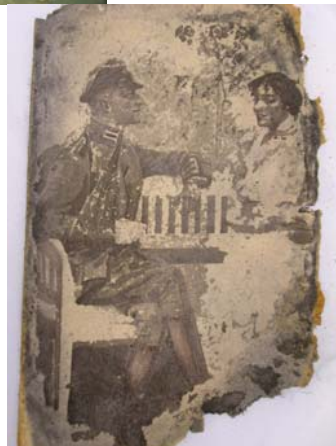
**Figure 2.2:** Postcards recovered from the SMS Karlsruhe March 2004. (a) *in situ*, (b) as recovered & (c) post conservation.

(b) postcard when recovered

(c) conserved postcard

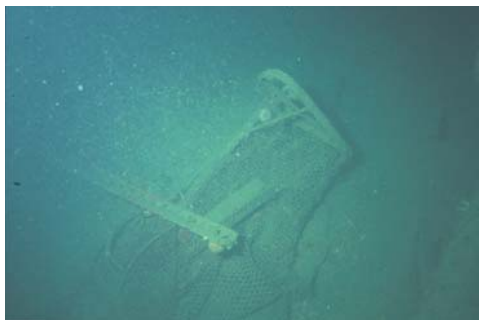
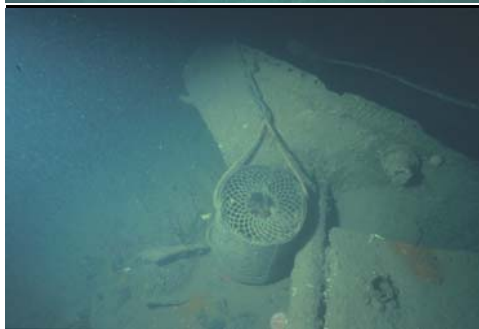
**Figure 2.3:** Fouled fishing gear on SMS Kronprinz Wilhelm.

However, in 2003 a fishing vessel reported snagging its clam dredges on the Kronprinz Wilhelm. Heriot-Watt University were asked to investigate the damage. During dives on the wreck several lost dredges were found along with other forms of fishing gear were found (Figure 2.3 a(a) & (b)). It could not be determined if damage to sections of the site along the seabed were the result of fishing gear or natural deterioration.

(a) Queen scallop trawl.

(b) Buckie pot.

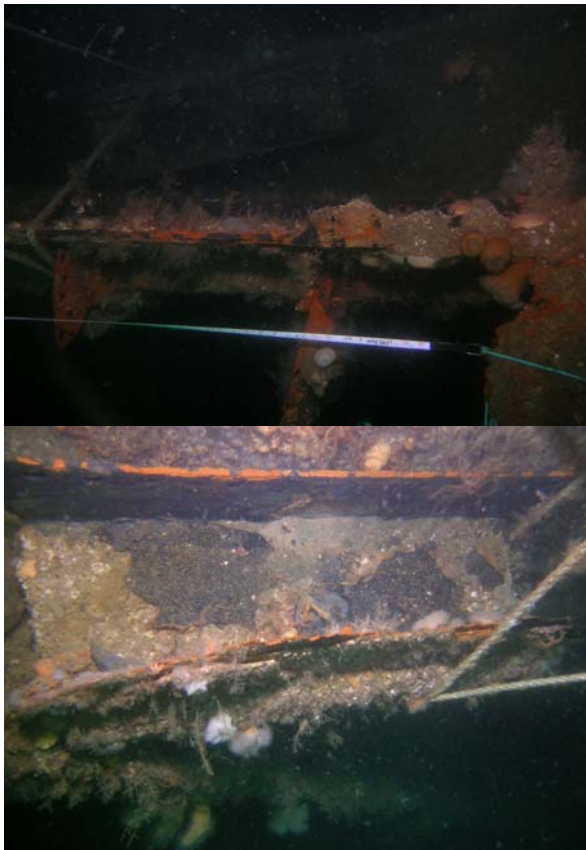
On a repeat visit to the SMS Brummer from the previous day the survey team noted that one of the two surface marker buoys on the shotline was missing. On reaching the wreck the divers noted that a large piece of metal to which the shotline had been attached had been pulled off the hull. This is shown in figures 2.4(a) and (b). What appears to have happened is that a passing vessel had fouled the shotline and as it was pulled taught it had simultaneously pulled the fastening off the hull and severed the line at the buoy.

(a) damage to hull caused by shotline fastening being torn off.

(b) Fastening suspended by shotline after being torn off hull.

**Figure 2.4:** Inadvertent damage sometimes occurs when passing vessels foul the shotlines. On occasion prior to the shotline being severed the fastening may be torn off the hull (b) resulting in hull damage (a).

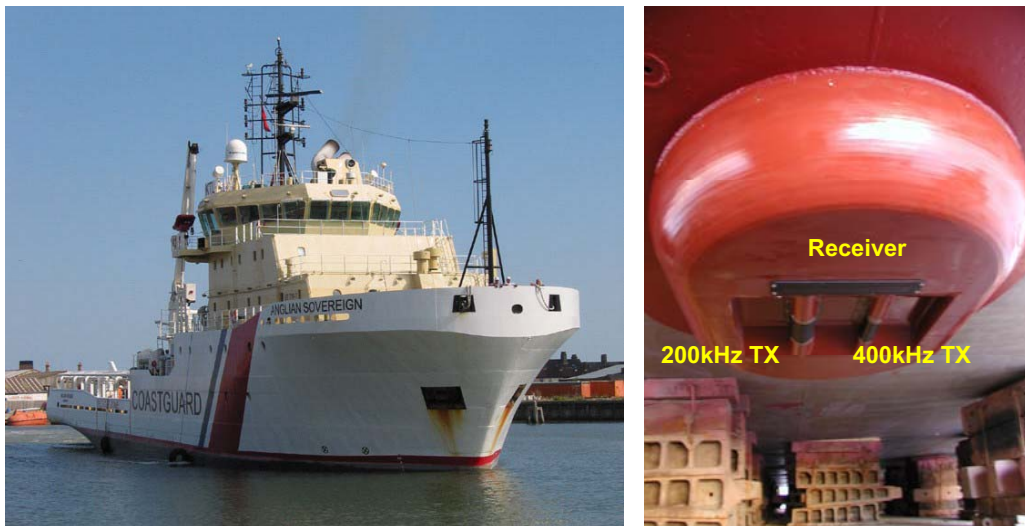
**Figure 3.1:** The ETV ANGLIAN SOVEREIGN, with which the survey was conducted. The ship has a hull-mounted Reson 7125 MBES system (right) for hydrographic surveying when not being used as an emergency towing vessel, making it an ideal platform for surveys such as ScapaMAP II.

Following discussions between Historic Scotland, the Maritime Coastguard Agency's Receiver of Wreck and SULA Diving it was proposed that the ETV ANGLIAN SOVEREIGN (Figure 3.1) be used to conduct a remote sensing survey over the Scheduled sites in Scapa Flow. The ANGLIAN SOVEREIGN is used for hydrographic surveys in support of the UK Civilian Hydrographic Programme when not in use as a towing vessel, and is permanently equipped for this purpose.

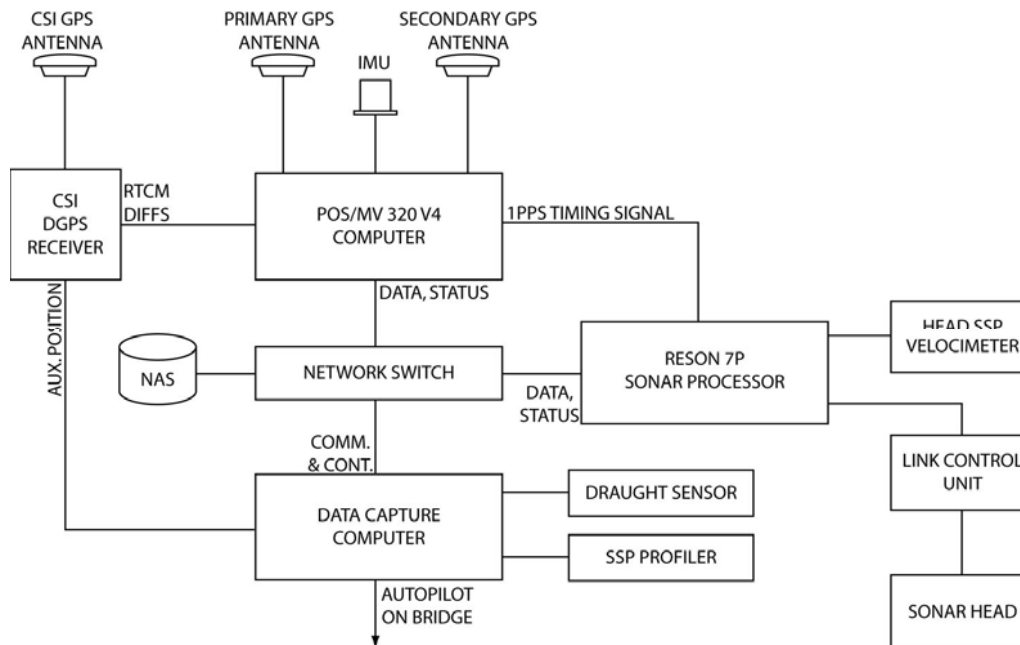
**Figure 3.2:** Hardware configuration of the survey suite of the ETV ANGLIAN SOVEREIGN. Note that the power supplies and some extraneous equipment (monitors, keyboards, etc.) have been omitted for clarity.

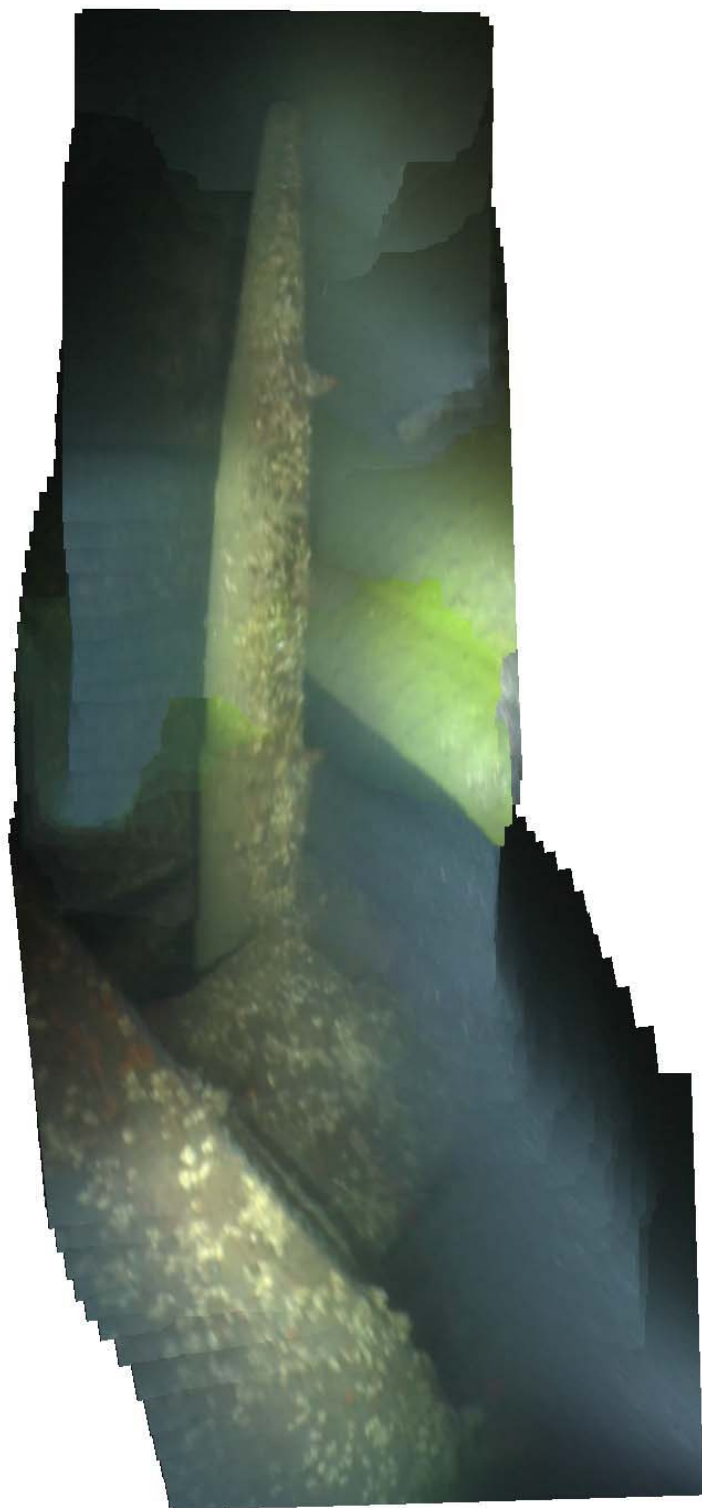
**Figure 4.6:** Mosaic of casement gun on the SMS Kronprinz Wilhelm.

Despite the depth to the seabed the battleships are popular dives as it is possible to see the casement guns (figure 4.6) and main turrets. Many divers also conduct penetration dives due to the many entry points. However, several divers have reported that access ways previously regularly used are no longer accessible while others have appeared, indicating settlement of the hull as a whole.

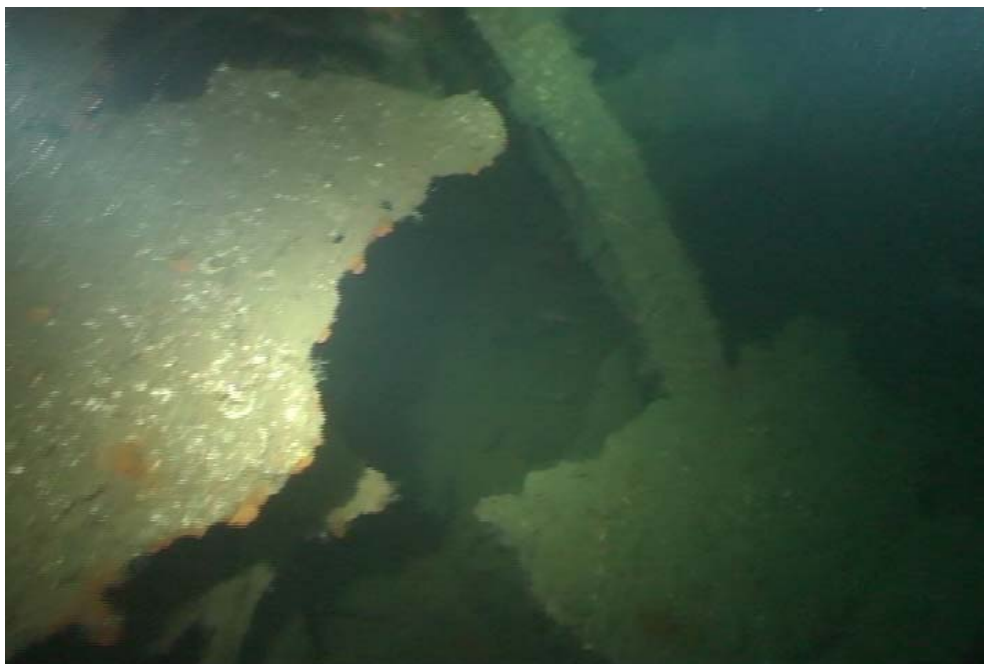
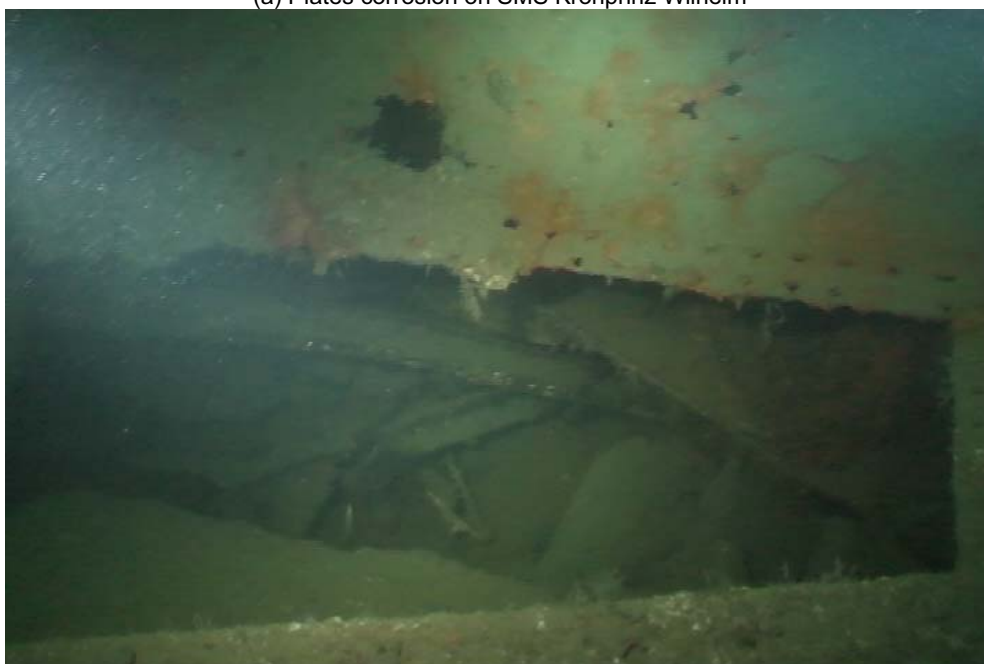
Although much of the hull condition at these sites can be attributed to salvage works, general deterioration has occurred since. Figure 4.7 show plate corrosion resulting in loss of material (a) and separation of the plates (b). Plate separation is most likely due to a combination of corrosion and physical strain placed on the riveted joints as the structure settles.

(a) Plates corrosion on SMS Kronprinz Wilhelm

(b) Plate separation and corrosion SMS Kronprinz Wilhelm

**Figure 4.7:** Images showing general deterioration on the battleships sites.

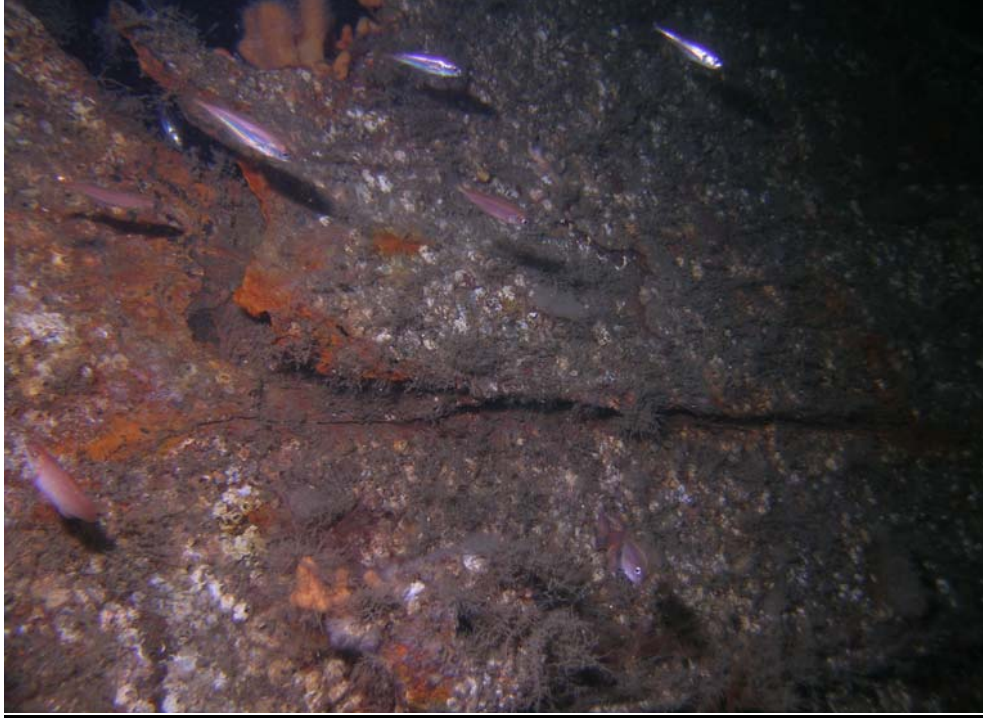
In addition the area immediately forward of this has also increased in size and several of the adjacent deck plates have fallen to the seabed. The area of the hull behind the bridge also shows signs of deterioration. Figure 4.13 shows a section of overlapping plates and the associated encrusting marine growth. On the right of the image the marine growth is undisturbed with no apparent

corrosion present. On the left of the image the plates have begun to separate due to settlement of the hull resulting in loss of the marine growth protection, and corrosion is apparent.

**Figure 4.13:** Image of overlapping hull plates on SMS Cöln showing corrosion where plates have separated.

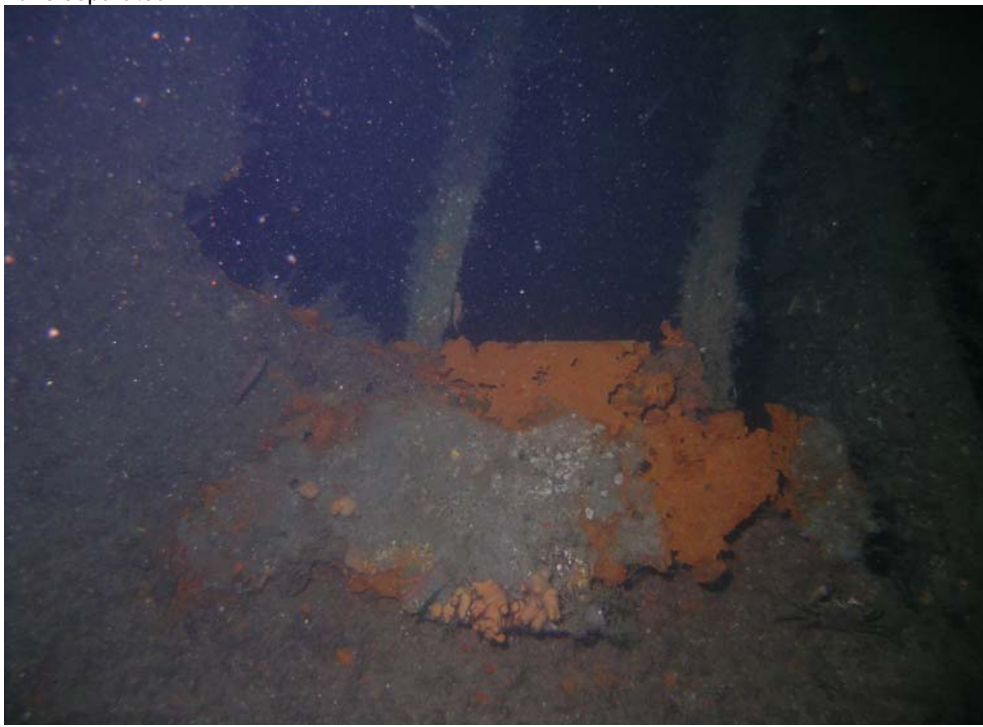
- An attempt to shot the wreck catching the edge and pulling it over as the shot is pulled;
- A diver inadvertently snagging equipment on the edge and pulling it over;
- Exhaled gas from a diver inside the wreck can accumulate in large pockets, if these escape suddenly they can damage weakened areas;
- A diver deliberately pulling the section back to allow access.

**Figure 4.14:** Image showing piece of corroded plate "pulled back".

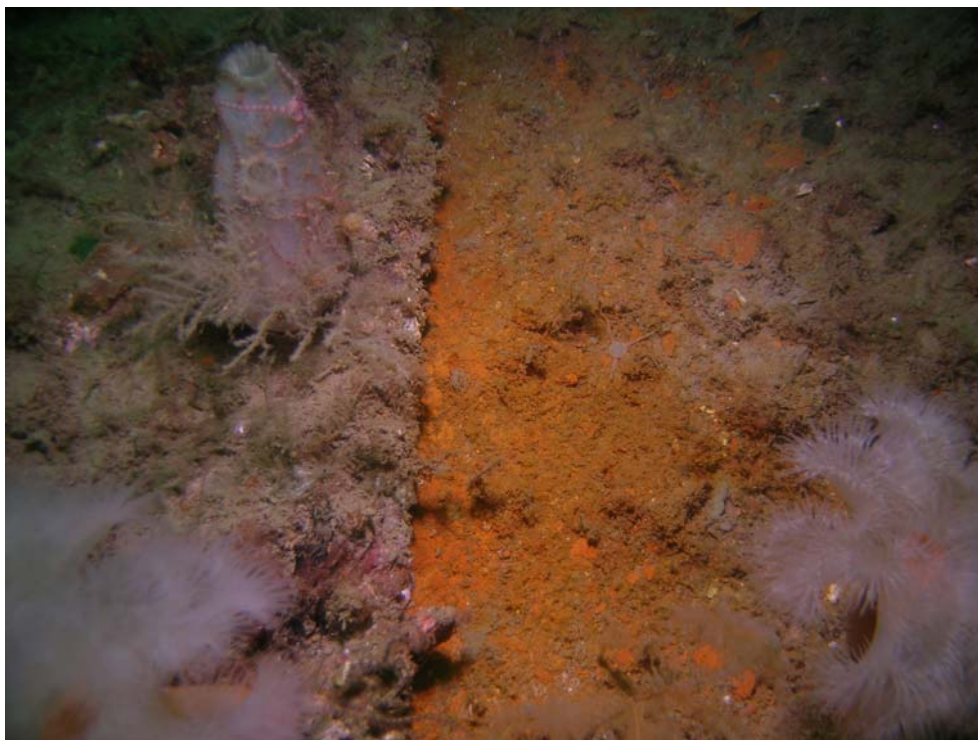
Other areas of the hull are also showing signs of stresses at plate overlaps as can be seen in figure 4.16. Figure 4.17 shows an area where corrosion has developed holes through the plates.

**Figure 4.16:** Corrosion along overlap indication plates beginning to separate.

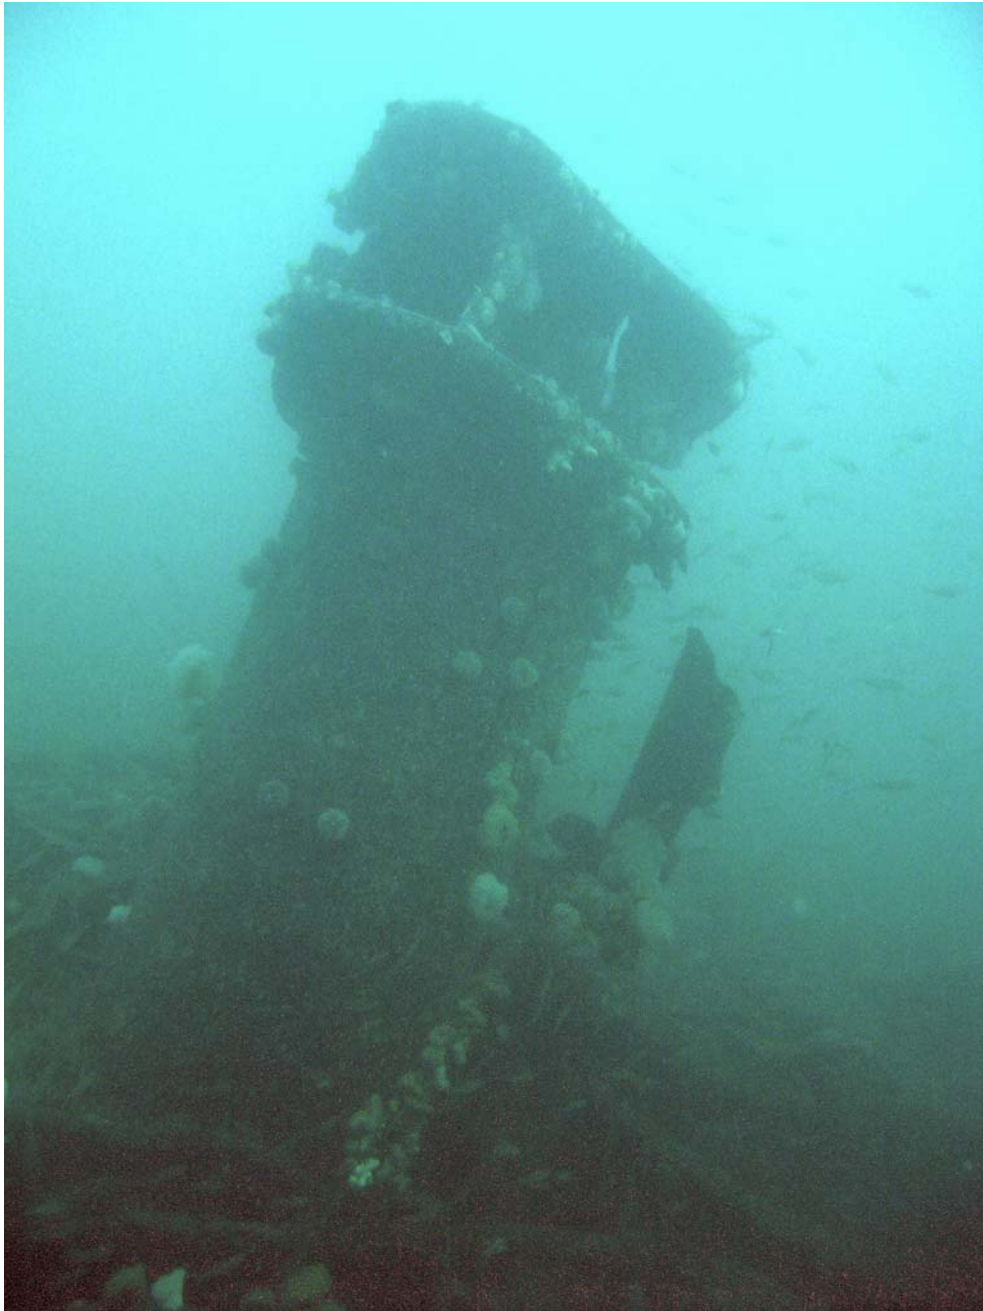
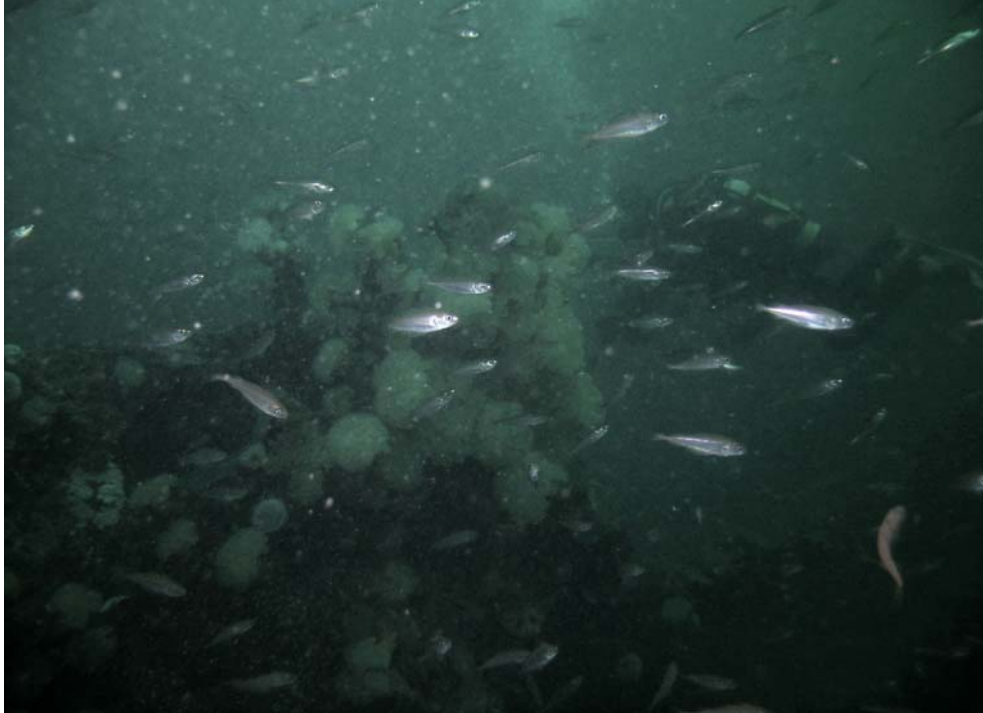
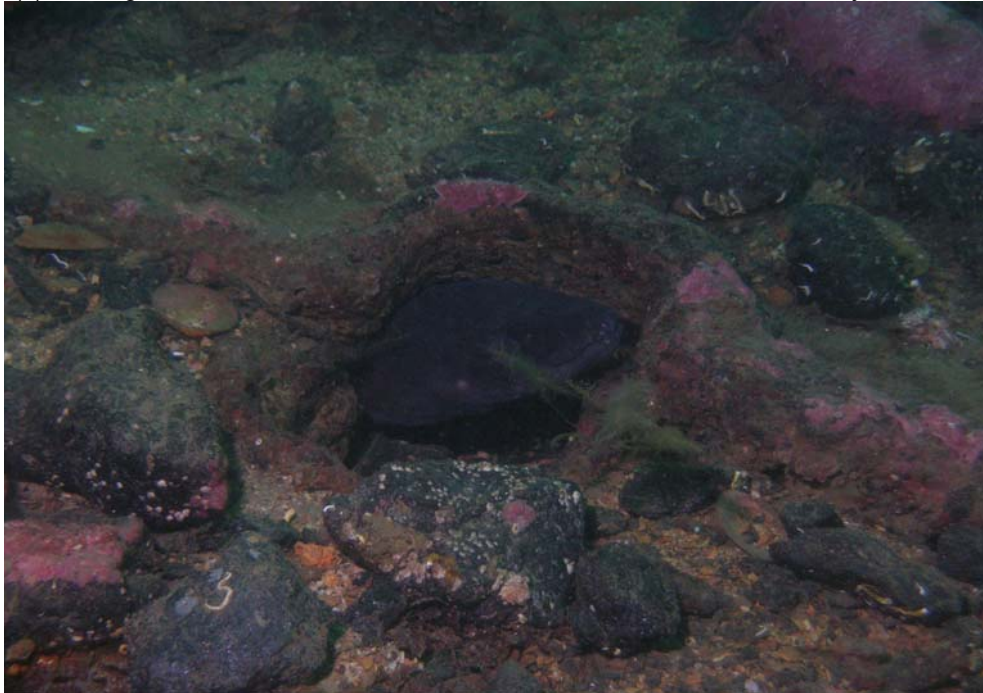
(a) Wreckage colonised with marine life.

(b) wreckage covered with the Plumose anemone *Metridium senile* and shoal of juvenile fish

(c) Conger eel.

**Figure 4.24:** SMS Seydlitz wreckage site is a popular second dive. Due to the shallow depth and slight current there is often an abundance of marine life. Wreckage has been colonised by a variety of species (a), and provides a refuge for juvenile fish (b) and in turn a habitat for predators such as conger eels (c).

The SMS Seydlitz is a popular second dive due to its shallower depth and the slight current means that there is often an abundance of encrusting marine life and fish as shown in figures 4.24(a) – (c). During a survey dive at this site, recreational divers were noticed fanning sediment away from a partially buried piece of debris, once uncovered the item was moved and a small quantity of oil was released from what was presumably a reservoir of some description.

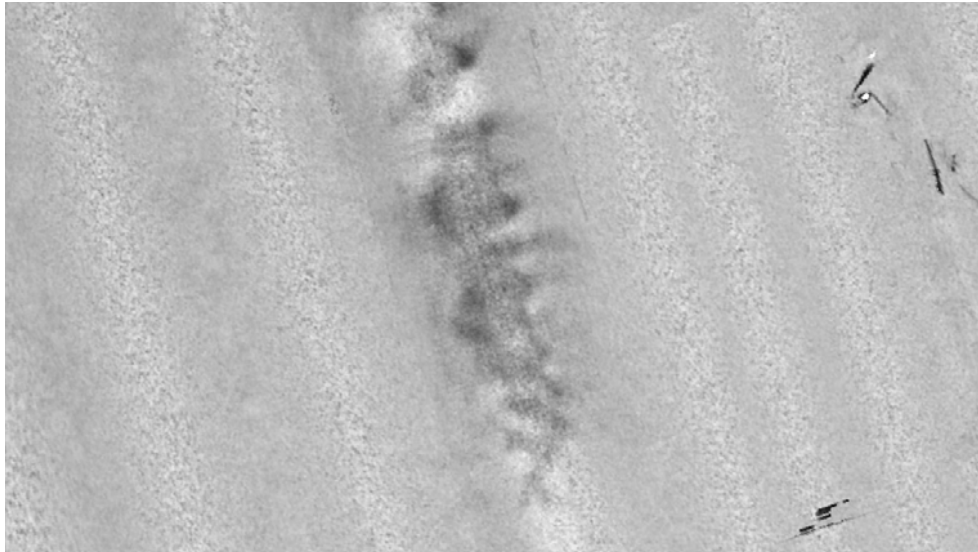
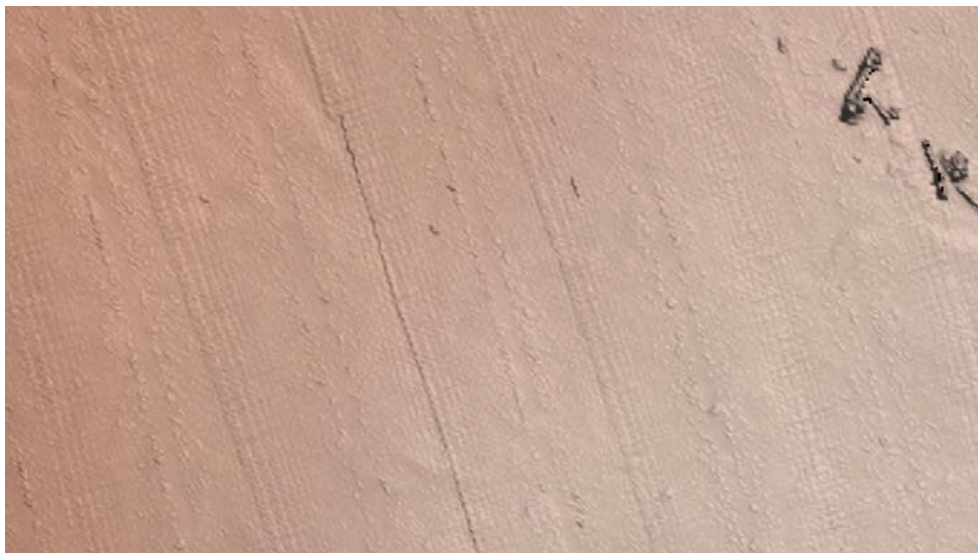
(b) Backscatter

(c) Colour-coded, shaded, bathymetry

**Figure 5.13:** Multibeam backscatter and bathymetry for the same section of Gutter Sound. The backscatter shows a significant anomaly that has no bathymetric expression, although the data agree on the objects in the top right of the imagery. Use of backscatter to identify sediment variabilities, for example due to differential erosion or pollutant absorption is a useful 'collateral' tool derived from baseline bathymetric surveys.

In our experiments, the most compelling use of backscatter is in its conventional survey mode; that is, to map changes in sedimentation around the areas of interest, or significant objects. In Figure 5.13, for example, a section of Gutter Sound, Orkney where the backscatter shows a significantly anomalous return for which there is no bathymetric explanation (even when the backscatter is heavily vertically exaggerated and strongly shaded as here so that centimetric artefacts become obvious). It is unknown whether this anomaly represents a difference in seabed surficial sediment, or whether it is a result of material left on the seabed due to salvage operations at some time in the past. However, the ability to map these changes, especially since this data is essentially 'free' from the bathymetric survey, can help in the rapid-response and baseline mapping segments of archaeological site investigation.
