# AUCHINDRAIN

AN ARCHAEOLOGICAL WATCHING BRIEF

## Data Structure Report

February 2012

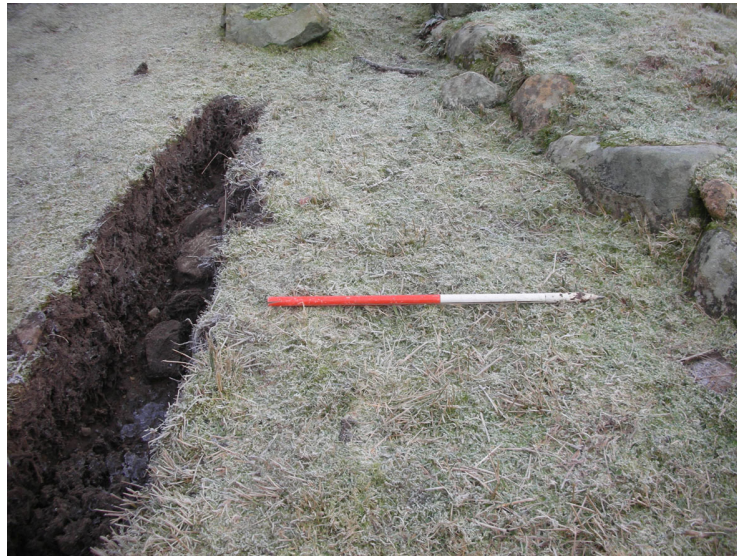
Possible W Edge of track running down W side of ACHDN CC

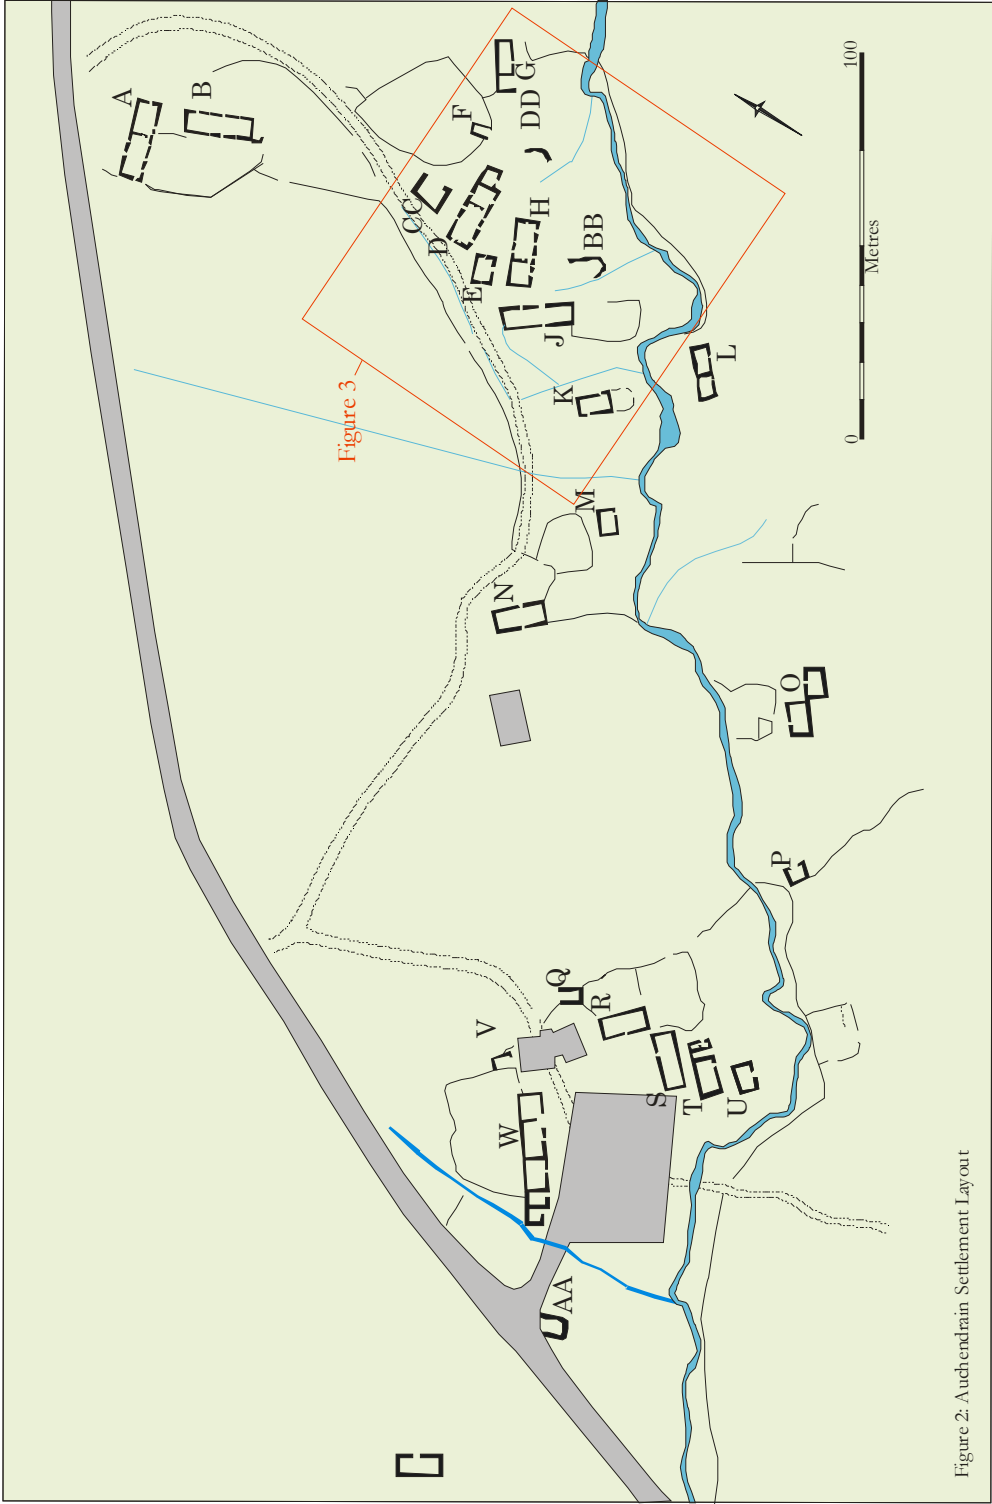
Figure 2: Auchendrain Settlement Layout

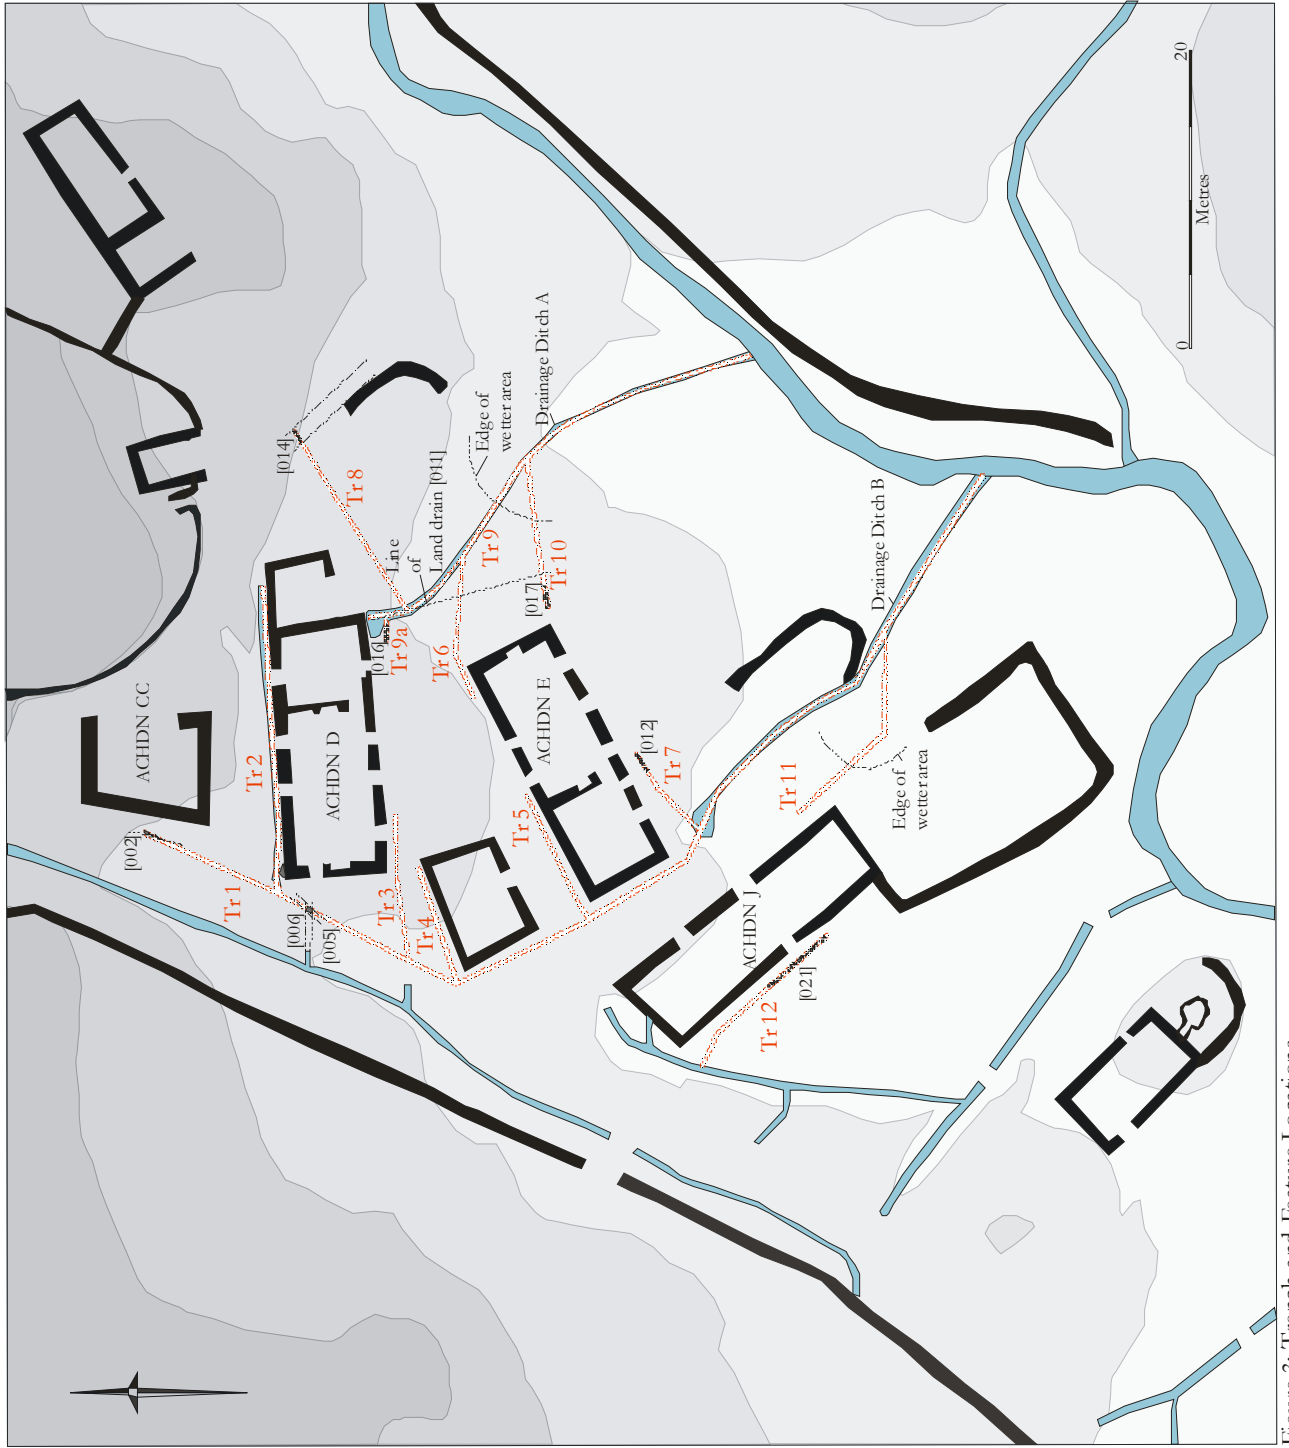
Figure 3: Trench and Feature Locations

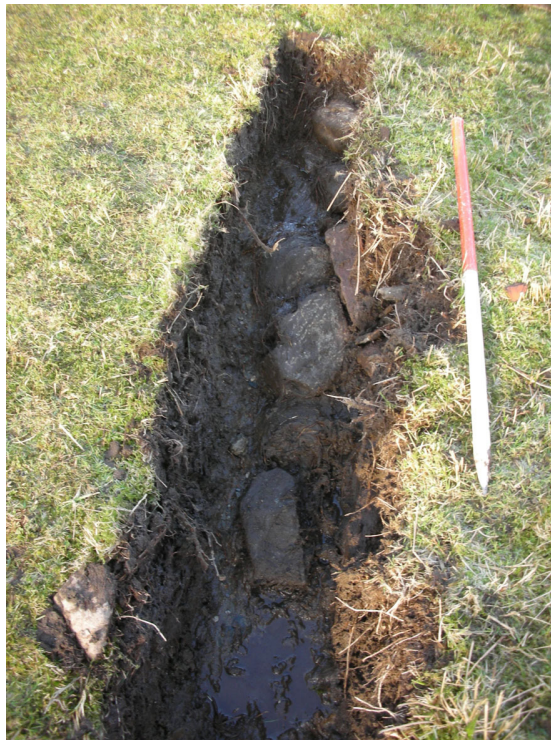
The Trench ran down the SW side of ACHDN CC and past the NW corners of ACHDN D and ACHDN E turning SE past the W side of ACHDN H, joining an existing drainage ditch (Ditch B) leading to the burn. At the very N end of the trench vegetation and topsoil cover [001] overlay a rough cobble surface [002] to a depth of 0.1m-0.3m. The surface was confined to the W side of the trench and could be traced for 1.60m. As the stones of the surface were relatively large its possible these form the edging to a surface running along the W side of ACHDN CC. The surface was left in situ

Cobbles [002]

- [002] Surface. W edge of a cobble surface running 1.60m from the N end of the trench. The surface consist of medium to large cobbles (maximum size 0.25m x 0.16m x 70mm).

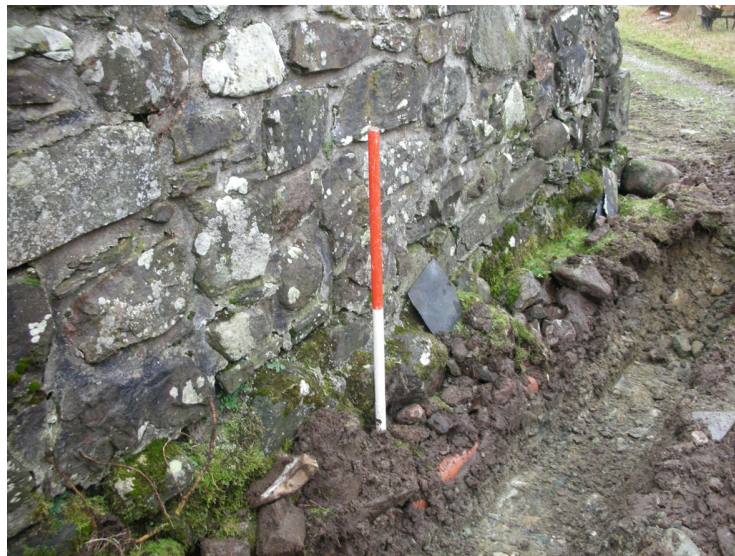
This trench ran down the N side of ACHDN E and connected with Trench 1 at the W. The Trench revealed the presence of a former drainage system running down the N side of the building. This consisted of a cut [009] 0.24m-0.40m wide cutting natural bedrock at the E and glacial till further to the W. The base of the cut was occupied by a ceramic land drain [008], this covered by large to medium cobbles [007].

Ceramic land drain running at rear of ACHDN E

- [006] Drain. Cement/concrete pipe running under track.
- [007] Fill. Backfill of land drain consisting of large to medium cobbles.
- [008] Fill. Ceramic flat bottomed land drain. 'Horse shoe' shaped in profile measuring 9" diameter by 14" in length.

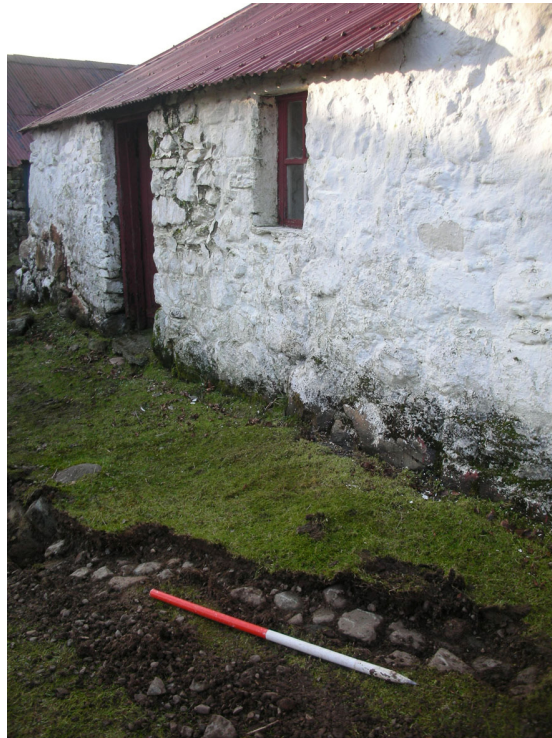
This trench ran along the S side of ACHDN H and connected with Trench 1 at the W. A cobbled surface [012] was initially encountered and the Trench moved E so this was not disturbed. The surface lay directly over natural glacial tills these encountered within the rest of the Trench. Over the natural at the W end of the trench was a deposit of up to 0.2m of recent gravel [013].

Cobbled Surface [012]

- [012] Surface. Surface consisting of small to medium pebbles/cobbles set into natural subsoil.
- [013] Layer/surface. Loose grey pink limestone gravel chippings.

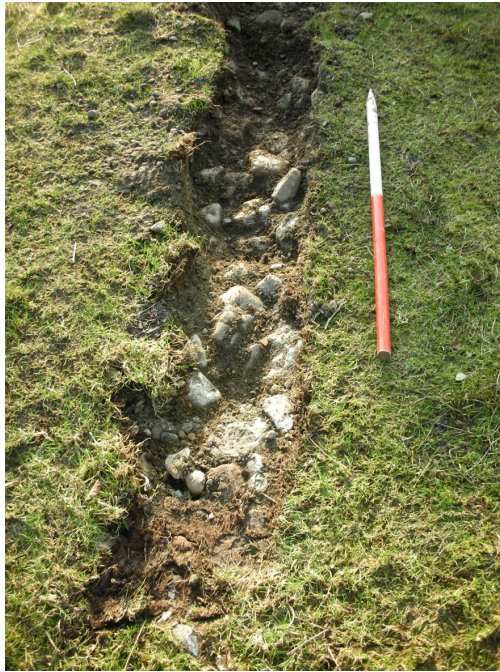
This Trench ran from the slope at the S of ACHDN F and connected with Trench 9 at the SW. A surface [014] was encountered at the E end of the trench, this left in situ. Within the rest of the trench up to 0.20m of topsoil lay directly over natural glacial tills. Surface [014] consisted of small to medium cobbles pressed into natural subsoil. The proximity of this surface to one encountered during evaluation work undertaken in 2011, make it likely that these area related, and if so might be contemporary with ACHDN DD.

Surface [014]

- [014] Surface. . The surface consisted of small to medium cobbles pressed into natural subsoil.
- [015] Fill? Consisted of dark grey silt with frequent large to medium cobbles mixed in with fragments of ceramic land drain.

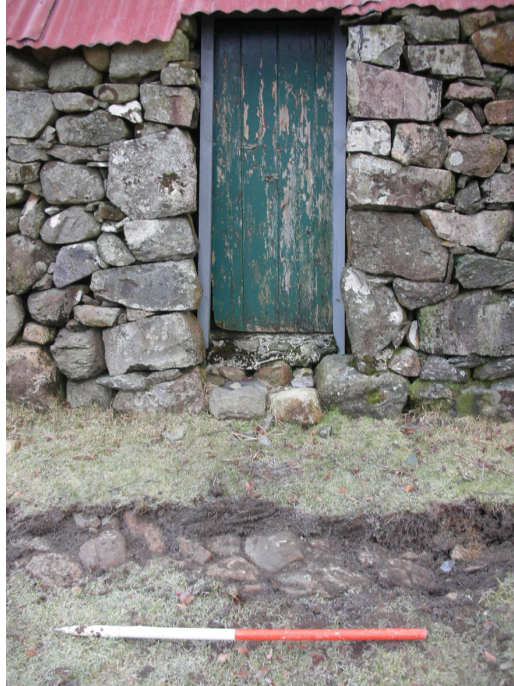
This Trench ran and along the W side of ACHDN J and connected to an existing drain at the NW. A cobbled surface [021] was traced for m running along the W side of the building and was left in situ. Where the surface ran out at the N it could be seen to have been lain directly over natural glacial tills.

Cobbled Surface [021]

[021] Surface. Cobbled surface consisting of medium large cobbles running along the W side of ACHDN J.

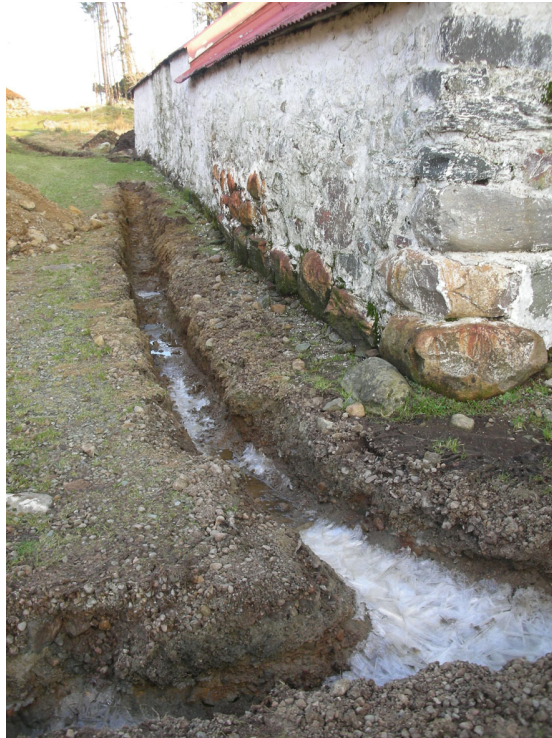
Trench 6

This Trench ran down the N side of ACHDN H turning SW and connecting to Trench 9. At the E end of the Trench topsoil lay directly over natural glacial till. Just beyond where the Trench turned SW were the remains of a disturbed ceramic land drain [011] along with backfill consisting of large to medium cobbles.
