**CASTLE DOUNIE,
NORTH KNAPDALE FOREST
ARGYLL**

**An Archaeological Evaluation
Data Structure Report**

June 2011

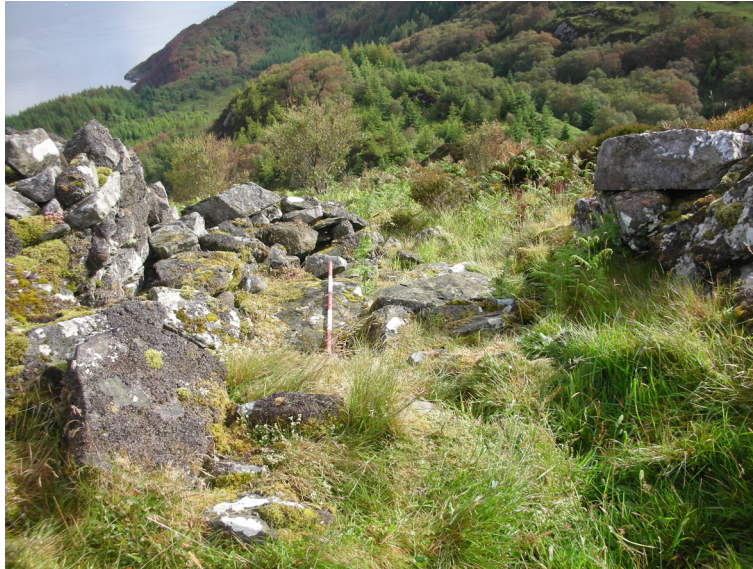
Entranceway prior to rubble removal

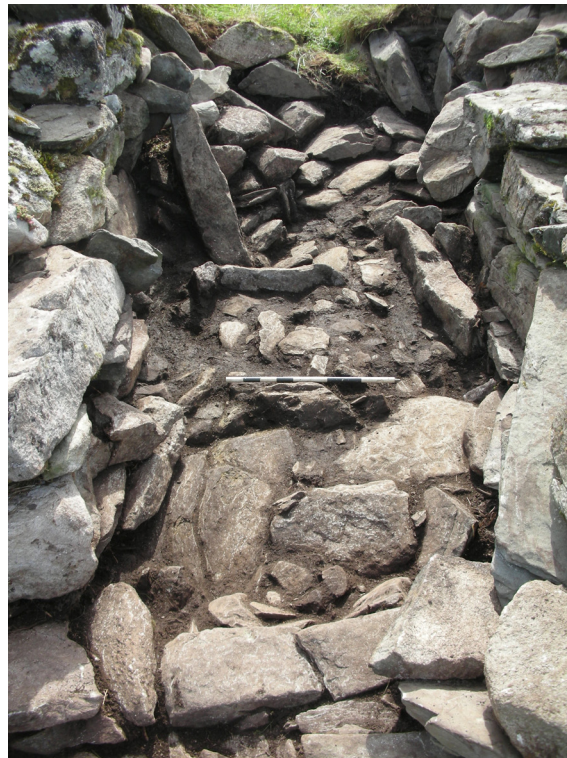
Entrance Passage from S

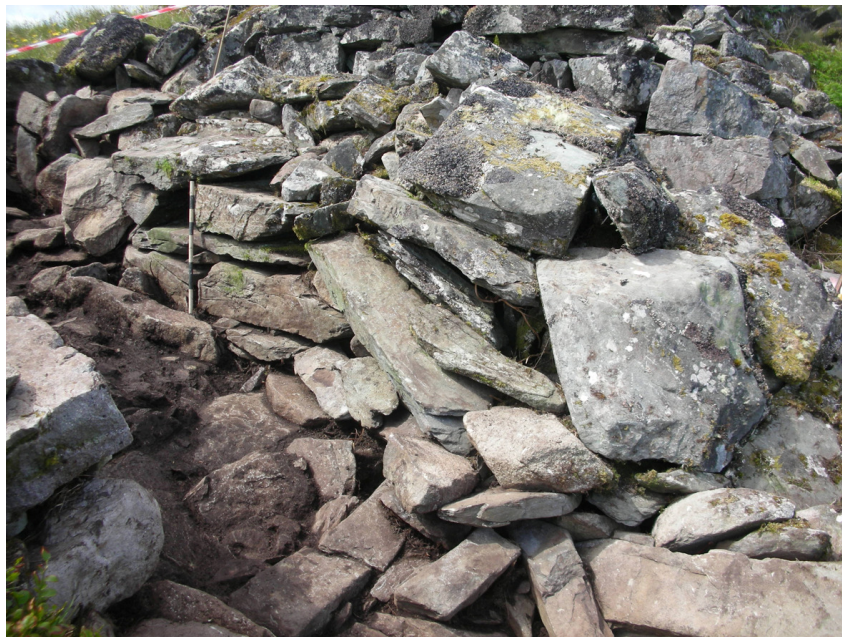
Collapsed Wall [006] from NE

[006] Wall. Western wall forming later entrance blocking/narrowing. Constructed from angular schist blocks the wall measured 2.70m long but this was distorted by the collapse of the N end of the wall material, the original length likely between 1.80m-2.0m. The remaining wall stands up to 0.75m high in 5 rough courses (largest block measured 0.95m x 0.27m x 0.20m).

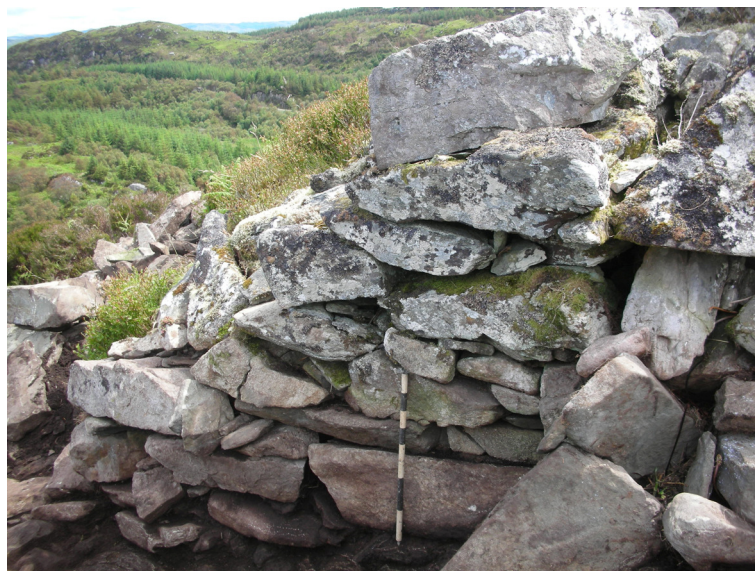
East Wall [005] from SW

[005] Wall. Eastern wall of entranceway, measuring 2.00m wide and standing up to 1.05m in 7 undisturbed rough courses. Constructed using mainly large angular schist blocks with smaller fragments used as levelling/hearding material. (largest block measured 0.80m x 0.36m x 0.20m)

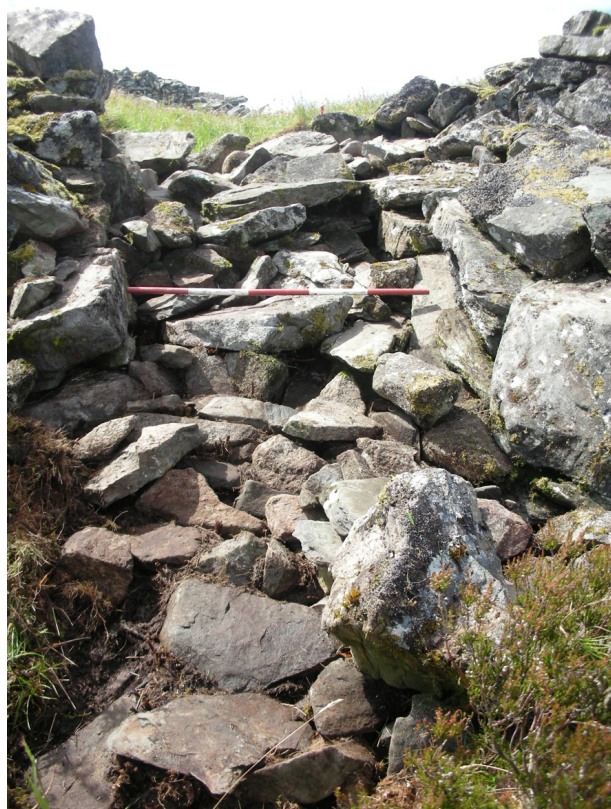
Rubble [002] in Entrance

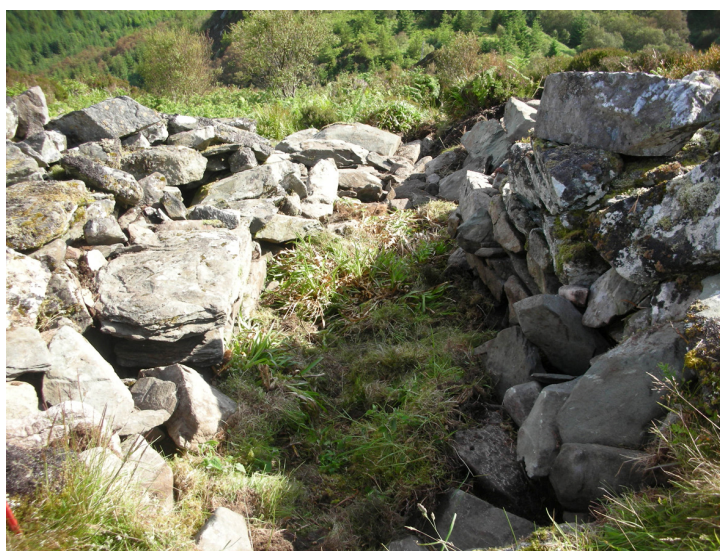
Consolidated Trench

The walls of the dun appear to be generally robust but some consolidation might be deemed necessary, if, as proposed, this becomes the public entrance onto the site. The mass of rubble seen to the N of the entrance passage also was partially uncovered during this phase of work and while this was not excavated it is still possible it still masks earlier built features.

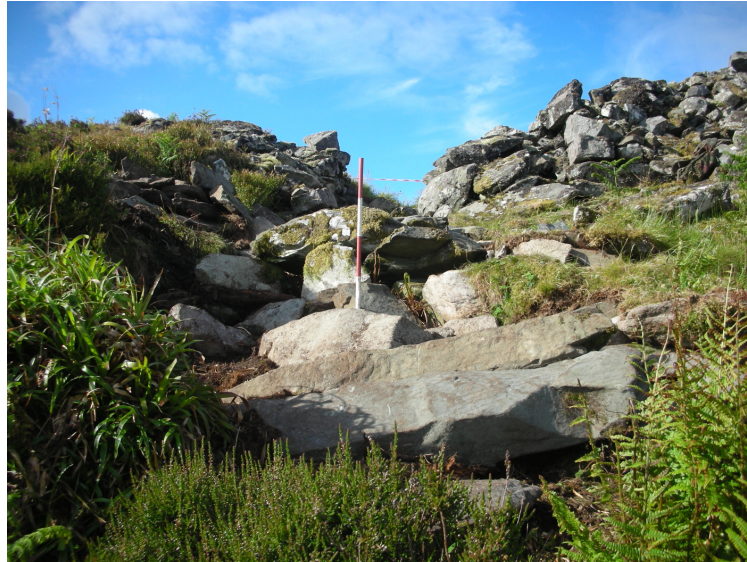
[002] Layer. Collapse/demolition, mainly consisting of epidiorite blocks tumbled into entranceway and to the north of the entrance. The largest block measured 1.60m x 0.50m x 0.20m.

Rubble at N of Entrance

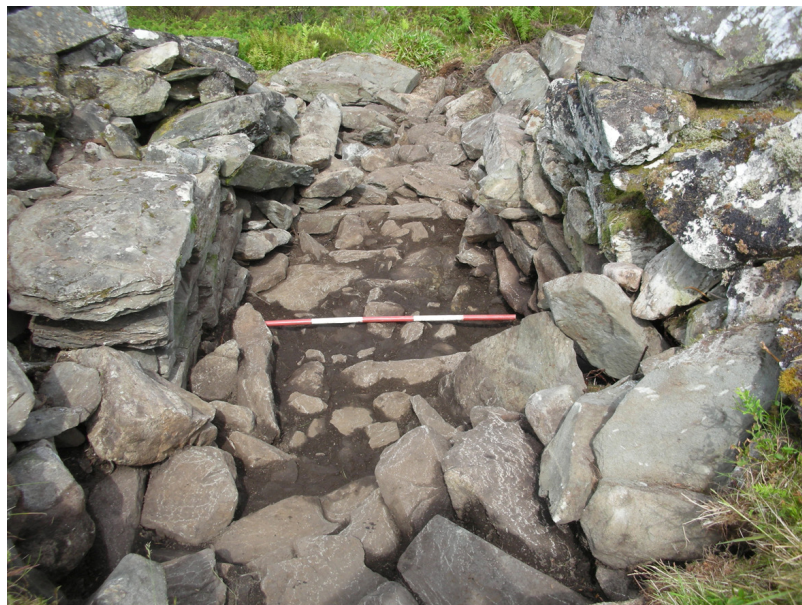
[004] Surface. Entrance surface, comprising of schist slabs and rubble levelling over natural bedrock. Several stones appear to lie E/W across entrance passage and may be intended as crude steps, largest stone 0.35m x 0.15m x 80mm.

Cleared Entrance from S

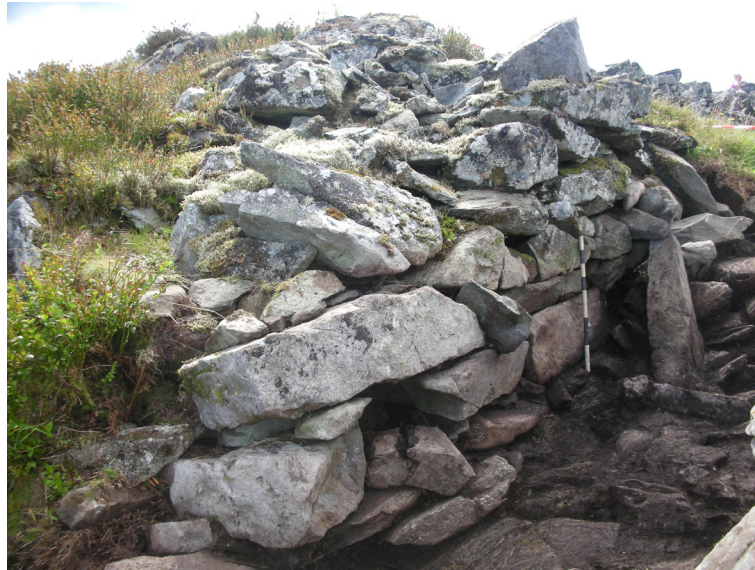
East side of Entrance Passage [005] from SW

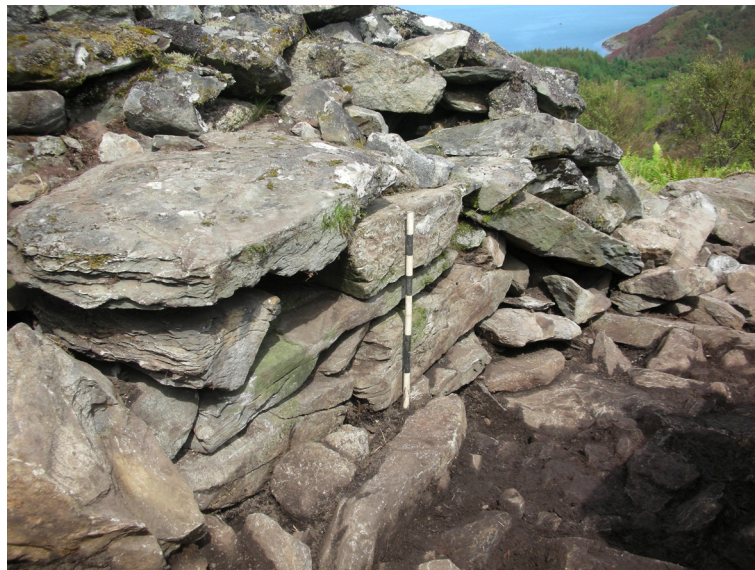
Later West side of Entrance Passage [006] from SE

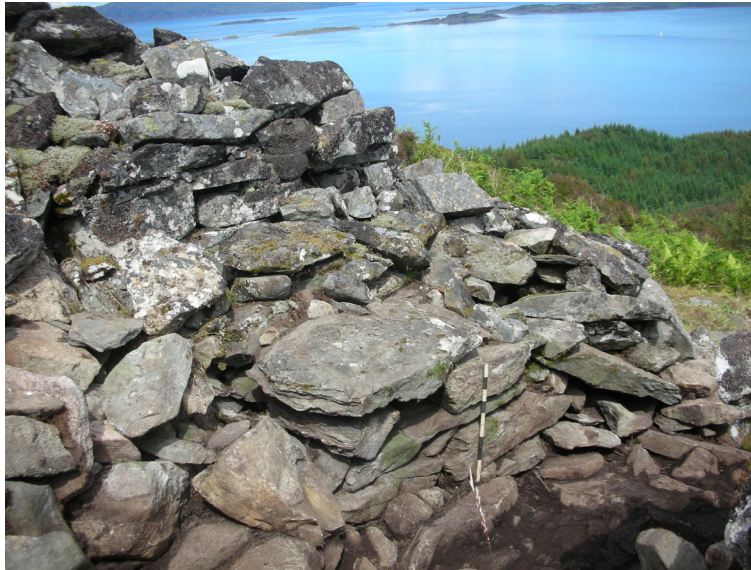
[007] Wall. Original W side of entrance and constructed from angular schist blocks the wall measured 2.0m long and stands up to 1.60m high in 10 rough courses (largest block measured 0.87m x 0.30m x 0.23m).

West side of Entrance Passage [006] in front of [007] from SE
