**Date: December 2004**  
**Client: Castle Rock Housing Association**  
**Project Code: CGE 02**

## **Archaeological Excavation at 144-166 Cowgate, Edinburgh. Data Structure Report**

**PROJECT SUMMARY SHEET (CGE 02)**

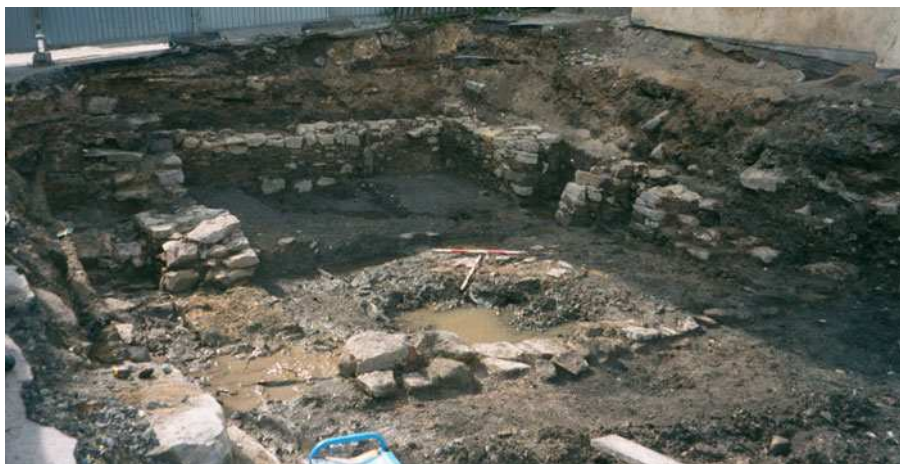
Plate 1. The medieval building from the southeast. East and south wall partly removed

The building exposed at the west end of the site was sub-rectangular in plan and measured 7.3 m long by 4.3 to 4.8 m wide externally (Figure 2). The walls were 0.5 to 0.75 m wide and survived up to a height of 1 m. There were twin doors separated by a pillar of masonry in the middle of the north wall (Plate 1). The original width of the building is unknown, as the south end of the building had been demolished to make room for wall [066] on a slightly more east-west orientation.

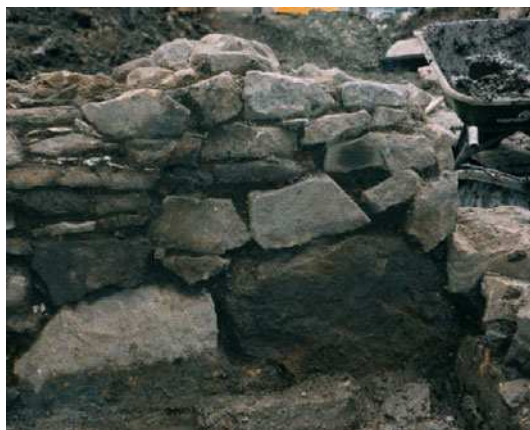
Plate 2. Rebuilt masonry in the east wall

oblique angle (Plate 2). There was clear evidence of rebuilding at the south end of the east and west walls of the building showing that they had been partly demolished and then rebuilt up against wall [066]. The wall continued westwards and eastwards beyond the corners of the older building (Figure 2). Wall [066] was quarried away down to below formation level immediately to the east of the building but reappeared some 3.5 m to the east (labelled [210] and could be traced for a further 19 m eastwards (Plate 3).

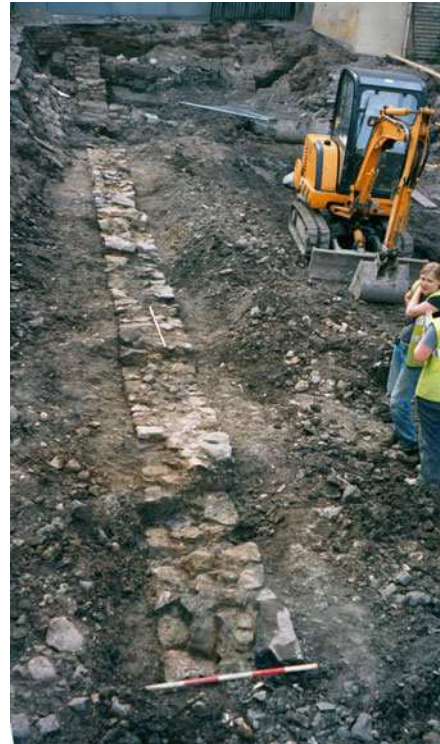
Plate 3. Wall [210]

In total the wall [066]/[210] was over 30 m in length. The east end of the wall [210] was uncovered during the watching brief. The wall appeared to have been quarried away at this point and would have originally continued further east (Figure 2). The wall was clay bonded and faced on both sides with a rubble interior. It was built from quarried stone and was 0.8 to 0.9 m wide.

The wall was cut by the large pit, exposing a full section of the remaining parts of the wall. The wall section was best preserved at the east end of the pit. Here it survived up to a height of 0.9 m resting on foundations 0.35 m deep. At this point the wall appeared to have been cut down from a higher level and built up against the north edge of a cut over 3 m wide and 1.3 m deep. The deposits on the south side of the wall appeared to be dumped in at a later stage filling in the cut.

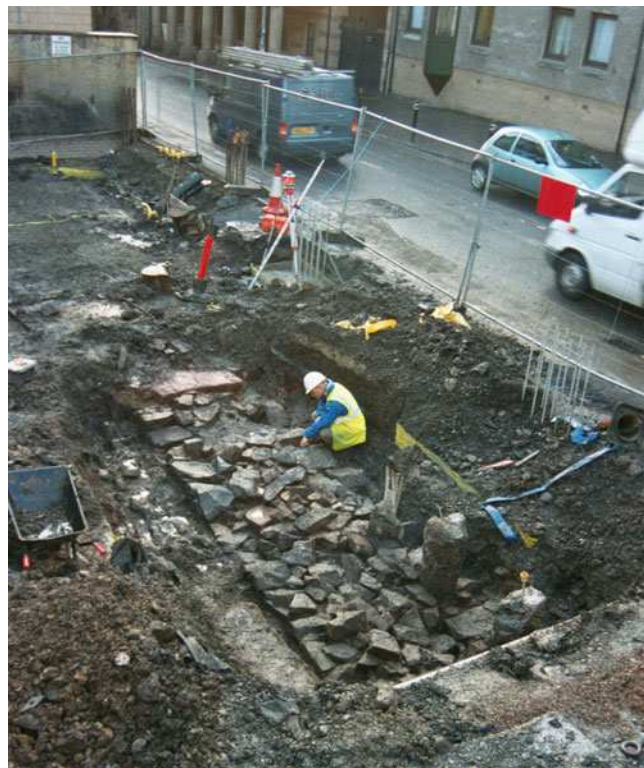
Plate 4. Wall [281]

Some 1.2 m to the east of wall [210] fragments of a second wall [281] was exposed. Its west end was partly exposed in a pit excavated to insert a manhole. The northwest end appeared to be a quarried edge or possibly left unfinished. A larger section of this wall was exposed in a trench some 2.5 m to the east (Figure 2). Here the wall was exposed over a distance of 6 m (Plate 4).

The wall was clay bonded, 1.8 m wide and faced on either side with sub rectangular sandstone blocks with a rubble infill in the middle. Only the top surface was exposed. However, in a sondage pit excavated on the north side of the wall the height was measured to over 0.9 m.

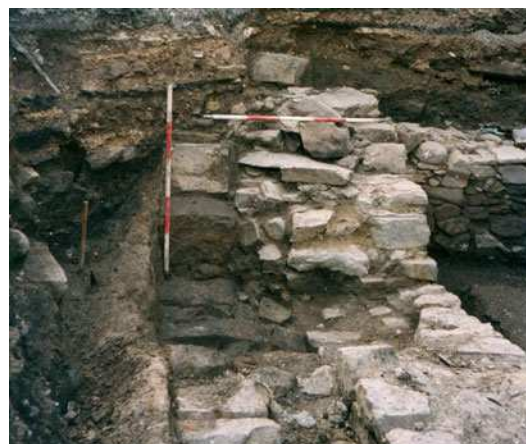
Plate 5. Wall [103] built over wall [066]

Wall [066] was reinforced by the construction of an external skin [103] on its south side. (Plate 5). The reinforcement comprised a clay-bonded wall faced on the outside by sub rectangular stone blocks with smaller rubble infill up against the south face of wall [066]. A wedge of clay [062] over 0.4 m deep was deposited up against the base of the wall along its south side. The added wall was 0.6 m wide taking the total width of the two walls up to 1.4 m. The wall survived up to a height of over 1.3 m at the southwest corner of the site. At this higher level the wall was built over the surviving remains of wall [066].

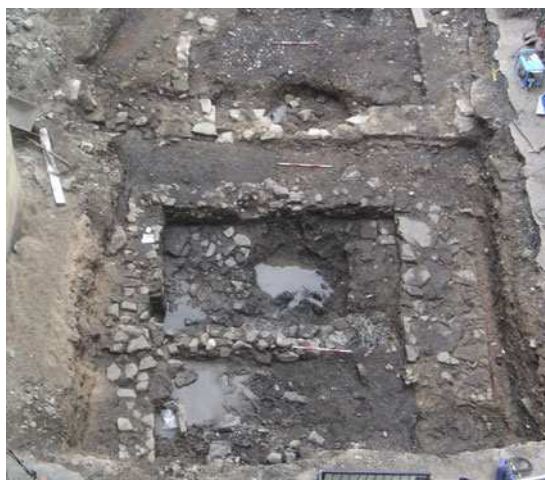
Plate 6. Later building phase (5)

The original building had its entrances to the north. However, at a later stage these entrances were blocked up. There were no traces of any entrances leading into the building from the east and west, which implies that the new entrance had to be from the south. There was no clear evidence of an entrance through the south walls [066]/[103] either. However, the south walls were quite low, especially in front of the east room of the building and only reaching its highest point at the southwest corner. The lower sections to the east were covered in a flagged surface (059), roughly level with the upper clay floor surface

within the west room. At this level the internal wattle wall between the two rooms had been replaced with a rough clay bonded wall [047] extending 2.9 m south from the pillar between the blocked door openings to the north (Figure 2). The wall was tapering in width from 0.55 m at the north end where it comprised two faces with rubble in the middle down to a single stone 0.3 m wide at the south end. It did not extend across to the south wall of the building leaving a 1.9 m wide gap to the south. This suggests that the wall did not extend to the full height of the building, perhaps tapering down from the north wall. This evidence suggests that at this stage the building was used as a shed, probably partly open to the south or with a part wooden south wall. It may even have lost its roof at this point.
