MCME17/001

MERCHISTON CAMPUS MAINTENANCE, EDINBURGH

*Results of an Archaeological Watching Brief
for Edinburgh Napier University*

June 2017

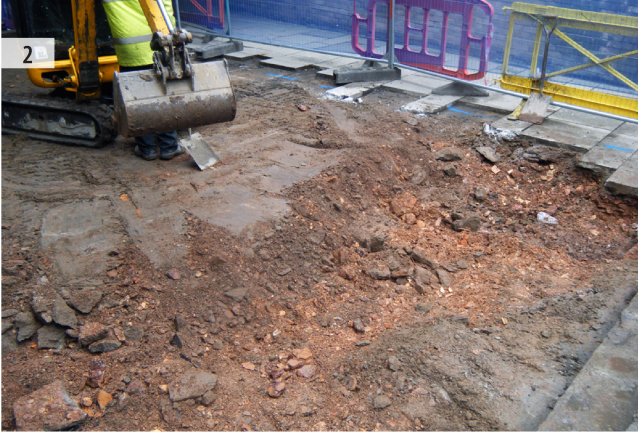
Upon removal of the concrete slabs that formed the existing steps a layer of light grey sands and concrete powder up to 0.2m thick was observed across the area (Illus 2). This deposit had been used form a level platform for the concrete steps.

ILLUS 2 Working shot showing sand levelling layer beneath slabs **ILLUS 3** Working shot showing red blaes across whole area

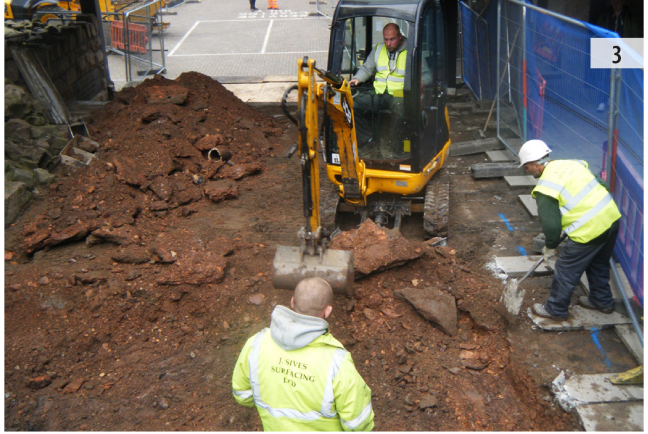
Beneath this a 0.3m thick layer of modern red blaes (inert waste deposits of colliery spoils that have been burnt or oxidised) was observed across the area (Illus 3).

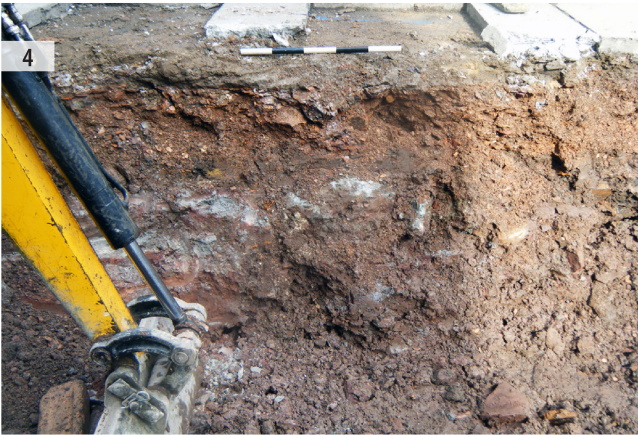
Beneath this and comprising the remaining 0.40m of removed deposits across the area was a made ground deposit consisting of bricks, broken sand stone, concrete and other modern debris in a mid-brown-grey sandy silt matrix (Illus 4). This deposit extended beneath the required depth of excavation across the area.

ILLUS 4 SW facing section showing made ground to bottom of excavation **ILLUS 5** N facing shot of interior of planter box excavated down to formation level **ILLUS 6** SE facing shot of stairs and shelf to be re-surfaced. New wall built during Phase 1 to the right. Phase 2 area between heras fence and outer wall to the left

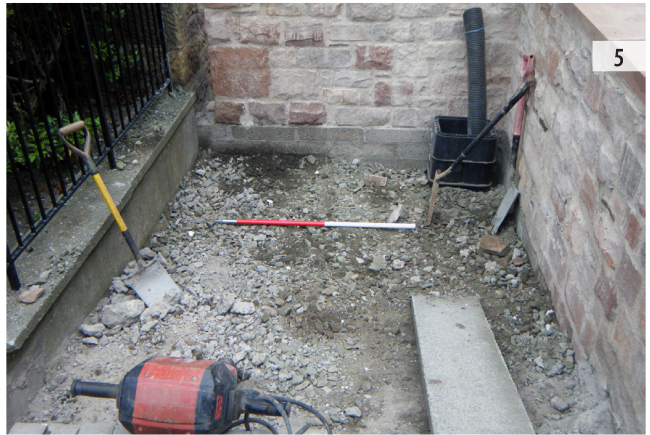
Monitoring of Phase 2 took place on the 21th June 2017. The planter box was 2m wide by 2.6m long. It was bounded to the east and north by a stone wall built during the previous construction phase. There was a plinth of concrete at the south end of the box which was removed by a handheld concrete breaker. The rest of the box was filled with Type 1 gravel down to and beyond the formation depth of 0.4m (Illus 5).

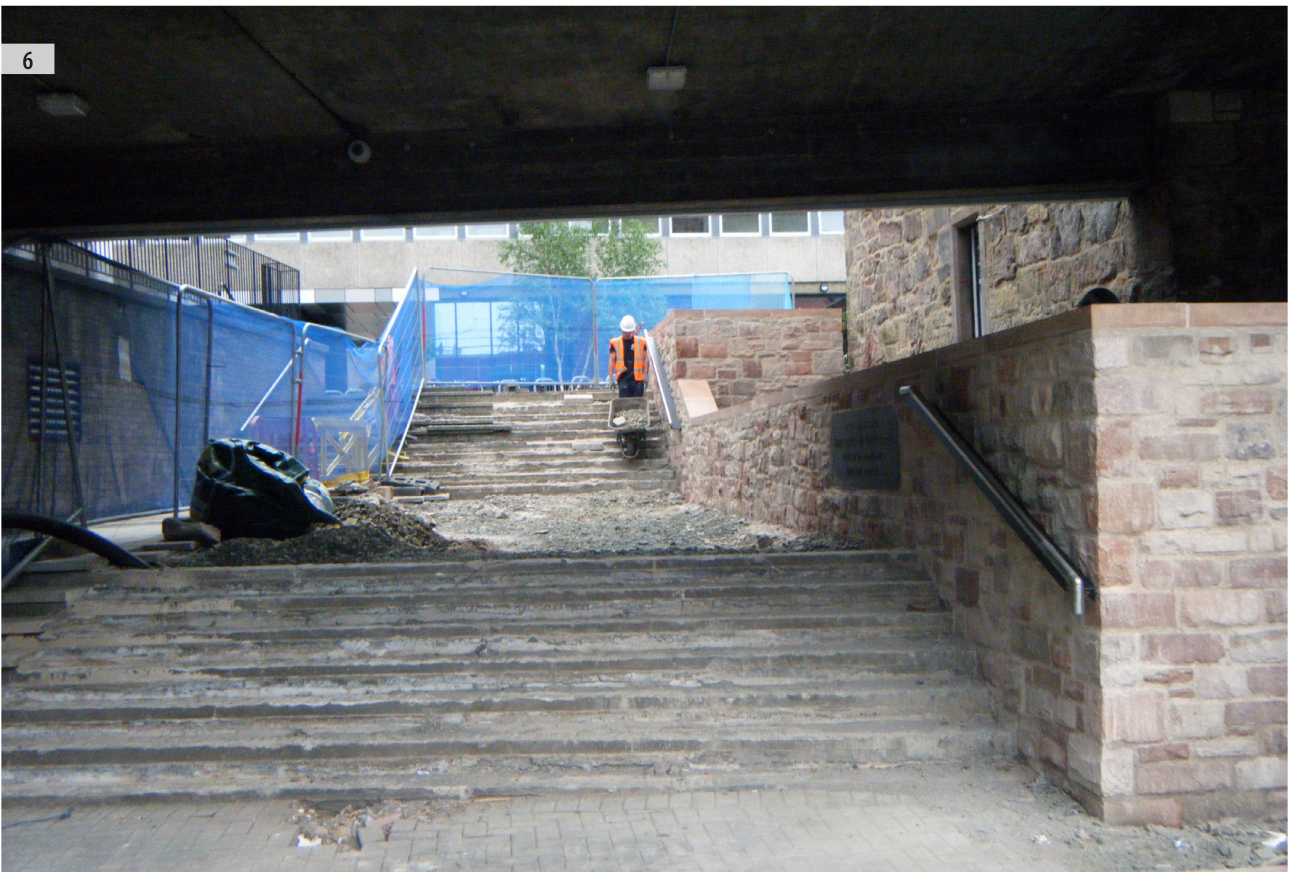
The remaining work within Phase 2 involved the replacement of slabs along a narrow corridor along the east side of the steps and a wide shelf in the middle of the steps (Illus 6). This work involved a minimum disturbance of the underlying ground and given the results from the adjacent work to the west during Phase 1 it would not disturb any significant archaeological deposits. It was therefore decided that no further archaeological monitoring was required.
