St. Ninian's Primary School, Stirling: Archaeological Evaluation Data Structure Report

AOC Project 23048 9th April 2015

Archaeological Evaluation Data Structure Report

AOC Project No: 23048

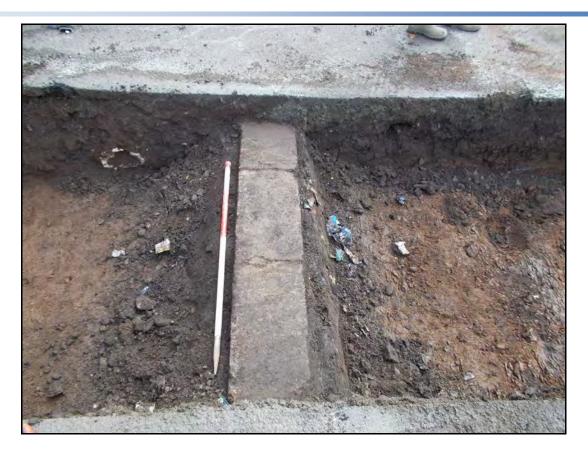
Plate 1 – Wall 1, Trench 2

- 4.3 Trench 2 was oriented NE-SW approximately 7.0 m SE of Trench 1 and measured 12.0 m x 1.6 m x up to 0.72 m deep. The B-horizon consisted of compact dark brown/black sandy silt with inclusions of modern ceramics, glass and rubbish including marbles, food wrappers and plastic bottles. A c.19th century rubbish pit was encountered 0.52 m from the SE end of Trench 2 and contained a possible bullet casing and a glass bottle. This pit measured 0.35 m in diameter x 0.33 m deep. Two walls were also encountered, Wall 1 (Plate 1) was located 3.0 m from the SE end and Wall 2 was located 2.6 m from the NW end. These walls were only one course thick and constructed of slabs measuring 0.32 m wide and roughly 0.5 m long and 0.1 m deep. It is likely they represent the foundations for the transportable buildings previously existing in this area.

- 5.1 The evaluation has clearly demonstrated that the Roman Road in the vicinity of the development area does not pass through the evaluation area. The walls encountered in Trench 2 are likely to represent the foundations for the transportable buildings previously existing in this area. This is further demonstrated by the school rubbish located around these walls (Plate 2).
- 5.2 No further archaeological works are deemed necessary within this part of the development area. This recommendation will require the approval of the Planning Officer (Archaeology) for Stirling Council.

> Wall 1 - Orientated NW-SE, 3m from NE end of trench, 0.32m wide x width of trench Wall 2 – Orientated NW-SE, 2.6m from SW end of trench 0.32m wide x width of trench

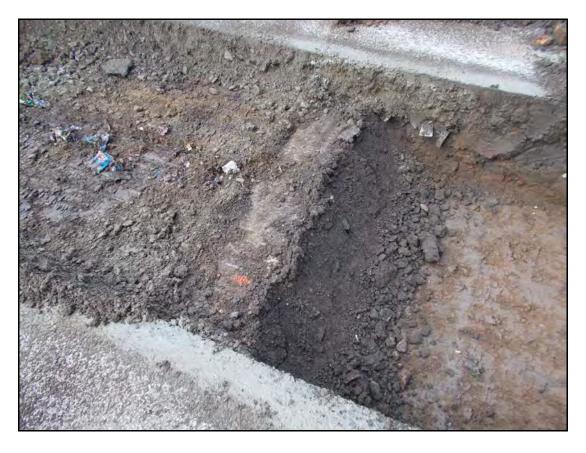
Plate 2 – Modern rubbish surrounding Wall 1, Trench 2

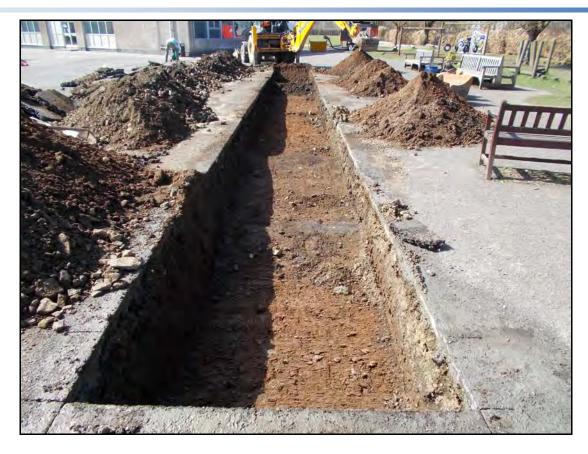
Plate 3 - General view of Trench 1

- 4.2 Trench 1 was oriented NE-SW and measured 20.0 m x 1.6 m wide x up to 0.64 m deep. It consisted of tarmac up to 0.1 m thick, overlying 'type 1' hardcore up to 0.2 m thick. The B-horizon consisted of compact dark brown/grey sandy silt with inclusions of modern ceramics and glass. A buried cable was encountered in Trench 1, 4.9 m from the SW end of the trench. This cable did not register on the Cable Avoidance Tool scan prior to excavation and is believed to be associated with the old transportable school buildings that used to be located in this area and as such, is disused.

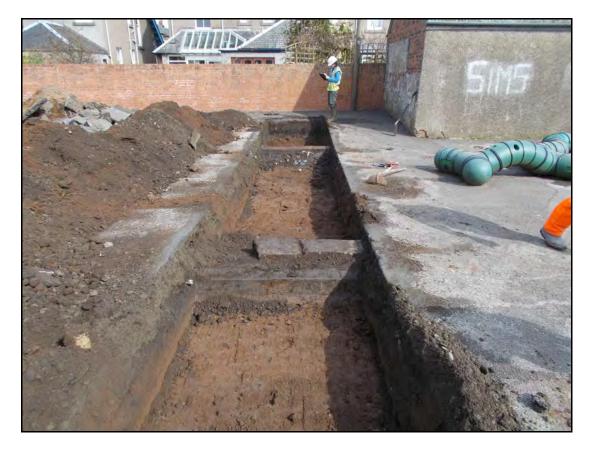
Plate 4 - General view of Trench 2

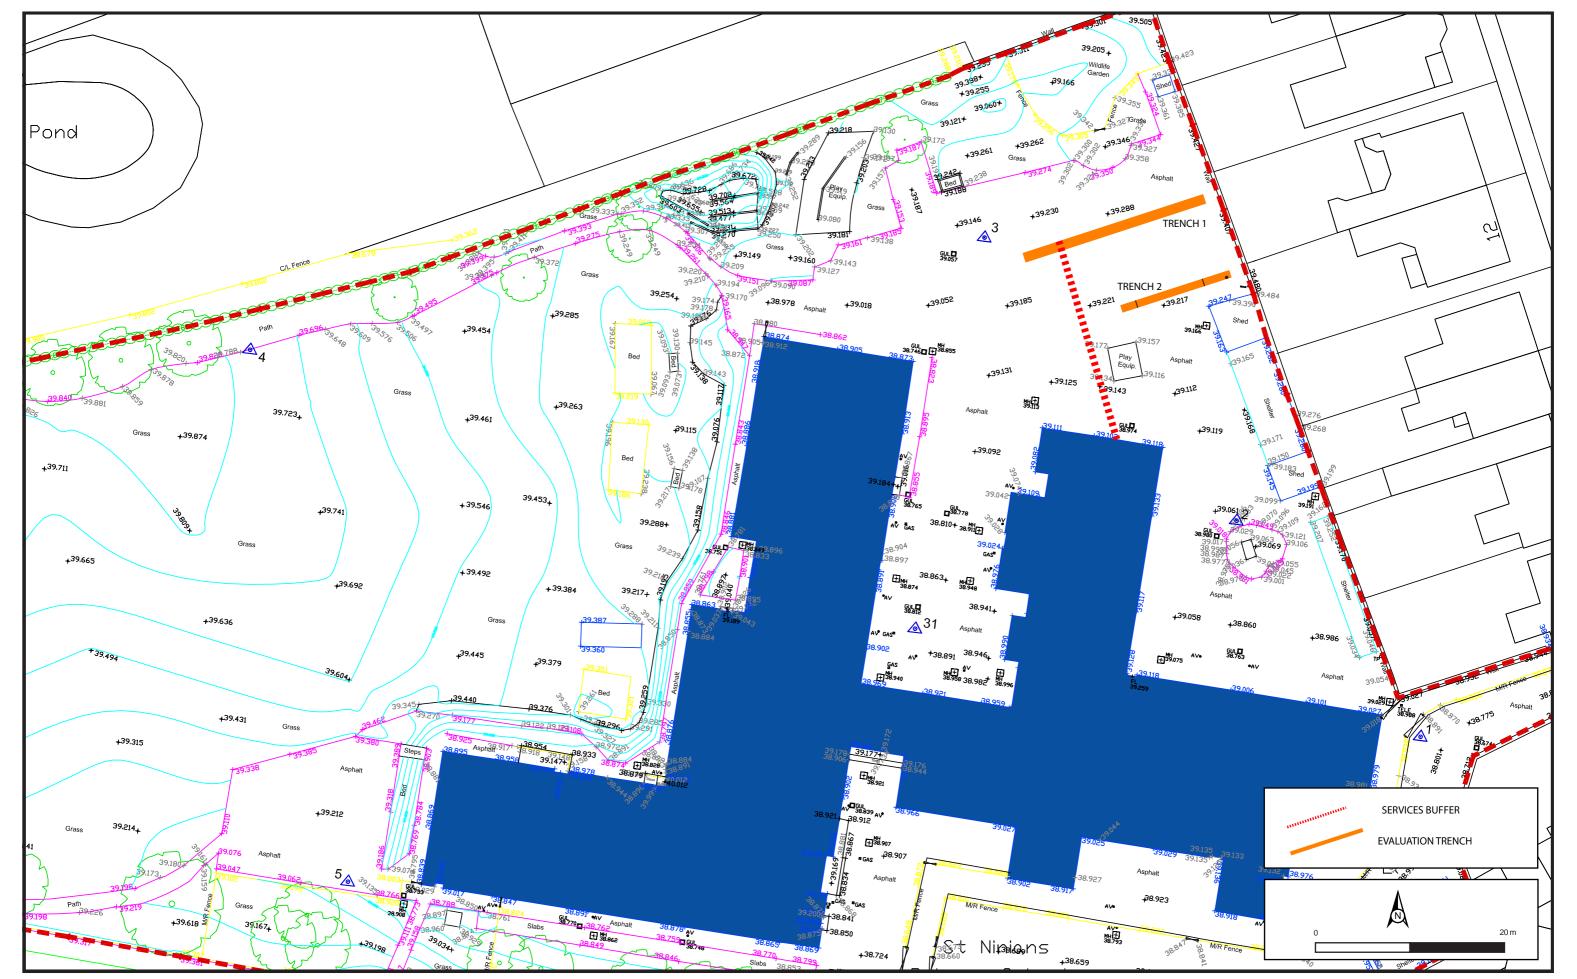
Figure 1: Site plan showing proposed position of evaluation trenches

- 4.1 The archaeological evaluation was undertaken on 8th April 2015. Weather conditions were good, allowing for good archaeological visibility throughout the evaluation. In total, 32 m of linear trench was opened aligned as per layout in Figure 1. Trench 2 was shortened to allow access to geotechnical surveyors currently working on the site and to avoid an unmarked electrical service (shown in Figure 1).
