# Ashludie House, Monifieth, Angus: Historic Building Recording Report

AOC Project: 23302

8<sup>th</sup> January 2016

<b>On Behalf of:</b>	<b>Miller Homes Clydesdale House 300 Springfield Parkway Baillieston Glasgow G69 6GA</b>
<b>National Grid Reference (NGR):</b>	<b>NO 49537 33260</b>
<b>AOC Project No:</b>	<b>23302</b>
<b>Planning Application No:</b>	<b>15/00099/FULM</b>
<b>OASIS Reference:</b>	<b>235866</b>
<b>Prepared by:</b>	<b>Diana Sproat</b>
<b>Date:</b>	<b>8<sup>th</sup> January 2016</b>

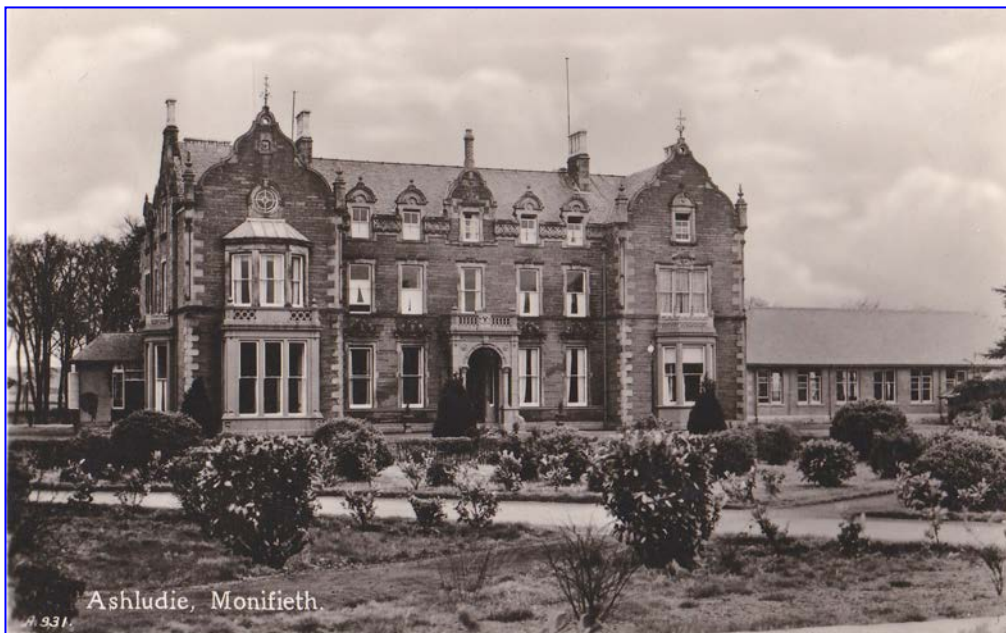
Figure 6: Archive photograph of Ashludie House from the SSW, ca. 1930s © RCAHMS – note east wing to the right and later porch to the north wing to the left

- 4.2 In June 1911, Alexander Gordon died at the age of 88. Two years later, the house and grounds were acquired by the Dundee Corporation and they later converted it into a sanatorium, as we can see on the 1923 Ordnance Survey map (Figure 4). It was opened on 9<sup>th</sup> February 1916. As you can see on Figure 4, two additional tri-form hospital wards were constructed to the south and south-east of the hospital respectively between its opening and the early 1920s, and there had been some small extensions to the east side of the main house. Figure 5 shows an archive photograph of Ashludie House in the early 20<sup>th</sup> century, and Figure 6 a later photograph showing the later hospital additions added in the 1930s onwards.

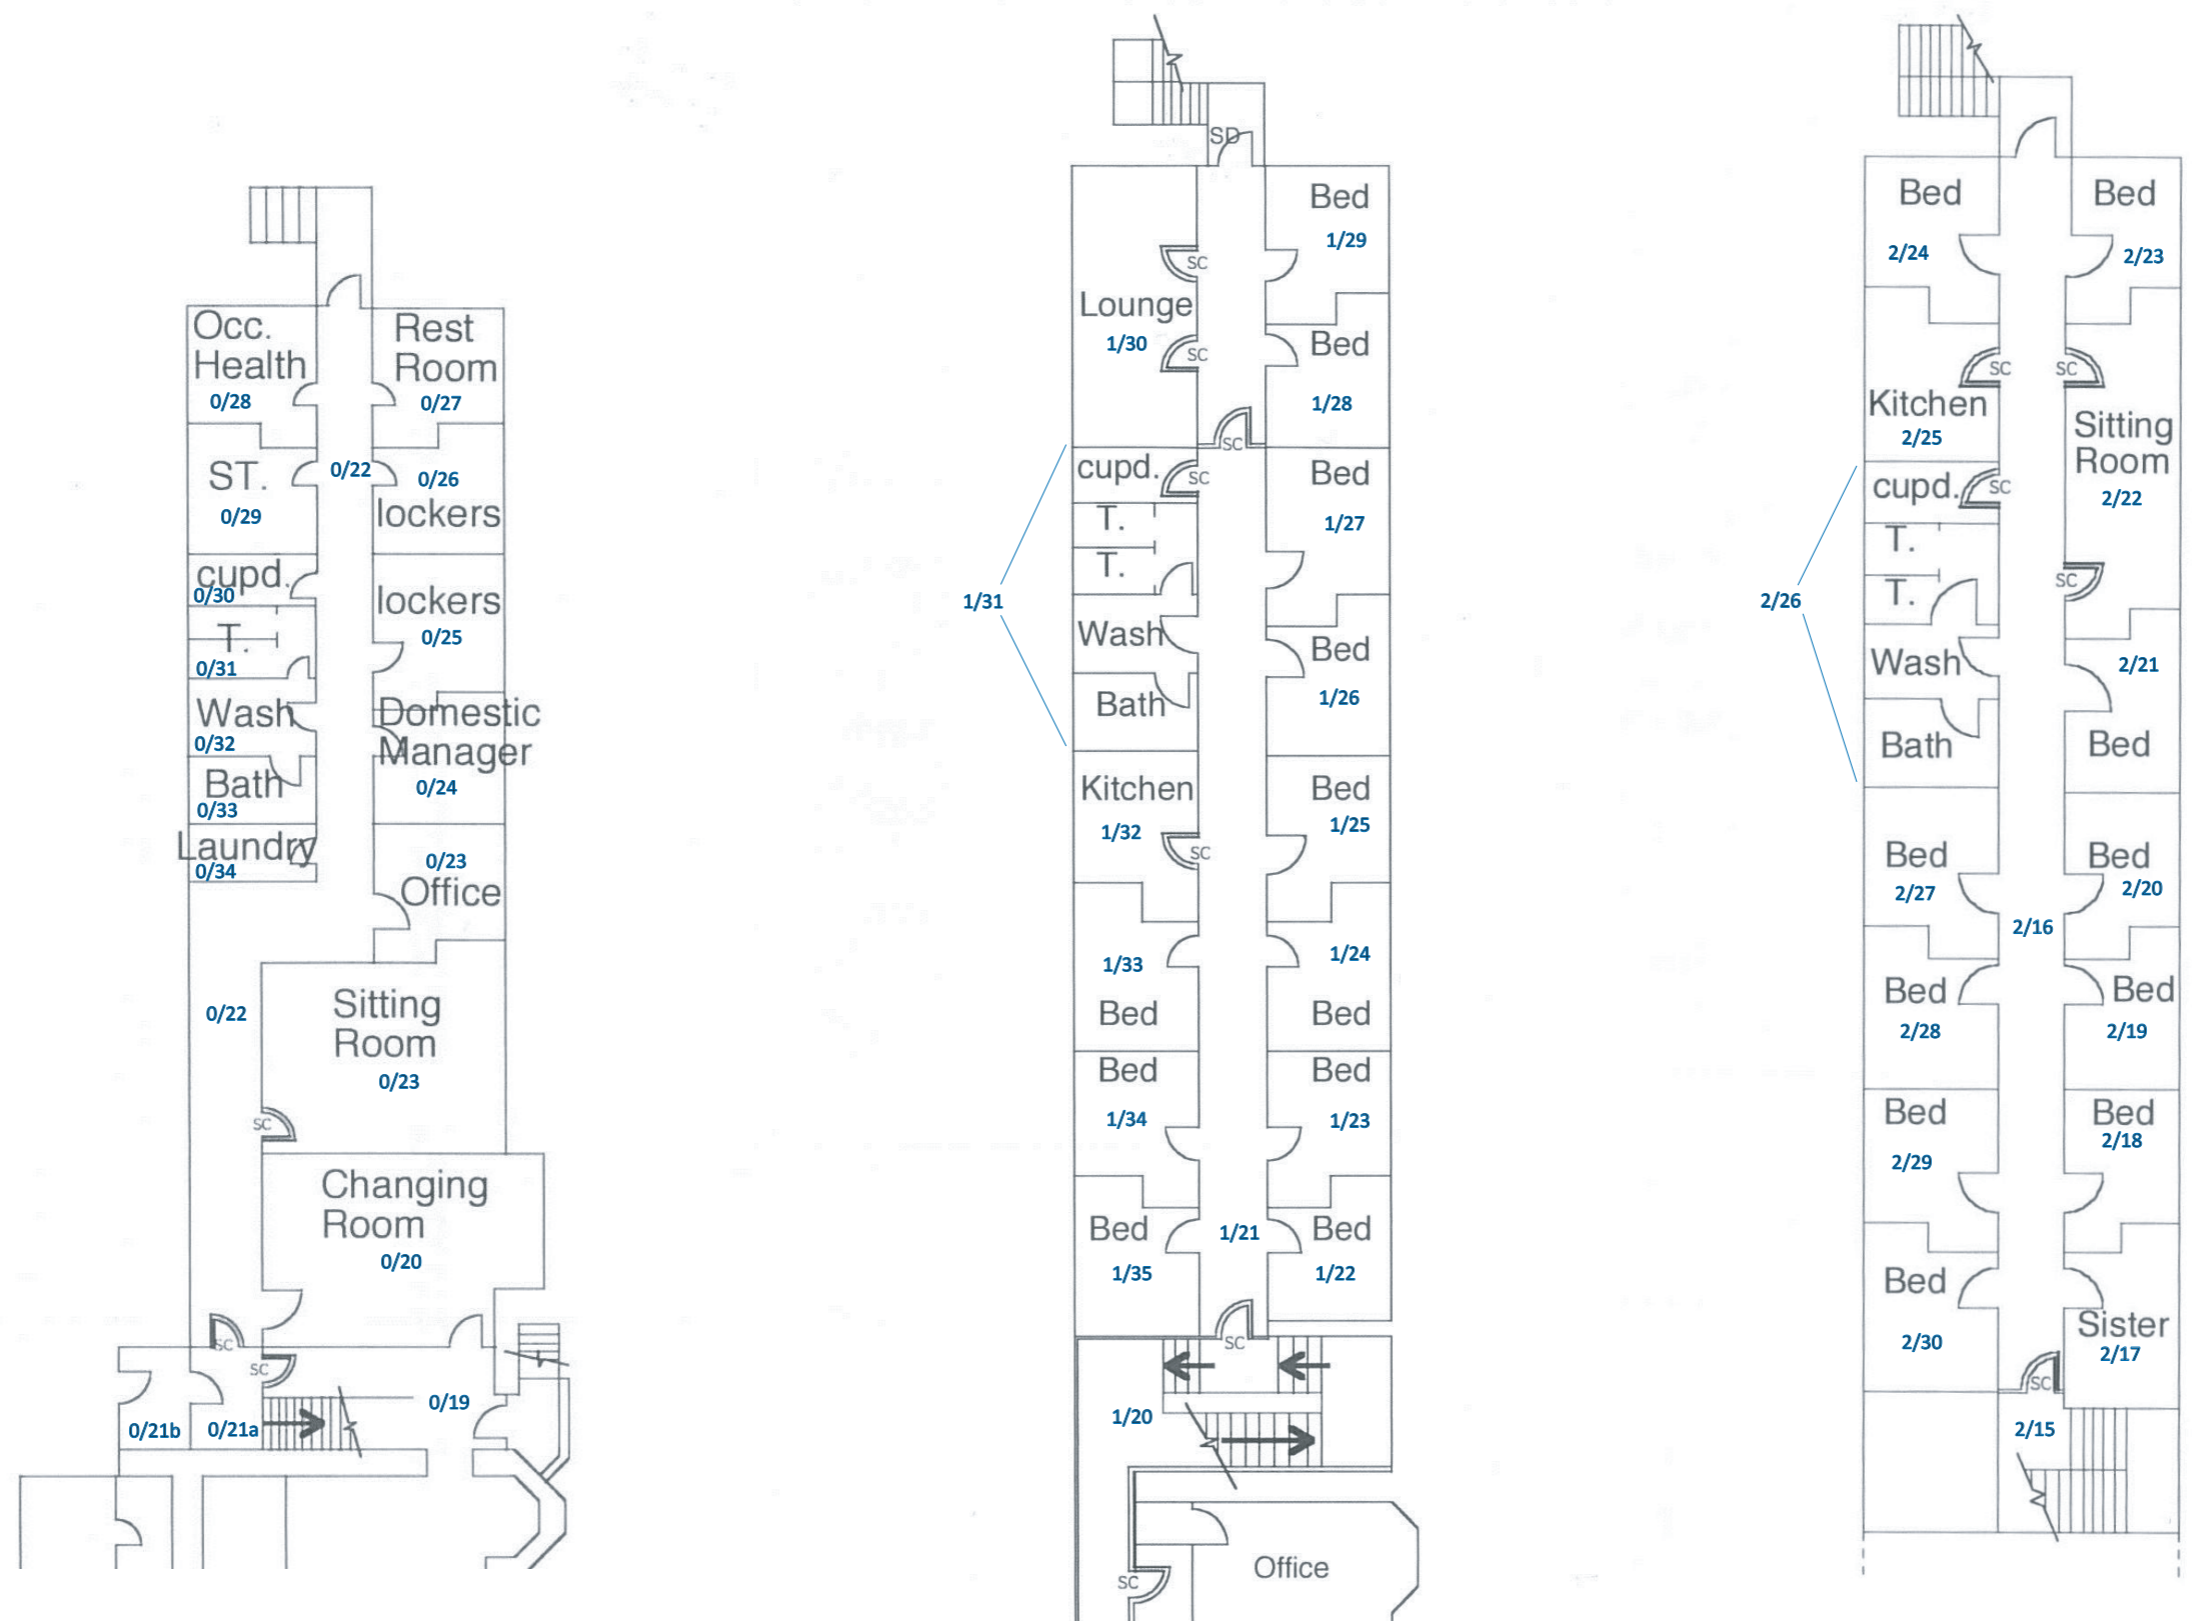
Figure 13: Ashludie House, Ground Floor Plan and First Floor Plan of Building D, North Block (provided by the NHS Trust)

This large three-storey wing is a fifteen- by one-bay building covered in roughcast render with a piended slate roof (Plates 155 - 160). Attached to the north side of the main house on the east side, all the windows are replacement one-over-one sash and case windows with projecting sills with a flat sill course above the ground floor level. Some of the original drainage features exist, although there has been a lot of replacement. To the south end of the west elevation is a projecting porch with a glazed timber-panelled door surrounded by further fixed pane glazing and a flat roof (Plate 161). On the same elevation, after the third bay from the north, is a row of smaller windows reflecting the toilet blocks within (eight to the ground floor and six to the first floor).

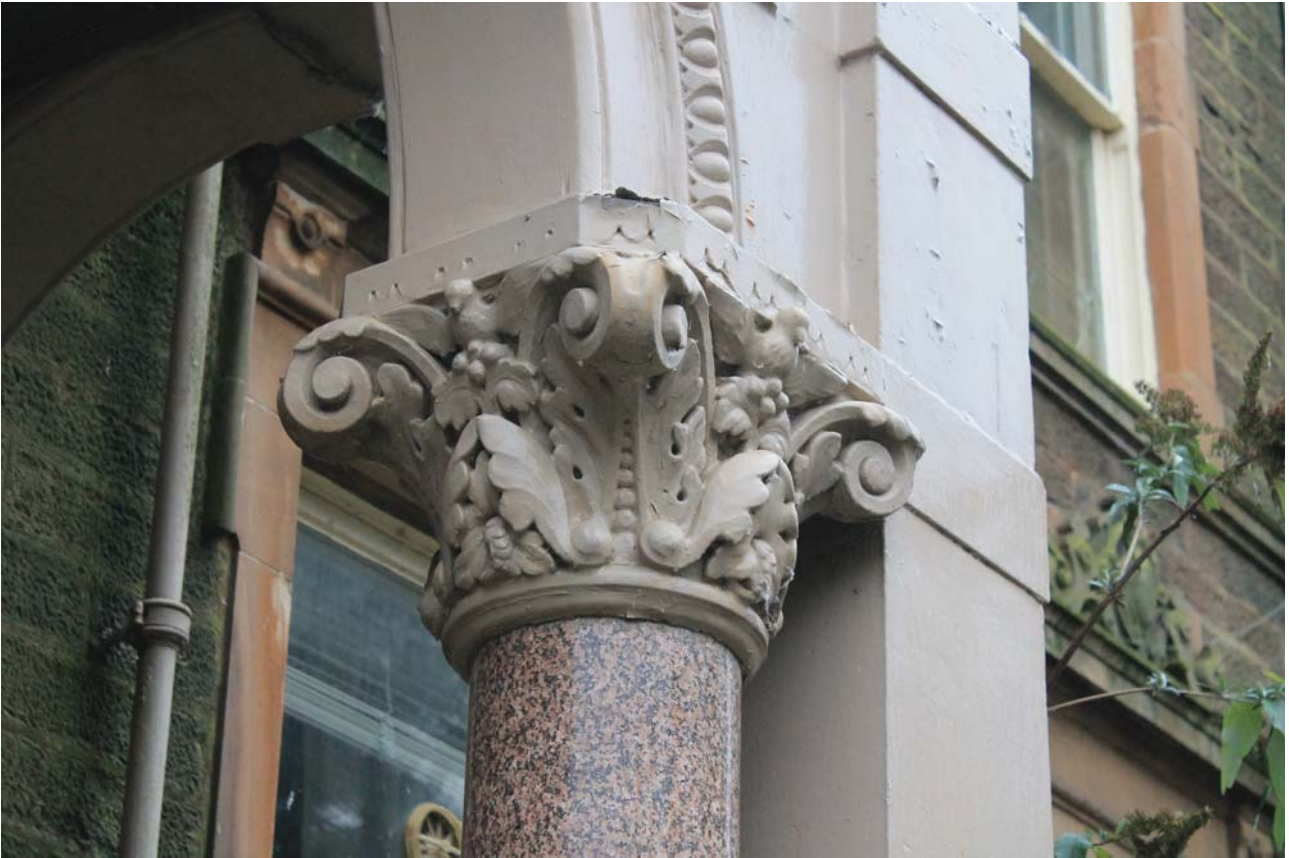
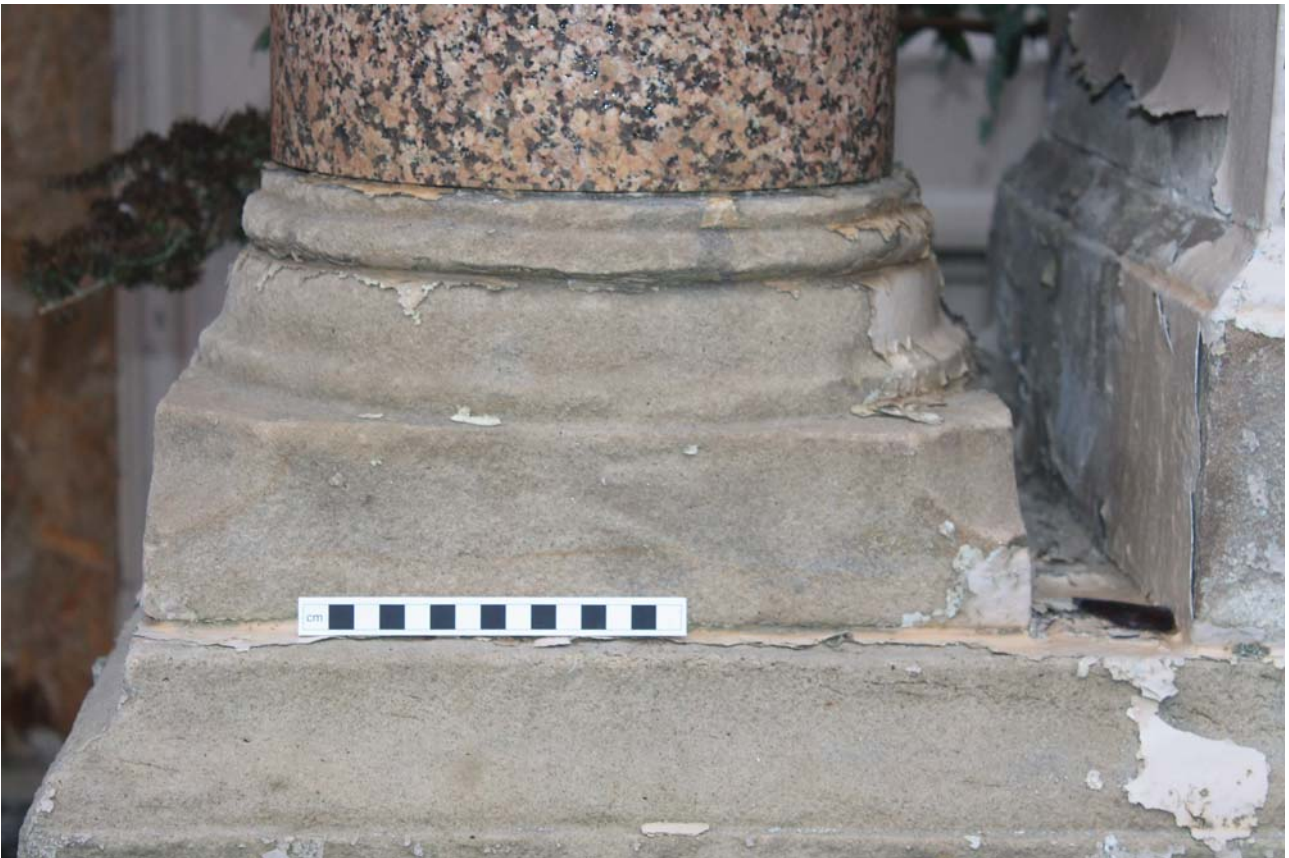
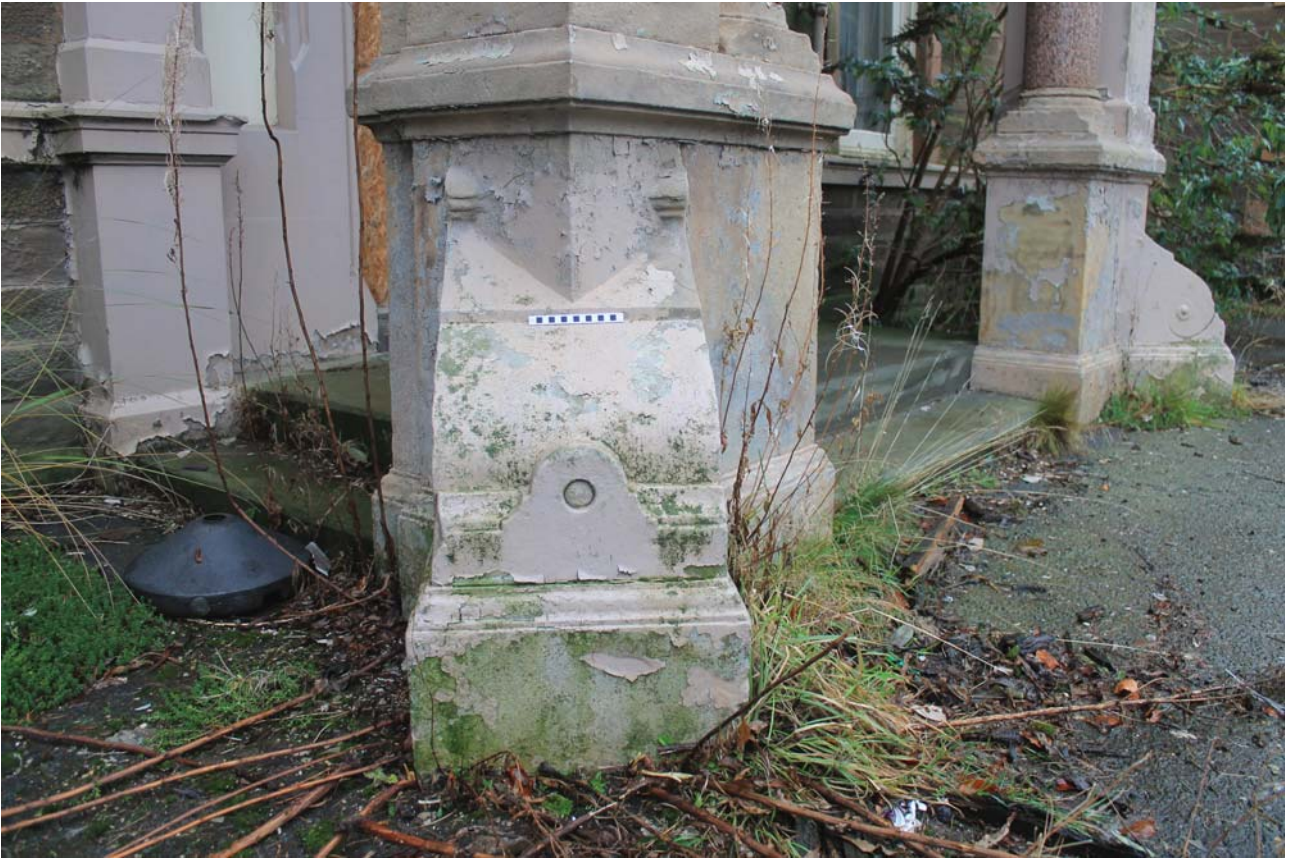
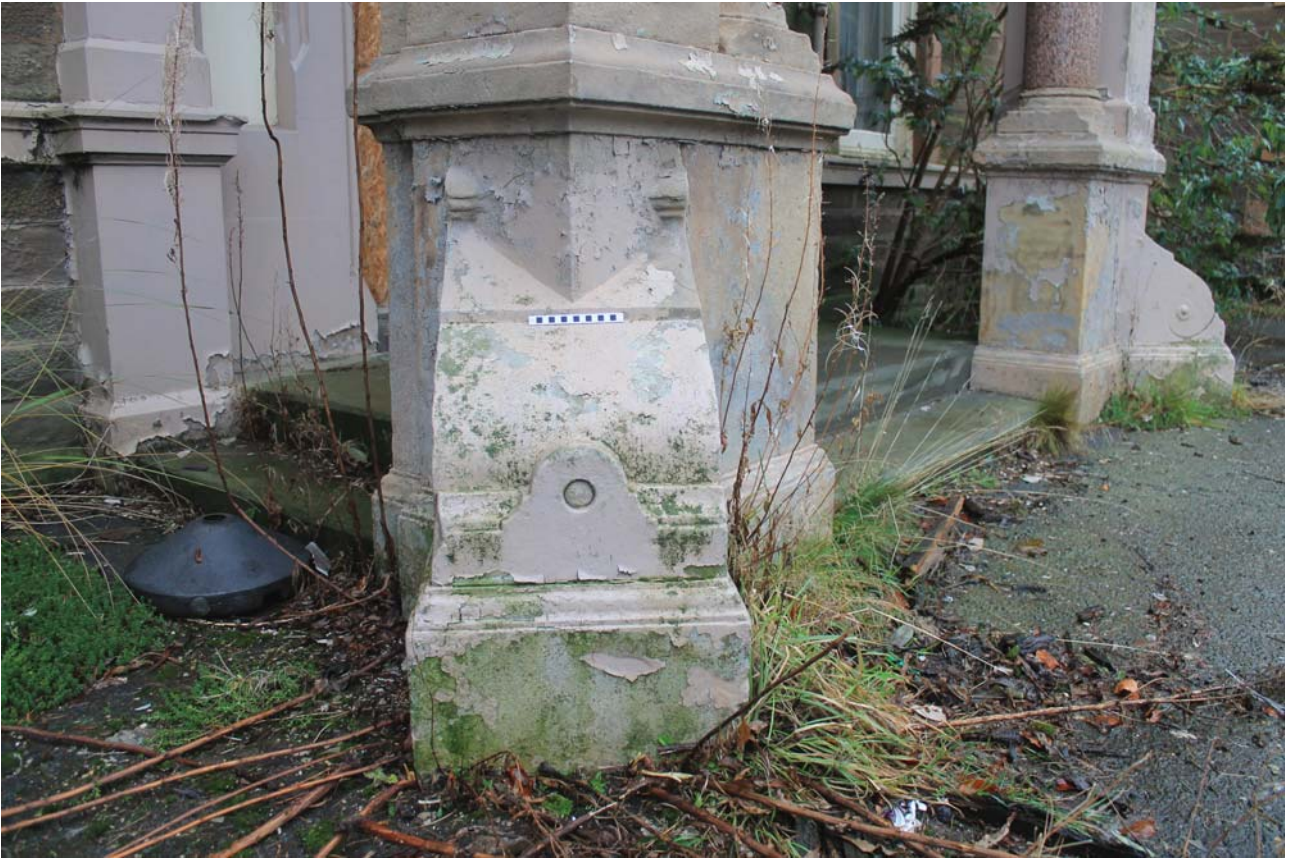
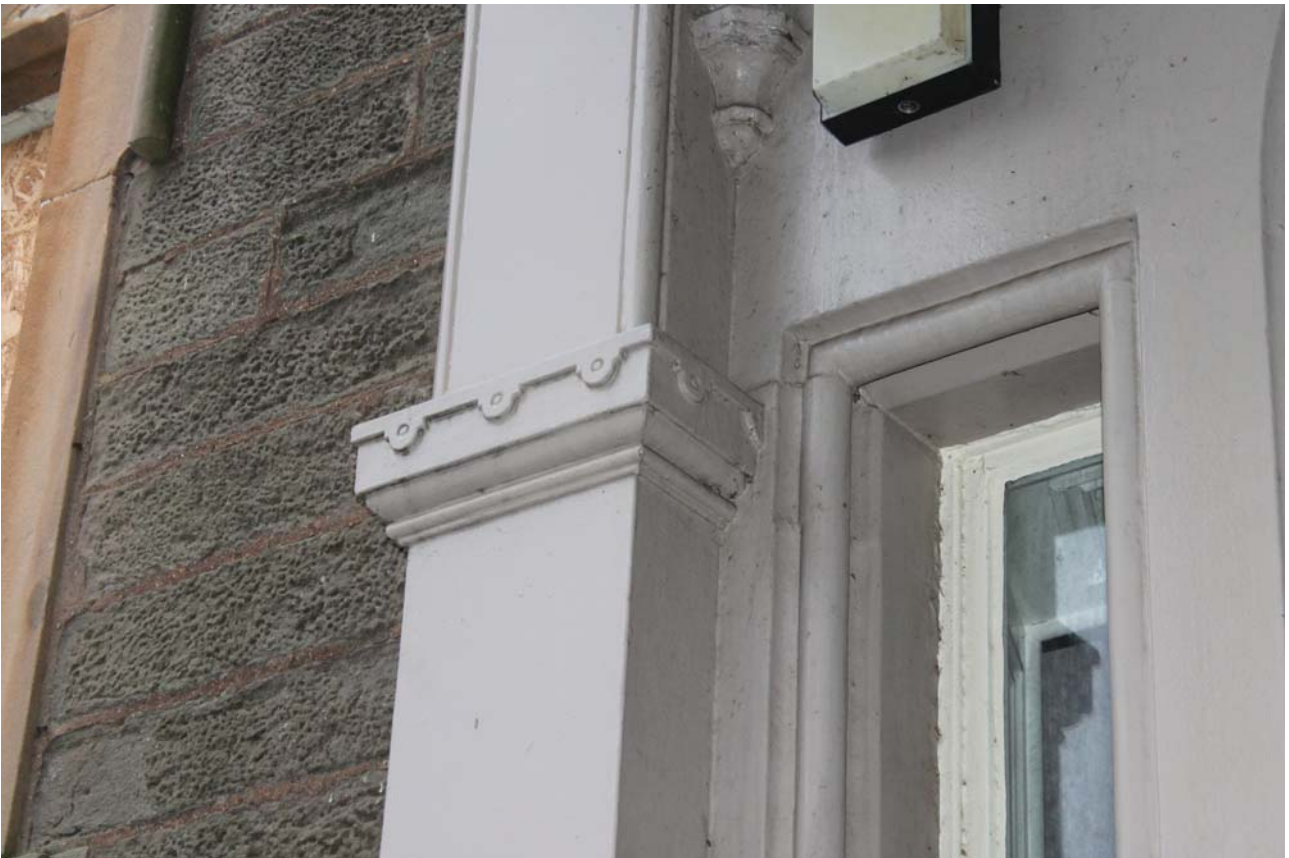
Plate 7: Ashludie House, South Elevation, detail of the composite capital to the column of the portico, from the south-west

Plate 8: Ashludie House, South Elevation, detail of the foot of the column of the portico, from the south

Plate 9: Ashludie House, South Elevation, detail of footings to the outside of the portico from the south-west

Plate 11: Ashludie House, South Elevation, detail of the footings on the west side from the south-west

Plate 12: Ashludie House, South Elevation, detail of the pilaster to the main entrance from the south-east

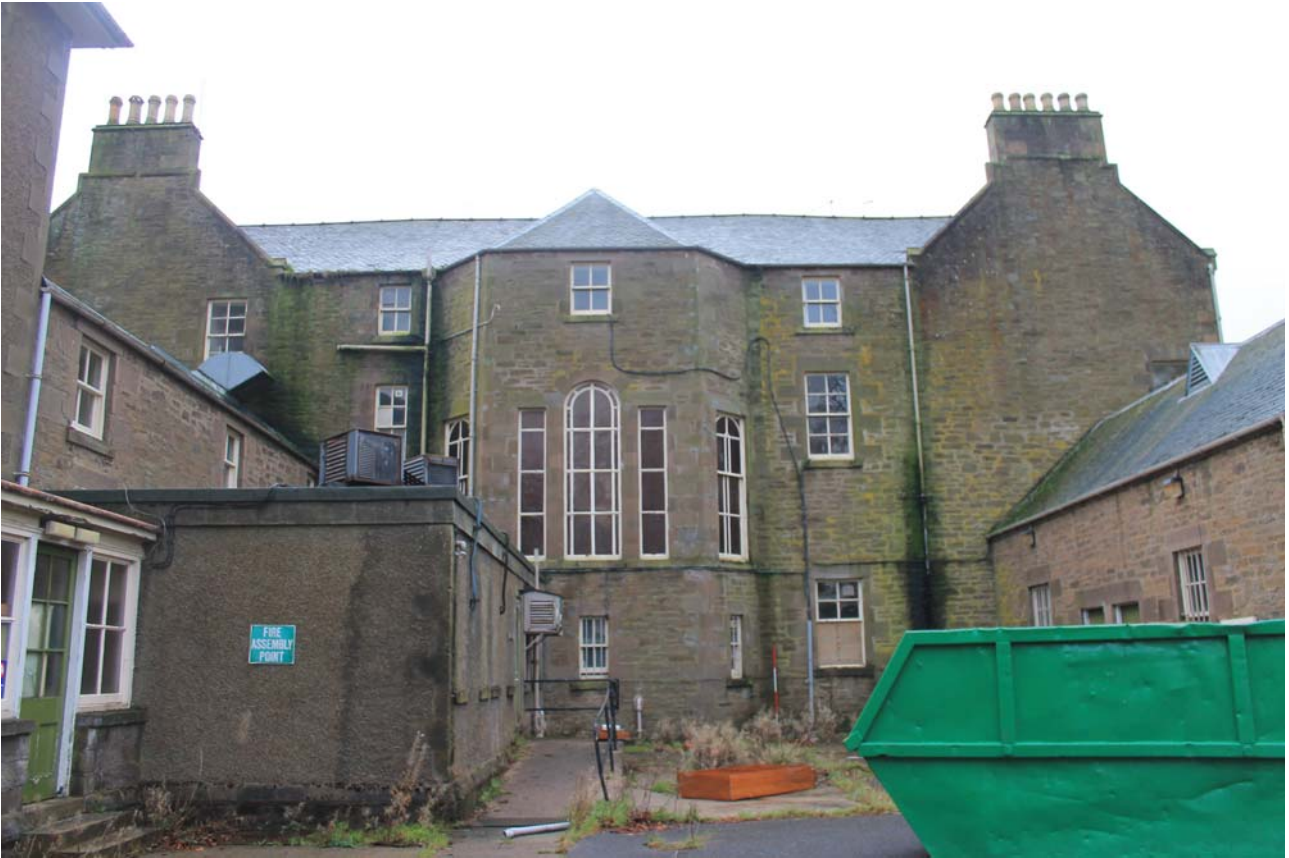
Plate 23: Ashludie House, North Elevation, general view from the north

This rear façade has largely been obscured by the later addition of Buildings B1 & B2 and the large three-storey wing Building D (Plate 23). It is dominated by the central angled bay here, which forms the main stairwell to the rear of the house, featuring the large stained glass windows at first floor level, depicting the position of the intermediate landing (Plate 24). Smaller windows feature to the ground floor level, as these depict areas consisting of small cupboards within (Plate 25). At attic level, there is a smaller single two-over-two window, and the whole is covered in a hipped slate roof with lead flashings going back to the main pitch. Flanking this to both sides is another single bay of windows, the first floor windows set slightly higher than the centre as these depict the true first floor level, all two-over-two timber sash-and-case.

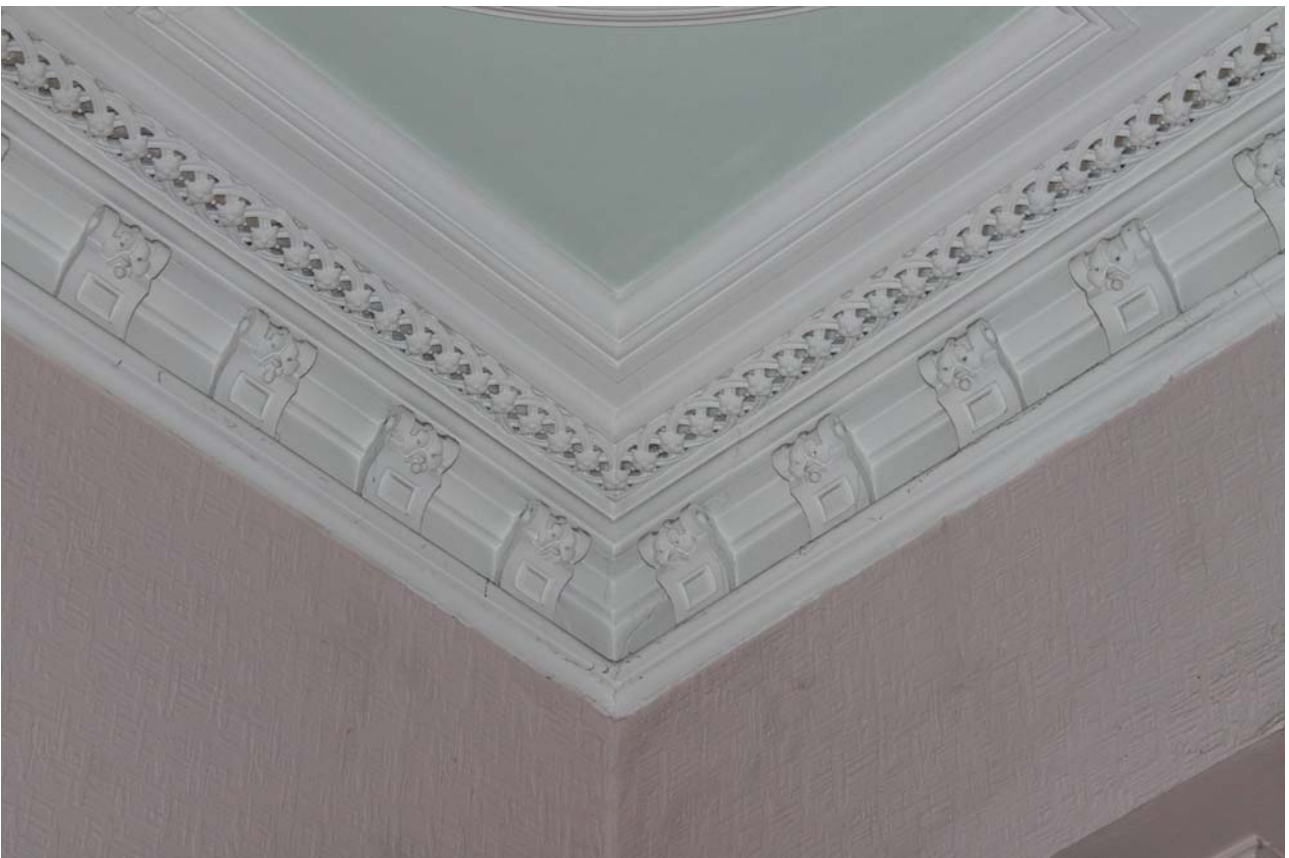
Plate 42: Room 0/1, detail of cornice from the in the north-west corner from the south-east

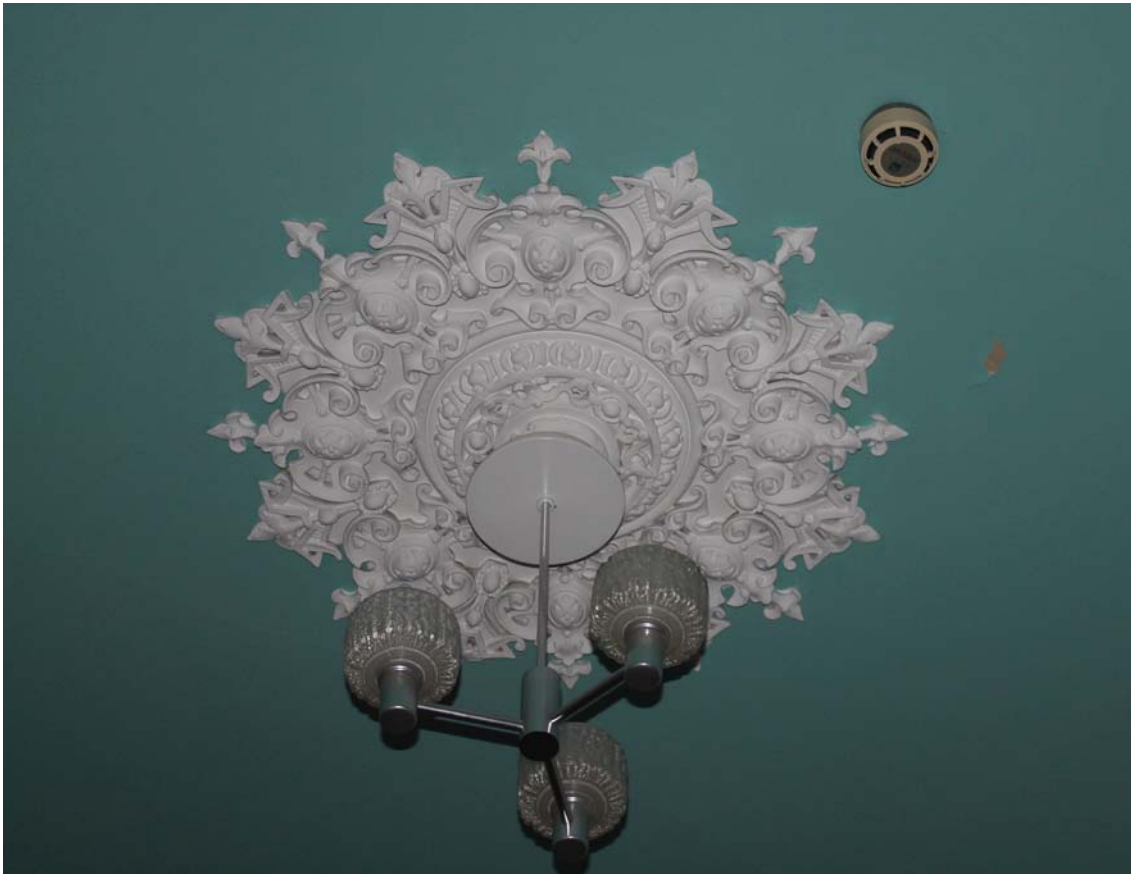
Plate 43: Room 0/1, detail of ceiling rose

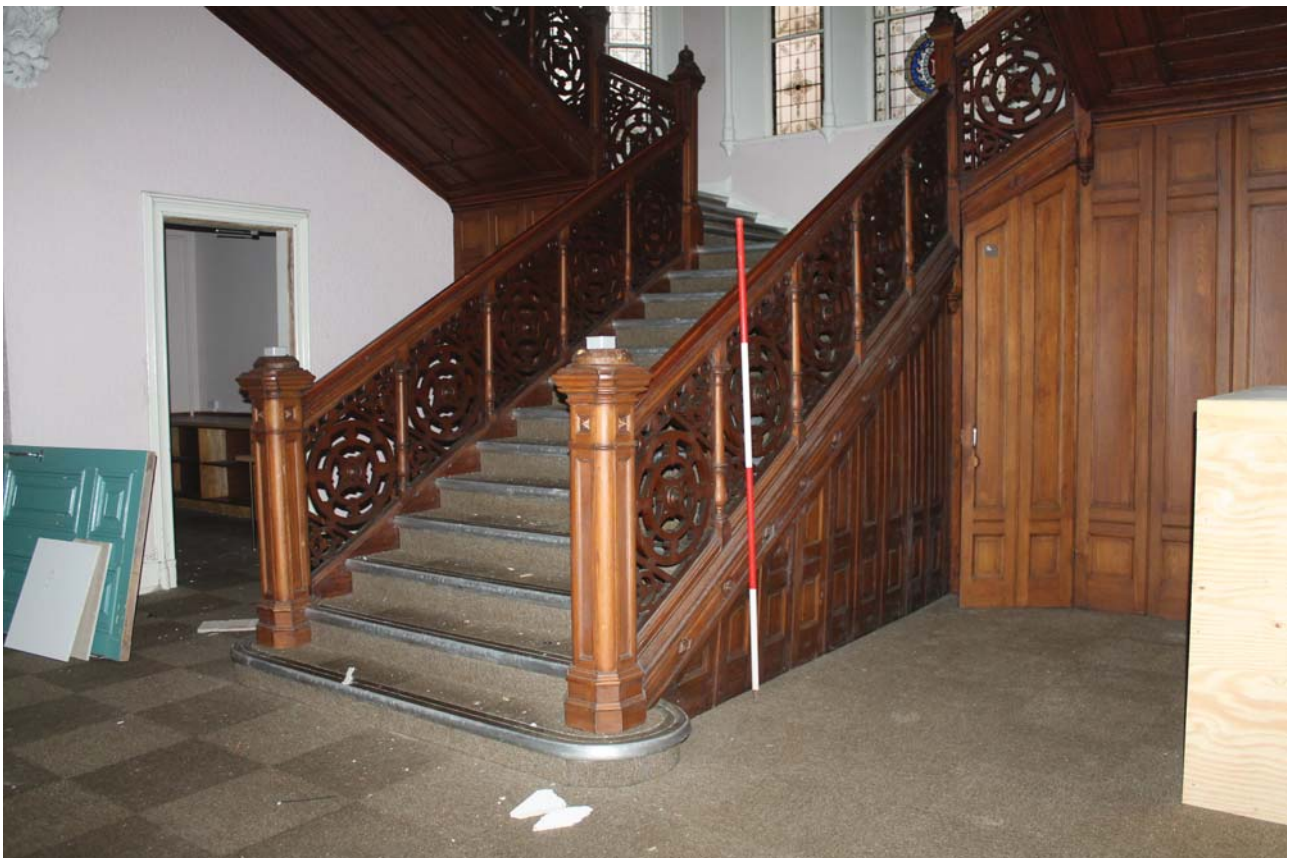
Plate 44: Room 0/2, detail of stair from the south-east

This large corridor links the main stairwell to the main entrance and the surrounding rooms, accessed through timber-panelled doors in moulded frames. To the north side is the large open well staircase with timber carved balusters and newel posts (Plates 44 - 46). The treads themselves have been covered in modern carpet with steel toes. At the half landing on the north wall is a tall round-headed tripartite window (cast-iron radiator below) in stained glass set back in a splayed bay with thin timber columns with Corinthian capitals with egg-and-dart framing above (Plates 47 – 50). The ensemble is flanked by windows in the same style, angled to the wall, as this splays back also.

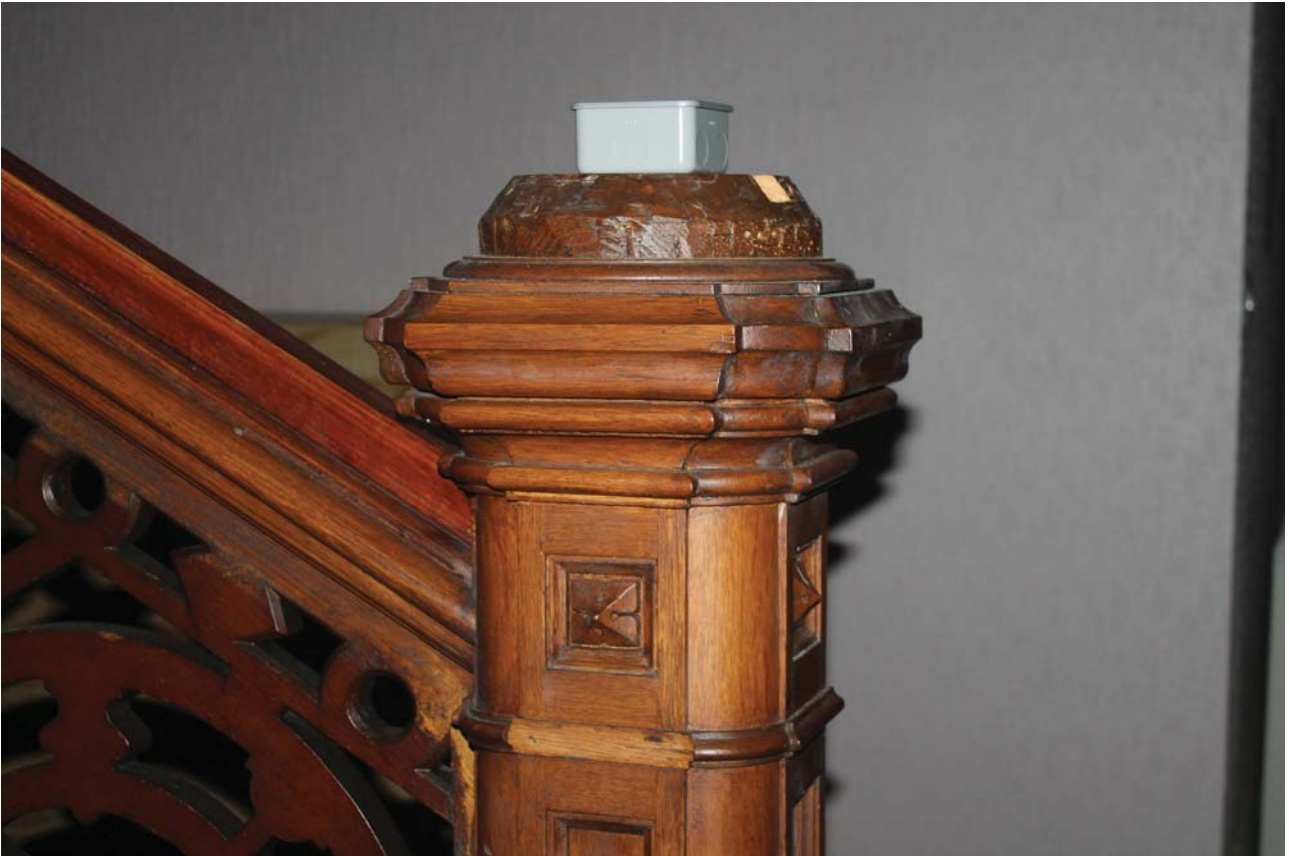
Plate 45: Room 0/2, detail of top of newel post to the stair from the south-west

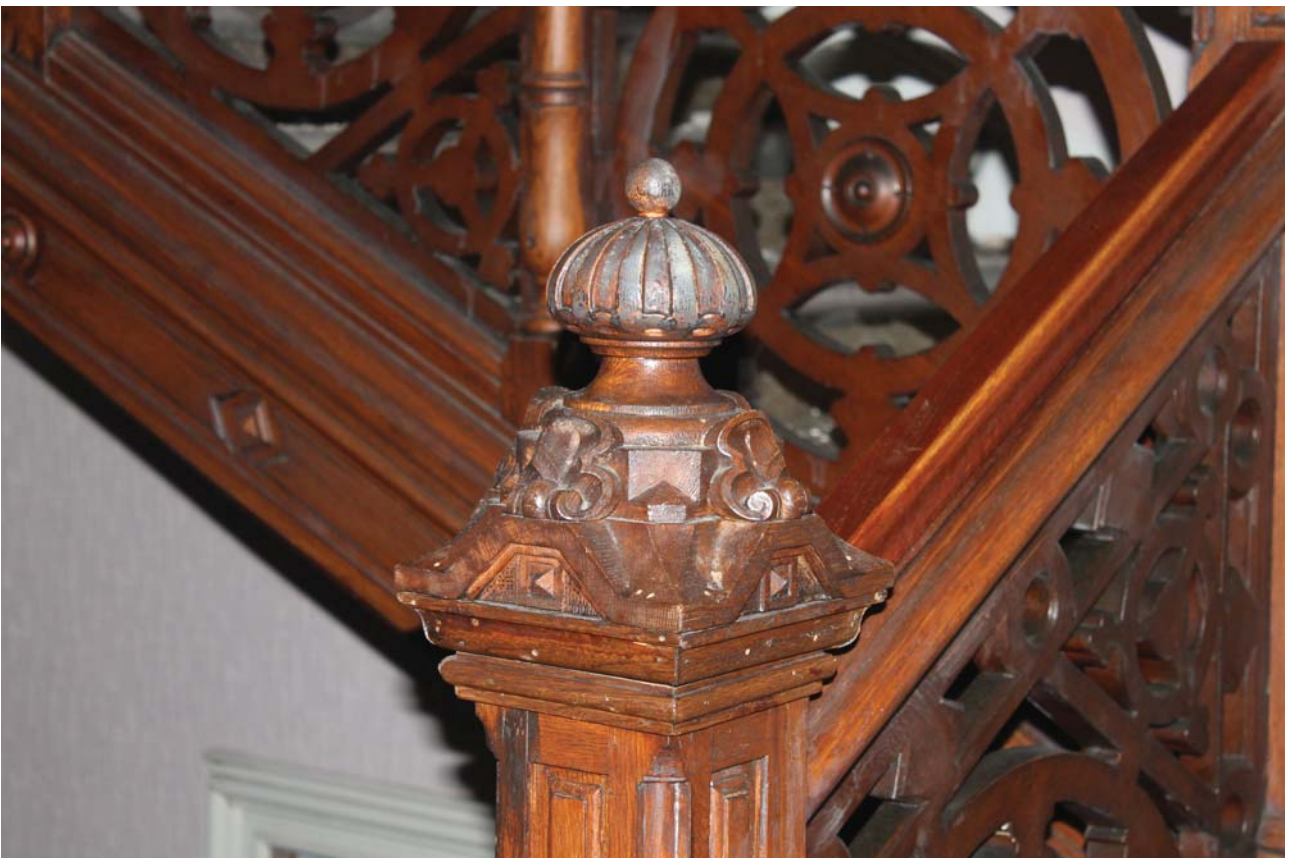
Plate 46: Room 0/2, detail of top of newel post to the stair from the north-east

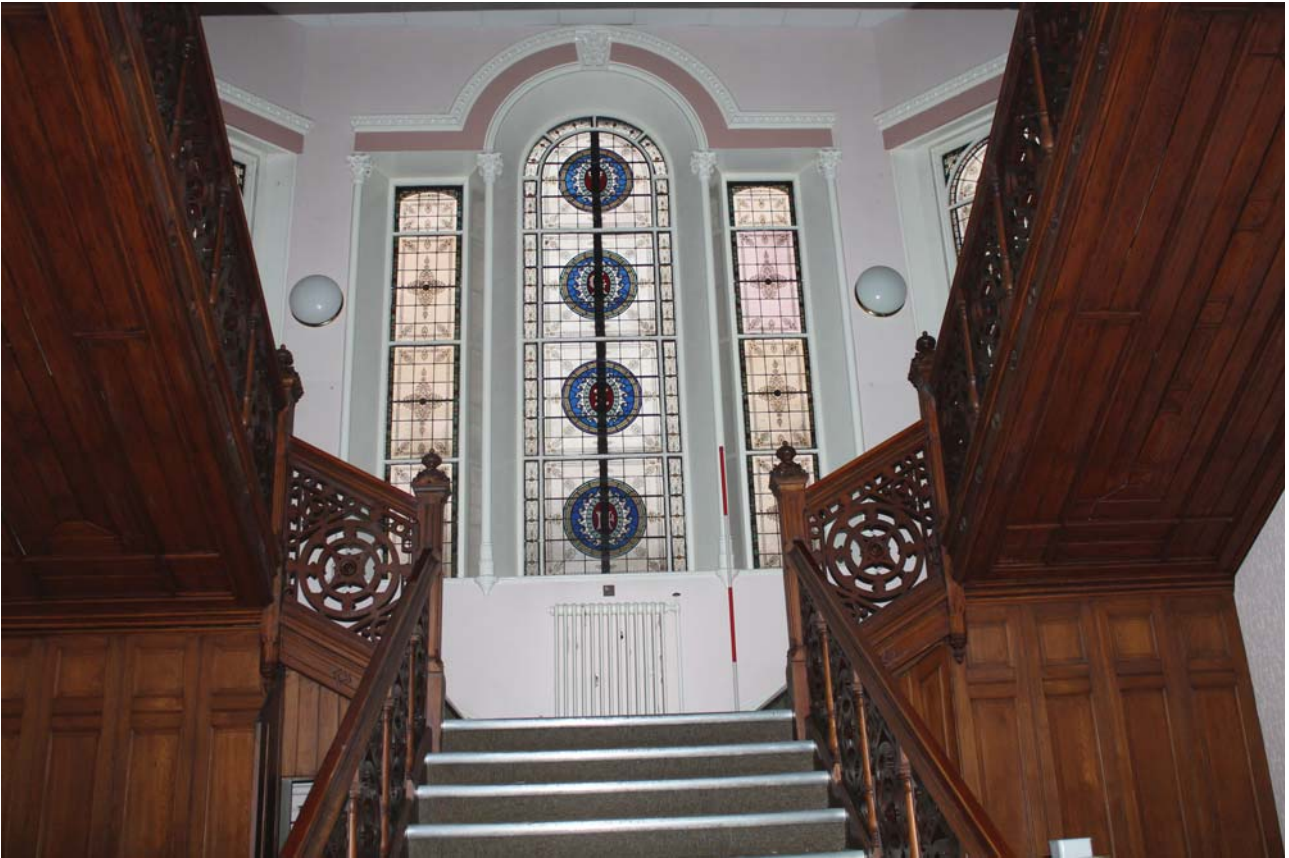
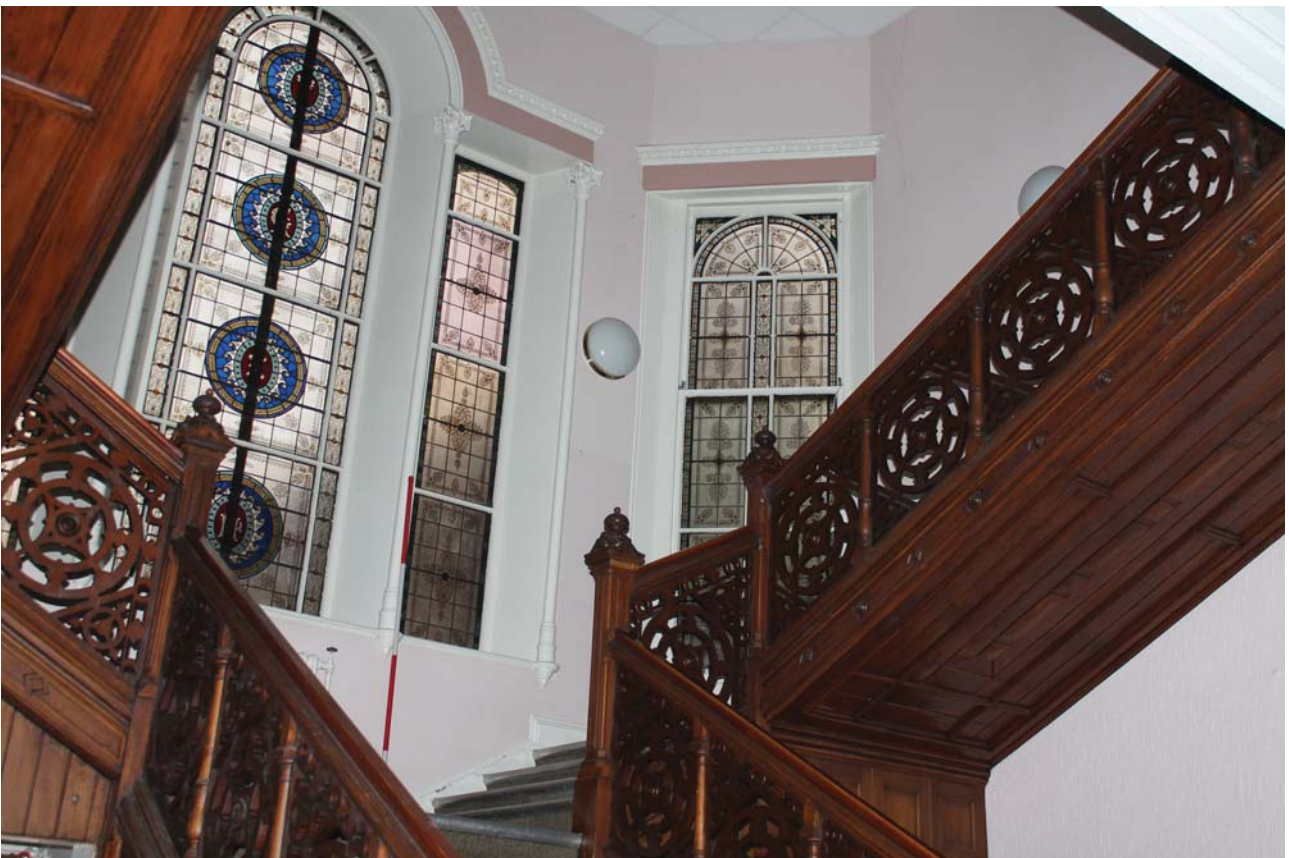
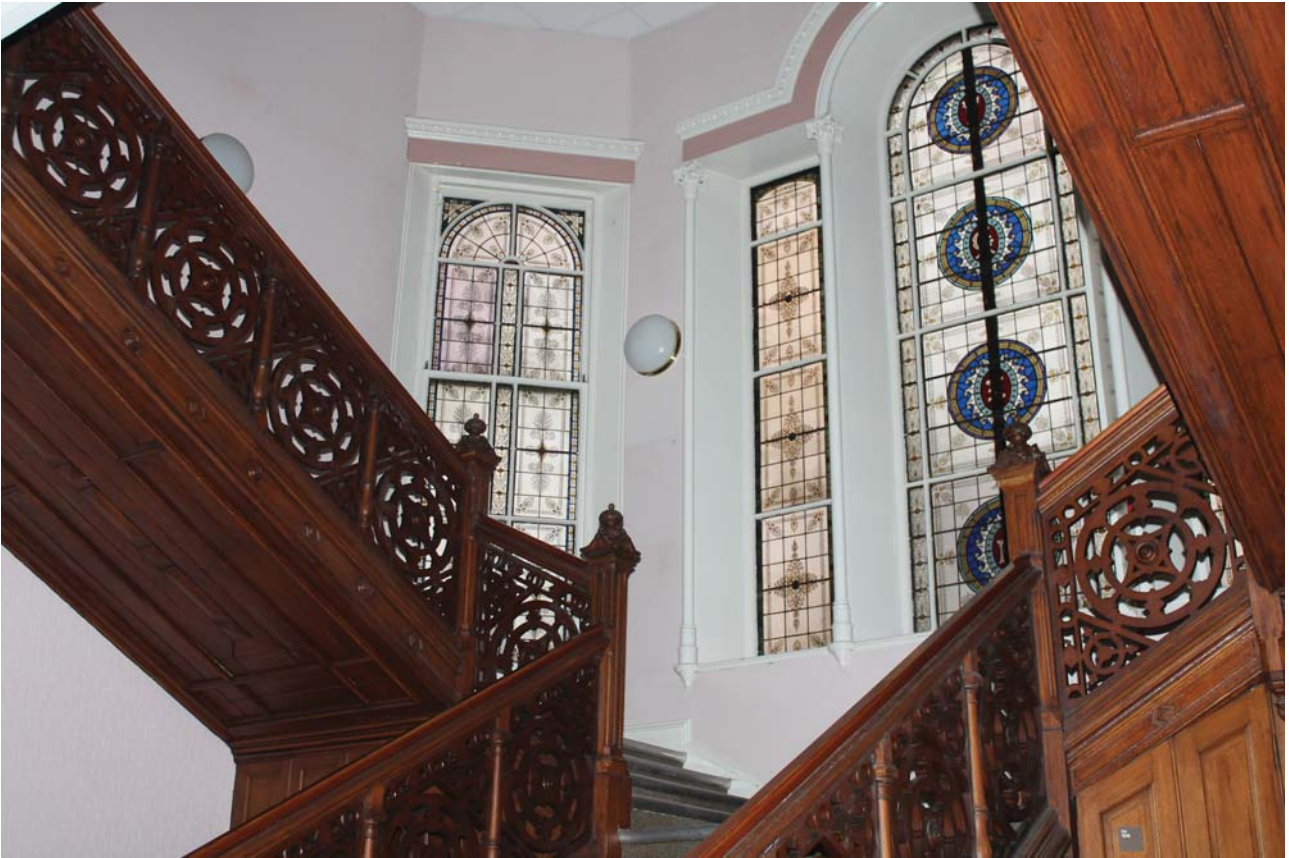
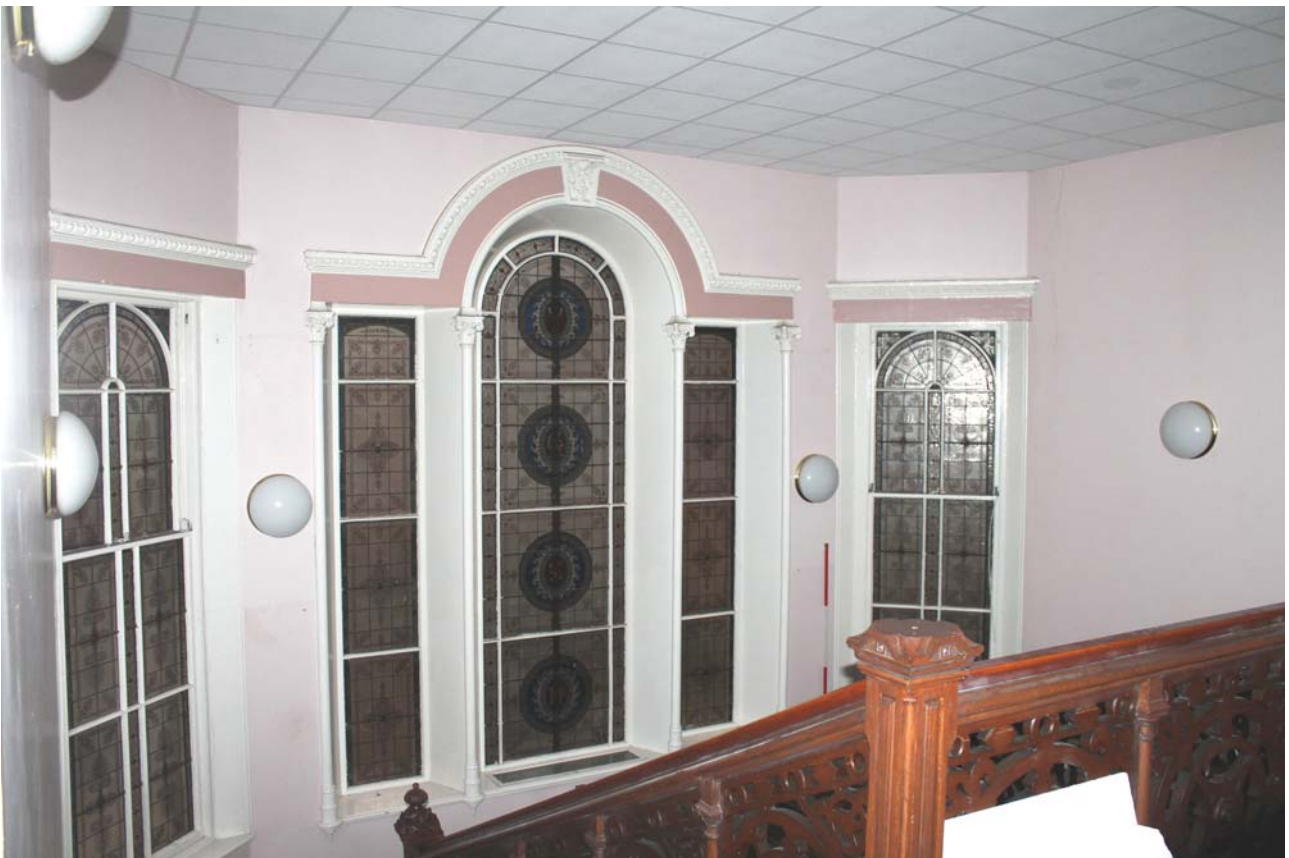
Plate 47: Room 0/2, general view of stained glass landing window in the north wall from the south

Plate 48: Room 0/2, general view of stained glass landing window in the north wall from the south-west

Plate 49: Room 0/2, general view of stained glass landing window in the north wall from the south-east

Plate 50: Room 0/2, general view of stained glass landing window in the north wall, taken from the first floor landing, from the south-west

within the two main reception rooms in the house (Rooms 0/6 and 0/7) in the ceilings set into the bay windows, as well as the fine stained glass window to the main stairwell (see below).

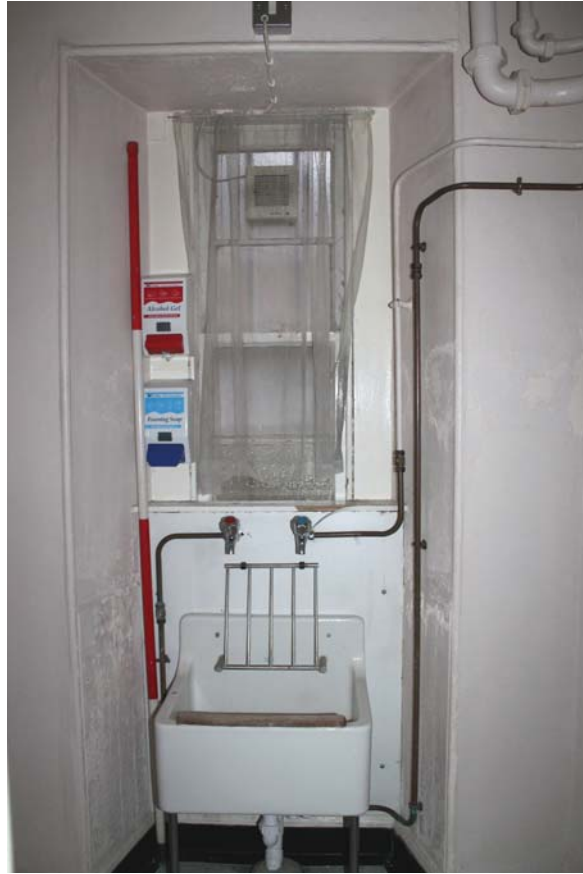
To the east and west side of the stair are two small rooms, the westernmost featuring a small sink with a thin one-over-three sash window, the easternmost a small service cupboard (Plate 51).

Plate 51: Room 0/2, detail of the window in the westernmost 'cupboard' (now forming a small washroom), from the south-east
