# Ashludie House, Monifieth, Angus: Historic Building Recording Report

AOC Project: 23302

8<sup>th</sup> January 2016

<b>On Behalf of:</b>	<b>Miller Homes Clydesdale House 300 Springfield Parkway Baillieston Glasgow G69 6GA</b>
<b>National Grid Reference (NGR):</b>	<b>NO 49537 33260</b>
<b>AOC Project No:</b>	<b>23302</b>
<b>Planning Application No:</b>	<b>15/00099/FULM</b>
<b>OASIS Reference:</b>	<b>235866</b>
<b>Prepared by:</b>	<b>Diana Sproat</b>
<b>Date:</b>	<b>8<sup>th</sup> January 2016</b>

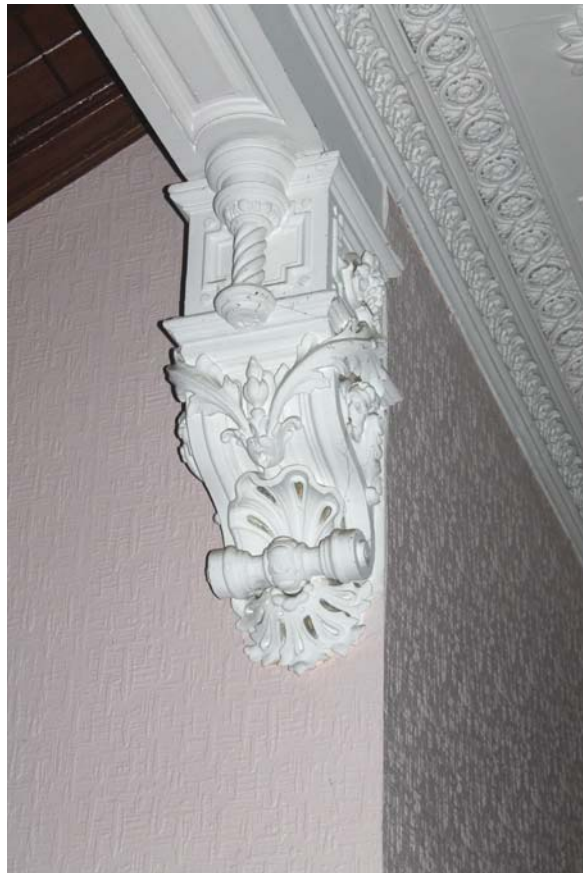
Plate 52: Room 0/2, detail of console bracket to the east side of the stair from the south-west

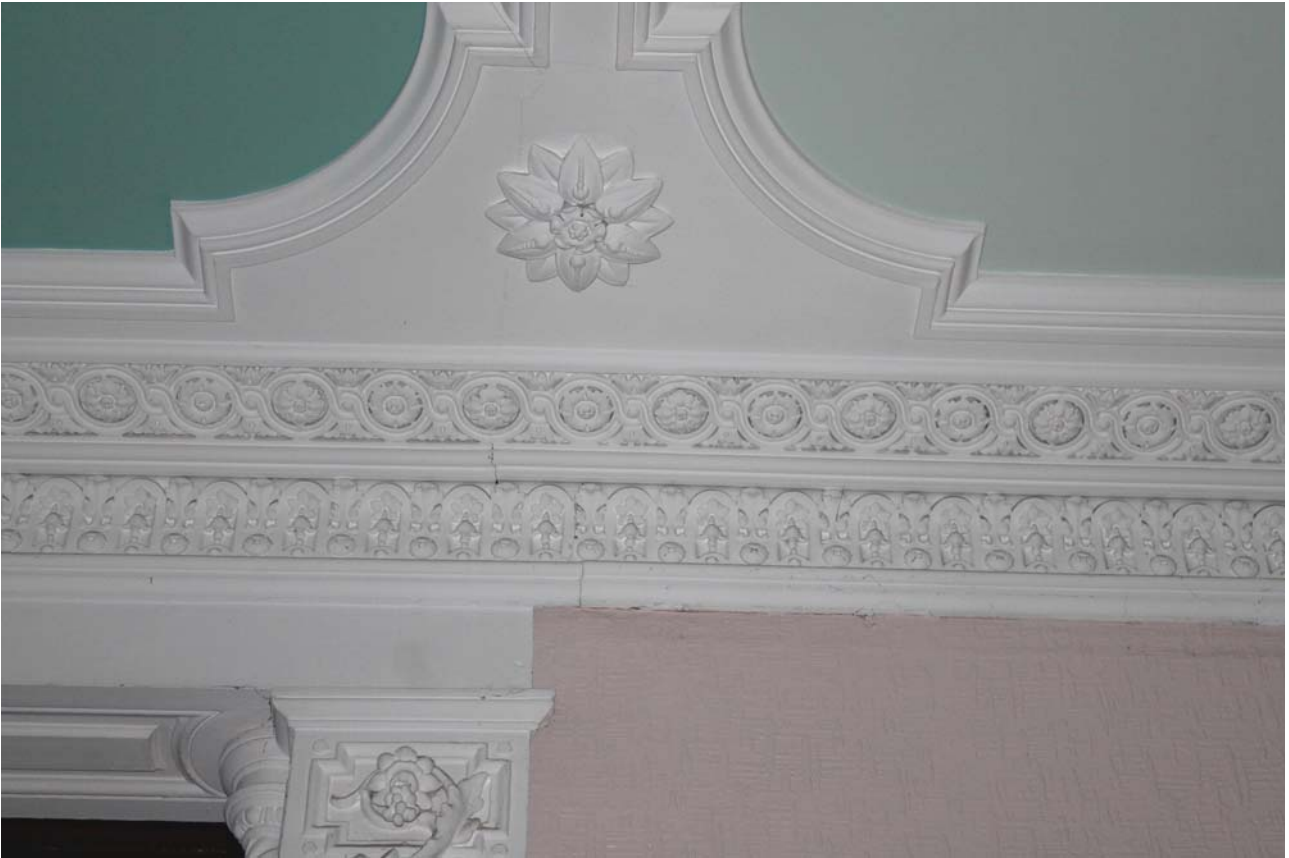
Plate 53: Room 0/2, detail of decorative ceiling from the south

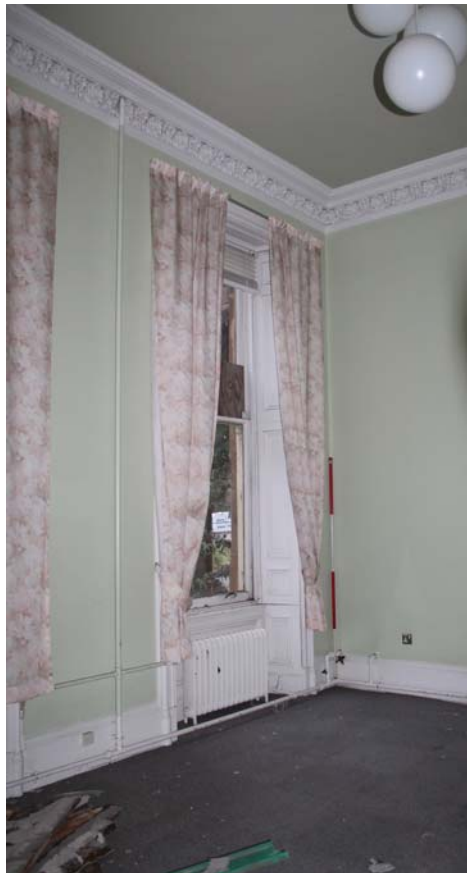
Plate 54: Room 0/4, general view showing window in the south wall from the north-west

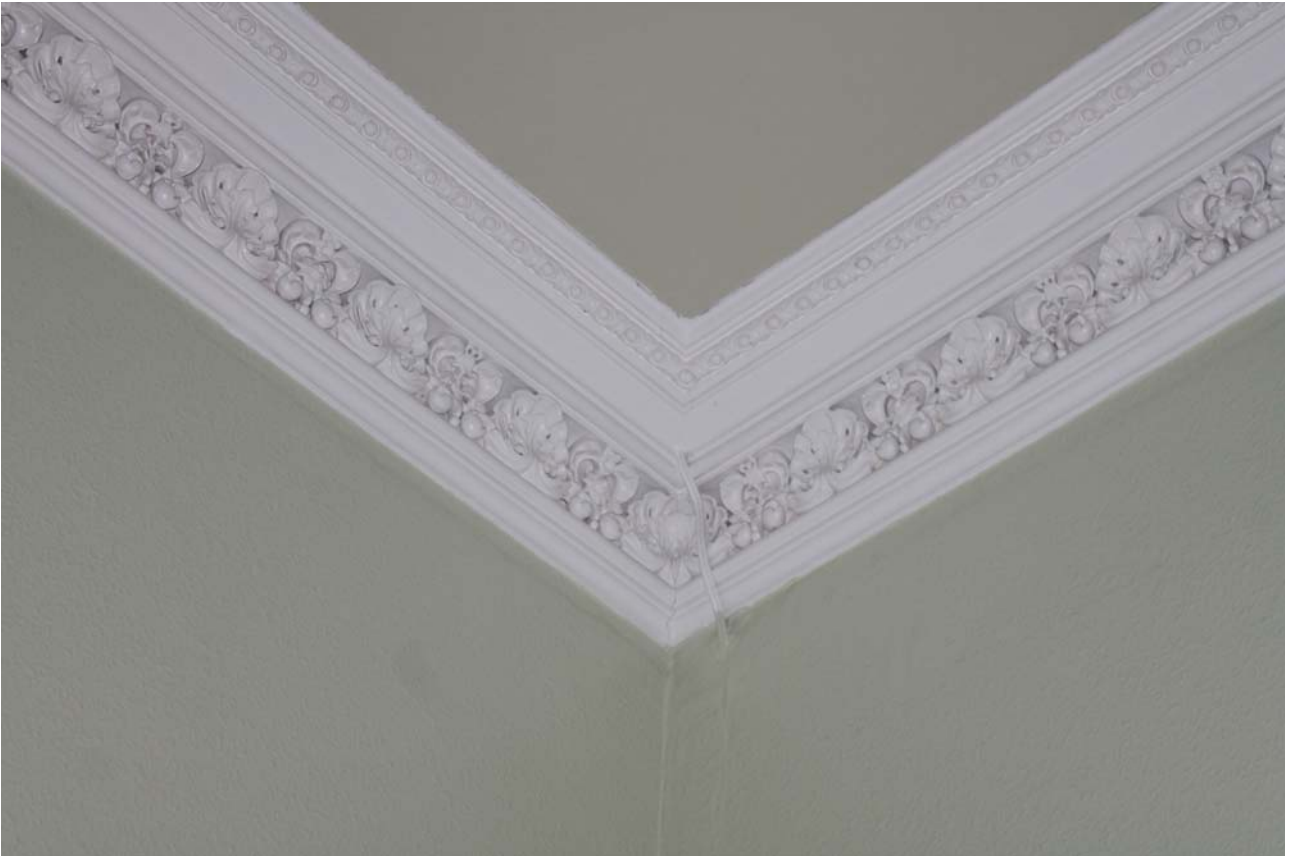
Plate 55: Room 0/5, detail of cornice

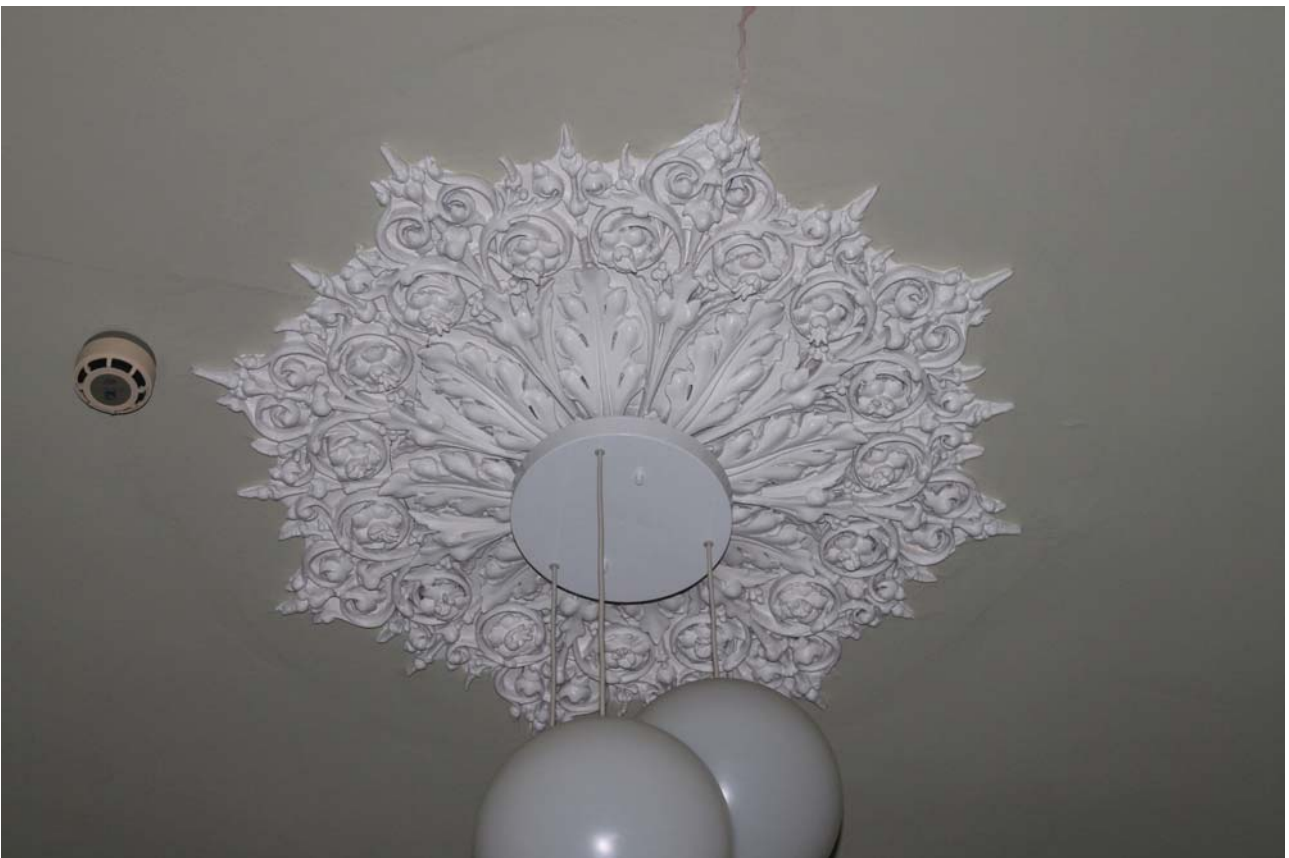
Plate 56: Room 0/5, detail of ceiling rose

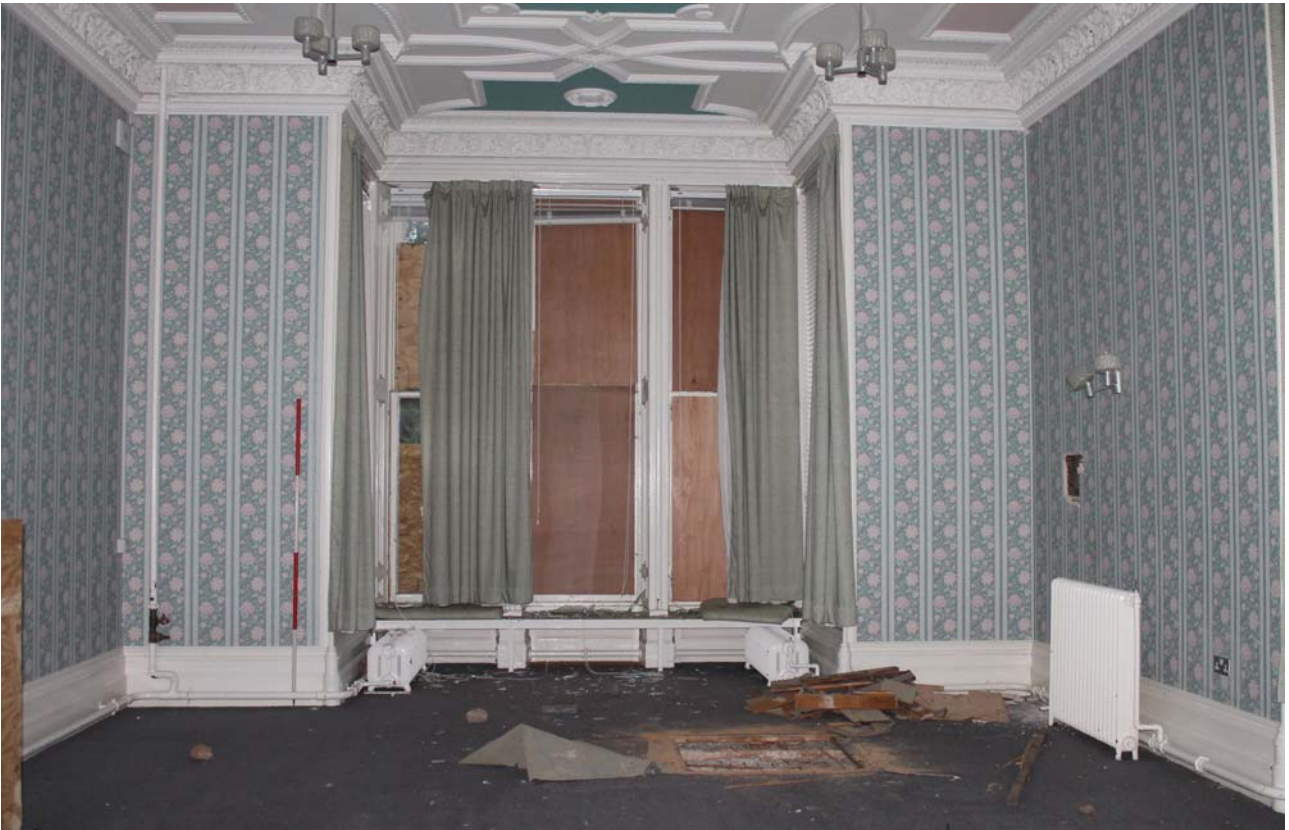
Plate 57: Room 0/6, general view showing bay window in the south wall from the north

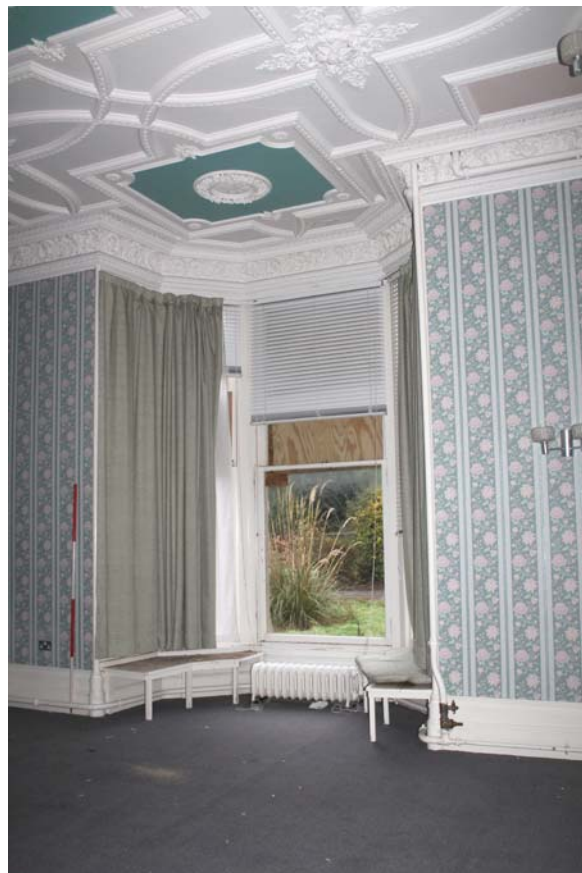
Plate 58: Room 0/6, general view of the bay window in the west wall from the north-east

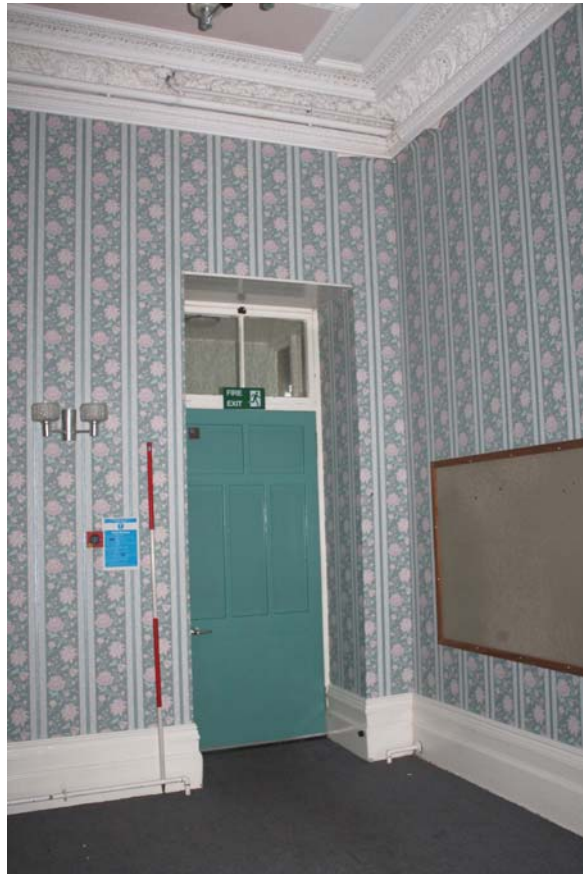
Plate 59: Room 0/6, detail of the door in the west wall from the east

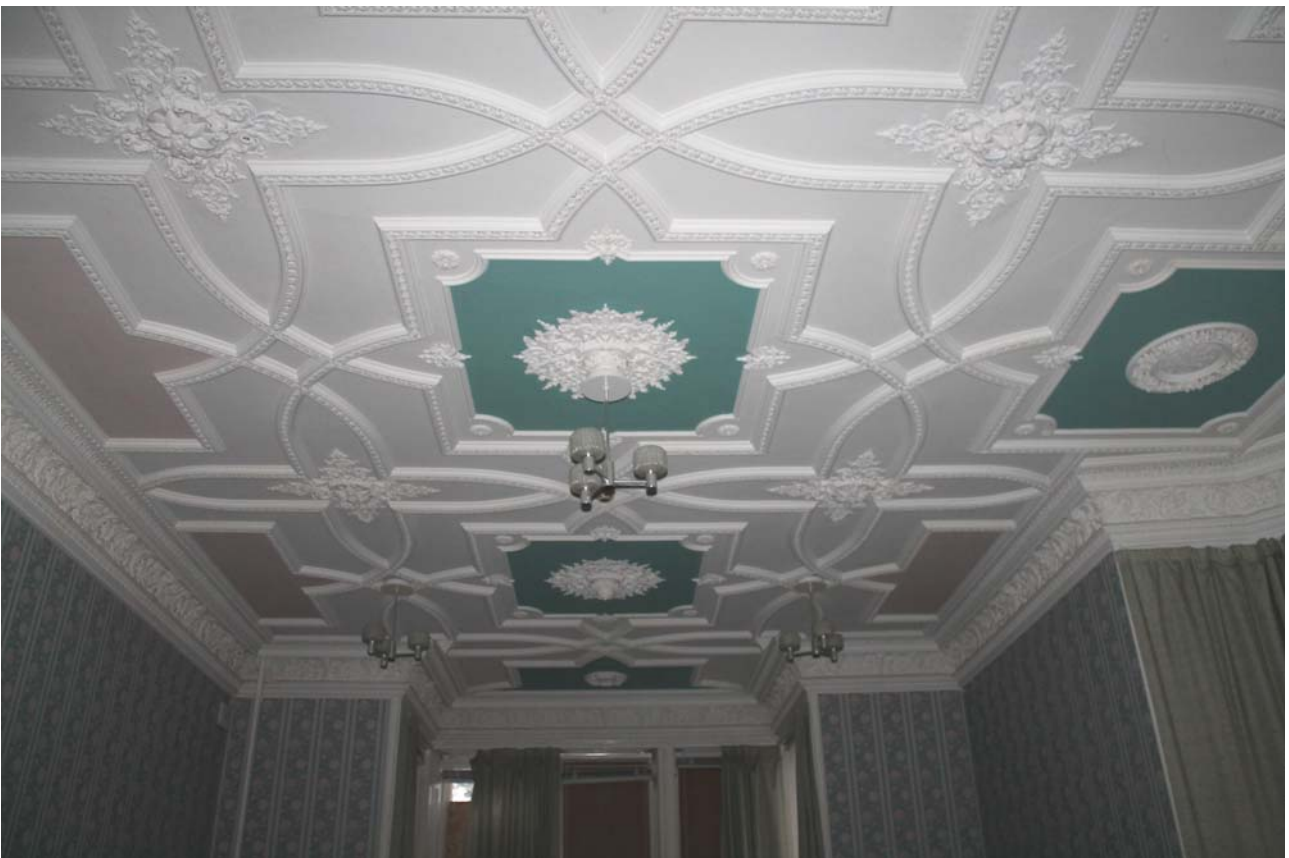
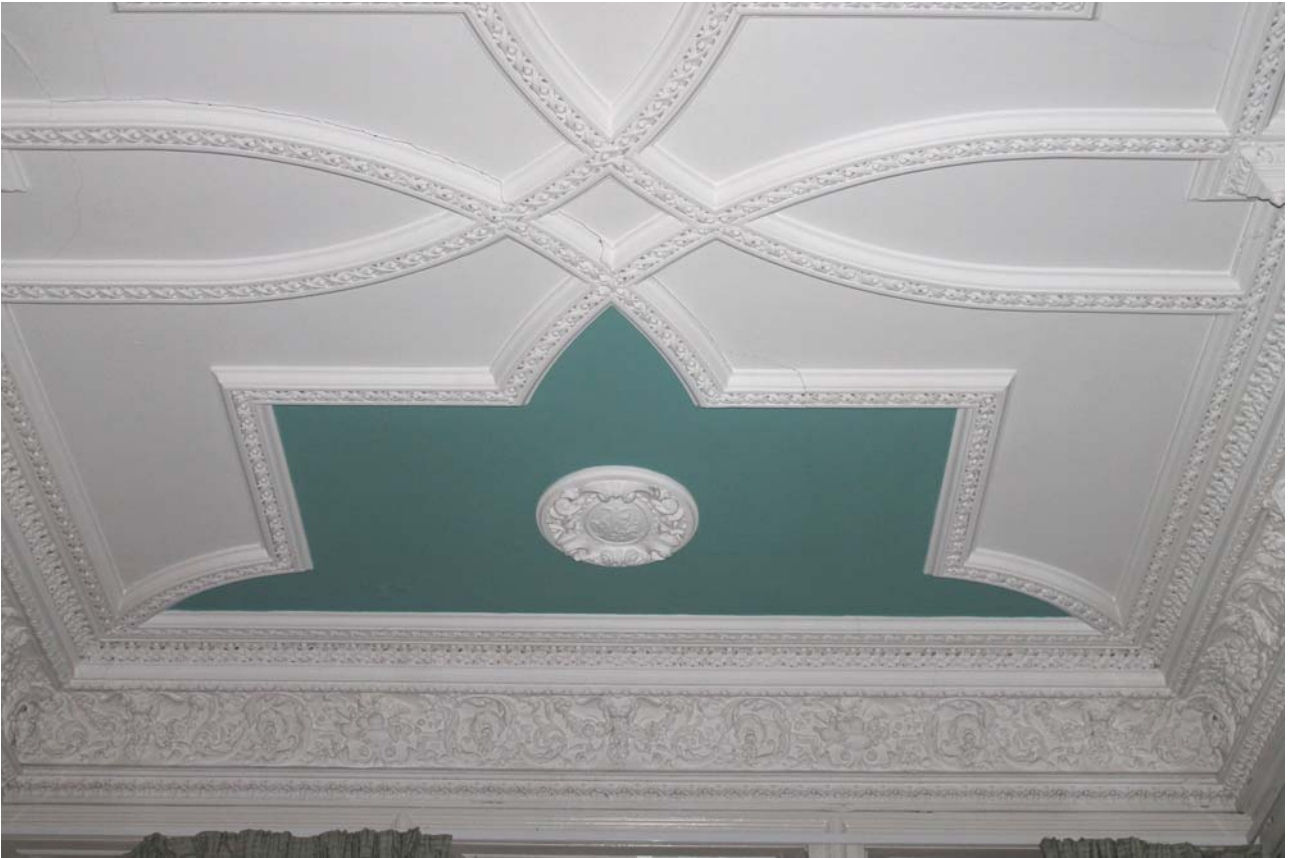
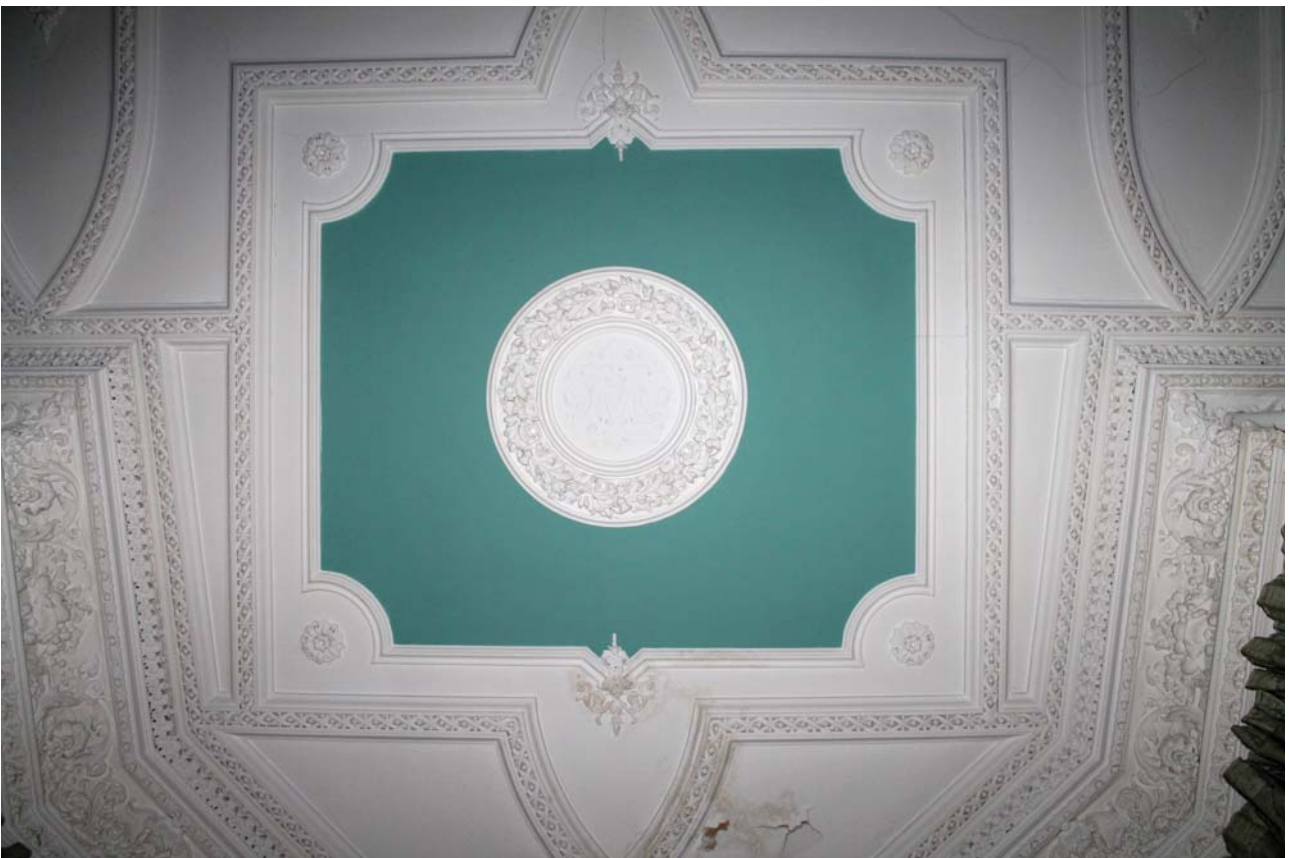
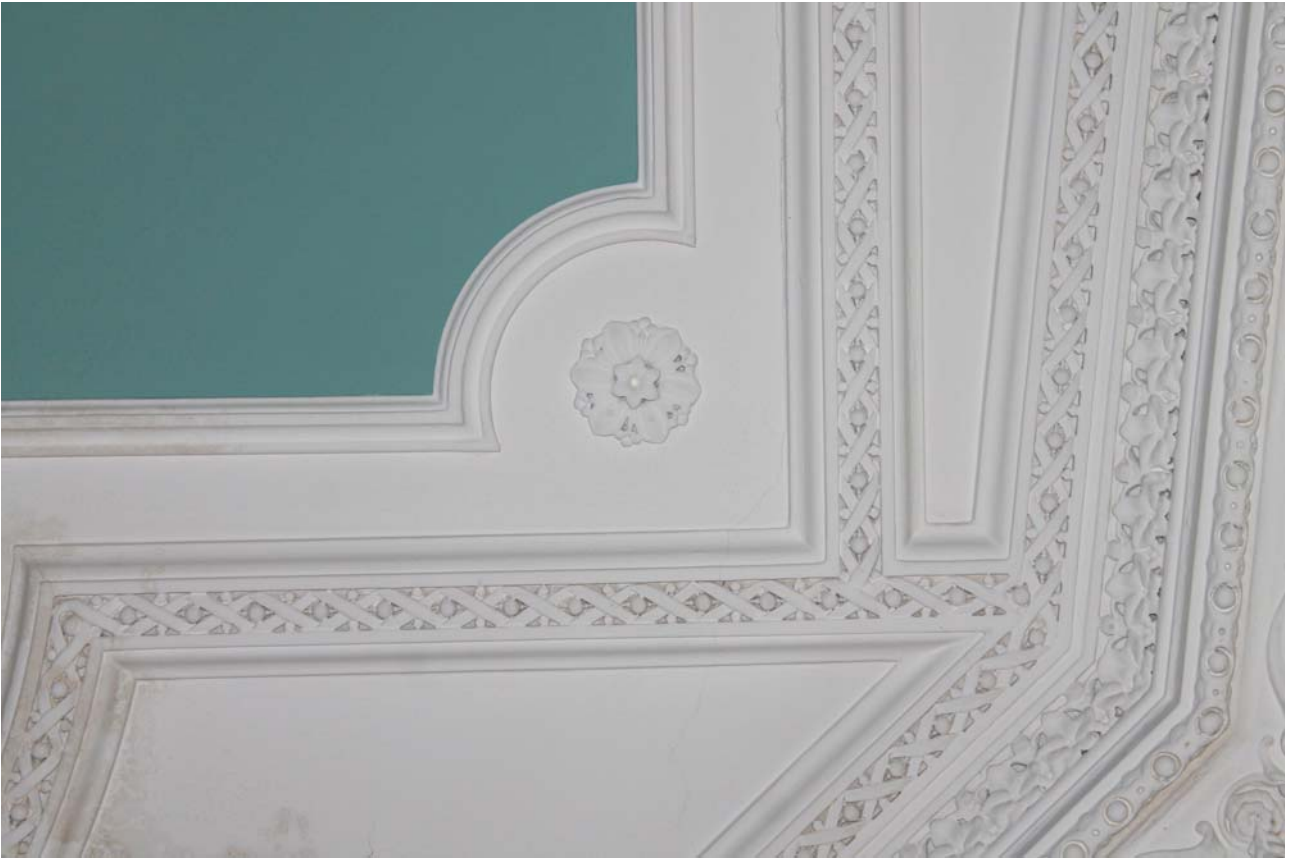
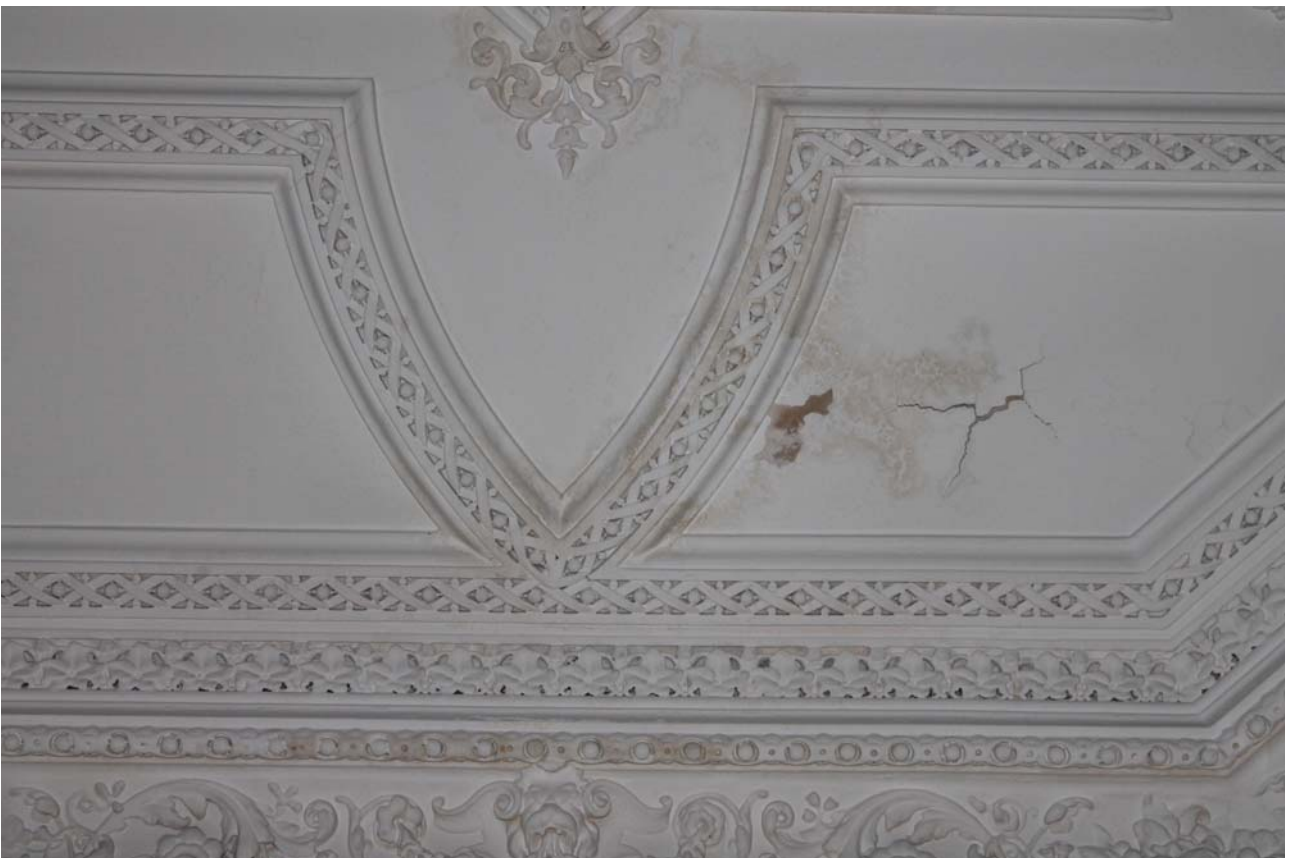
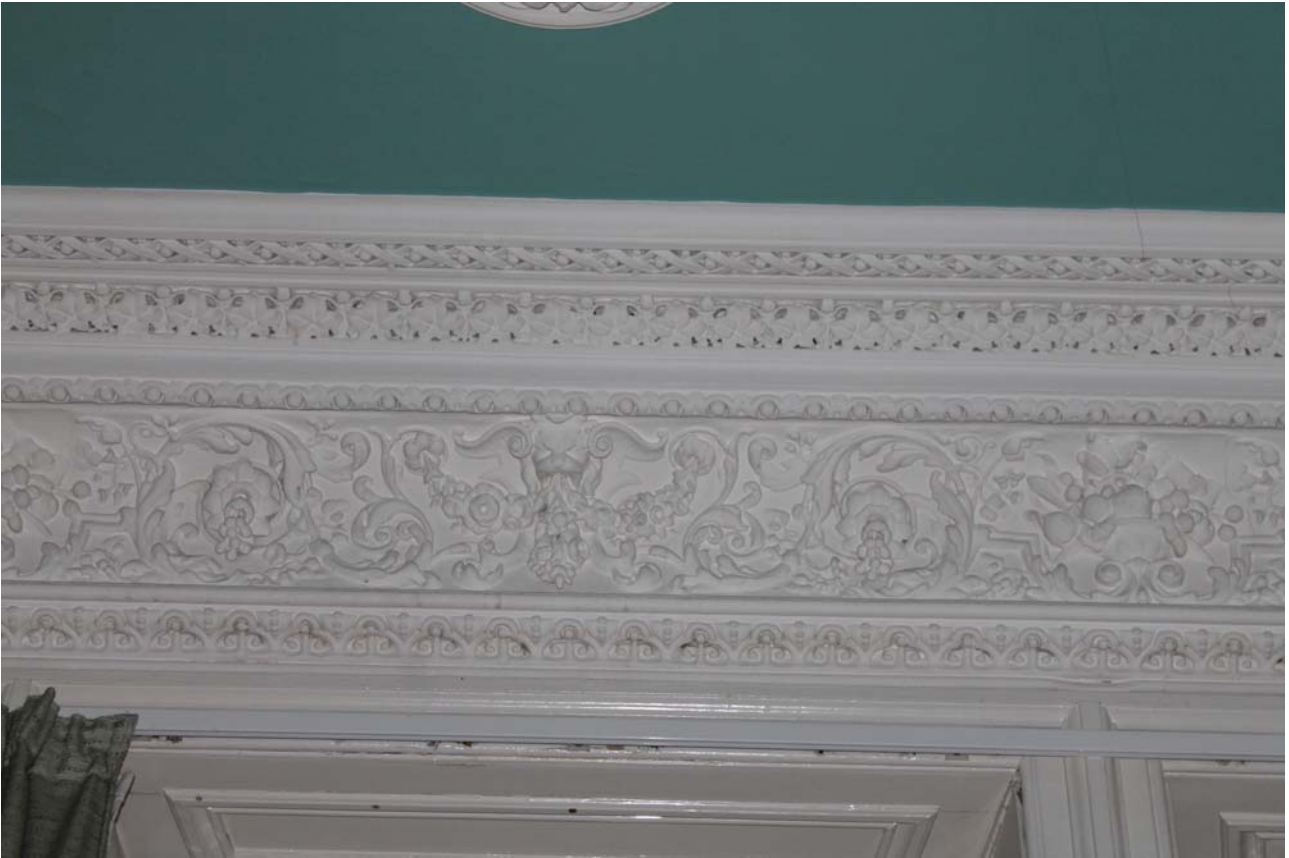
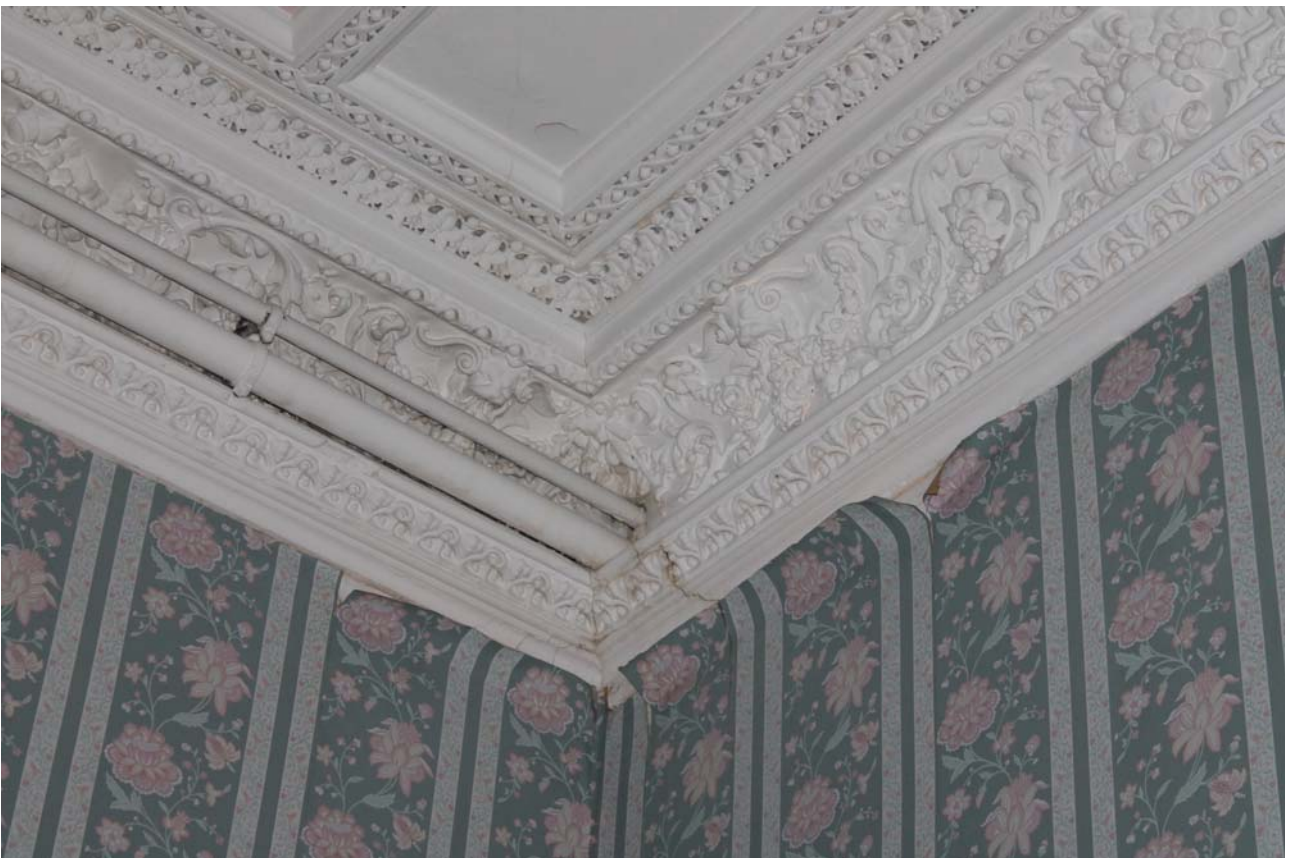
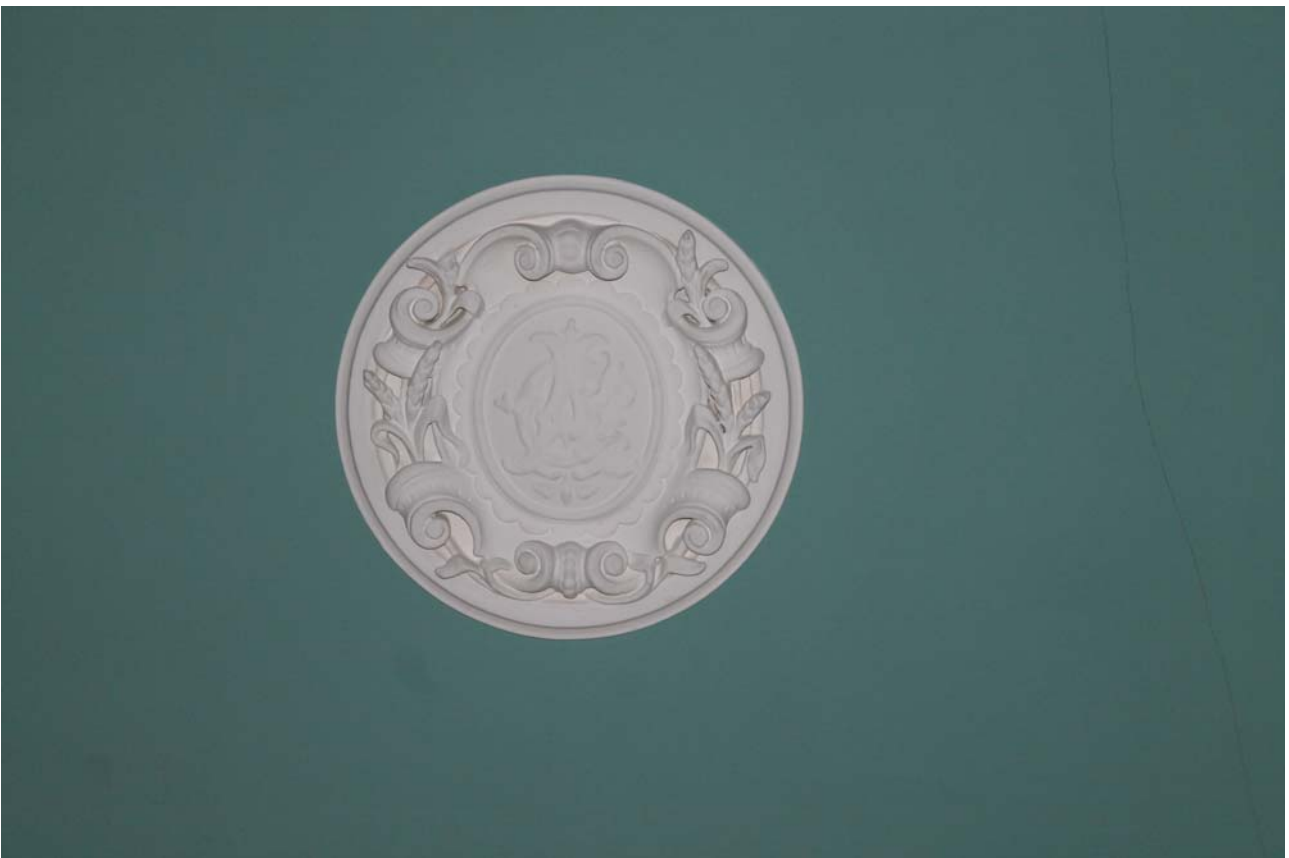
Plate 60: Room 0/6, general view of the ceiling from the north

Plate 61: Room 0/6, detail of ceiling

Plate 62: Room 0/6, detail of ceiling

Plate 63: Room 0/6, detail of ceiling

Plate 64: Room 0/6, detail of ceiling

Plate 65: Room 0/6, detail of cornice

Plate 66: Room 0/6, detail of cornice

Plate 68: Room 0/6, detail of ceiling (carved emblem)

The decorative ceilings, however, are clearly one of the main features of interest in the house, not least because of their survival, condition and detail. No expense appears to have been spared in Rooms 0/6 and 0/7, the former (possible) drawing room and dining room respectively, clearly an attempt to both express wealth and impress visitors. The style and arrangement of the ceilings are fairly standard for the early-mid Victoria period (geometric patterns punctuated by smaller details, acanthus leaf ceiling roses) and, as mentioned above, managed to incorporate the personal touches of the Gordon family. The stairwell is also equally elaborate with a large open-well stair with almost every detail in carved timberwork. Even the servants' stair, Room 2/2, also has a decorative balustrade and newel. This may have been due to its partial visibility to the main first floor landing, but often in Victorian country houses seemingly unnecessary.

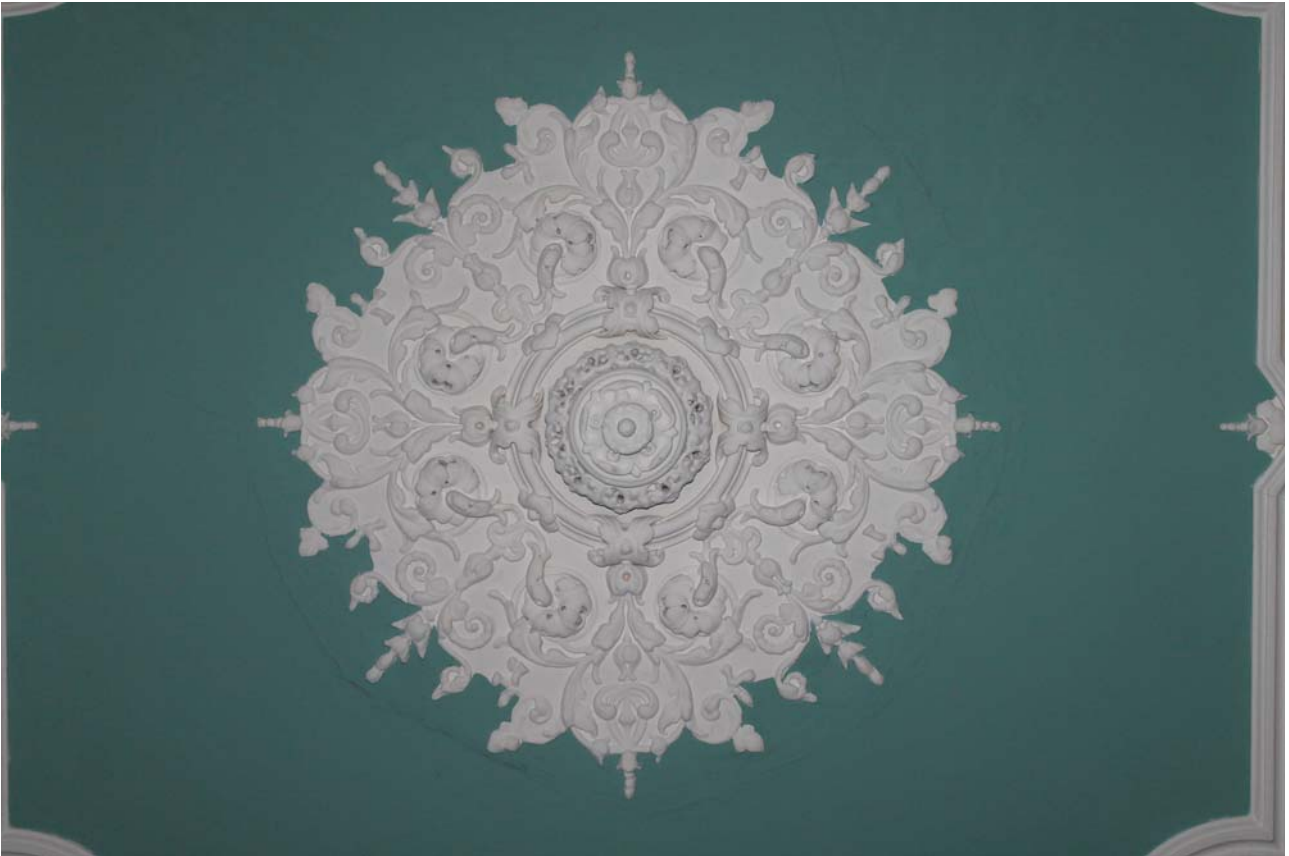
Plate 67: Room 0/6, detail of ceiling rose
