# Ashludie House, Monifieth, Angus: Historic Building Recording Report

AOC Project: 23302

8<sup>th</sup> January 2016

<b>On Behalf of:</b>	<b>Miller Homes Clydesdale House 300 Springfield Parkway Baillieston Glasgow G69 6GA</b>
<b>National Grid Reference (NGR):</b>	<b>NO 49537 33260</b>
<b>AOC Project No:</b>	<b>23302</b>
<b>Planning Application No:</b>	<b>15/00099/FULM</b>
<b>OASIS Reference:</b>	<b>235866</b>
<b>Prepared by:</b>	<b>Diana Sproat</b>
<b>Date:</b>	<b>8<sup>th</sup> January 2016</b>

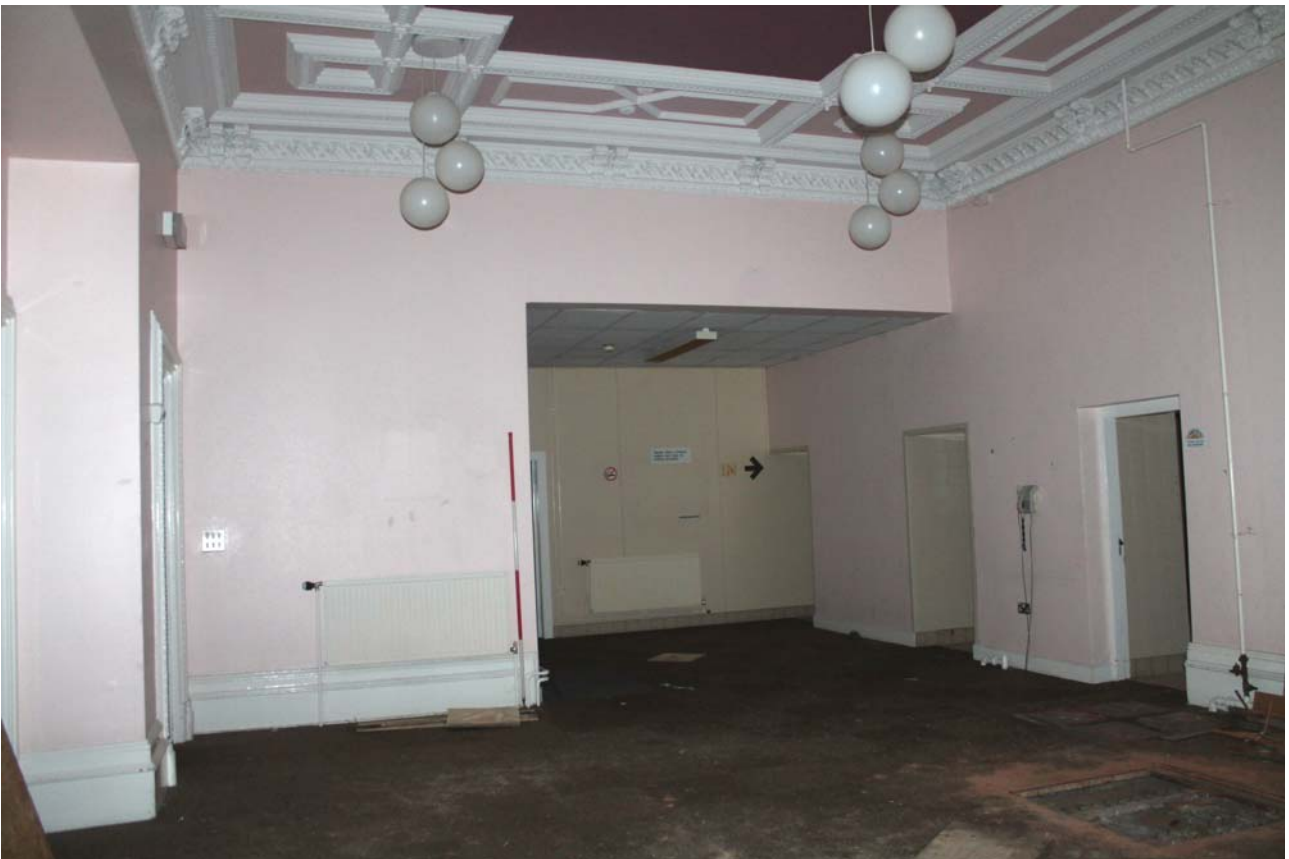
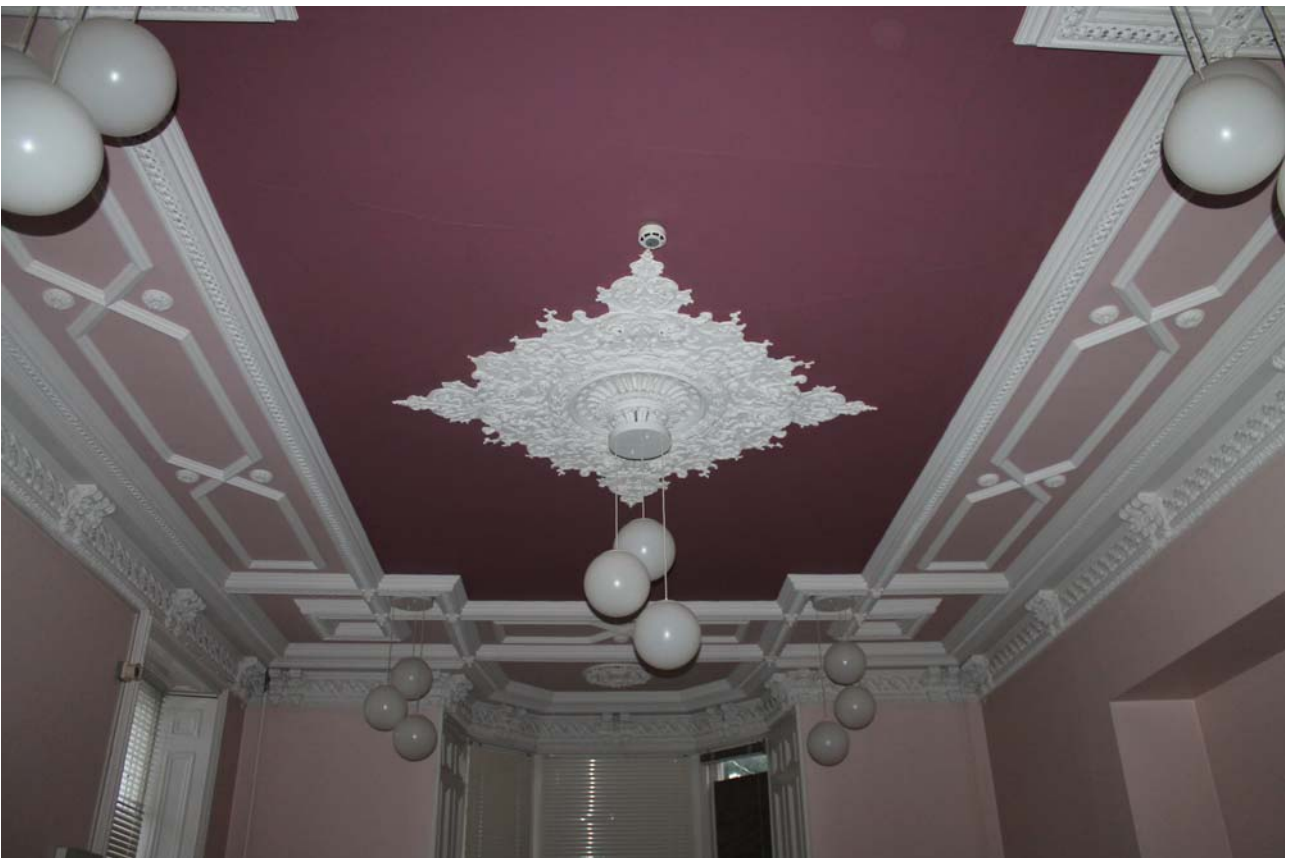
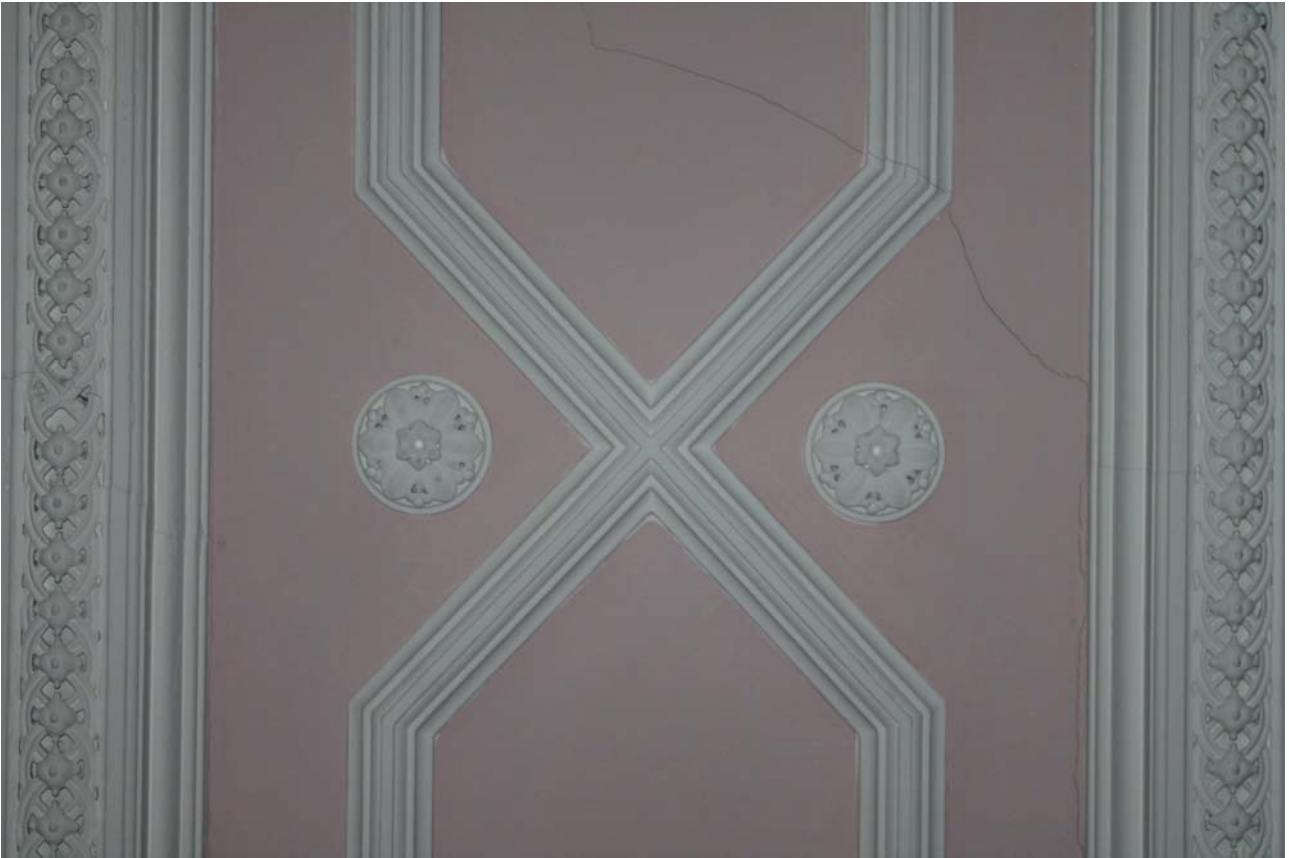
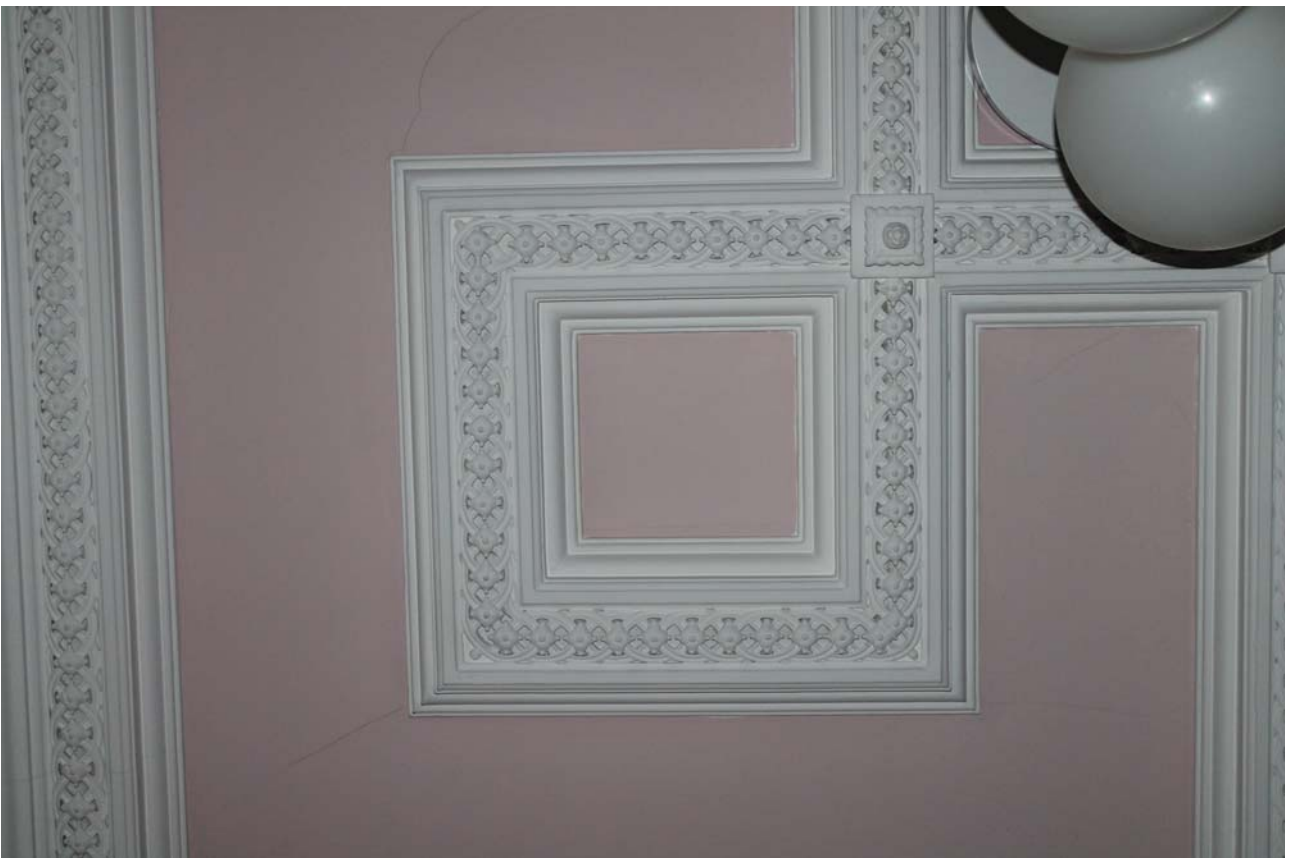
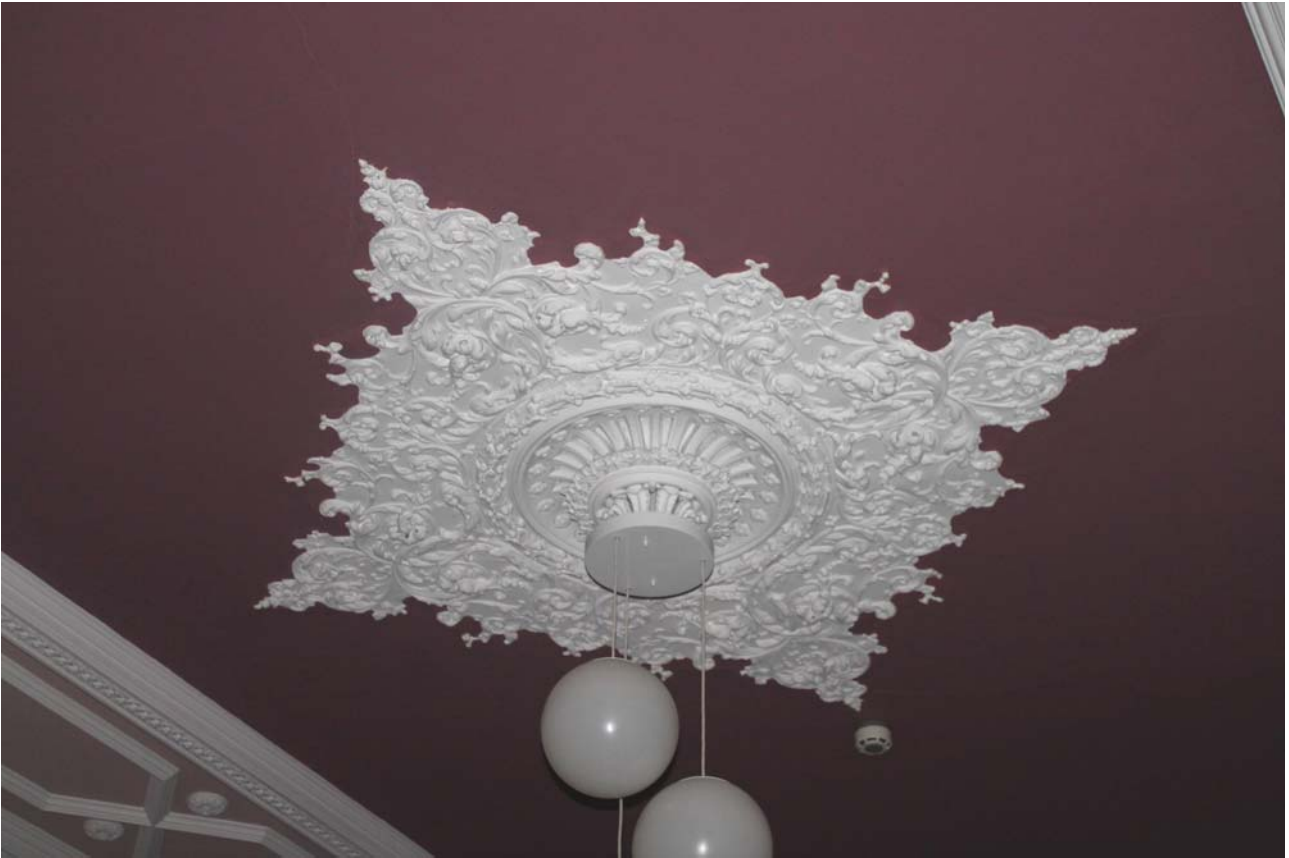
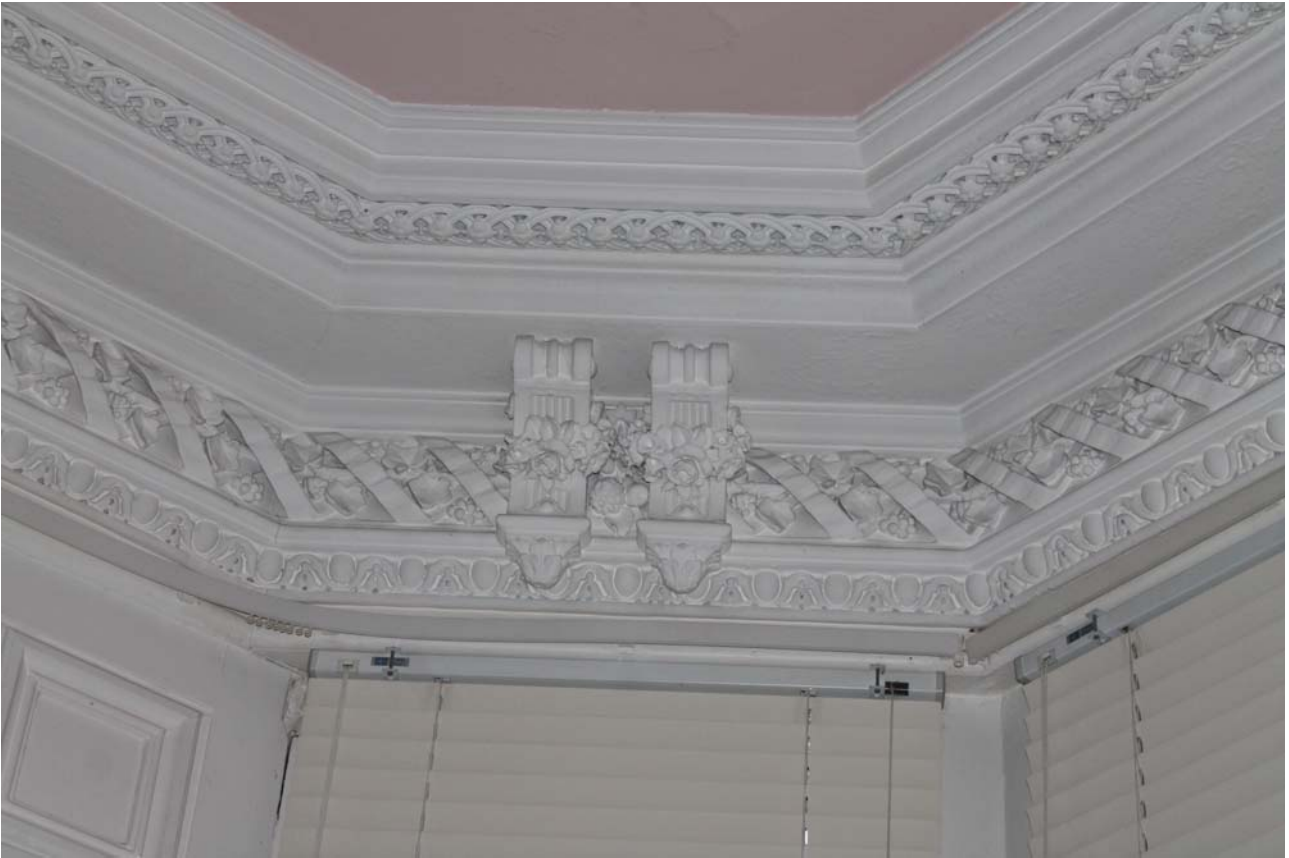
Plate 71: Room 0/7, general view from the SSW

Plate 72: Room 0/7, detail of ceiling from the north

Plate 73: Room 0/7, detail of ceiling

Plate 74: Room 0/7, detail of ceiling

Plate 75: Room 0/7, detail of ceiling rose

Plate 77: Room 0/7, detail of cornice showing console brackets on the south wall from the north

The decorative ceilings, however, are clearly one of the main features of interest in the house, not least because of their survival, condition and detail. No expense appears to have been spared in Rooms 0/6 and 0/7, the former (possible) drawing room and dining room respectively, clearly an attempt to both express wealth and impress visitors. The style and arrangement of the ceilings are fairly standard for the early-mid Victoria period (geometric patterns punctuated by smaller details, acanthus leaf ceiling roses) and, as mentioned above, managed to incorporate the personal touches of the Gordon family. The stairwell is also equally elaborate with a large open-well stair with almost every detail in carved timberwork. Even the servants' stair, Room 2/2, also has a decorative balustrade and newel. This may have been due to its partial visibility to the main first floor landing, but often in Victorian country houses seemingly unnecessary.

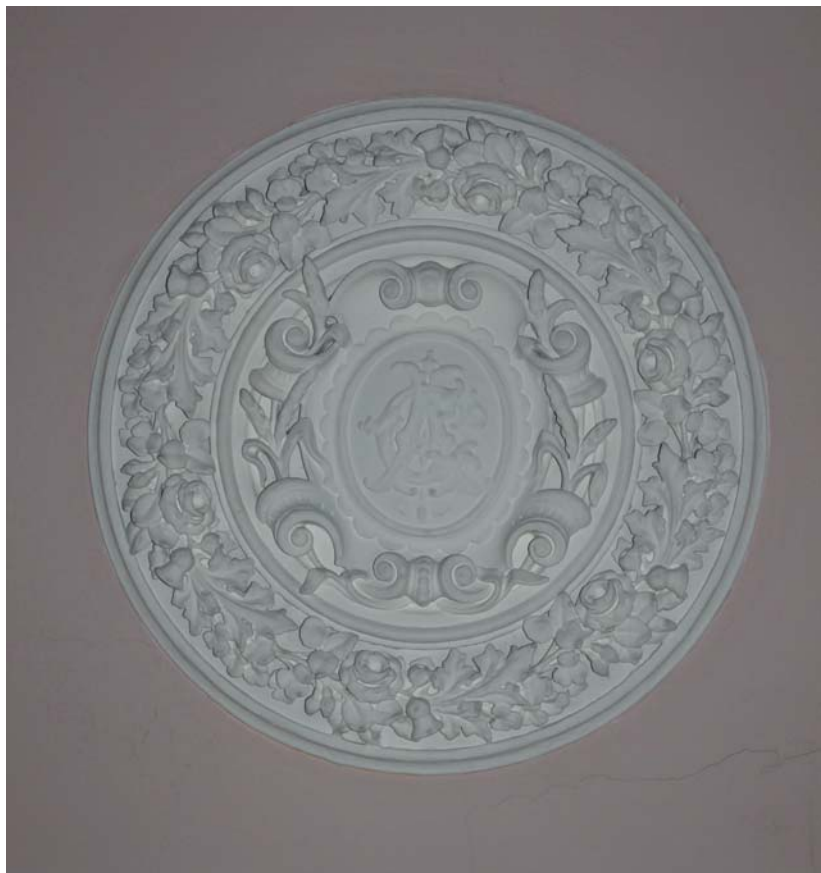
Plate 76: Room 0/7, detail of ceiling (carved emblem)

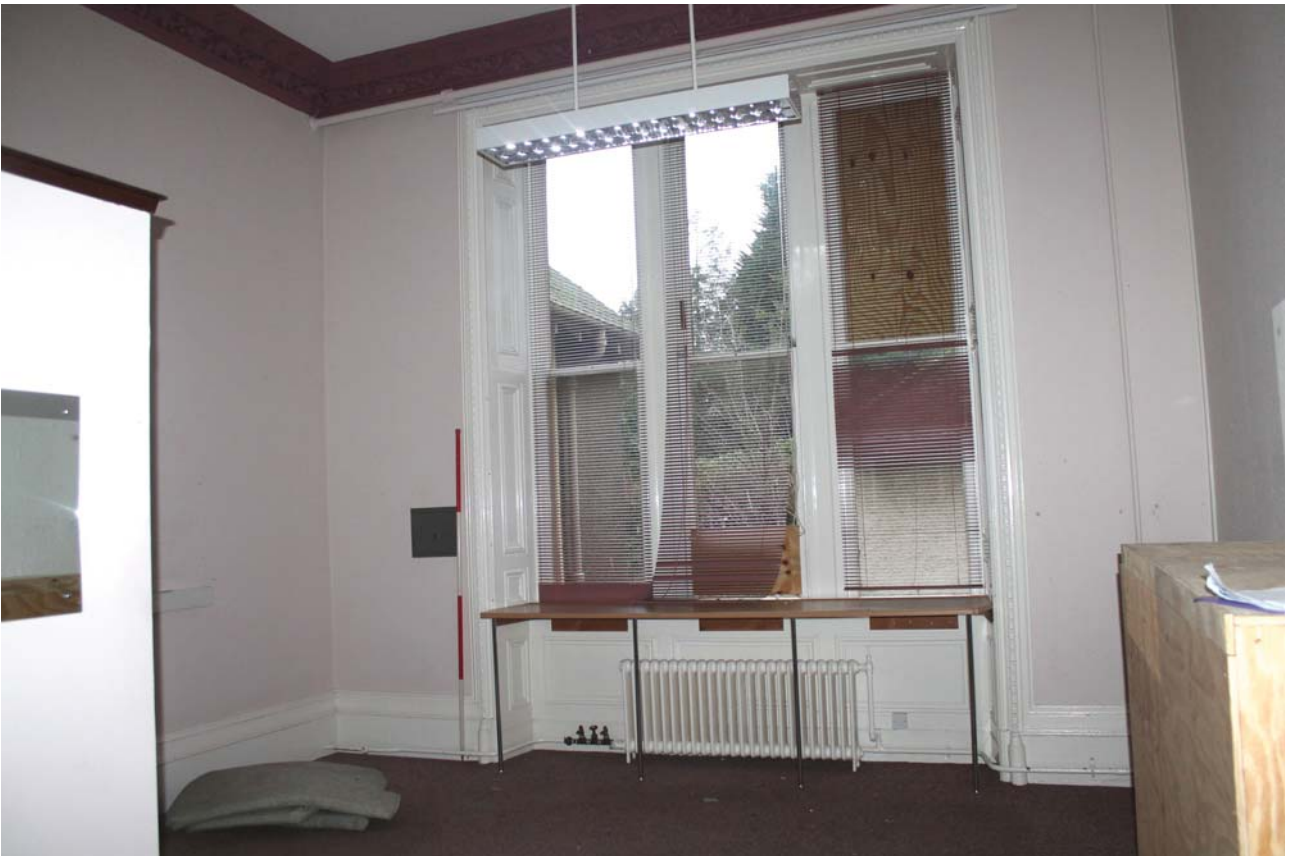
Plate 78: Room 0/8, general view from the north-east

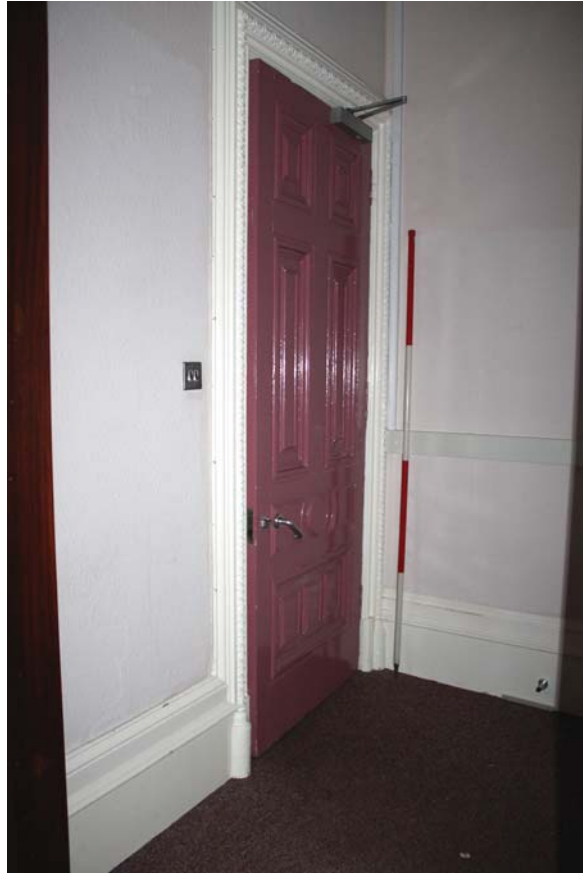
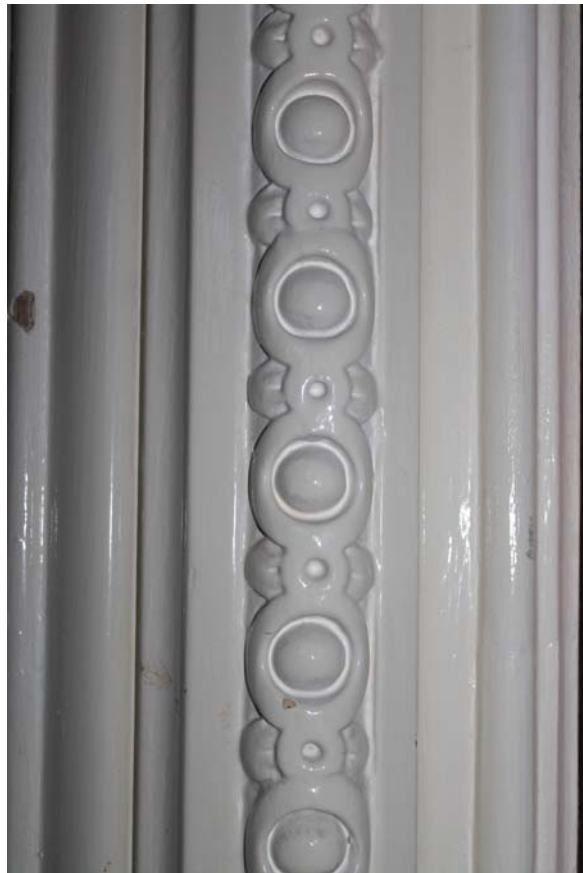
panelled door, as elsewhere (Plate 79 & 80). Another adjacent door to the north side provides access to Room 0/9.

Plate 79: Room 0/8, detail of door in the east wall from the north-west

Plate 80: Room 0/8, detail on the side of the door in the east wall from the west

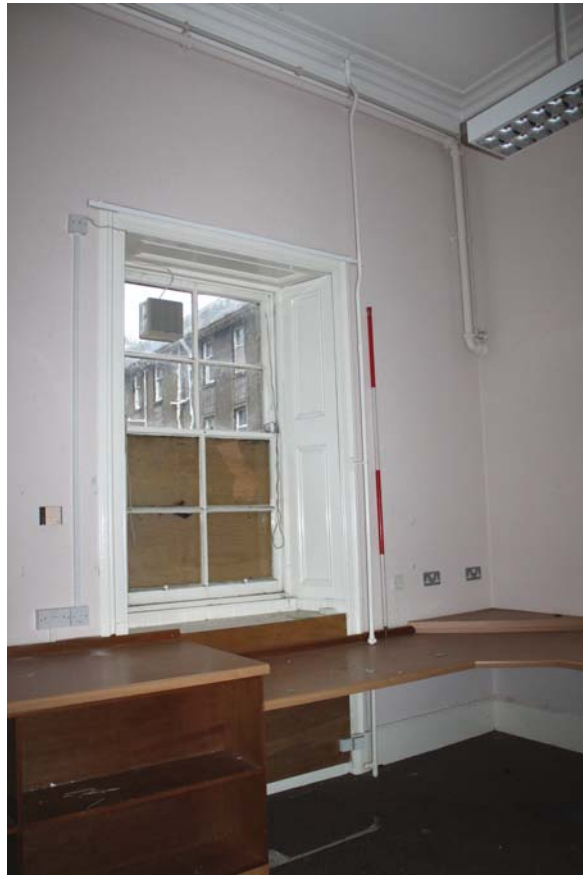
This small office has a relatively plain skirting, a deep moulded cornice, with two access doors – to the east and west walls respectively, the latter leading to Room 0/9. There is a splayed timber-panelled window to the north wall with modern desk units in front (Plate 81). More cast-iron pipes run around the room and through to Room 0/8 to the west. To the south wall is a small blocked-off area in plasterboard.

Plate 81: Room 0/9, general view from the south-west

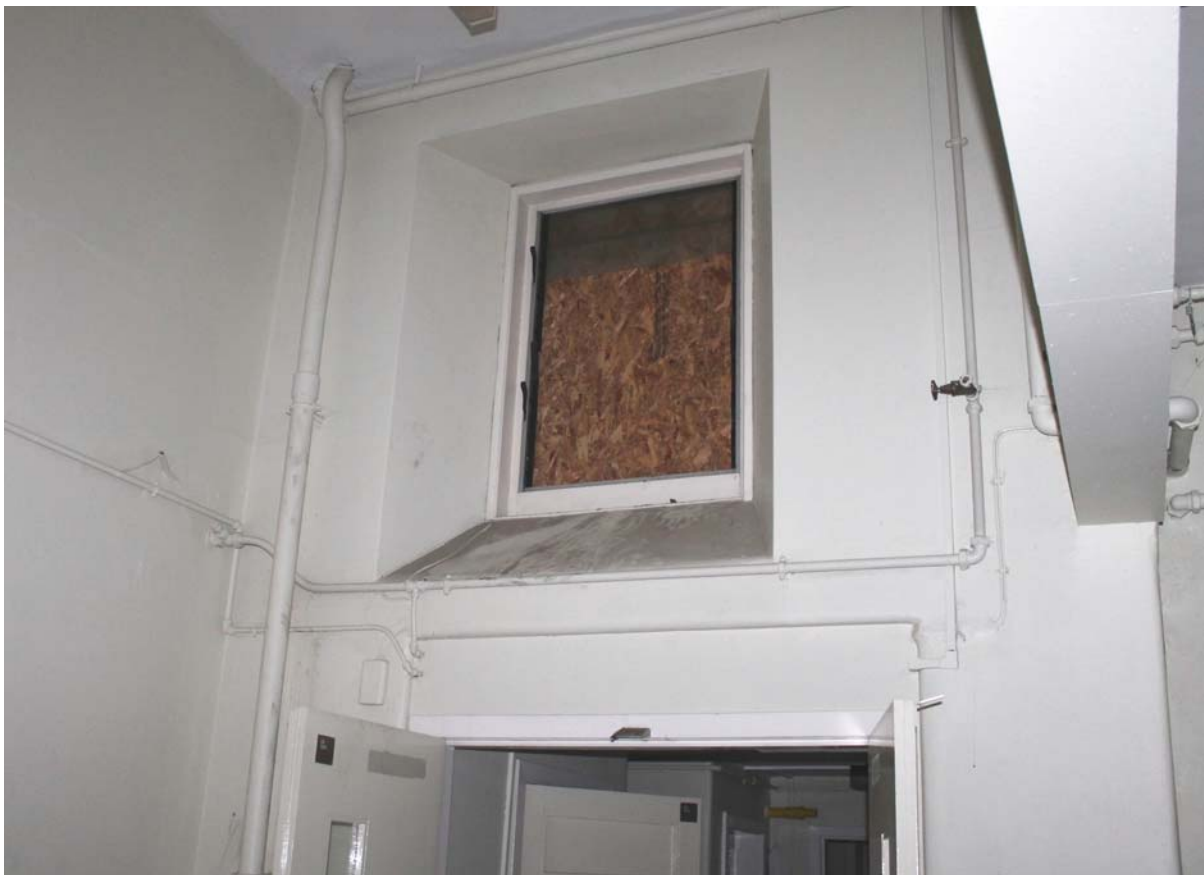
This small room is now part of the later hospital kitchens, which has been totally modified. Now with no windows, skirting or cornice, the only evidence of it being part of the original house is the window set high in the north wall (Plate 82).

Plate 82: Room 0/10a, detail of upper level window to the north wall from the SSE

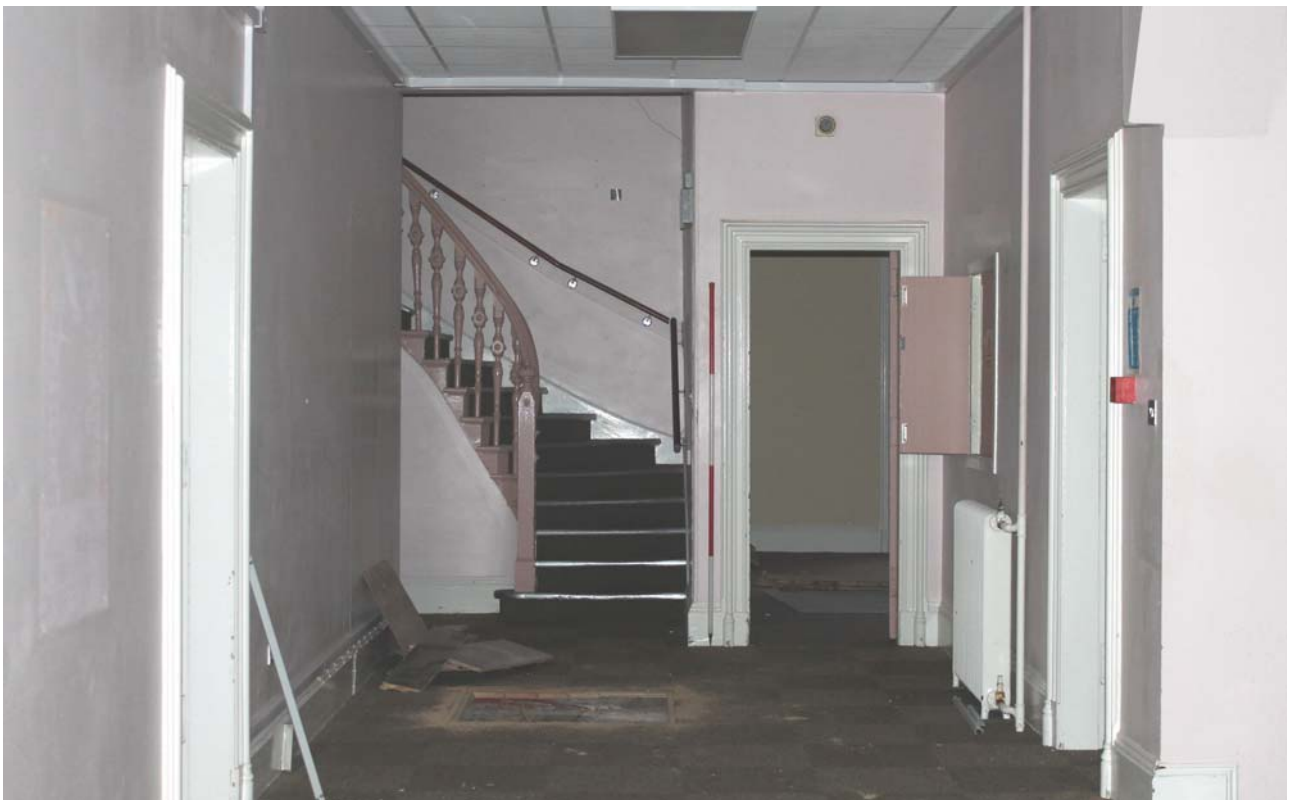
This is the main landing/corridor to the first floor of the main house with a tall moulded skirting, suspended ceiling, concealing any evidence of a former cornice or ceiling, all four timber-panelled doors to the surrounding rooms (mostly all former bedsits), with the stair to the north side (Plate 84). The top of the landing here has a decorative baluster (Plate 85).

Plate 84: Room 1/1, general view from the east

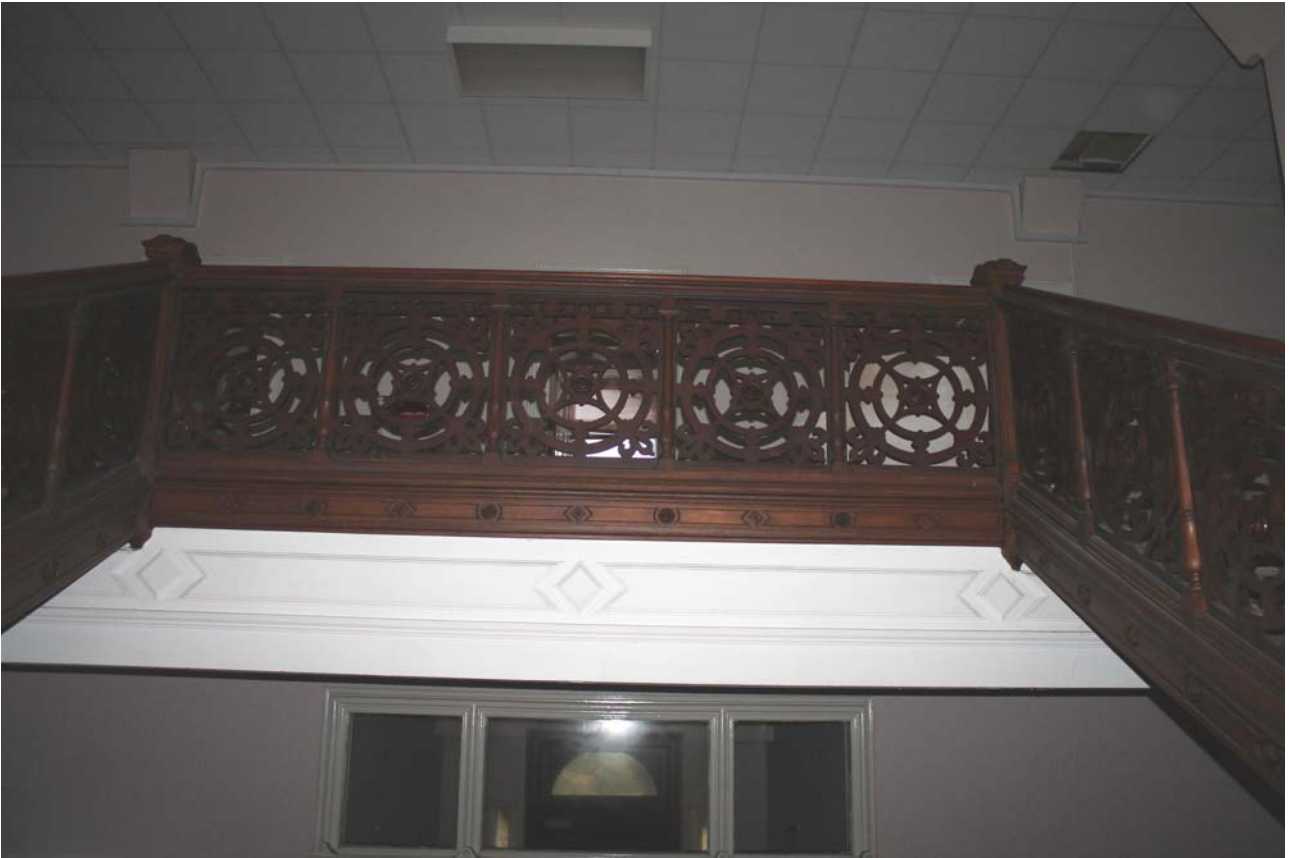
Plate 85: Room 1/1, detail of landing balustrade from the north

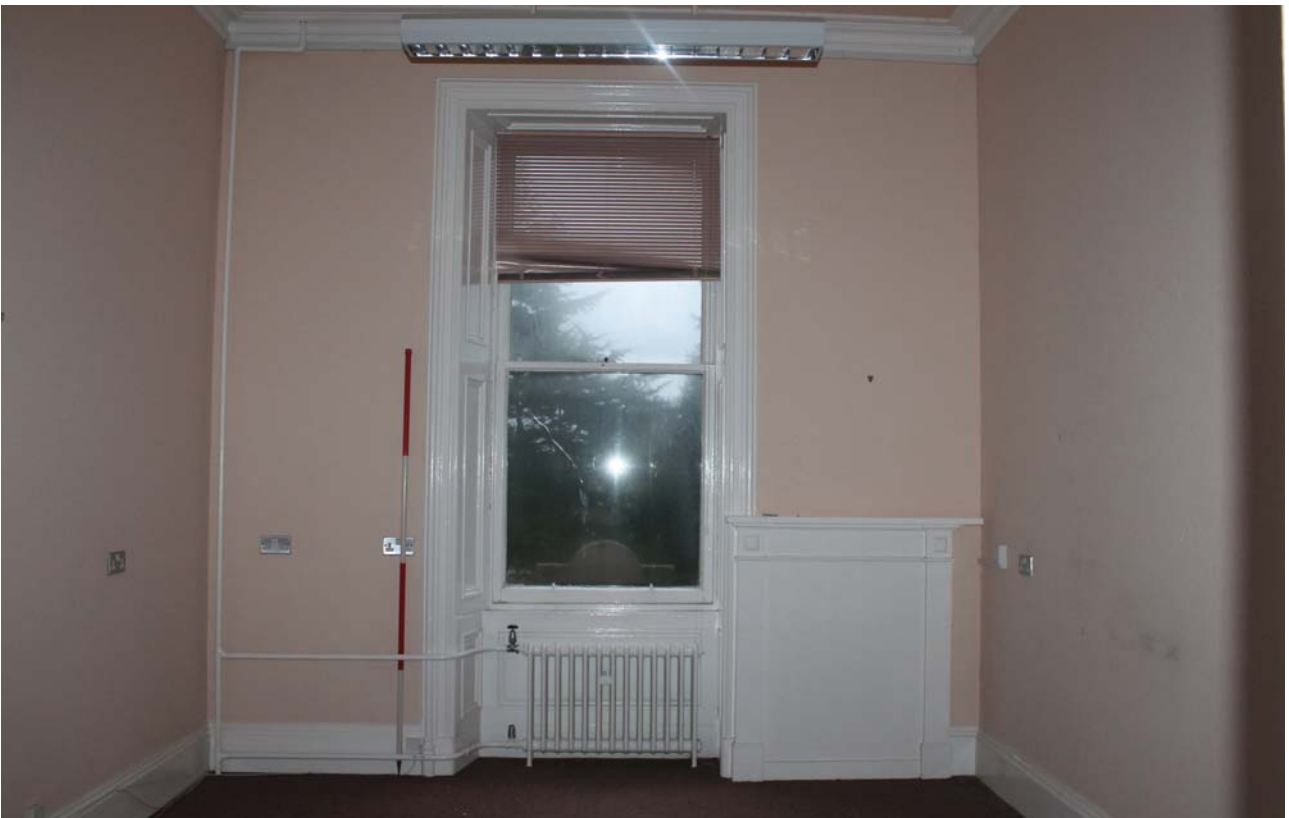
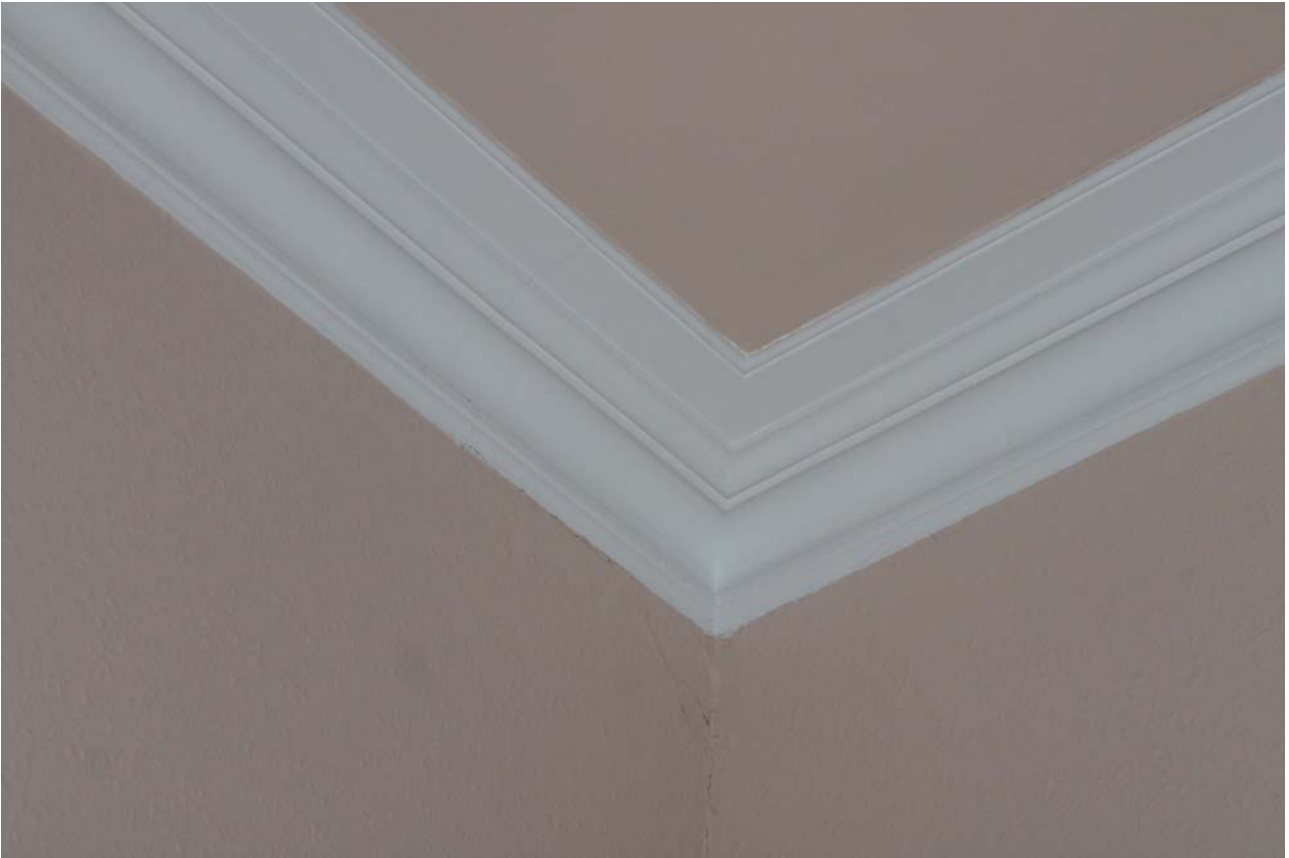
These former bedrooms are all furnished the same, a central row of rooms to the south of the main house, all with splayed windows to the south wall, high skirtings and plain moulded cornice to all rooms, depicting an original arrangement (Plates 86 & 87). There is evidence of only one fireplace, however, to the west side of the south wall of Room 1/3, although of course any others could have been removed and blocked over.

Plate 86: Room 1/3, general view showing window and fireplace in the south wall from the north

Plate 87: Room 1/3, detail of cornice

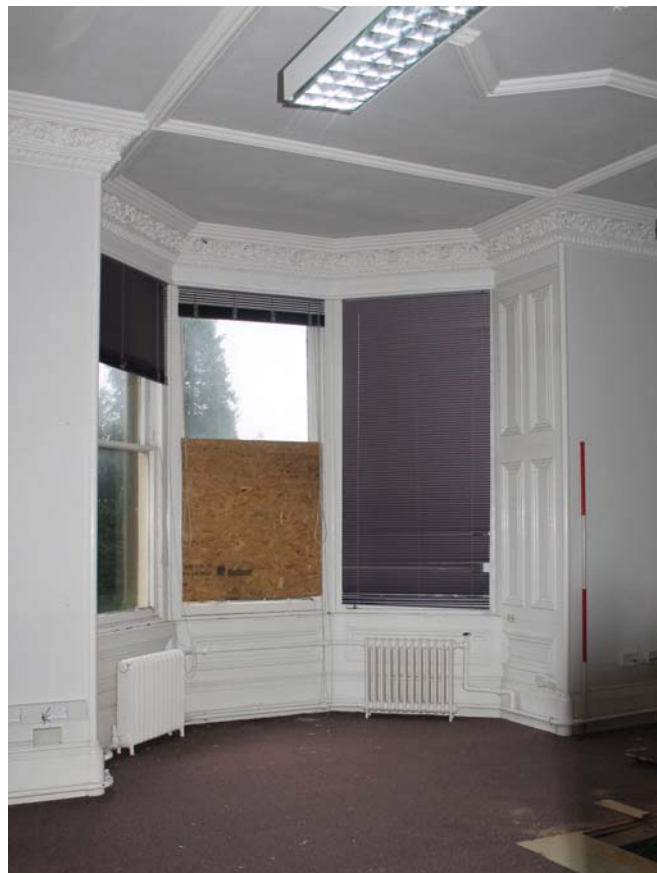
This large room is located over Room 0/6 to the south-west of the main house with a tall moulded skirting and a plain modern inward-opening fire door to the north wall and a large bay window to the south wall (Plate 88). In the west wall is a boarded-over fireplace (presumably marble) flanked by a window to the north side (Plate 89) and a recess to the south.

Plate 88: Room 1/16a, general view showing bay window in the south wall from the NNE

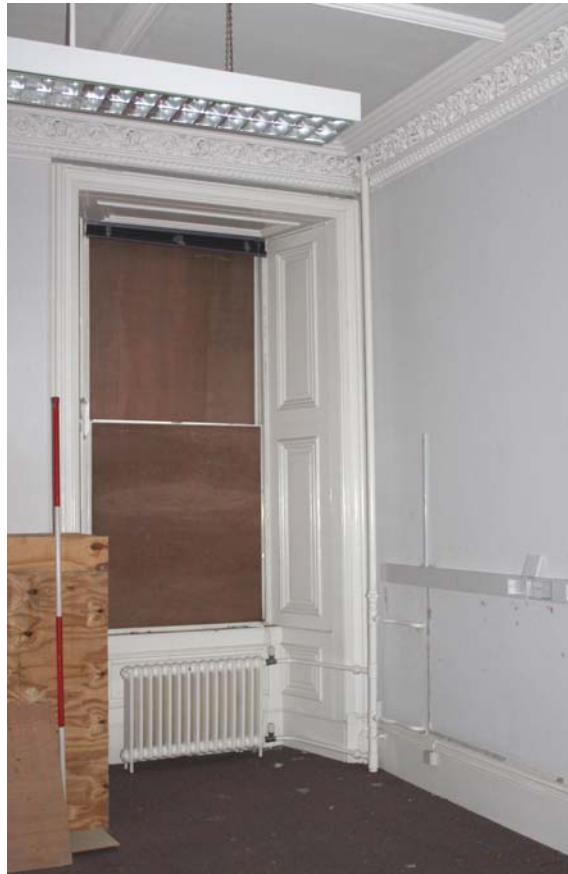
Plate 89: Room 1/6a, detail of window in the west wall form the SEE

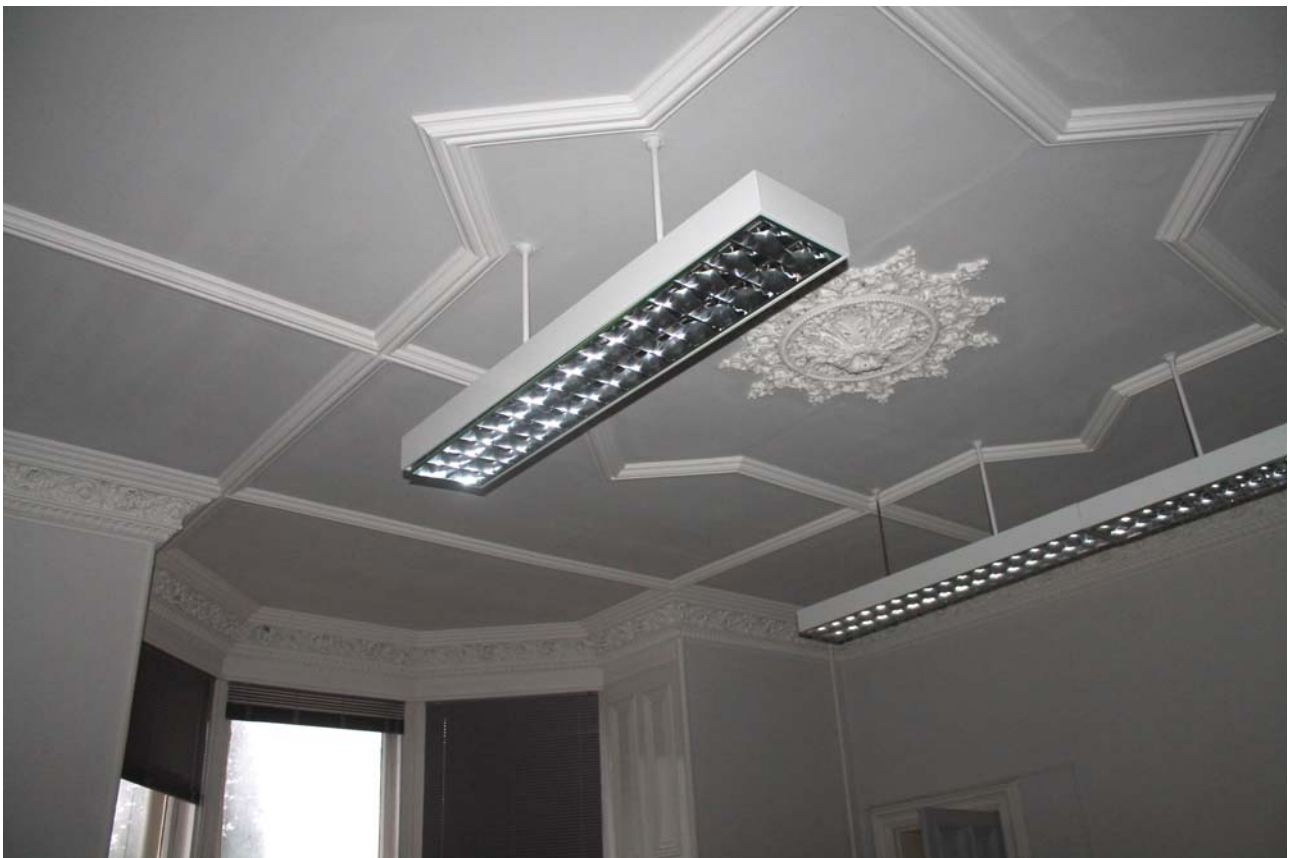
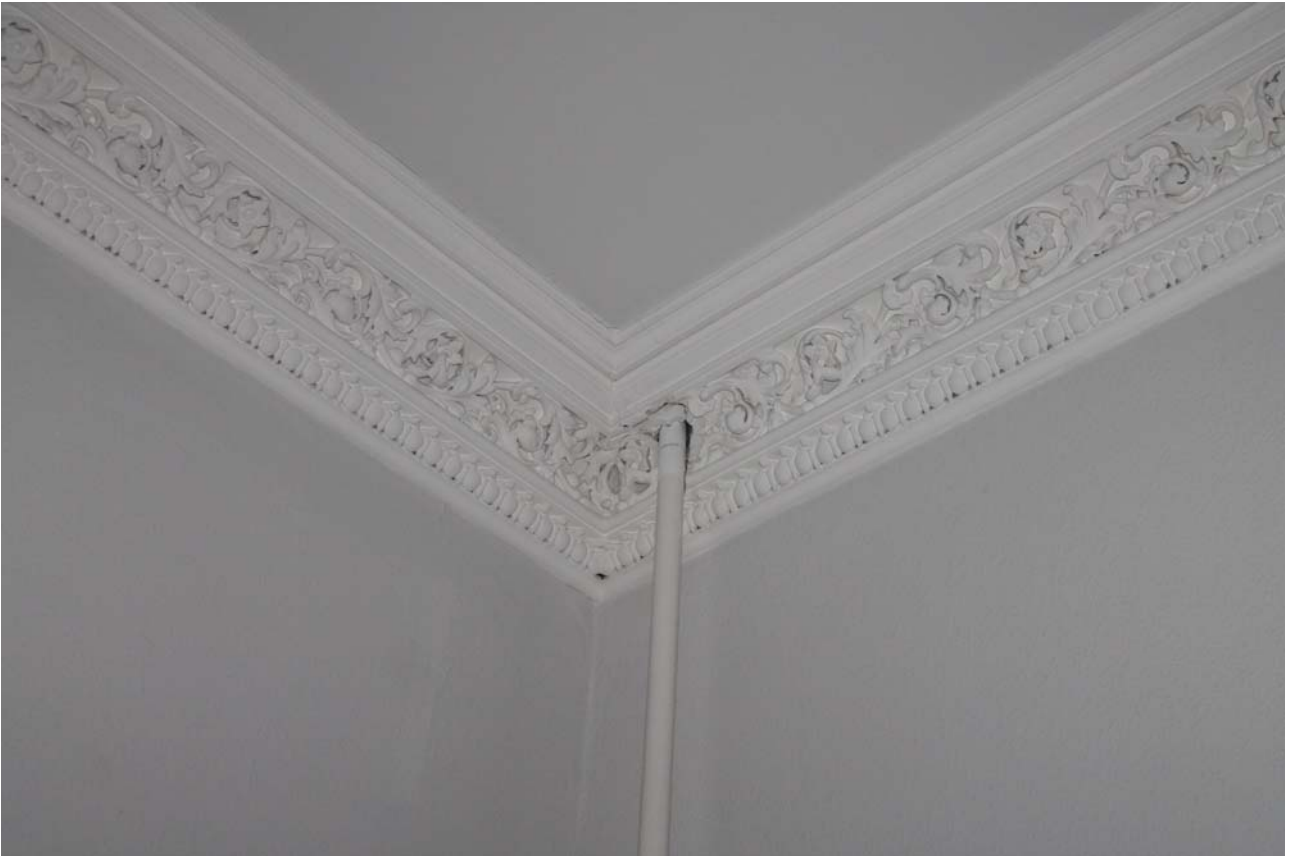
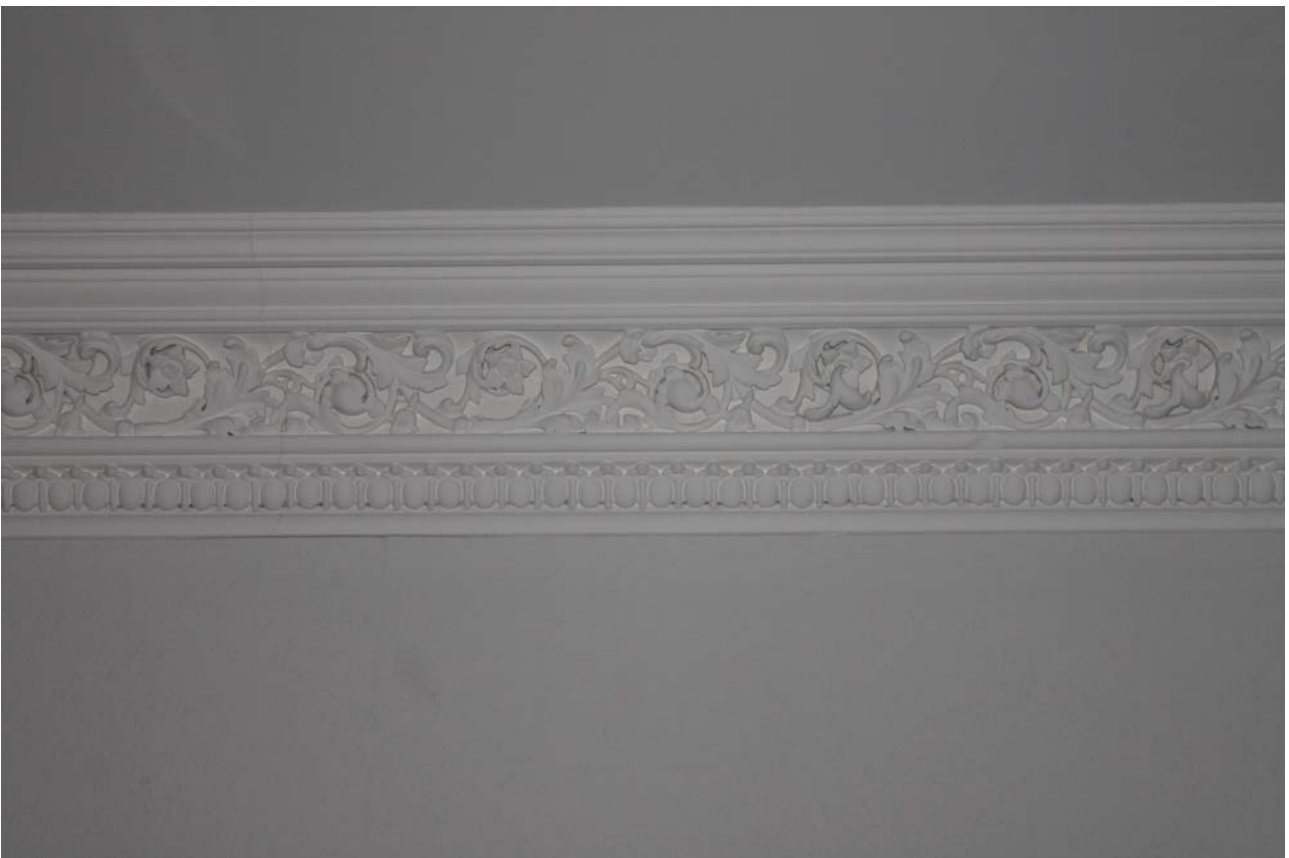
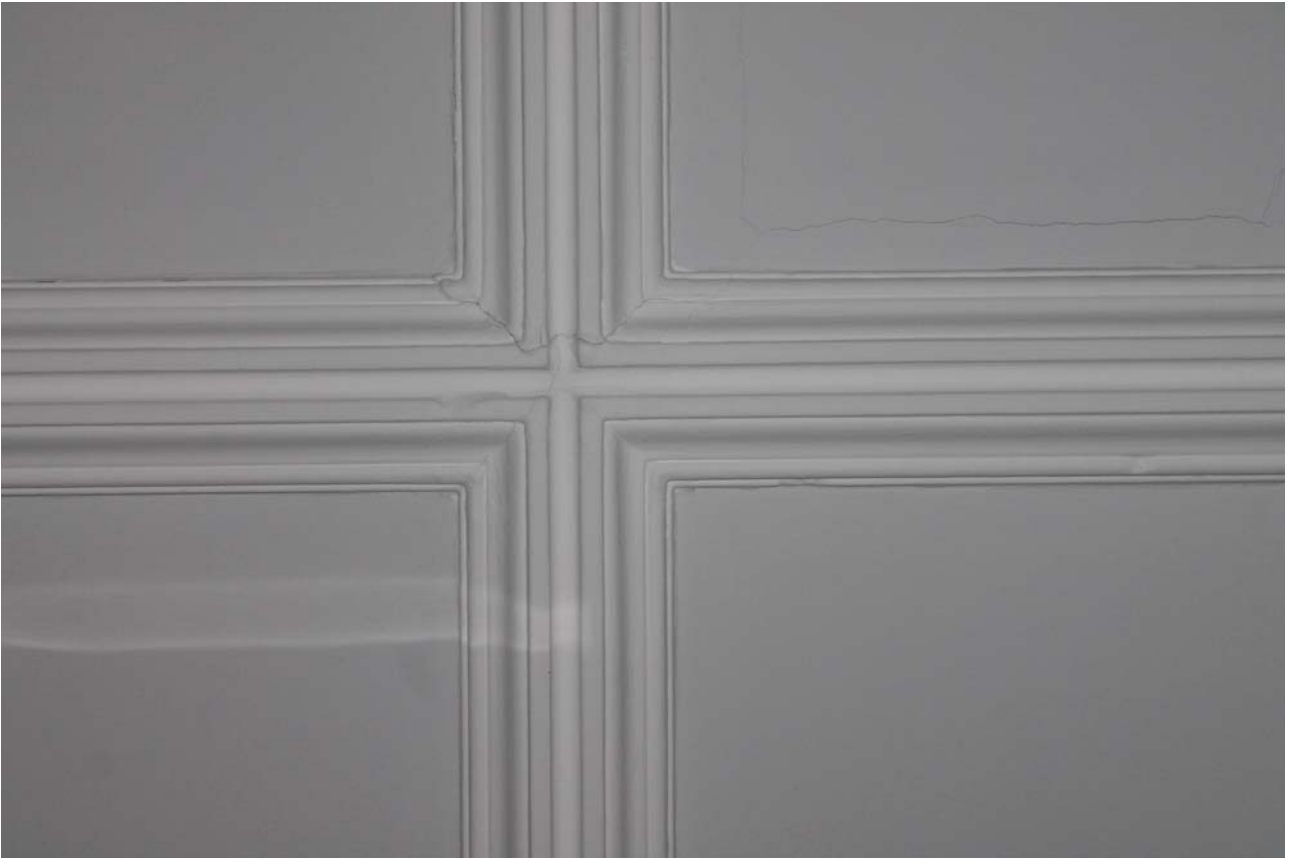
It has a highly decorative moulded ceiling, matching the quality of those seen to the ground floor with a deep rose and vine cornice with egg-and-dart detailing below and geometric patterns around a highly decorative ceiling rose (Plates 90 – 93).

Plate 90: Room 1/6a, detail of ceiling from the north-east

Plate 91: Room 1/6a, detail of cornice

Plate 92: Room 1/6a, detail of cornice

Plate 93: Room 1/6a, detail of ceiling
