# Ashludie House, Monifieth, Angus: Historic Building Recording Report

AOC Project: 23302

8<sup>th</sup> January 2016

<b>On Behalf of:</b>	<b>Miller Homes Clydesdale House 300 Springfield Parkway Baillieston Glasgow G69 6GA</b>
<b>National Grid Reference (NGR):</b>	<b>NO 49537 33260</b>
<b>AOC Project No:</b>	<b>23302</b>
<b>Planning Application No:</b>	<b>15/00099/FULM</b>
<b>OASIS Reference:</b>	<b>235866</b>
<b>Prepared by:</b>	<b>Diana Sproat</b>
<b>Date:</b>	<b>8<sup>th</sup> January 2016</b>

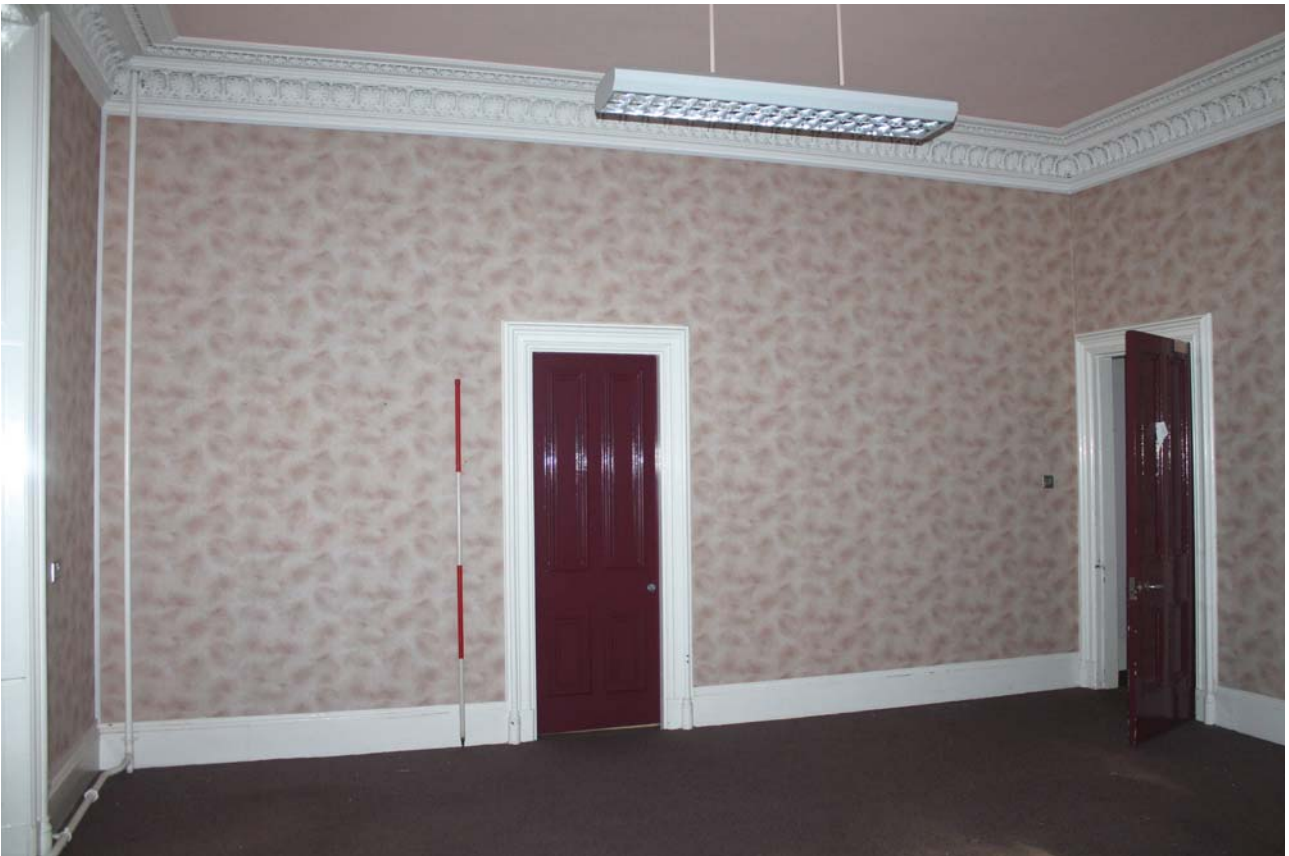
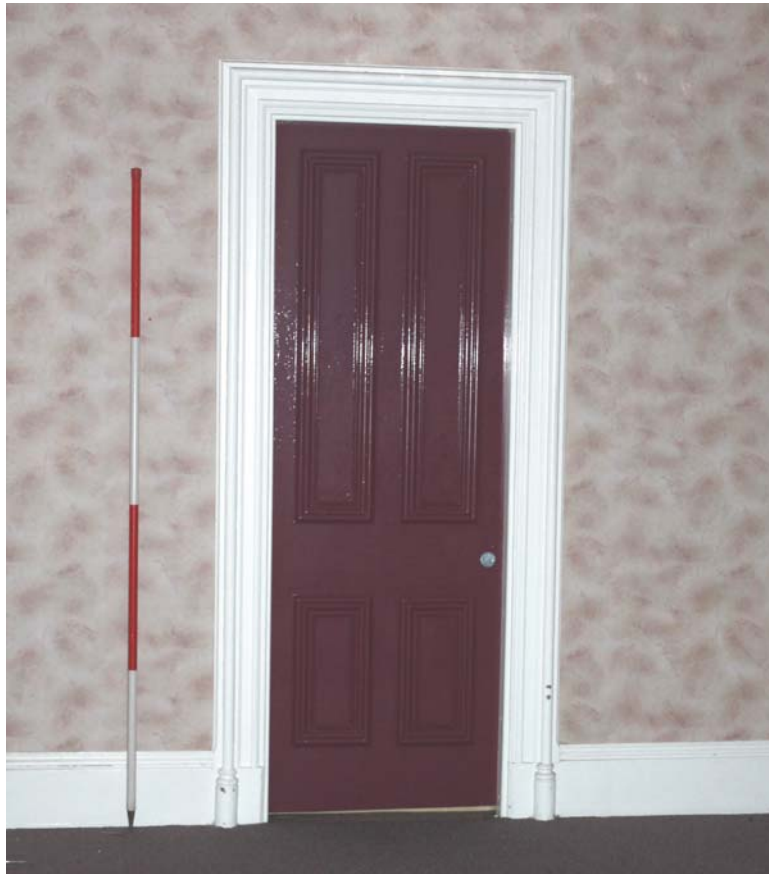
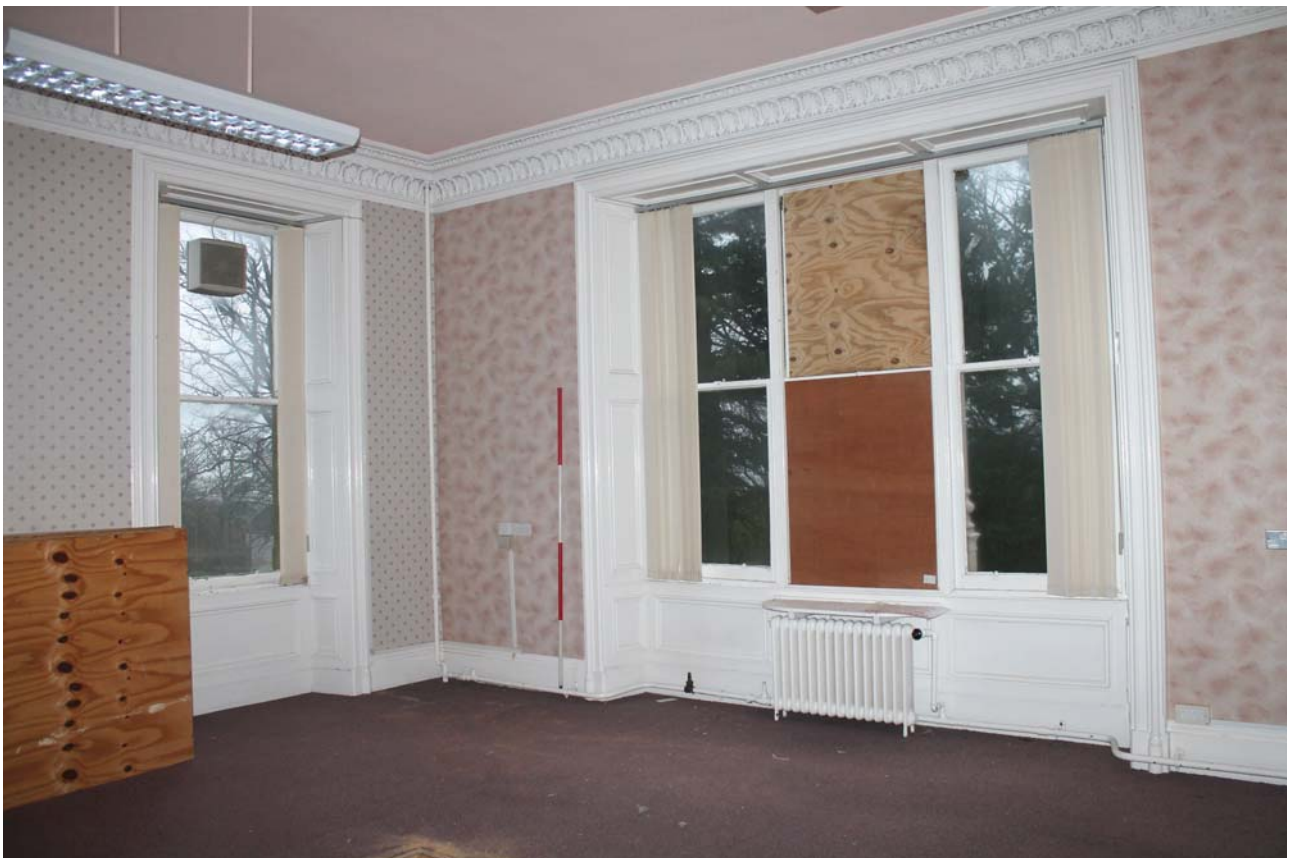
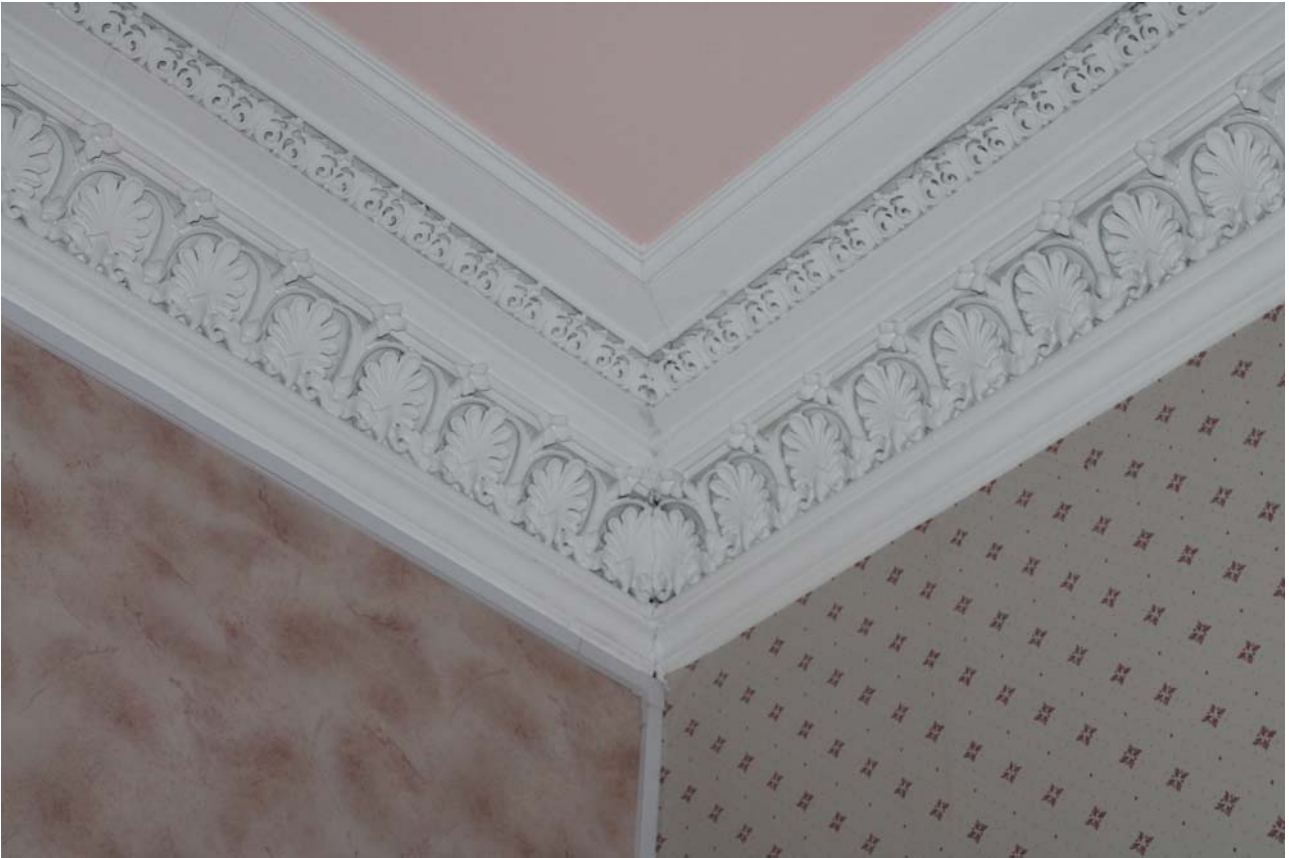
The south-east equivalent of Room 1/6, this large former bedroom has a high skirting with two access doors to the west wall – one to the north providing access from the main corridor and another to the centre of the wall – now blocked – through to Room 1/5, indicating 1/5 to be a possible en-suite bathroom (Plates 94 & 95). To the south wall is a tripartite window with a single window to the south side of the east wall (Plate 96). There is no decorative ceiling here, only a decorative cornice (Plate 97).

Plate 94: Room 1/7, general view of the west wall from the SEE

Plate 95: Room 1/7, detail of door in the west wall from the east

Plate 96: Room 1/7, general view from the north-west

Plate 97: Room 1/7, detail of cornice

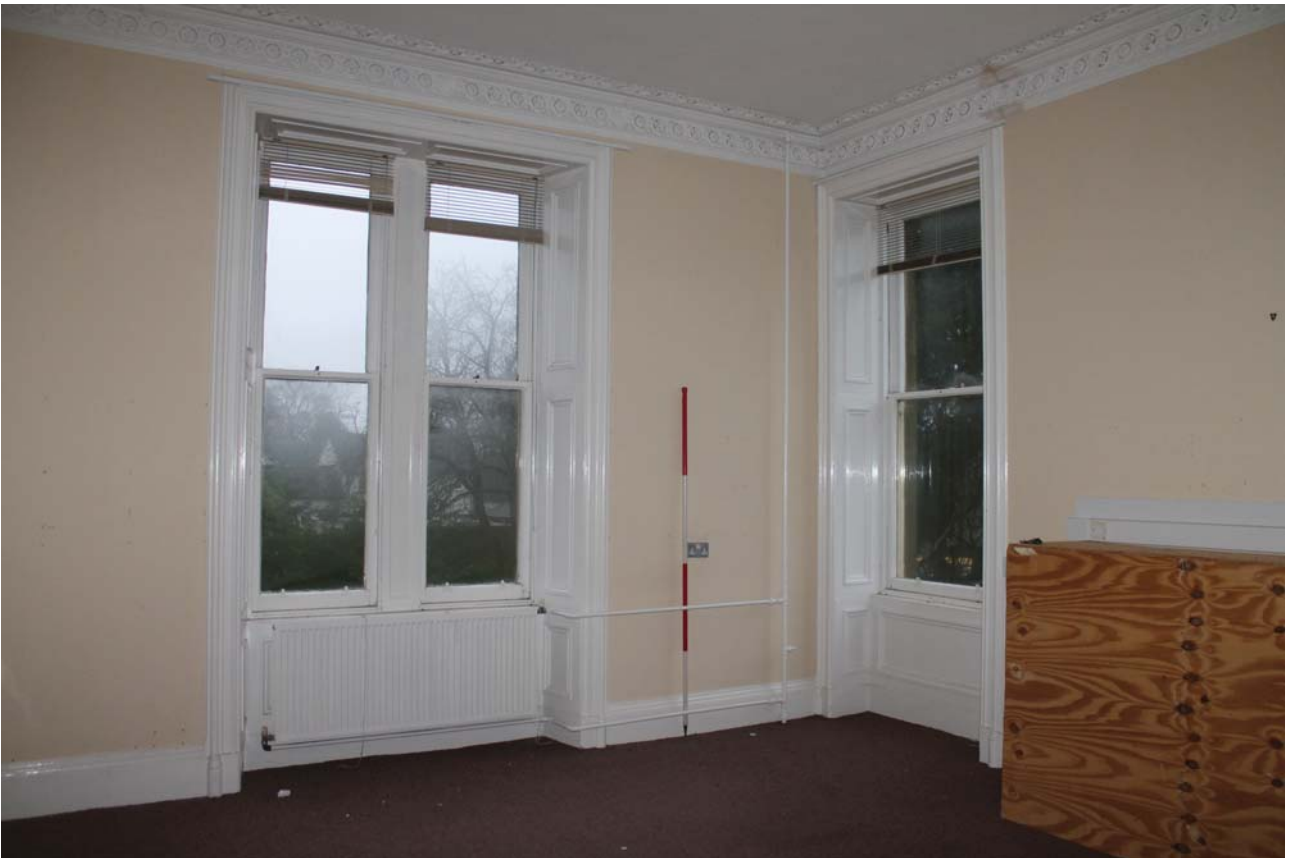
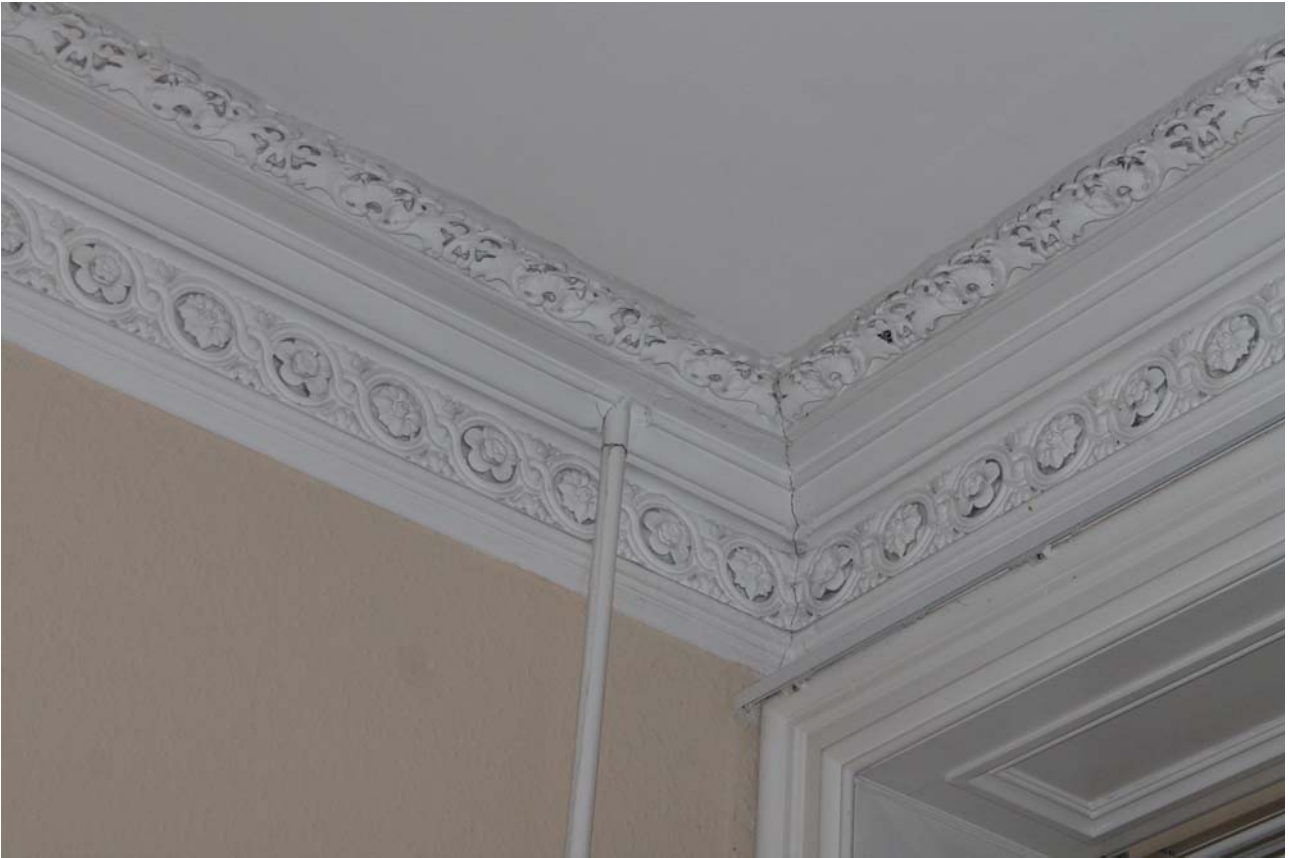
Another bedroom, this has a tall skirting, access from the main corridor to the east wall and another boarded-over fireplace to the north wall. There is a double window to the west wall, with a modern radiator installed below and another single window to the west side of the north wall (Plate 98). It has a highly decorative cornice consisting of an acanthus leaf and flower design (Plate 99).

Plate 98: Room 1/8, general view from the south-east

Plate 99: Room 1/8, detail of cornice

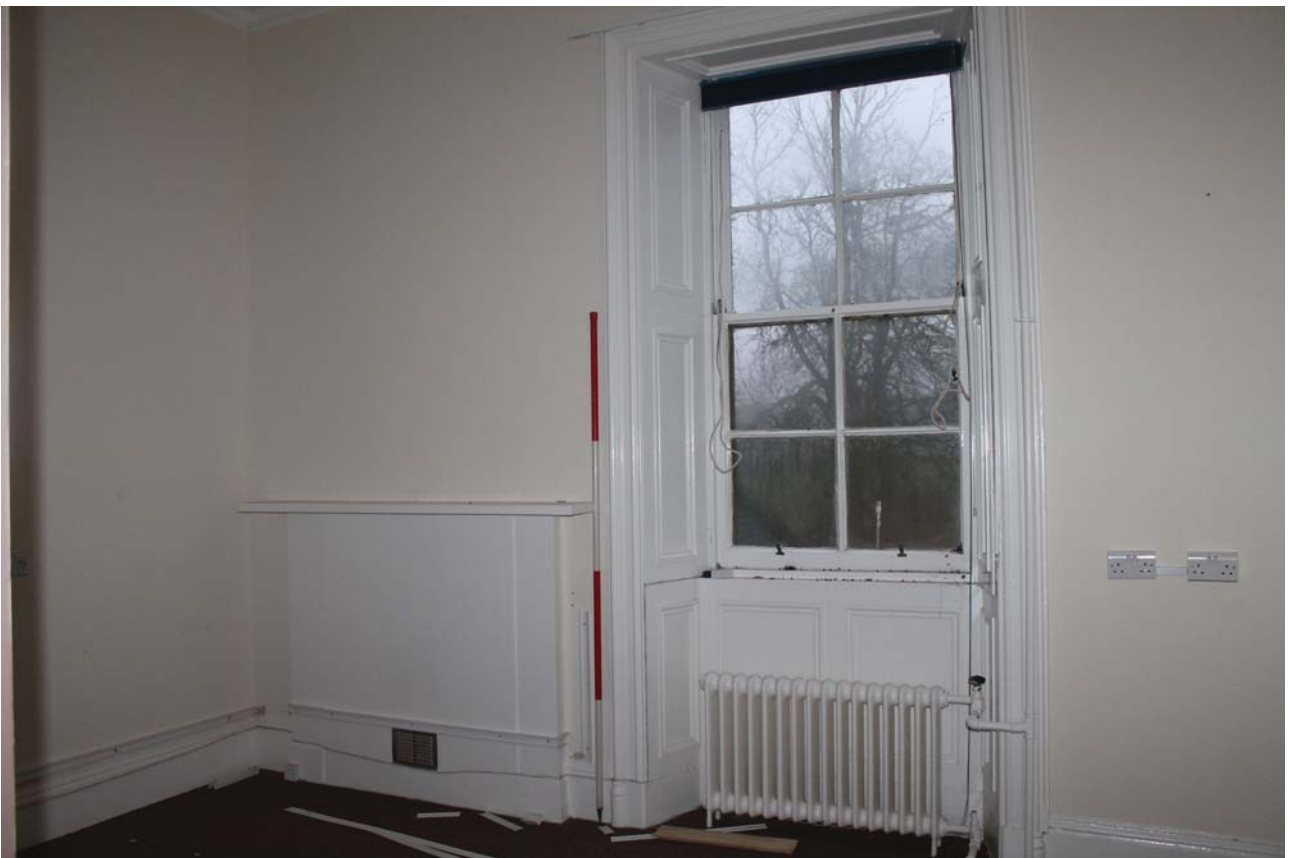
Room 1/9 to the east of Room 1/8 is accessed from the corridor to the south wall with a single splayed window to the north wall (Plate 100). It also features another smaller blocked fireplace to the north wall, to the immediate west of the window, identical to that seen in Room 1/3.

Plate 100: Room 1/9, general view showing window and fireplace in the north wall from the south-east

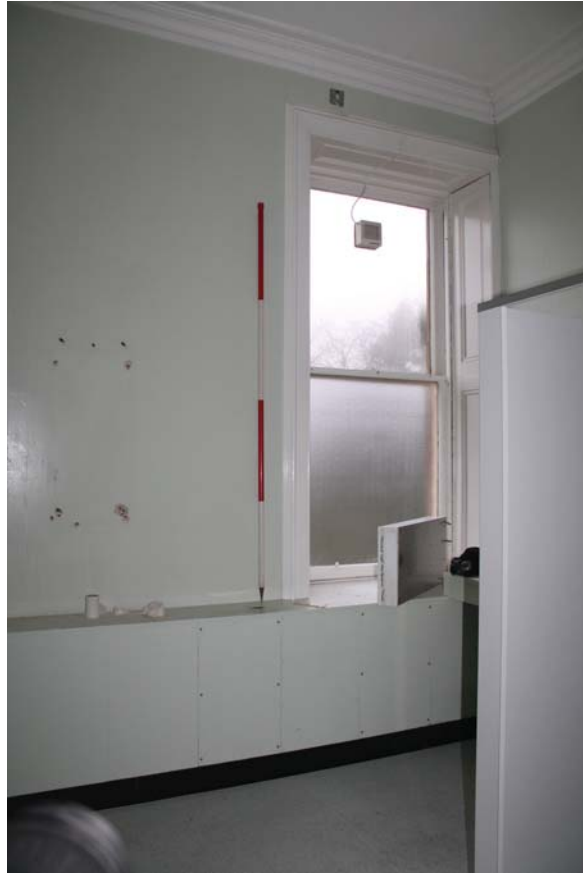
Located to the east side of the staircase, Room 1/10a has been latterly converted into a modern toilet block with two cubicles and modern bathroom fittings with a window surviving to the north wall (Plate 101). The adjacent 1/10b is a small store room.

Plate 101: Room 1/10a, general view from the south-west

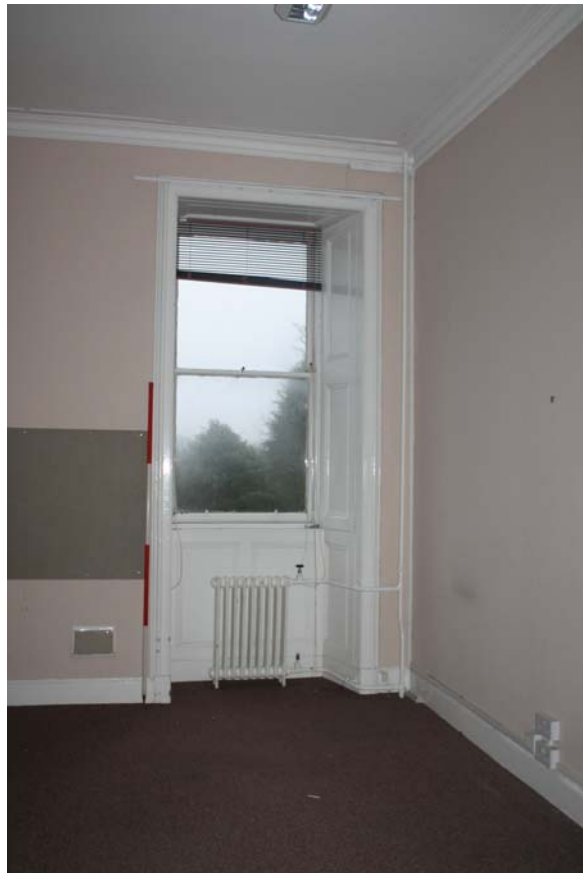
Located to the immediate north of Room 1/7, Room 1/11 has a short moulded skirting and plain moulded cornice throughout with a single window to the east wall (south side) with cast-iron radiator below (Plate 102). There is also an access to the north wall into Room 1/12 (a modern door) with another single window to the east wall, although this forms the southern part of a double window here, a later partition between this and Room 1/13 disturbing it (Plate 103). Both 1/12 and 1/13, as with 1/11, have plain skirting and plain moulded corning throughout indicating the original layout, however.

Plate 102: Room 1/11, general view from the NWW

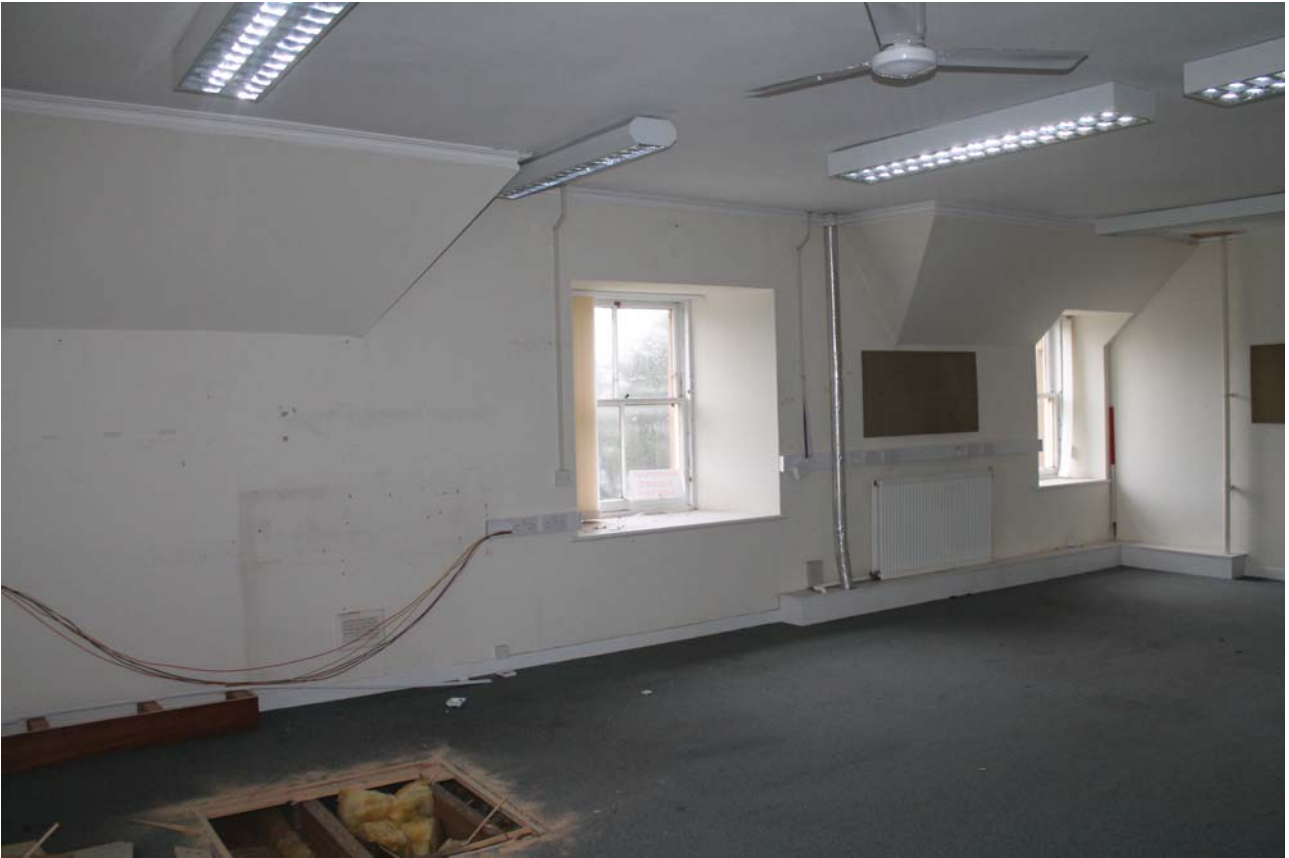
Plate 109: Room 2/3, general view from the south-east

The largest of the attic rooms, Room 2/3, this is an L-shaped room (the north-east part forming the stair 2/2) with two single windows to the west wall, the southernmost splayed, the northernmost straight-set (Plate 109). To the south wall is the splayed oculus window seen to the exterior (Plate 110).

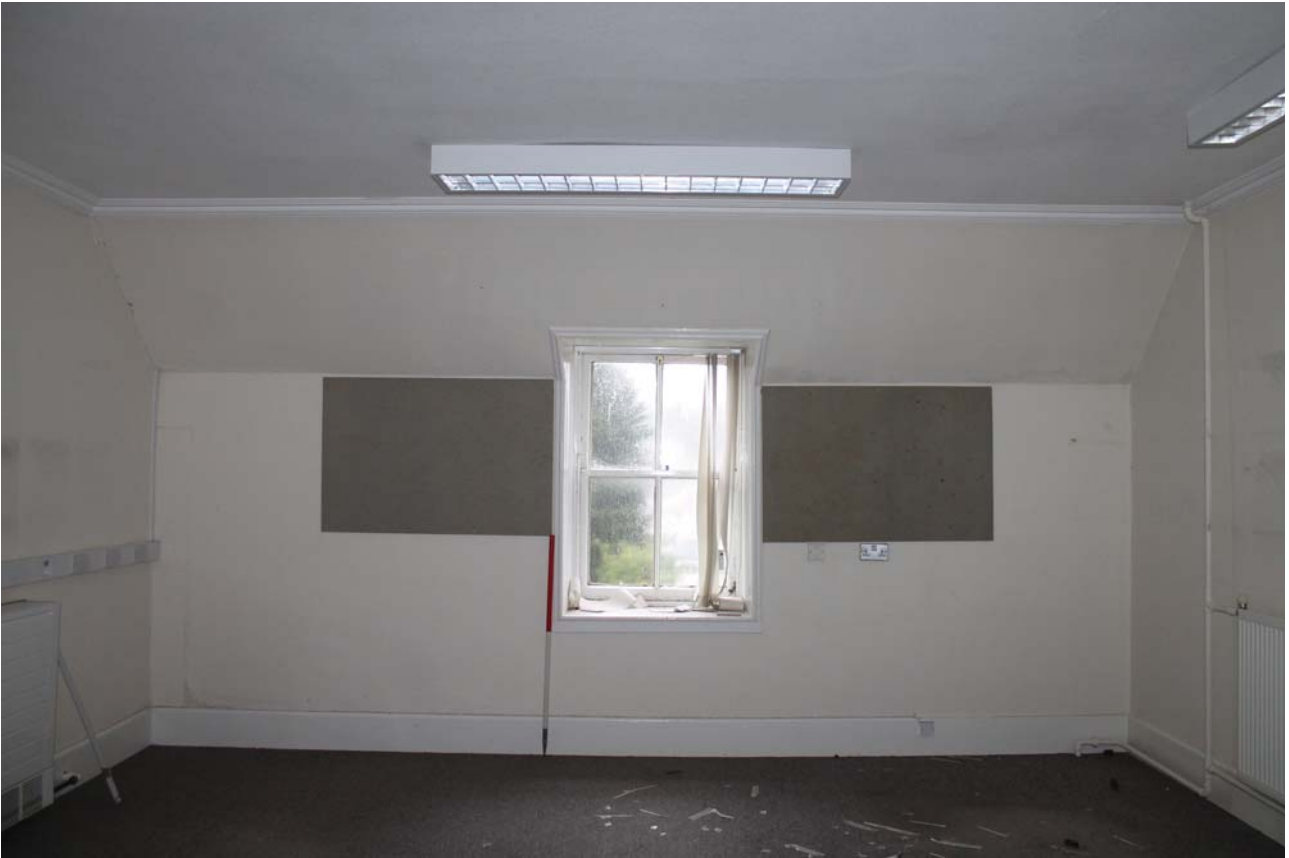
Plate 111: Room 2/4, general view from the east

Room 2/4, to the north-west of the attic level, has another square-set window in the west wall with vertical timber-panelling in the window bay (Plate 111). To the east side, this smaller room has a splayed window to the north wall (Plate 112) with another small area blocked-off to the south-east corner of the room. Room 2/6 is located above the main stairwell and thus is angled to the north-west and north-east sides with a small square-set window to the north wall (Plate 113).

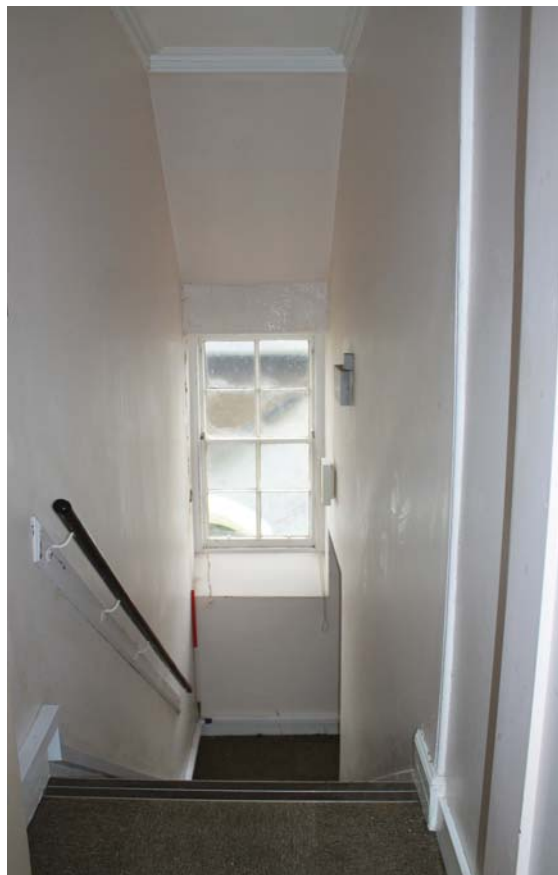
Plate 114: Room 2/8, detail of stairwell from the south

Room 1/7a has now been converted into toilets with modern bathroom fittings, with a small store room to east (1/7b), mimicking the arrangement of the rooms in the floor below. To the north of this, Room 1/7c, accessed through a small door to the east wall of 1/6, is a small store room with another small splayed window to the west side of the north wall. Room 2/8 is the top of the stair to the east side of the house from the first floor with a stair window to the north wall (Plate 114).

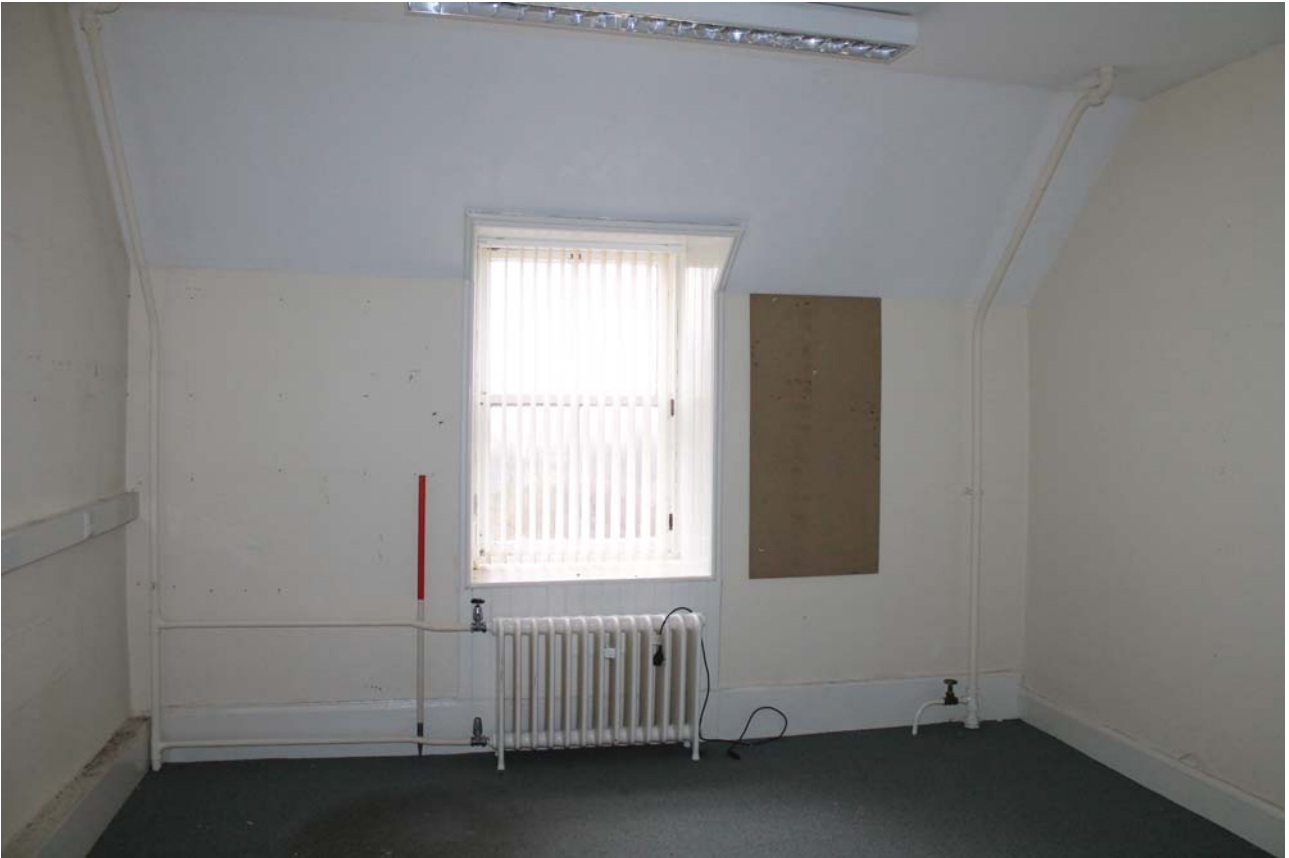
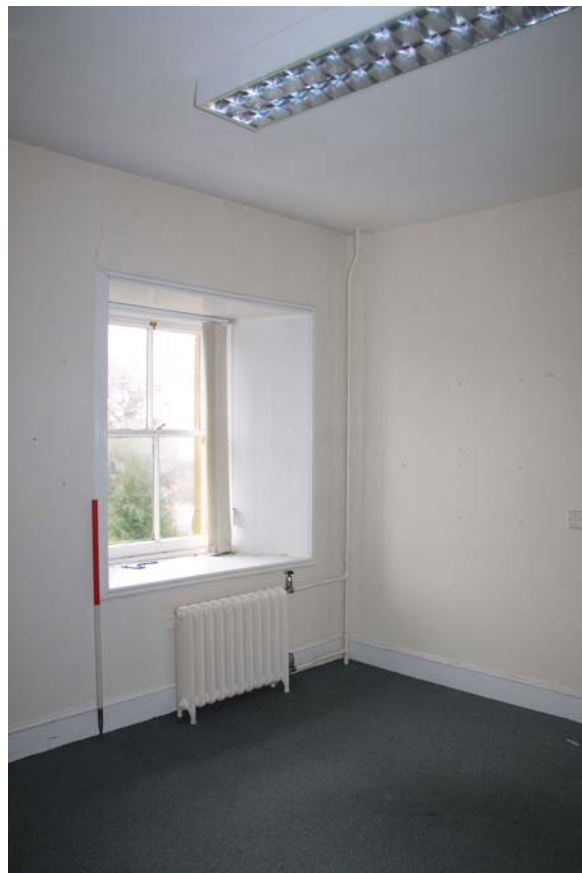
To the east wing of the main house is a suite of the main house. Both Room 2/9 and 2/11 have straight-set windows to the east wall, the central Room 2/10 east wall a splayed window (Plates 115 & 116). The larger Room 2/11 also has another splayed window to the south wall (Plate 117).

Plate 115: Room 2/9, general view from the NWW

Plate 116: Room 2/10, general view from the north-west

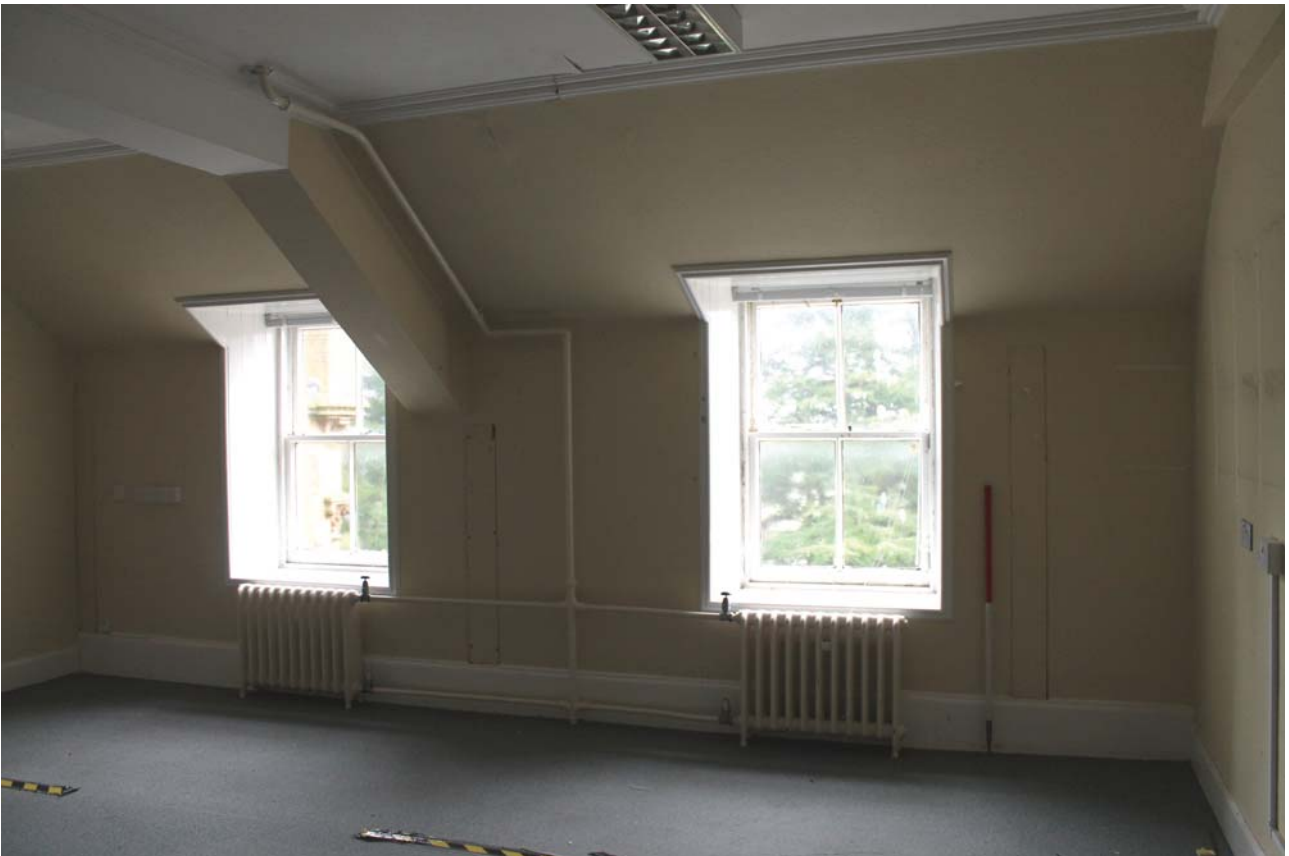
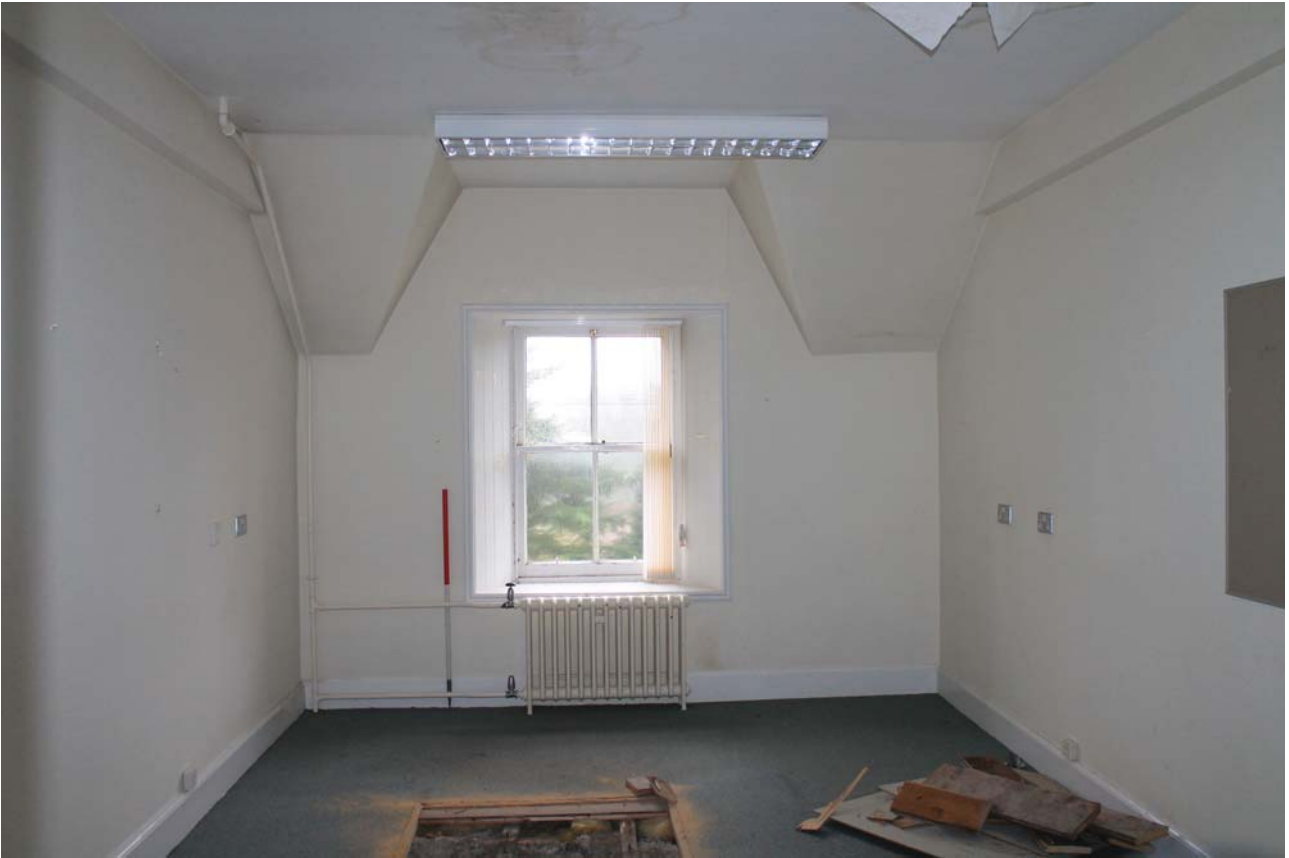
This suite of three rooms to the south of the main house forms two two-bay rooms flanking a central single-bay room, all with splayed windows to each bay to the south wall (Plates 118 & 119). The east wall of Room 2/12, and the west wall of Room 2/14, also has blocked fireplaces with timber surrounds (Plate 120).

Plate 118: Room 2/12, general view from the north-west

Plate 119: Room 2/13, general view from the north

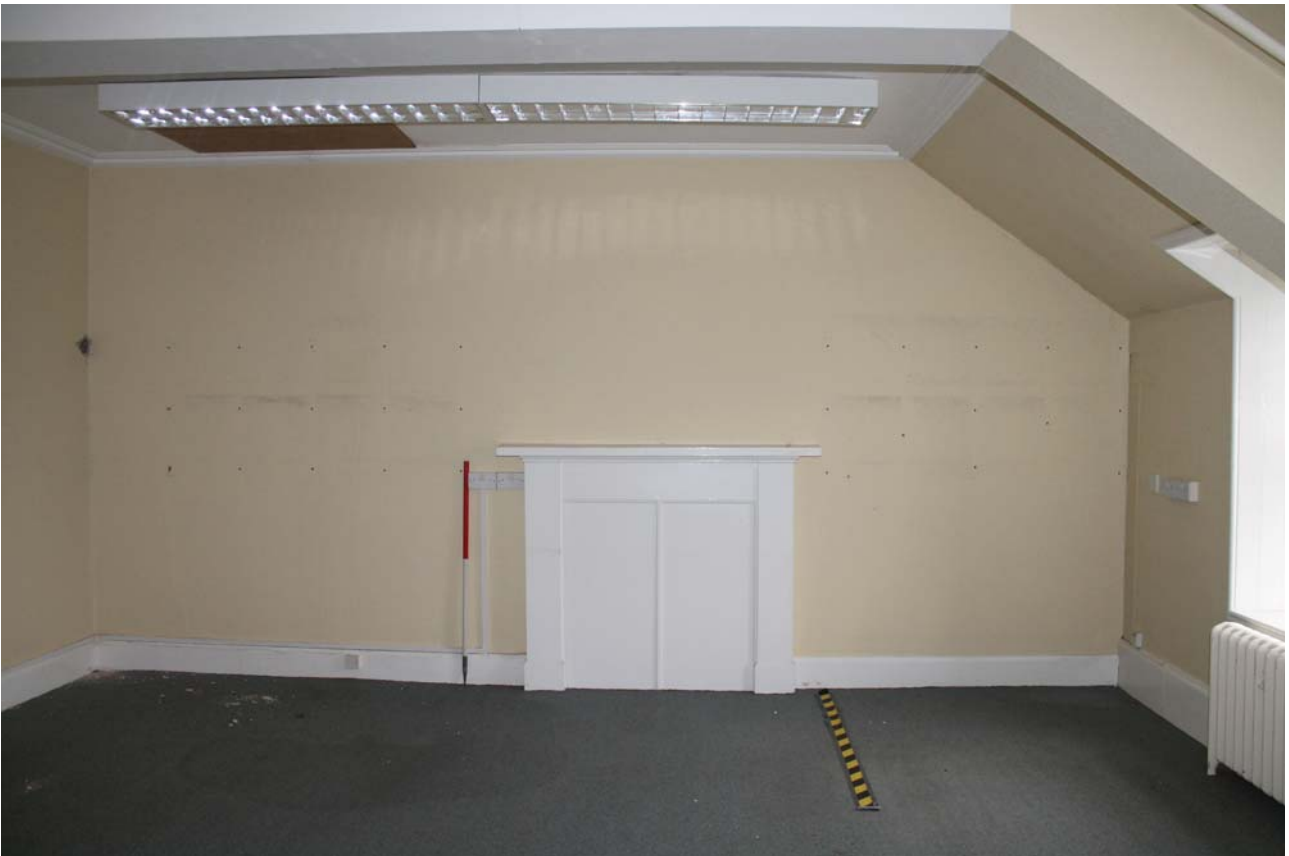
Plate 120: Room 2/12, general view of east wall showing fireplace from the west

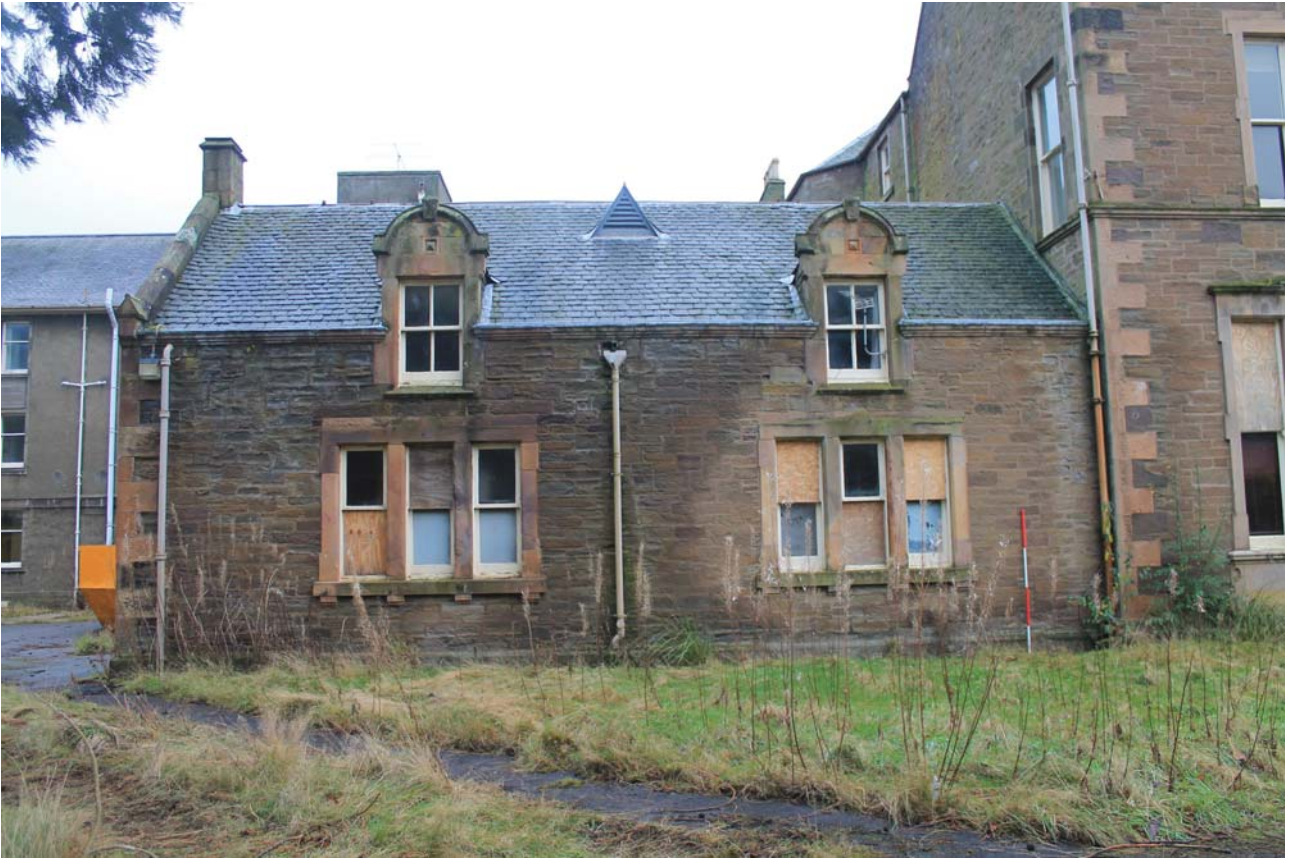
Plate 123: Building B1, West Elevation, general view from the west

The west elevation is the much neater façade, facing outwards so as to be generally seen rather than the opposite courtyard elevation (Plate 123). There are two bays here – identical – with two tripartite windows with fine comb-dressed projecting surrounds (Plate 124). To the first floor are single two-over-two timber sash-and-case dormer windows to each bay with round-headed pediments rising above the eaves, a plainer version to that seen in the main house (Plate 125). There is also a triangular vent just below the apex of the roof in this side.

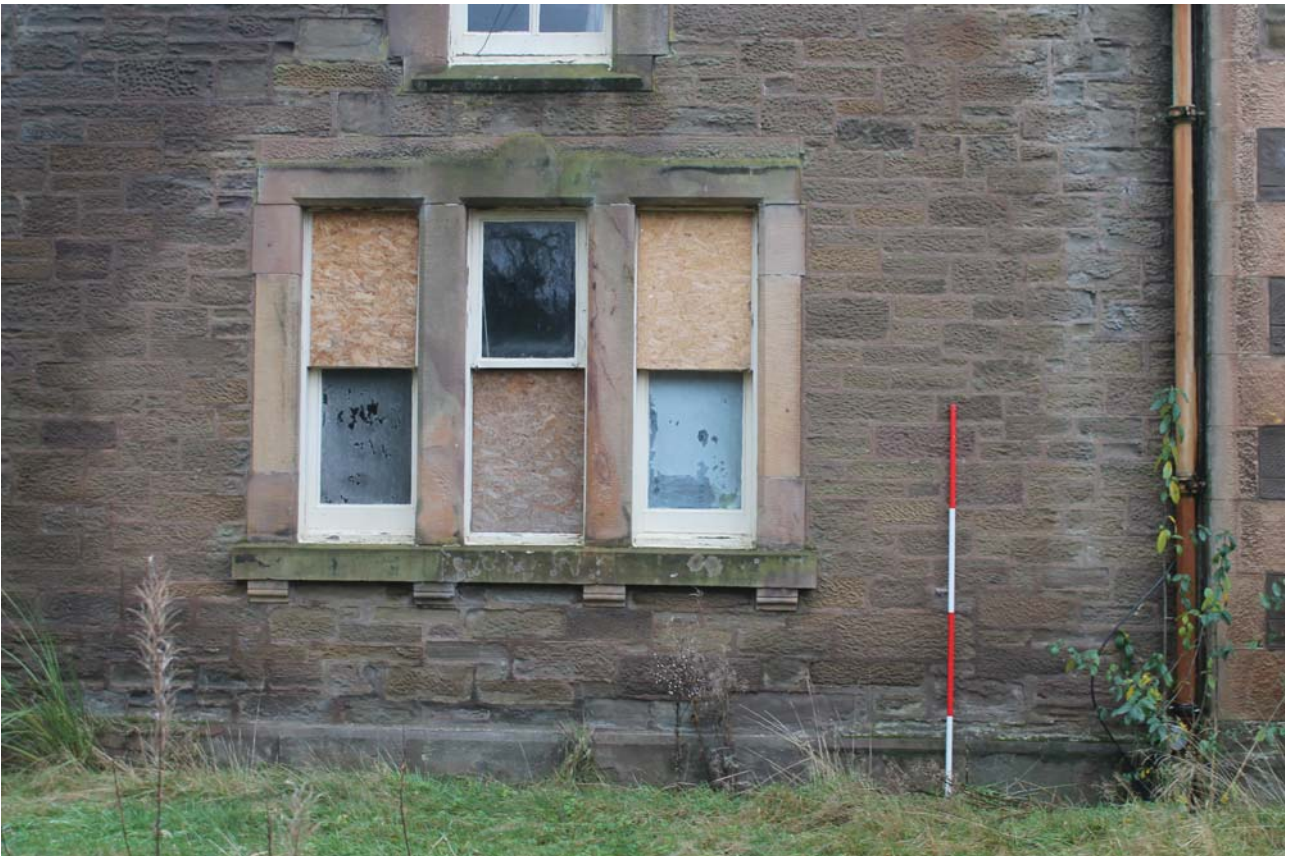
Plate 124: Building B1, West Elevation, detail of ground floor tripartite window from the west

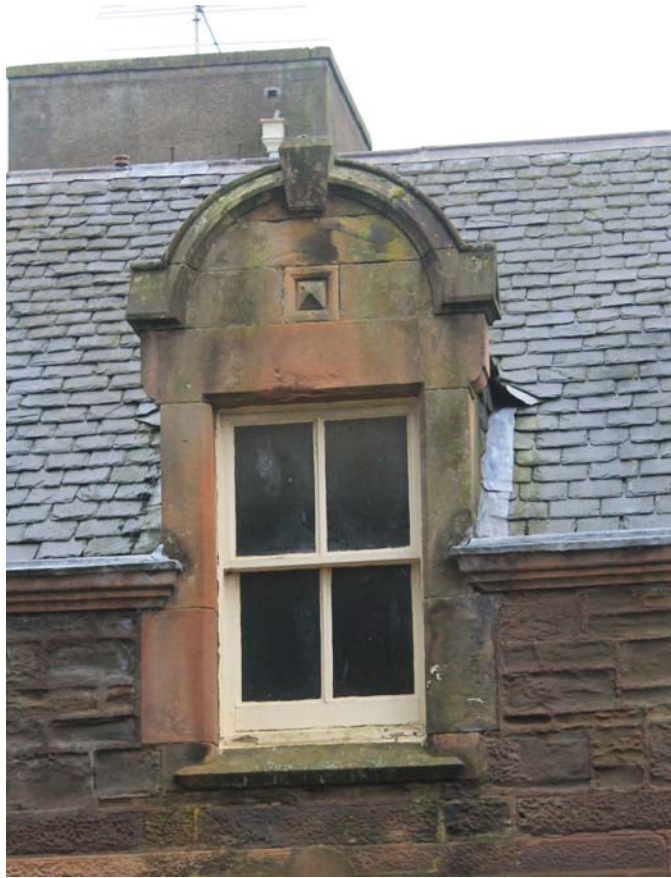
Plate 125: Building B1, West Elevation, detail of dormer window from the west

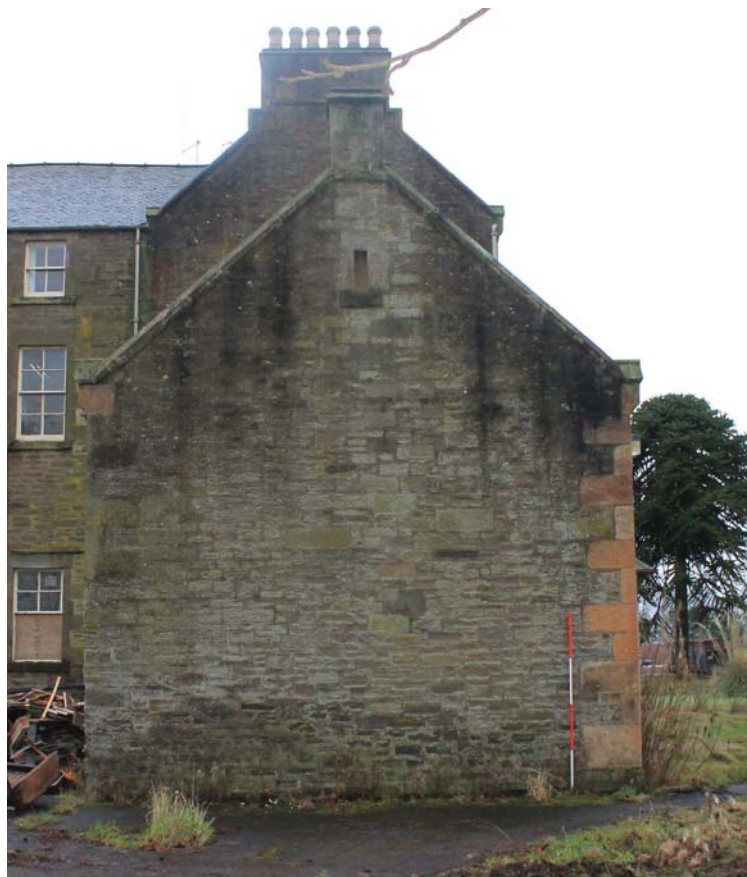
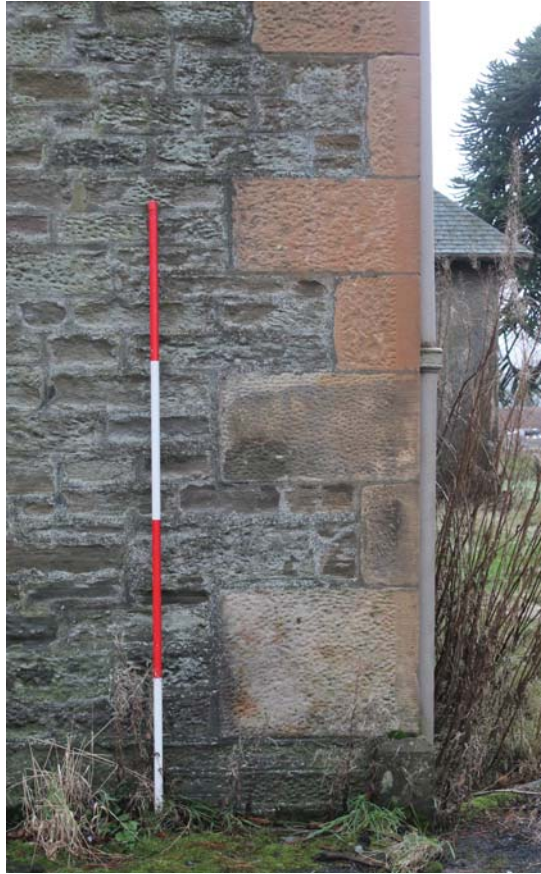
The north elevation is plain, with light pink quoins to the west side (Plates 126 & 127).

Plate 126: Building B1, North Elevation, general view from the north

Plate 127: Building B1, North Elevation, detail of quoins from the north
