# Ashludie House, Monifieth, Angus: Historic Building Recording Report

AOC Project: 23302

8<sup>th</sup> January 2016

<b>On Behalf of:</b>	<b>Miller Homes Clydesdale House 300 Springfield Parkway Baillieston Glasgow G69 6GA</b>
<b>National Grid Reference (NGR):</b>	<b>NO 49537 33260</b>
<b>AOC Project No:</b>	<b>23302</b>
<b>Planning Application No:</b>	<b>15/00099/FULM</b>
<b>OASIS Reference:</b>	<b>235866</b>
<b>Prepared by:</b>	<b>Diana Sproat</b>
<b>Date:</b>	<b>8<sup>th</sup> January 2016</b>

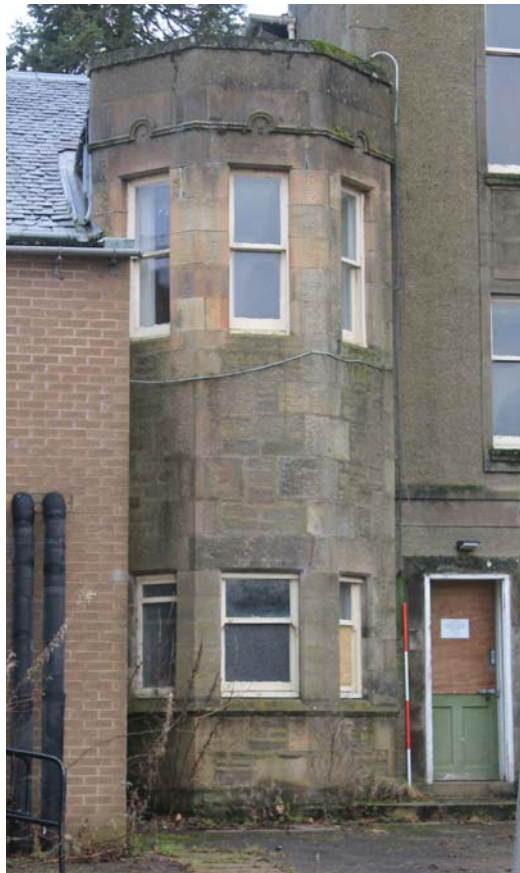
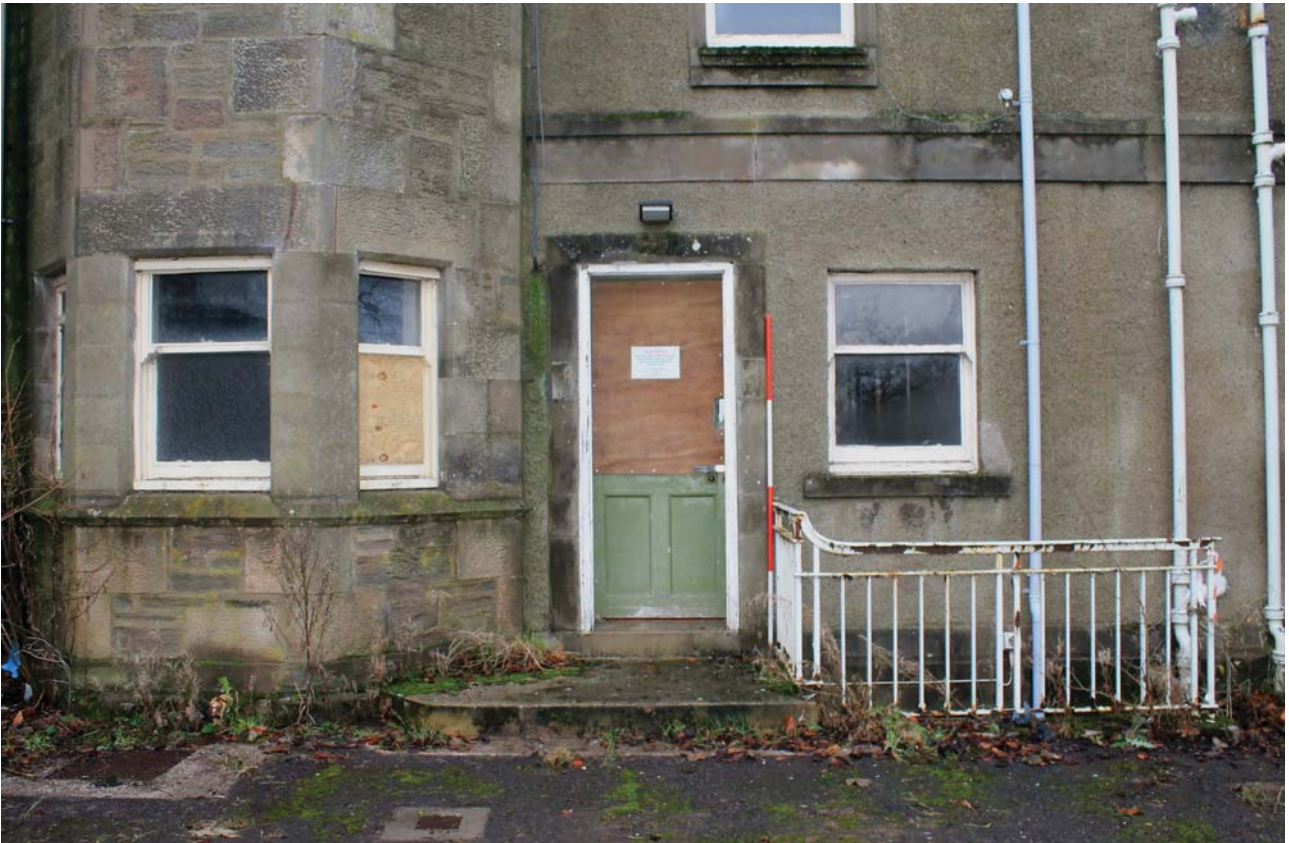
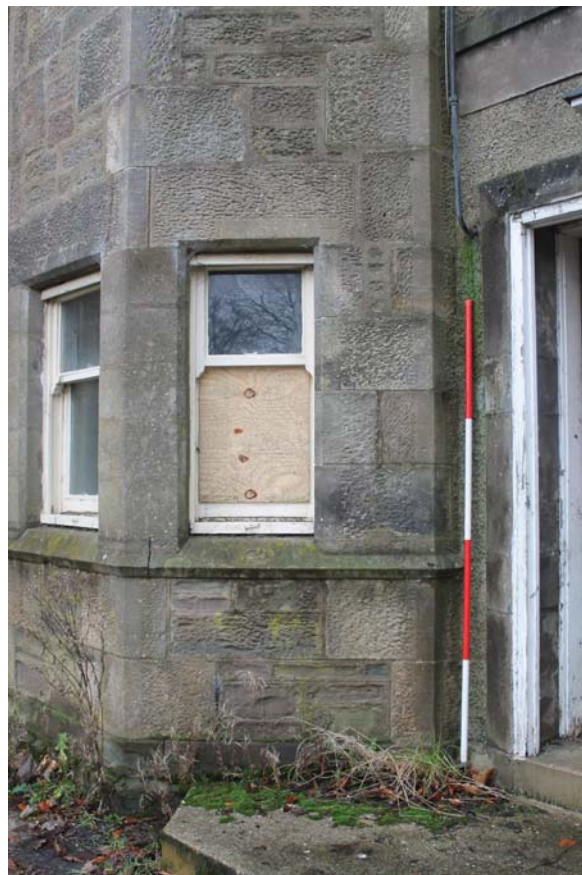
This building, mimicking Building B1, is heavily obscured by the later additions. The east elevation has been abutted by Building D and consists of a two-storey bay window to the south side, rising to a pediment (Plates 128 - 130). The east elevation is largely obscured by the flat roofed extension to the front (Plate 131). All that can be seen on this side is three small first floor windows (corresponding to a small corridor leading to the North Wing, Building D).

Plate 128: Building B2, East Elevation, detail of ground floor and first floor bay windows to the south end from the east

Plate 129: Building B2, East Elevation, general view of the ground floor from the east

Plate 130: Building B2, East Elevation, detail of window in the north-east angle of bay window from the north-east

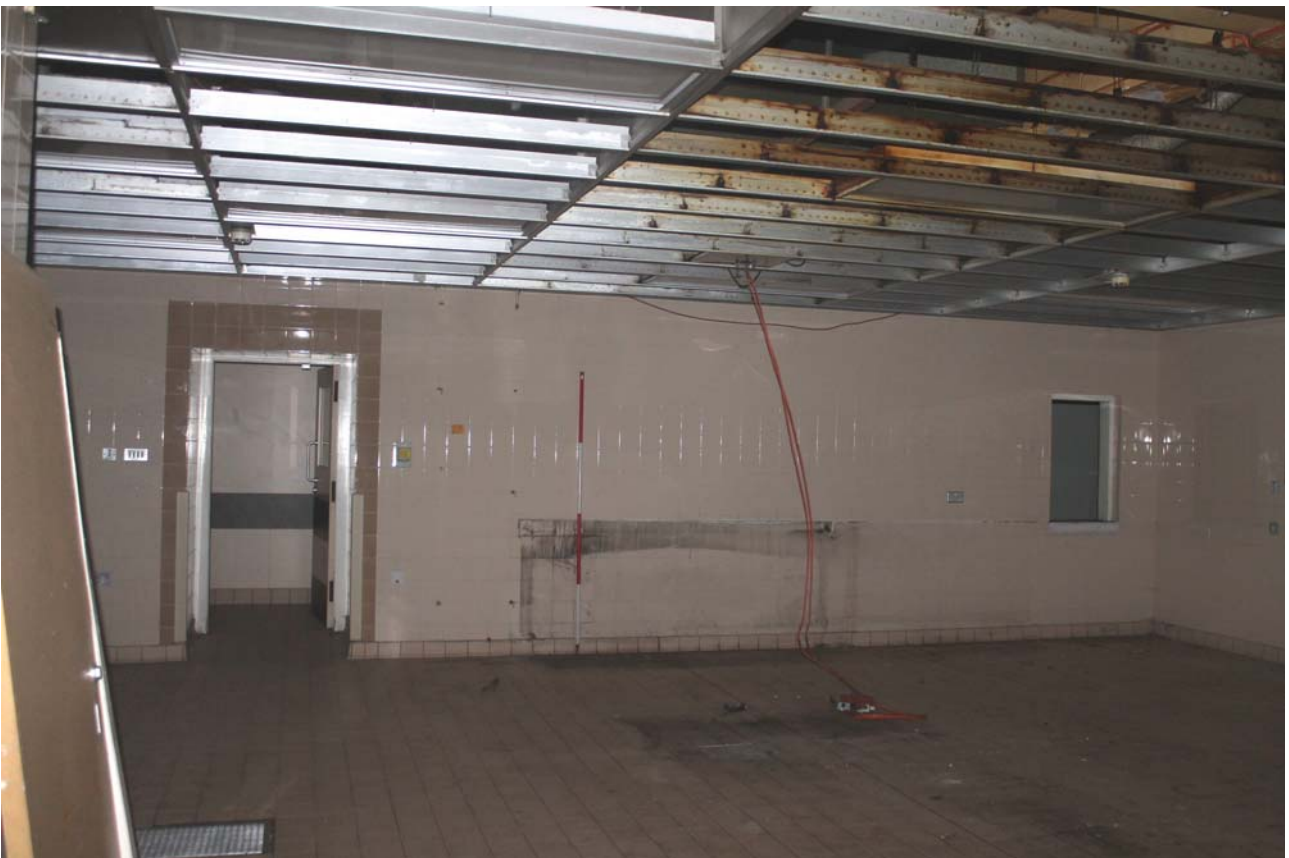
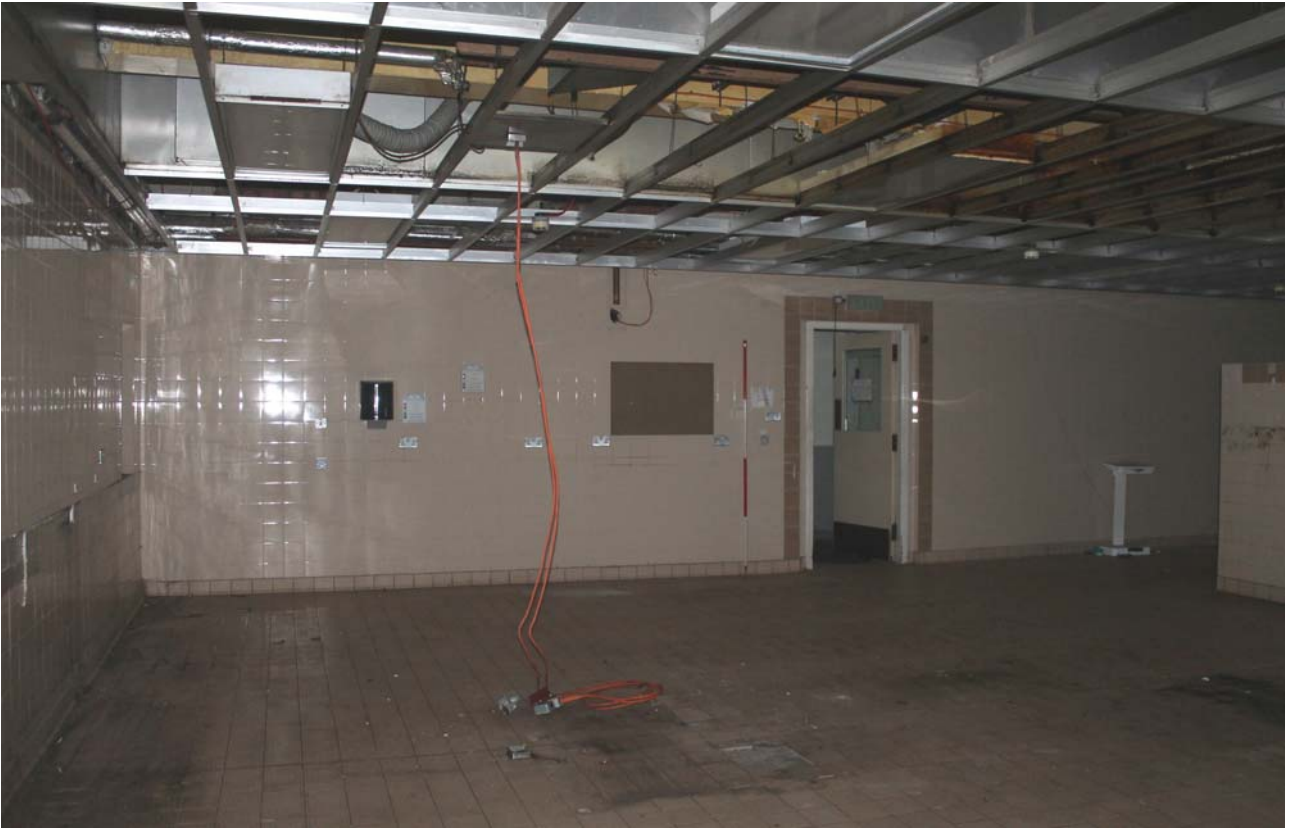
Only one room exists now belonging to this annexe to the ground floor, Room 0/11, which had been fully converted and altered to accommodate the main kitchens for this part of the former hospital (Plates 132 & 133). With tiled floors and walls, it contains no windows apart from the bay window to the north side of the east wall (Plate 134).

Plate 132: Room 0/11, general view from the north

Plate 133: Room 0/11, general view from the east

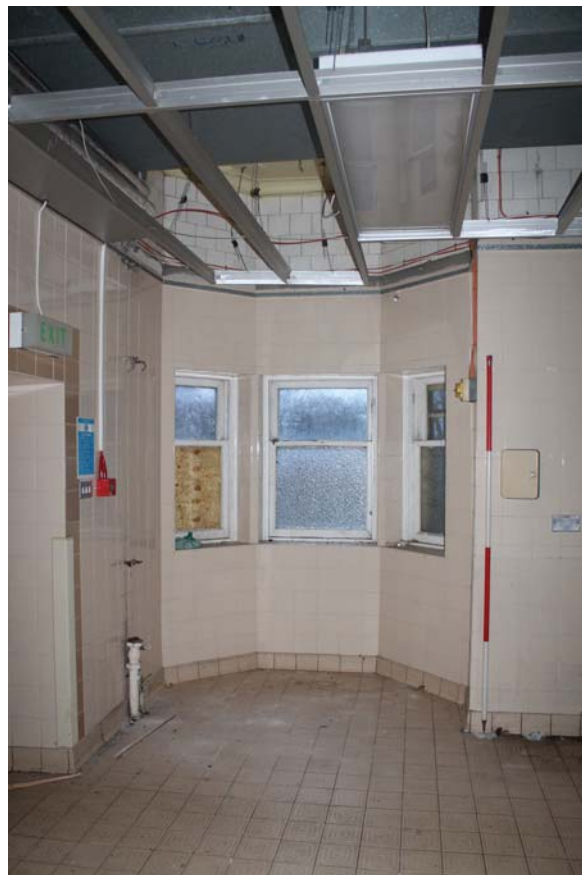
Plate 134: Room 0/11, detail of the bay window to the north side of the east wall from the west

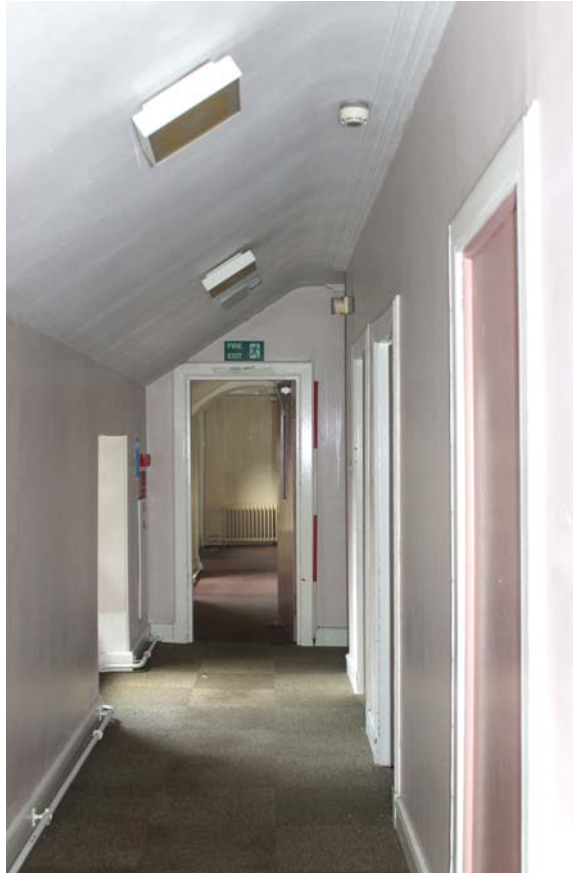
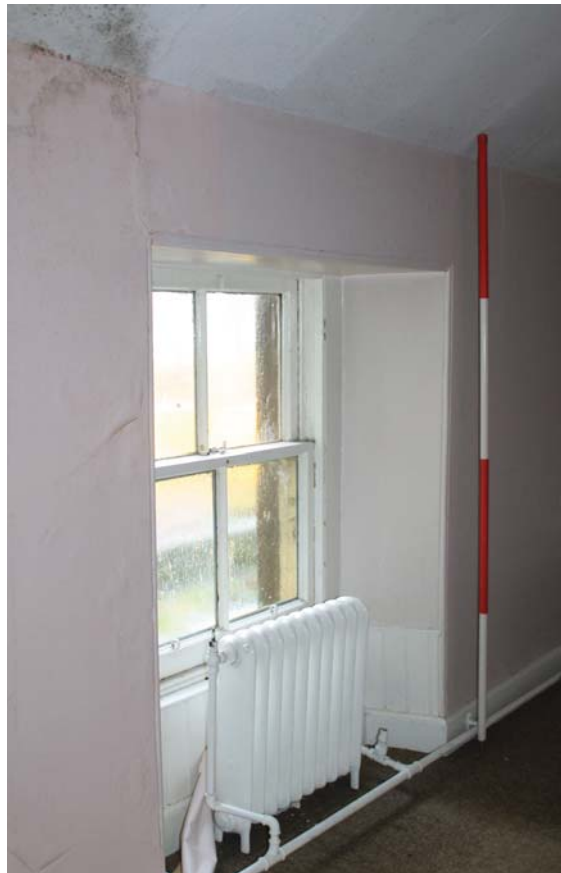
To the first floor, there is a corridor to the west side – Room 0/15 – with the aforementioned three splayed windows to the west wall (Plates 135 & 136). A series of rooms is then accessed to the east side – Rooms 1/16 – 1/18, all with simple moulded cornices. Room 1/16 is a large room, now covered in ventilation equipment, with a square-set window to the east wall and a blocked doorway to the east side of the south wall (Plate 137). Room 1/17 consists of a small room – another square-set window in the east wall (Plate 138), with a small store room to the west. Room 1/18 forms the upper level of the bay window on this side to the east wall with another additional store room to the west (Plate 139). A shorter stretch of corridor – to the north of 1/15, links to these rooms here, which also connect to the North Wing, Building D (Plate 140).

Plate 135: Room 1/15, general view from the south

Plate 136: Room 1/15, detail of corridor window in the west wall from the south-east

Looking at the cartographic evidence it appears that the flat roof extension to Building B2 to the west side – Room 0/15 – was a later addition to the complex to provide more storage and ancillary rooms to the kitchens. The linking building between the East Block (C) and the main house (A) – Room 0/12 and the eastern half of Room 0/11 – also looks to be very modern in build and perhaps replaced another build here. It provides a servery located between the kitchen and the dining room and was perhaps added when the kitchen and dining area were re-modelled to accommodate a much larger staff at the hospital. Other smaller additions within the main house (A) consist of modern toilet/bathroom fittings and various divisions within the later kitchen areas.

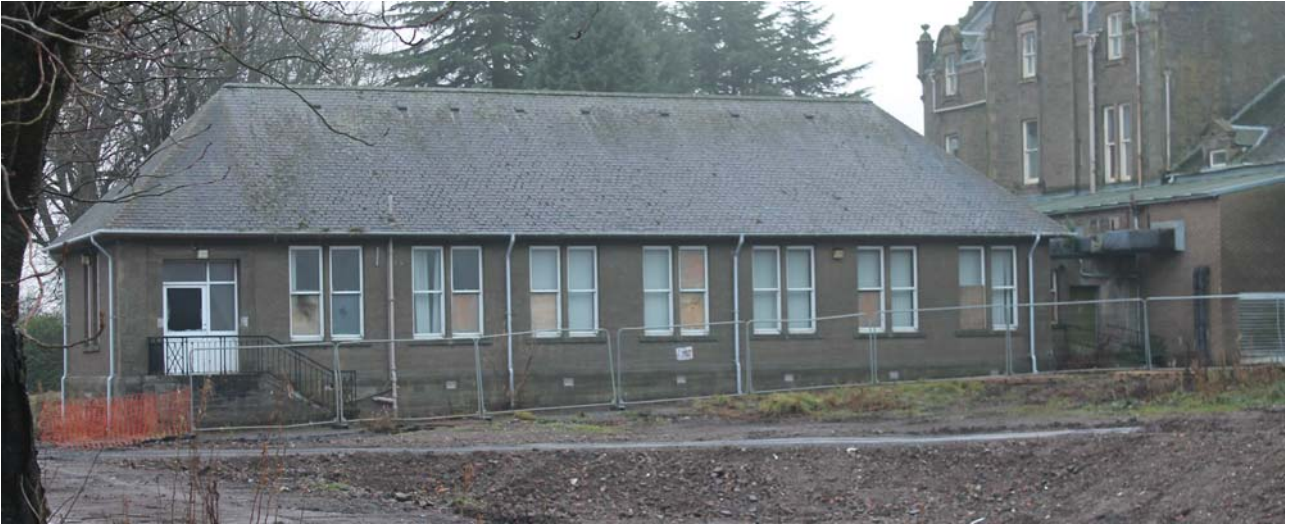
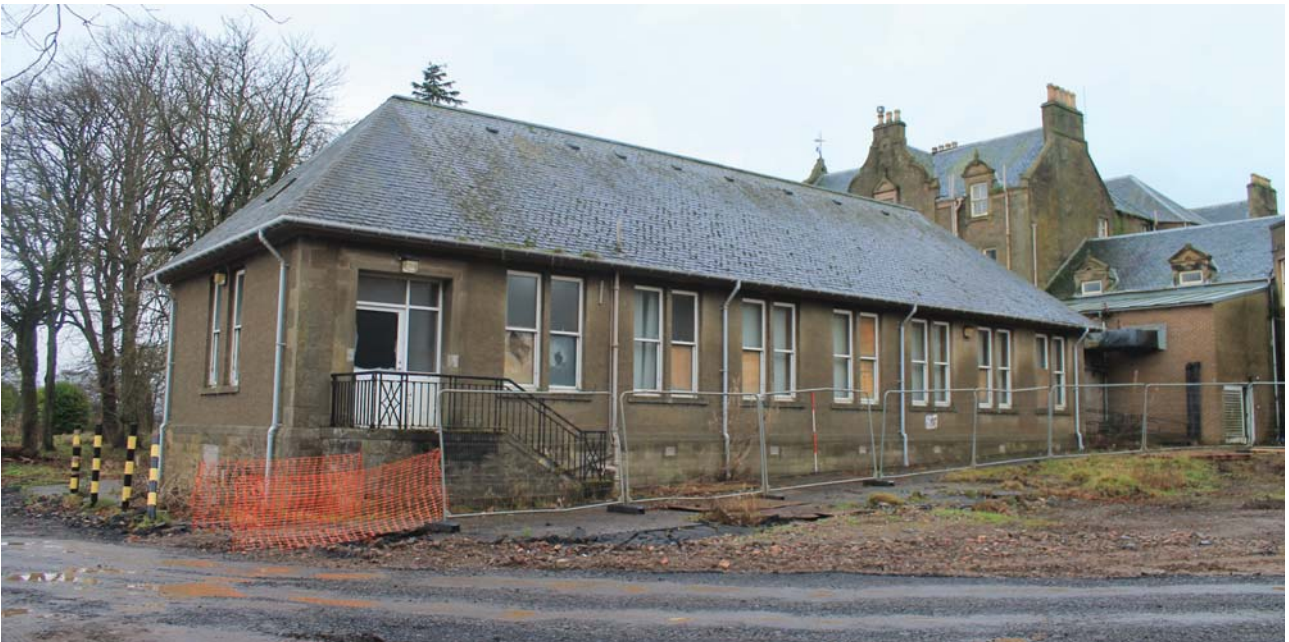
This wing was constructed in the 1930s and consists of an eight- by one-bay single-storey wing with a hipped slate roof, constructed of coursed stone, although is roughcast rendered throughout (Plates 141 & 142). It has modern replacement doors and UPVC windows throughout and a large glazed bay to the far easternmost bay of the north and south elevations creating a fire exit on both sides, each approached by a set of external steps (Plates 143 & 144). To the west side of the north and south elevations is a large sliding door accessed from a small ramp (Plate 145 & 146).

Plate 141: Building C, East Wing, general view from the east

Plate 142: Building C, East Wing, general view from the north-east

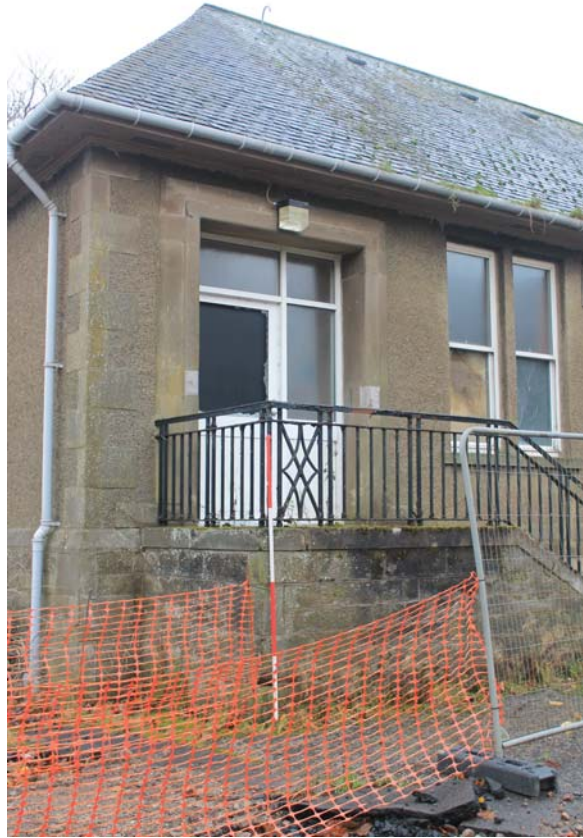
Plate 143: Building C, East Wing, North Elevation, detail of easternmost bay from the north-east

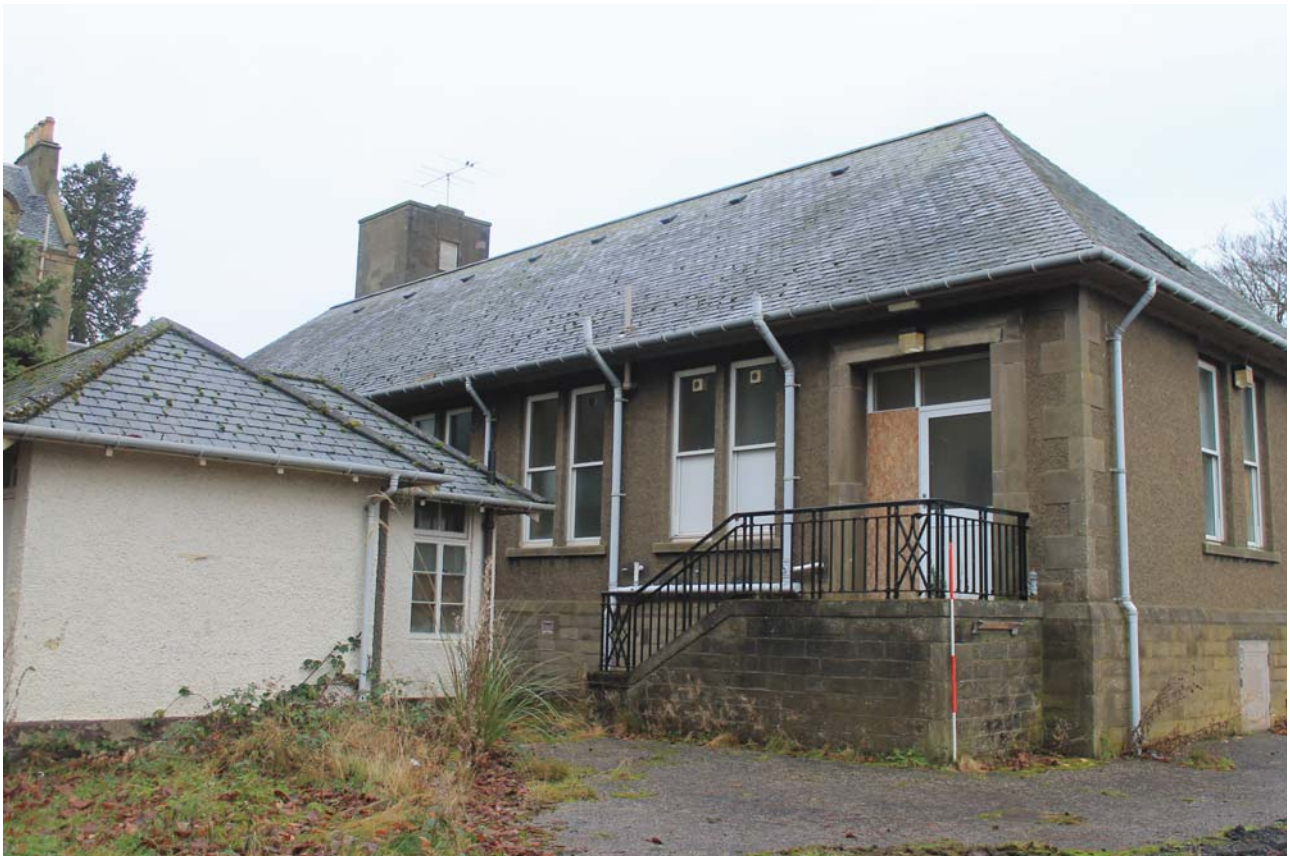
Plate 144: Building C, East Wing, South Elevation, detail of easternmost bay from the south-east

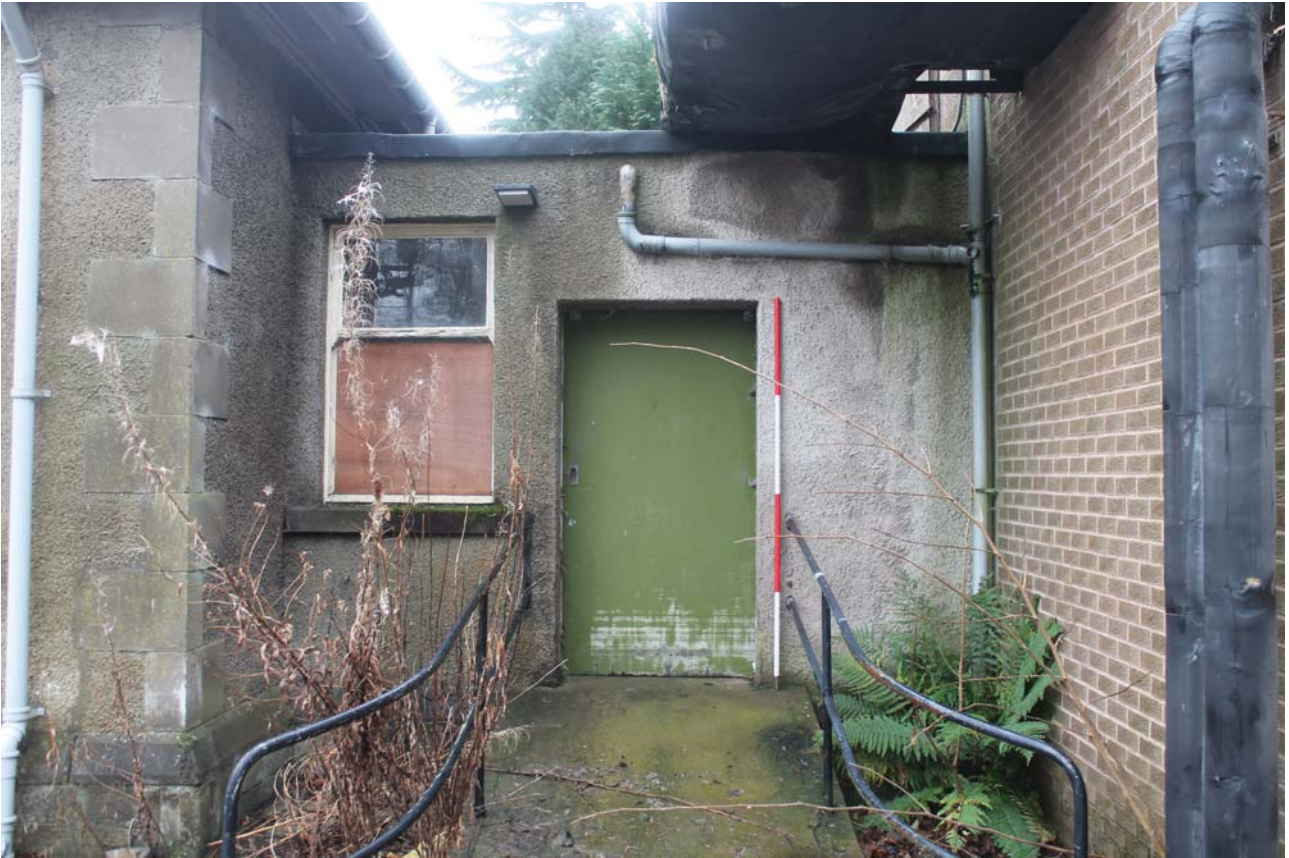
Plate 145: Building C, East Wing, North Elevation, detail of westernmost bay from the north

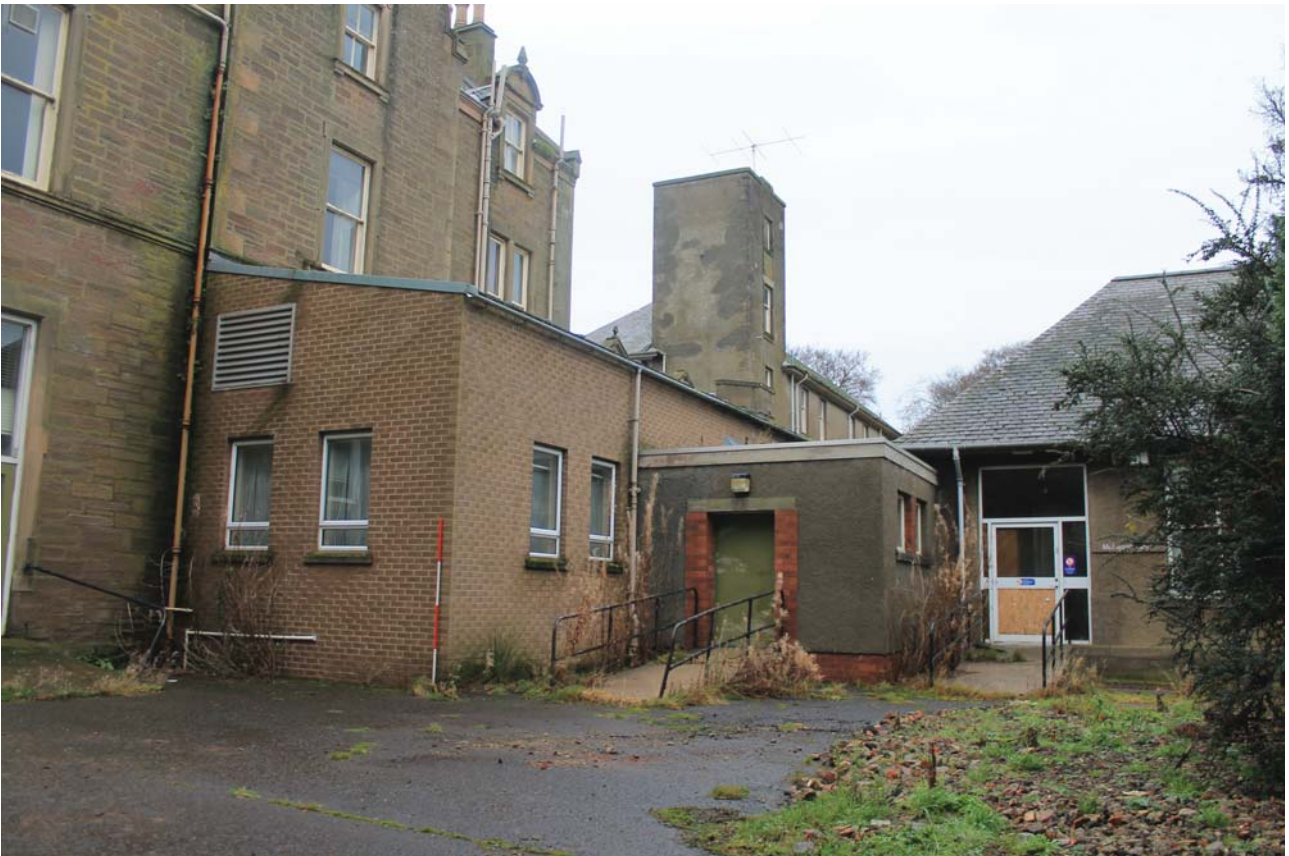
Plate 146: Building C, East Wing, South Elevation, general view of the westernmost bays showing the later brick build, from the south-east

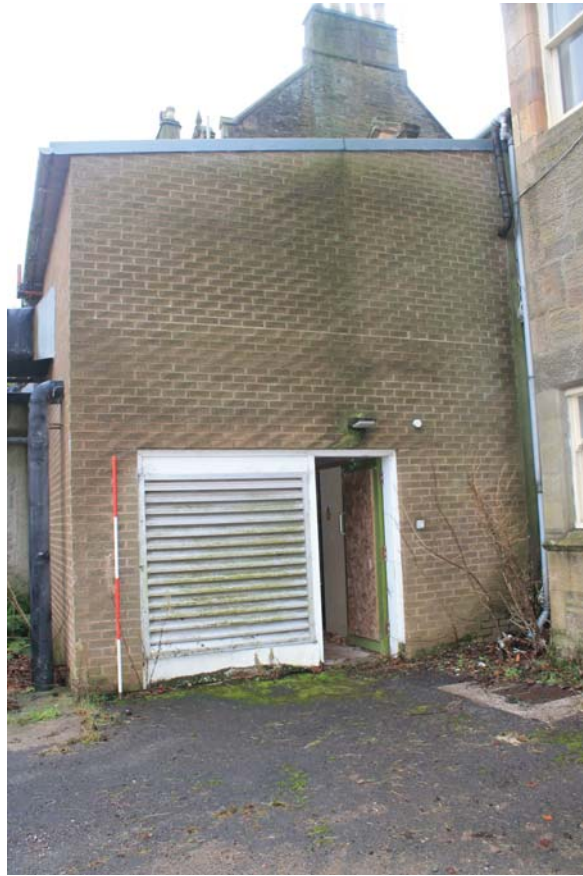
It is clear that this East Wing was originally separate from the main house and has been connected to it by the later addition of a double-height red brick building (Plates 147 & 148). With a lean-to roof, it has UPVC bottom-opening casements to Room 0/12 inside.

Plate 147: Building C, East Wing, North Elevation, detail of the westernmost bay showing the later modern lean-to, from the north

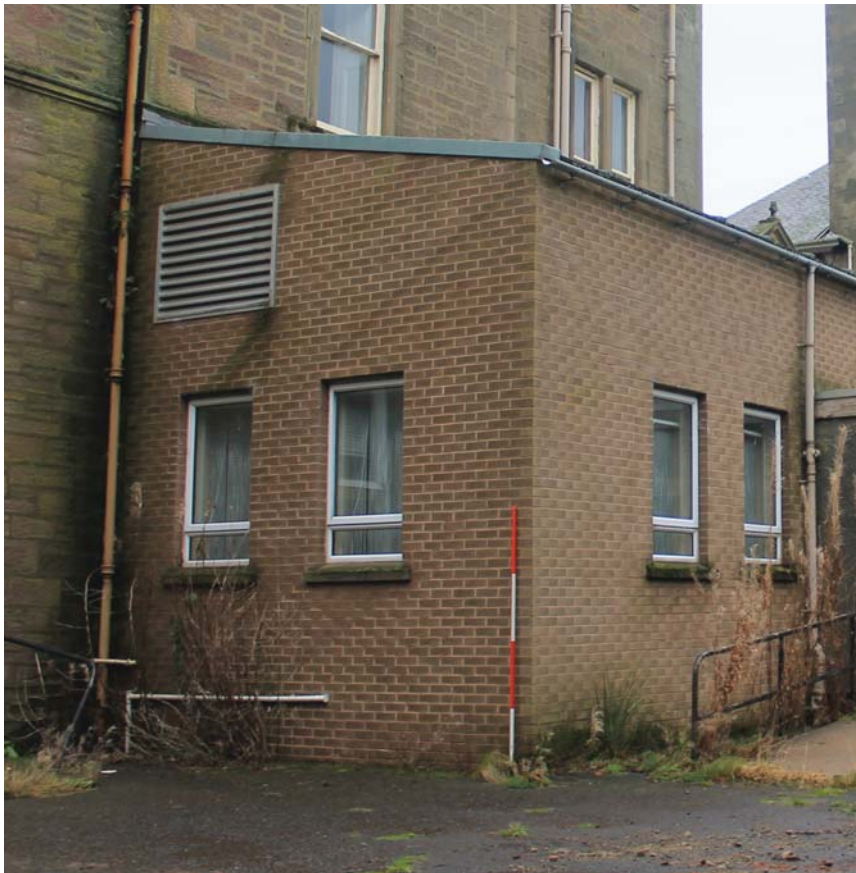
Plate 148: Building C, East Wing, general view of modern lean-to building from the south-east

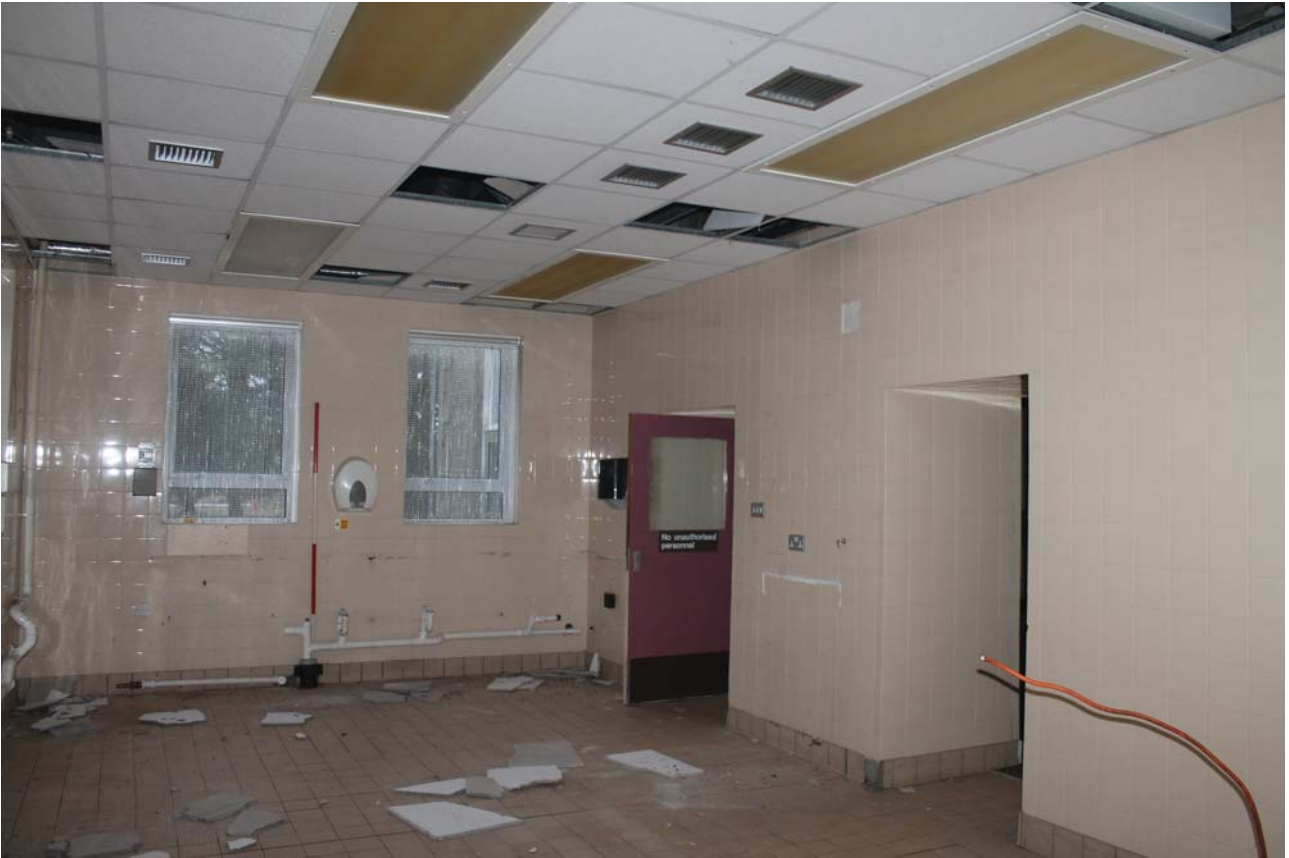
Internally it forms a main hall with rooms to east side, connected to the main house by Room 1/12 (Plate 149). Adjacent to Dining Room 0/7, it accesses and links from 0/7 to kitchen 0/11 with tiles floor and walls. There are two windows to the south wall and two to the east, all UPVC bottom-opening casements.

Plate 149: Room 0/12, general view from the north-east

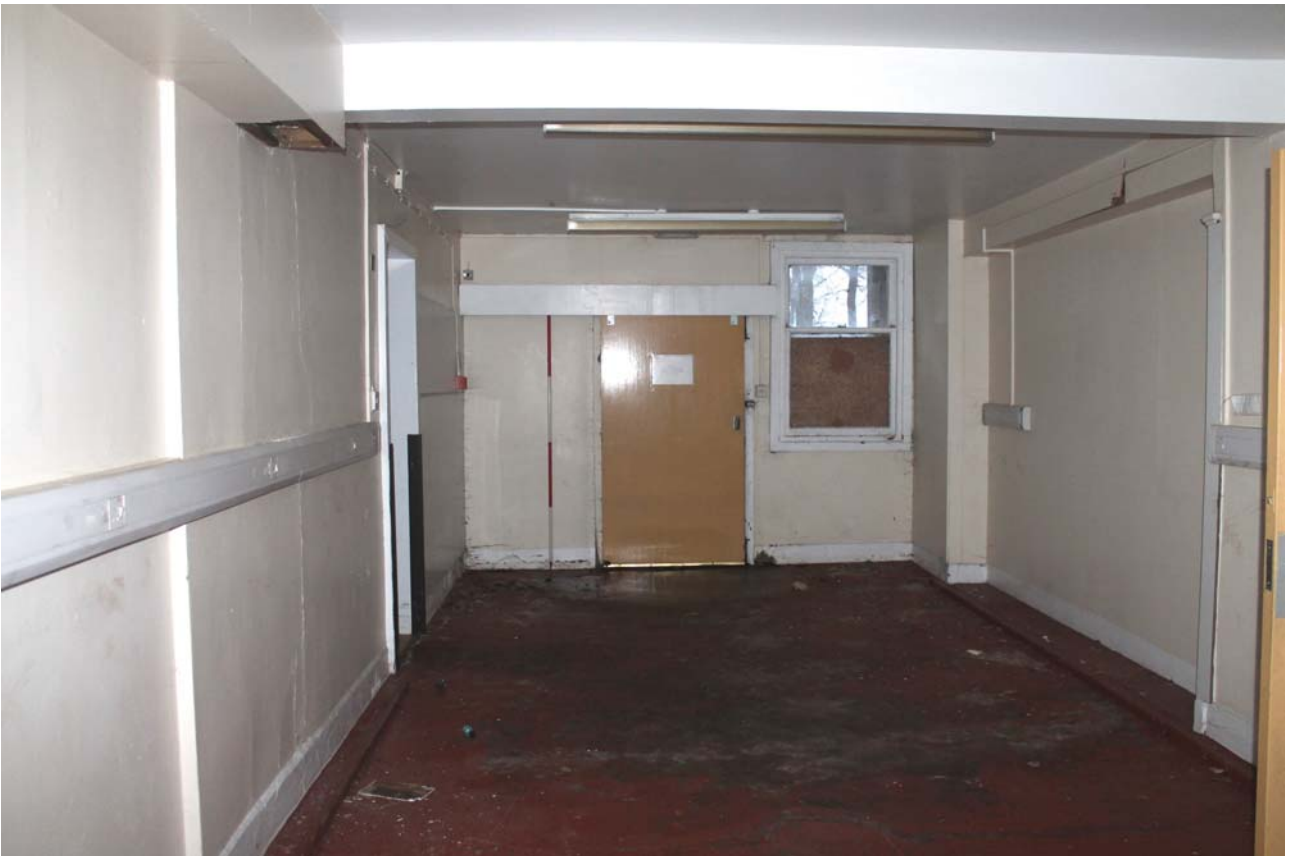
The main East Wing then links from kitchen Room 0/11 through an open doorway into Room 0/16, another linking and loading area with sliding doors to the north and south walls with two bottom opening casements to the east wall (Plates 150 & 151).

Plate 150: Room 0/16, general view from the south

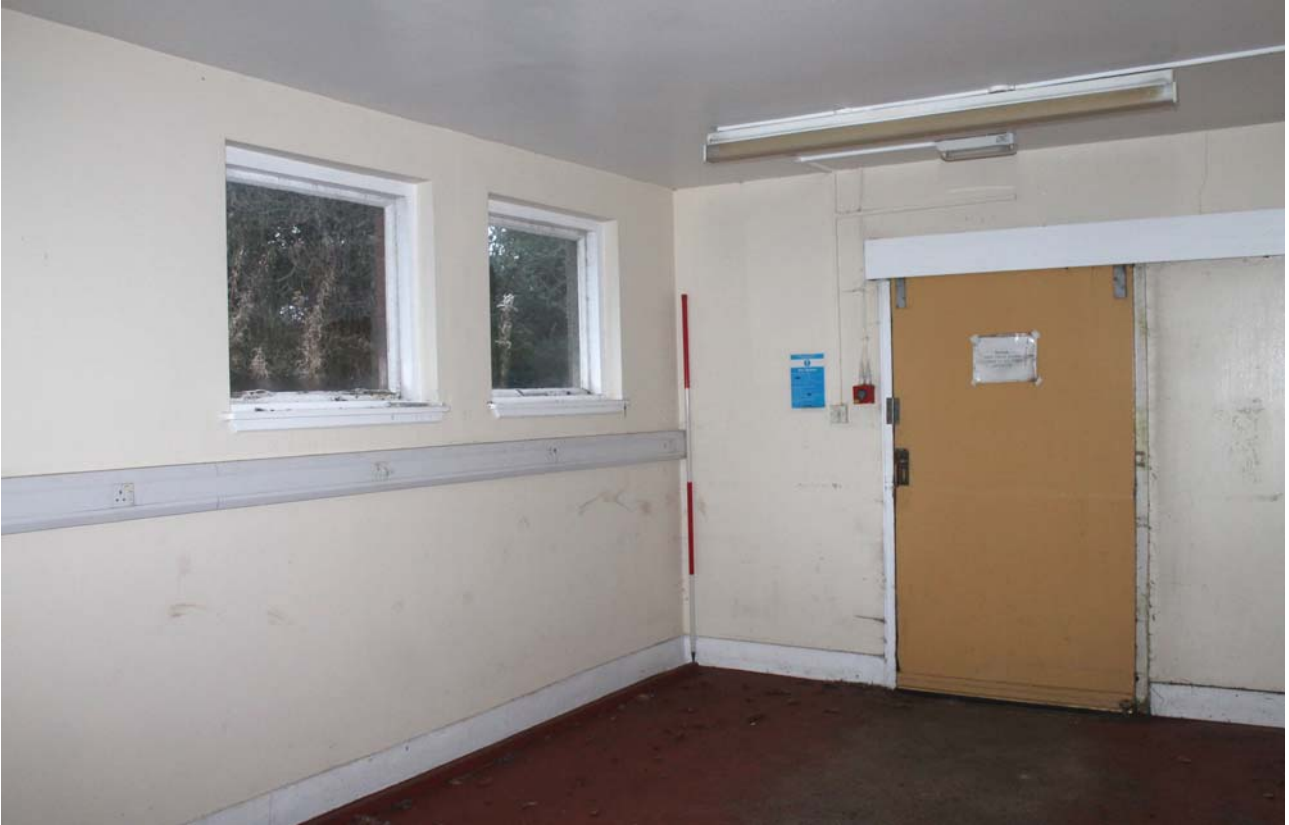
Plate 151: Room 0/16, general view from the north-west

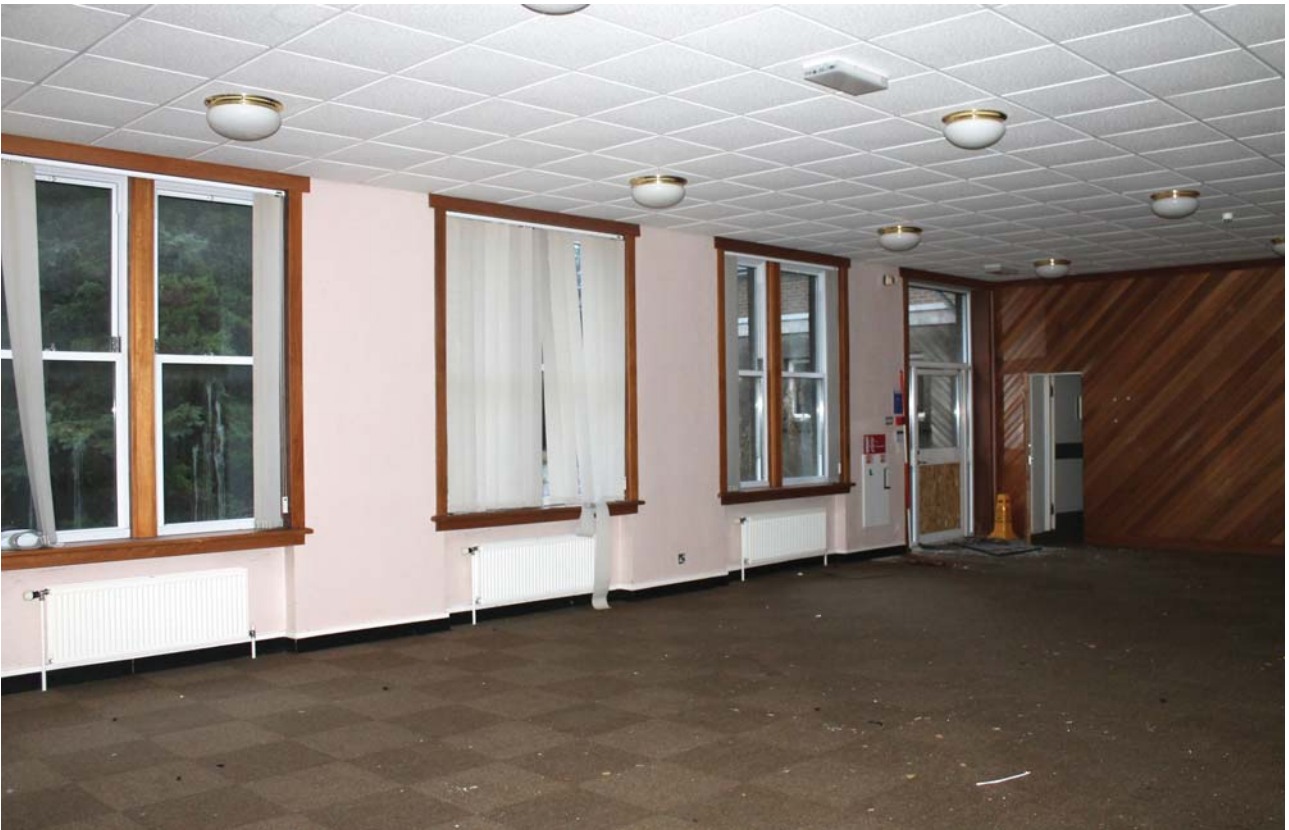
The East Wing then has a large former area of office space, 1/17, five bays wide, windows to the north and south walls of each bay with three doorways to ancillary rooms to the east side (Plates 152 & 153). Rooms 0/18a – consist of a kitchen to the south, toilets to the centre and more office space to the north side, with an arched door between (Plate 154). The fire exit doors are located to the east end of the north and south walls here.

Plate 152: Room 1/17, general view from the north-east

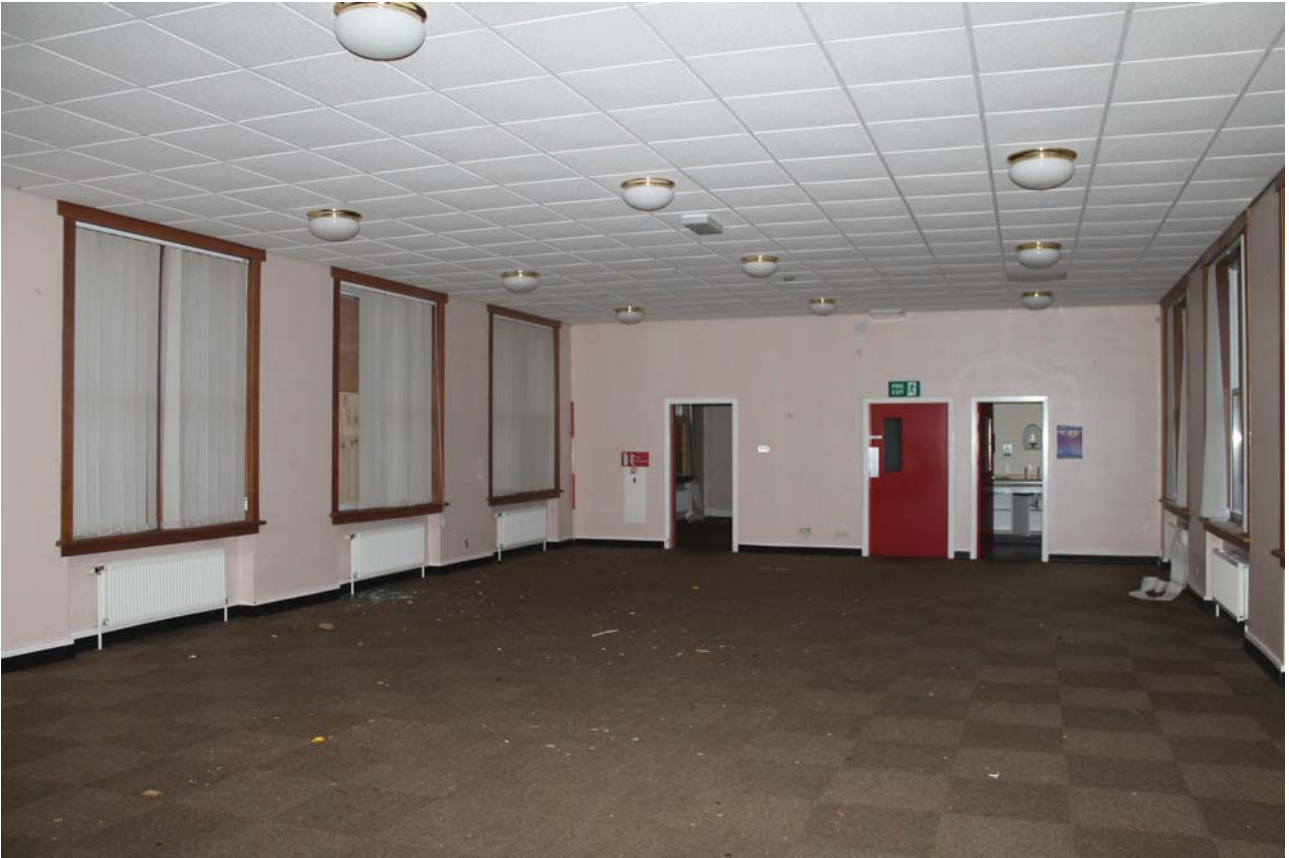
Plate 153: Room 0/17, general view from the SWW

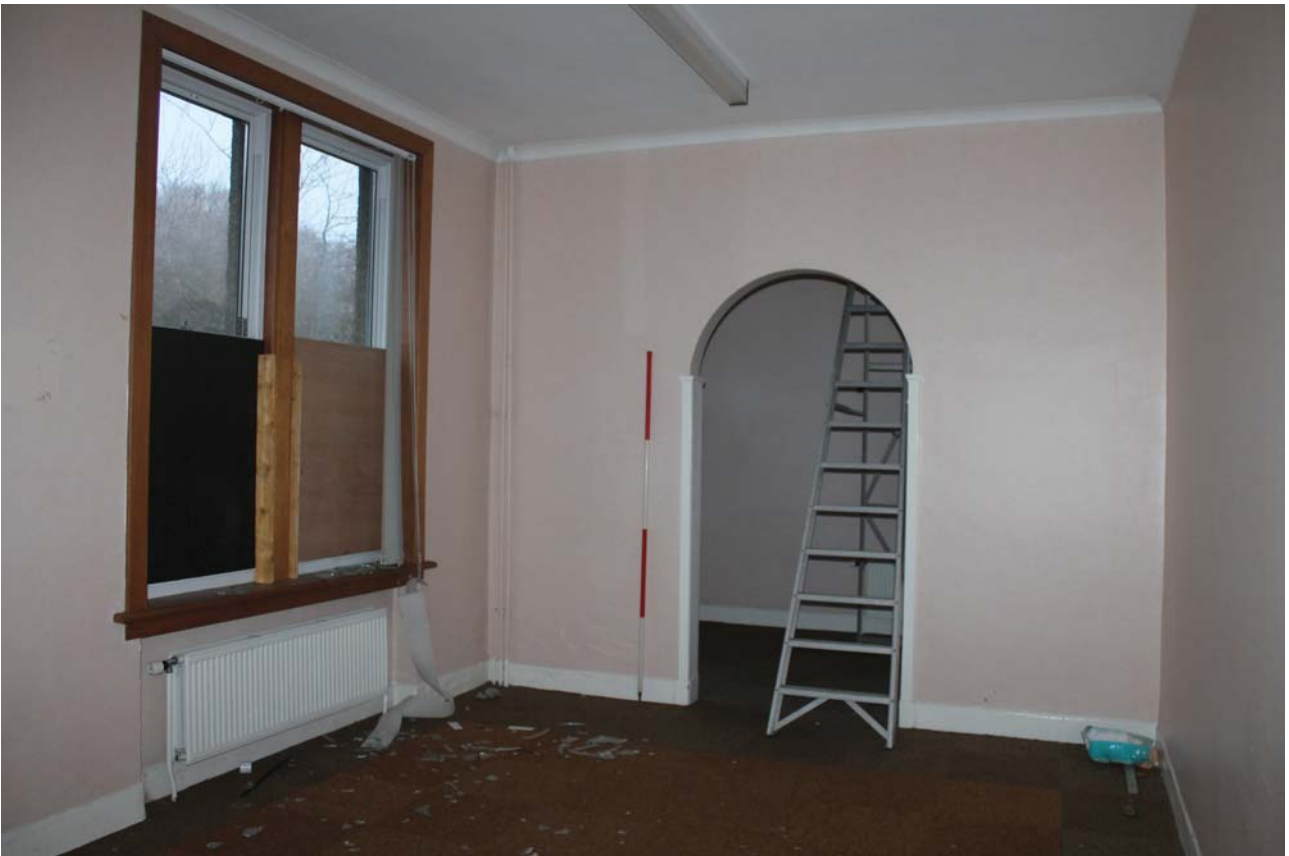
Plate 154: Room 0/18d, detail of archway from the west
