# Ashludie House, Monifieth, Angus: Historic Building Recording Report

AOC Project: 23302

8<sup>th</sup> January 2016

<b>On Behalf of:</b>	<b>Miller Homes Clydesdale House 300 Springfield Parkway Baillieston Glasgow G69 6GA</b>
<b>National Grid Reference (NGR):</b>	<b>NO 49537 33260</b>
<b>AOC Project No:</b>	<b>23302</b>
<b>Planning Application No:</b>	<b>15/00099/FULM</b>
<b>OASIS Reference:</b>	<b>235866</b>
<b>Prepared by:</b>	<b>Diana Sproat</b>
<b>Date:</b>	<b>8<sup>th</sup> January 2016</b>

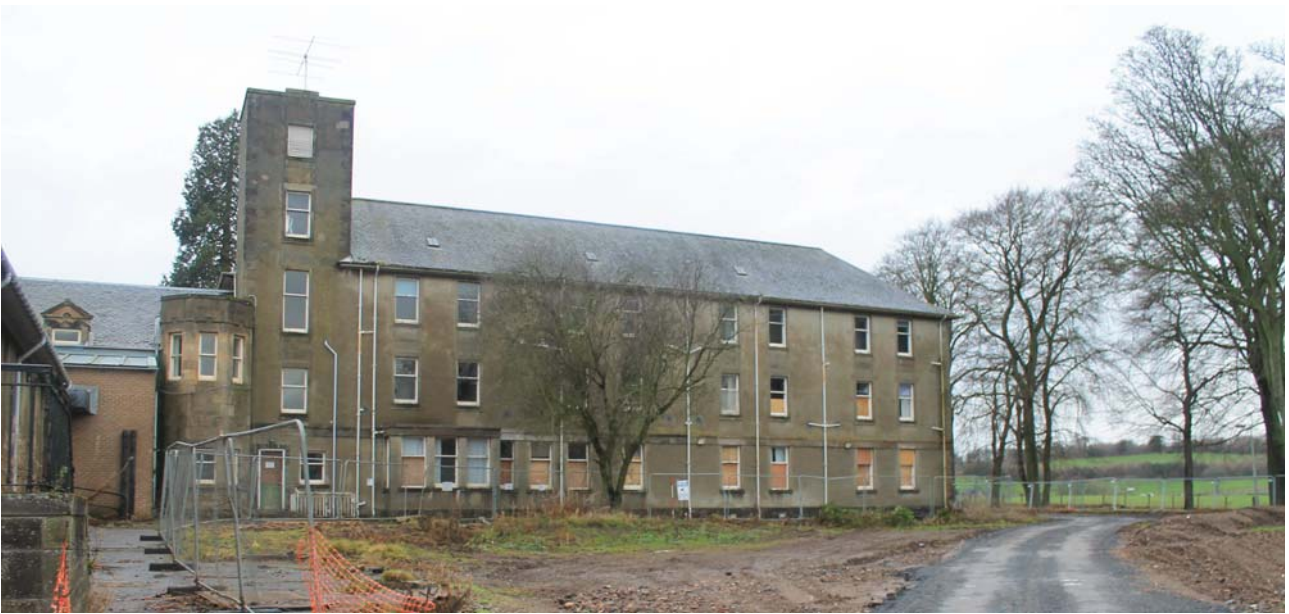
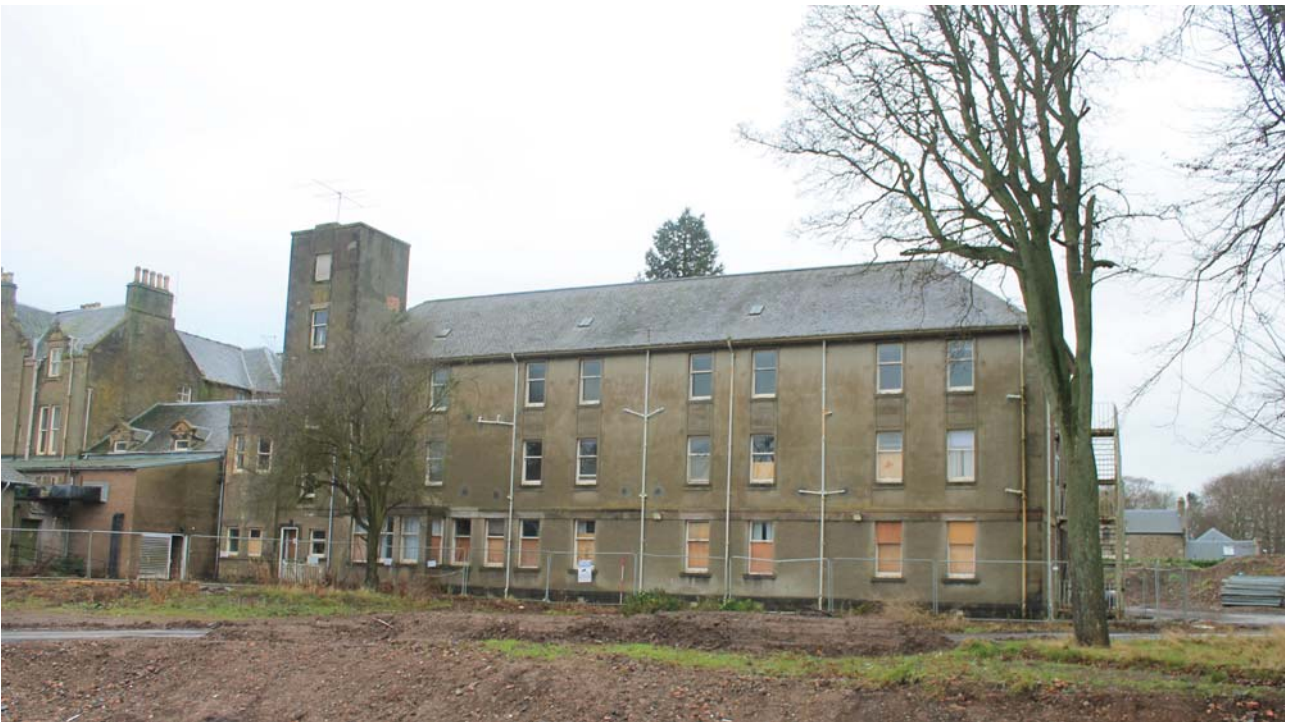
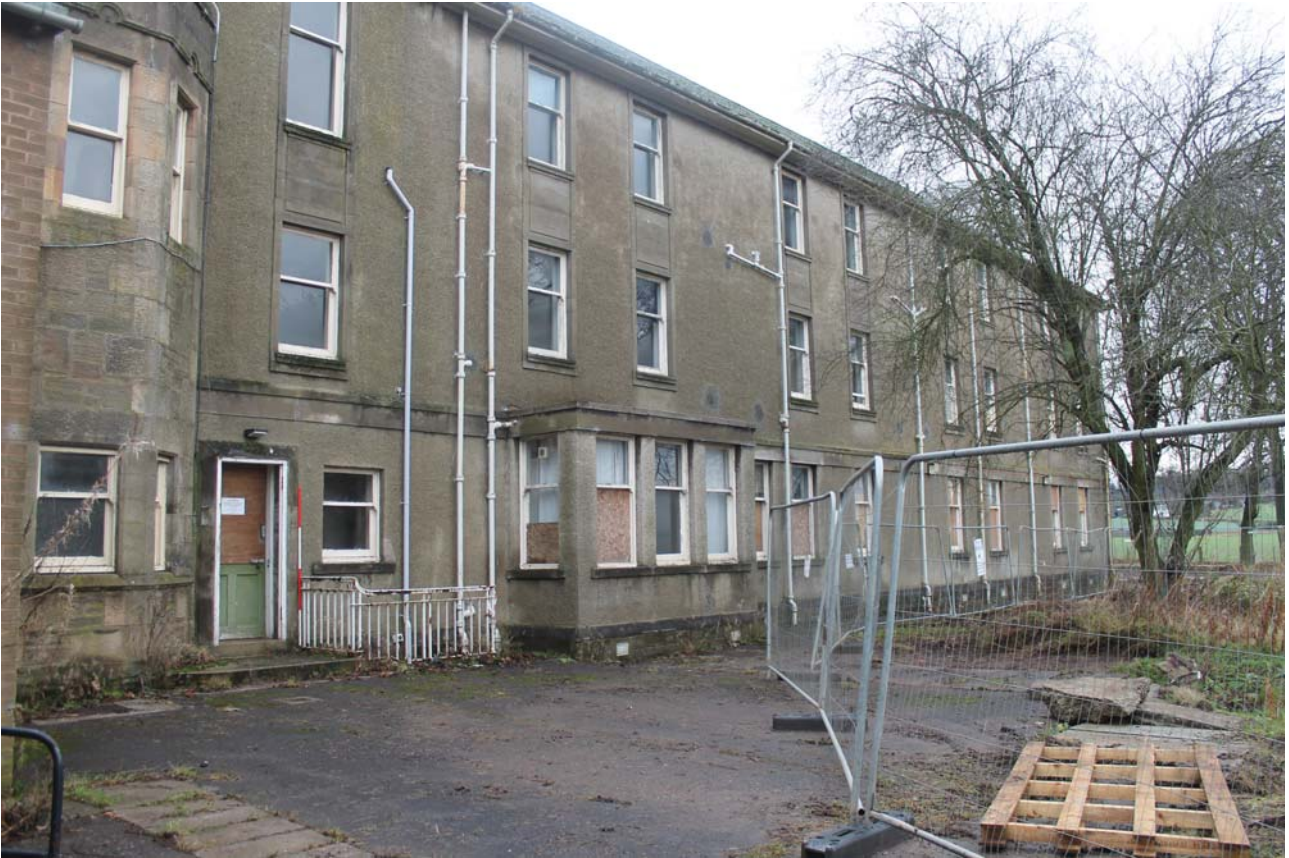
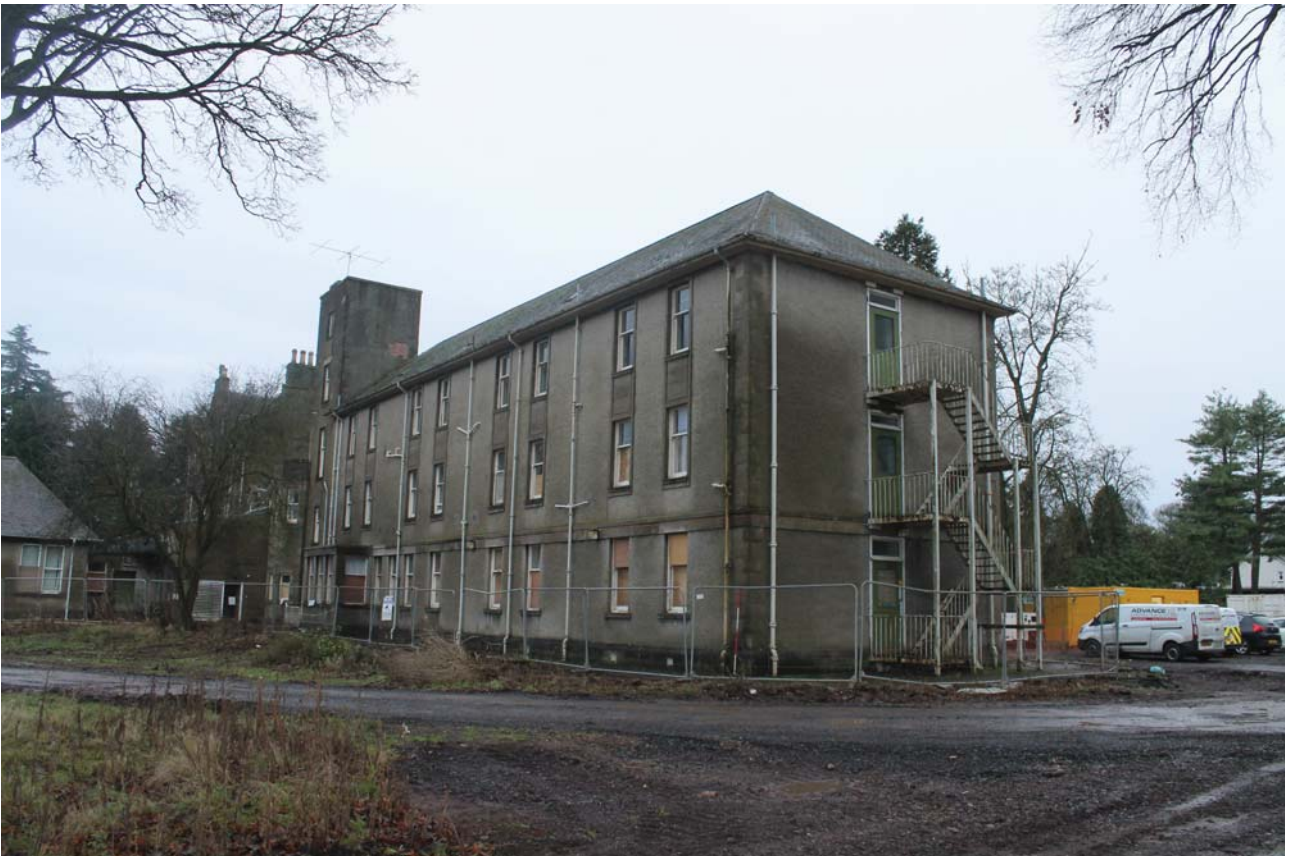
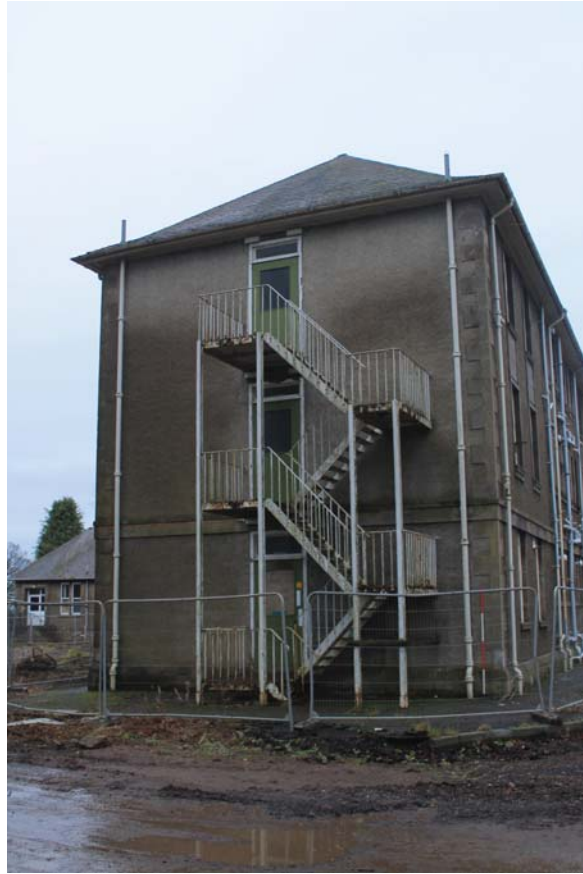
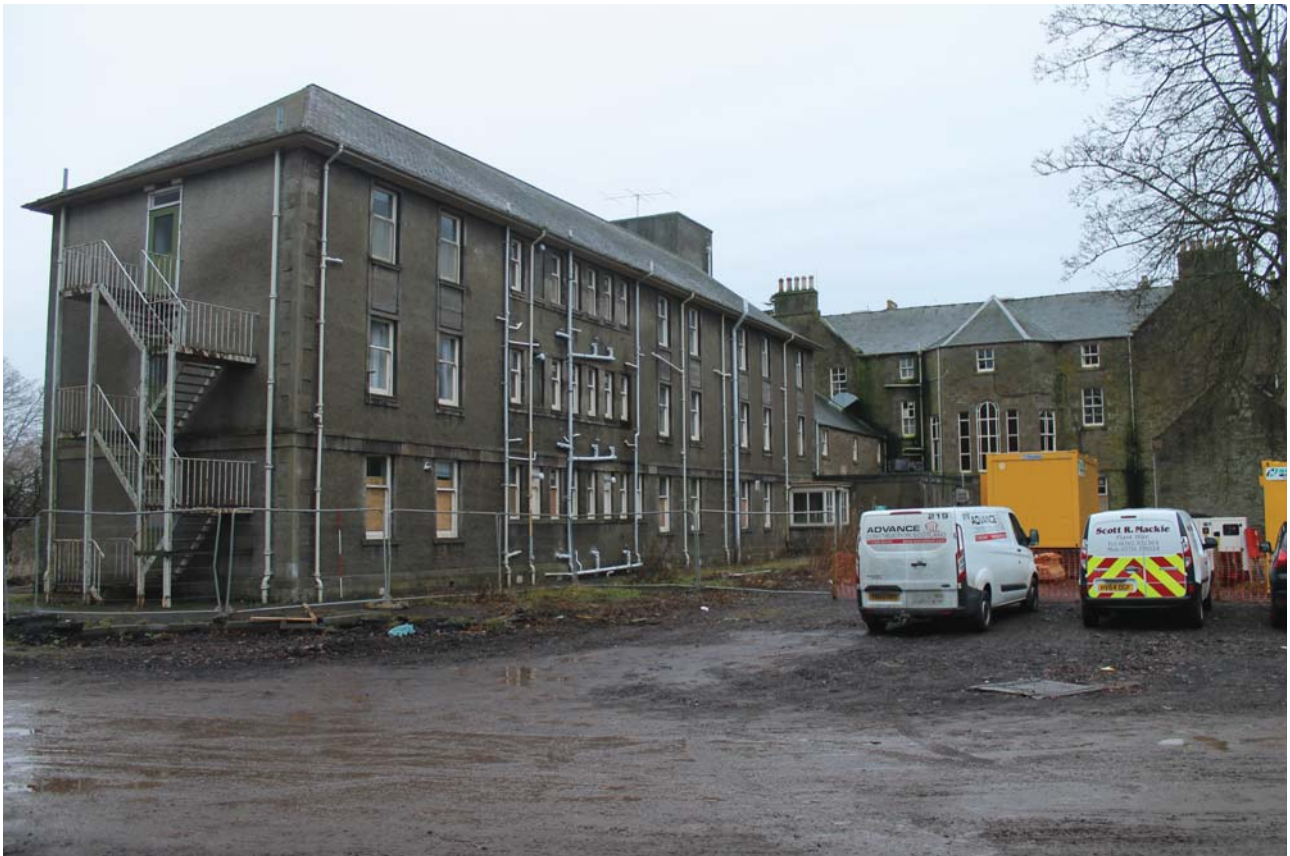
This large three-storey wing is a fifteen- by one-bay building covered in roughcast render with a piended slate roof (Plates 155 - 160). Attached to the north side of the main house on the east side, all the windows are replacement one-over-one sash and case windows with projecting sills with a flat sill course above the ground floor level. Some of the original drainage features exist, although there has been a lot of replacement. To the south end of the west elevation is a projecting porch with a glazed timber-panelled door surrounded by further fixed pane glazing and a flat roof (Plate 161). On the same elevation, after the third bay from the north, is a row of smaller windows reflecting the toilet blocks within (eight to the ground floor and six to the first floor).

Plate 155: Building D, North Wing, general view from the SEE

Plate 156: Building D, North Wing, general view from the north-east

Plate 157: Building D, North Wing, East Elevation, general view from the south-east

Plate 158: Building D, North Wing, general view from NNE

Plate 159: Building D, North Wing, North Elevation, general view from the NNW

Plate 160: Building D, North Wing, general view from the north-west

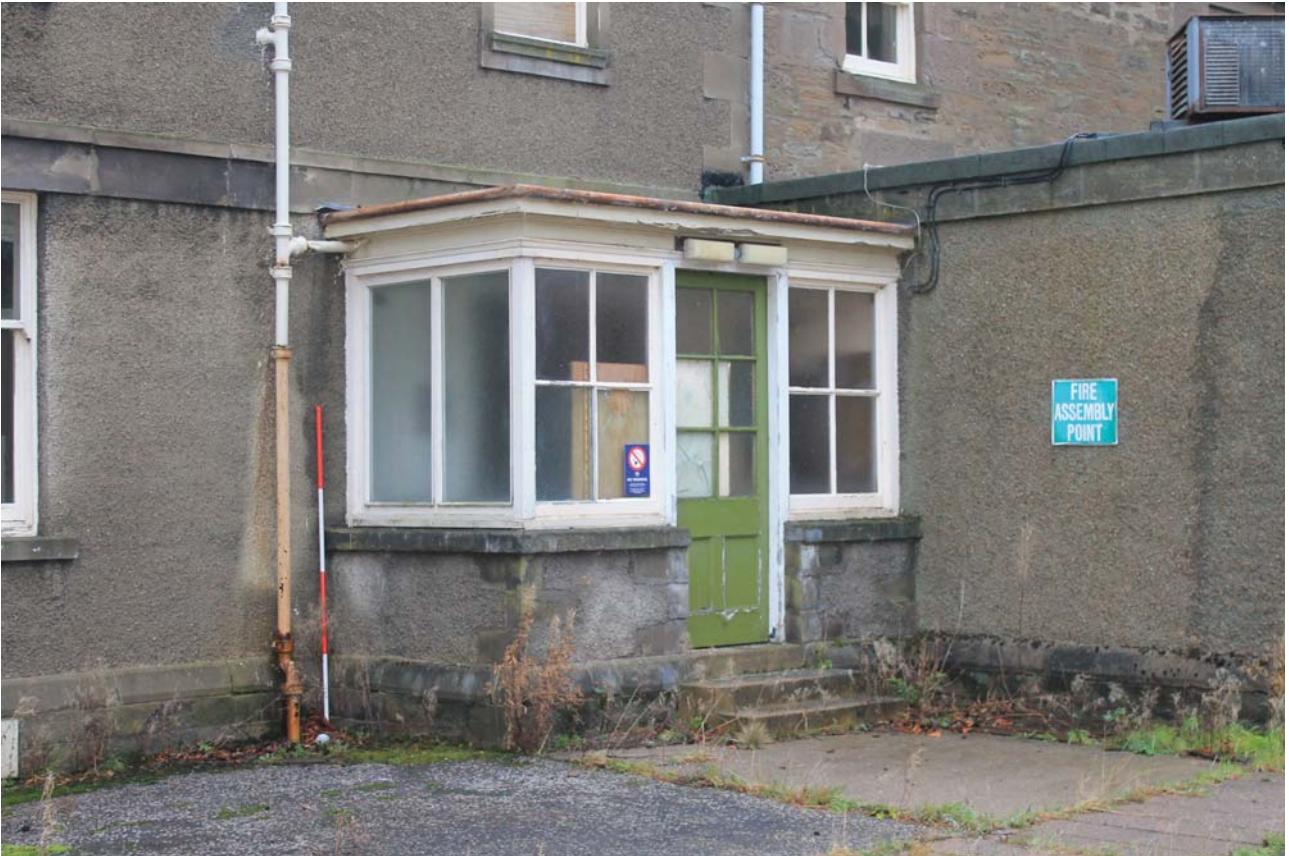
Plate 161: Building D, North Wing, West Elevation, detail of porch to the south side from the north-west

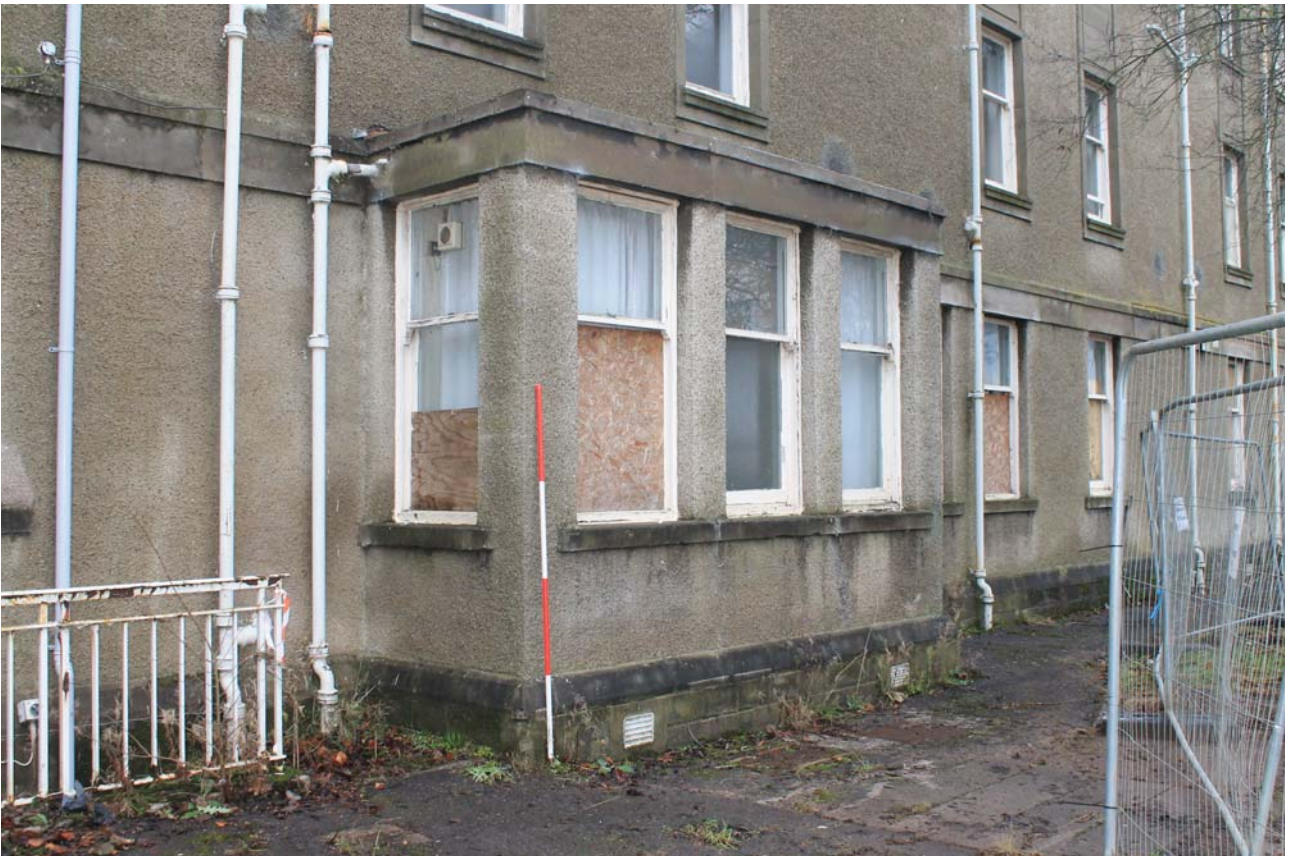
The east elevation is a slightly neater façade with a projecting three-bay porch to the south side (Plate 162). Above this, the building rises to a flat roof above consisting of the main stairwell. There is a single bay to the north elevation with a fire escape door to each floor level. Immediately in front of Building B2 – the North Annexe to the main house to the west side – is a single-storey flat-roofed extension also, covered in a roughcast render (Plate 163). It also has a number of its windows blocked up with a simple modern glazed door approached from a concrete ramp.

Plate 162: Building D, North Wing, East Elevation, detail of bay window to the south side from the south-east

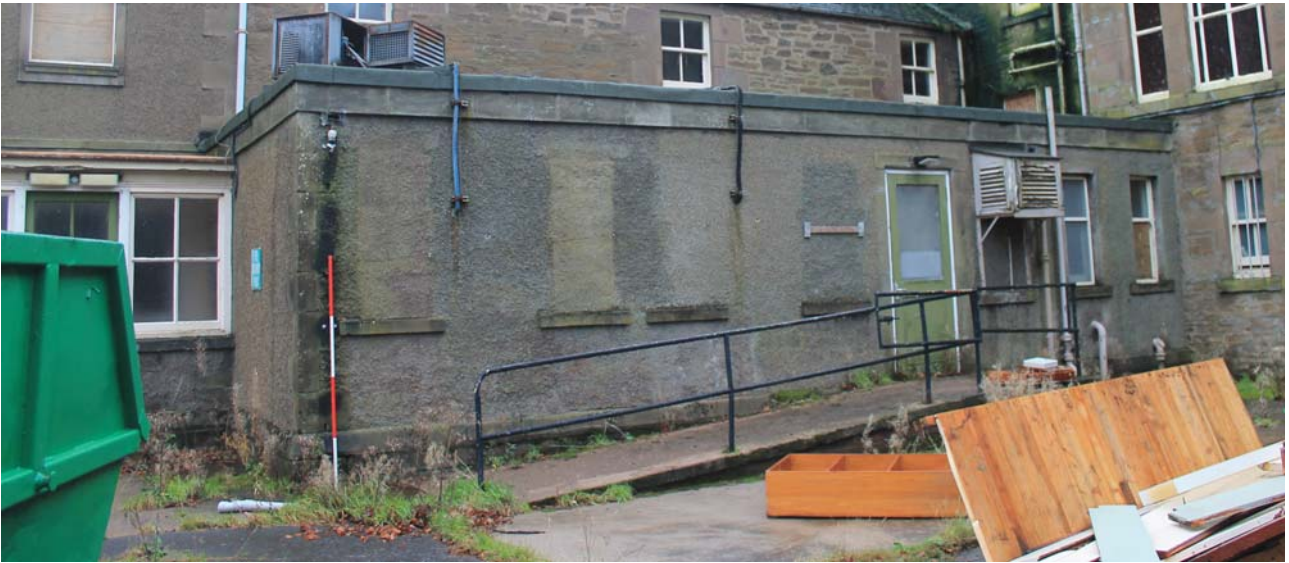
Plate 163: Building D, North Wing, West Elevation, detail of flat-roofed extension to the south side from the NWW

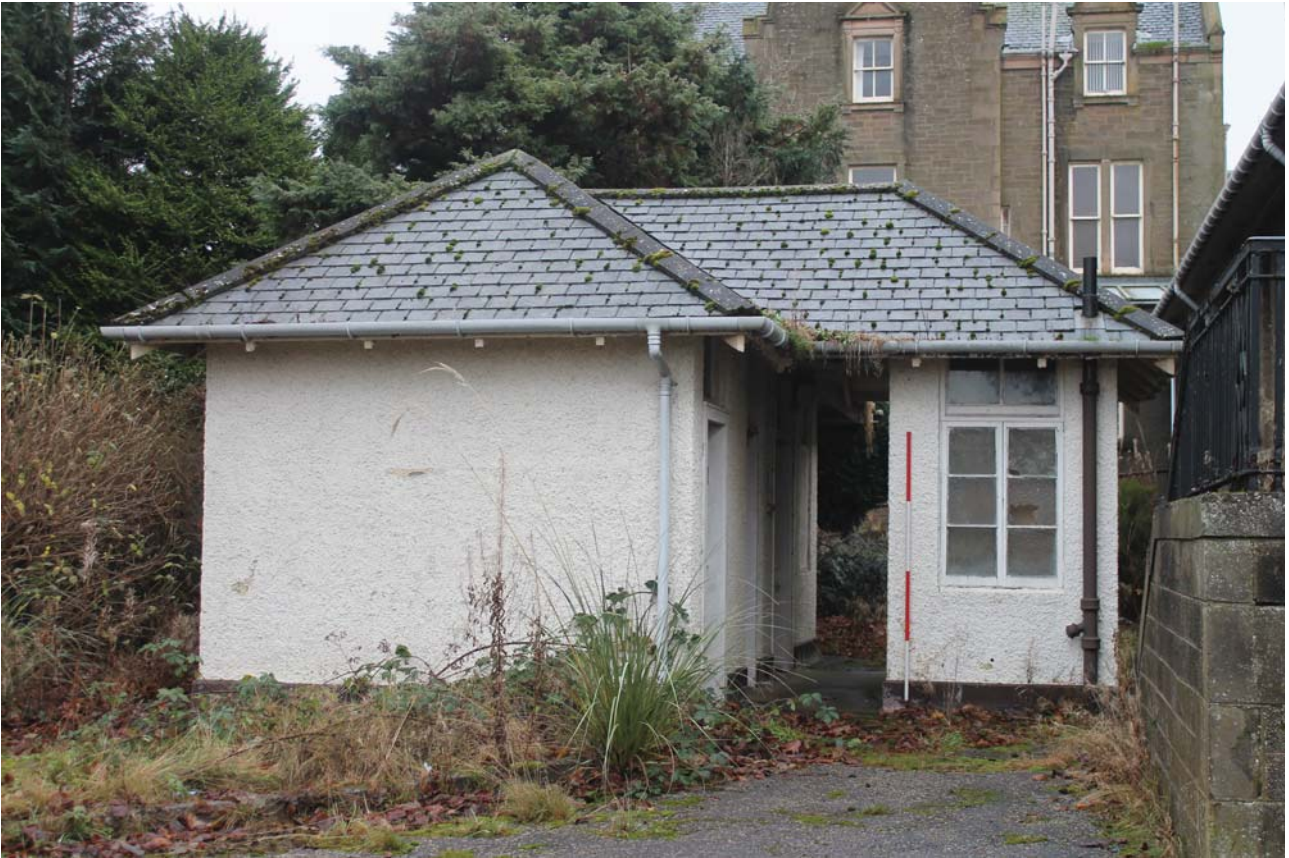
- 5.8.1 These two small toilet blocks are identical, located to the south (E) and west (F) respectively (Plates 177 & 178). They are both brick-built with a roughcast render and a hipped slate roof with stone ridge tiles, modern doors and timber-framed casement windows.

Plate 177: Building E, Toilet Block, general view from the east

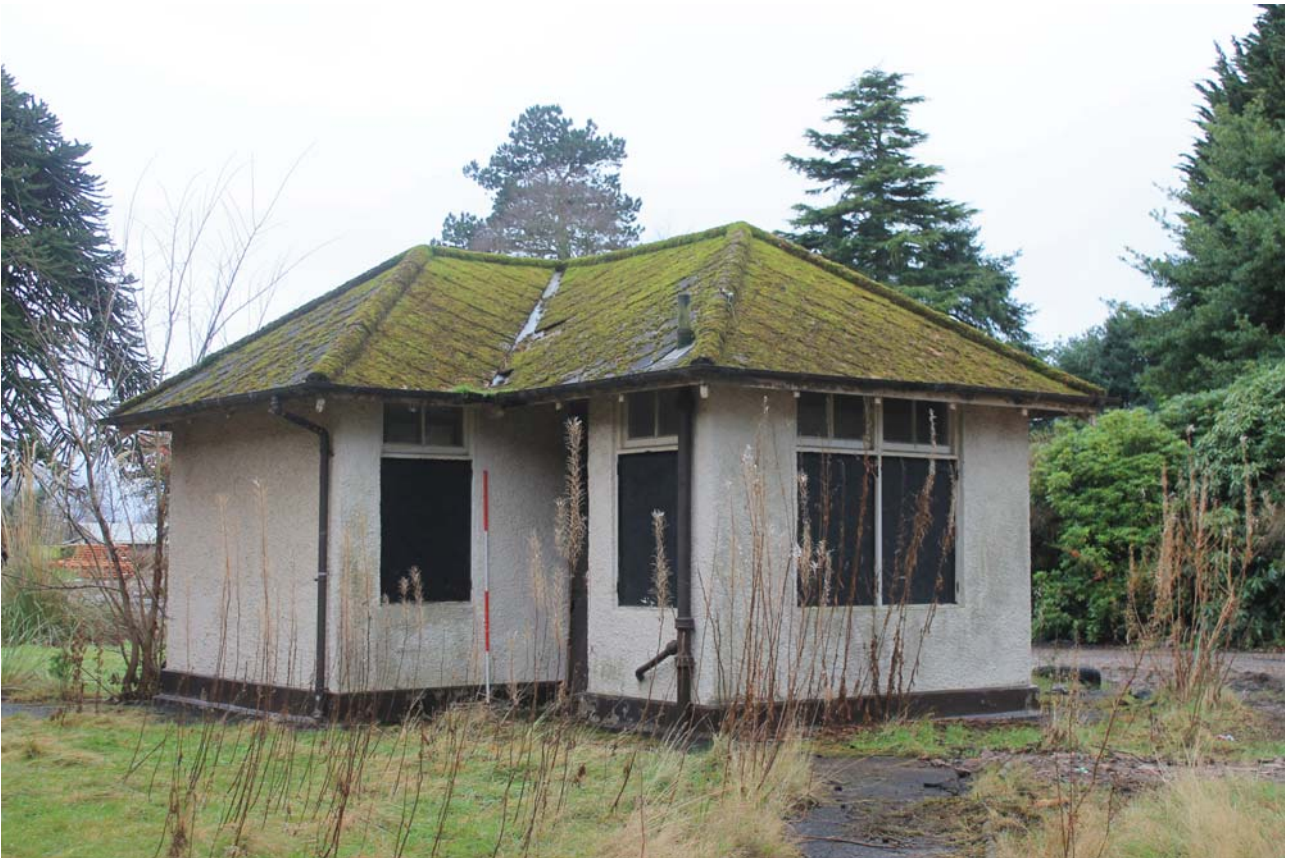
Plate 178: Building F, Toilet Block, general view from the north-east

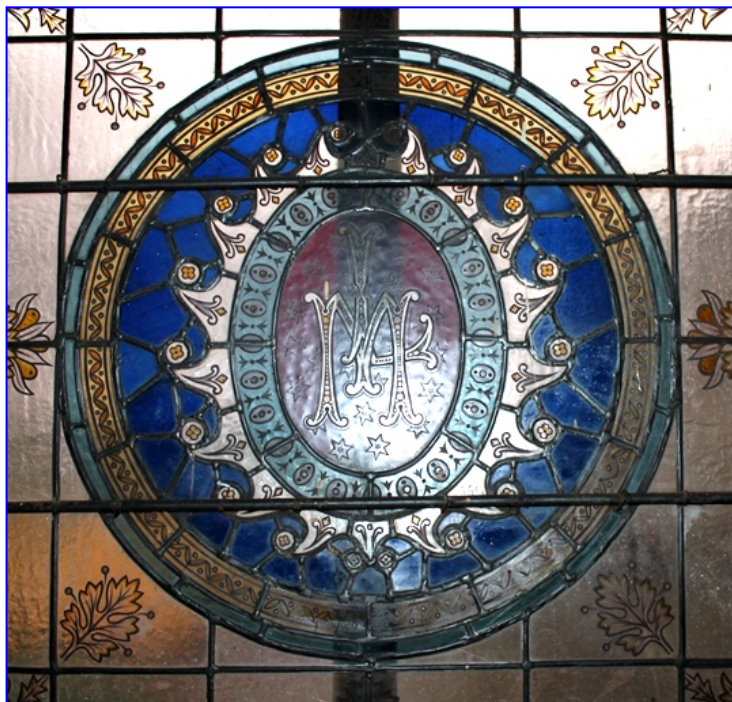
Detail of the initials ML to the stained glass window in the intermediate landing of the main stairwell

within the two main reception rooms in the house (Rooms 0/6 and 0/7) in the ceilings set into the bay windows, as well as the fine stained glass window to the main stairwell (see below).
