Merchiston House, Brookfield, Renfrewshire: Archaeological Evaluation Data Structure Report

AOC Project 23326
25th January 2016

On Behalf of:	CgMs Consulting Ltd. 9-10 St Andrew Square Edinburgh EH2 2AF
National Grid Reference (NGR):	NS 42075 64320
OASIS No:	241569
AOC Project No:	23326
Prepared by:	Kevin Paton
Date of Fieldwork:	18th to 22nd January 2016
Date of Report:	25th January 2016

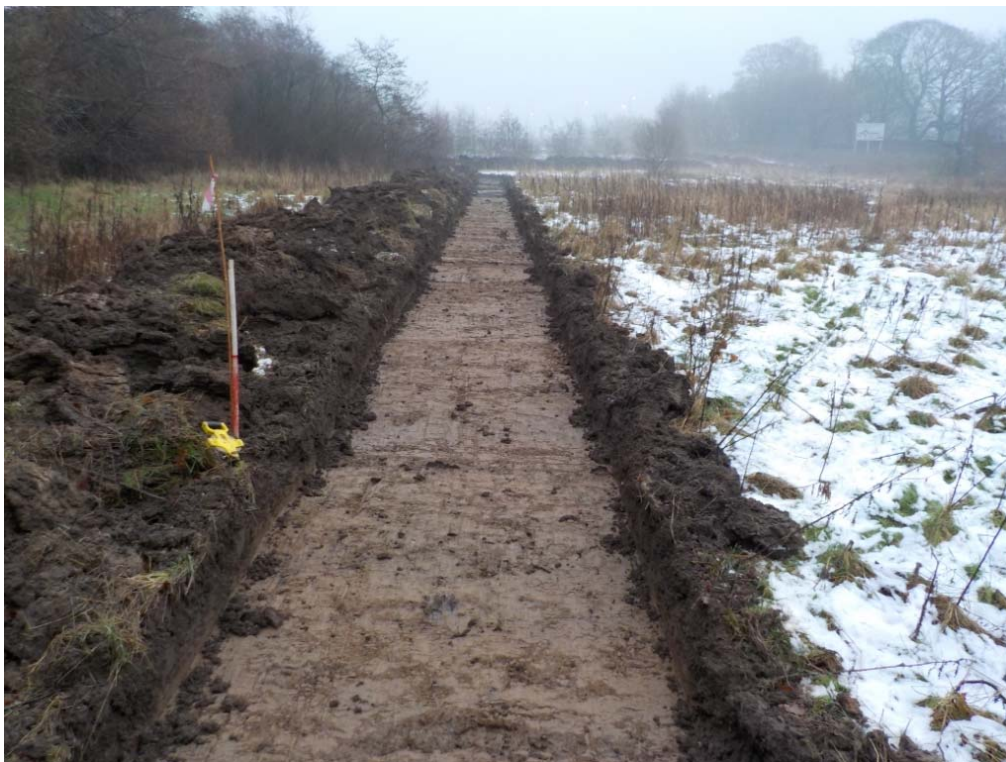
- 4.2 The soil make-up throughout the development area varied across the site. Trenches 1-3, and 17-19 consisted of 0.35 m of dark brown clay loam topsoil overlying the underlying orangey brown or grey clay subsoil (Plate 1). However, the other trenches all encountered various depths of made ground, mainly consisting of a dark grey silty clay with frequent plastic, glass, brick and timbers, along with occasional modern brick and breeze block as well as a few hand made bricks and 19th and 20th century white ceramics. In Trenches 4-8, 12, 13, 15 and 16 the made ground measured between 0.3 m and 1.5 m, and directly overlay the clay subsoil (Plate 2), but Trench 14 consisted of made ground overlying the previous topsoil. Finally, Trenches 9-11 were found to have been located over the line of a probable sewer (not recorded in the available services data) with up to 2.05 m of made ground encountered.

Plate 1 - Post excavation view of Trench 17

<i>Excavated Orientation</i>	E to W
<i>Soil Make-up</i>	Topsoil and Made Ground mix (0 m to 22 m) – dark greyish brown silty clay with frequent plastic, glass, brick and timbers, along with occasional modern brick and breeze block as well as a few hand-made bricks and 19 th and 20 th century white ceramics – max depth 0.55 m Topsoil (22 m to 65 m) – dark brown clay loam with frequent stone, coal flecks and occasional white ceramics – max depth 0.3 m
<i>Significant Features</i>	None
<i>Other Features</i>	Modern drain with type 1 fill at 7.1 m aligned N-S; Modern drain with type 1 fill at 14.6 m aligned NNW-SSE; Modern drain with type 1 fill at 16 m aligned NW-SE.
<i>Natural Subsoil</i>	Orangey brown clay
<i>Finds</i>	None

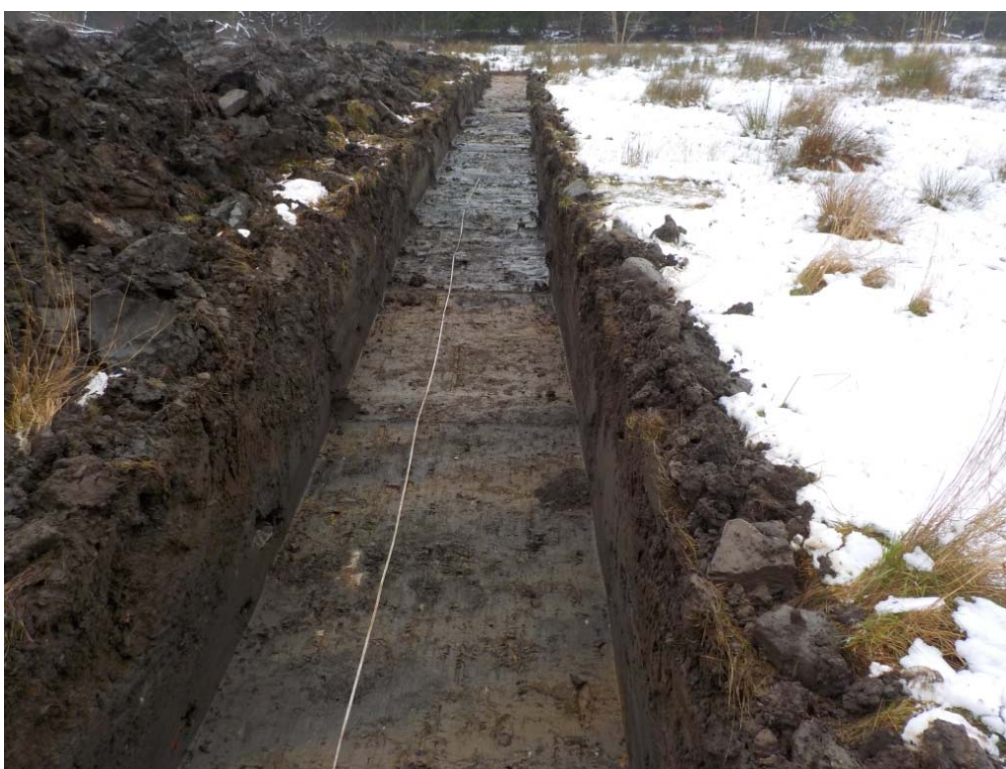
Plate 2 - Post excavation view of Trench 4

<i>Dimensions</i>	50 m by 2 m
<i>Total Area</i>	100 m ²
<i>Excavated Orientation</i>	NW to SE
<i>Soil Make-up</i>	Topsoil (0 m to 13 m) – dark brown clay loam with frequent stone, coal flecks and occasional white ceramics – max depth 0.26 m; Made Ground (13 m to 50 m) – dark grey silty clay with frequent plastic, glass, brick and timbers, along with occasional modern brick and breeze block as well as a few hand-made bricks and 19 th and 20 th century white ceramics – max. depth 1.2 m.
<i>Significant Features</i>	None
<i>Other Features</i>	Ceramic tile drain at 5 m aligned NE-SW
<i>Natural Subsoil</i>	Orangey brown clay - disturbed
<i>Finds</i>	None
