Macallan Distillery, Craigellachie, Moray: Historic Building Recording Report

AOC 22624
27th August 2014

| Planning Application No: | 14/00662/APP |

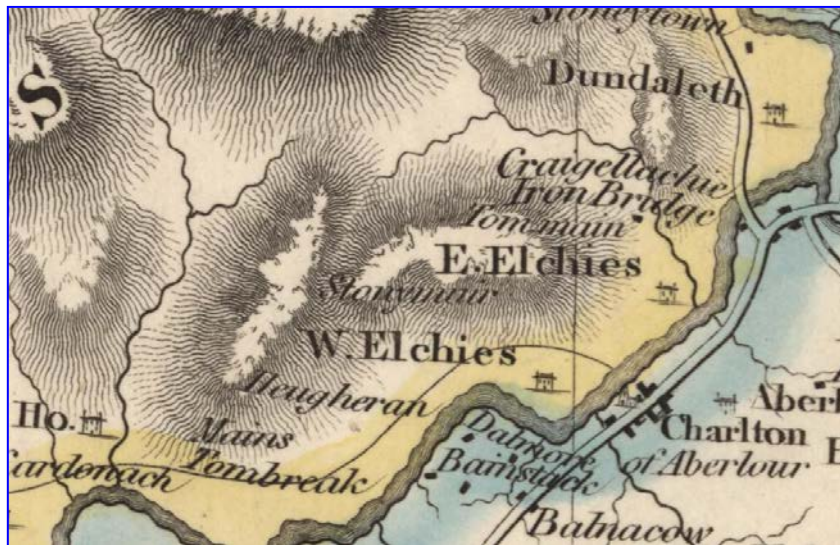
Figure 2: Extract from Thomson's map, 1830

- 4.1 The Macallan Distillery was established in 1824 by Alexander Reid who was a barley farmer and school teacher. Indeed, farmers had been growing barley in the area on their farms for hundreds of years, fermenting the barley in the winter and later distilled into whiskey. Alexander Reid first leased eight acres from the Earl of Seafield to establish his distillery adjacent to Easter Elchies House. The earlier maps are too small scale to show any detailed buildings, and no distillery is annotated on Thomson's 1830 map (Figure 2). Unfortunately, there is no more detailed maps up until 1870, with the First Edition Ordnance Survey (Figure 3). Here we can see a complex of distillery buildings within a well-established and large distillery. The site was taken over by the partnership of Priest and Davidson in 1847 and they may have extended the distillery at that time. Easter Elchies House was also extended in 1857 with a staggering 29 additional rooms added by 1861. Later in 1868, the distillery changed ownership again when it was bought by James Stuart.

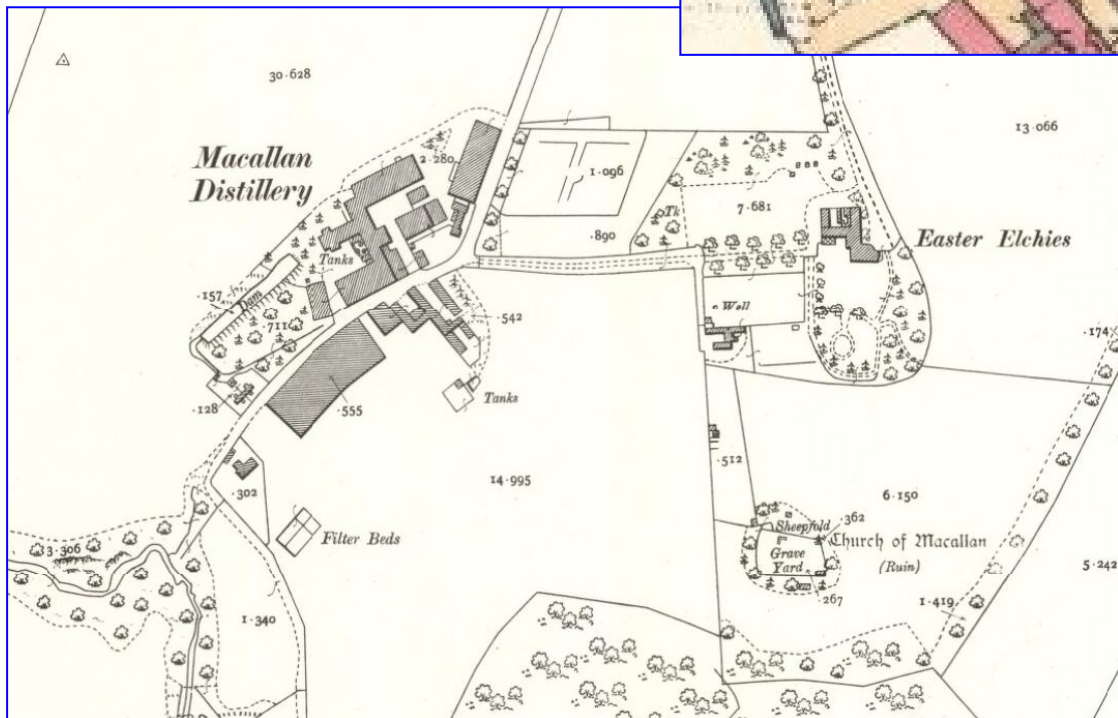
Figure 4: Extract from Ordnance Survey map, 1905

- 4.2 Into the 20th century, the 1905 Ordnance Survey map shows the expansions to the distillery by this time (Figure 4). A large distillery building has been added to the south-west with more filter beds, and more buildings have also been added to the north-east. This may indicate the expansions by new owner Roderick Kemp, who took over the distillery in 1892. By 1909, upon Kemp's death, his descendants managed the business through a Trust.

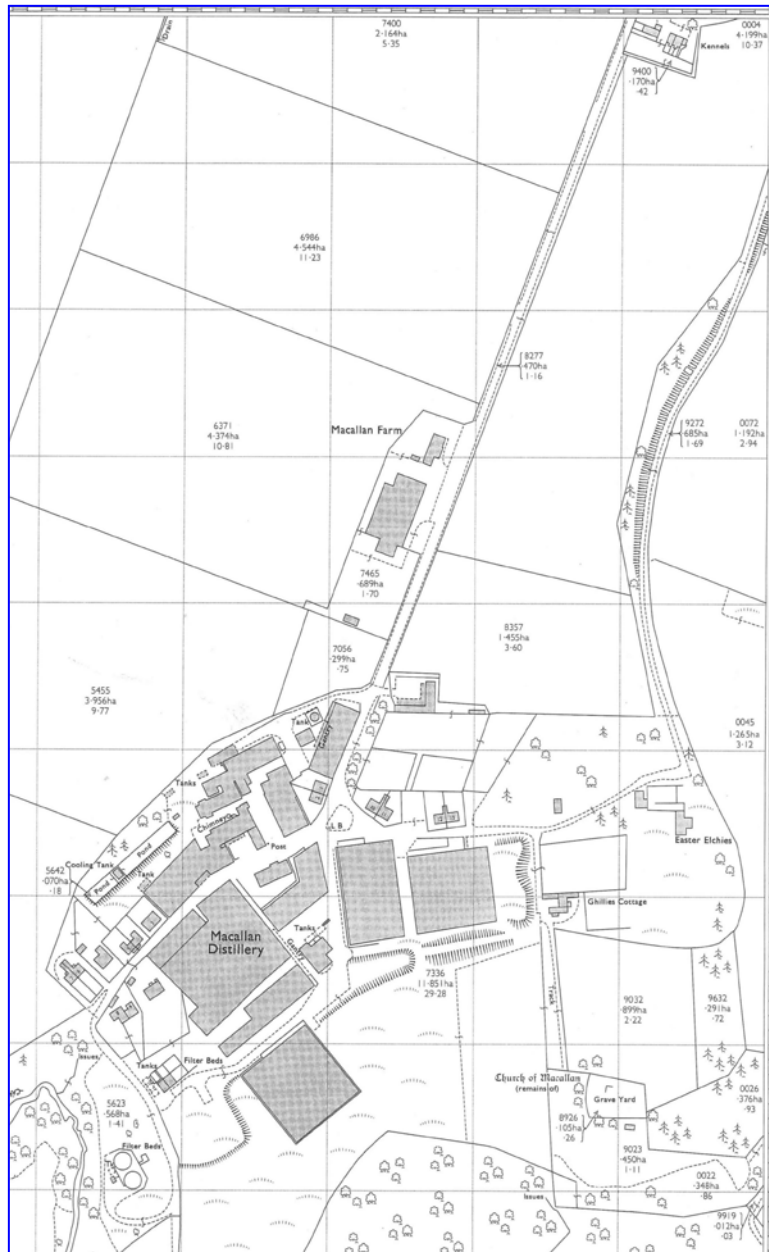
Figure 5: Extract from Ordnance Survey map, 1970

3.5 Into the 1970s, the next detailed 1970 1:2500 Ordnance Survey map shows the alterations to the distillery buildings since the late 1950s (Figure 5). Boiler House 2 has been constructed, along with the tank to the north, although the other Boiler House has not. Still House 2 has been constructed, although the buildings to the south-west have a different arrangement to the present day. The area of Still House 1 has been filled in since the late 1950s, however, and to the north of this, the buildings that were present in the 1905 map are still in place. These were all taken down to make way for the new Still House and associated Tun Room and Mash House in 1974. By the 1983 Ordnance Survey map, the buildings remain much the same as they are in the present day, apart from the small building to the immediate east of Still House 2. This was taken down between 2010 – 2011 to make way for a small visitor centre leading up to the first floor of Still House 2.

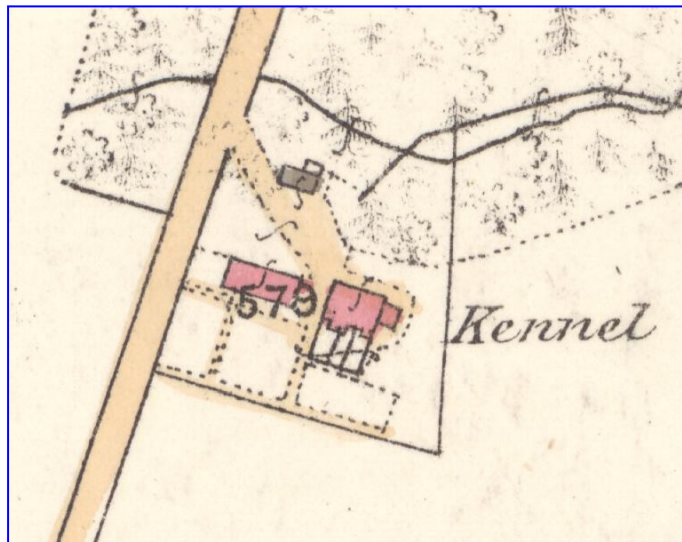
Figure 6: Extract from the Ordnance Survey map, 1874 (surveyed in 1870)

5.7.1 The small cottage and kennels (occupied at the time of survey) first appears on the 1877 Ordnance Survey map (see Figure 6 below). The previous maps are too small scale to identify the cottage and kennels, so it may be earlier than this. The cottage is a small three-bay single-storey stone rubble building with attic and droved stone surrounds to the openings and quoins (Plate 38). It has a central door to the main elevation to the south-west flanked by tall windows with two dormers above in the pitched slate roof. A single chimney stack adorns each gable and there is a modern extension to the rear (Plates 39 & 40).

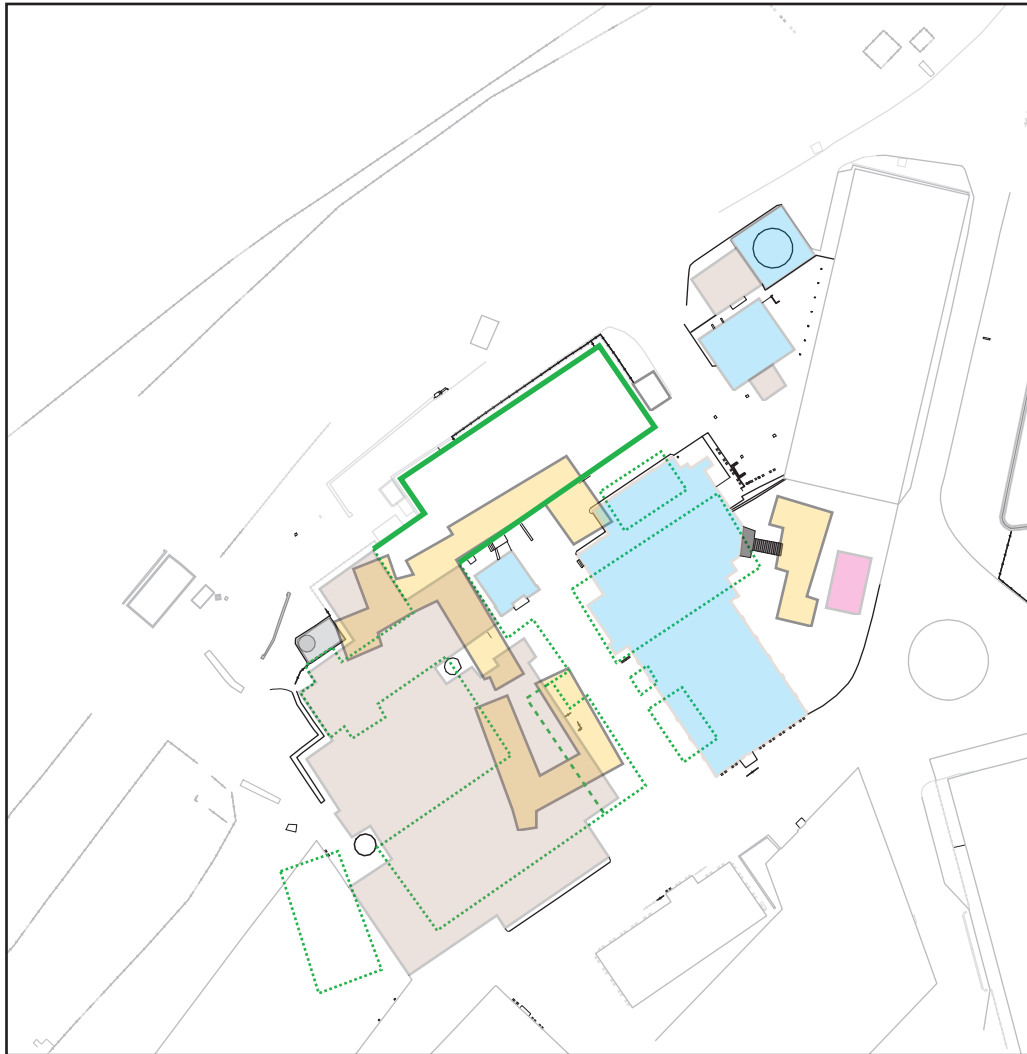
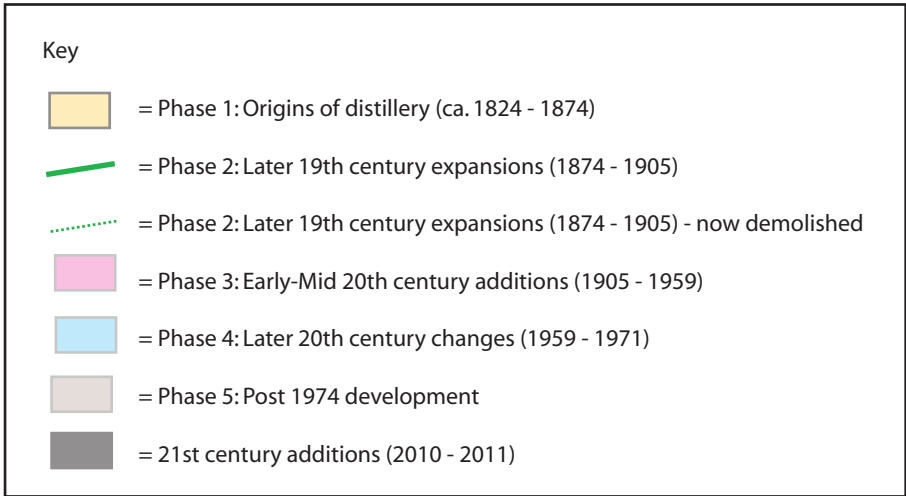
Figure 7: Phased site plan of buildings under investigation

- 6.1 The basic phasing of the buildings is described above in Section 4, and can be summarised in a small phase plan in Figure 7. It is clear the earliest buildings that survive here consist of the Hi-Mac building and a small section of the Malt Storage building. The earliest origins of the distillery are all gone with most earlier 20th century buildings also removed. The majority of the buildings on the site were late 20th century in date, including the two large Still Houses.

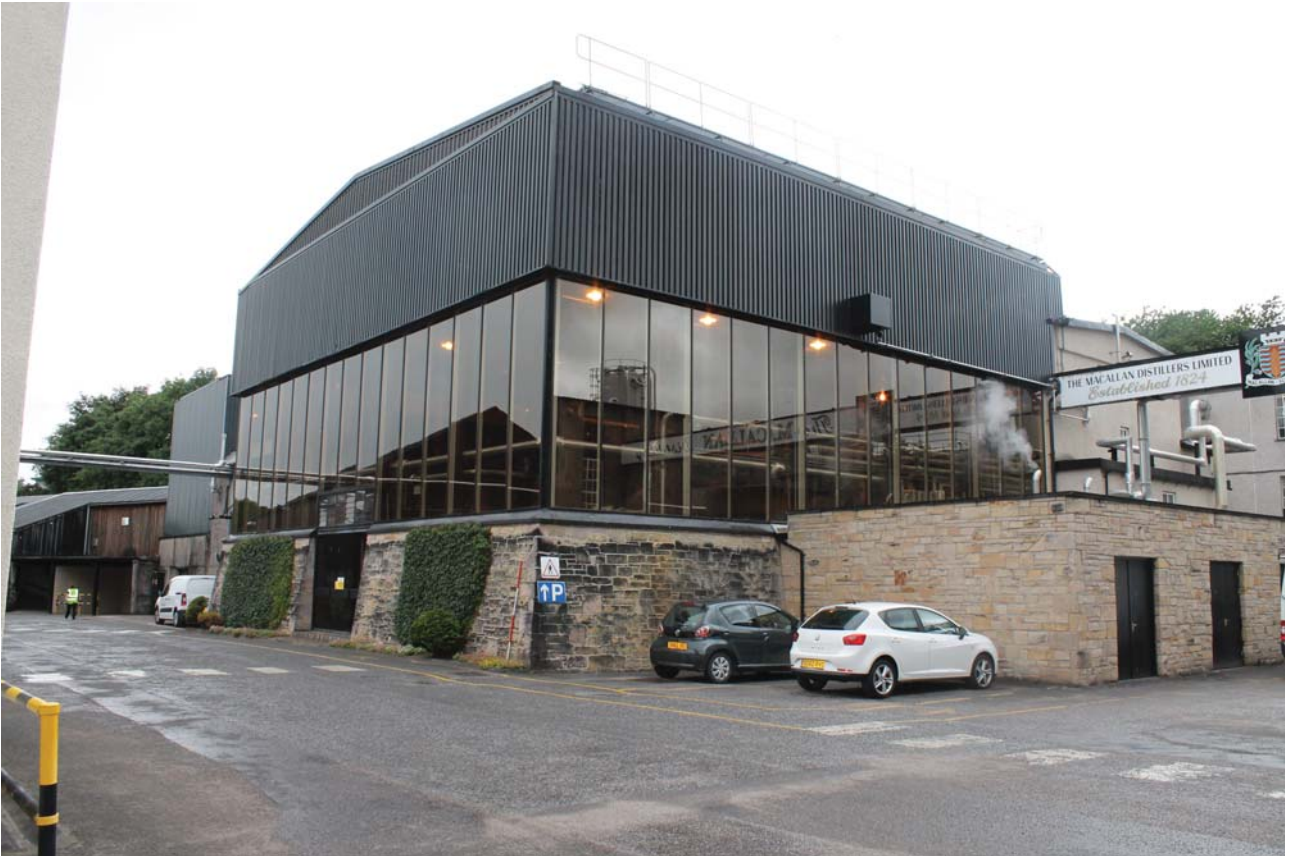
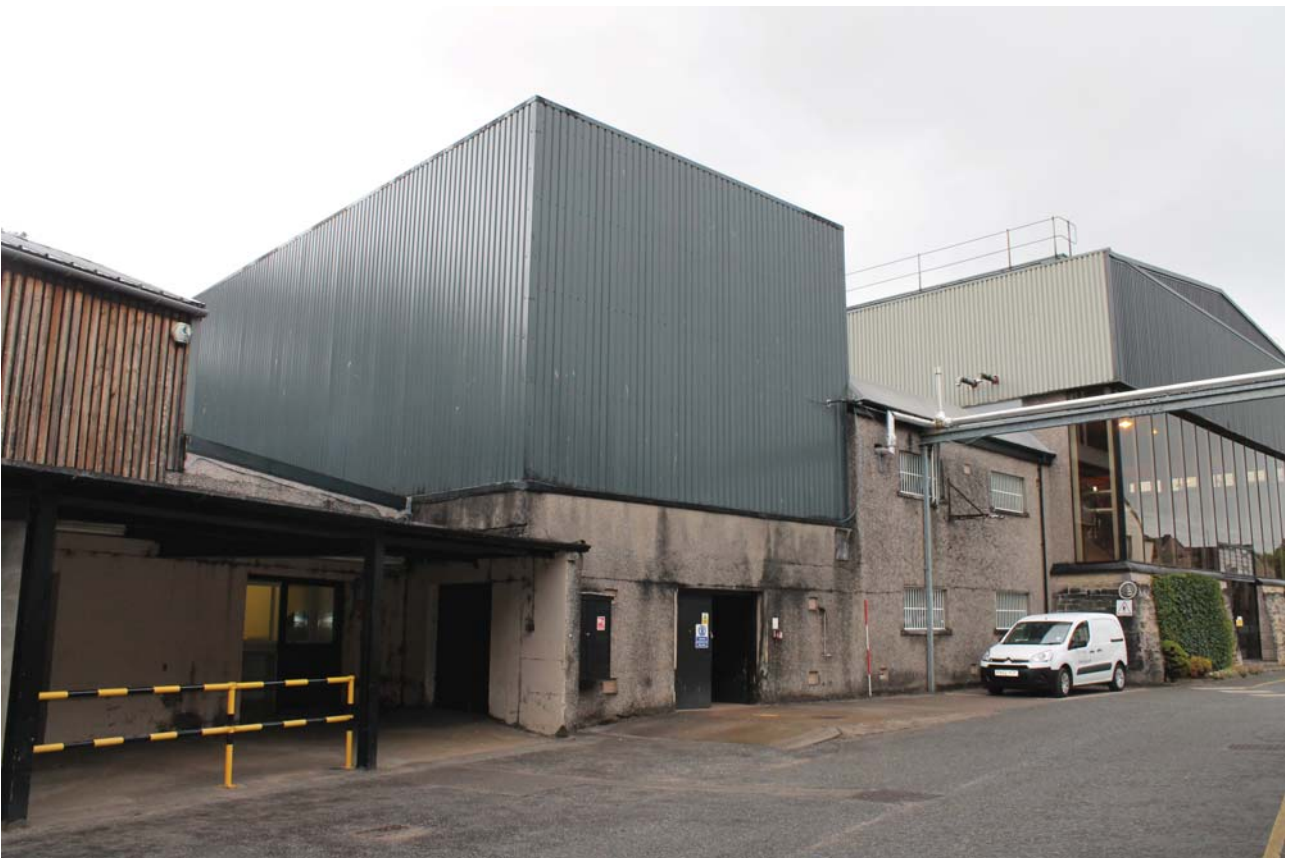
Plate 1: Still House 1, general view from the east

Plate 2: Still House 1, general view from the west

5.1.1 Still House 1 is a relatively late addition to the complex, constructed ca. 1974, with the main building being largely constructed of glass over a stone wall with steel cladding above (Plate 1). To the south-west side is a smaller range of buildings, clad in a roughcast render with steel sheeting to the upper floors (Plate 2). Internally, the main entrance served as the bottom of the copper stills, used on the distillery tours, with the main copper stills reached by a first floor gantry level (Plates 4 & 5).

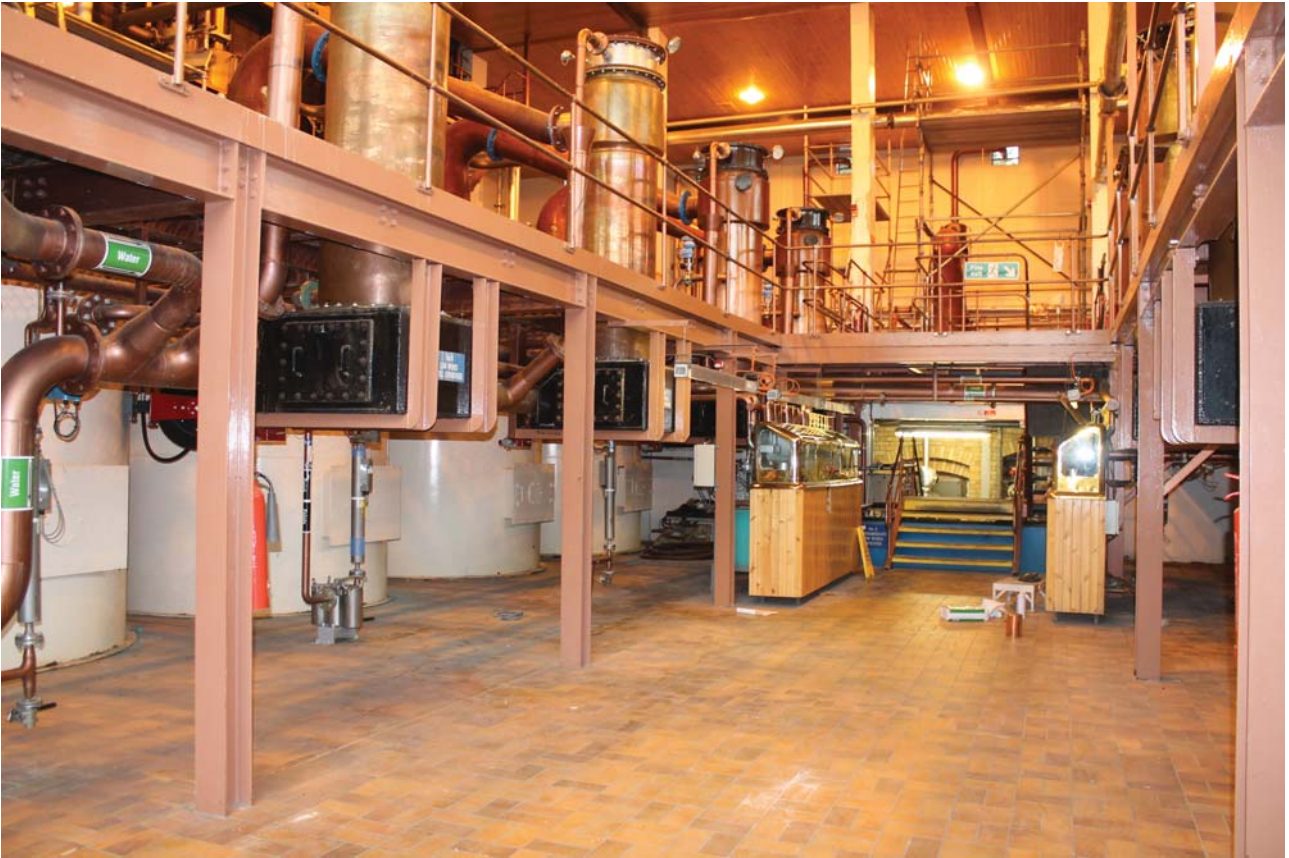
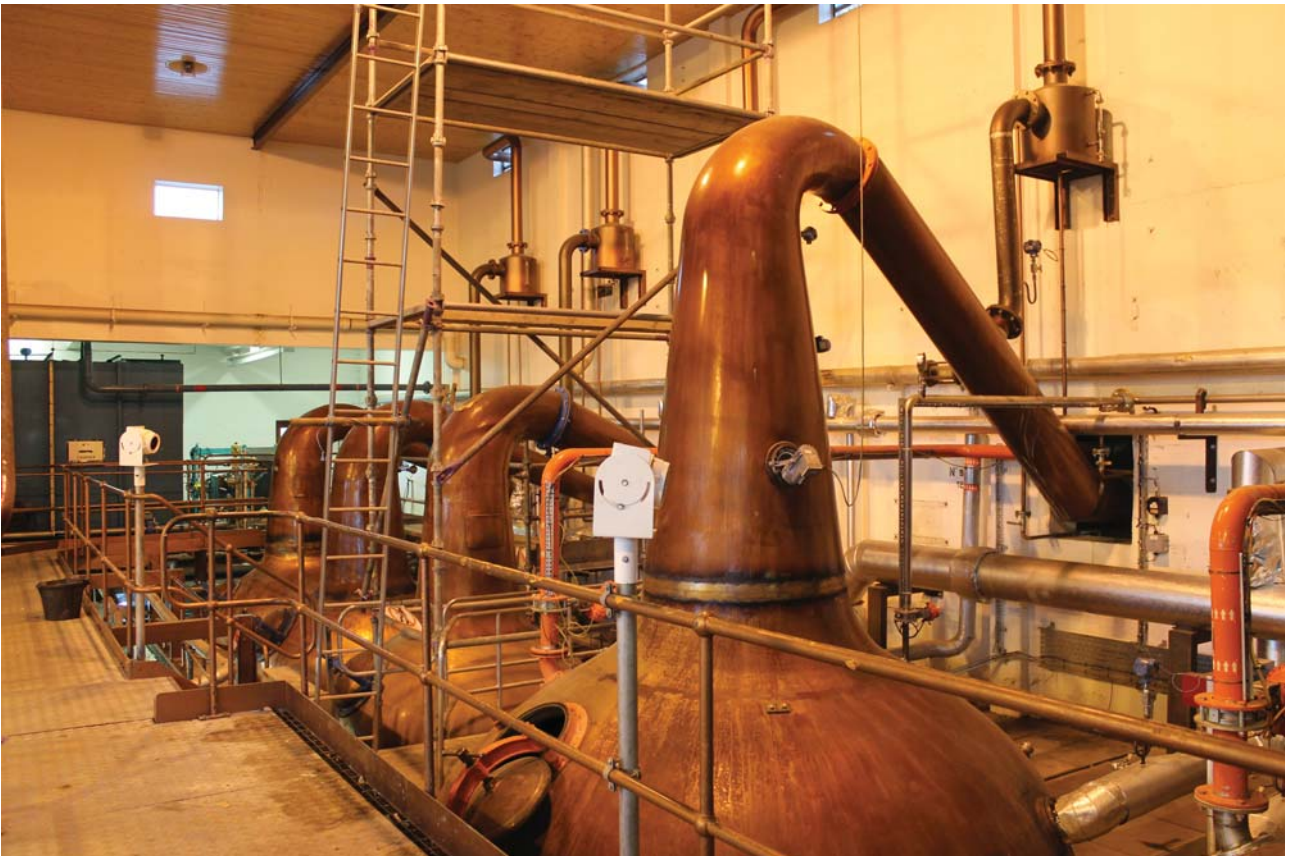
Plate 3: Still House 1, general view of the interior from the south-east

Plate 4: Still House 1, general view of the upper floor showing the copper stills from the east

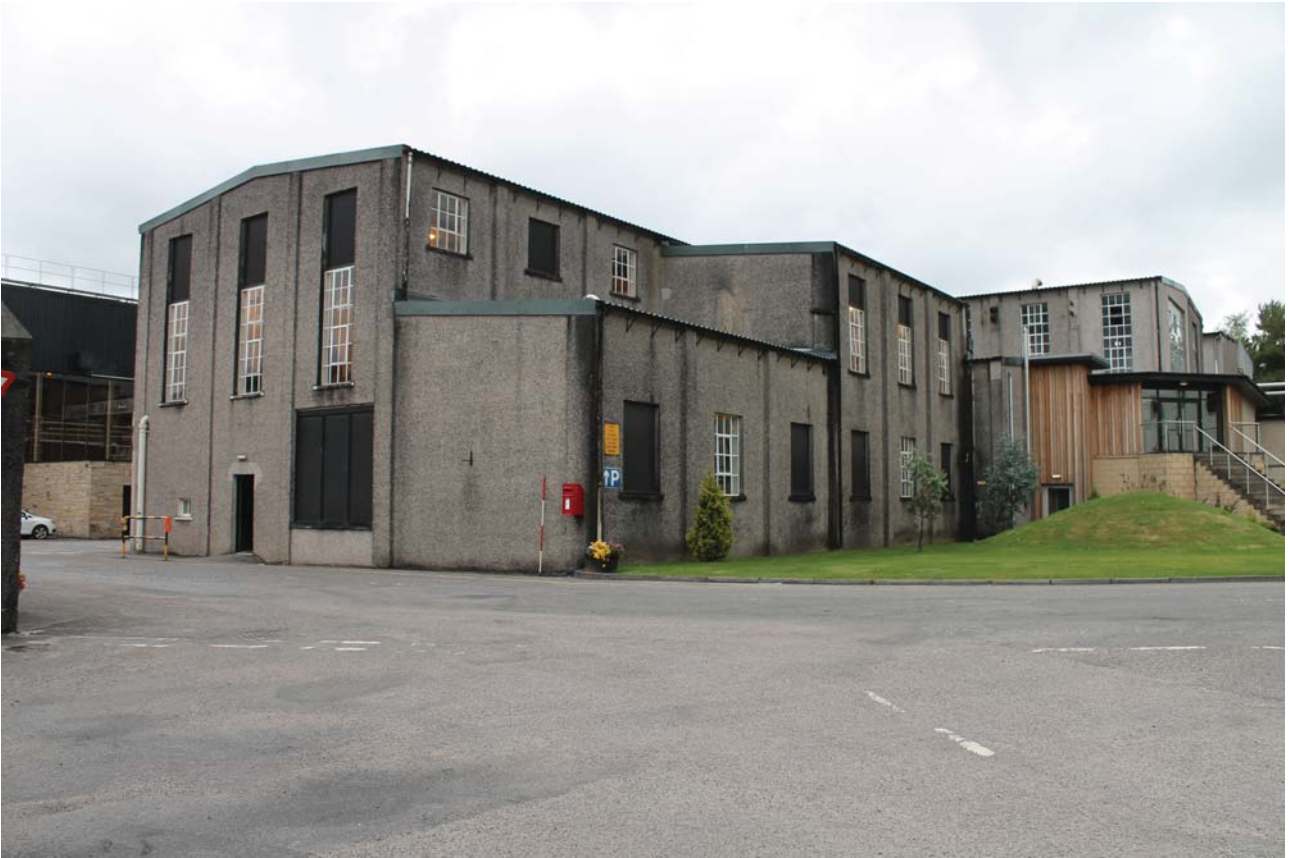
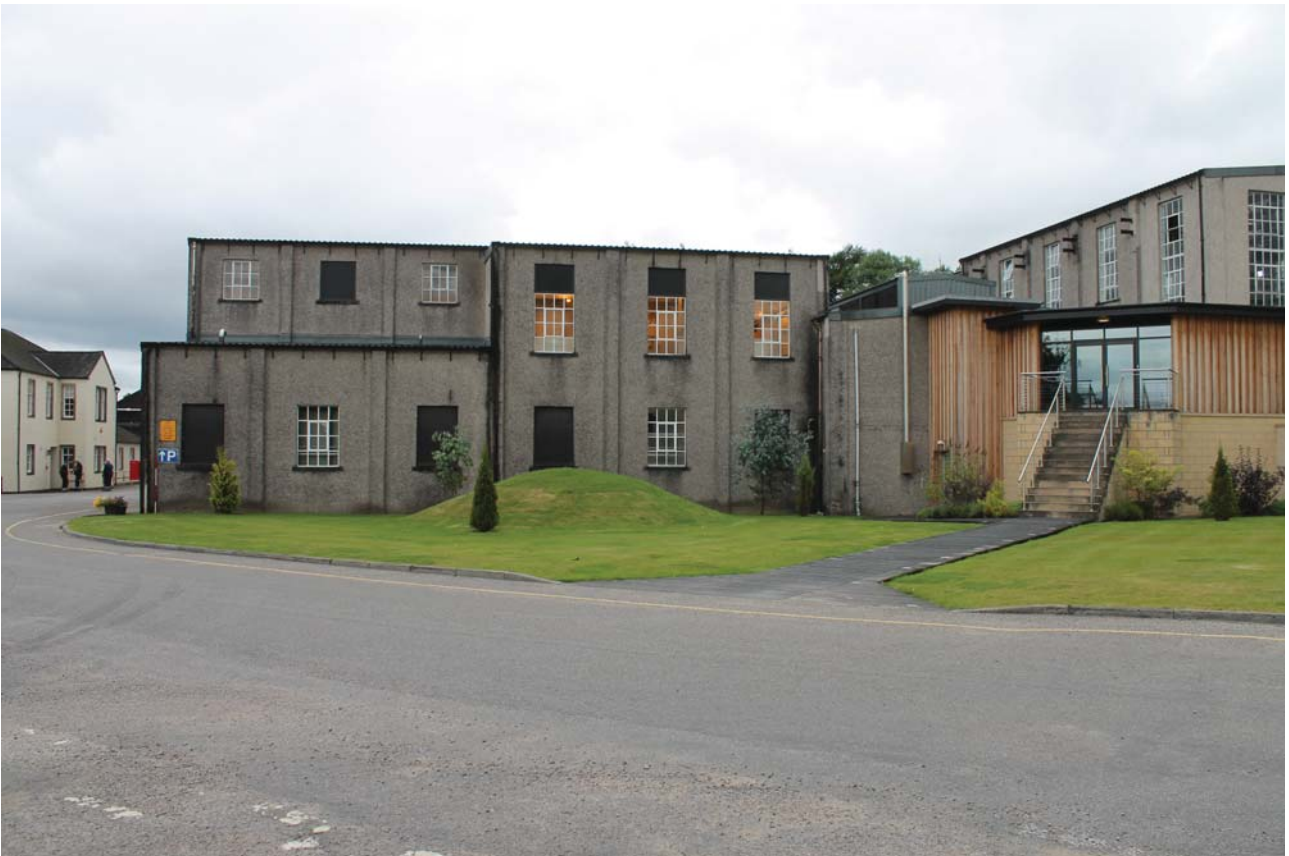
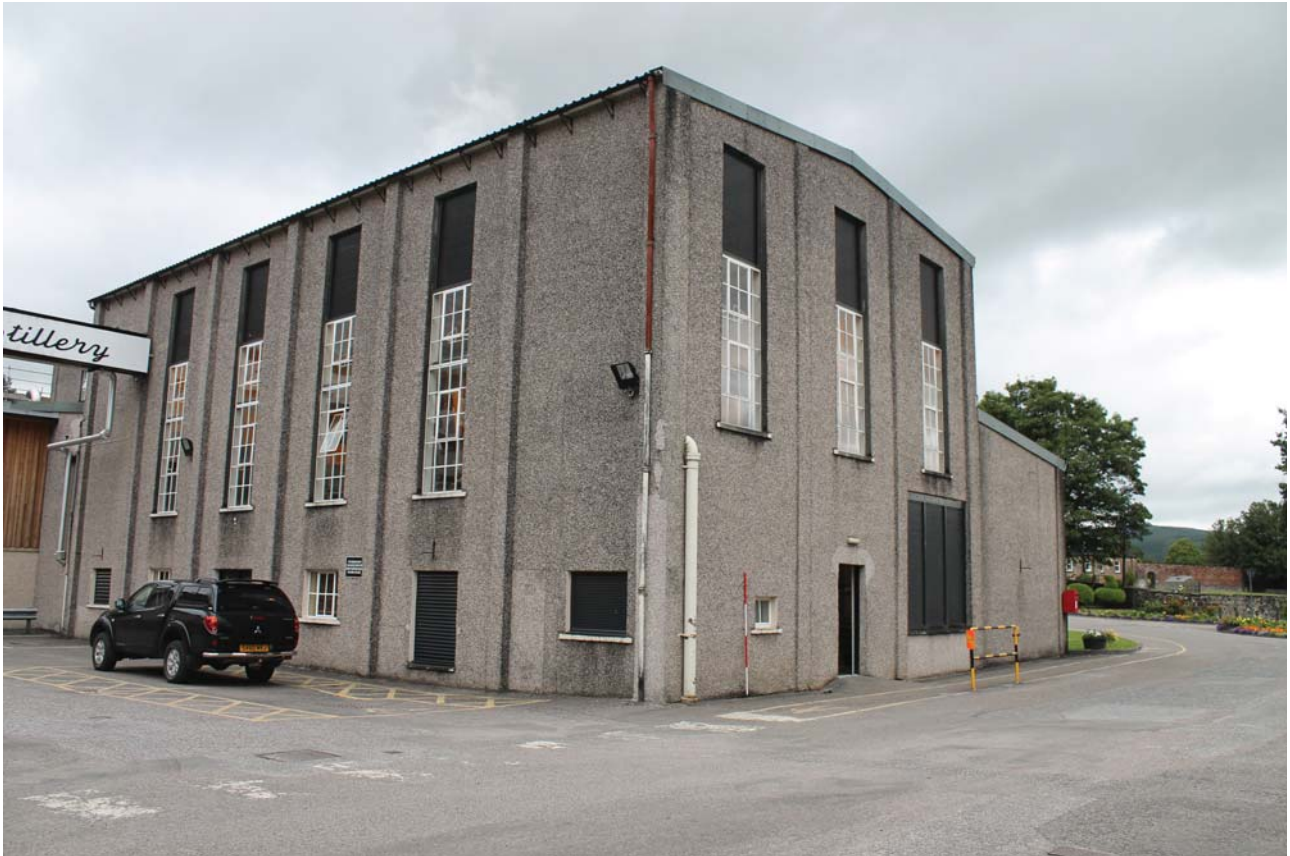
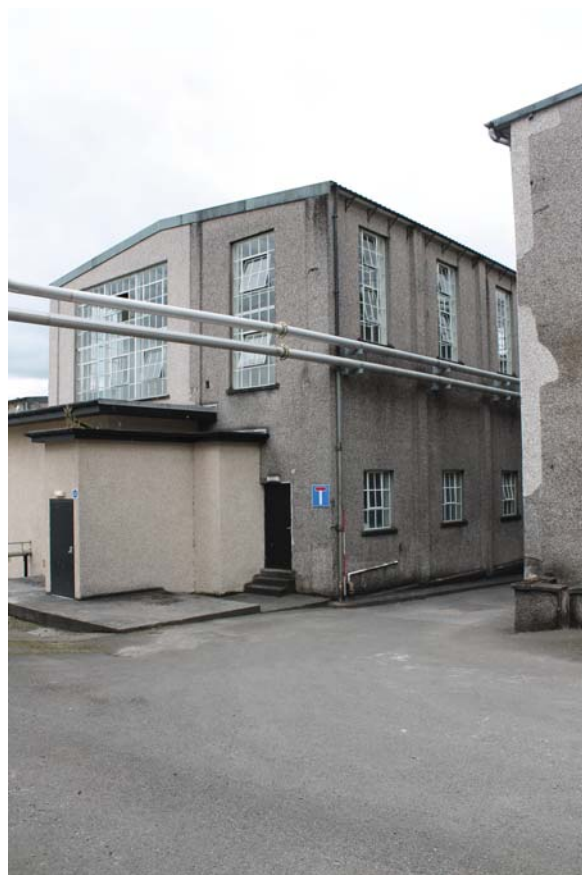
Plate 5: Still House 2, general view from the east

Plate 6: Still House 2, general view from the north-east

Plate 7: Still House 2, general view from the south

Plate 8: Still House 2, general view from the north

5.2.1 Still House 2 is also a 20th century build, constructed in ca. 1959 - 1971, and is a large two-storey still house in brick with a roughcast render (Plates 5 – 8). The house is generously fenestrated with central-opening casements with a modern corrugated steel roof. A much more modern first floor porch and public entrance – used on the whisky tours – has been inserted to the east corner. Internally, the ground floor contains the casks with the copper stills above at gantry floor level (Plates 8 & 10).

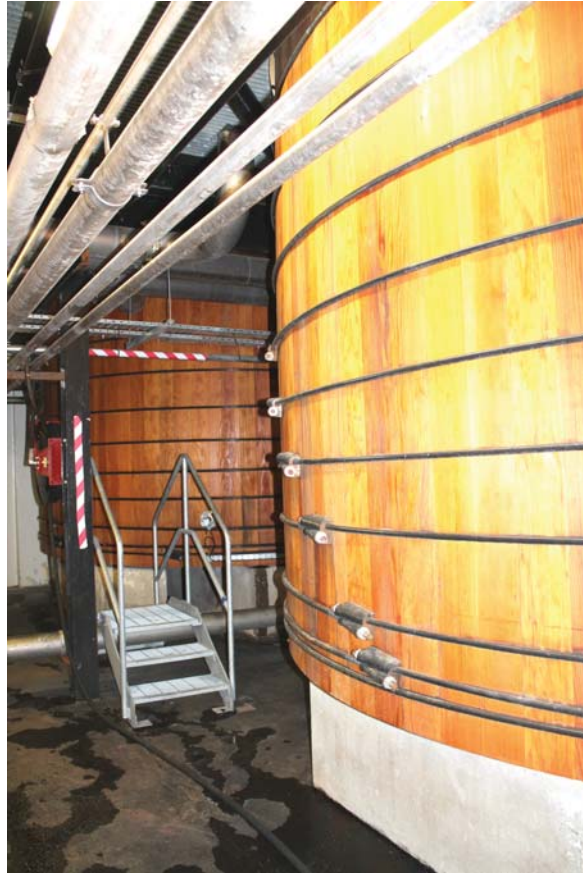
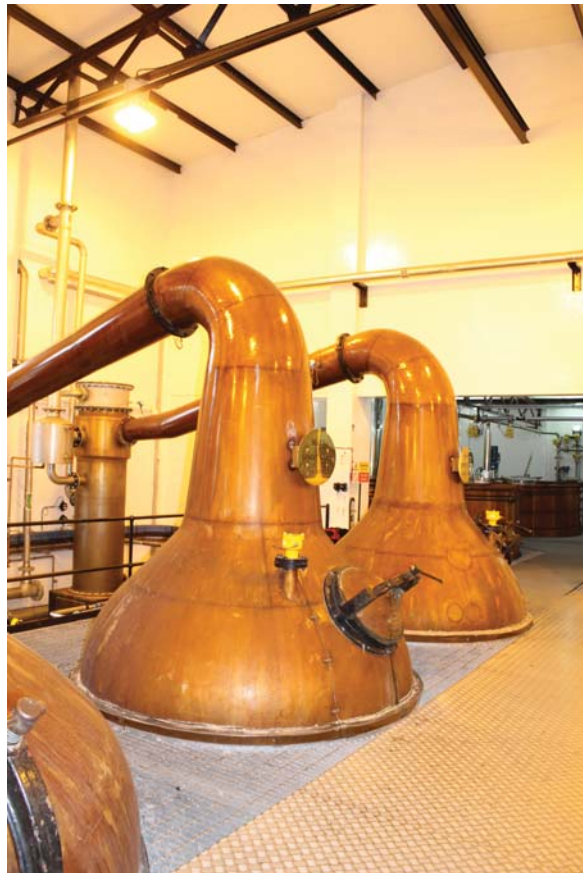
Plate 9: Still House 2, general view of the interior ground floor

Plate 10: Still House 2, general view of the upper level showing the copper stills from the south

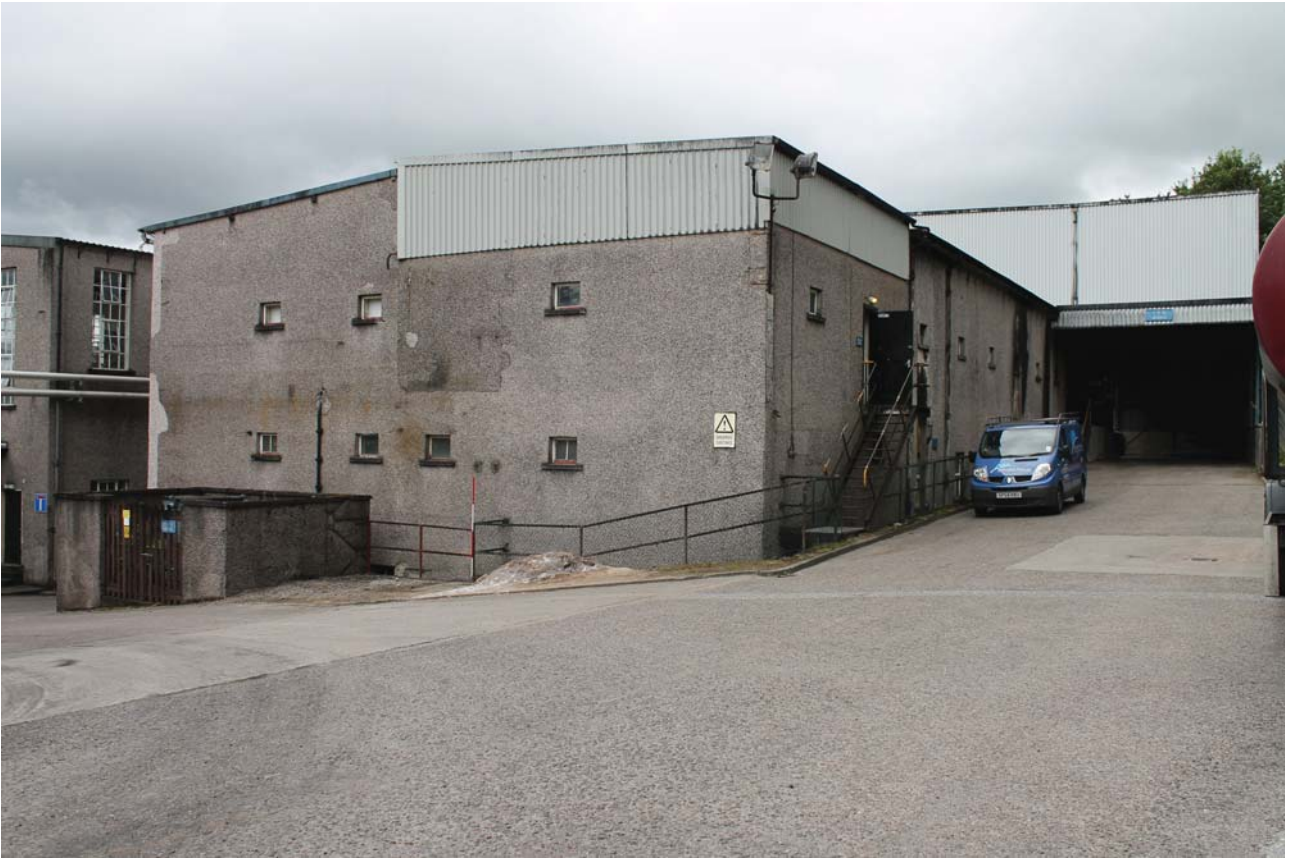
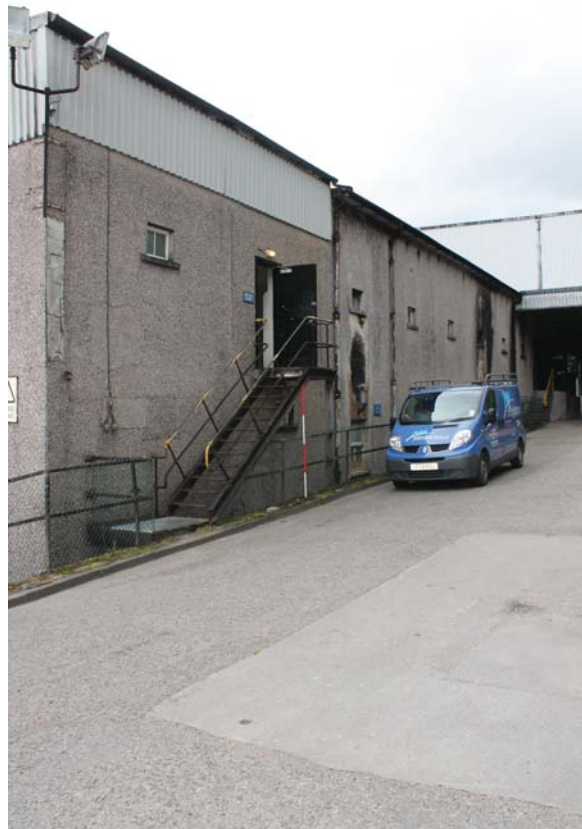
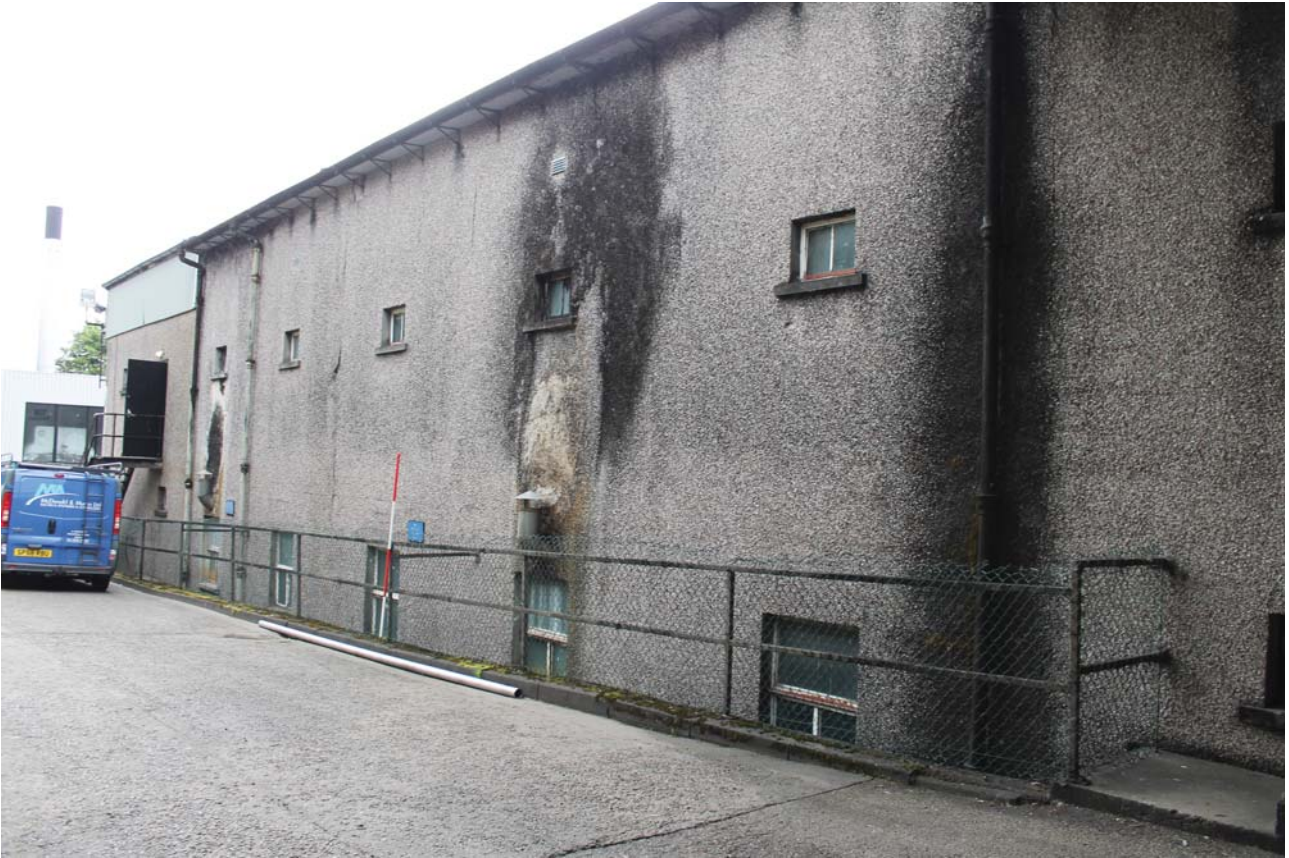
Plate 11: Hi Mac Building, general view from the north

Plate 12: Hi Mac Building, general view of the north-west elevation from the north

Plate 13: Hi Mac Building, general view of the north-west elevation from the west

5.3.1 The ‘Hi-Mac’ building is probably the oldest surviving part of the complex, together with a small area of the Malt Storage building to its south-west. It appears for the first time on the 1905 Ordnance Survey map – having replaced an earlier thinner building – and therefore dates from between 1870 – 1905. It has several floor levels, and was still used by the distillery at the time of survey, although large areas were left empty. Constructed of brick, the building is roughcast rendered with small discreet windows rising up to a shallow pitched roof with corrugated steel sheeting (Plates 11 – 13). Given the sharp rise in the ground level towards the north-west, the ground floor to the south-east side is a basement level to the north-west. There is a large loading lay to the south-west end constructed of steel sheeting.
