Macallan Distillery, Craigellachie, Moray: Historic Building Recording Report

AOC 22624
27th August 2014

| Planning Application No: | 14/00662/APP |

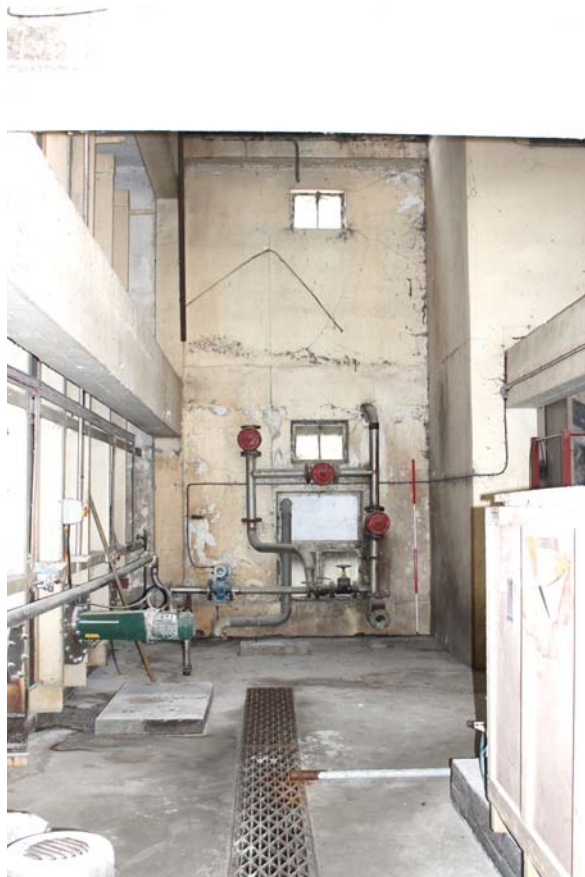
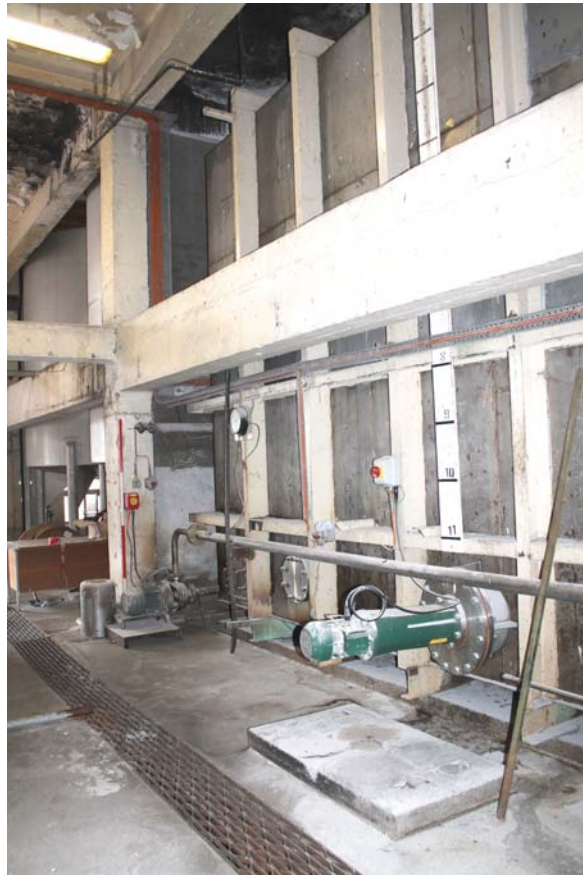
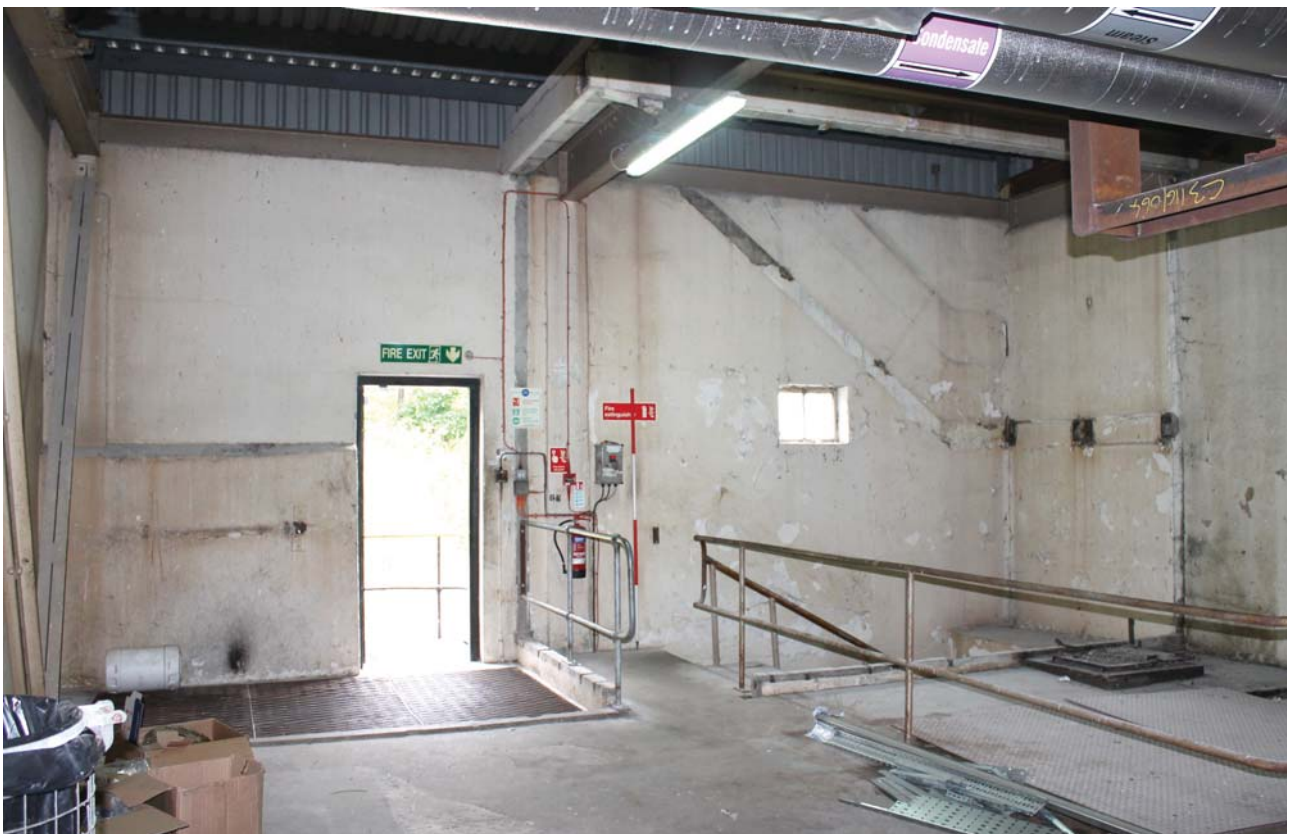
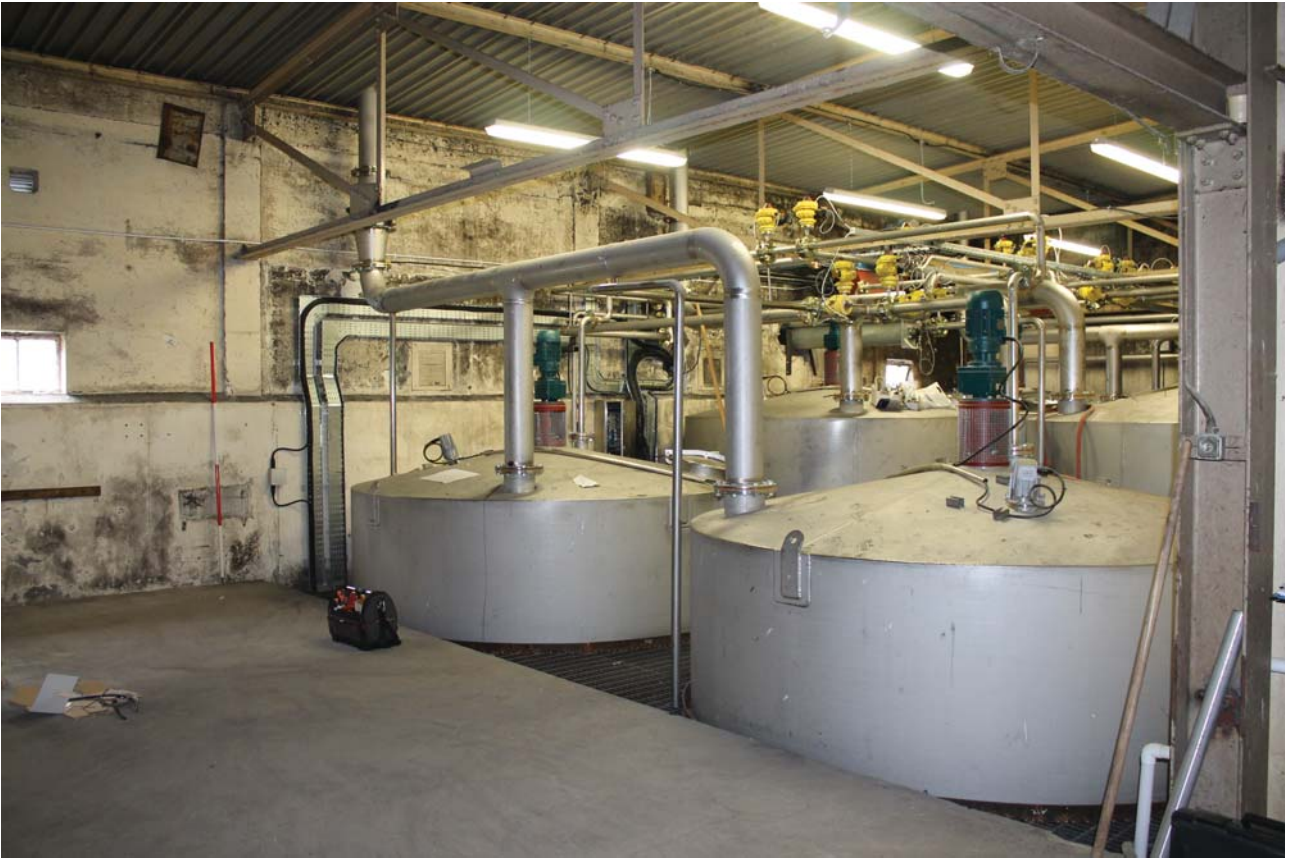
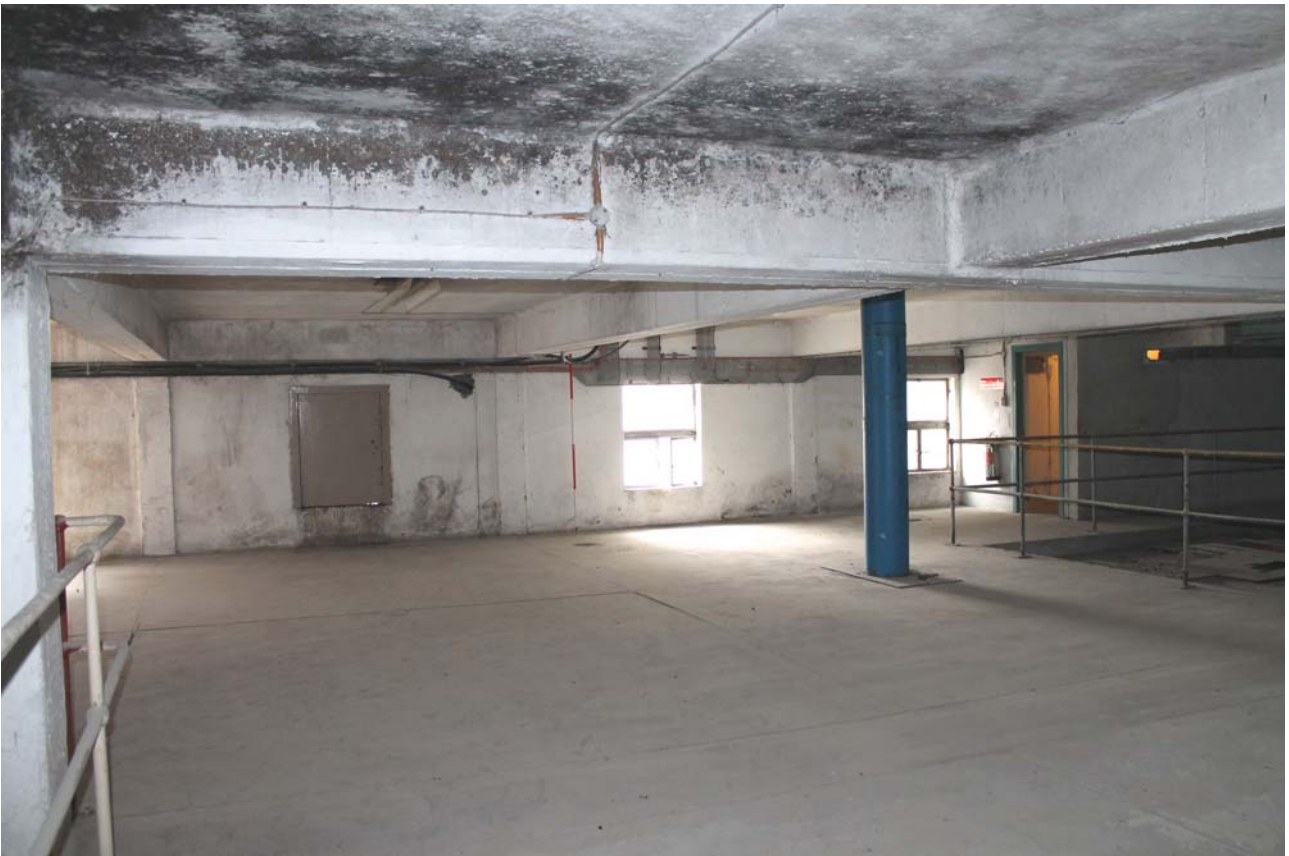
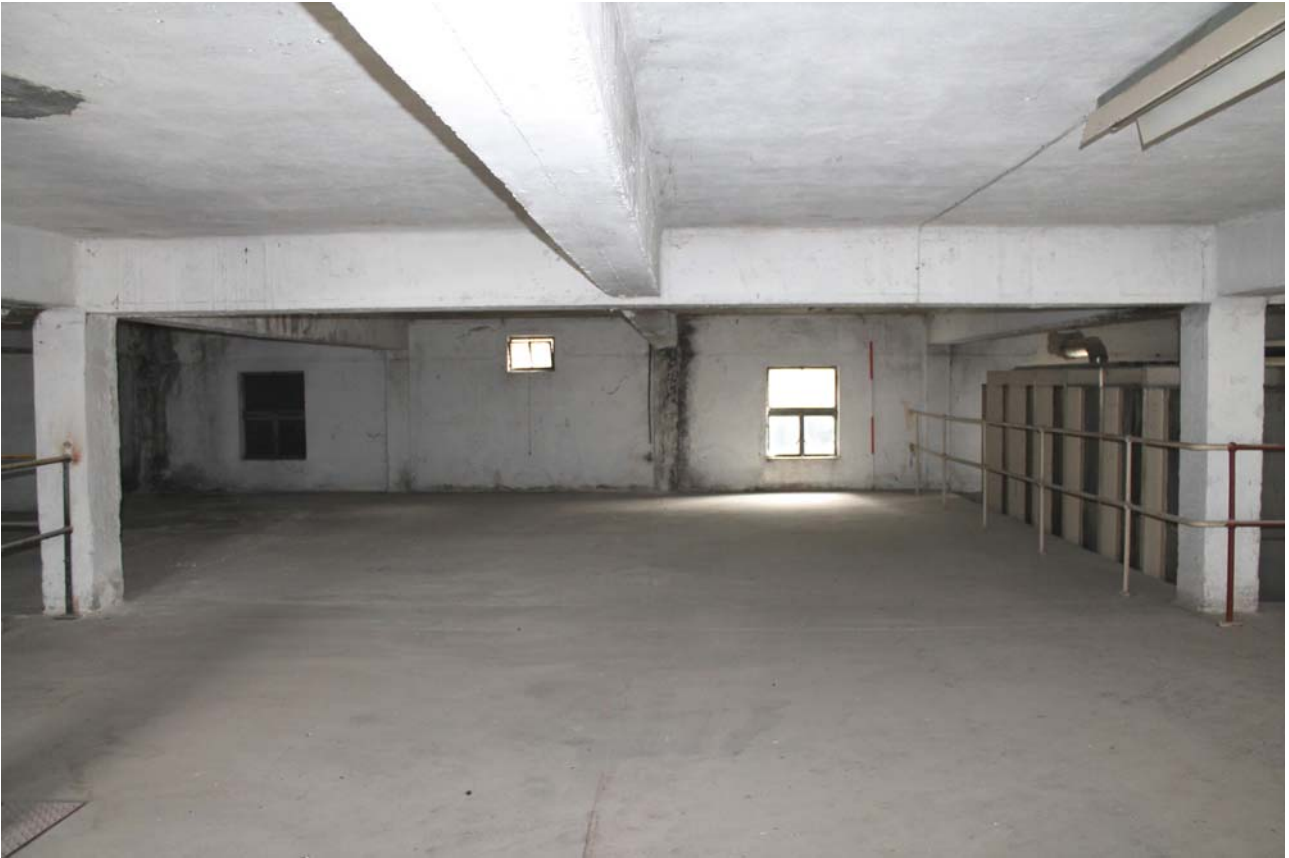
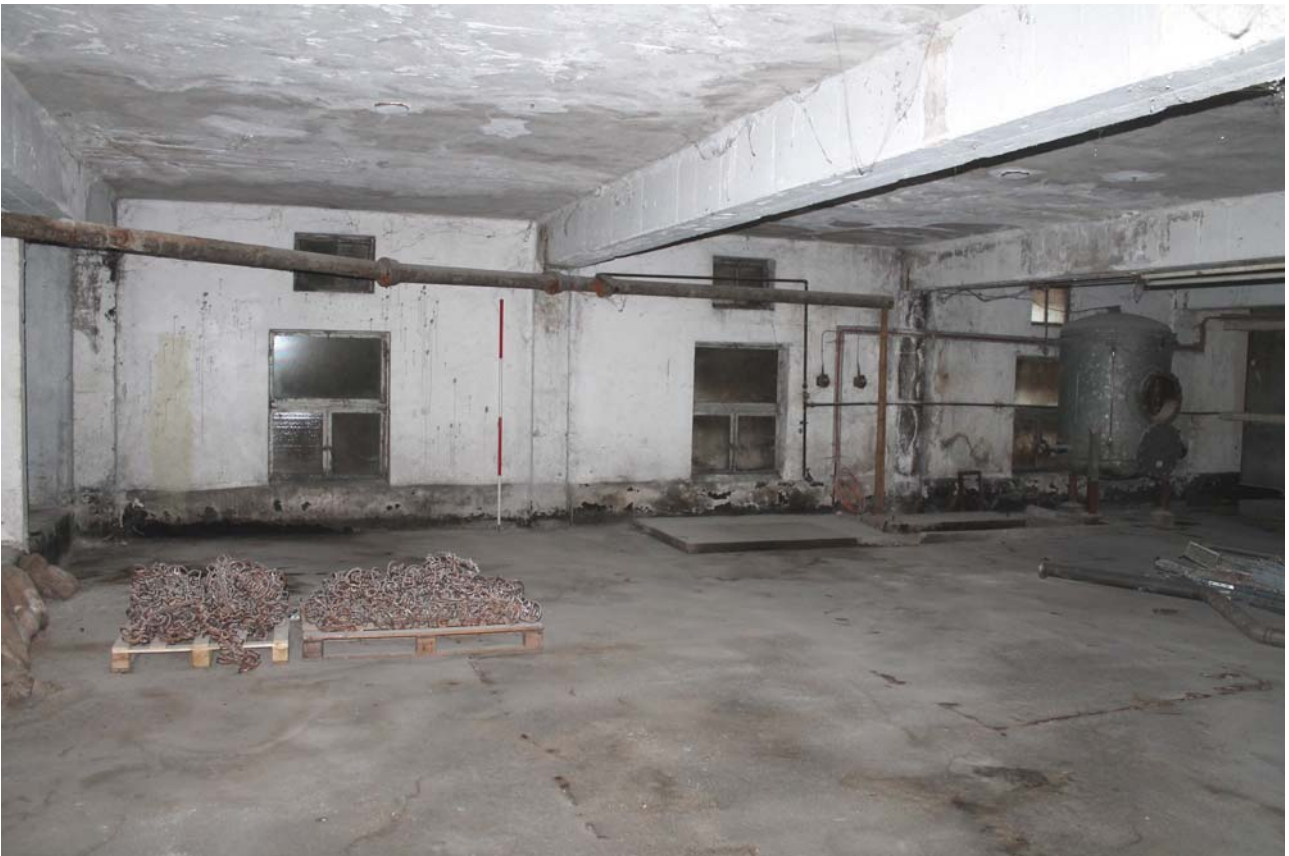
Plate 14: Hi Mac Building, general view of the interior to the north-east side from the south-east

Plate 15: Hi Mac Building, general view of the interior to the north-east side from the north

Plate 16: Hi Mac Building, general view of the attic level to the north-east side from the south-east

Plate 17: Hi Mac Building, general view of the attic level to the north-east side from the north

Plate 18: Hi Mac Building, general view of the empty second floor level to the south-west side, from the north-west

Plate 19: Hi Mac Building, general view of the empty first floor level to the south-west side, from the north-west

Plate 20: Hi Mac Building, general view of the empty first floor level to the south-west side, from the south

5.3.2 Internally, the ground floor is currently in use, with the base of the tanks to the centre and some disused equipment to the north-east side (Plates 14 & 15). A concrete stair in the north corner leads straight up to the attic storey of the building and the top of the tanks (Plates 16 & 17). Another concrete stair to the west corner leads to a number of redundant storerooms to the south-west side of the building (Plates 18 – 20).

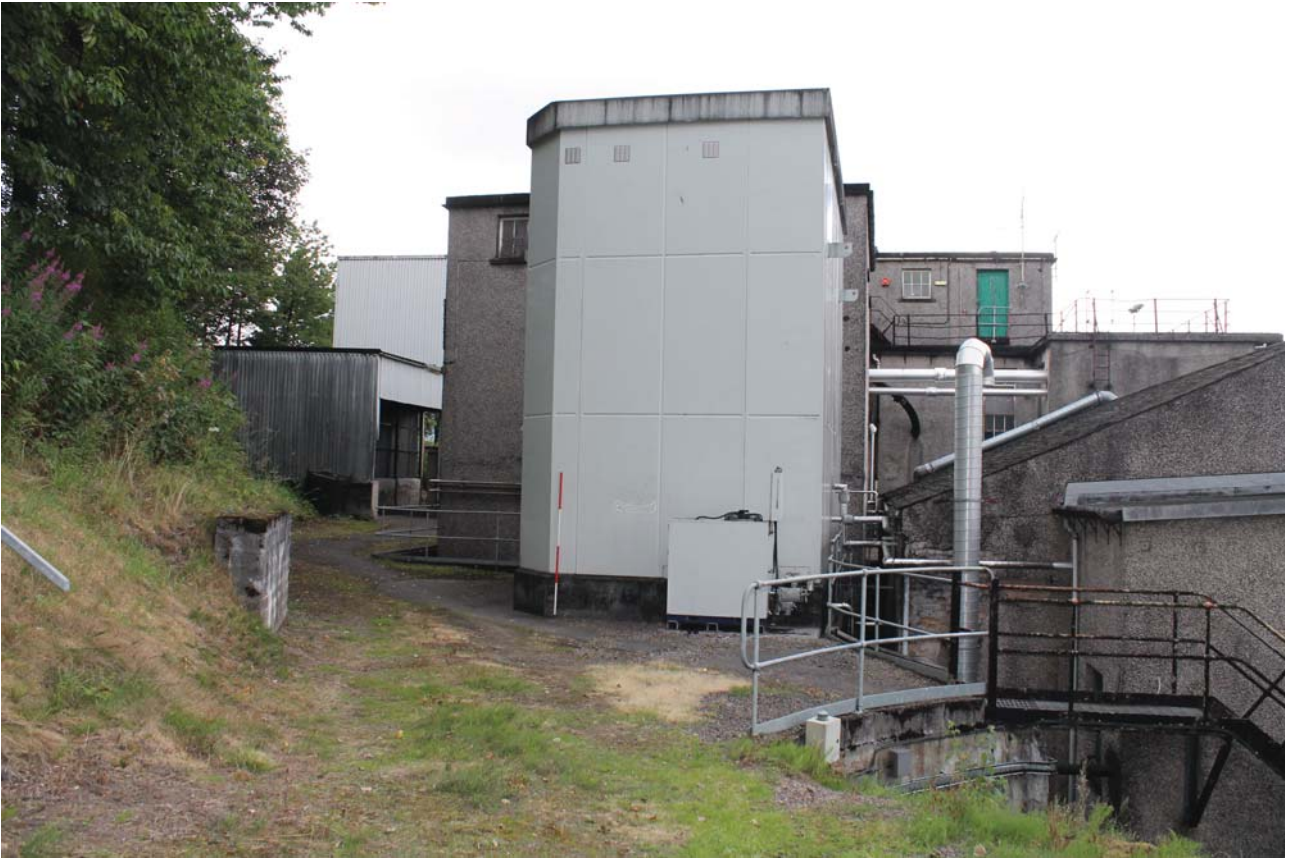
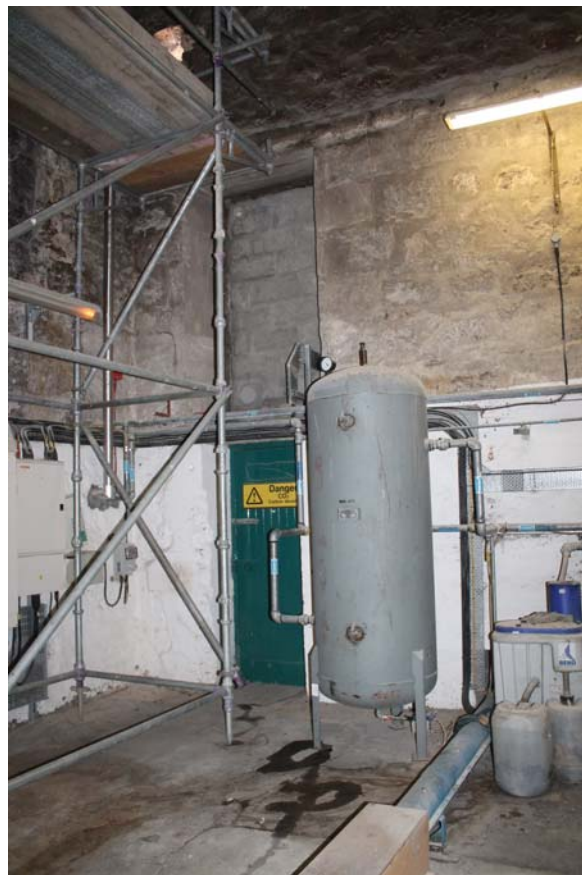
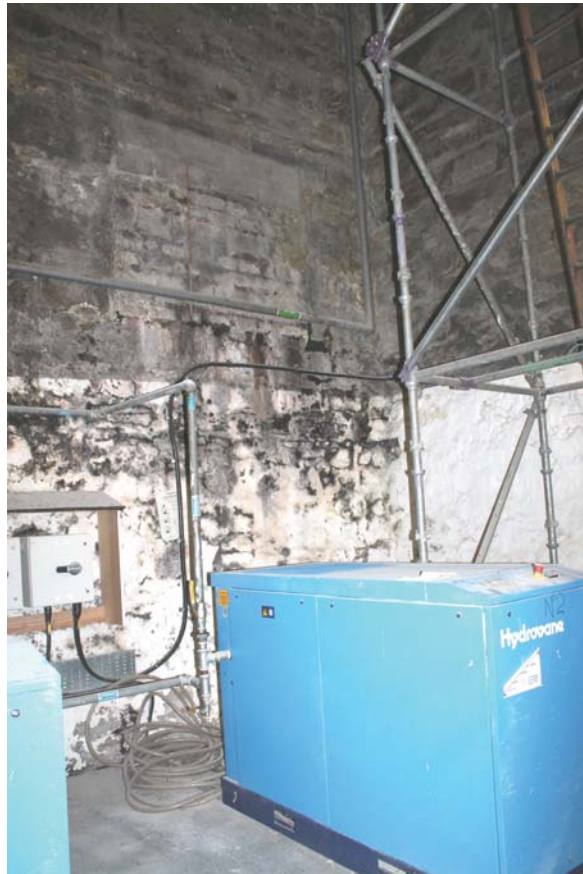
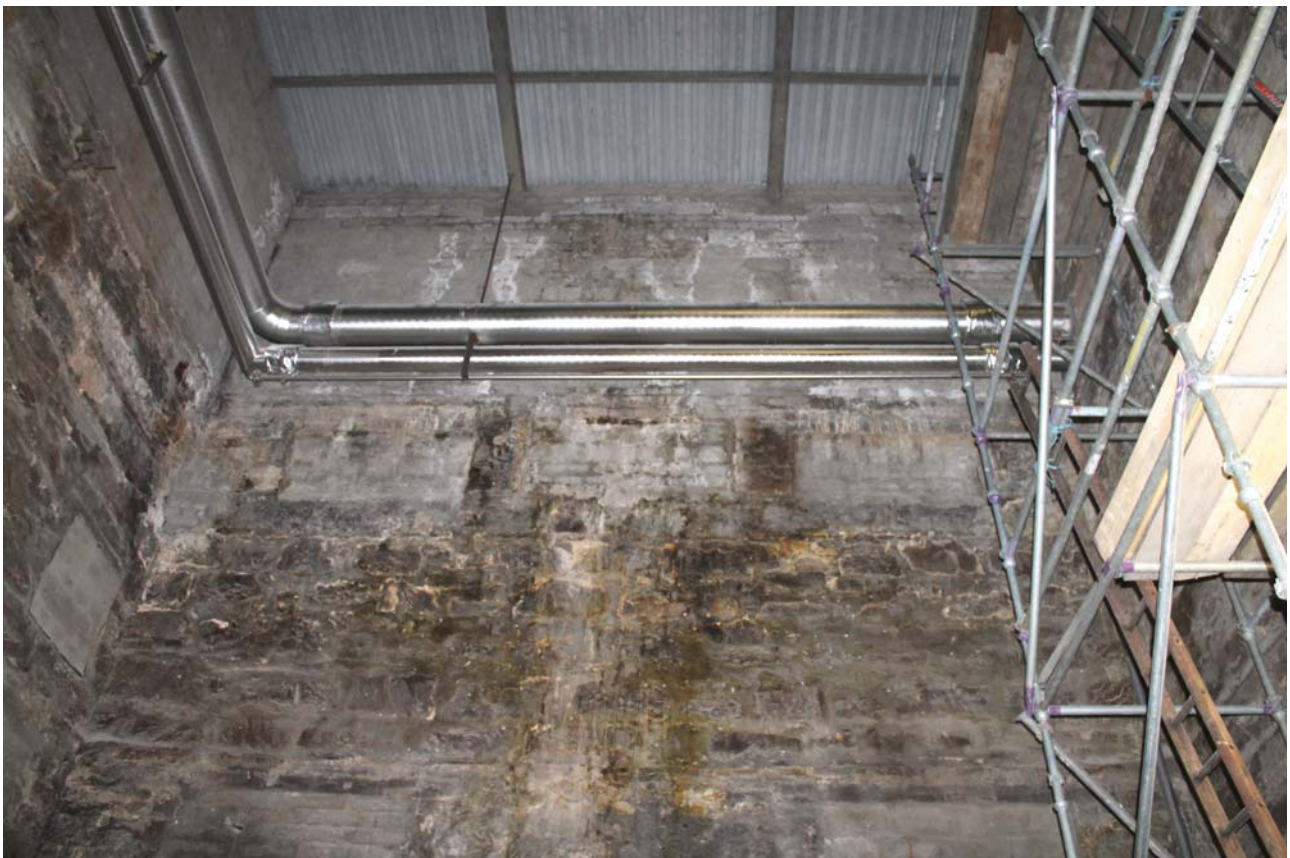
Plate 21: Malt Storage Building, general view from the south-west

Plate 22: Malt Storage building, general view of the stone wall construction to the north corner of the building, from the north

Plate 23: Malt Storage building, general view of the stone wall construction to the north corner of the building, from the south

Plate 24: Malt Storage building, general view of the stone wall construction to the north corner of the building, from the south-west

5.3.3 The Malt Storage building to the south-west of the Hi-Mac is obscured by a large steel clad extension to the south-west side, but is also roughcast rendered (Plate 21). Internally, the north-east side has the remains of a stone-built walling, most probably part of the earliest mill in this position. It is a simple rectangular room, with internal scaffolding, with a number of bricked-up openings at all levels (Plates 22 - 24). The rest of the interior is a fairly modern passageway and smaller offices.

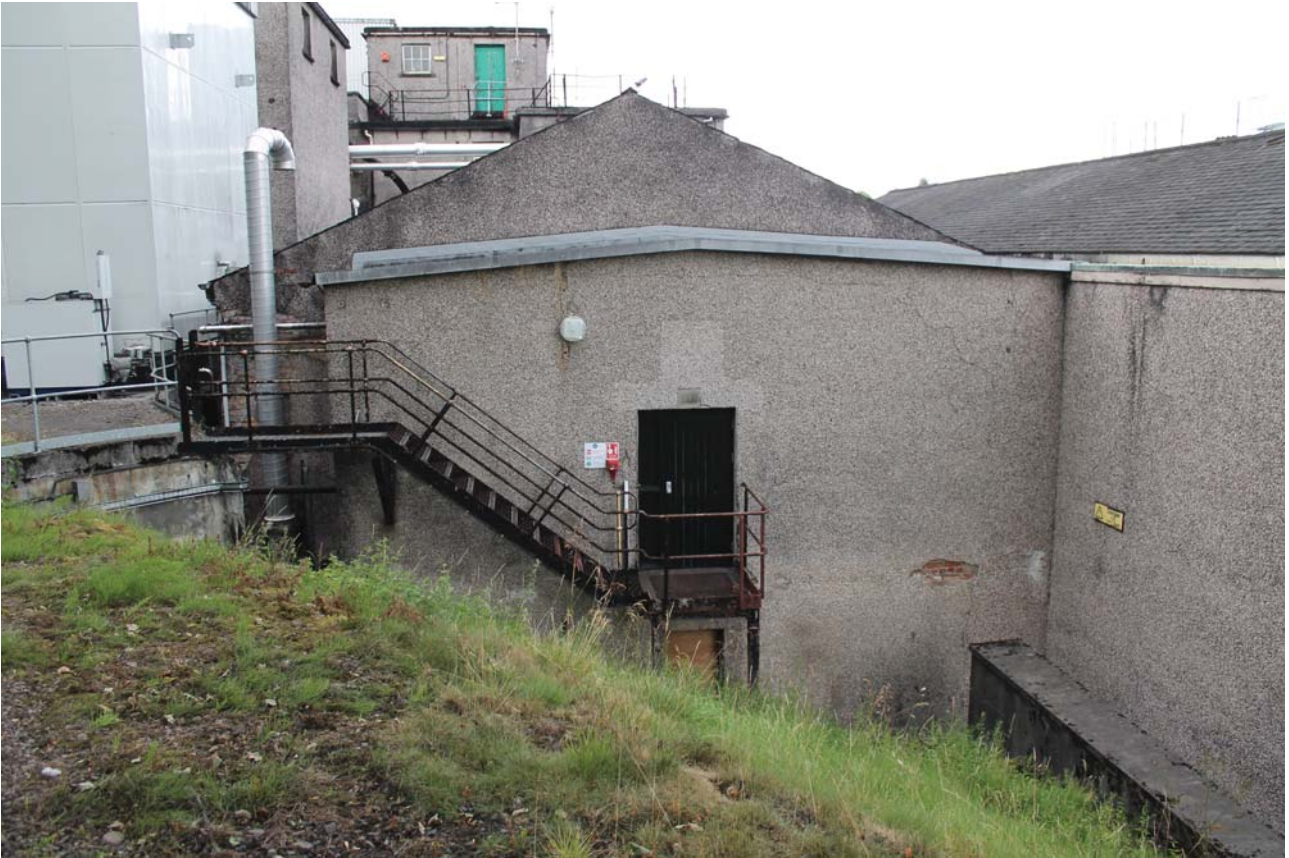
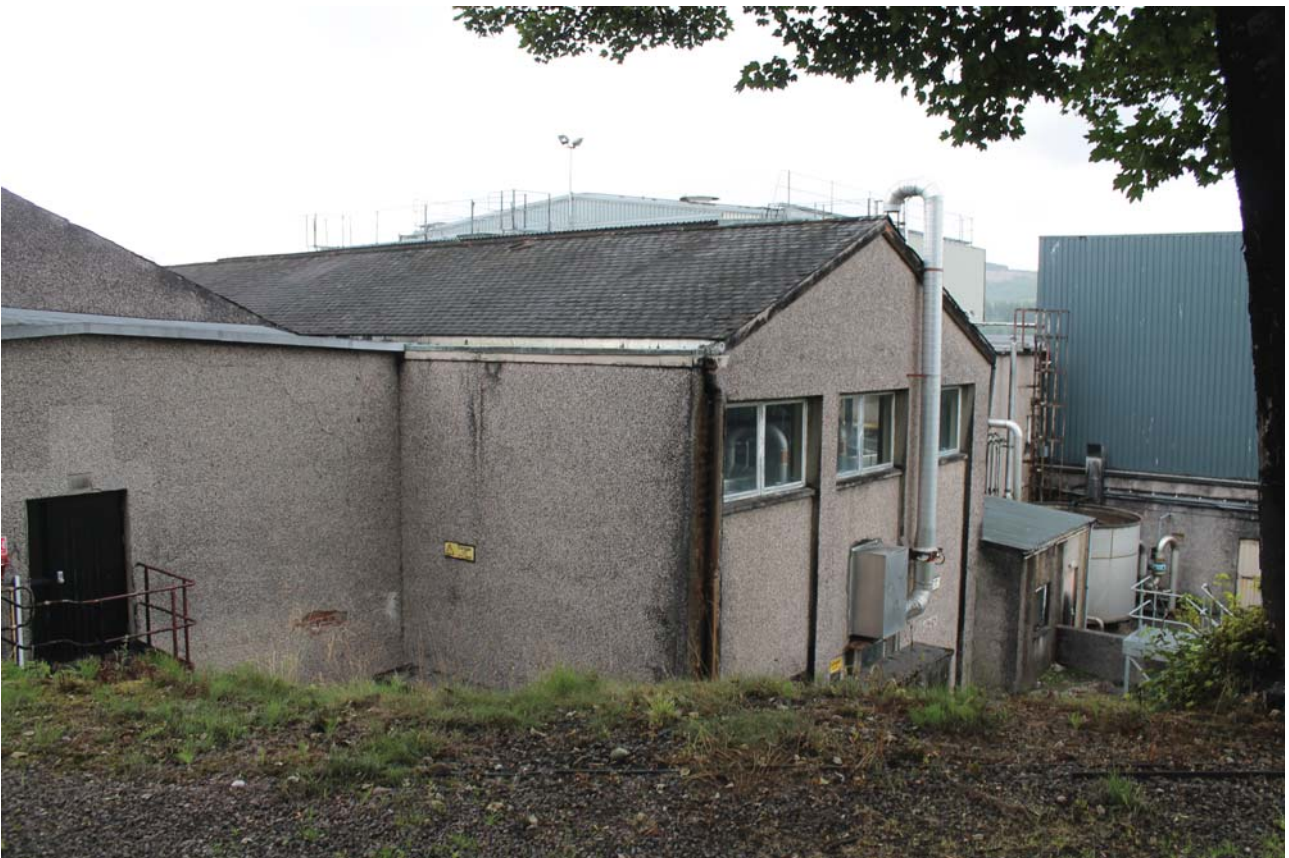
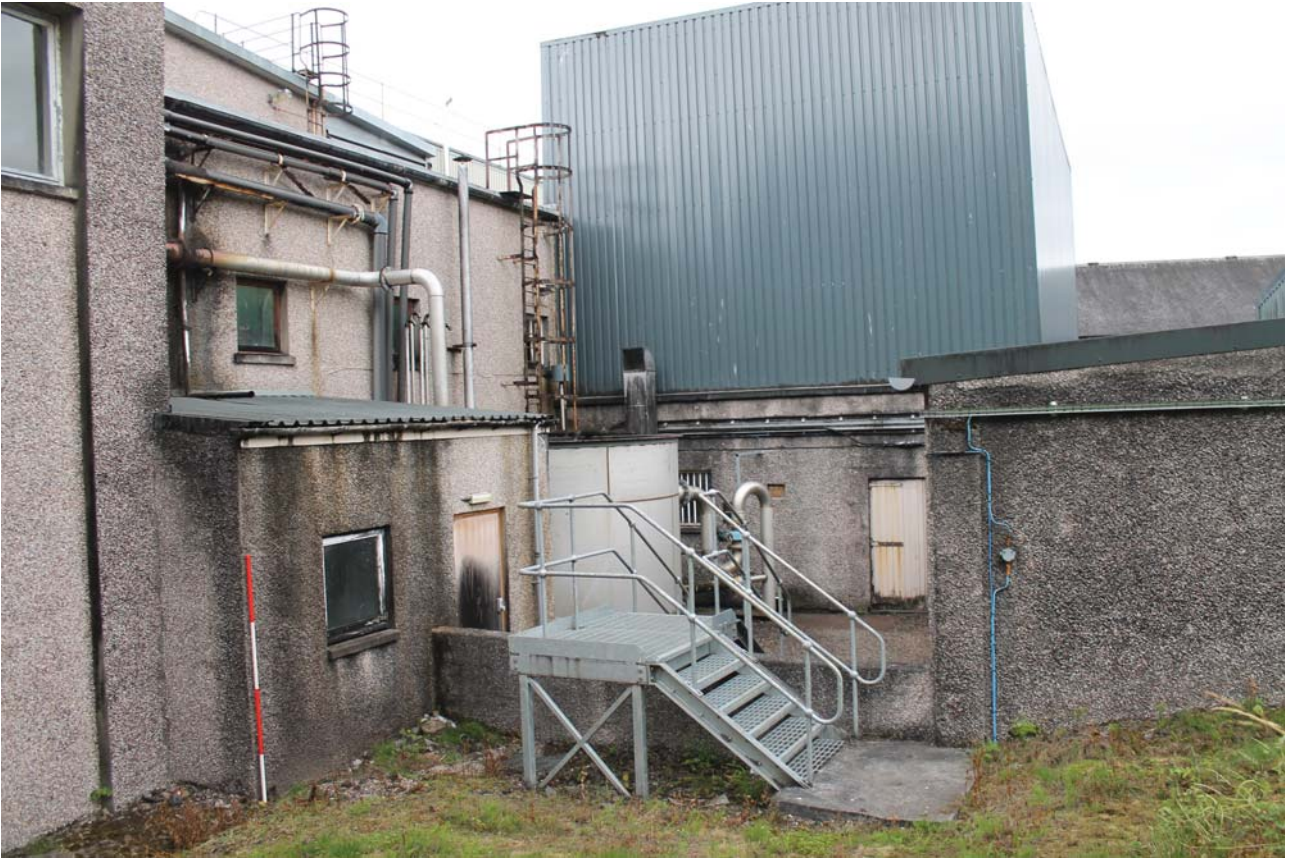
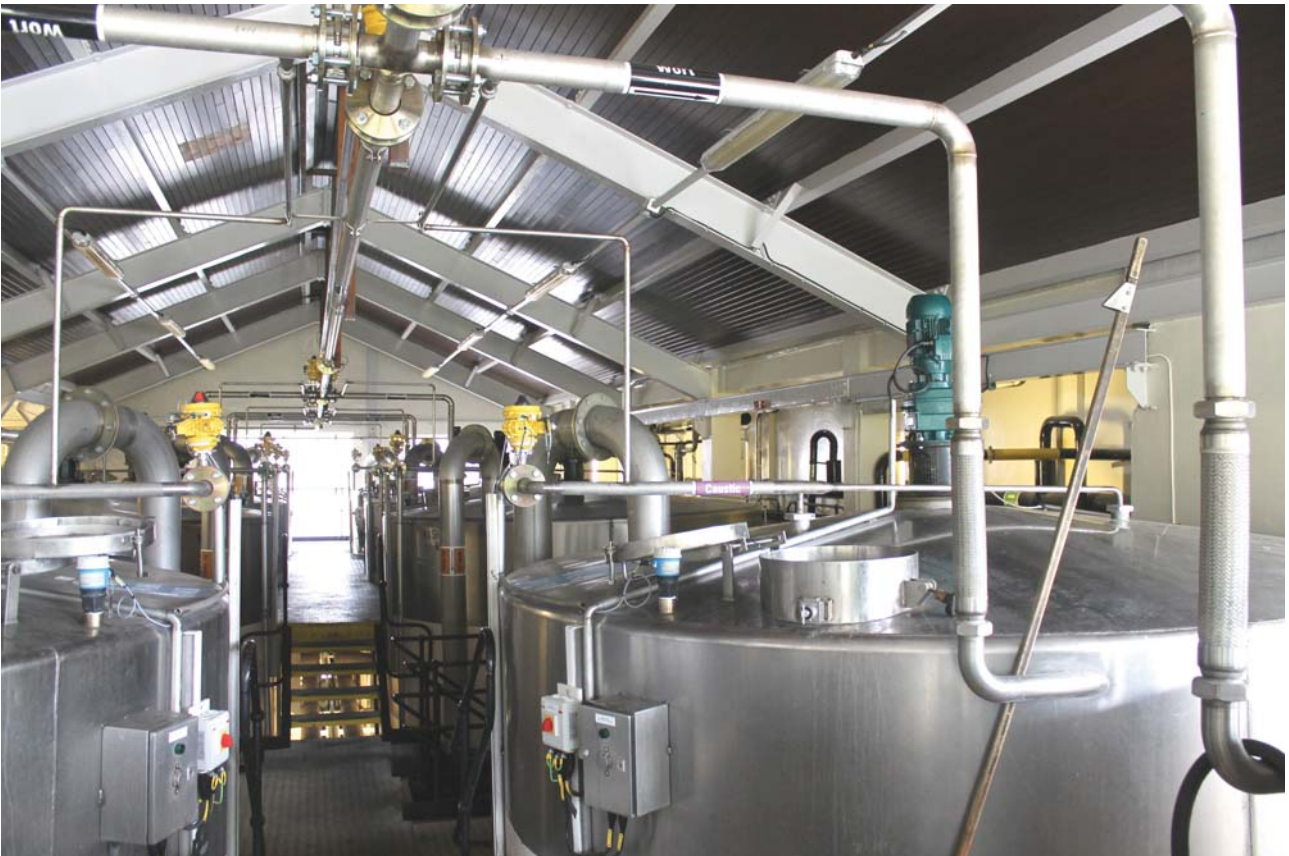
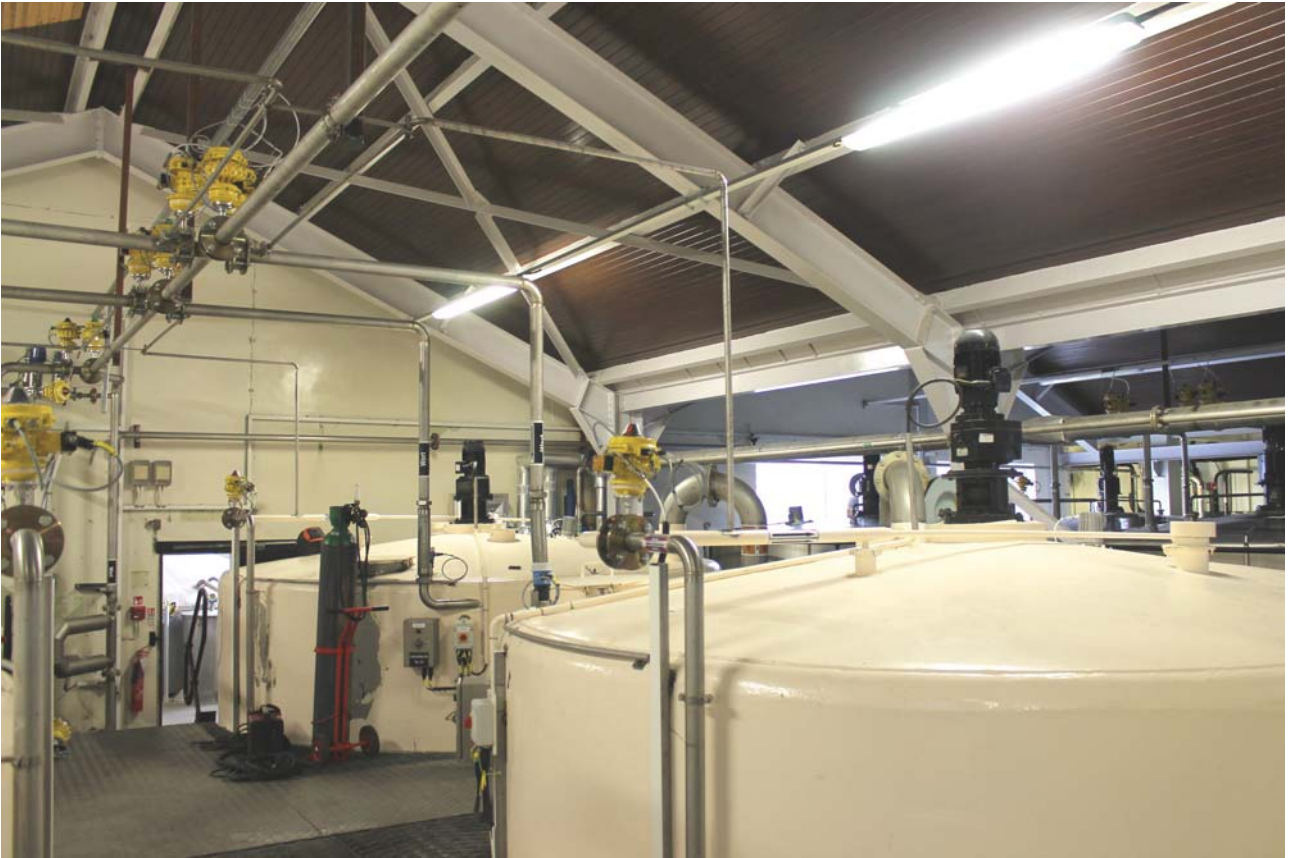
Plate 25: Mash House 1, general view from the south-west

Plate 26: No 1 Tun Room, general view from the west

Plate 27: No 1 Tun Room, general view from the west

Plate 28: No 1 Tun Room, general view of the upper level from the south-west

Plate 29: Mash House 1, general view of the upper level from the west

5.4.1 The Mash House and No 1 Tun Room is also brick with a roughcast render with a shallow pitched roof (Plates 25 – 27). They are contemporary with Still House 1, constructed in 1974. Internally, the space is filled with mash tuns with a gantry level above (Plates 28 – 29).

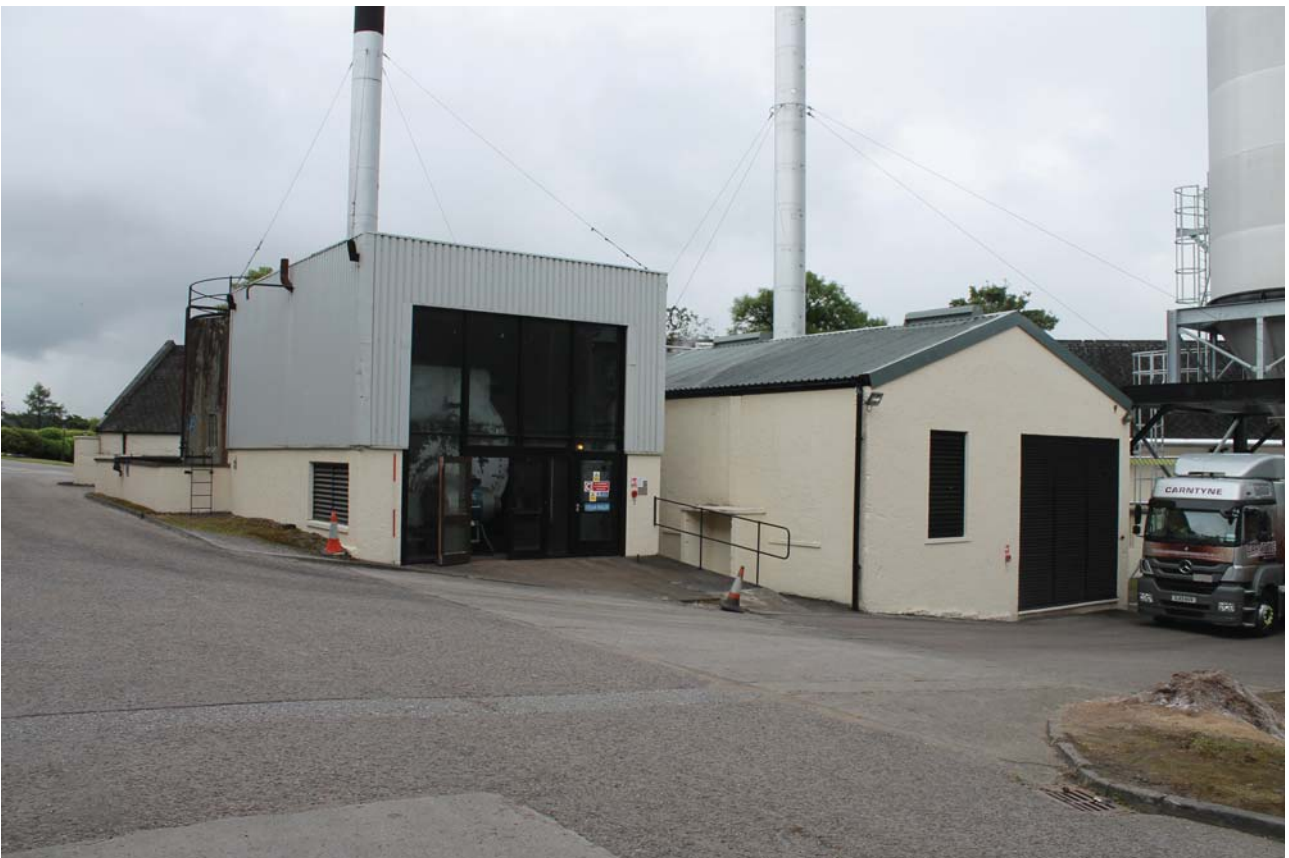
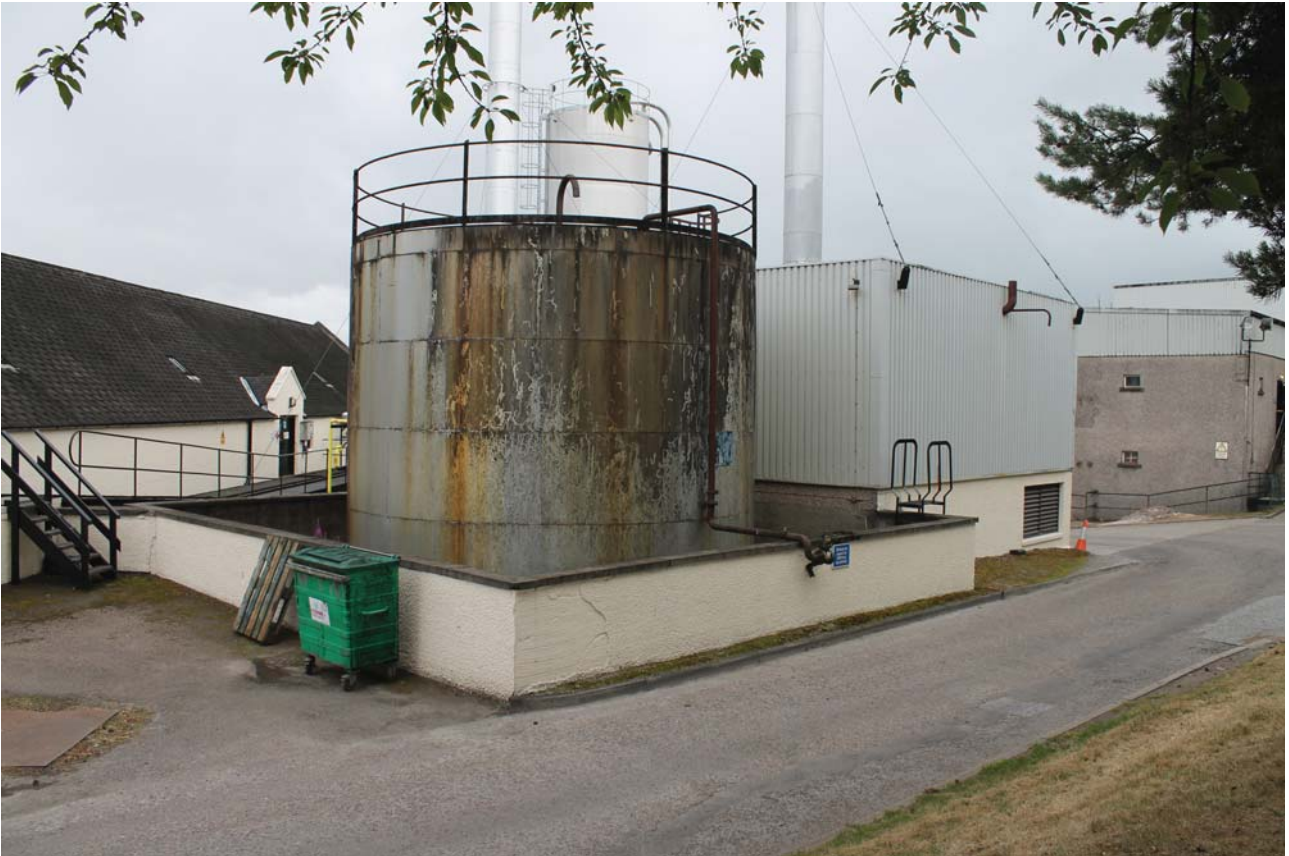
Plate 30: Boiler House 1 & 2, general view from the west

Plate 31: Boiler House 2, general view from the east

5.5.1 The two boiler houses to the north-east end of the complex are relatively modern additions and are rendered over a brick construction (Plates 30 & 31). The southernmost boiler house (2) was added 1959 – 1971, together with the large tank to its north. The later one (1) was added 1979 – 1989.
