Macallan Distillery, Craigellachie, Moray: Historic Building Recording Report

AOC 22624
27th August 2014

| Planning Application No: | 14/00662/APP |

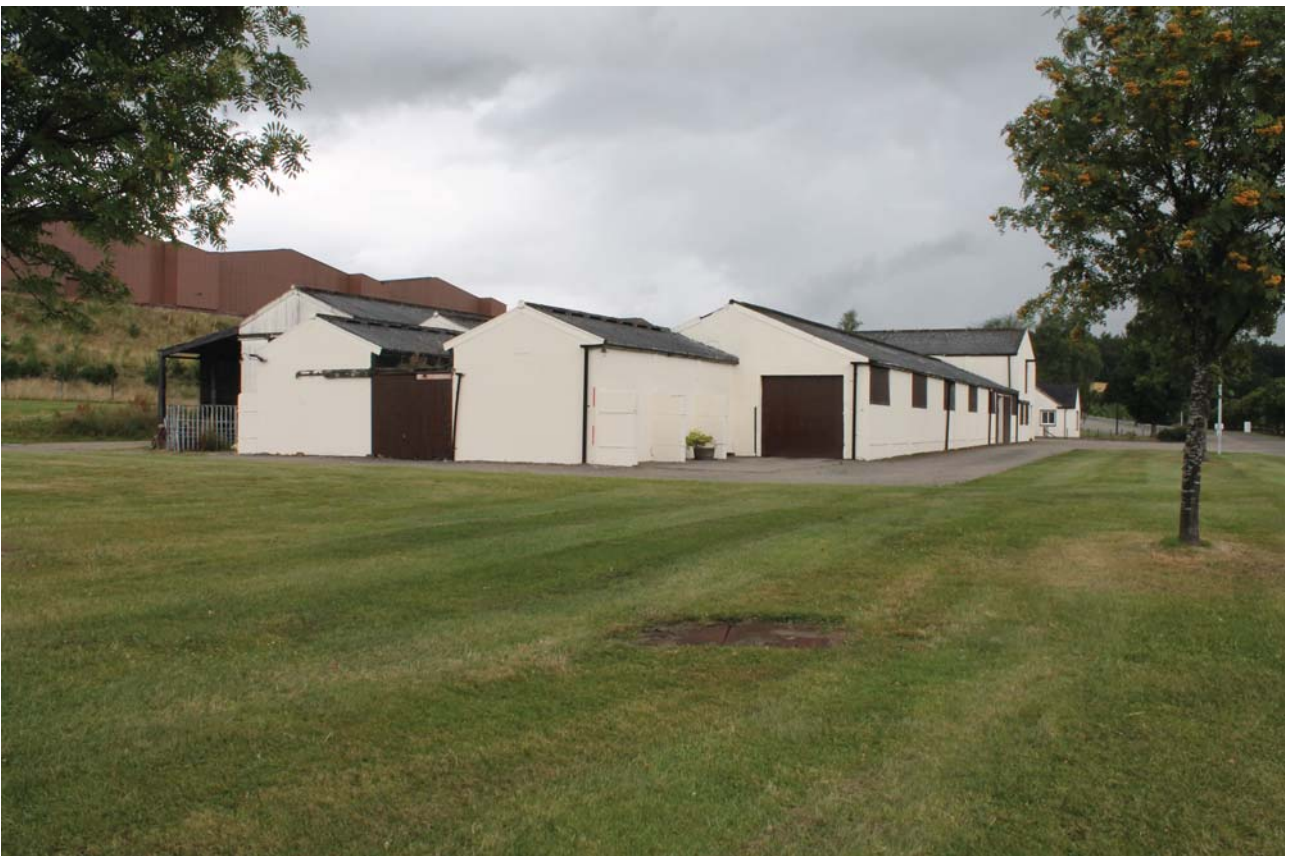
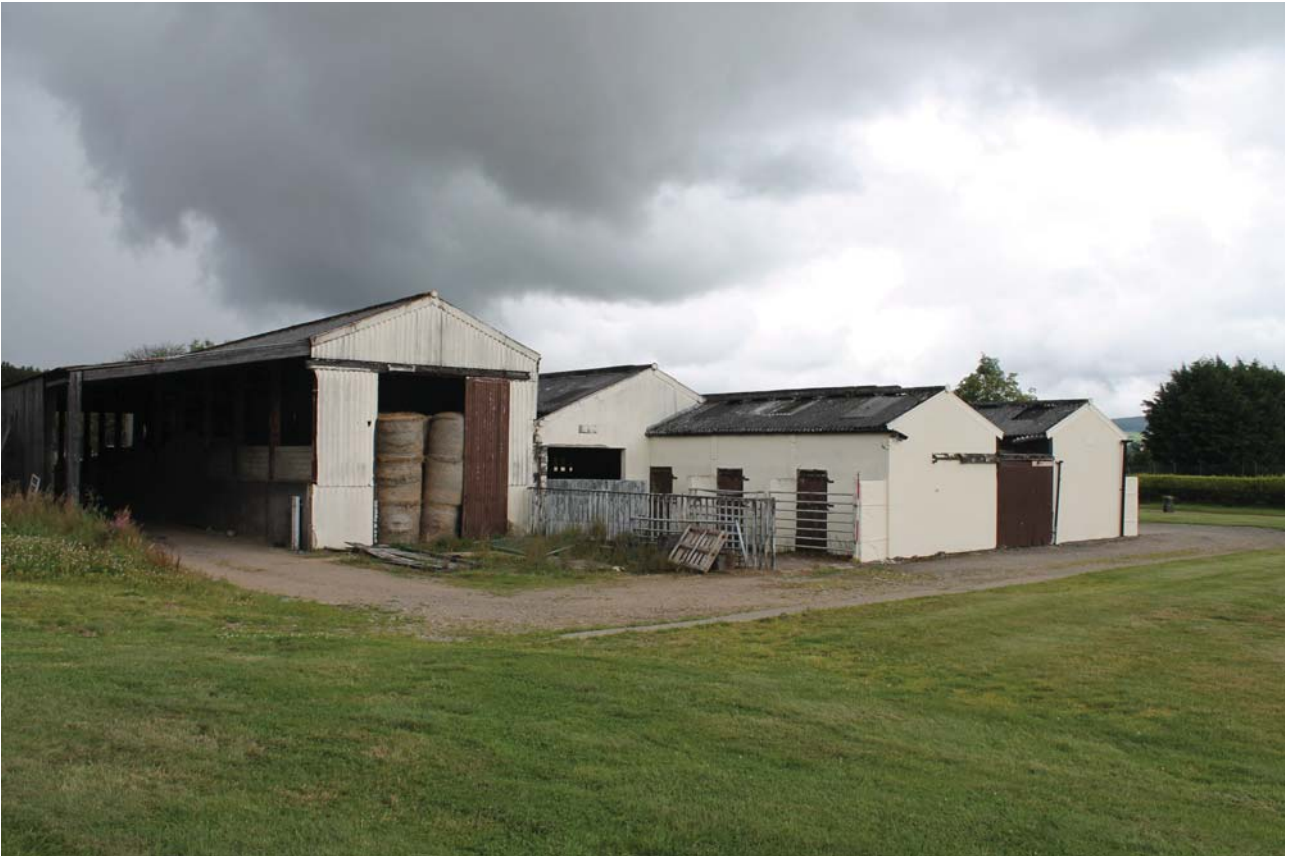
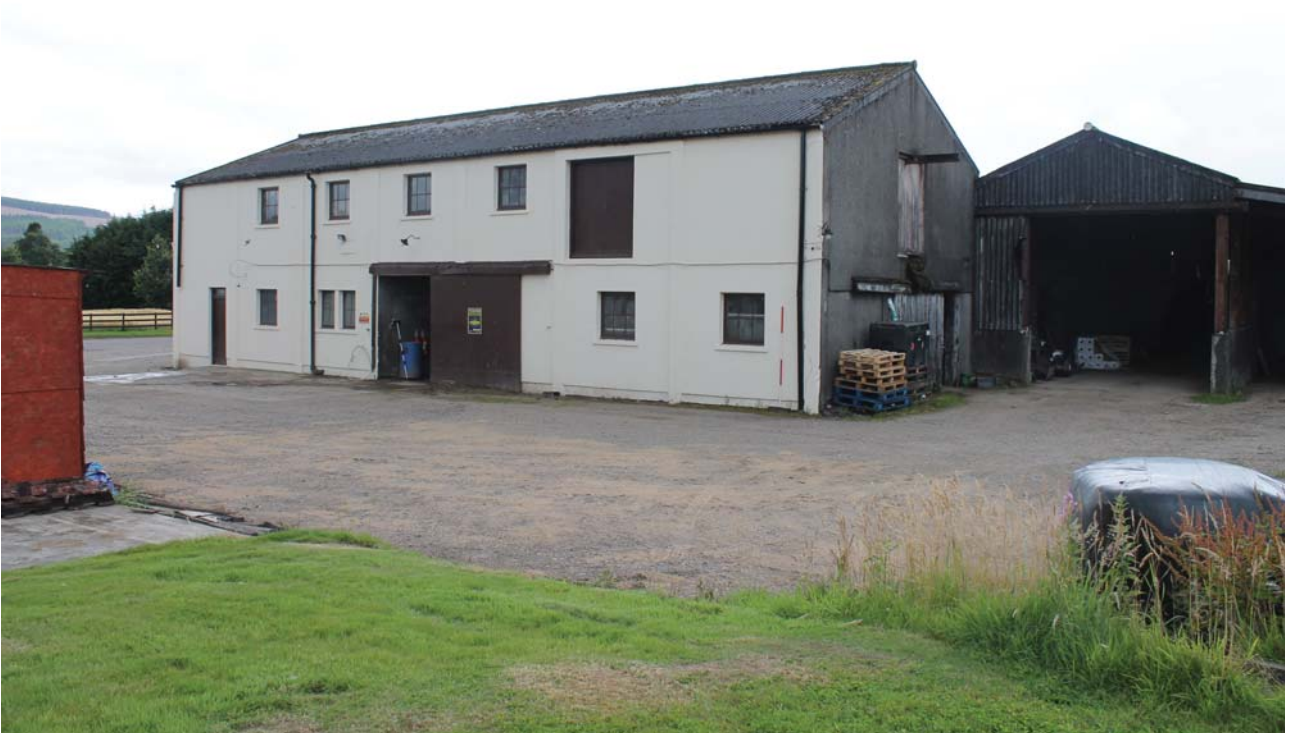
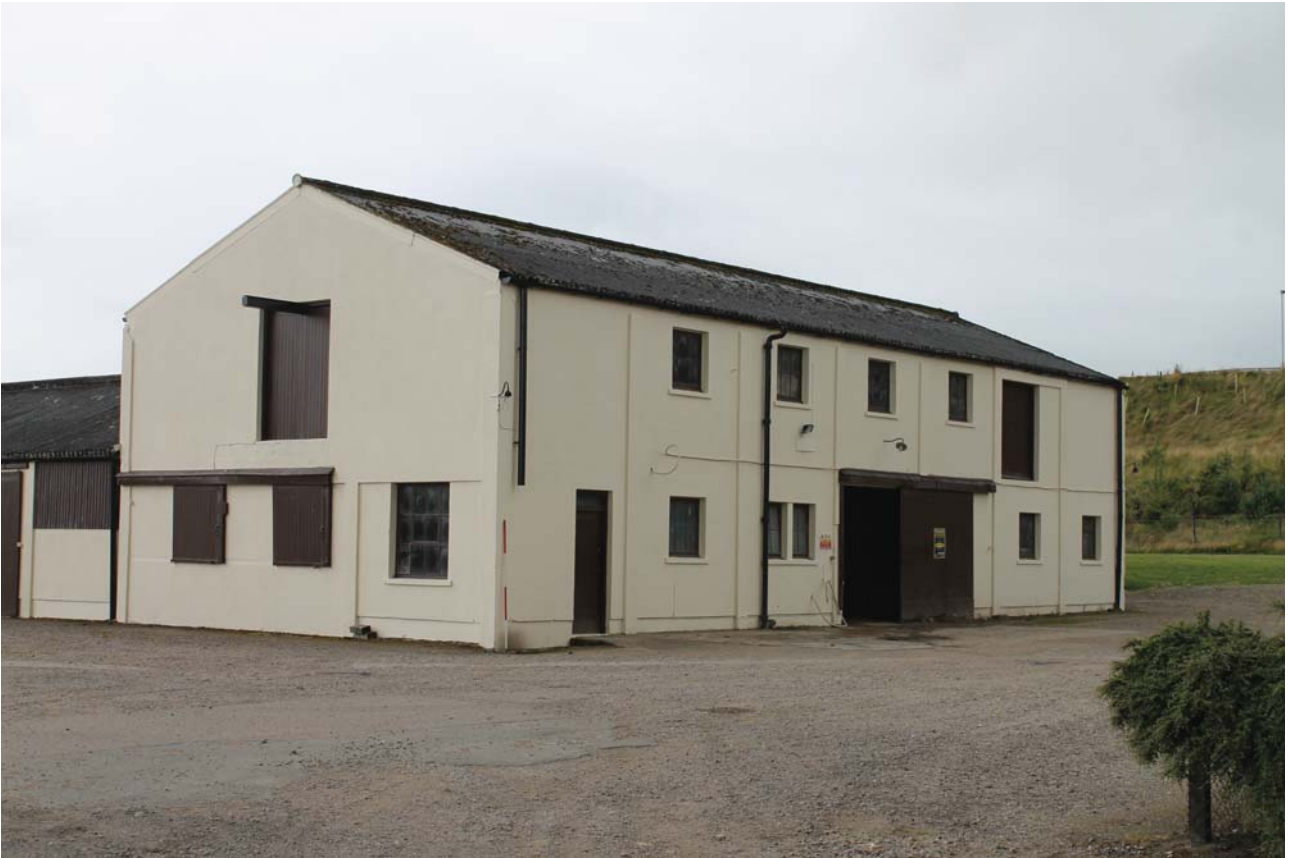
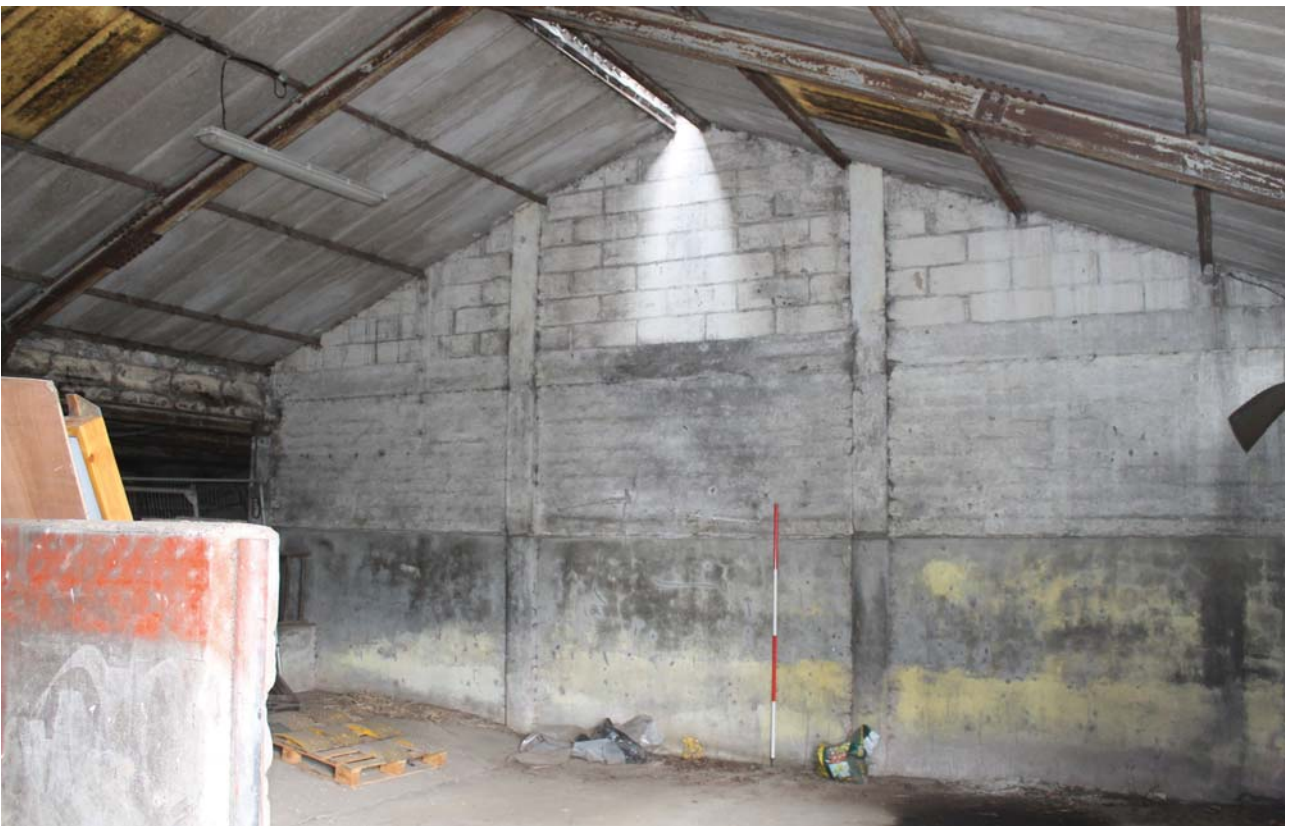
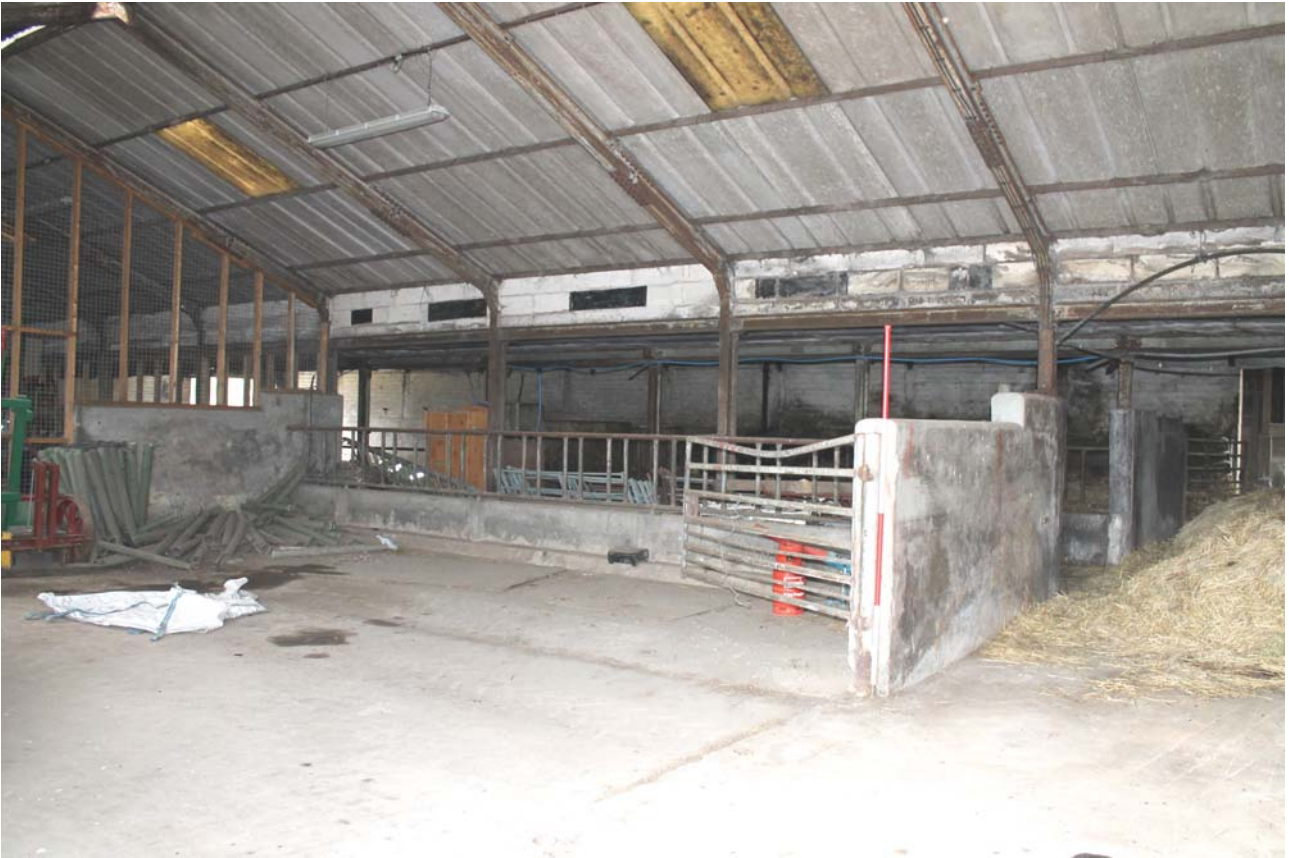
Plate 32: Farm Buildings, general view from the south

Plate 33: Farm Buildings, general view from the north-west

Plate 34: Farm Buildings, general view from the north

Plate 35: Farm Buildings, general view from the east

Plate 36: Farm Buildings, general view of the internal cow byre from the south

Plate 37: Farm Buildings, general view of the internal cow byre from the east

5.6.1 The farm buildings are early 20th century in date, first appearing on the 1959 Ordnance Survey map, and consist of a small range of cow byres and hay store (Plates 32 - 35). The main block to the north-east side is a five by three-bay two-storey block with a store room to the ground floor and hay loft above. The rest of the complex consisted of a large cow byre with a steel covered tractor shed to the rear (Plates 36 & 37).

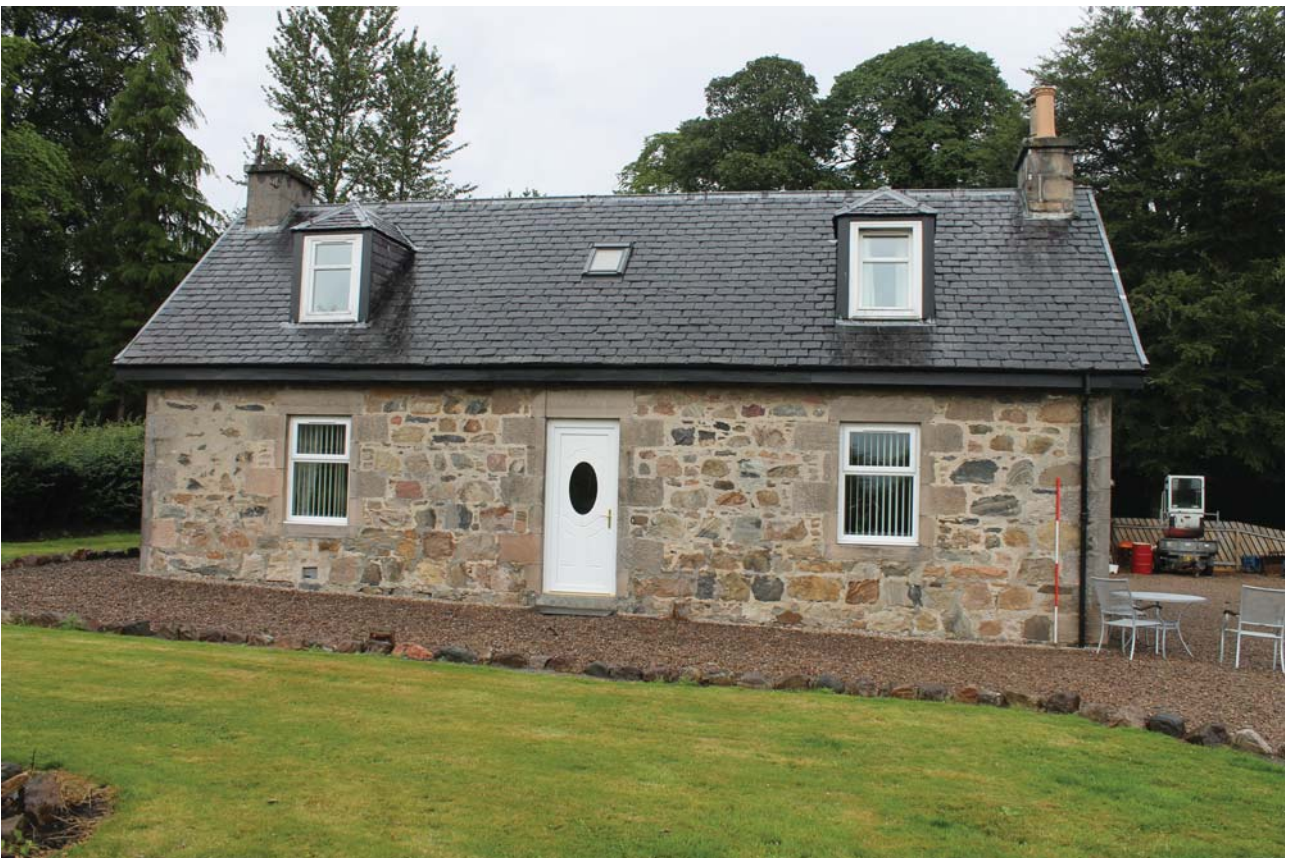
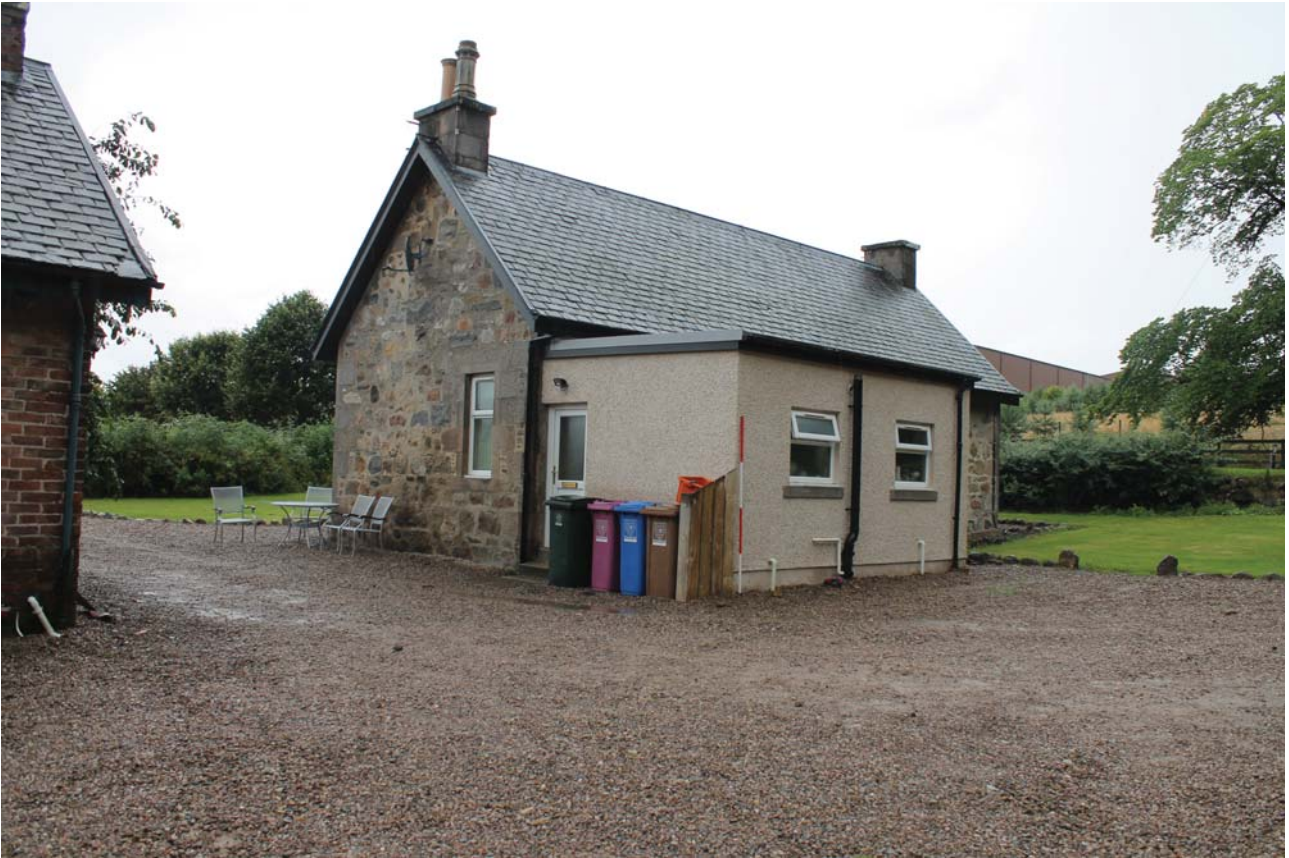
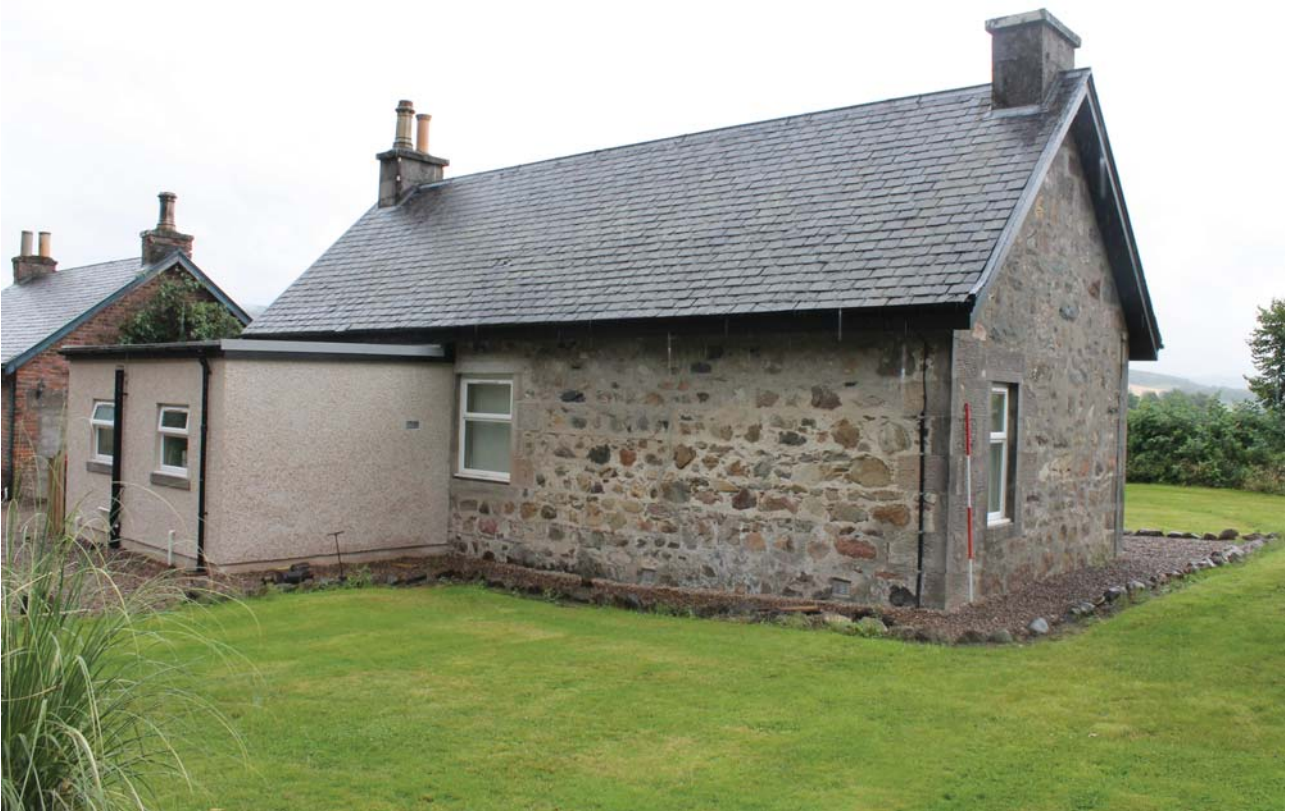
Plate 38: Cottage, general view from the south-west

Plate 39: Cottage, general view from the north

Plate 40: Cottage, general view from the north-west

5.7.1 The small cottage and kennels (occupied at the time of survey) first appears on the 1877 Ordnance Survey map (see Figure 6 below). The previous maps are too small scale to identify the cottage and kennels, so it may be earlier than this. The cottage is a small three-bay single-storey stone rubble building with attic and droved stone surrounds to the openings and quoins (Plate 38). It has a central door to the main elevation to the south-west flanked by tall windows with two dormers above in the pitched slate roof. A single chimney stack adorns each gable and there is a modern extension to the rear (Plates 39 & 40).

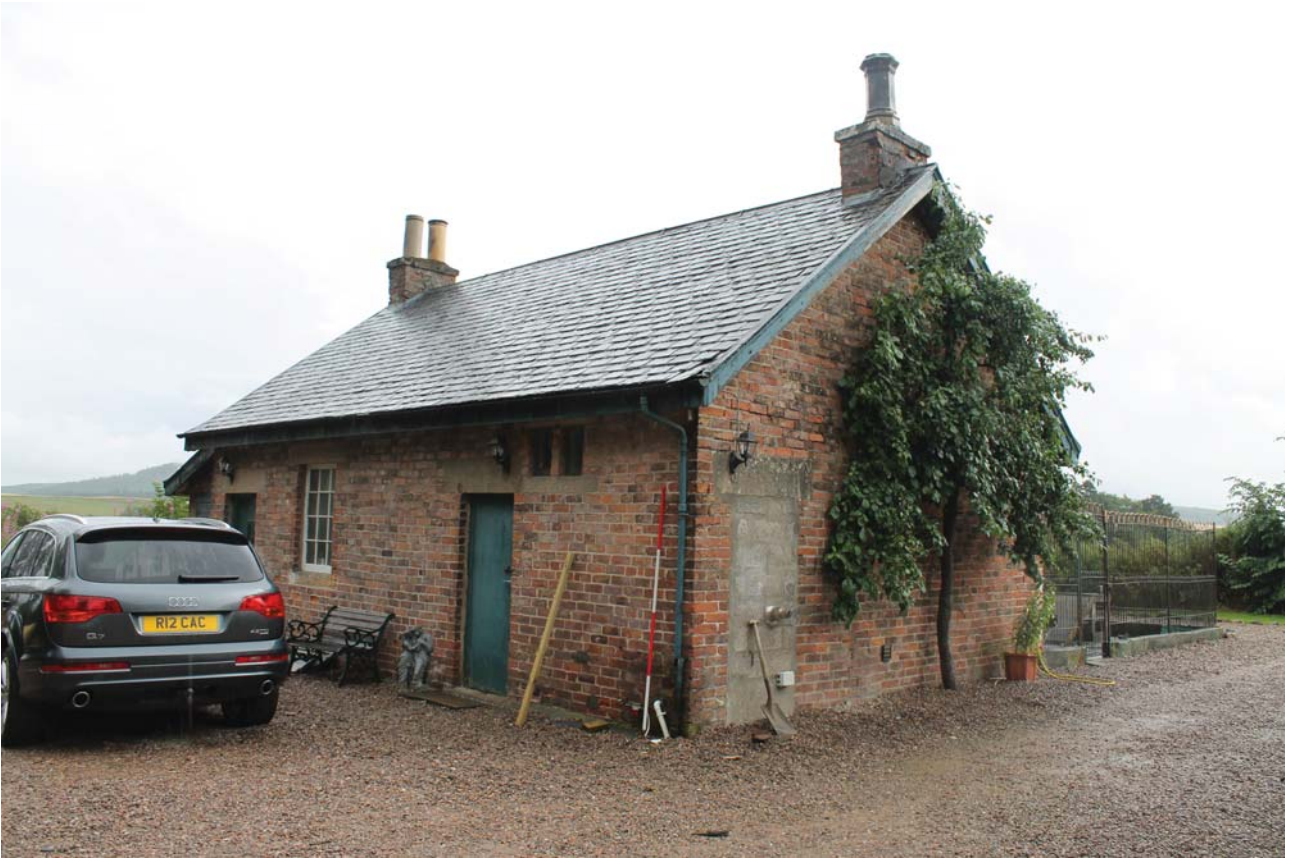
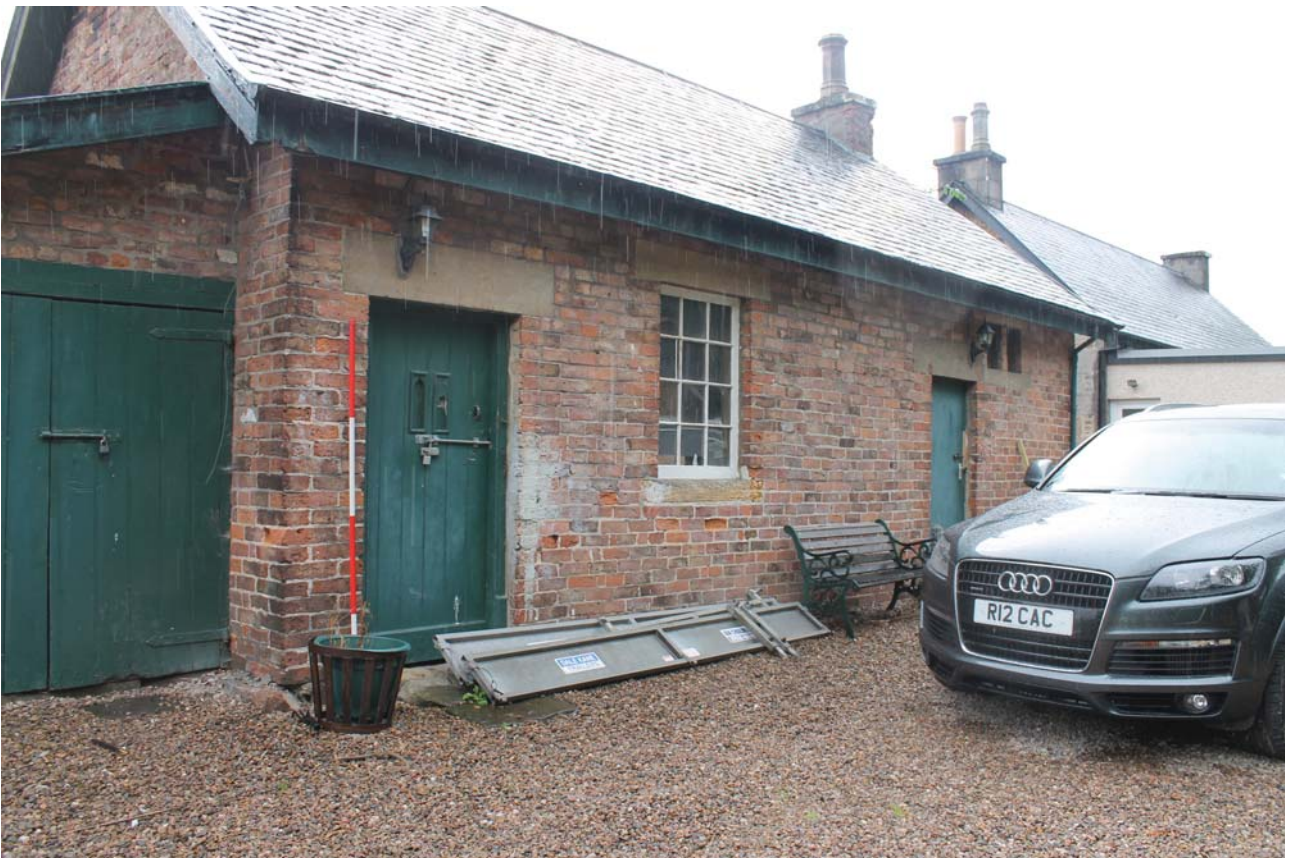
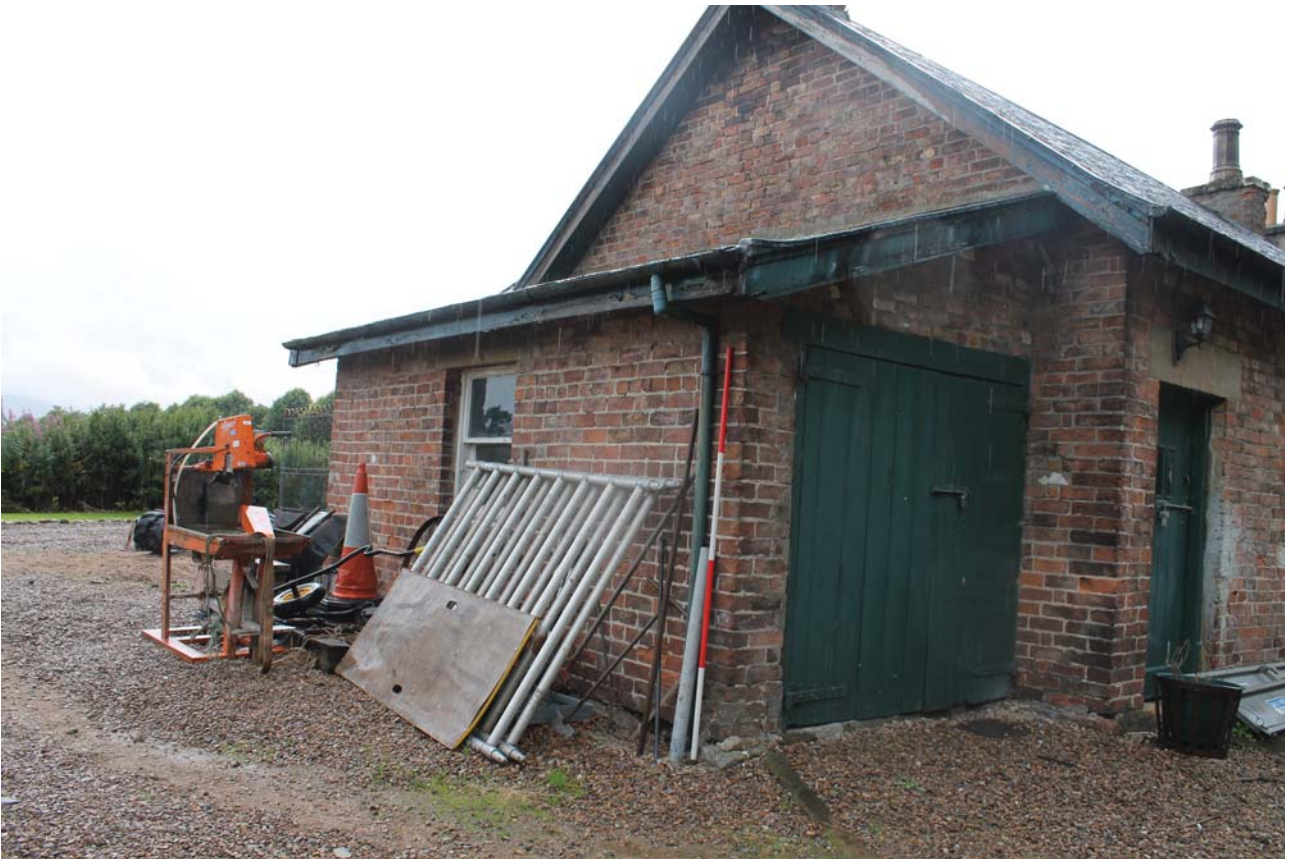
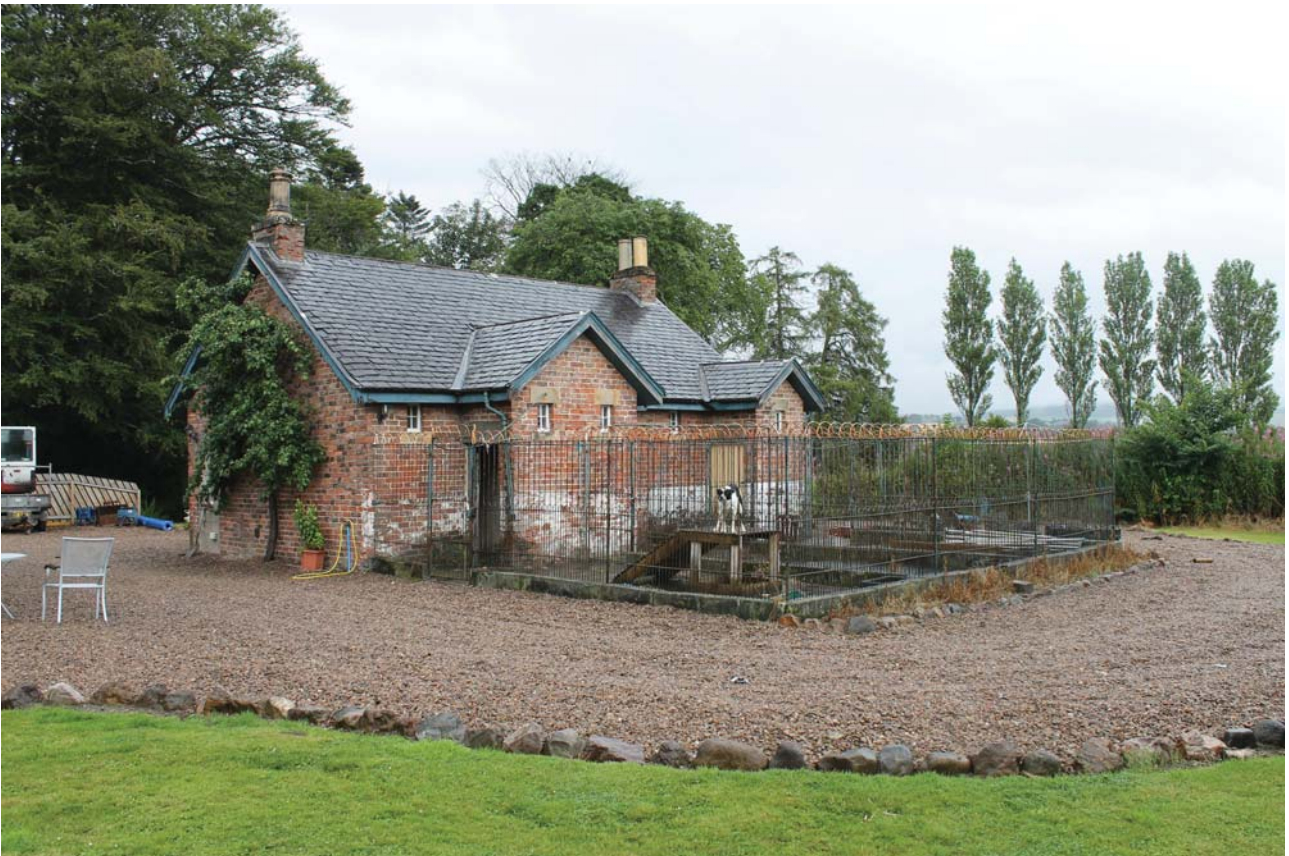
Plate 41: Kennels, general view from the west

Plate 42: Kennels, general view of the north-east elevation from the east

Plate 43: Kennels, general view of the lean-to to the south-east side, from the east

Plate 44: Kennels, general view from the south

5.7.2 The kennels are a small single-storey three by one-bay brick-built structure to the east of the cottage with a pitched slate roof and brick chimney to each gable (Plate 41). There are two main doorways through to the 'rear' of the kennels with sandstone lintels and a window in between with additional ventilation holes to the west side. There is also a small lean-to extension to the south-east side, which appears to be in place at the time of the 1874 map (Plates 42 & 43). The rear south-west side of the kennels, an open area for the dogs, has small high-set windows and two projections with their own pitched gables (Plate 44).
