Kindrochit Castle  
Braemar  
Aberdeenshire  
Second Interim Report on Watching Brief

## ARCHAEOLOGICAL EVALUATION

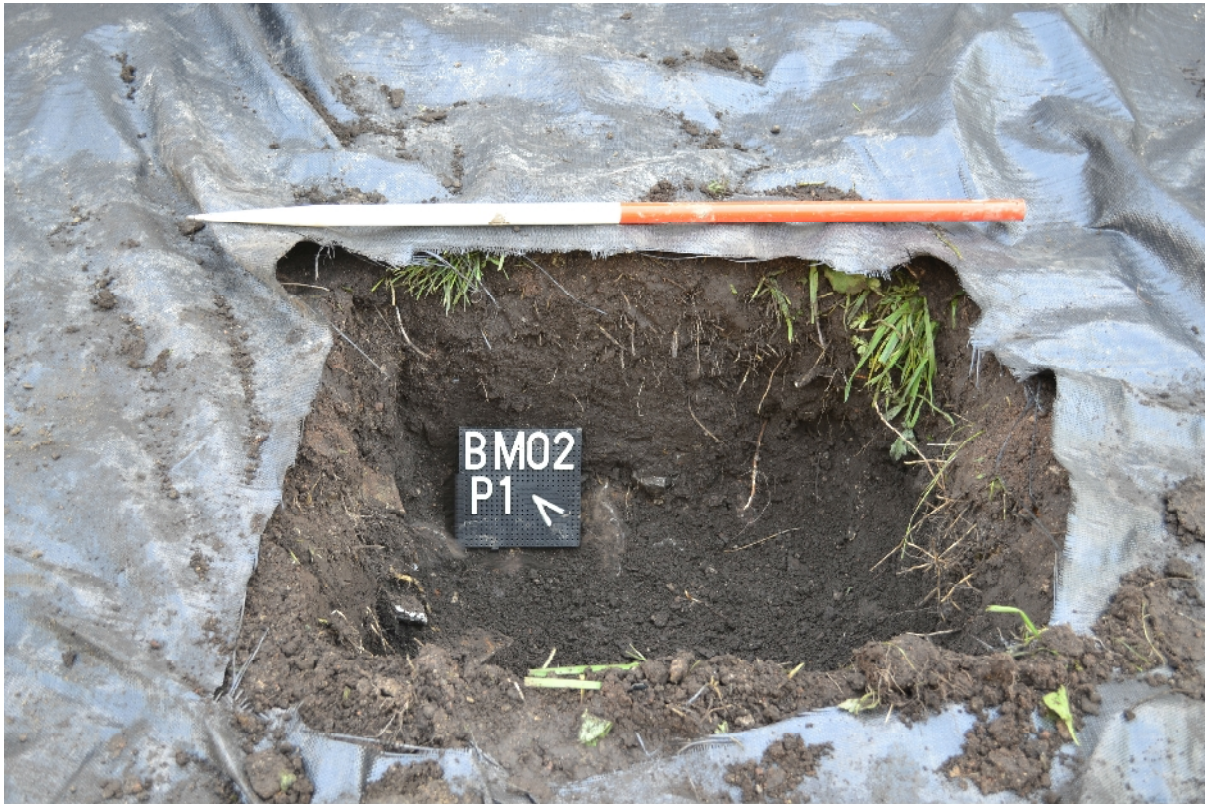
Fig 1: Pit 1, post-excavation, view NE

Pit 1 (P1) was located within the courtyard 2m west of Wall Face 25 (see Illus 2) and measured 0.5m x 0.6m (E-W), 0.25m deep. P1 descended through turf into loose, re-deposited spoil containing c.30% sub-angular stones and stone fragments.

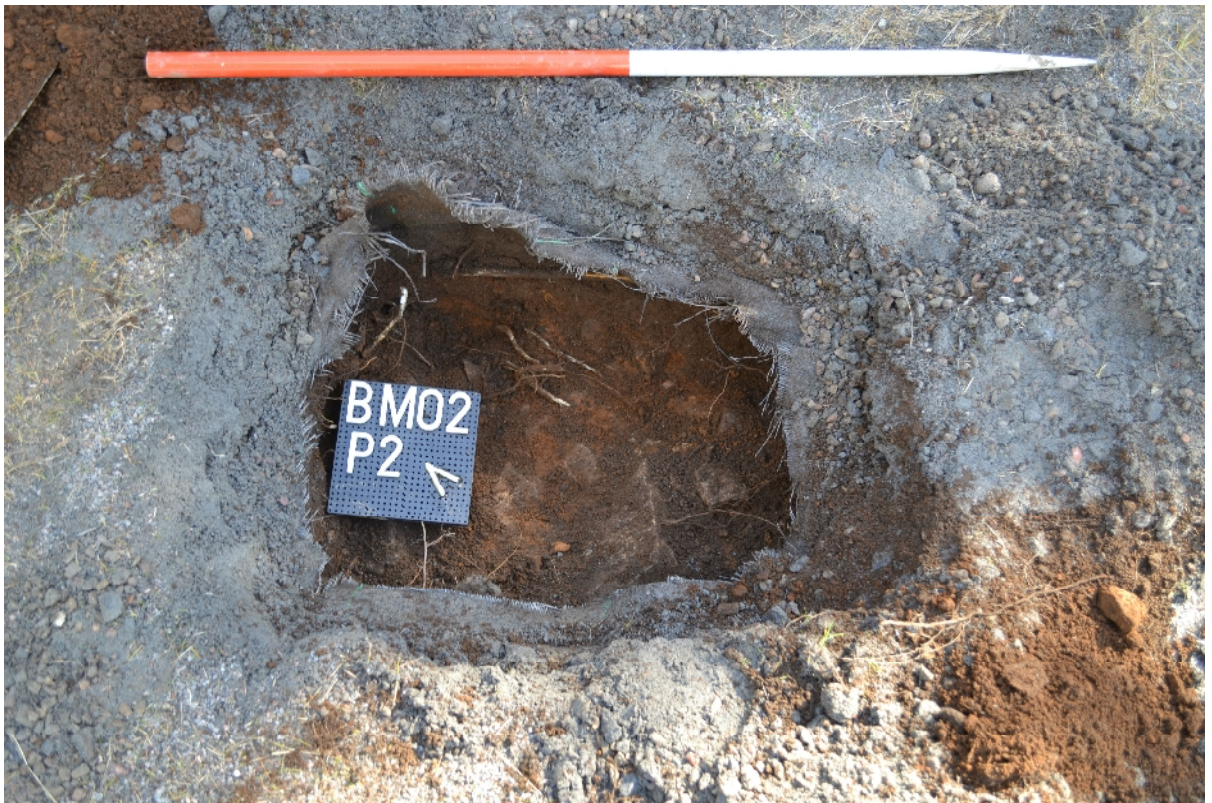
Fig 2: Pit 2, post-excavation, view NE

Pit 2 (P2) was located within the north-east corner of the Phase 1 remains (see Illus 2), measured 0.5m x 0.5m, 0.2m deep, and descended through recently-deposited gravel and geotextile into undisturbed yellow-orange stony subsoil.

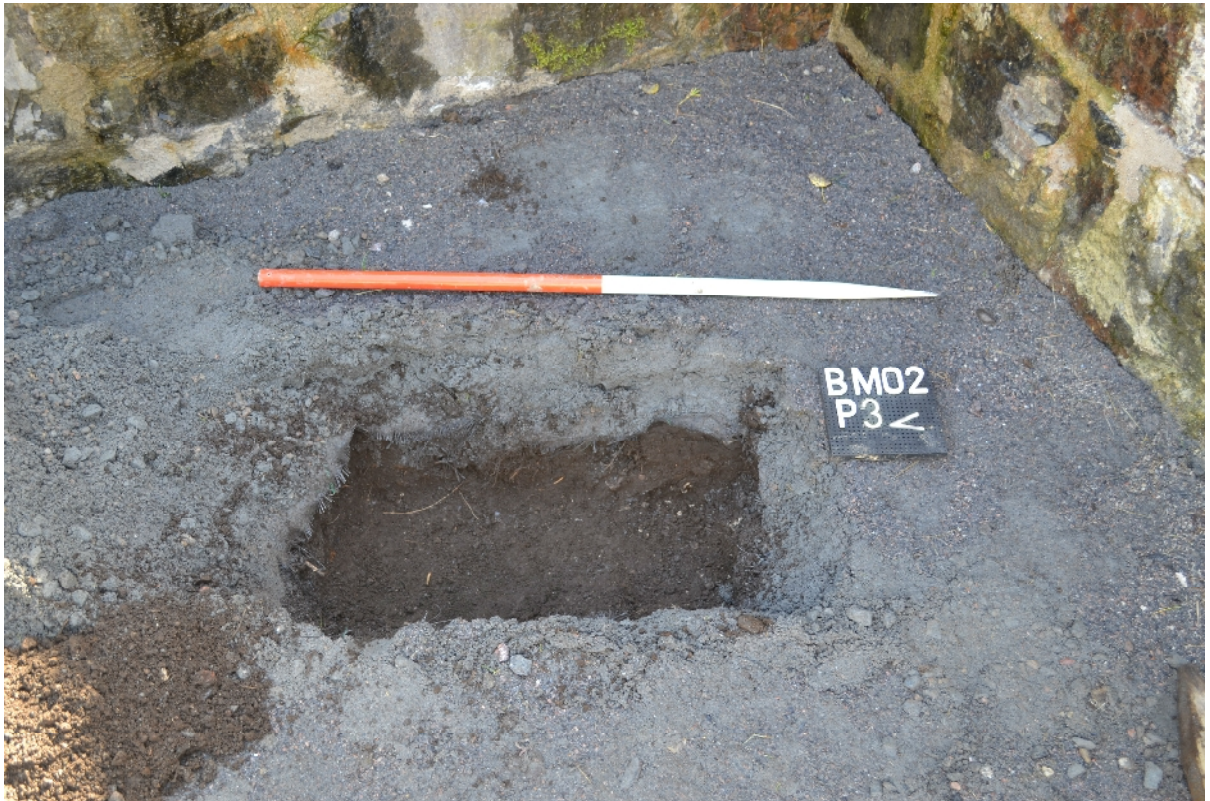
Fig 3: Pit 3, post-excavation, view E

Pit 3 (P3) was located within the south-east corner of the Phase 1 remains, 1m from the apex (see Illus 2) and measured 0.6m x 0.4m (N-S), 0.2m deep, descending through recently-laid gravel and geotextile into moderately compact brownish-grey silt, c.10% pebbles.
