**REPORT  
TO  
N & H McGUIRE JOINERS LIMITED**

**CONSTRUCTION OF NEW JOINER'S SHOP,  
ANCASTER SQUARE NORTH, CALLANDER**

**WATCHING BRIEF  
SEPTEMBER 2015**

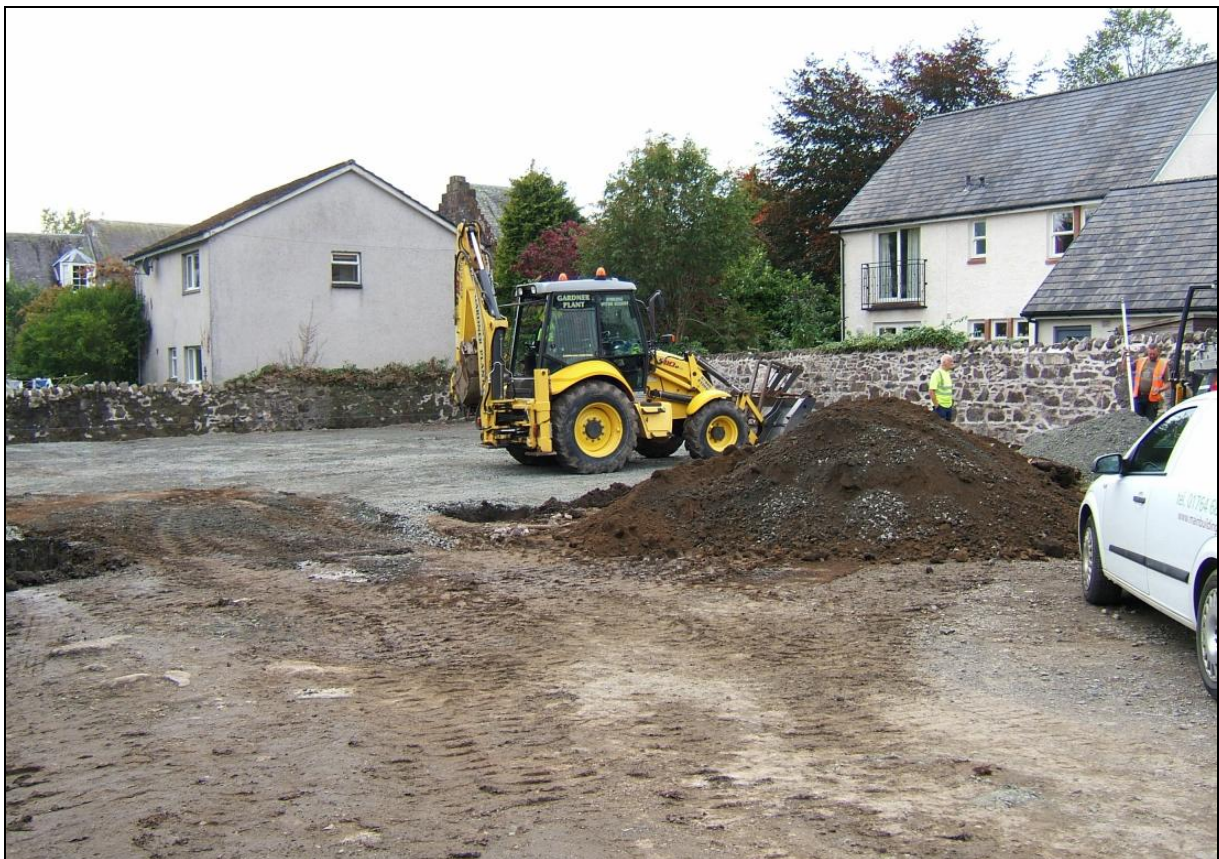
*The site viewed from the north-east*

The main trenches, all 18m long, measured 0.7m wide and up to 0.7m deep although the west trench was barely 0.2m deep in places whereas the trenches for the column bases were up to 0.8m deep. All the trenches cut through 0.15m of type 1 aggregate, laid over the site prior to the excavation, and underlying debris resulting from the demolition of the earlier workshop

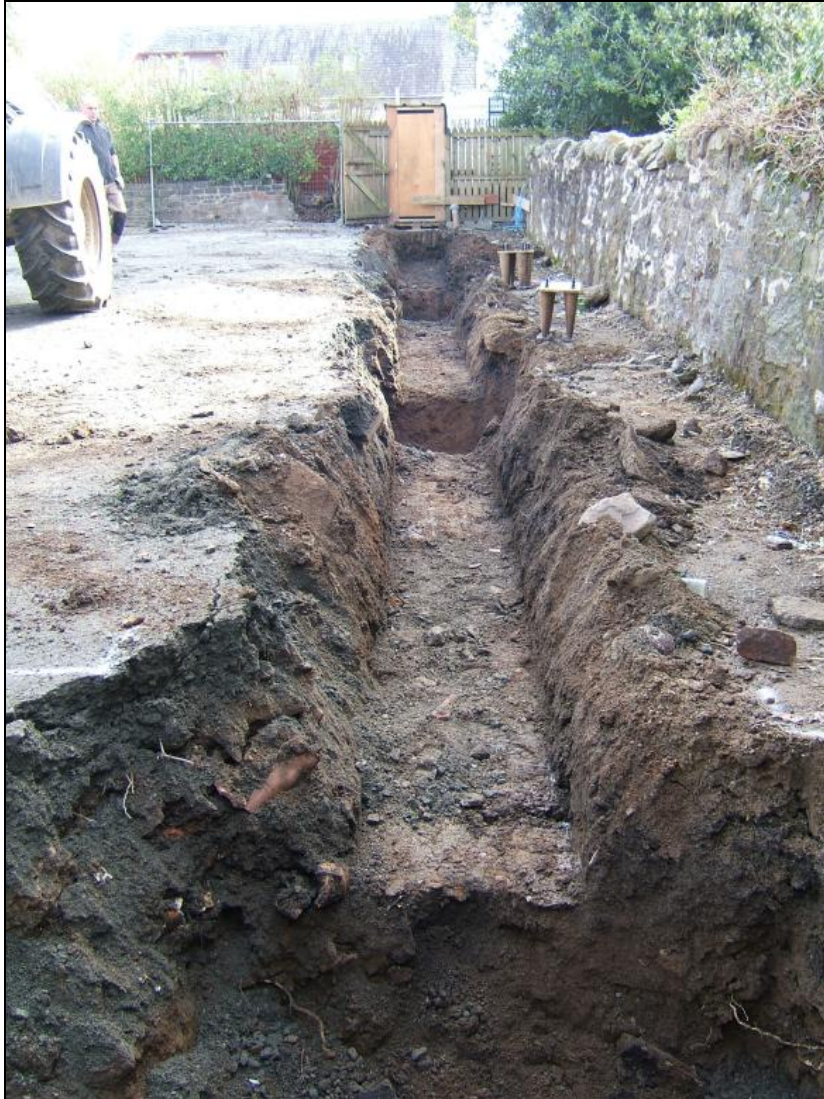
and perhaps other buildings of relatively recent age. This material, which included concrete, brick, rubble and ceramic tile fragments, was not bottomed in parts of the east and west trenches. Otherwise, the removal of the modern debris revealed glacial till of mid-brown silt, orange sand, gravel and occasional boulders. Only in parts of the east trench did topsoil of dark brown silty loam survive; elsewhere it had been removed, probably during construction and demolition work in the 20th century.

*South trench viewed from the west*

No structures, features or deposits of archaeological significance were uncovered in any of the trenches and no pre-20th-century artefacts retrieved from the site.

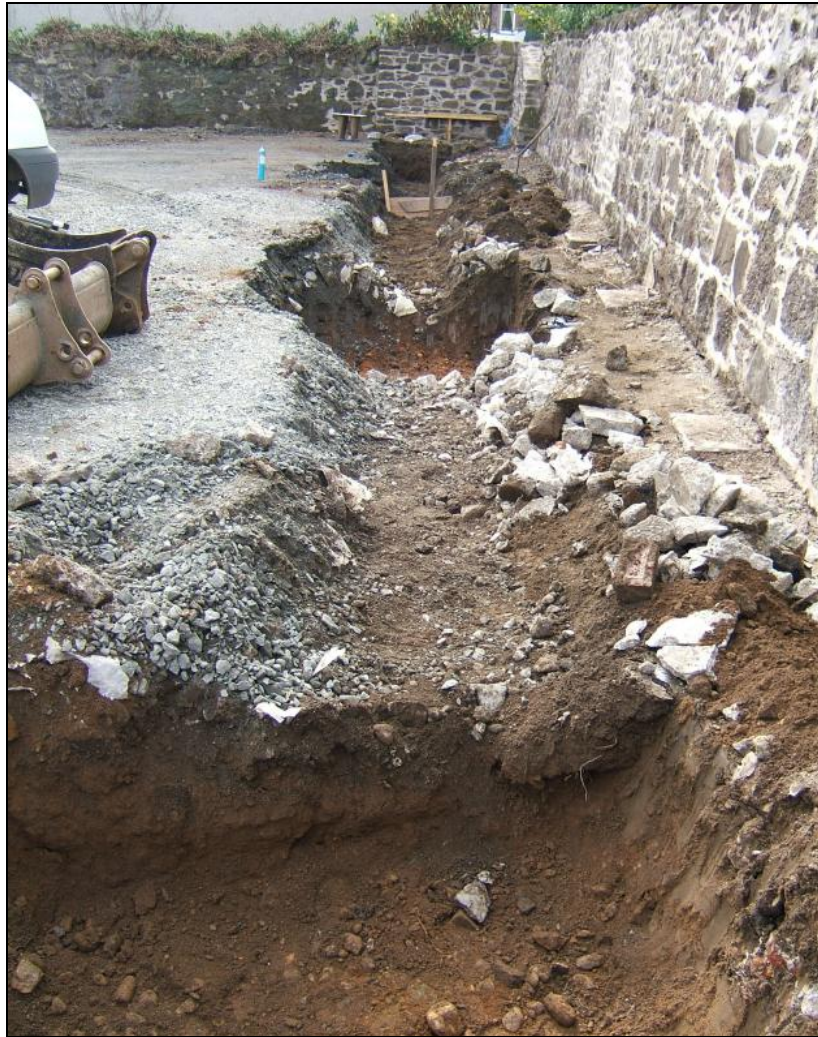
*West trench viewed from the north*
