**REPORT
TO
SCOTTISH & SOUTHERN ENERGY**

**GLENSCORRODALE
THE ROSS
ISLE OF ARRAN**

**ARCHAEOLOGICAL
WALK-OVER SURVEY
APRIL 2015**

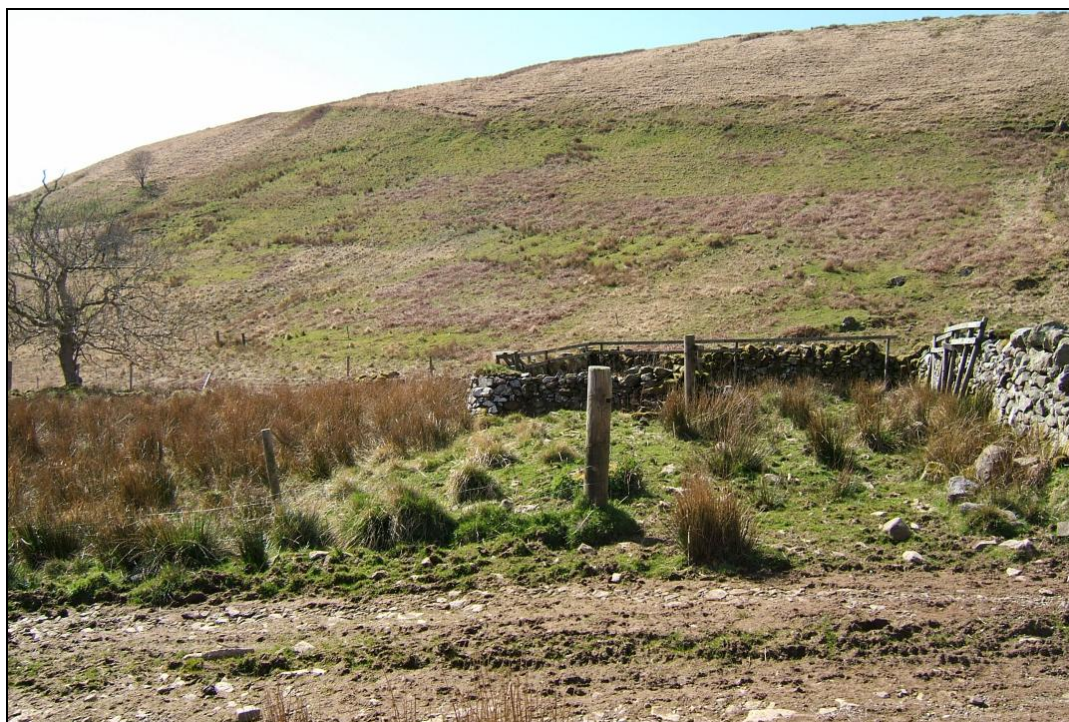
The only structures visible at Corriehiam were at NR 95421 26494, where one small enclosure measuring some 7m square and remnants of a few drystone walls survive.

Remains of Corriehiam (Site 5), viewed from the north

The enclosure and other walls of Corrieham are clearly visible and should present no problem of identification and the boundaries of Sites 6, 7 and 8 should also be relatively easy to recognize. It is recommended that when working in those areas crews should take particular care not to damage any of those structures, either by inserting poles or storing materials near them or by driving through them.

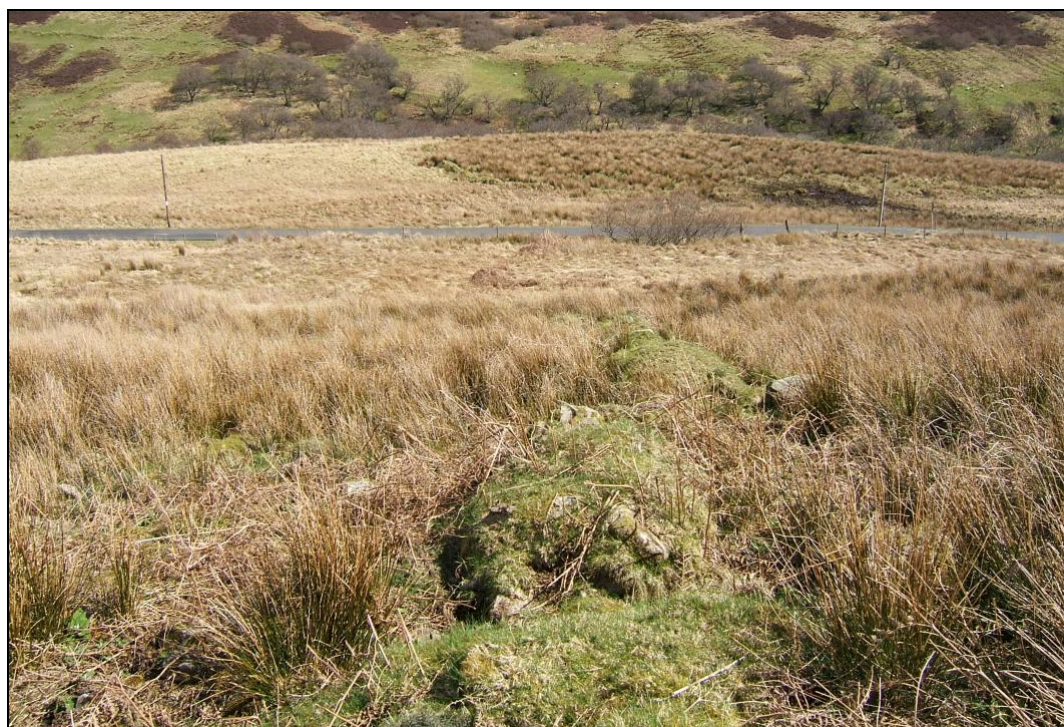
A grass-covered stone bank was noted at NR 95534 26479 from where it extends to the east and west.

Site 6 wall, viewed from the west

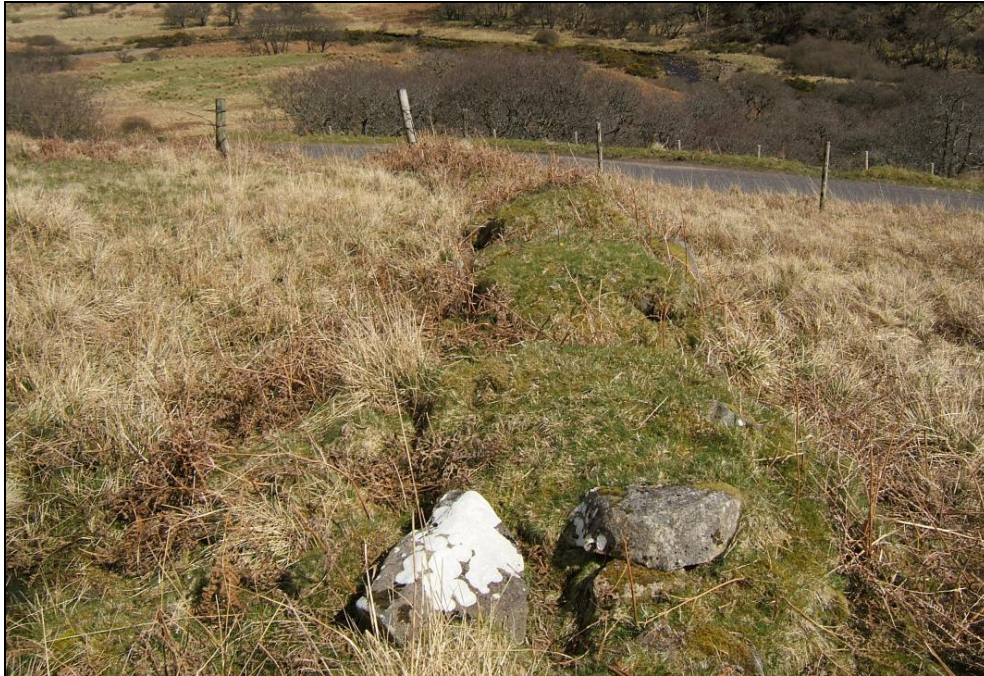
At NR 95677 26829 and extending to the east and west are the remains of another stone boundary wall covered in vegetation.

Site 7 wall, viewed from the west

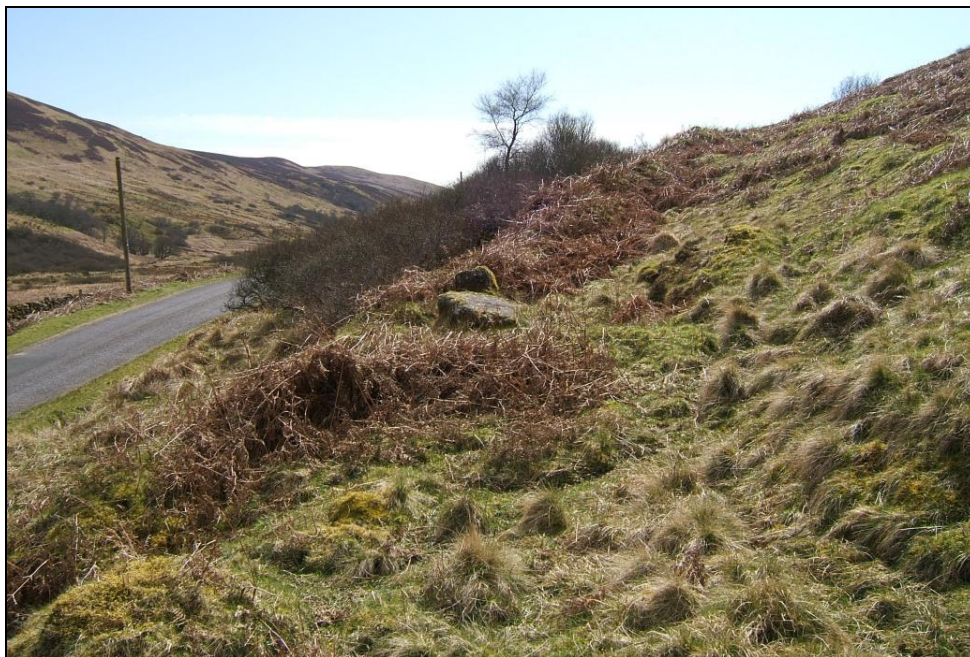
To the west of Glenscorrodale, around NR 96254 27879, is a turf-covered bank that meanders approximately north/south but whose course was difficult to follow through dead bracken.

Site 8 wall, viewed from the north
