**REPORT  
TO  
ALLT ENTERGY LIMITED**

**KENKNOCK  
HYDRO-ELECTRIC SCHEME  
GLEN LYON**

**Desk study  
and  
walk-over survey  
May 2015**

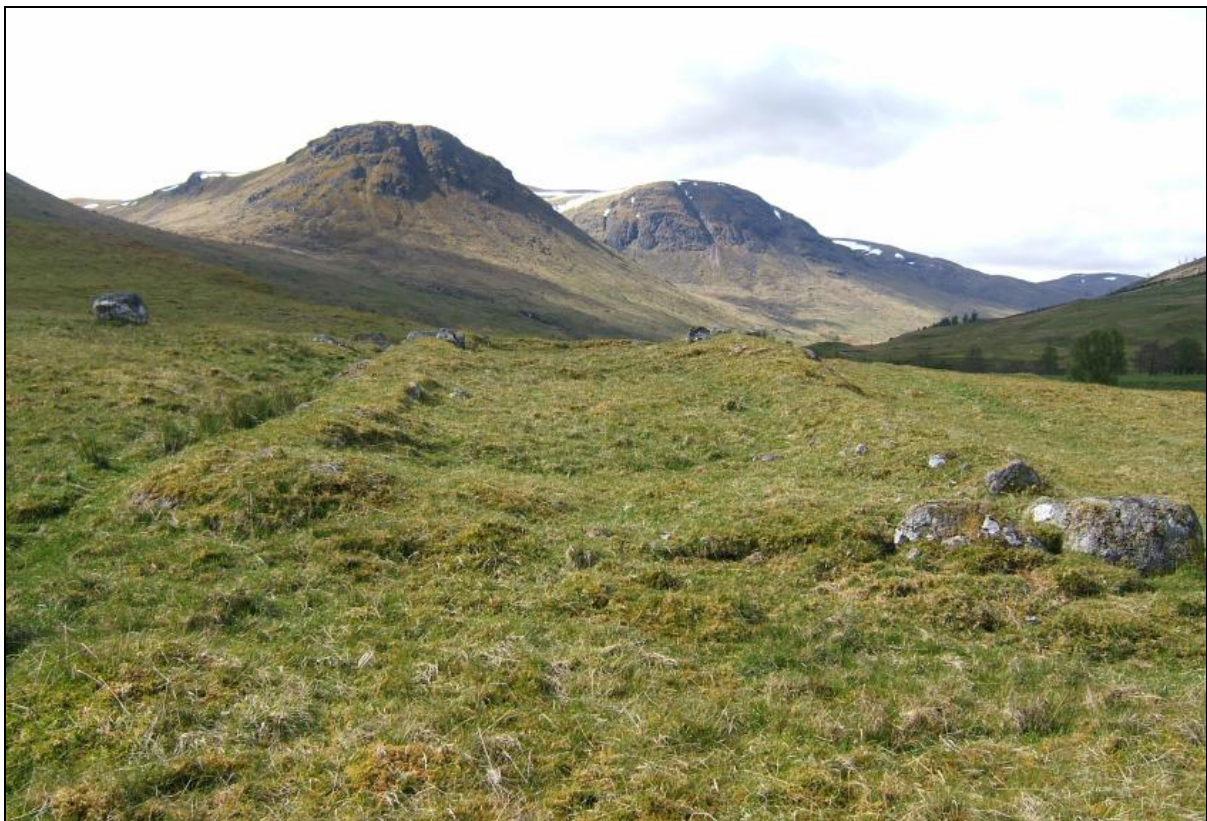
### *Structure 1 (Photos 3, 4)*

Structure 1 is located at NN 53236 44114 and comprises the remains of a building measuring some 21m north/south by 5m wide over drystone rubble walls, a maximum two courses of which survive. There is a cross wall 8m from the building's south end. No further features are discernible.

*Site 2, Structure 1, viewed from the north*

The various structures identified at these sites all lie relatively close to the proposed route of the new access road. It is recommended that each of them is protected by a fence prior to the commencement of trenching for the access road.

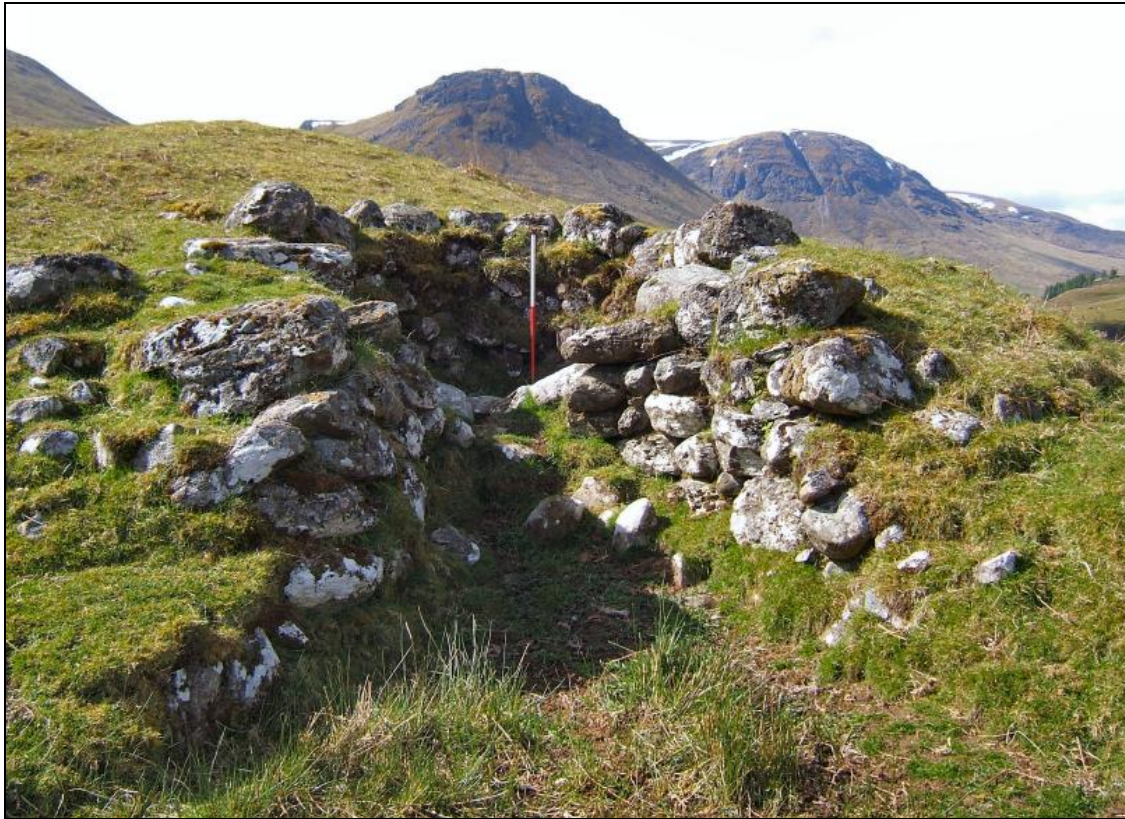
### *Structure 3 (Photos 6-8)*

At NN 53214 44037, some 80m from Structures 1 and 2 but presumably associated with them, are the remains of a kiln, surviving to a height of 1.5m. Its bowl measures 1.7m in diameter while the flue extends to the north, widening from 0.6m at the bowl to 1.7m at its mouth.

*Site 2 kiln, viewed from the north*

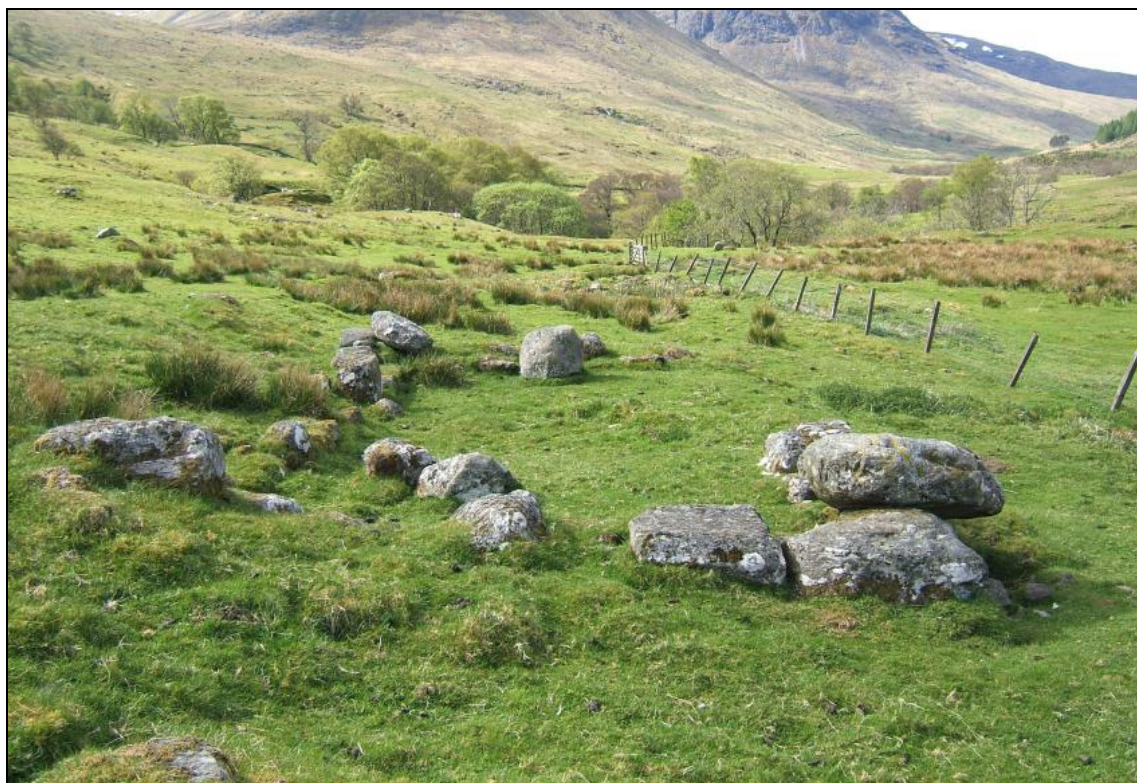
#### *Structure 1 (Photos 9, 10)*

Structure 1, located at NN 53095 43738, measures 9m north/south by 4m wide over drystone rubble walls of which a maximum of one course survives. There appears to have been an entrance midway along the east wall.

*Site 3, Structure 1, viewed from the north*

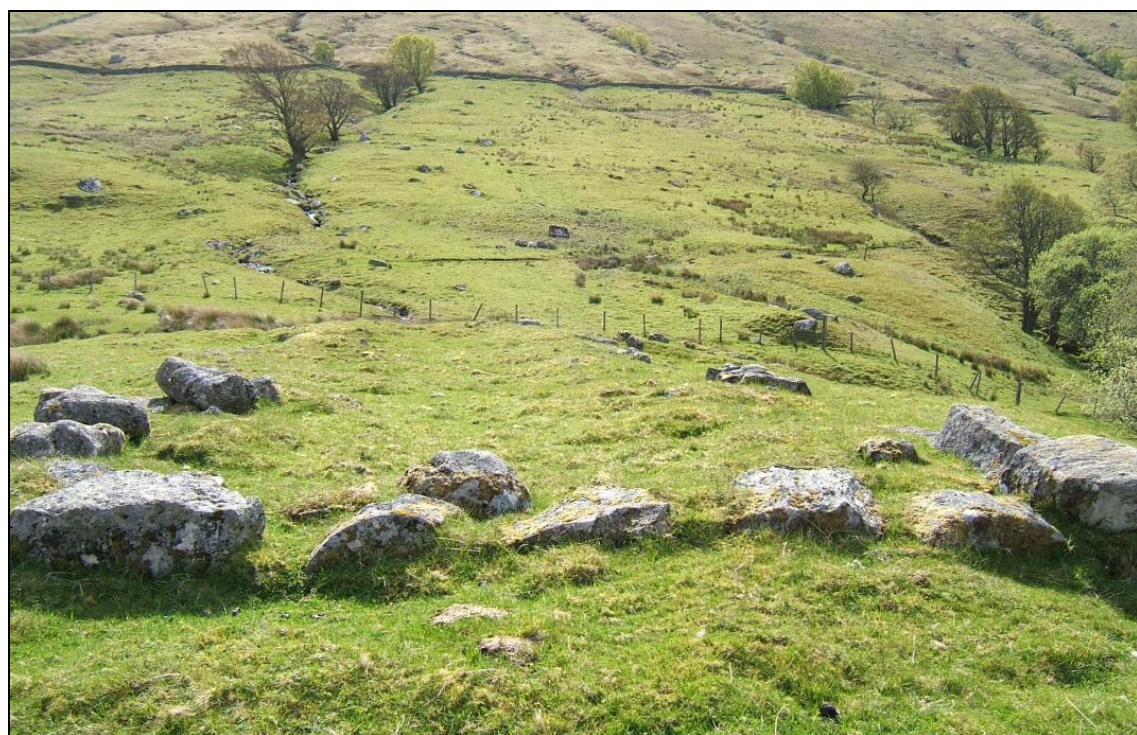
#### *Structure 2 (Photos 11, 12)*

The sparse remains of Structure 2 are located at NN 53038 43695, in a separate field from the one through which the new access road will run. This long building measures some 26m east/west by 5m wide overall, its walls almost completely covered by grass.

*Site 3, Structure 2, viewed from the west*

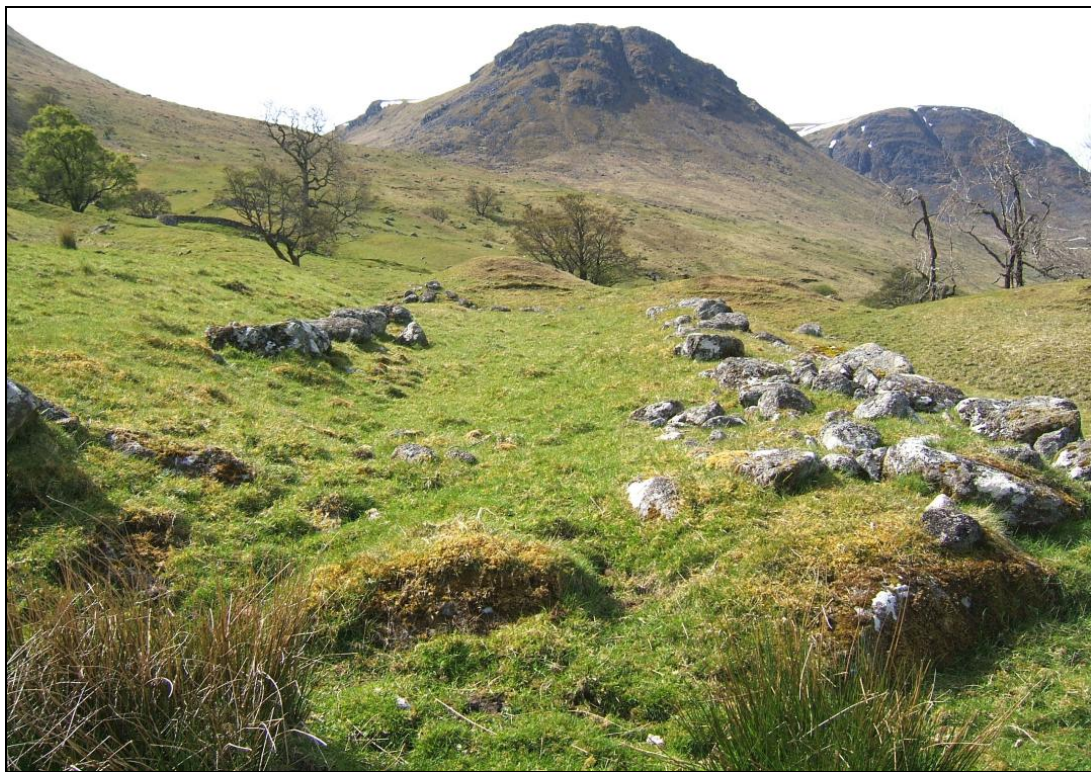
### *Structure 1 (Photos 15, 16)*

Structure 1 is located at NN 53015 43498 and set on a platform supported on its west side by a low retaining wall. The building measures some 23m north/south by 4.5m wide, its walls standing to a maximum of two courses high and including some very large boulders.

*Site 4, Structure 1, viewed from the north*

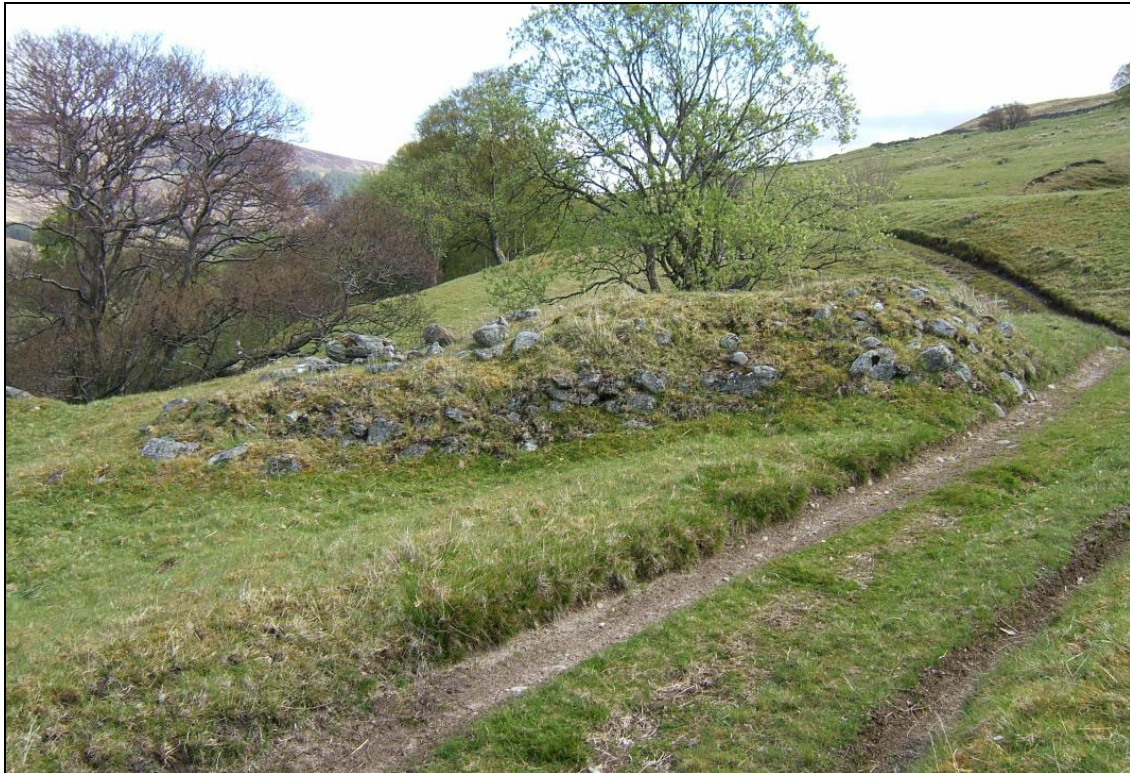
### *Structure 2 (Photos 17-19)*

The remains of this small, bicameral building are located at NN 52996 43496, to the immediate west of the existing farm track. It measures 6m east/west by 4m wide, its turf-covered walls standing to a maximum height of 1m on the building's south side.

*Site 4, Structure 2, viewed from the south*

It should be noted that Structure 2 at Site 4 is located immediately adjacent to the existing farm track. As a consequence, the new road should deviate considerably from this structure which should still be fenced off for its protection.

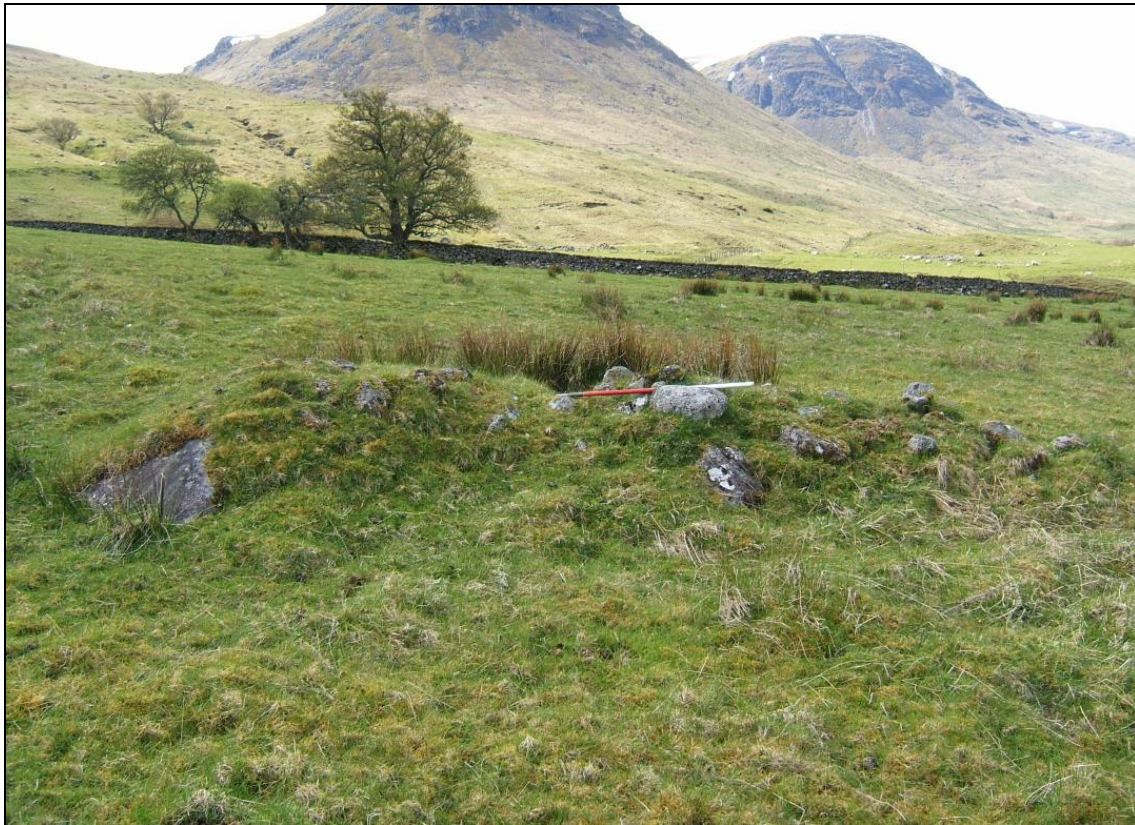
**Site 8 (Photos 29, 30)**

At NN 52979 43440, approximately 200m north of Site 4, is an oval mound measuring 4m east/west by 1.6m wide and 0.7m high. It is grass-covered but appears to comprise mostly boulders. It does not resemble any of the field clearance cairns in the area and it is tentatively interpreted as a prehistoric burial mound.

*Site 8: possible burial mound, viewed from the north*

Although its interpretation as a burial mound has yet to be confirmed, it is recommended that Site 8 is surrounded by a protective fence prior to the commencement of the development.

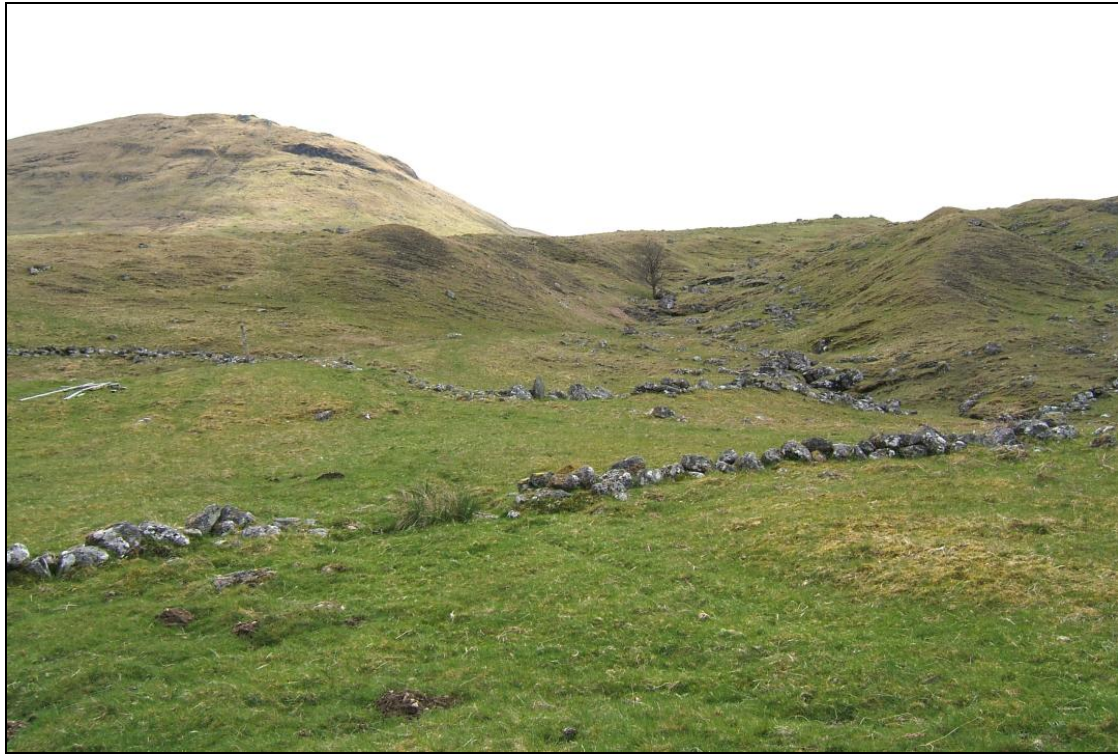
Both the new access track and the penstock will cross field walls. The new track is most likely to utilise existing gateways through walls that still define individual fields. The penstock, however, will cross the sparse remains of walls that no longer function as field boundaries, including what may have been the head-dyke for settlements arranged along the west bank of the river (see photo below).

*View to the south-east along the penstock route*

It is recommended that the penstock is taken through existing breaches in these walls and, if any walls are damaged during the development, they should be reinstated following the completion of the hydro scheme.
