Project Code: PRSS10  
Date of report: May 2010  
Client: Scottish Coal

## RESULTS OF A WALKOVER SURVEY & ARCHAEOLOGICAL EVALUATION AT PONESK REMAINDER SURFACE MINE, EAST AYRSHIRE

# RESULTS OF A WALKOVER SURVEY & ARCHAEOLOGICAL EVALUATION AT PONESK REMAINDER SURFACE MINE, EAST AYRSHIRE

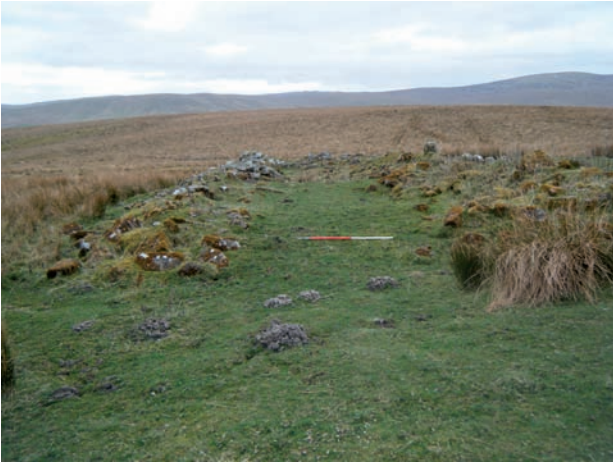
**Illus 4**  
'Cairniebottom' looking south-east

The survey of Cairniebottom revealed the remains of a low turf-covered building that measured 22.5 x 6.8m externally, with walls roughly 0.7m wide and up to 1m high in places (Illus 4-6). The building was aligned NW-SE, falling to the SE. Around it was a spread of collapsed stone

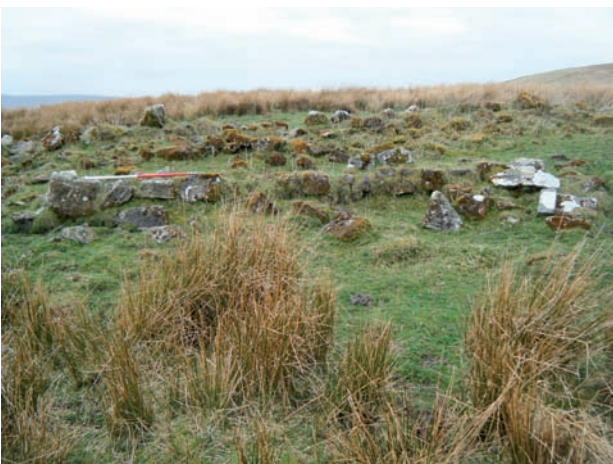
**Illus 5**  
'Cairniebottom' looking south-west

and turf superstructure. There was an entrance towards the NW end of the more northerly long wall and there was a marked change in level in the SE half of the building, representing a step down. There were also traces here of a central drain. Initial field observations suggested this was present in a possible byre, with the higher part of the building being a small dwelling.

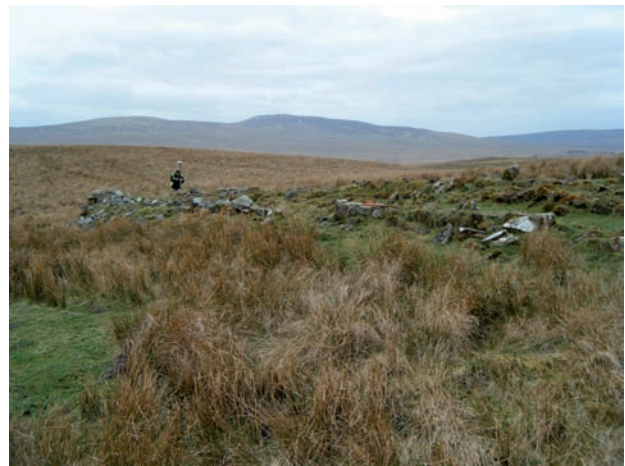
**Illus 6**  
'Cairniebottom' looking south

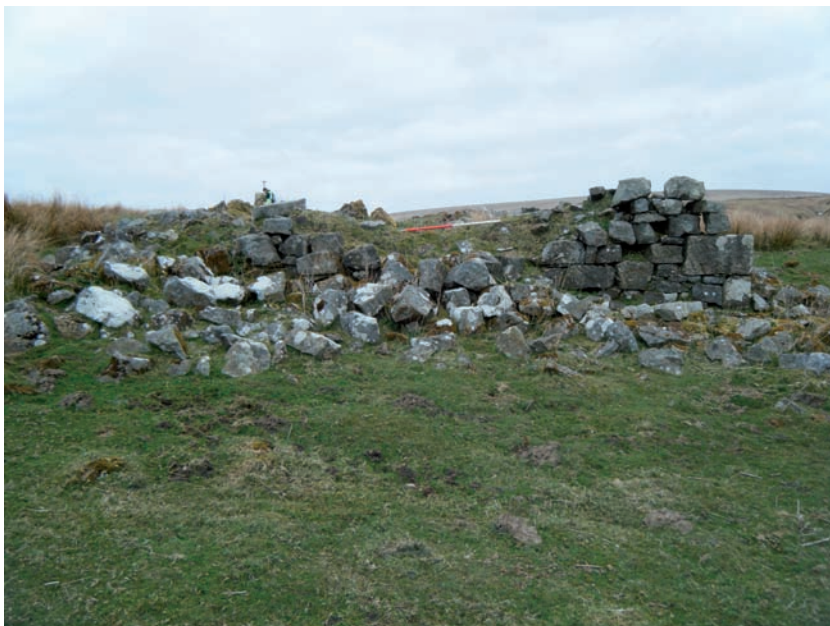
The building was formed by a low random rubble wall that presumably formed a base for a turf superstructure. The construction of the northern part of the building differed slightly with the wall containing large orthostats, while the southwest facing external wall of the byre had been built with more formal squared rubble (Illus 7 and 8).

**Illus 7**  
Byre end-wall looking northwest

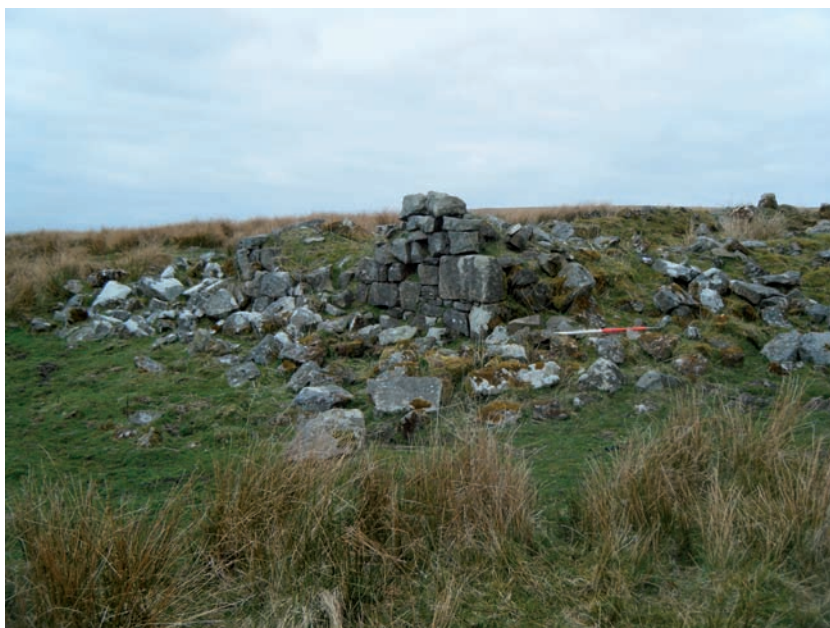
**Illus 8**  
Byre end-wall looking west

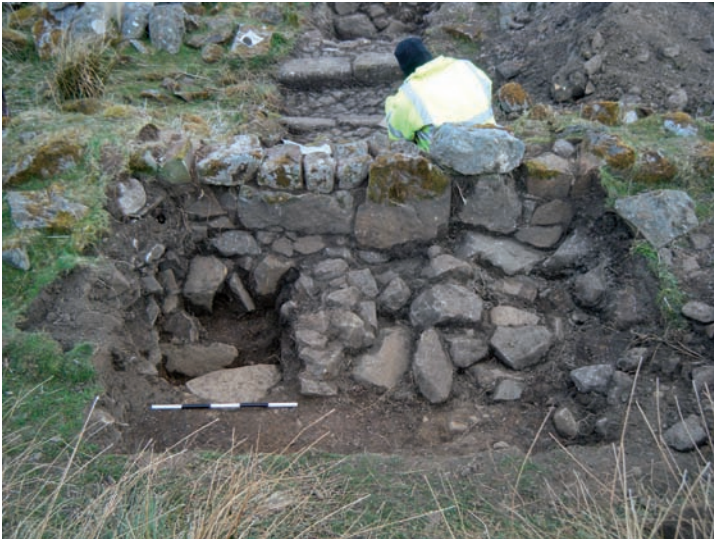
stood to a height of 0.8m and was 0.7m wide. The lower 0.3m projected from the wall face and was partially built over a stone-lined drain (006) that ran down the outside of the building and had been capped with tightly packed random rubble (Illus 10). The north wall (005) shared the same construction but stood to a height of 1m in order to compensate for a drop in ground level. It was also narrower, with a width of 0.6m (Illus 11). A stone-capped drain was present next to the interior face of this wall.

**Illus 10 (left)**  
Wall 004 and drain 006

**Illus 11 (right)**  
Wall 005

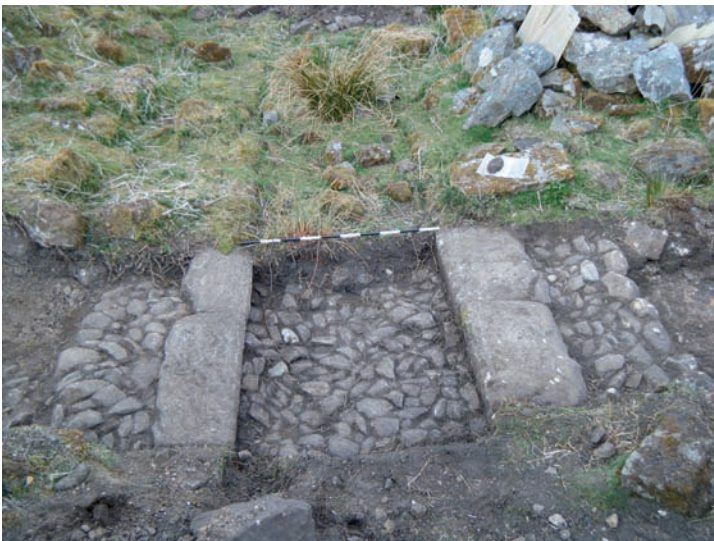
The eastern end of Trench 1 exposed the enclosure bank (018) associated with the farmstead, showing it to be constructed of unbonded stone. It was 0.8m wide. A deposit of stone (019) abutting this to the north is likely to be tumble from the enclosure bank (Illus 13). The enclosure was also exposed in Trench 3 where it was formed by a well-constructed drystone wall (031) that was 0.56m wide and 0.43m high (Illus 14).

**Illus 13 (right)**  
Enclosure wall/bank 018

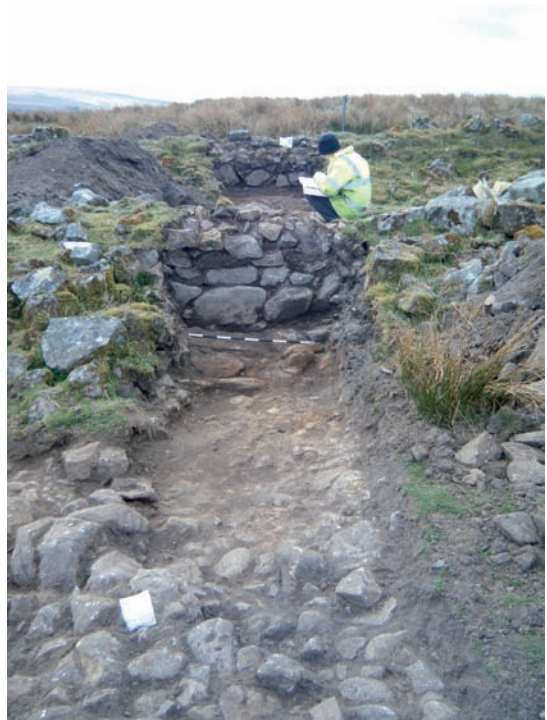
The drain noted in the initial survey was also exposed in Trench 1. It was located centrally within the building and was constructed with two parallel lines of large rectangular stones flanked on the outside by a 0.4m wide cobbled strip. This formed a channel 0.9m across and 0.1m deep. The base of the channel was also lined with cobbles (Illus 12).

**Illus 12 (left)**  
Stone drain 012 in Trench 1

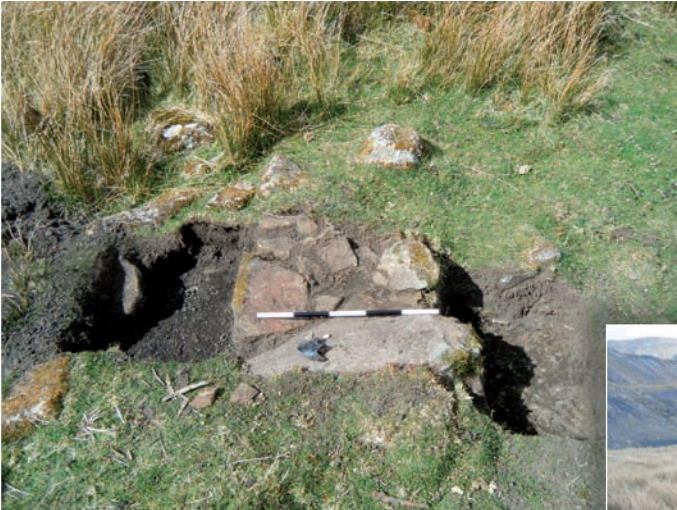
**Illus 14 (left)**  
Wall 031 in Trench 3

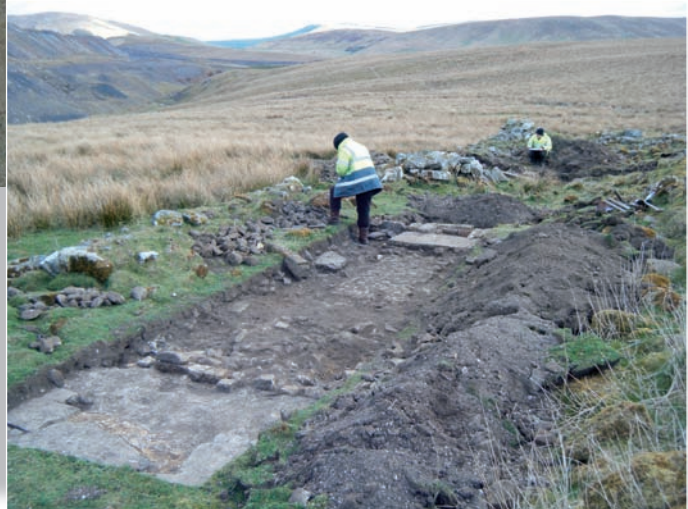
Trench 2, measuring 10m by 2m, was placed in the centre of the dwelling in order to locate the hearth (if present) and to investigate the drop in level within the building (Illus 15). The northwest end of the trench revealed a floor surface constructed with a mixture of large flagstones (021), lime mortar and cement mortar (022). This was present to the

**Illus 15 (below)**  
View of Trench 2

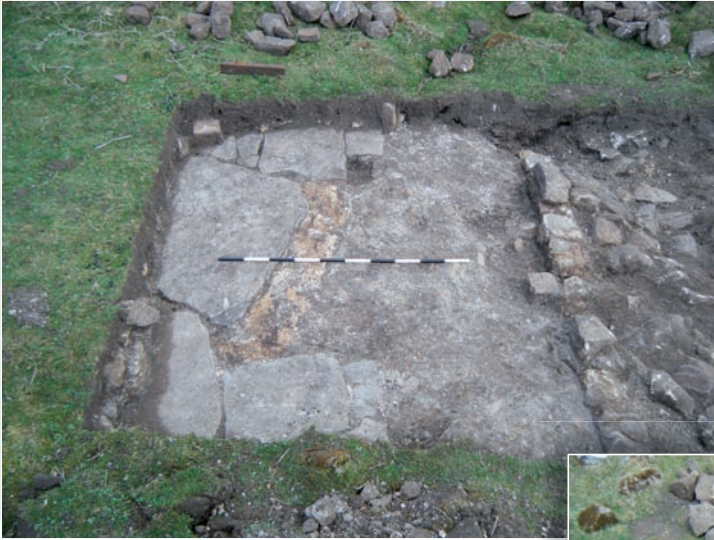
north of a narrow internal wall, 0.15m wide, constructed from random rubble and bonded with lime mortar (023) (Illus 16). To the southeast of this was a spread of stone rubble (024) likely to be collapse from the adjacent wall.

**Illus 16 (left)**  
Stone and mortar floor in Trench 2

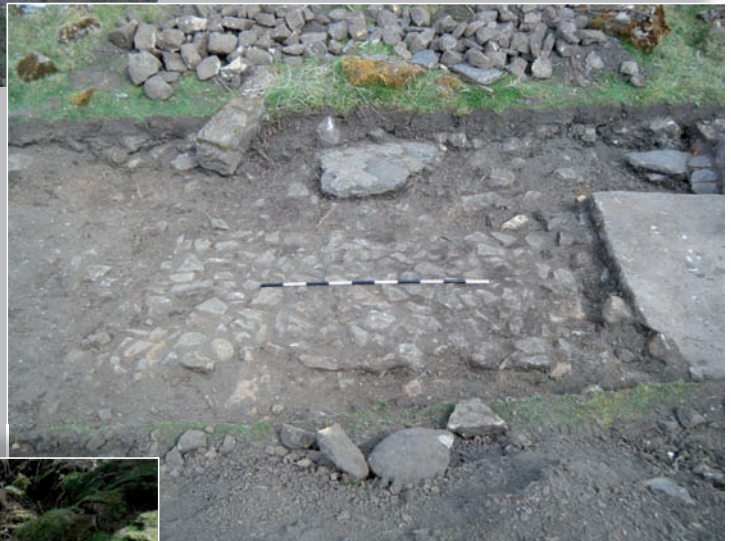
Beyond the rubble spread was a cobble surface (025), roughly 2.2m by 1m in extent. This was rectangular in shape and ran parallel with the building (Illus 17). It abutted a large rectangular flagstone (027), measuring 1.25m by 0.65m, which had been placed up against the end wall of the dwelling (029). This wall was 0.7m wide and was constructed of squared rubble bonded with coarse lime mortar and stood to a height of 0.4m. Several of the larger stones had tool marks on the surface. Within this wall was a brick- and stone-built fireplace, 0.6m wide and 0.5m deep (Illus 18). The bricks were unfrogged and displayed no maker's mark. The discovery of the end wall of the original dwelling showed it to be

**Illus 17 (right)**  
Cobbled surface 025

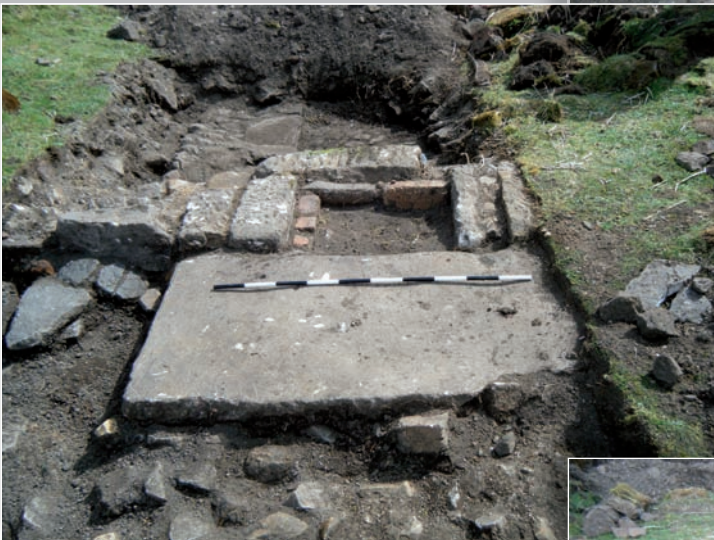
**Illus 18 (left)**  
Fireplace 028

027	Tr.2	Structure	A large flagstone 1.25m x 0.65m abutting fireplace (028) and wall (029).
028	Tr.2	Structure	A brick and stone lined fire place that cuts into stone wall (029). The red un-frogged bricks were bonded with lime mortar and only stood one course high. The fire place measured 0.6m x 0.5m and was only 0.1m high.
029	Tr.2	Structure	An NE-SW aligned rubble stone wall forming the western gable end to the domestic house and dividing this from the attached byre. The wall was 0.7m wide and 0.39m high and bonded with a course lime mortar.
030	Tr.2	Deposit	Loose mid-brown sandy clay with occasional charcoal fleck inclusions. Fill of fire surround (028).
031	Tr.3	Structure	An NW-SE aligned drystone wall forming part of an enclosure wall associated with the dwelling to the south. The wall was approximately 0.56m wide and 0.43m high comprising of poorly sorted angular and sub-angular stones.

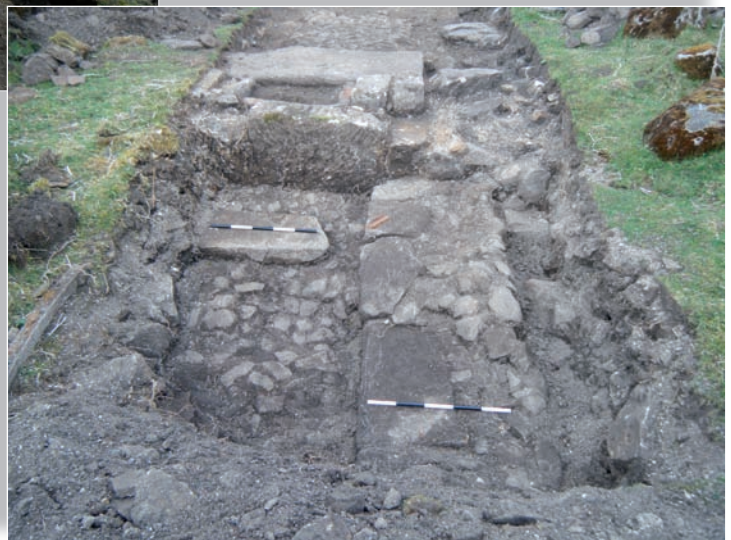
The drop in elevation noted in the initial survey, and present at the end of Trench 2, was shown to be where the byre abutted the end wall of the original dwelling (Illus 19). On the south side of the dwelling wall was the continuation of the stone built channel (012) that had been encountered in Trench 1.

**Illus 19 (right)**  
Stone drain 012 in Trench 2
