MEMORIAL HOSPITAL, ABBEY WALK,  
ST ANDREWS, FIFE

*Archaeological Monitoring*

*for Watkin Jones Group*

*May 2014*

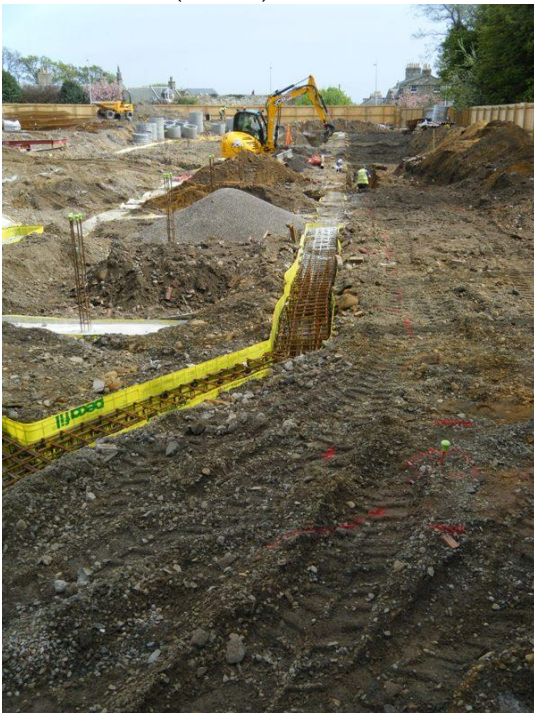
The service pipe trenches were located along the perimeter of the site with two long lengths along the east and west boundaries. The trench along the eastern boundary (Trench 1) was positioned close to the top of the bank that led down to the Kinnes Burn (**Illus 3**).

Illus 3 General site view showing the excavation of Trench 1, facing north.

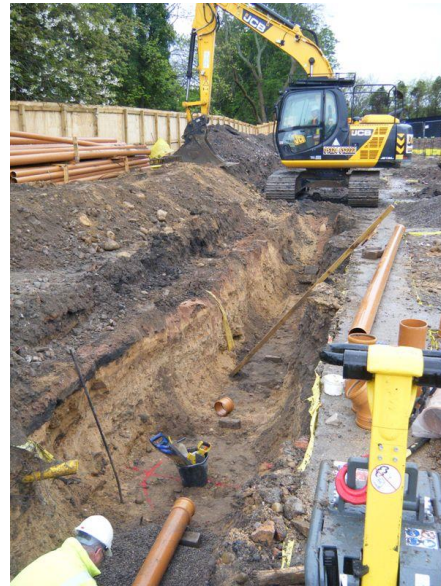
The trench recorded between 0.1 and 0.4m of made ground, comprised of dark brown sand with frequent construction debris inclusions, overlying the mid yellow sand and gravel geological subsoil (**Illus 4**) at approximately 5.5m OD

Illus 4 View of Trench 1 showing the west facing section 30m from the north end

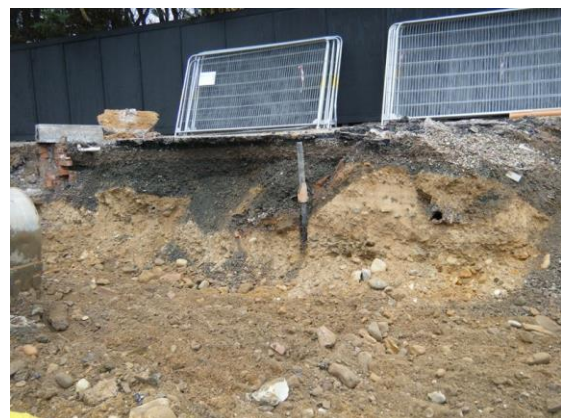
A second shorter trench (Trench 02) ran along the western perimeter close to the Leonard's Field development. The excavation of this trench required the ground level to be reduced by approximately 1.5m. This exposed the east facing section of the development perimeter close to the south-west end, revealing the geological subsoil immediately underlying the tarmac surface of the existing car park at approximately 8m OD (**Illus 5**). The ground reduction of this area also revealed that the sand and gravels had been cut by a number of modern service pipes and manholes associated with the demolished hospital.

Illus 5 East facing section at the south end of Trench 2 ground reduction

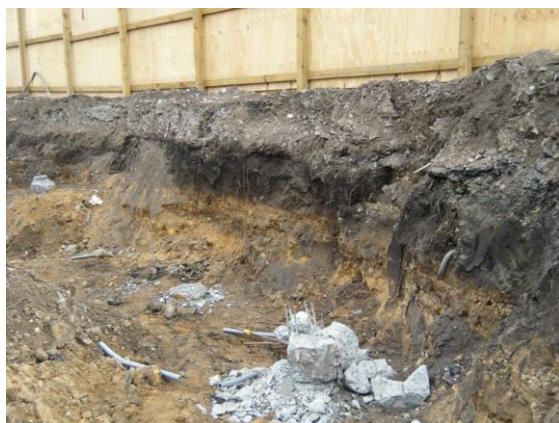
A third (foundation) trench (Trench 03) close to the northern perimeter of the development area was also monitored. The trench was approximately 1m wide and excavated to a maximum depth of 1.5m. Inspection of the sections exposed by the excavation of this foundation trench revealed that close to the north-east corner of the development area evidence of a buried soil overlying the sand and gravel geological subsoil (Illus 5) was present. The soil comprised dark brown sand with occasional small stone inclusions. This material had a maximum depth of 0.5m (approximately 5.5m OD) and was sterile of archaeological features or artefacts. The buried soil was overlain by 0.5m of made ground, although the interface between the two layers was very diffuse. This would indicate that the buried soil had probably been horizontally truncated removing any surviving old ground surface. The south facing section along the northern perimeter showed that the buried soil became less prevalent towards the west side of the site with no evidence of this material identified at the western end of Trench 3.

Illus 6 Detail of the buried soil recorded in the south facing section at the north-east corner of the development area.

With the exception of the buried soil recorded at the north-east end the programme of monitoring revealed that the majority of site had probably been

horizontally truncated by modern construction works as no old ground surfaces or subsoil were present. No features or artefacts of archaeological significance were identified during these monitoring works.
