VERNACULAR BUILDING 34

CAIRNIEBOTTOM, EAST AYRSHIRE: CASE STUDY OF A NINETEENTH- CENTURY SMALLHOLDING

Ross Murray and Bruce Walker

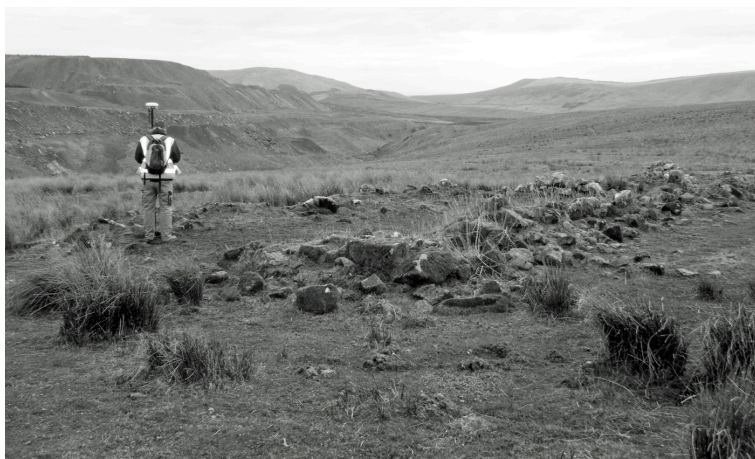
Figure 2. View of Cairniebottom during initial survey, looking south-west.

The survey of Cairniebottom revealed the remains of a low turf-covered building that measured 22.5 by 6.8 metres (74 x 23 ft) externally, with walls roughly 0.7 metre (2 ft 3 in) wide and up to 1 metre (3 ft 3 in) high in places (see fig.2). The building was aligned north-west to south-east, falling to the south-east. Around it was a spread of collapsed stone and turf superstructure. There was an entrance towards the north-west end of the more northerly long wall, and there was a marked change in level in the south-east half of the building, representing a step down. There were also traces here of a central drain. Initial field observations interpreted this south-east half as a possible byre, with the higher north-west part of the building being a small farmhouse.

The building was formed by a low random rubble wall that presumably formed a base for a turf superstructure, given that there were insufficient levels of rubble present around the building to suggest that the walls stood to its full height. The construction of the northern part of the building differed slightly, with the wall containing large orthostats (large stones set upright), while the south-west-facing external wall of the byre had been built with more formal squared rubble.

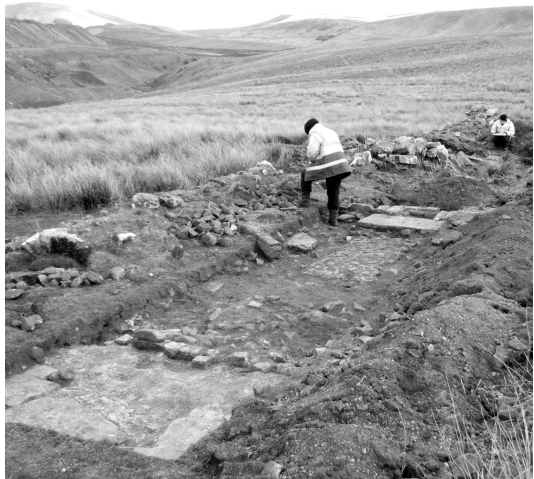
Figure 4.
View of the house end
of Carniebottom,
looking south-west.

farmhouse in order to locate the hearth (if present) and to investigate the drop in level within the building noted during the initial survey. The north-west end of the trench revealed a floor surface, comprising a mixture of large flagstones, lime mortar and cement mortar, which was present to the north of a narrow internal wall. To the south-east of this was a spread of stone rubble likely to be collapse from the adjacent wall (see fig.4).

Beyond the rubble spread was a cobble surface, roughly 2.2 metres (7 ft 2 in) by 1 metre (3 ft 3 in) in extent, which abutted a large rectangular flagstone set next to the end wall of the farmhouse. This wall was 0.7 metre (2 ft 3 in) wide and was constructed of squared rubble bonded with coarse lime mortar and stood to a height of 0.4 metre (1 ft 4 in). Several of the larger stones had tool marks on the surface. Within this end wall was a brick- and stone-built fireplace, 0.6 metre (2 ft) wide and 0.5 metre (1 ft 8 in) deep; the bricks had not been frogged (the indentation on one of the longer faces that reduces the weight of the brick and assists laying and adhesion) and displayed no maker's mark. The drop in elevation, noted in the initial survey, was shown to be where the byre abutted the end wall of the original farmhouse. On the south side of the farmhouse wall, in the byre, was the drain noted in the initial survey. This comprised two parallel lines of large

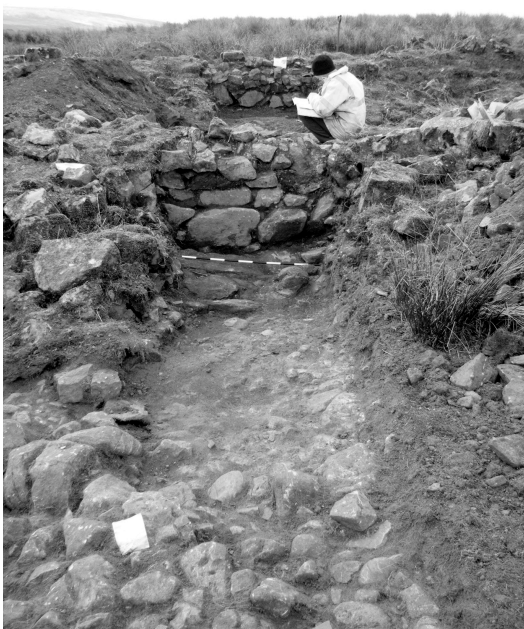
*Figure 5.
View of collapsed enclosure bank
(foreground) and
external wall of
the byre, looking
south-east.*

The trench placed across the putative byre exposed both walls of the building, showing them to be built of random rubble, bonded with rough lime mortar (see fig.5). The south wall stood to a height of 0.8 metre (2 ft 7 in) and was 0.7 metre (2 ft 3 in) wide, with the lower 0.3 metre (1 ft) projecting from the wall face. This was built partially over a stone-lined drain that ran down the outside of the building and had been capped with tightly packed stones. The north wall shared the same random rubble and lime mortar construction, but was narrower with a width of 0.6 metre (2 ft), and stood to a height of 1 metre (3 ft 3 in) in order to compensate for a drop in ground level. Another stone-capped drain was present next to the interior face of this wall. The drain noted in the trench to the north also continued into this part of the byre (see fig.6).

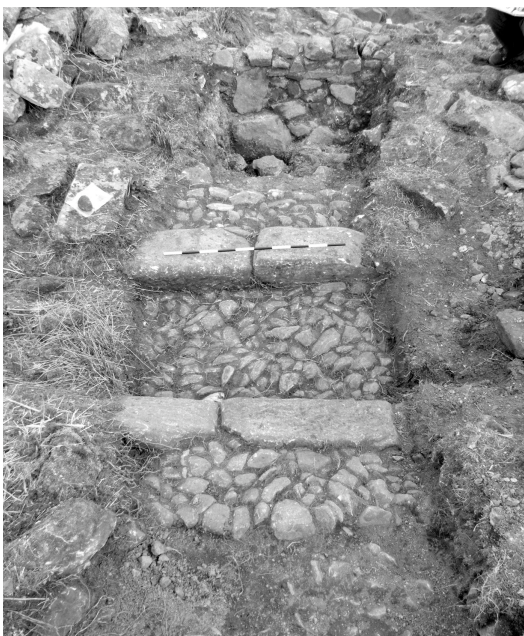
*Figure 6.
View of stone drain in
the centre of the byre.*

rectangular stones flanked on the outside by a 0.4-metre-wide (1 ft 4 in) cobbled strip forming a channel 0.9 metre (3 ft) across and 0.1 metre (4 in) deep. The base of the channel was also lined with cobbles.
