Project Code: TIGL08
Planning Ref No: F/APP/2006/4605
Date of Report: November 2010
Client: Trump International Golf Links

GOLF COURSE & RESORT DEVELOPMENT, MENIE ESTATE, ABERDEENSHIRE

Report on Archaeological Test Pits along lines of deep drains
on the Championship Golf Course

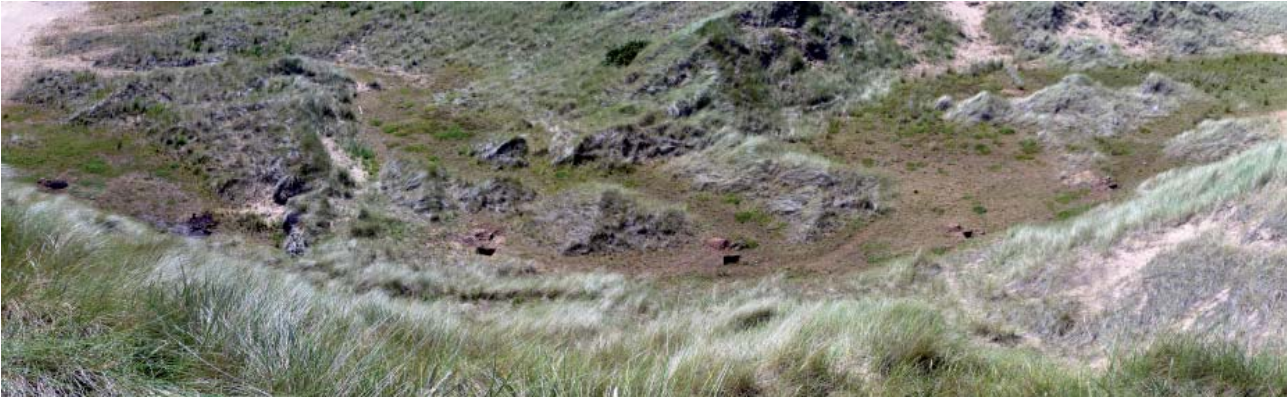
Illus 3

Panoramic view towards test pits TP05–09

The line of DR1 ran from the dune slack up into a blow-out amongst the hind dunes (Illus 2, 3). A total of 17 pits were excavated along the line of DR1 (TP1–17). They were located at a distance of 10m except for TP13 and TP14 that were 33m apart. This was due to the presence of a recent platform that had been built from sand on top of Flint Scatter 2.

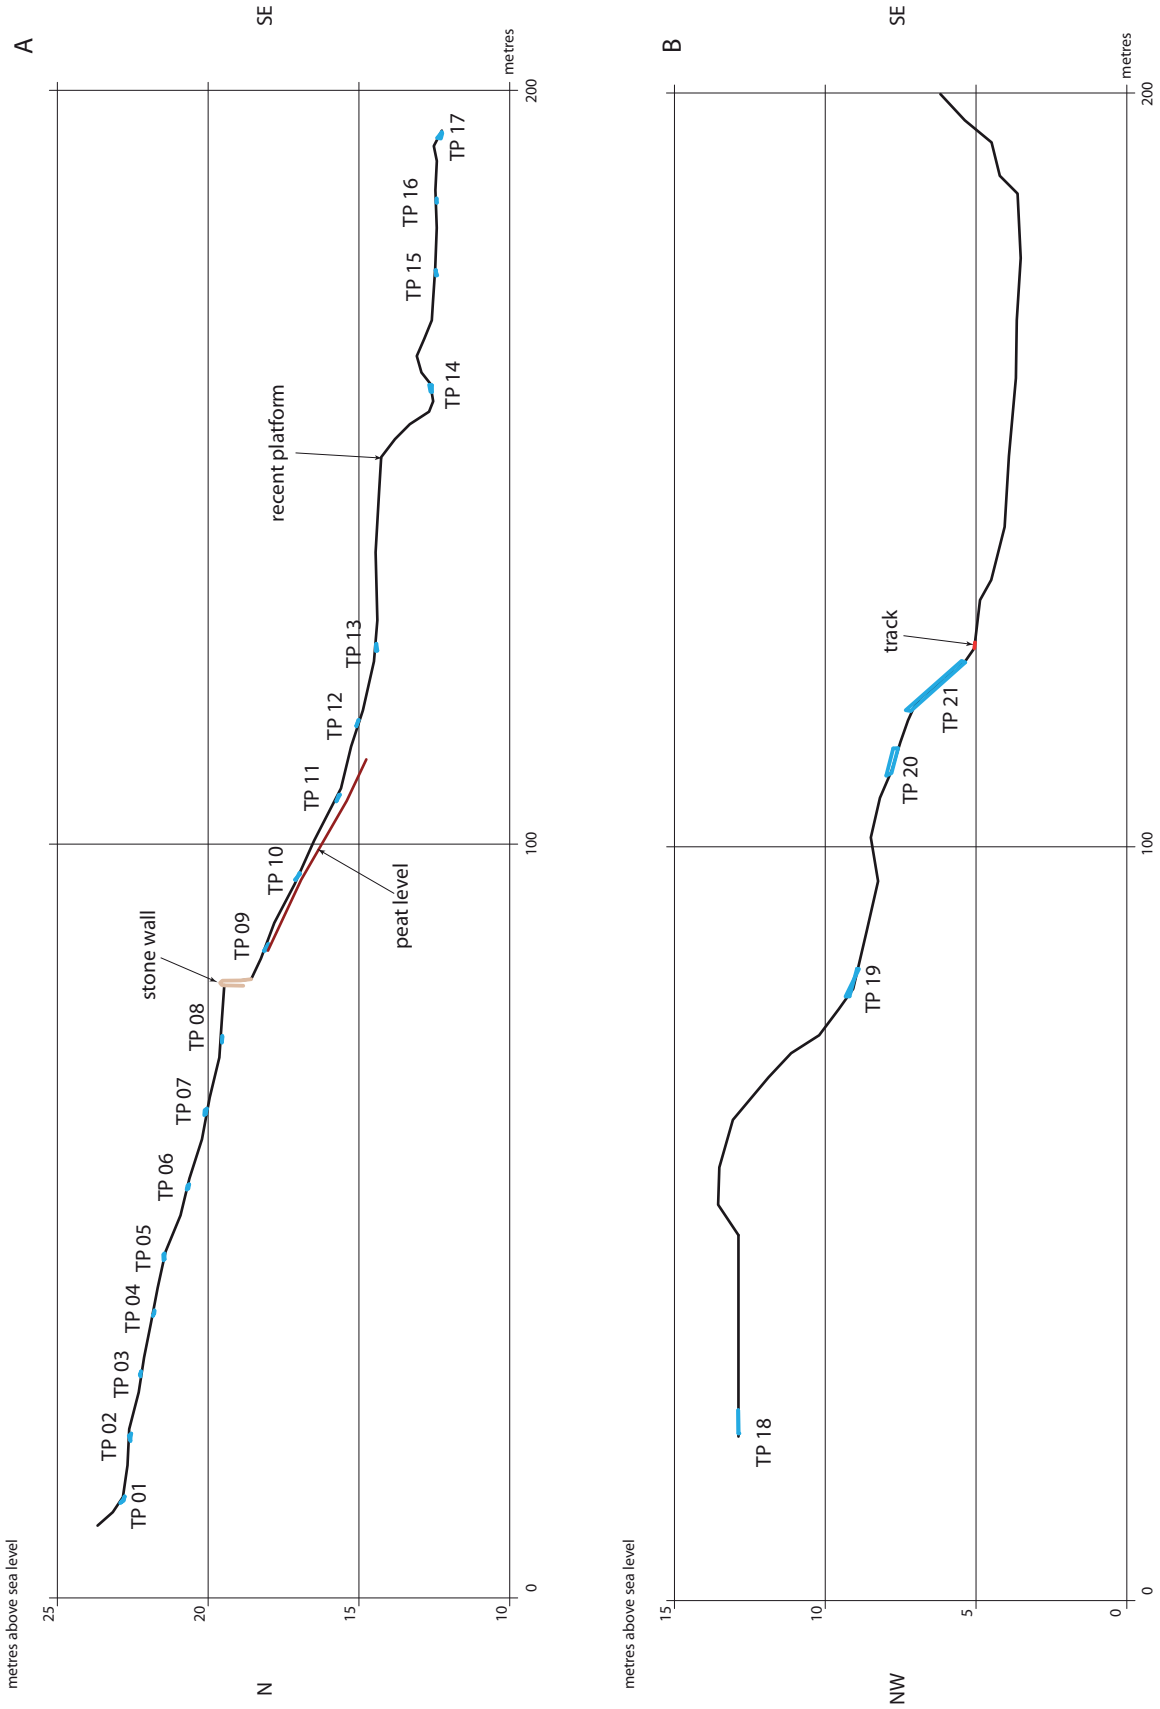
Illus 4
Profile along Drain 1 (A) and Drain 2 (B). Exaggerated vertical scale

Test pits TP09–13 was cut into the steeper slope. A peat horizon representing an old ground surface was recorded in the upper pits. The depth of this horizon increased down the slope as the deposits of windblown sand deepened towards the foot of the slope and was therefore not encountered in the two lower pits (Illus 4a).

Test pit TP21 was cut across the line of a low linear cliff discovered during previous field work (Illus 4b). The trench exposed a section across an old sea-eroded cliff edge cut into grey stony till overlying red sand (Illus 5). In front of the cliff was wedge of eroded clay and stone, below a layer of beach shingles (Illus 6). The entire feature was covered in dune sand. The grey clayey till was also exposed in TP20 some 5m to the north-west.

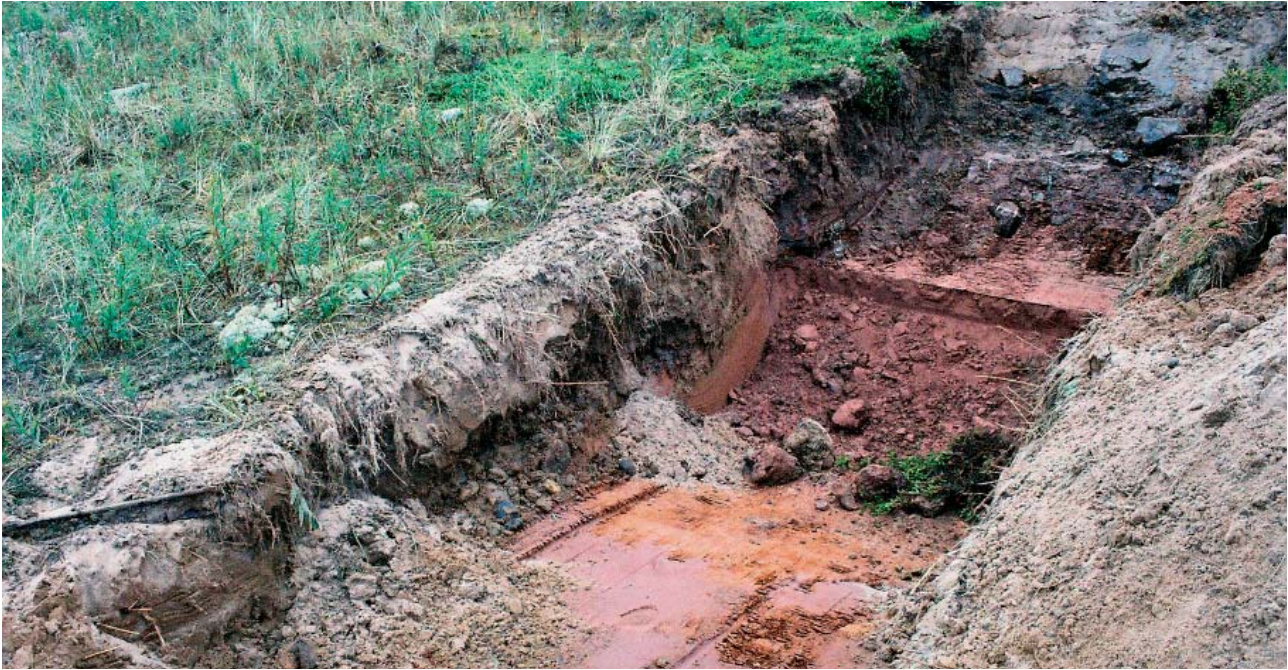
Illus 5
Fossil sea-eroded cliff exposed in test pit 21

Another significant result from this work was the identification of a fossil sea cliff at 5m above the present sea level. The cliff is formed by sea erosion of glacial till overlying red sand. This cliff may have been formed around the post-glacial sea level maximum during the 7th millennium BP (Dalland & Lochrie 2009). The beach shingles at the front of the cliff contained flint nodules presumably washed out of the till which is a likely source of the flint scatters recorded in this area.

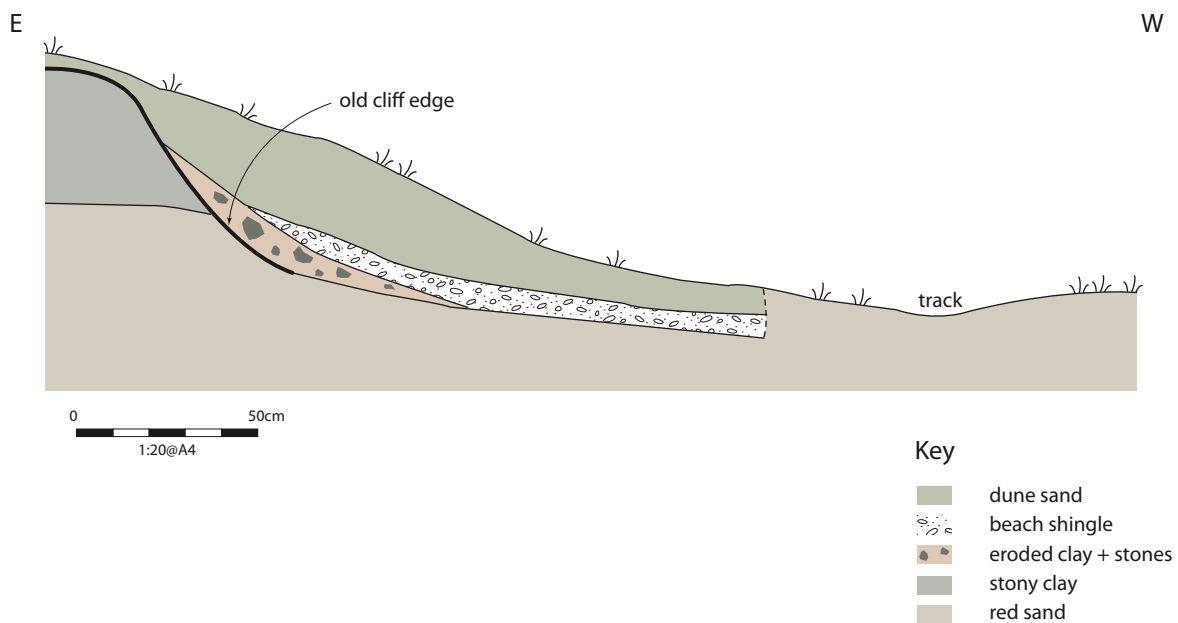
Illus 6
Sketch drawing of profile across sea-eroded cliff exposed in test pit 21

Test pit TP 21
Drain DR 2
Surface Grass and crowberry shrub
Pit depth 1m
Stratigraphy The trench was cut across a low linear break of slope previously identified as a fossil storm beach (Dalland & Lochrie 2009). The sides of the trench were unstable which prevented any detailed recording of the section; however it was possible to record a sketch section showing the main features (Illus 6).
 The profile indicated that the break of slope was formed as wave erosion had formed a low cliff by cutting into subsoil comprising grey stony clay till overlying red sand. In front of the cliff edge was a wedge of eroded clay and stone underlying a layer of rounded beach pebbles. The eroded cliff was covered by a layer of windblown sand.

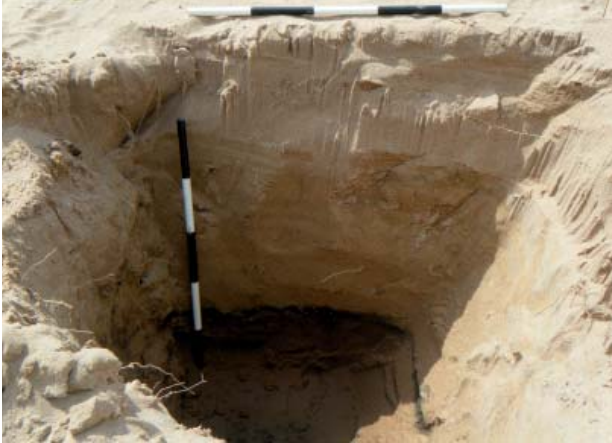
Test pit	TP 01
Drain	DR 1
Surface	No vegetation
Pit depth	0.65m
Stratigraphy	
0–0.5m	–
0.5–0.52m	Dark grey silty sand. Dune stabilization horizon
0.52–0.65m +	Mid yellow–gray fine sand. No inclusions. Probably wind-blown deposit

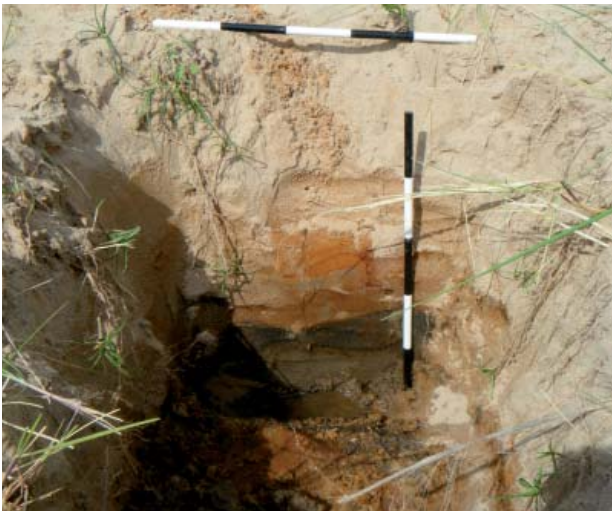
Test pit	TP 02
Drain	DR 1
Surface	Patchy grass – mostly marram grass
Pit depth	0.55m
Stratigraphy	
0–0.4m	Clean wind blown sand, reddish iron pan in lower parts
0.4–0.45m	Dark grey silty sand. Dune stabilization horizon
0.45–0.55m +	Pale grey clean sand. No inclusions

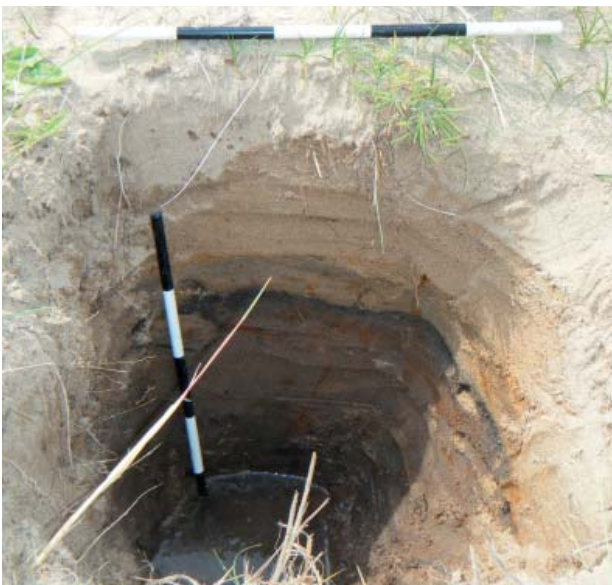
Test pit	TP 03
Drain	DR 1
Surface	Patchy vegetation – mostly marram grass
Pit depth	0.65m
Stratigraphy	
0–0.3m	Clean wind blown sand
0.3–0.32m	Dark grey silty sand. Dune stabilization horizon
0.32–0.65m +	Pale grey clean sand. No inclusions. Probably wind-blown deposit

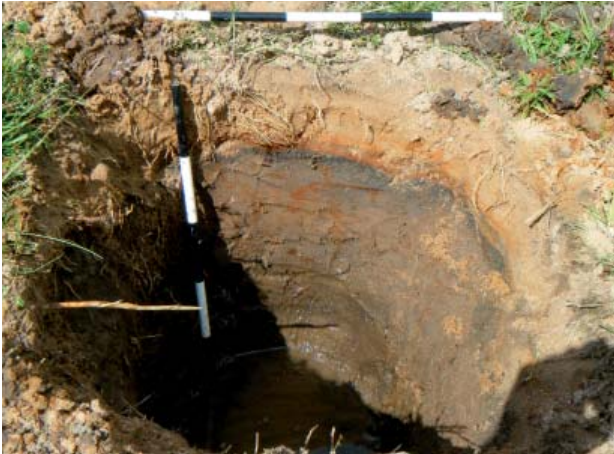
Test pit	TP 04
Drain	DR 1
Surface	Grassy turf
Pit depth	0.5m
Stratigraphy	
0–0.1m	Clean wind blown sand, iron pan at base
0.1–0.12m	Dark grey silty sand. Dune stabilization horizon
0.12–0.5m	Mid grey fine sand. No inclusions
0.5m +	Stony sand – not excavated

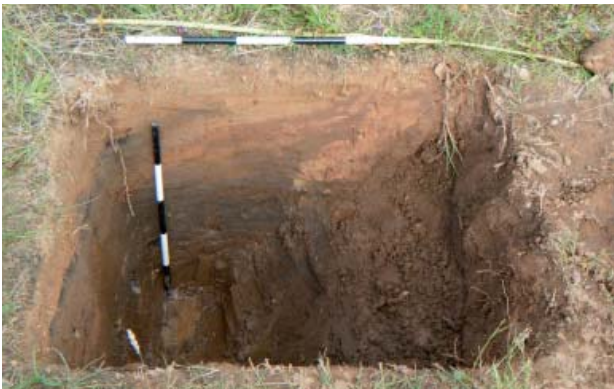
Test pit	TP 05
Drain	DR 1
Surface	Grassy
Pit depth:	0.65m
Stratigraphy	
0–0.2m	Clean sand mixed with patches of clay – looks like redeposited upcast from some cut feature deep enough to disturb clay at base of sequence
0.2–0.5m	Mid grey silty sand. Old ground surface?
0.5–0.65m	Pale brown gritty sand
0.65m +	Pale brown clay

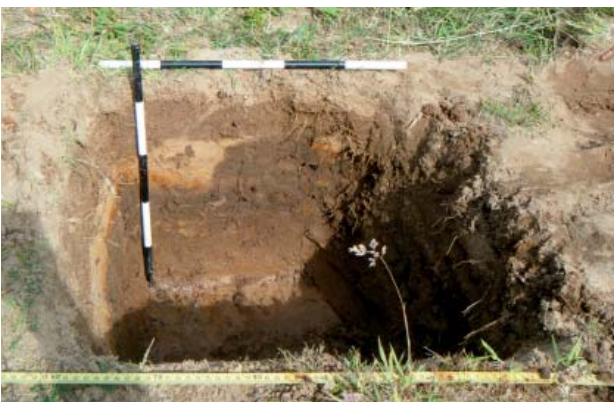
Test pit	TP 06
Drain	DR 1
Surface	Grassy
Pit depth	0.4m
Stratigraphy	
0–0.12m	Pale brown slightly silty sand with occasional small stones
0.12–0.3m	Mid brownish grey silty sand with occasional small stones. Contained one piece of struck flint; SF No 1
0.3–0.4m	Pale brown slightly silty sand with few stones. The sand is quite coarse and gritty – unlike wind-blown dune sand
0.4m +	Stiff pale brown clay. Solid thick layer – not bottomed

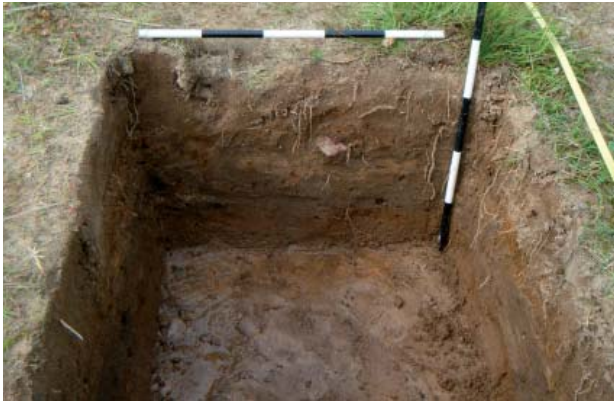
Test pit	TP 07
Drain	DR 1
Surface	Grassy
Pit depth	0.39m
Stratigraphy	
0–0.13m	Pale brown slightly silty sand with occasional small stones
0.13–0.19m	Mixed/mottled slightly silty sand. Pockets of pale sand and patches of iron pan
0.19–0.3m	Mid grey silty sand with occasional small stones. Old ground surface? Contained a piece of struck flint; SF No 2
0.3–0.39m	Pale brown rather coarse, gritty sand
0.39m +	Pale brown stiff clay – not excavated

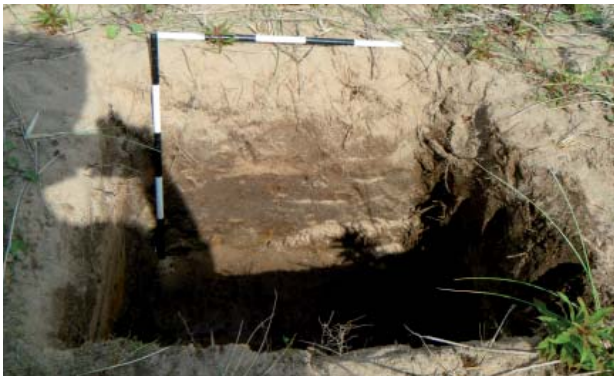
Test pit	TP 08
Drain	DR 1
Surface	Patchy vegetation
Pit depth	0.45m
Stratigraphy	
0–0.25m	Pale brown slightly silty sand, rather patchy. Gully filled with clean sand running across pit – possibly an erosion gully
0.25–0.4m	Mid grey silty sand. Old ground surface? Contained a piece of struck flint; SF No 3
0.4–0.45m +	Coarse gritty pale brown silty sand

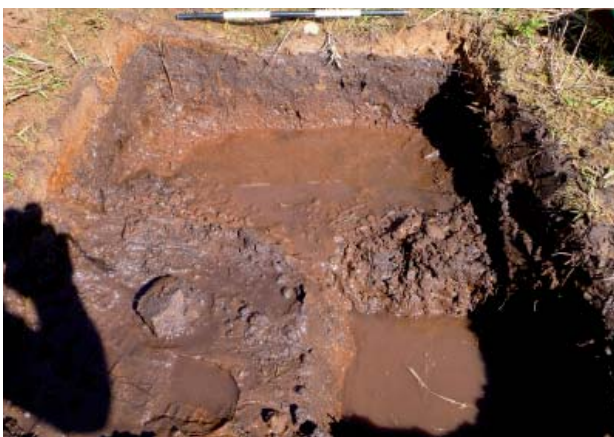
Test pit	TP 09
Drain	DR 1
Surface	Grassy
Pit depth	0.4m
Stratigraphy	
0–0.02m	Vegetation and root mat
0.02–0.07m	Fine sand with occasional small stones. The context was sampled (20l) and sieved on site. The unsorted residue was retained; SF No 14
0.07–0.2m	Dark grey silty sand with moderate small stones. Same as the buried soil seen further down the slope (TP 10, 11, 12), but as the peat here is not protected by sand and the iron pan being much shallower, so peat has all oxidized. The context was sampled (40l) and sieved on site. The unsorted residue was retained; SF No 15
0.2–0.4m +	Pale brown clayey sand – subsoil

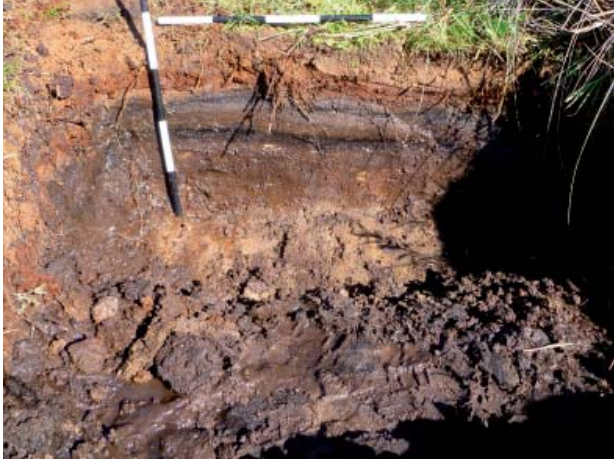
Test pit	TP 10
Drain	DR 1
Surface	Grassy
Pit depth	0.34m
Stratigraphy	
0–0.02m	–
0.02–0.05m	Soft sand with occasional small stones. The context was sampled (20l) and sieved on site. The unsorted residue was retained; SF No 12
0.05m	Iron pan
0.05–0.15m	Mid grey fine sand with organic lenses
0.15–0.34m	Solid peat at top, grading into coarse sandy / gravely peat at base. The context was sampled (20l) and sieved on site. The unsorted residue was retained; SF No 13
0.34m +	Tough pale brown sandy clay – natural subsoil beneath buried soil

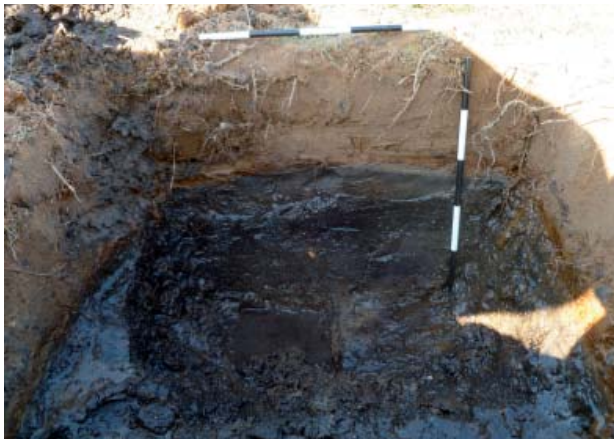
Test pit	TP 11
Drain	DR 1
Surface	Grassy
Pit depth	0.6m
Stratigraphy	
0–0.02m	Vegetation and root mat
0.02–0.05m	Fine wind blown sand with occasional small stones. The context was sampled (60l) and sieved on site. The unsorted residue was retained; SF No 10
0.05–0.2m	Fine wind blown sand
0.2m	Iron pan
0.2–0.3m	Mid grey sand with organic patches
0.3–0.5m	Peat. Grades from solid, firm highly organic peat at top, to sandy / gravely silt at base. Buried soil. The context was sampled (40l) and sieved on site. The unsorted residue was retained; SF No 11
0.5–0.6m +	Firm clayey sand – subsoil relating to peaty soil profile above

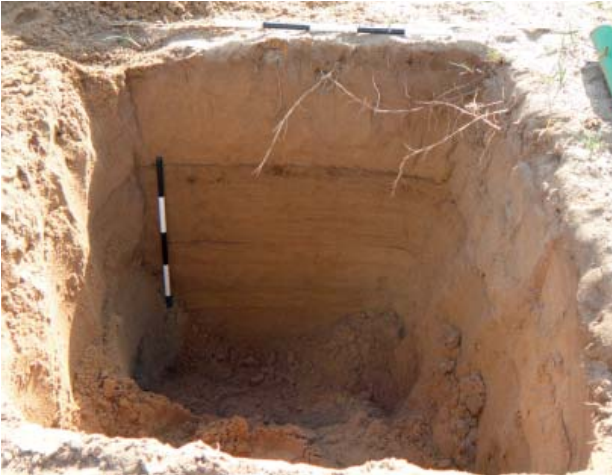
Test pit	TP 12
Drain	DR 1
Surface	No vegetation
Pit depth	0.9m
Stratigraphy	
0–0.05m	Soft sand with occasional small stones. The context was sampled (80l) and sieved on site. The unsorted residue was retained; SF No 8
0.05–0.29m	Soft fine sand. No inclusions
0.29–0.3m	Thin dark silty / stony line – sort of crust with moderate small stones. The context was sampled (20l) and sieved on site. The unsorted residue was retained; SF No 9
0.3–0.9m +	Fine sand with frequent dark silty laminae. No stones at all

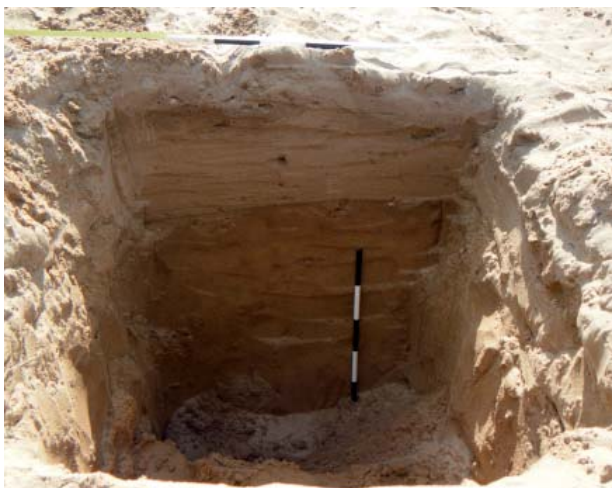
Test pit	TP 13
Drain	DR 1
Surface	No vegetation
Pit depth	1m
Stratigraphy	
0–0.15m	Fine sand with occasional small stones. The context was sampled (80l) and sieved on site. The unsorted residue was retained; SF No 6
0.15–0.3m	Fine sand with no inclusions
0.3–0.35m	Mid brown silty sand. Appears as a crust above a thin stony layer. The context was sampled (20l) and sieved on site. The unsorted residue was retained; SF No 7
0.35–1m +	Fine sand, no inclusions

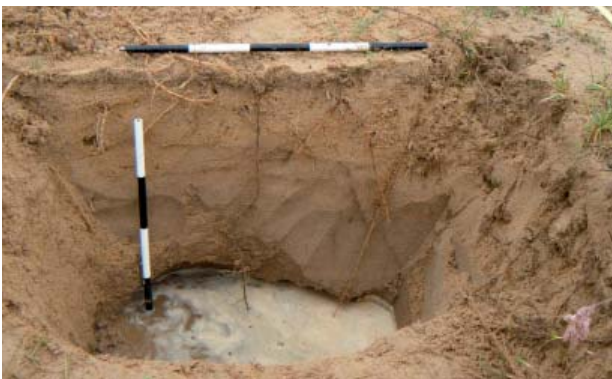
Test pit	TP 14
Drain	DR 1
Surface	Sparse vegetation
Pit depth	1m
Stratigraphy	
0–0.03m	Root mat. Some organic material
0.03–0.15m	Pale fine sand with occasional stones
0.15–1m +	Fine wind blown sand

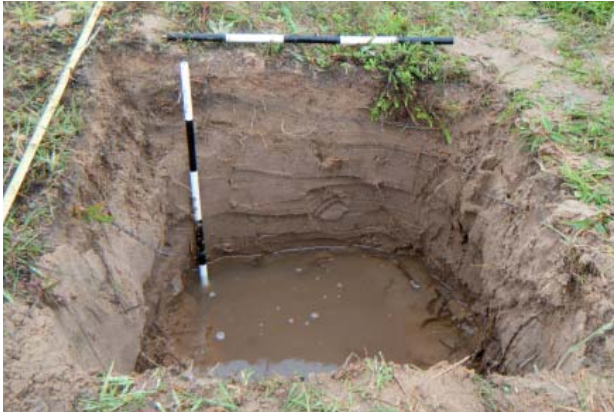
Test pit TP 15
Drain DR 1
Surface Sparse vegetation
Pit depth 0.5m
Stratigraphy
 0–0.09m Laminated sand with organic lenses and occasional very small stones. Root penetration
 0.09–0.13m Clean fine sand. No inclusions. Very occasional small stones
 0.13–0.5m + Clean wind blown sand

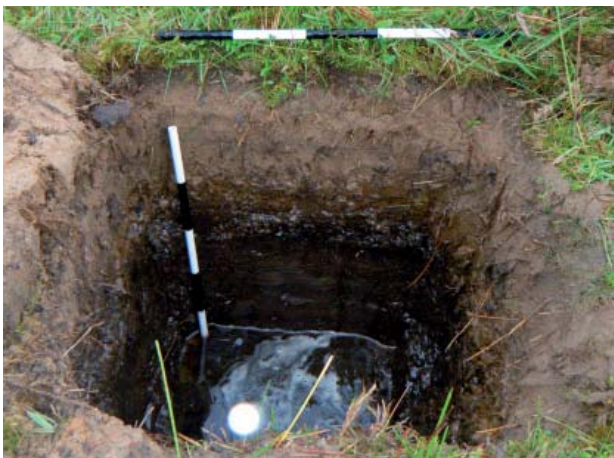
Test pit TP 16
Drain DR 1
Surface Grassy
Pit depth 0.62m
Stratigraphy
 0–0.25m Fine sand – root mat on top
 0.25–0.35m Peat
 0.35–0.48m Laminated sand with organic lenses
 0.48–0.57m Peat
 0.57–0.62m + Mid brown sand

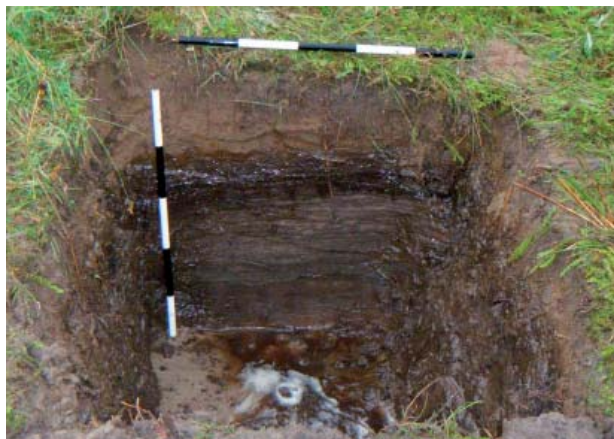
Test pit TP 17
Drain DR 1
Surface Grassy
Pit depth 0.6m
Stratigraphy
 0–0.25m Fine sand - root mat on top
 0.25–0.36m Peat
 0.36–0.46m Laminated sand and peaty material
 0.46–0.6m Peat
 0.6m + Clean wind blown sand

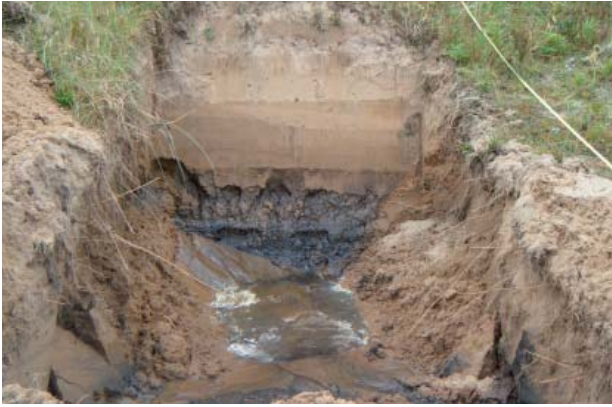
Test pit TP 19
Drain DR 2
Surface Grassy
Pit depth 1.2m
Stratigraphy
 0–1m Wind blown sand
 1m–1.2m + Dark grey sandy silt.
Comment Due to collapsing sides the stratigraphy was recorded from the side of the trench

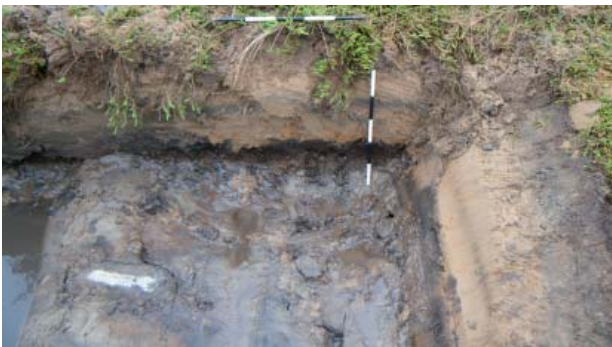
Test pit TP 20
Drain DR 2
Surface Grass and crowberry shrub
Pit depth 0.5m
Stratigraphy
 0–0.4m –
 0.40–0.5m Dark grey silty sand – Old ground surface?
 0.5m + Clay till containing moderate large stones

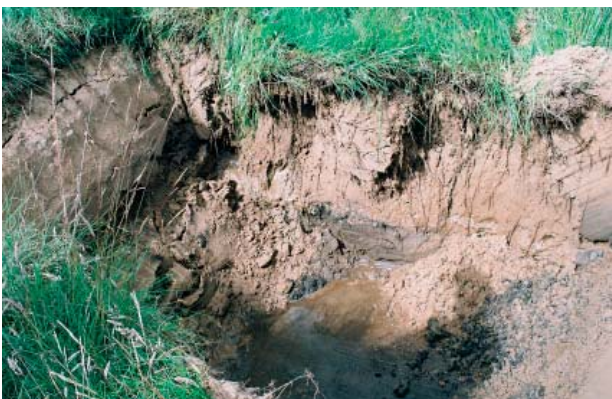
Test pit TP 22
Drain DR 3
Surface Grassy
Pit depth 1.6m
Stratigraphy
 0–1.1m Wind blown sand
 1.1–1.3m Dark grey sand (due to organic content?)
 1.3–1.6m + Yellow sand
Comment Due to collapsing sides the stratigraphy was recorded from the side of the trench

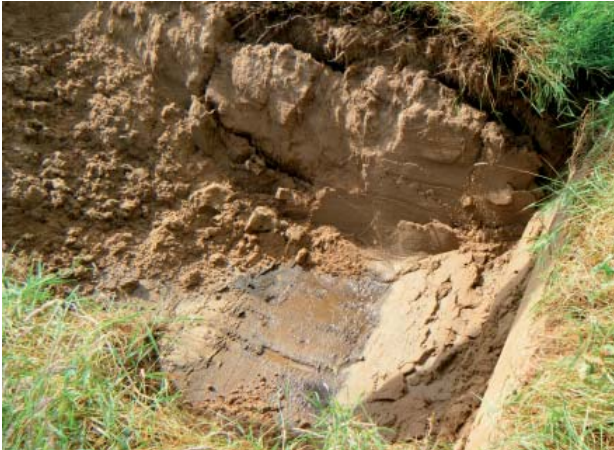
Test pit TP 23
Drain DR 3
Surface Grassy
Pit depth 1.2m
Stratigraphy
 0–1.2m Wind blown sand
 1.2m + –
Comment Due to collapsing sides the stratigraphy was recorded from the side of the trench

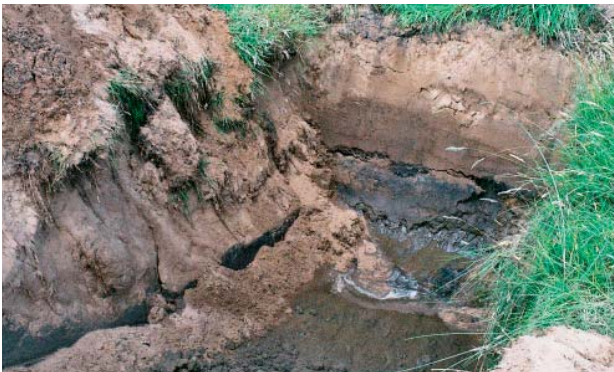
Test pit TP 24
Drain DR 3
Surface Grassy
Pit depth 1.5m
Stratigraphy
 0–0.1m Root mat
 0.1–1m Sand
 1–1.2m Black organic sandy layer
 1.2–1.5m + Dark grey sand
Comment Due to collapsing sides the stratigraphy was recorded from the side of the trench

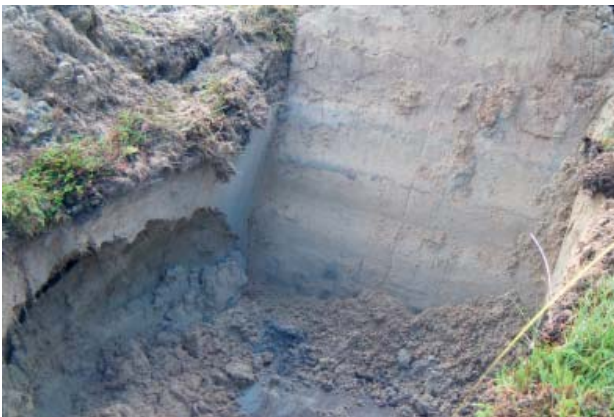
Test pit TP 25
Drain DR 3
Surface Grass and crowberry shrub
Pit depth 1.4m
Stratigraphy
 0–0.1m Root mat
 0.1–1.2m Fine windblown sand
 1.2–1.4m Mid grey sand
 1.4m + –
Comment Due to collapsing sides the stratigraphy was recorded from the side of the trench

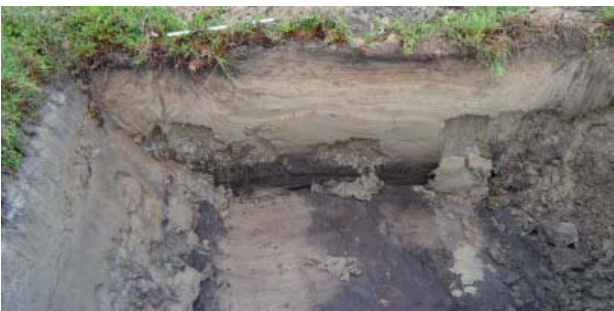
Test pit TP 26
Drain DR 3
Surface Grass and crowberry shrub
Pit depth 0.9m
Stratigraphy
 0–0.1m Vegetation, root mat
 0.1–0.7m Fine wind blown sand – no inclusions
 0.7–0.9m Peat
 0.9m + –
Comment Due to collapsing sides the stratigraphy was recorded from the side of the trench

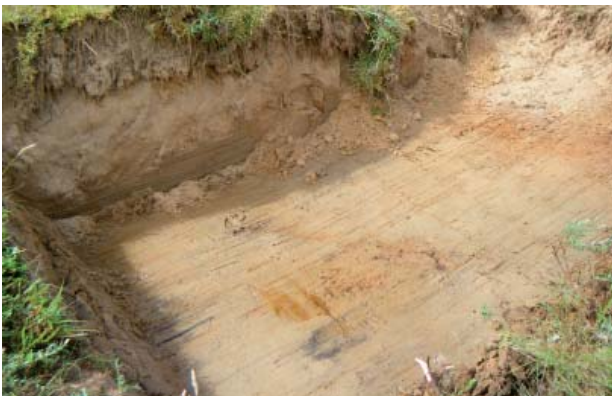
Test pit TP 28
Drain DR 4
Surface Grass and crowberry shrub
Pit depth 0.7m
Stratigraphy
 0–0.1m Vegetation and root mat
 0.1–0.7m + Sand
Comment Due to flooding, the pit had to be abandoned at 0.7m

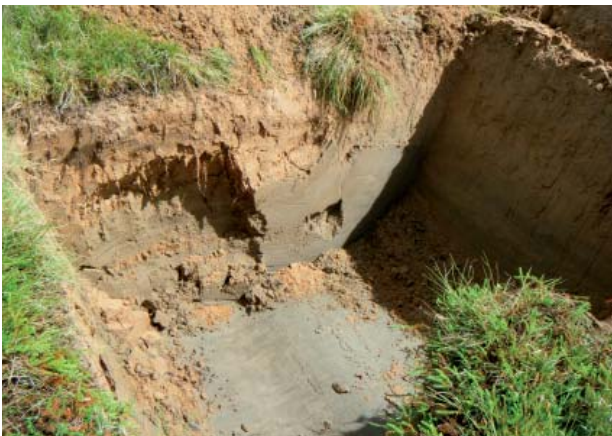
Test pit TP 29
Drain DR 4
Surface Grass and crowberry shrub
Pit depth 1.4m
Stratigraphy
 0.1–0.25m Sand
 0.25–0.35m Brown sand
 0.35–0.5m Yellow fine sand
 0.5–1.4m + Grey sand

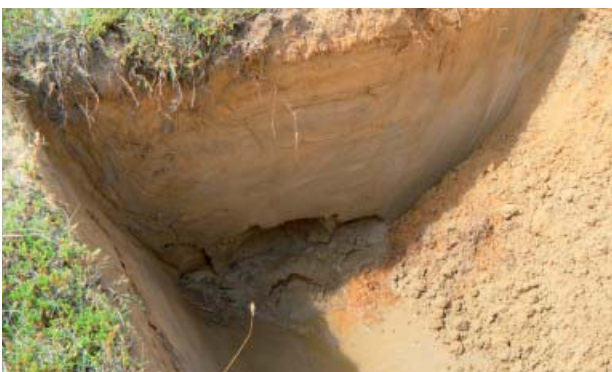
Test pit TP 30
Drain DR 5
Surface Grass and crowberry shrub
Pit depth 1.3m
Stratigraphy
 0.1–1.3m + Fine sand.
Comment Due to collapsing sides the stratigraphy was recorded from the side of the trench

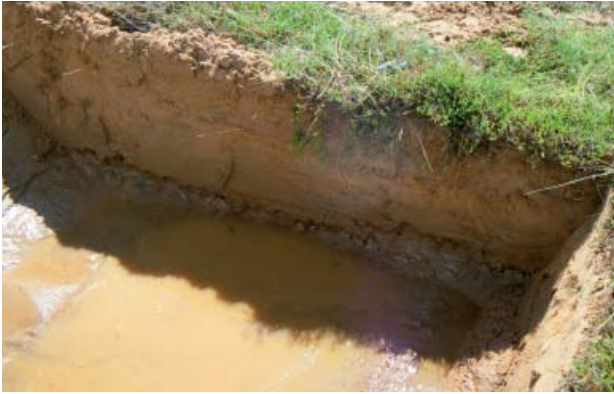
Test pit TP 31
Drain DR 5
Surface Grass and crowberry shrub
Pit depth 0.6m
Stratigraphy
 0–0.1m Vegetation and root mat
 0.1–0.6m Fine sand
 0.6m + –

The fieldwork also recorded the presence of flints outwith the area previously identified from surface finds. The two cores retrieved from test pit TP31 were found in a layer below 0.6m of windblown sand. This find indicates that there could be further flint scatters in the area that are currently buried below windblown sand and thus not visible on the surface. All flints recorded during this fieldwork did not differ significantly from flints retrieved from this area previously (Dalland & Lochrie 2009).

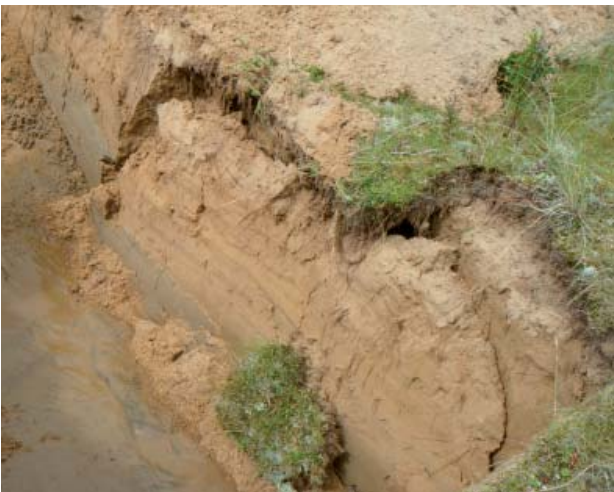
Test pit TP 32
Drain DR 5
Surface Grass
Pit depth 1.3m
Stratigraphy
 0.1–1.3m + Fine sand – no stones
Comment Due to collapsing sides the stratigraphy was recorded from the side of the trench

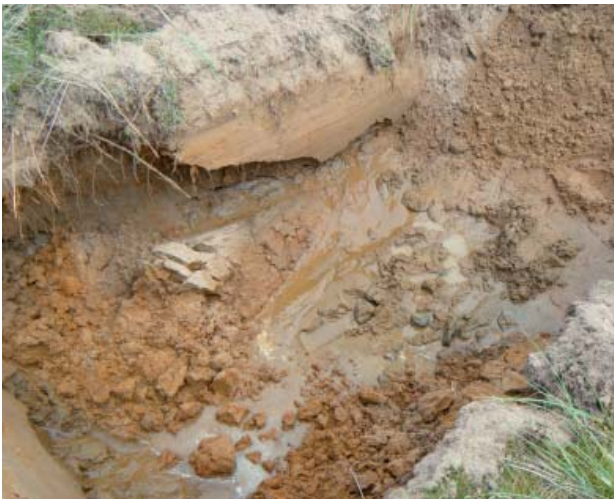
Test pit TP 33
Drain DR 5
Surface Grassy
Pit depth 0.9m
Stratigraphy
 0.1–0.9m Sand
 at 0.9m
Comment Due to collapsing sides the stratigraphy was recorded from the side of the trench

A possible drain was seen in pit TP33 comprising a discrete band of beach pebbles running diagonally across the pit at 0.9m below the surface.

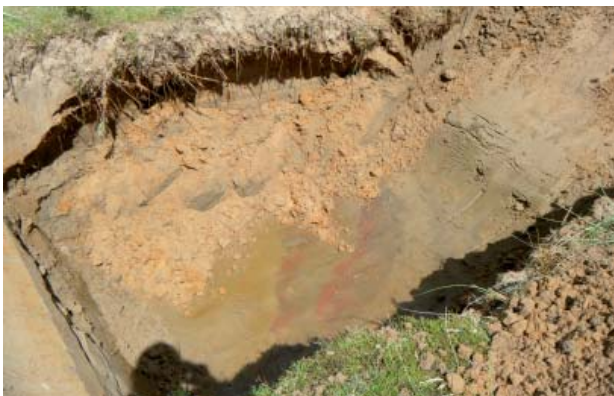
Test pit TP 34
Drain DR 5
Surface Grass
Pit depth 1m
Stratigraphy
 0–0.1m Vegetation and root mat
 0.1–1m + Sand
Comment Due to collapsing sides the stratigraphy was recorded from the side of the trench
