# SKAILL FARM, WESTNESS, ROUSAY, ORKNEY:

A MEASURED SURVEY OF A  
19TH CENTURY FARMSTEAD

Piers Dixon

2019

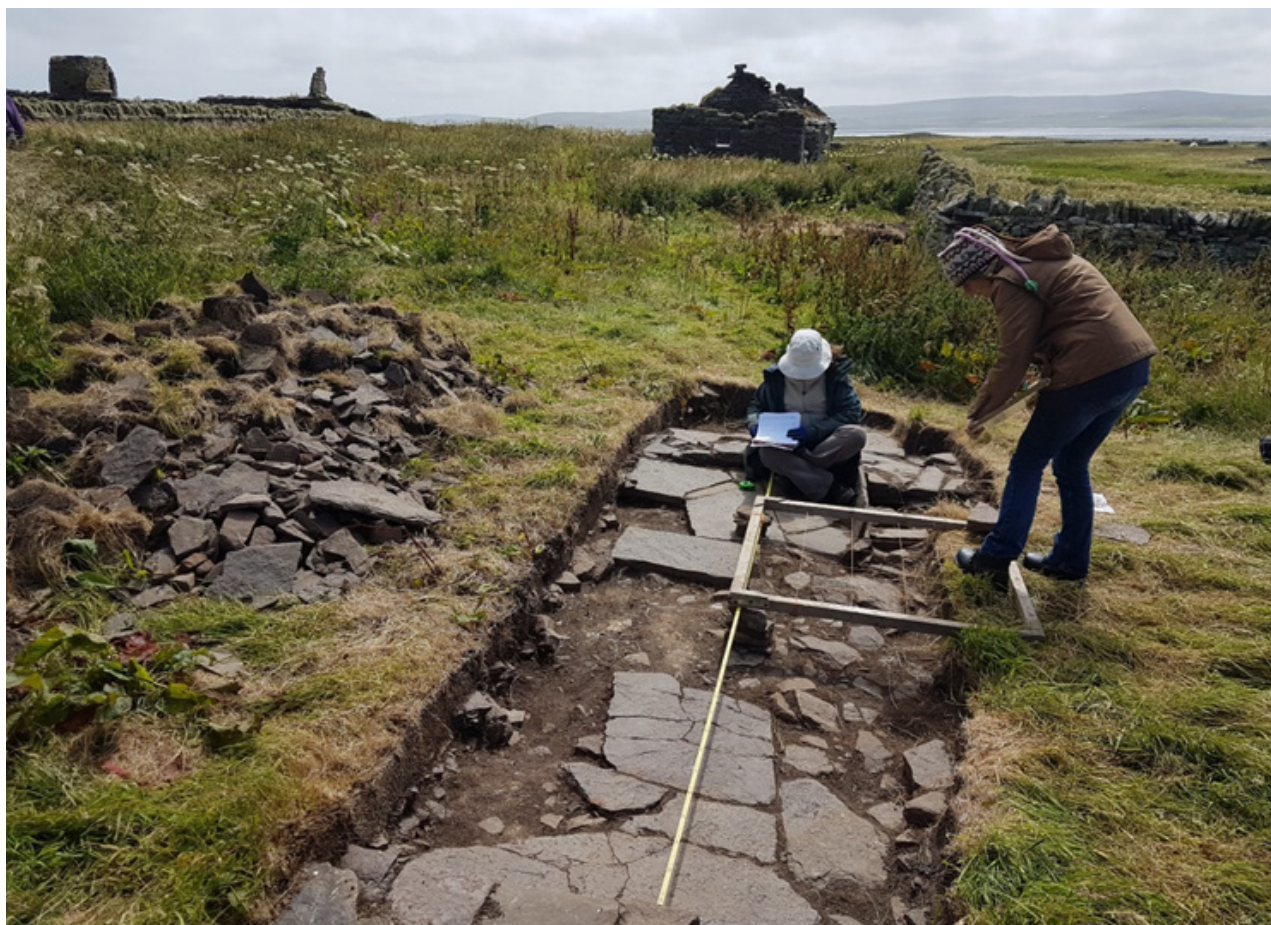
Illus 3. Excavation across the kiln-barn in 2017, the exposed paving probably belonging to a winnowing floor.  
© UHI Archaeology Institute.

About 35m to the north are the footings of a kiln-barn (C) with a pot at its east end measuring about 1.8m in diameter within a wall 1m in thickness by 0.5m in height. The grass-grown footings of the rest of the building extend 15m downslope to the west and contain three compartments. A trench excavated across the northernmost by UHI in 2017 (Illus 3) revealed a flagstone floor between two parallel stone walls (Lee et al. 2017, 146). Another possible building (D), its walls reduced to grass-grown banks, is situated 10m to the west. Either this structure was intentionally open-ended on the south-west or this end has been truncated – perhaps removed when the adjacent stone walls associated with the later period of occupation, were built.

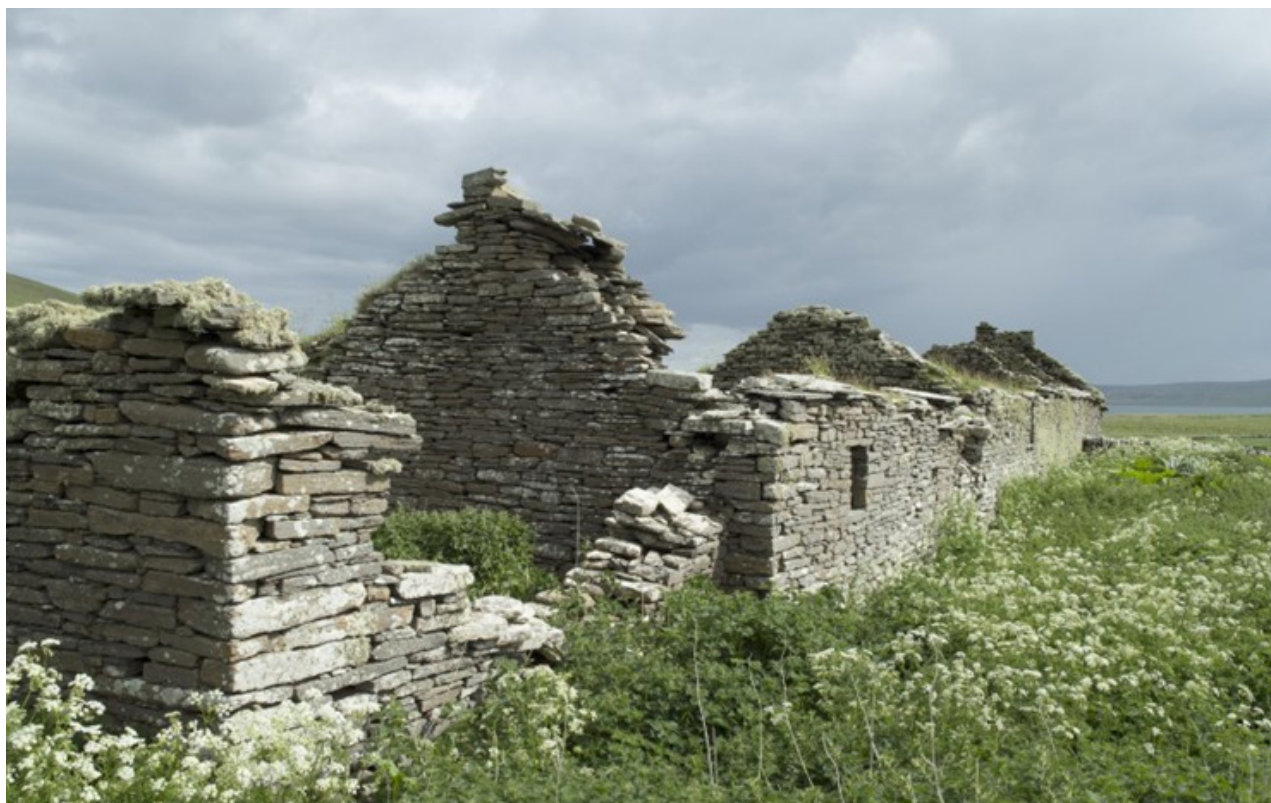
Illus 5. Farmhouse from the north-west showing the main phases of construction. DP256459.

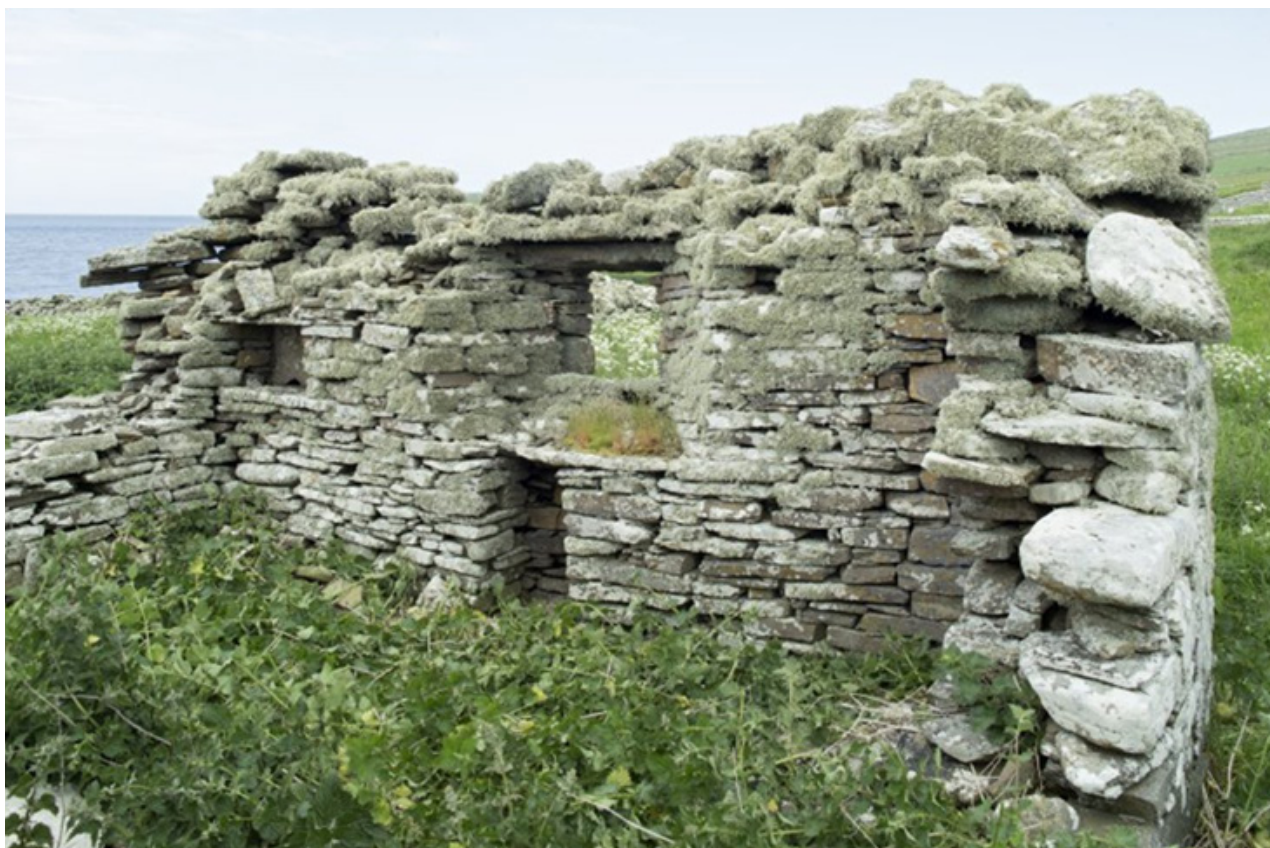
Illus 6. View from south-east of the inside face of the north wall of the dairy that is attached to the north end of the farmhouse. Like all the windows in the range, the one shown here has a wide internal splay, and the small ambry or niche to its left is but one of a number throughout the building. The possible cheese press under the window sill is an unusual but not unknown feature of rural buildings of this date. DPI51832.

is a recess that may have contained a cheese press (Illus 6). It measures 0.4m in width by 0.35m in depth and 0.75m in height. Similar recesses containing presses may be found in farm-buildings of 18th and 19th century date in other parts of Scotland (e.g. East Eninteer, Aberdeenshire (Canmore ID 178522) or The Hill, Ayrshire (Canmore ID 233945)). Running along the entire length of the east side of the building is a terrace, 2m-3m in breadth, which has been cut into the natural slope on the east. Adjacent to this terrace and opposite the centre of the range is the site of a possible midden, marked by a rectangular hollow measuring 3.5m from north to south by 2m transversely. Excavations by UHI in 2016 revealed evidence for an earlier phase of farmhouse parallel and to the west of the surviving range, with Norse structures below this on a different, east to west, alignment (Lee et al. 2016).

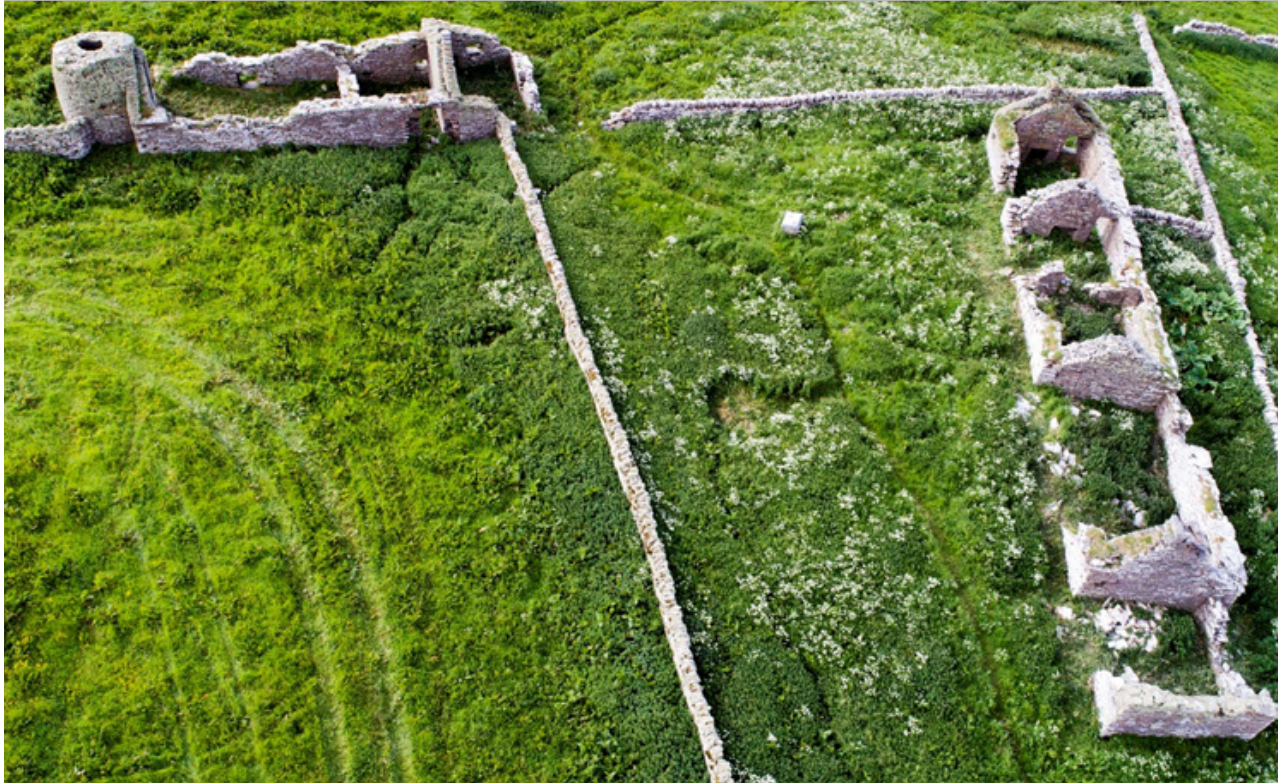
Illus 7. An oblique aerial image taken from the west by a UAV, showing the relationship of the two buildings that comprised the mid-19th century farmstead. DP255131.

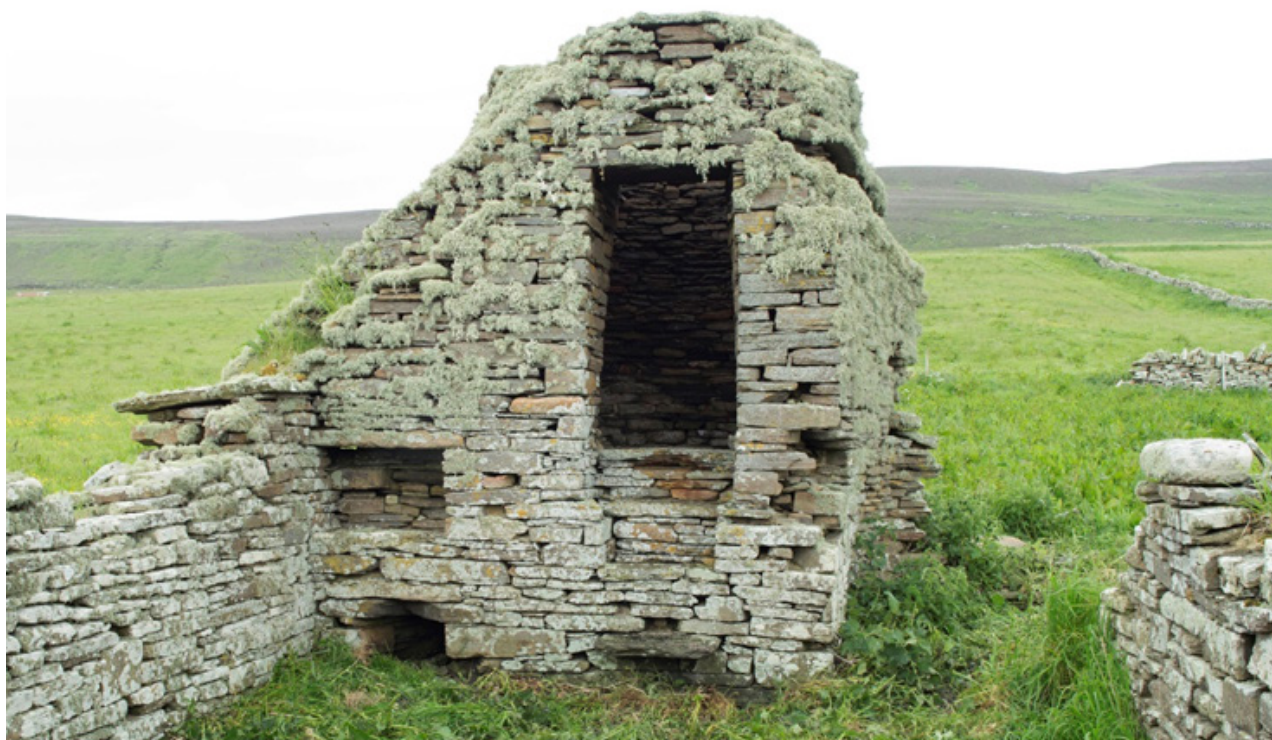
Illus 9. View from west of the east end of the kiln barn, showing the flue (bottom left) with an ambry (possible peat-store) above and the entrance into the interior of the kiln. The grain-store stood immediately to the right of the kiln, its walls now reduced to footings. DP256441.

The kiln measures up to 1.8m in diameter within walls 0.6m thick and its chimney stands to a height of 3.3m above ground-level. However, it has evidently lost a few courses off its top. Rubble within the bottom of the bowl will account for some of the missing courses but it is probably the case that, like numerous similar structures in Orkney and Caithness, the upper, narrowest, part of the chimney was made of turf, now dissipated by the wind and rain. There is a ledge (0.1m wide) that once supported a drying floor 0.9m above the rubble infill in the base of the kiln. Additional support was provided by a timber beam that spanned the void between the entrance to the kiln and its east side, where the end of the beam was secured within in a socket in the ledge. Access up into the kiln was from the interior of the barn via four steps in an opening 0.7m wide, 2m high on its outside but only 1.3m high where it met the inner face of the bowl (Illus 8 & 9). On the south side of the kiln, just above the level of the drying floor, a chute 0.25m wide allowed dried grain to be transferred directly into the grain store. A narrow flue runs north-west from the base of the kiln to the location of the fireplace in the north-east corner of the barn above which is an ambry that may have been used to store peat. The dairy is an addition to the kiln-barn, its north-east corner abutting the north-west corner of the earlier structure and its east wall being bonded in to the barn's south-west corner. A row of joist sockets with a drip-course above in the external face of the west gable of the barn shows that the roof of the dairy was a lean-to construction. Access to the interior was via a doorway at the west end of the north side and there was a window in the middle of both the west and south sides, the former situated over a drain which ran out of the building beneath it. In the south wall there are three ambries, stacked one above another, in the east corner and a tall, narrow cheese press is situated at floor level between them and the window (Illus 10).

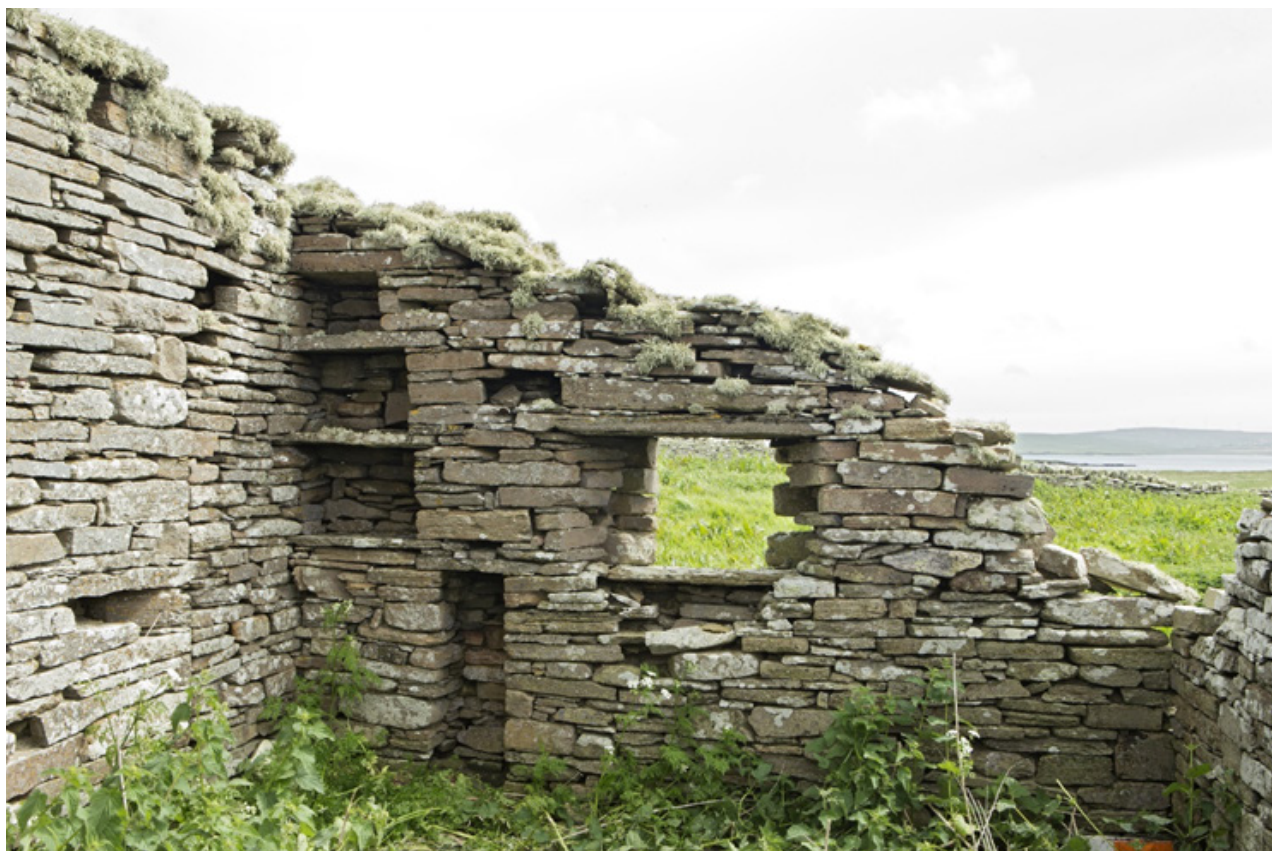
Illus 10. View from north of the stacked shelving, cheese-press and window in the south wall of the dairy. DP256478.
