Project Code: PFHO08
Planning Application Ref No: IN-08-702
Date of report: April 2010
Client: Tulloch Homes Ltd

SUDS POND AND ASSOCIATED WORKS AT PARKS FARM, INVERNESS

Results of an Archaeological Evaluation

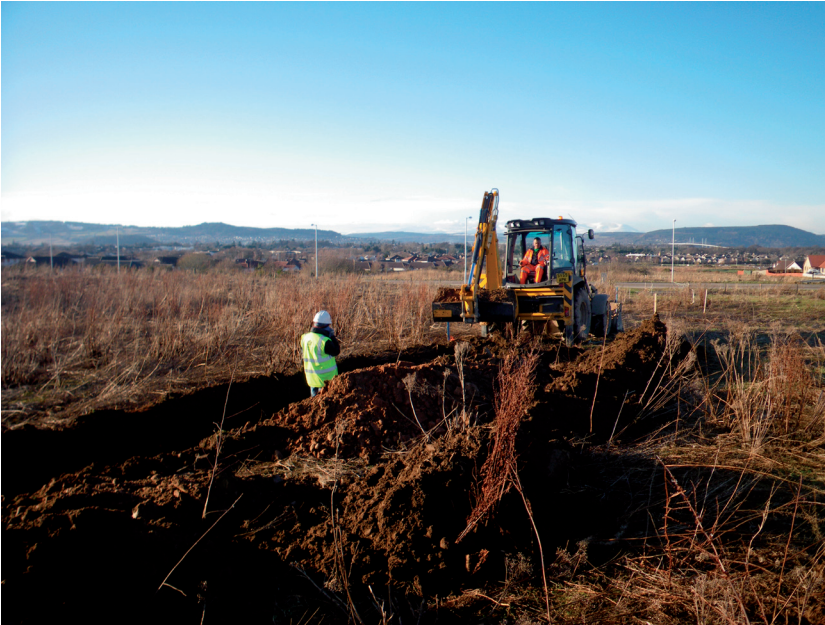
Illus 3
Excavating trench 2

All excavation was undertaken by a mechanical excavator equipped with a 1.80m flat-bladed ditching bucket, working under the direct guidance of an archaeologist (See Illus 3).

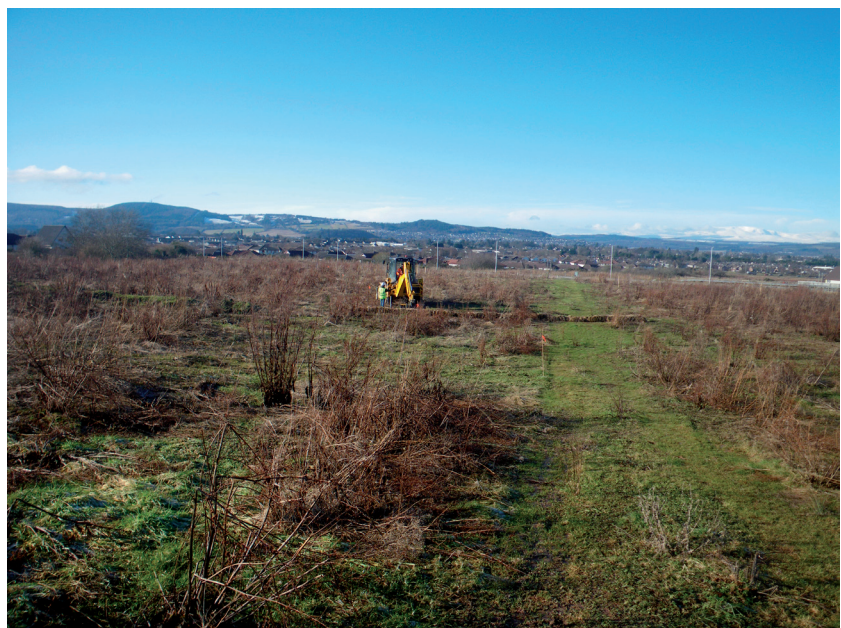
Illus 4
Area of evaluation

Six trenches were excavated, two along the course of the proposed storm drainage and the remaining four, targeted on the area of the SUDS Pond

(Illus 4). Full descriptions of each trench can be found in Appendix 1. Results are summarized below.

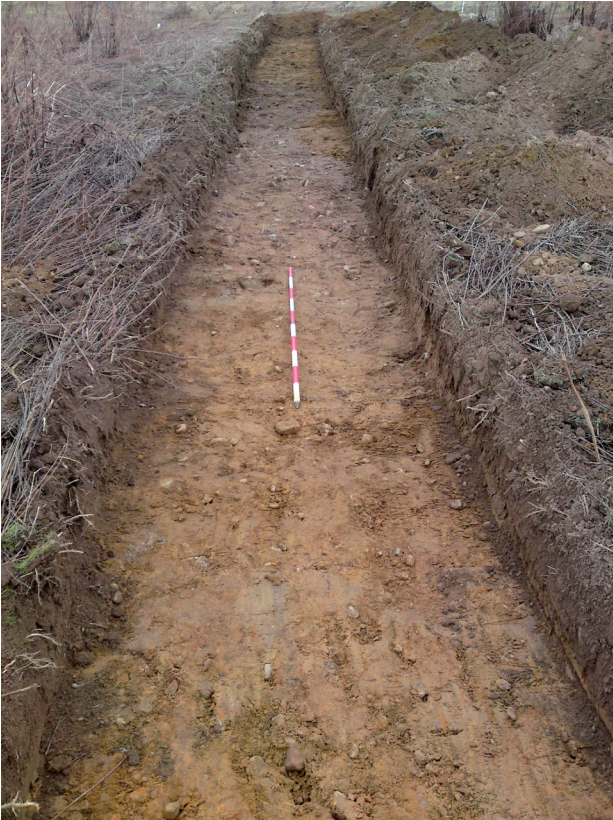
Illus 5

A deposit of loose medium brown sand with pebble inclusions was seen in trenches 3, 4 and 5 and had a maximum width of 5m. After investigation, this deposit was interpreted as natural in origin and most likely evidence of a former stream bed. (Illus 5). Ceramic field drains were present within these trenches, orientated in various directions. No archaeological features or finds were present.

Post excavation shot of trench 4 showing evidence of stream bed
