# PETROL STATION WEST OF CROALL BRYSON & CO PINNACLEHILL INDUSTRIAL ESTATE, KELSO

*Archaeological Evaluation*

*for Kier Scotland on behalf of Sainsbury's*

*April 2011*

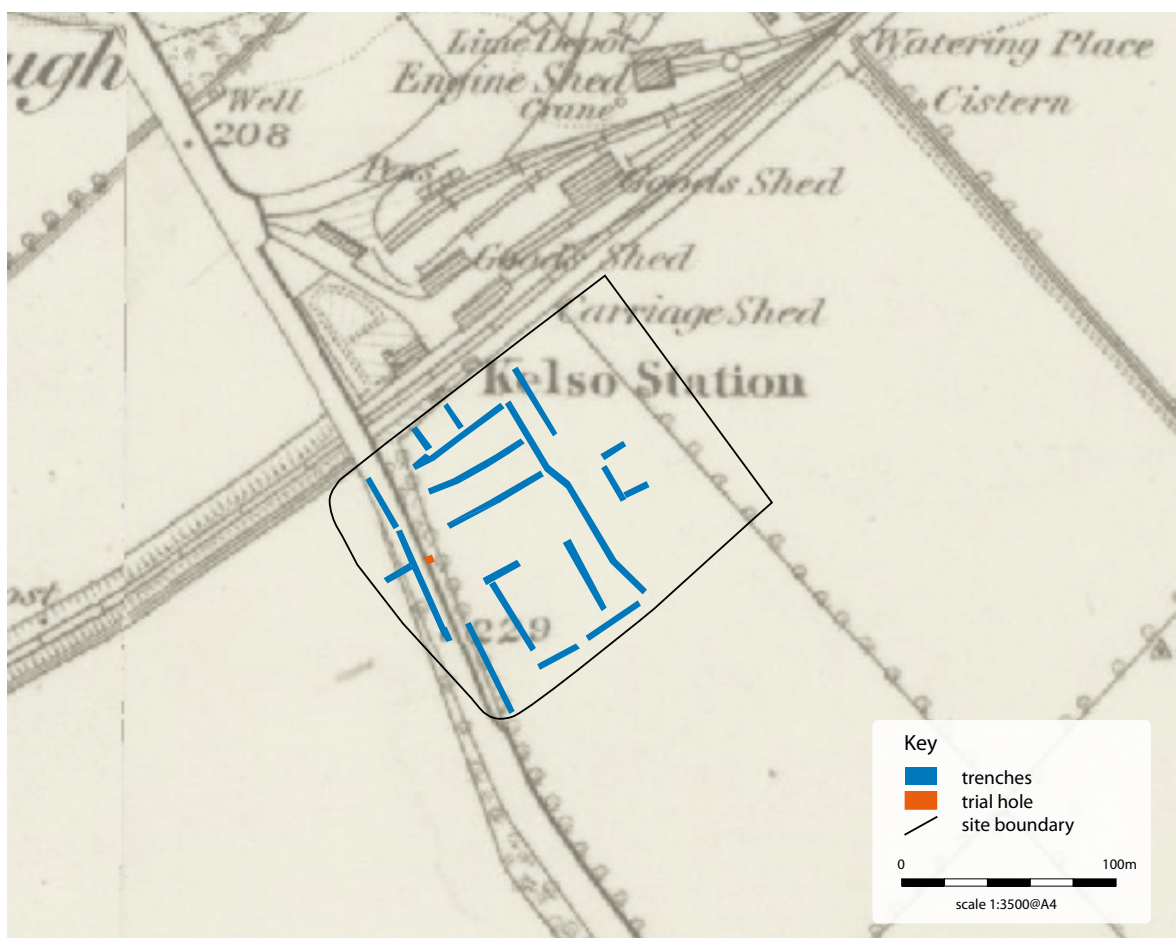
**Illus 3**  
OS map 1863

The bank at the west of site is the remains of the old station road leading up to a bridge over the railway line. The line of this and the location of the trenches can be seen on the 1st edition Ordnance Survey map (Illus 3). The trenches excavated through this mound show that it was constructed of redeposited natural sands and clays. The old road surface was not surviving but the large amount of tarmac and concrete in the upper deposits in trenches 1–3 show that the road was disturbed and re-deposited. The line of the old road was shown by the survival of the ditch forming the gutter. Wall [008] can also be seen on the 1st edition map and this forms the eastern extent of the old station road.

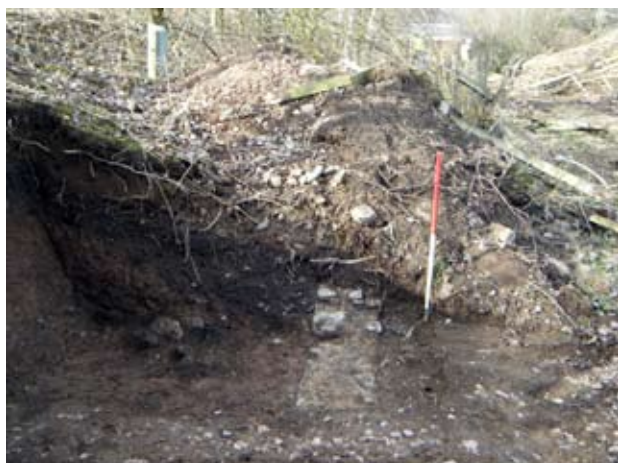
**Illus 4**  
Wall [008] and bank of Old Station Road

4 At the east of the mound a trial hole dug by contractors on site was excavated through the same deposits seen in trenches 1–3 forming the mound. A small mortar bonded stone wall [008] running north-west to south-east formed the eastern edge of the mound. Wall [008] survived up to 0.8m deep with five courses. It was 0.55m wide and was revealed for a length of 1.2m (Illus 4).

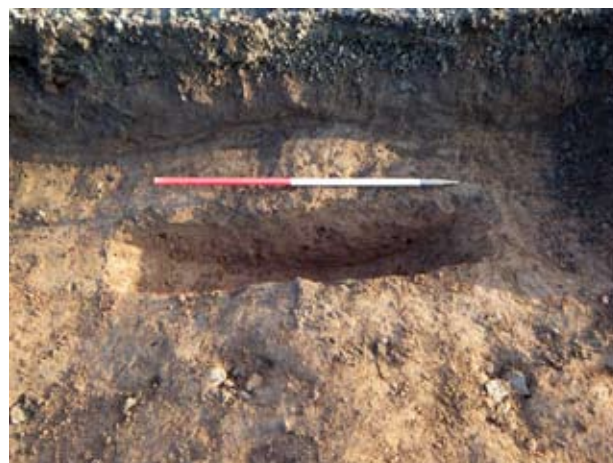
**Illus 5**  
Furrow [015]

Trenches 5, 6 and the northern end of Trench 16 were excavated through the former car park. Their profiles consisted of up to 0.3m of gravel surfacing overlying 0.2m of modern mixed deposits consisting of crushed brick, gravel and clay overlying in turn the glacial till deposits. Four furrows [013, 015, 017, 019] were exposed in these trenches. All the furrows were oriented northwest to southeast, ranged from 1.26 to 2.5m wide, and survived up to 0.35m deep. The furrows were all filled with a compact grey clay, interpreted as post-abandonment infilling (Illus 5).

The furrows are the remnants of the former rig and furrow field system although no dating evidence was recovered from these features they are likely to be post-medieval in date.
