Borders Railway Project Fountainhall Station (Site 182) Enhanced Historic Building Survey

Report No. 3207

**Borders Railway Project
Fountainhall Station (Site 182)
Enhanced Historic Building Survey
Report No. 3207**

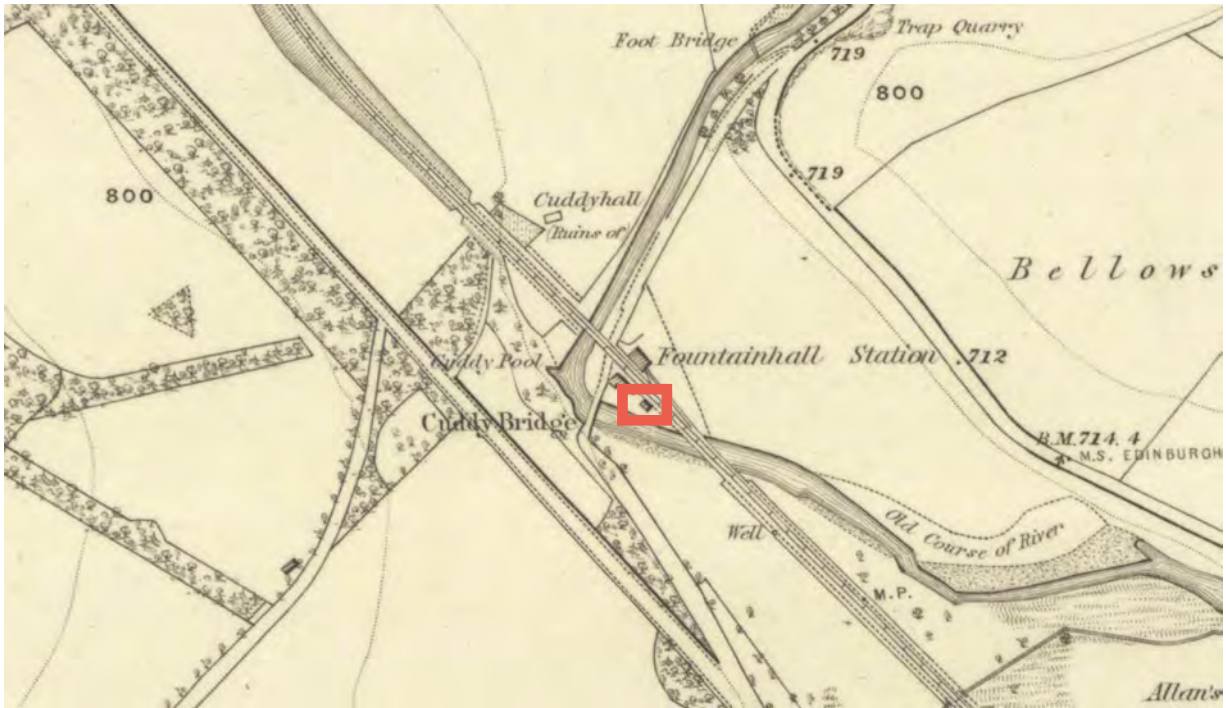
Fig. 2a Extract from map by Ordnance Survey, 1st Edition, 1854 showing location of water tower

The 1854 First Edition Ordnance survey map (Fig 2a) shows the station before the Lauder branchline was built. The water tower is shown on the southwest side of the stationhouse as a single rectangular building. A goods shed is shown on the opposite line.

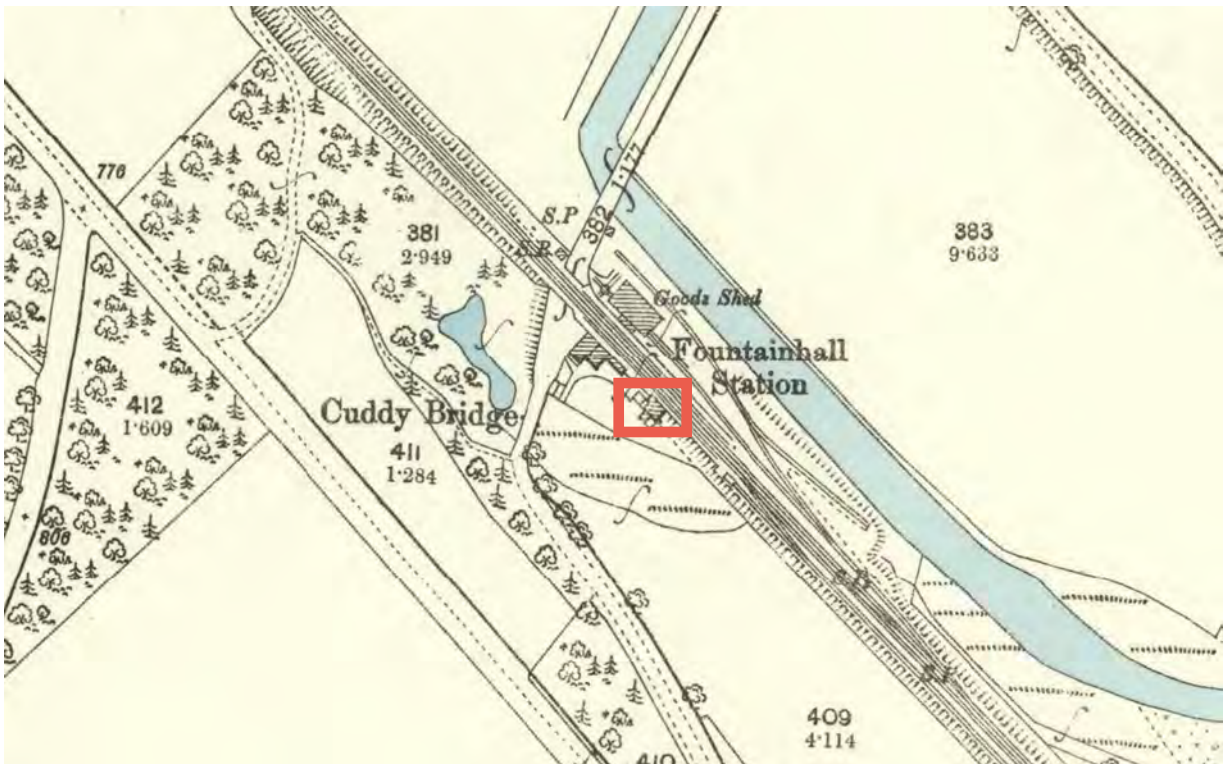
Fig. 2b Extract from map by Ordnance Survey, 2nd Edition, 1892 showing location of water tower

The 1892 Second Edition Ordnance Survey map (Fig 2b) shows the water tower with two small outshot structures attached to its southwest side.

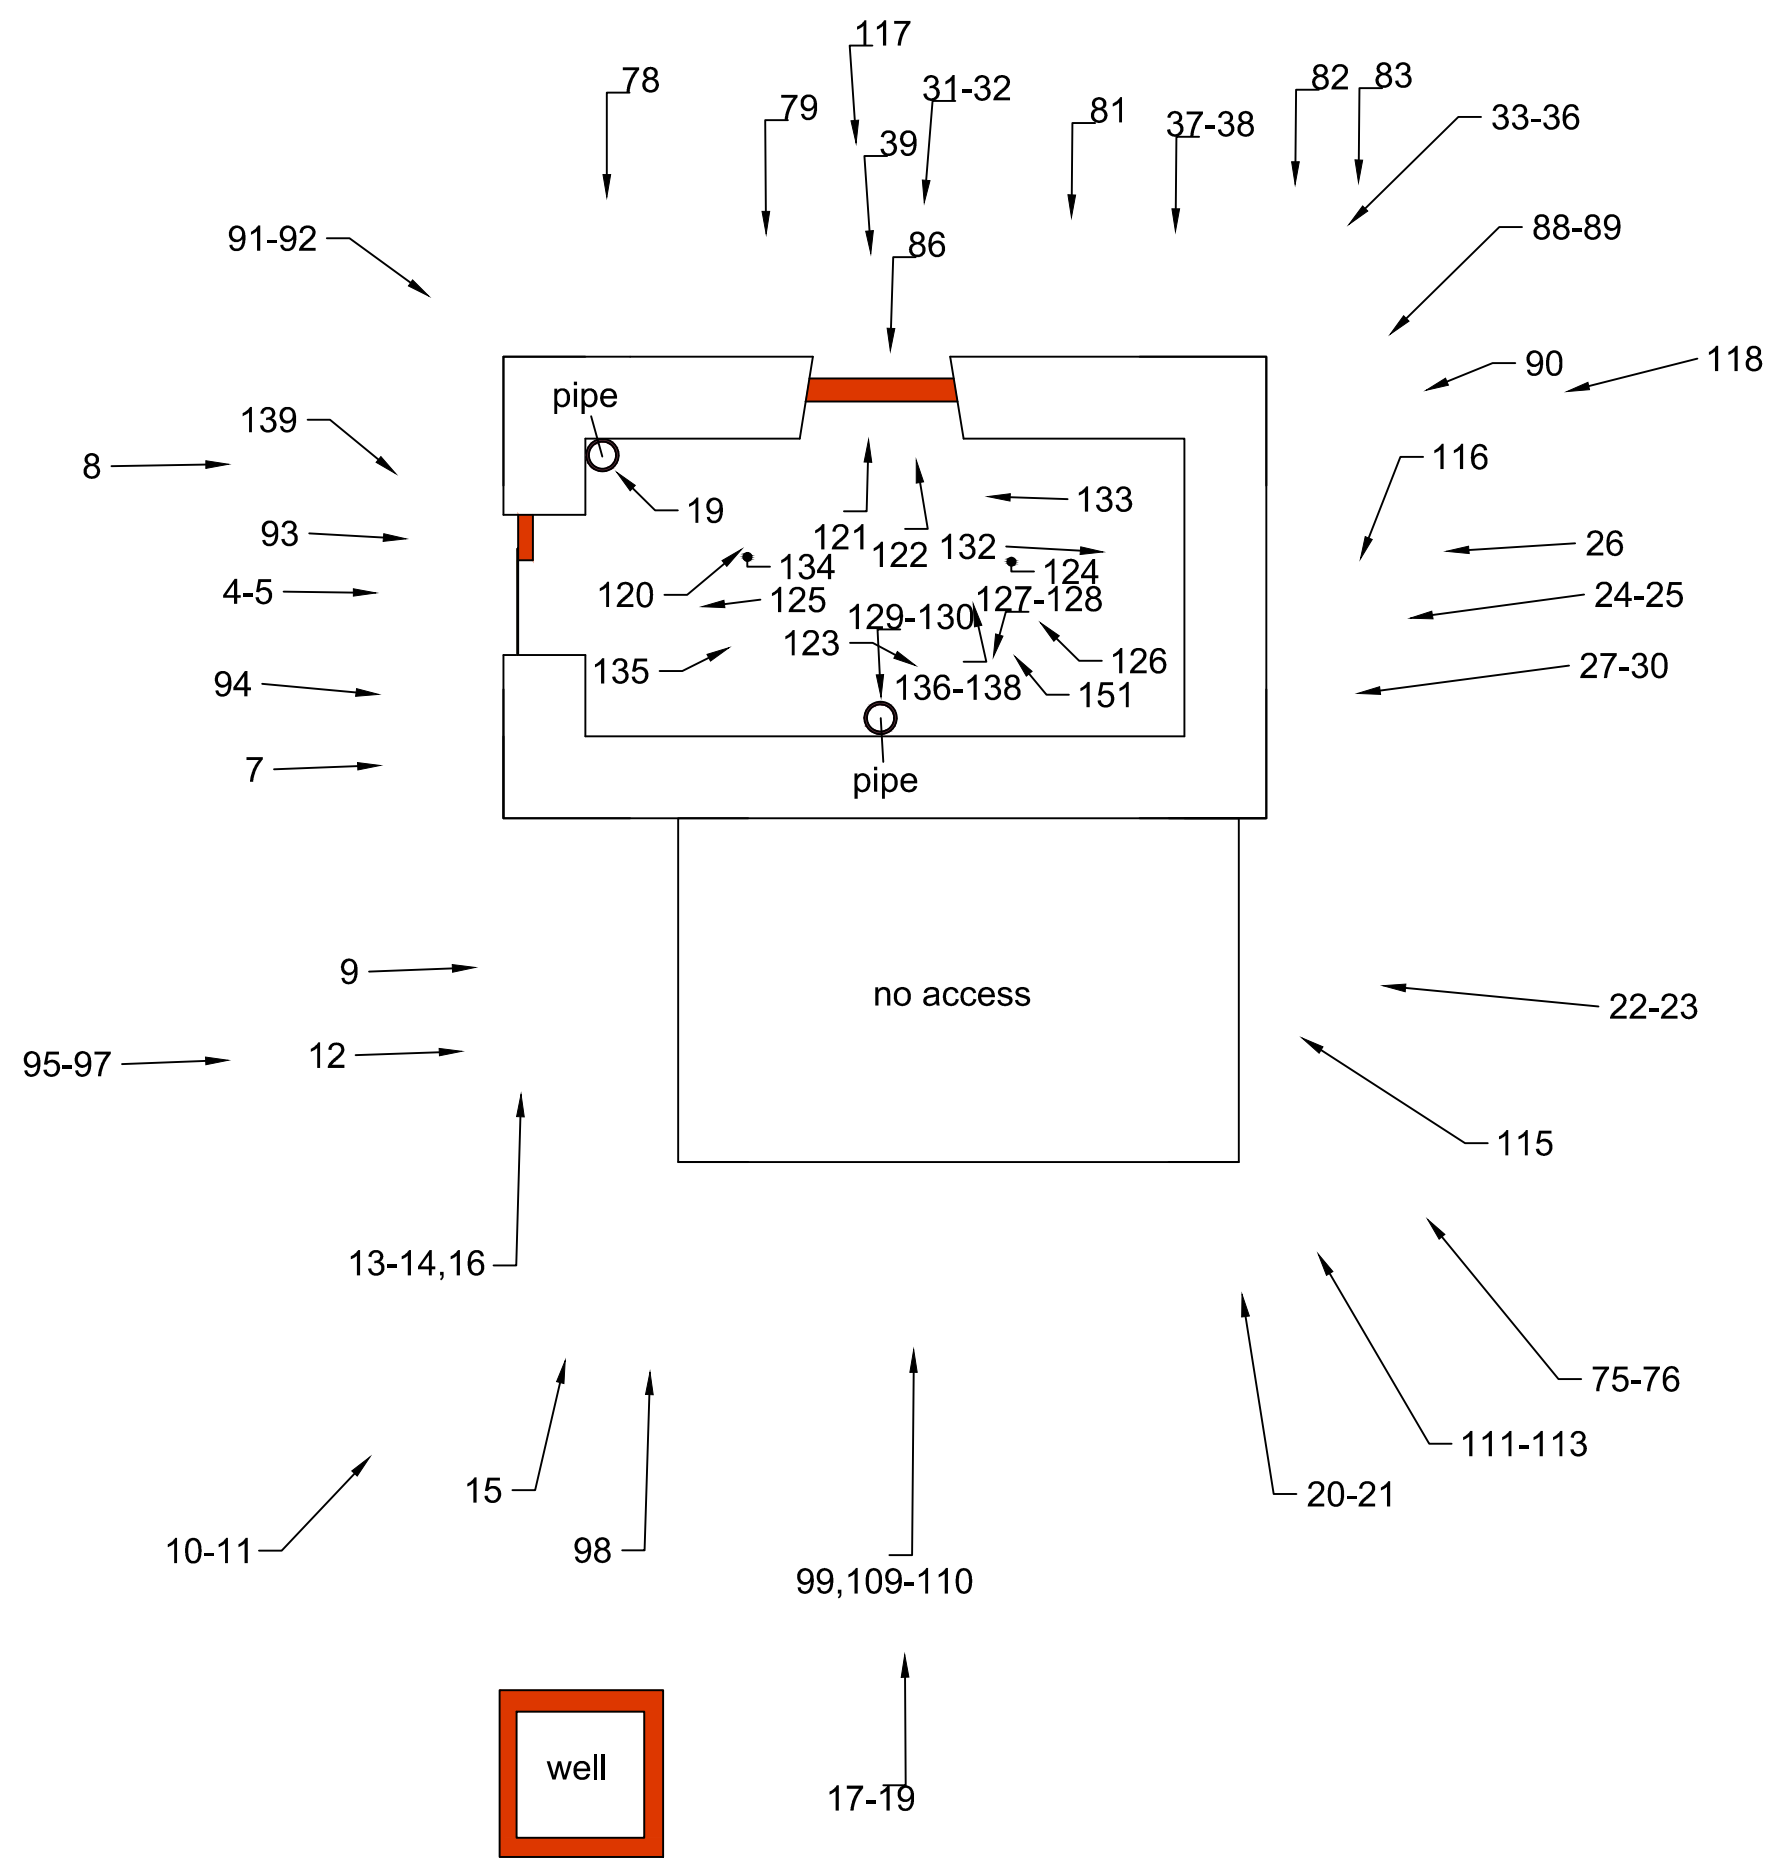
| Fig. No: | 3 | Report No: | 3207 |

The water tower (main block) occupied a rectangular footprint with an outshot structure (rear block) built on its west side. Access to the main block was originally via two doors one on the north and the other on the east elevation. The walls of the main block were 0.65m thick. No interior access was available to the rear block on the grounds of health and safety.

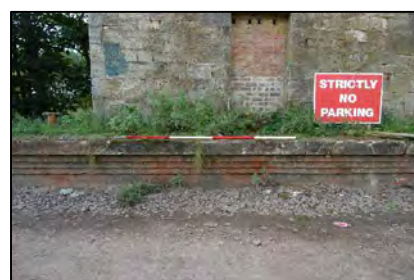
Fig. 5b East-facing elevation, northern end

The remains of the up-platform measured 125m long and approximately 1m high. Both its north and south terminuses survived. The platform had been breached and this provided two sections through the structure. One section illustrated as an inset on Fig 5a shows the north-facing section with brickwork that toed outwards before being capped by concrete curbs that measured 1.2m long and 0.53m wide. The body of the platform had been created using coal waste.

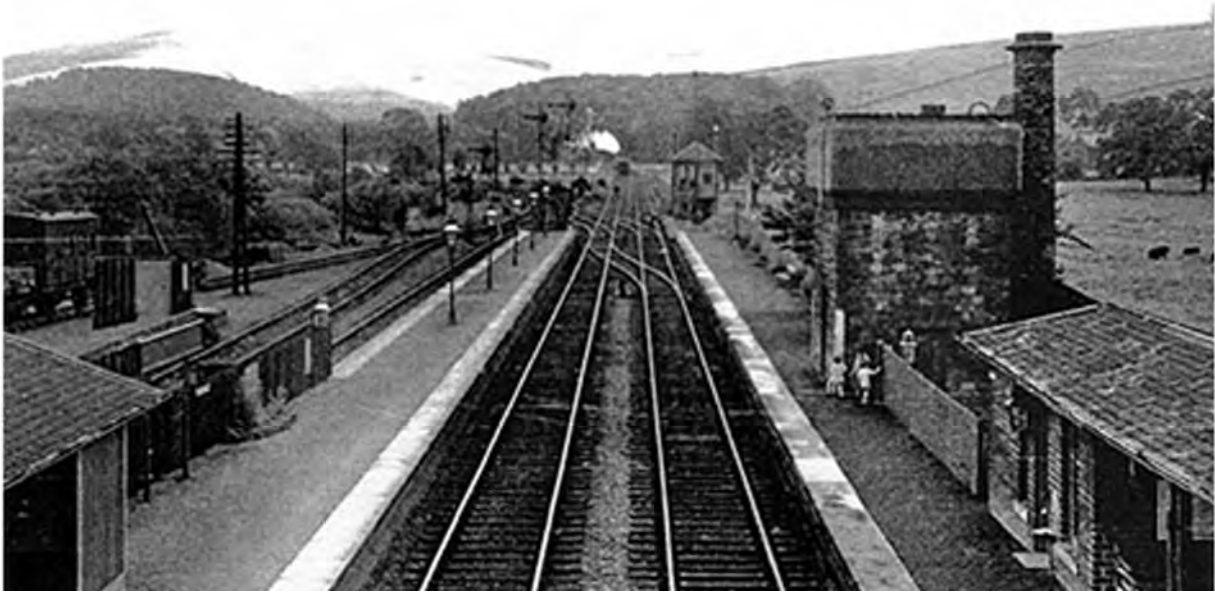
Plate 1 shows the water tower with a tank and chimney stack attached to its rear in 1945. Plate 2 shows the water tower in 1960 with the chimney and water tank no

Plate 1 Fountainhall Station in c.1945. The water tower and chimney can be seen on the right of the photograph (Source Disused Stations)

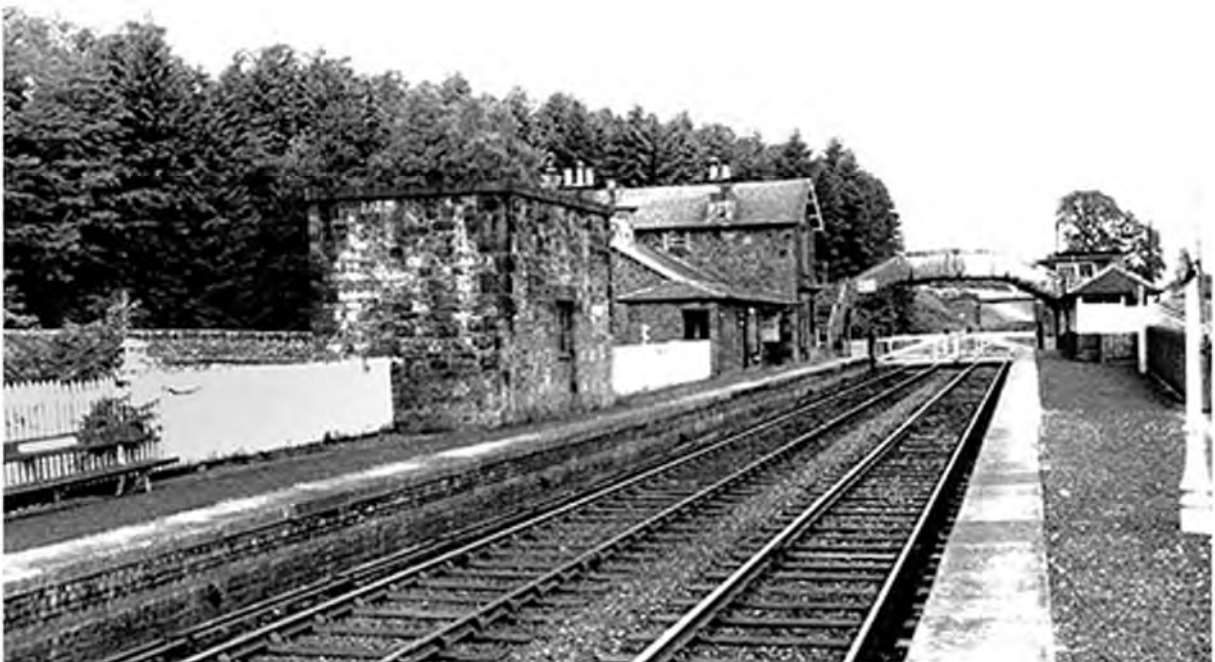
longer present. Plate 3 shows Fountainhall (following closure) looking south in 1974 with the two platforms and the station house, the water tower is in the distance.

Plate 2 Fountainhall Station looking north from the up platform in the late 1960s showing that the water tank had been removed (Source Disused Stations)

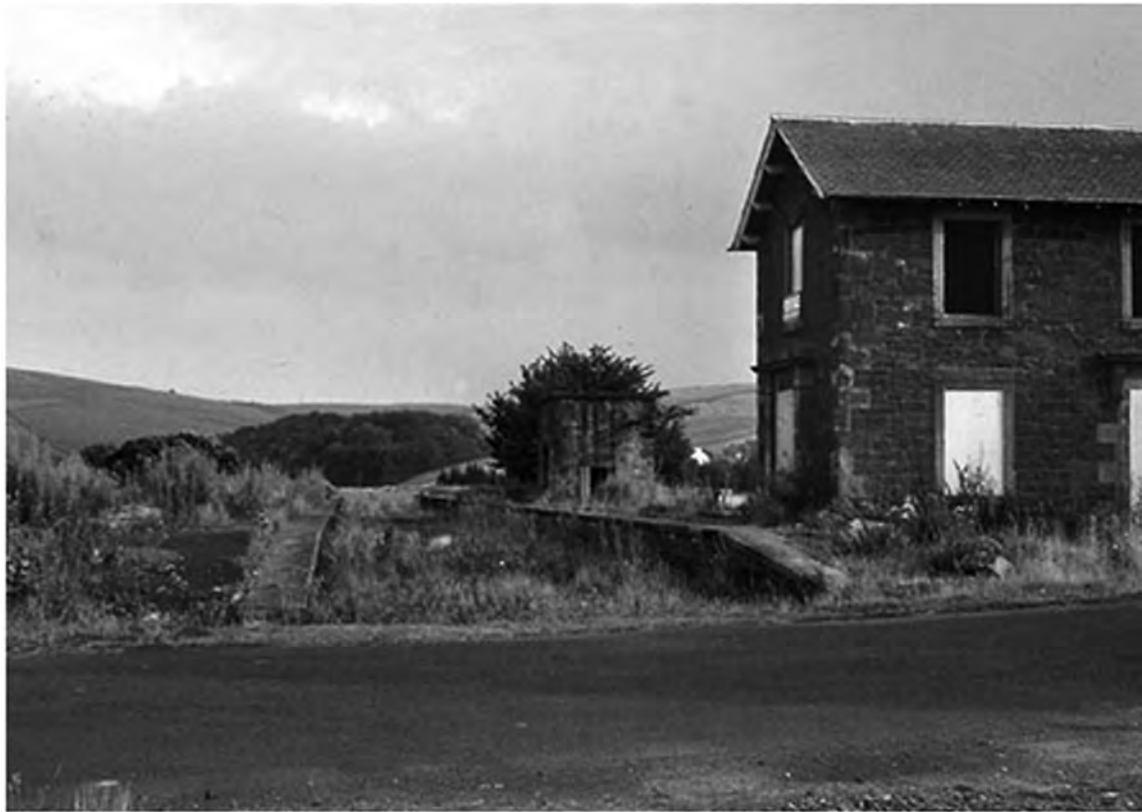
Plate 3 Fountainhall Station and platforms looking south in August 1974
(Source RCAHMS)

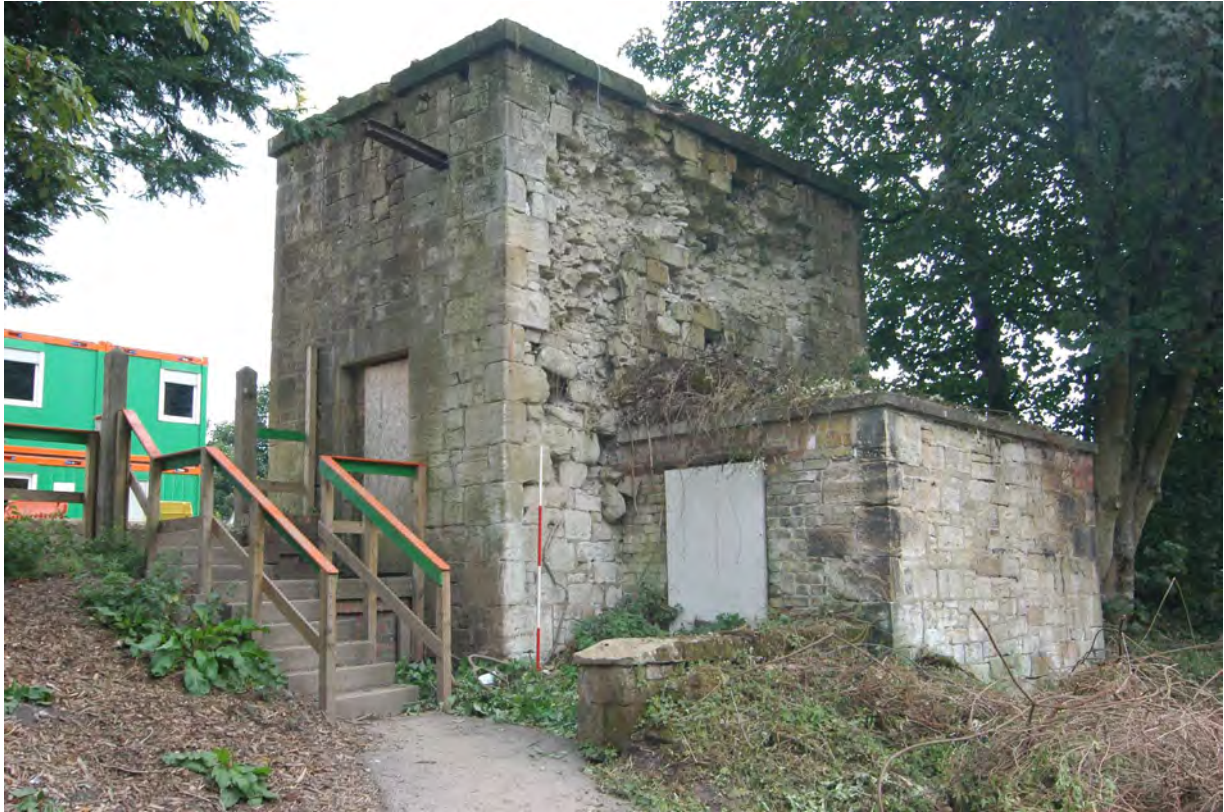
The north-facing elevation of the main block measured 5.83m high and 3.82m wide and was constructed of snecked sandstone with ashlar dressings. A central door surround measured 2.1m high by 1m wide and contained a red-painted panelled door hidden behind a plywood shutter. The door surrounds were droved and the lintel had been stugged. A pair of blocked slit-vents were situated at the wall head.

The rear block measured 2.2m high and 2.2m wide and was set back from the north-facing elevation of the main block. The rear block had a central opening that was blocked with red brick. Most of its elevation had been refaced with brickwork.

Plate 5 Oblique north-facing elevation of the water tower and outshot building

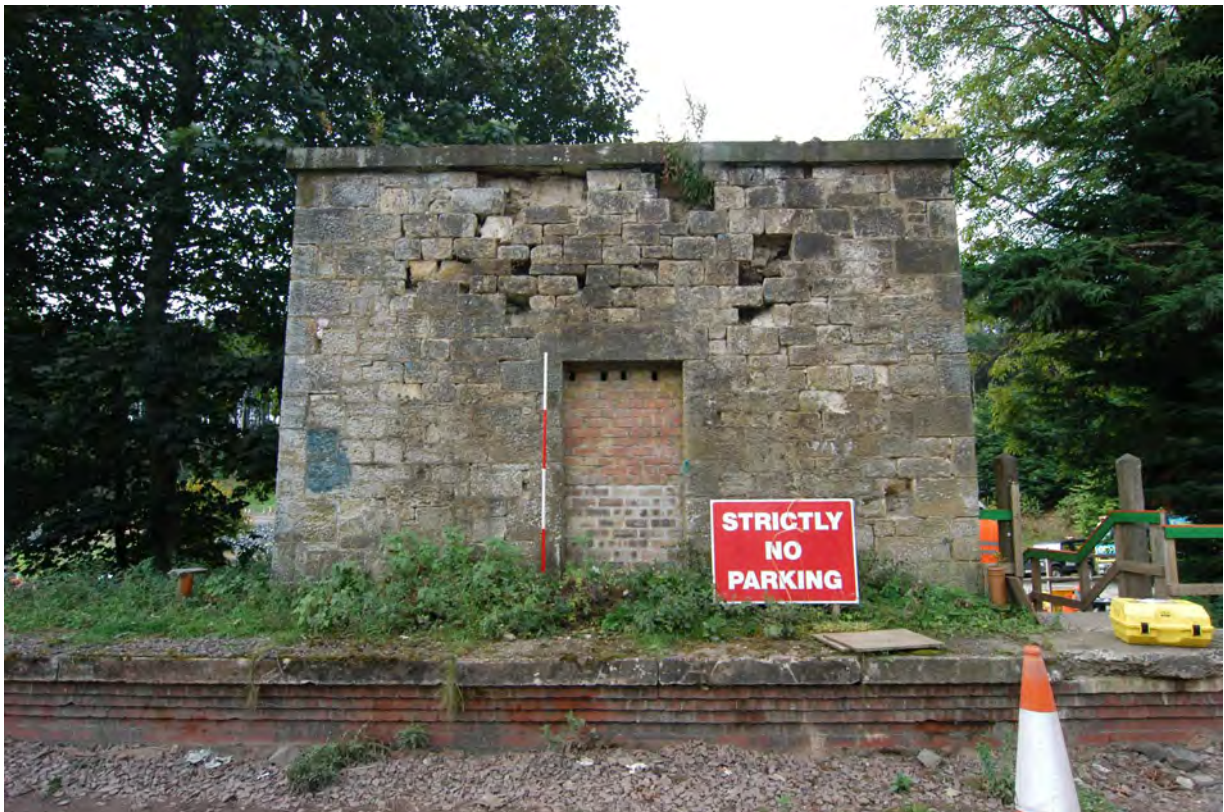
The east-facing elevation measured 3.95m high and 6.21m wide and was constructed of snecked sandstone blocks framed with ashlar dressings. A brick-blocked central door measured 2m high and 1.08m wide. Two types of brick had been used to block the opening suggesting that the top half of the opening may have housed a window prior to its removal and the opening then being fully blocked. At the top of the brickwork small vents had been created. The wall head was capped by five slabs of sandstone.

Plate 6 East-facing elevation of the water tower

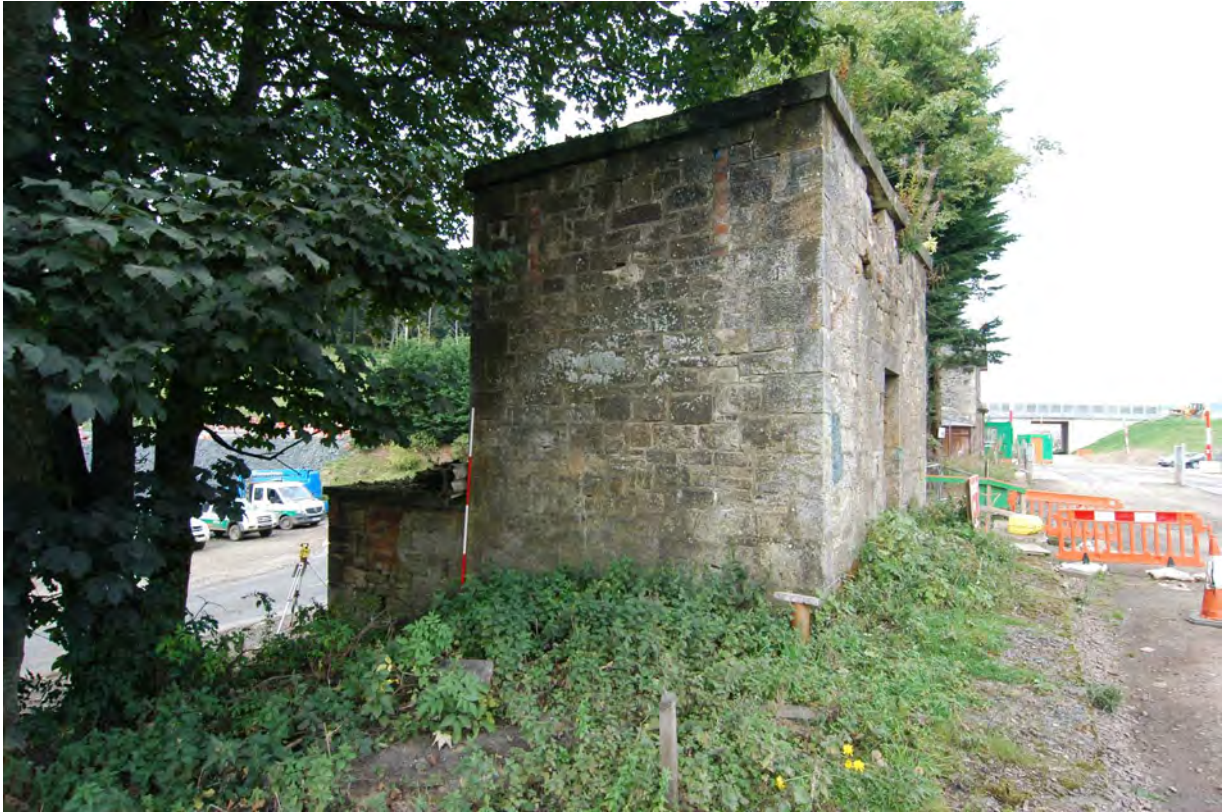
The south-facing elevation of the main block measured 4.1m high by 3.82m wide and incorporated the water tower and attached rear block. The elevations were constructed of snecked sandstone with droved ashlar dressings that measured on average 0.5m (long) and 0.35m (short). Two bricked-up slit vents were situated below the wall head that was capped with sandstone slabs.

The rear block measured 2.2m high and 2.7m wide and was constructed of rough-dressed sandstone blocks with ashlar dressings at the north-east corner. A small brick-blocked window occupied the centre of the elevation. Courses of brick had been inserted into the corner above the ashlar quoins. Smaller brick fillets had been built on top of the stone-built elevation to form a level wall to support a presumably later concrete slab roof.

Plate 7 South-facing elevation of the water tower

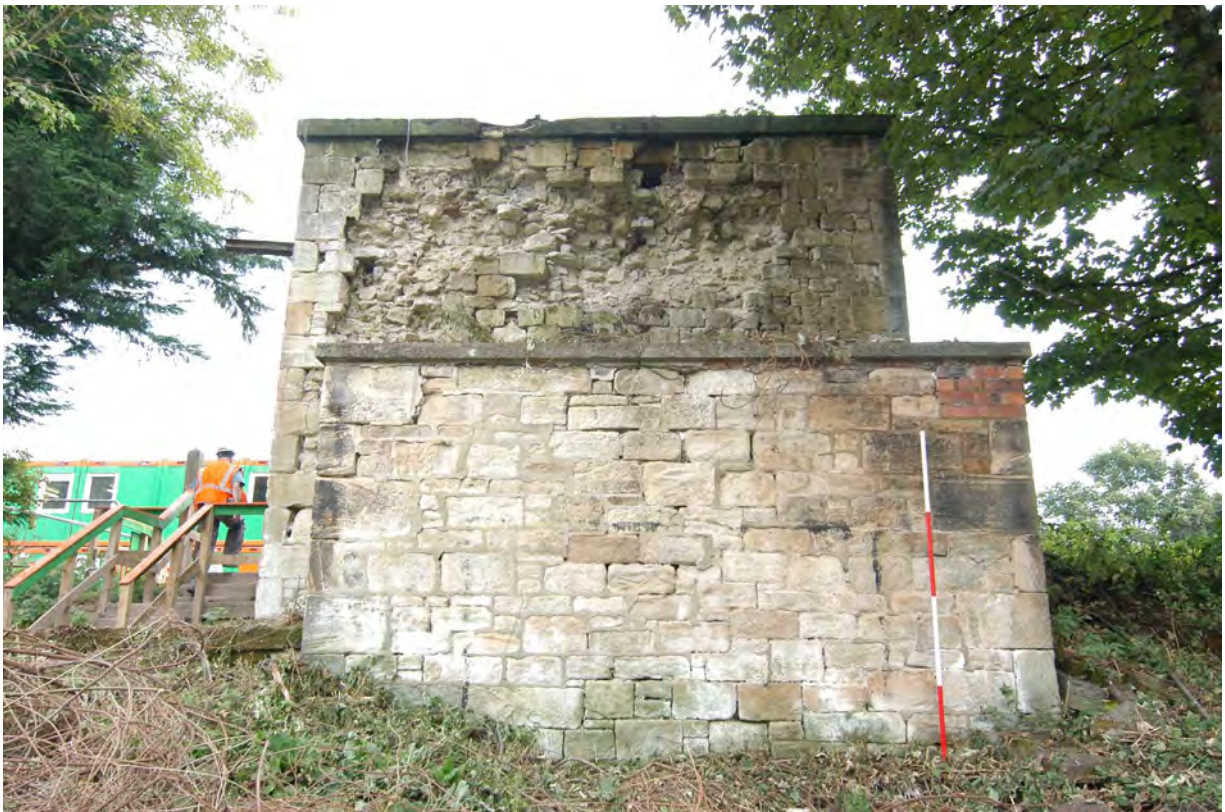
The west-facing elevation of the main block measured 4.51m high and 6.21m wide and was built of coursed sandstone and framed with ashlar dressings. About 40% of the walls facing stonework had collapsed revealing its mortar-bonded rubble hearting.

The rear block measured 4.5m wide and 2.2m high and was constructed of snecked sandstone blocks. It was advanced from the main block by 2.7m. Courses of red-brick had been inserted in to the corner of the wall head at its south end to form a level wall to support a presumably later concrete slab roof.

Plate 8 West-facing elevation of the water tower

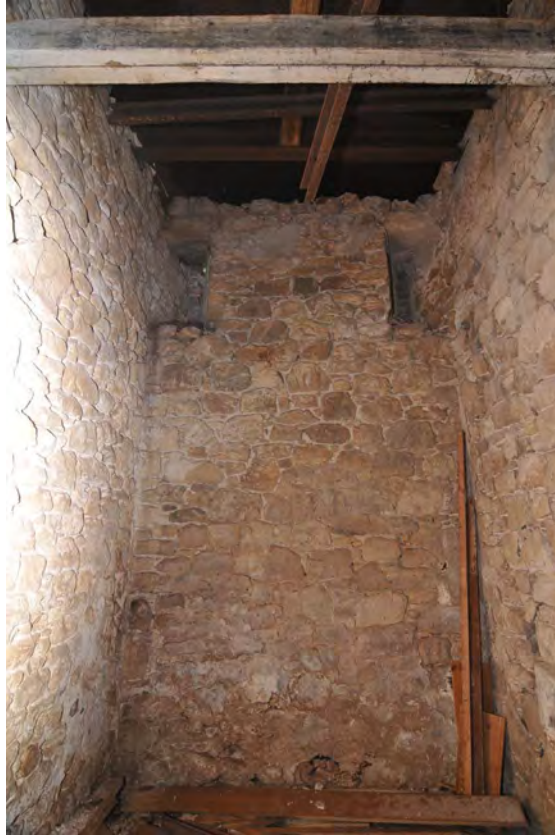
The internal north-facing was a featureless random rubble build with two blocked slit-vents situated near the wall head.

Plate 9 Interior north-facing elevation with blocked up slit vents near the wall head

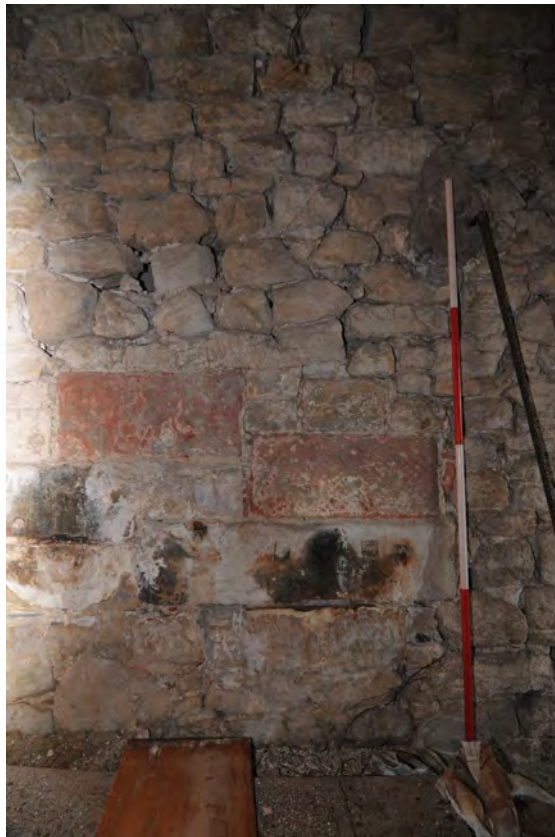
The internal east-facing elevation was constructed of random rubble but it also contained five sandstone blocks at its mid-centre. These were partly oil-stained and two contained small iron-fixing bolts. Together these were interpreted as marking the position of an internal diesel engine that may have functioned in the supply of water later on in the use of the structure. It is thought that the presence of the chimney to the rear of the structure may be evidence of a steam engine having been used for this purpose earlier in the life of the structure. A wooden beam spanned the interior at just below the level of the ceiling. A cast-iron pipe protruded out of the ceiling and ran down the middle of the elevation and exited through the wall and out in to the small structure that adjoined the external west-facing elevation. Like the pipe in the corner of the south-facing elevation this may have been a water pipe associated with the supply of water to the tank above.

Plate 10 Interior east-facing elevation with oil stained masonry blocks

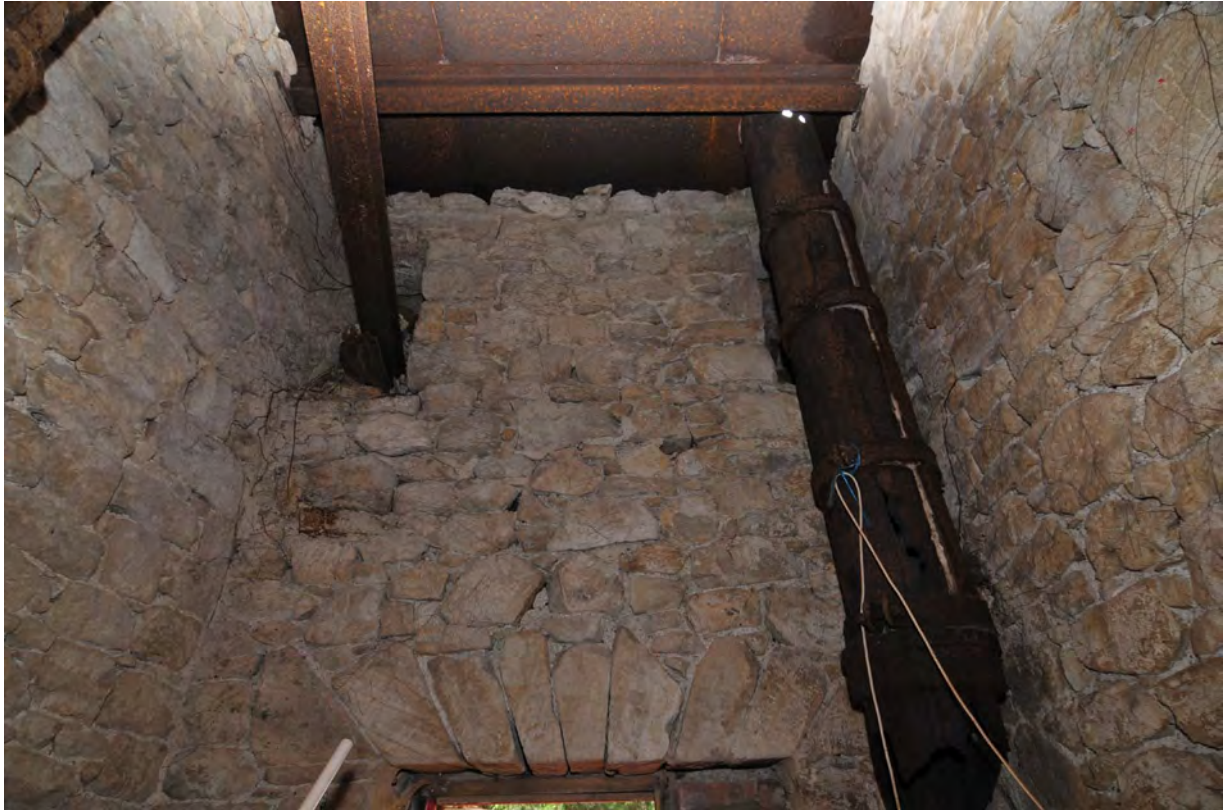
The internal south-facing elevation contained a central panelled door set within a timber frame. The fabric above it contained a flat relieving arch constructed of seven voussoirs. In the right-hand corner was a large 30mm diameter pipe that was held together with bolted rings. The pipe protruded through the ceiling but was cut off above ground level. This may have been a water pipe associated with the supply of

water to the tank above. A large void on the left and side (facing) contained a supporting iron I-beam.

Plate 11 Interior south-facing elevation above the door with pipe work

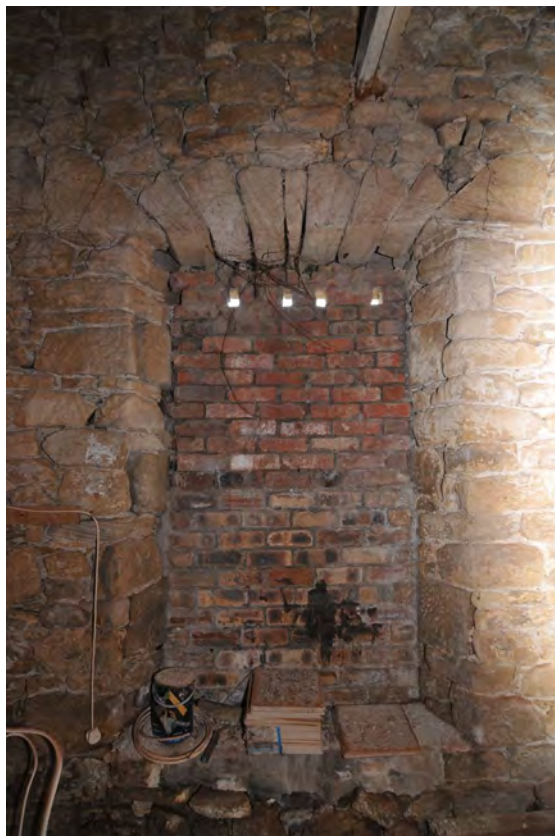
The internal west-facing elevation contained a blocked central door opening with splayed reveals and surmounted by nine vousours forming a flat relieving arch. A large timber beam protruded across the upper section of the elevation. Two types of brick blocking work were present in the door opening.

Plate 12 Interior west-facing elevation blocked opening

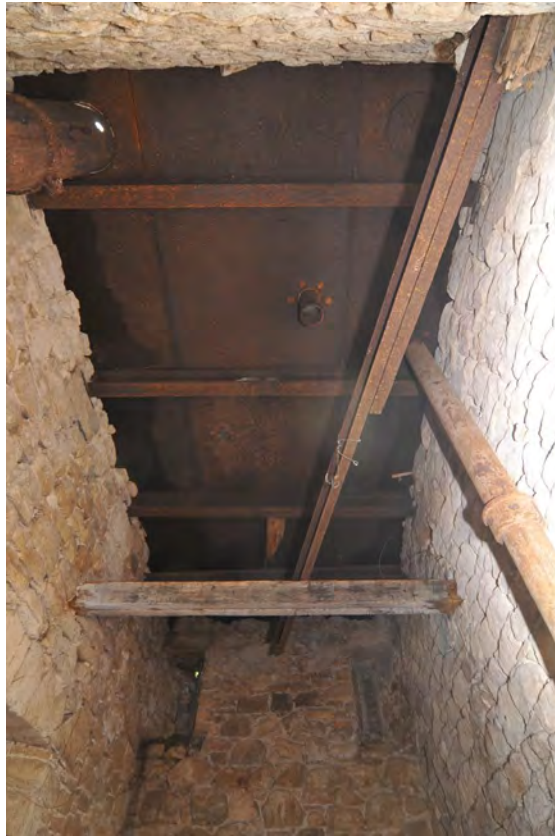
The ceiling comprised three sheets of iron running north to south and supported on four steel I-beams. The remains of three cast-iron pipes protruded out of the ceiling. One ran down the middle of the east-facing elevation and exited through the wall in to the small structure that adjoined the external west-facing elevation. The second ran down the corner of the structure between the south and west-facing internal elevations and the third was located broadly within the centre of the ceiling. It is presumed that these were all associated with the supply of water to the tank that once sat on top of the stone tower.

Plate 13 Interior ceiling showing iron plates and pipe work

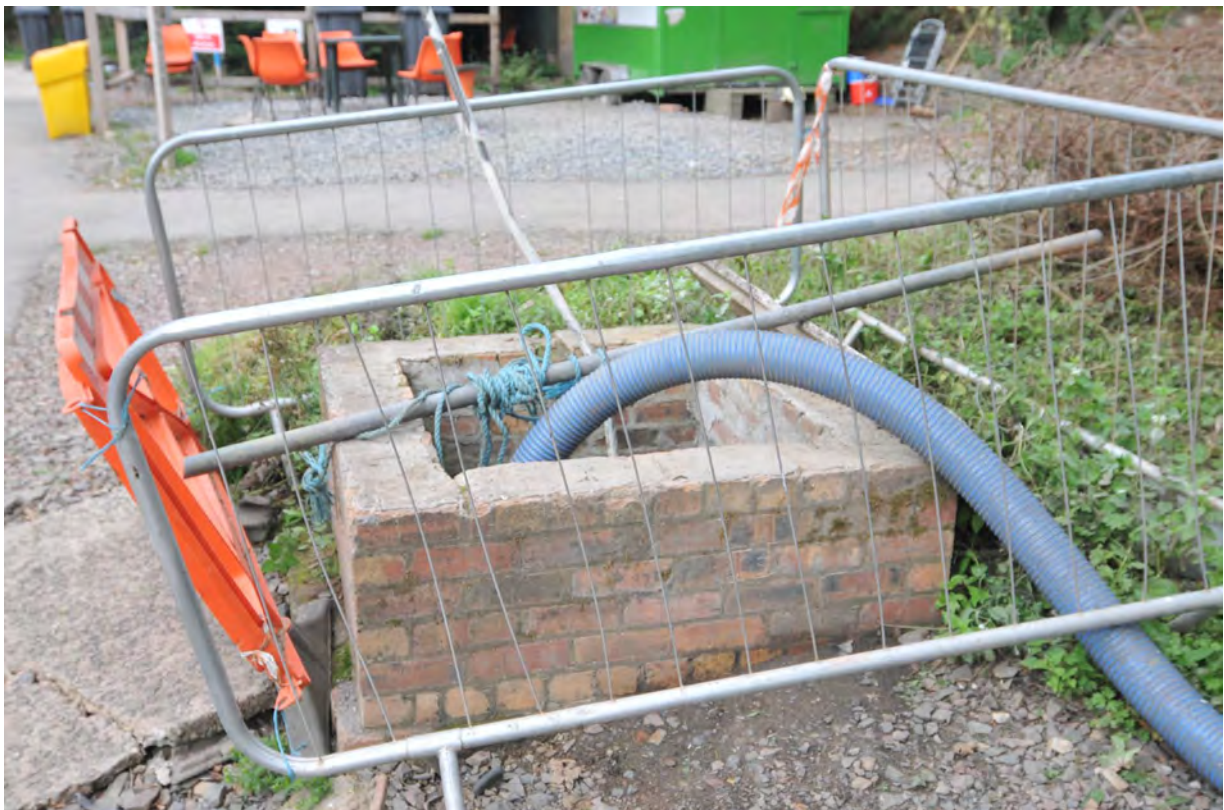
Plate 14 General shot of well

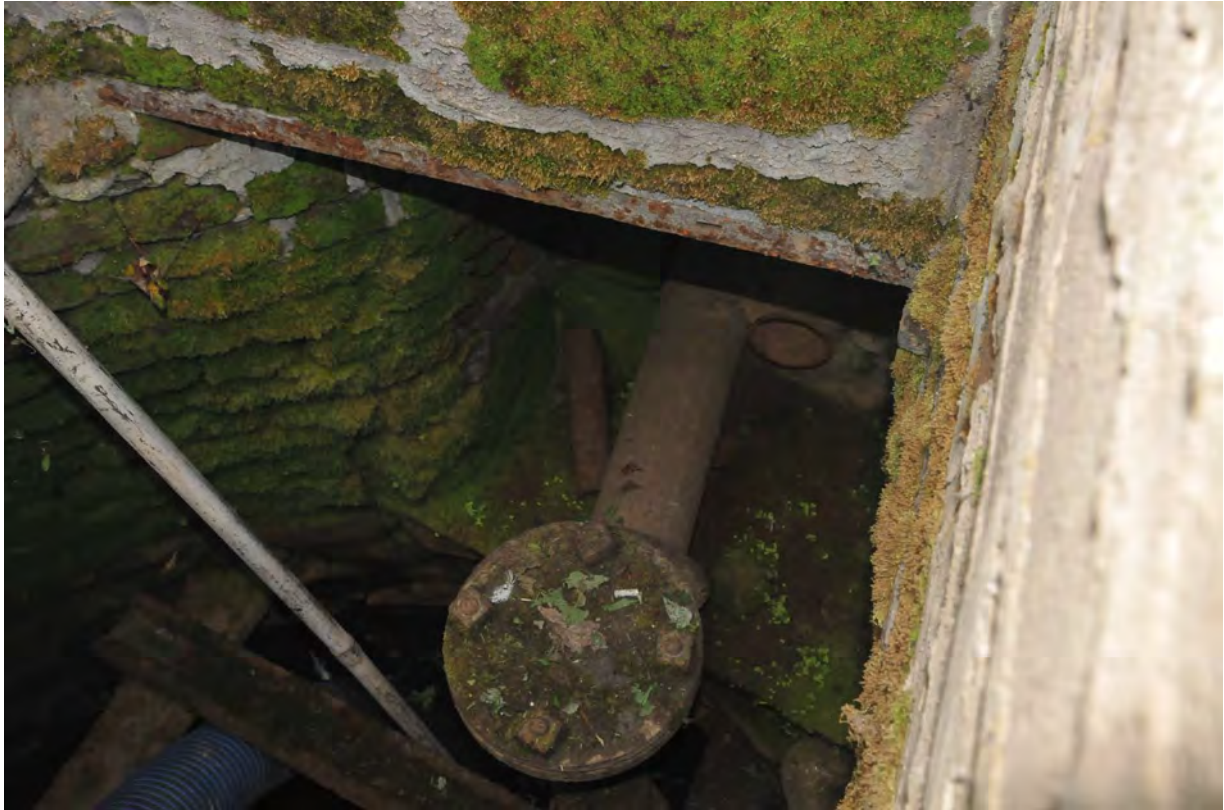
Situated on the west side of the water tower approximately 10m from the rear outshot building was a well. The well contained a pair of cast-iron riser pipes one of which had a circular inspection flange held down with four hexagonal bolts (Plate 15). Sections of railway line had been used to brace the vertical sections of the surviving riser pipe.

Plate 15 Well interior showing riser pipe and steel work below

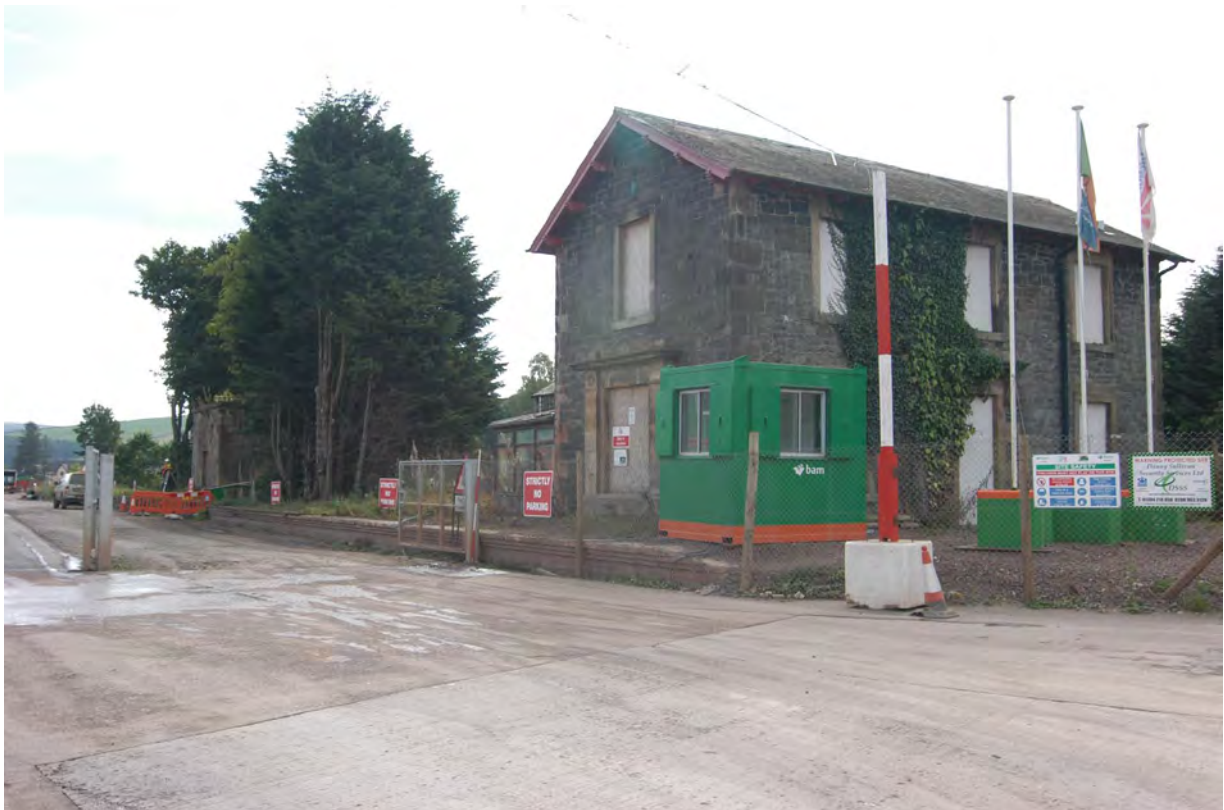
Plate 16 Northern terminus of the up platform and the former Station House
