**Crunklaw Steading, nearDuns  
Scottish Borders  
Historic Building Survey**

**Report No. 3340**

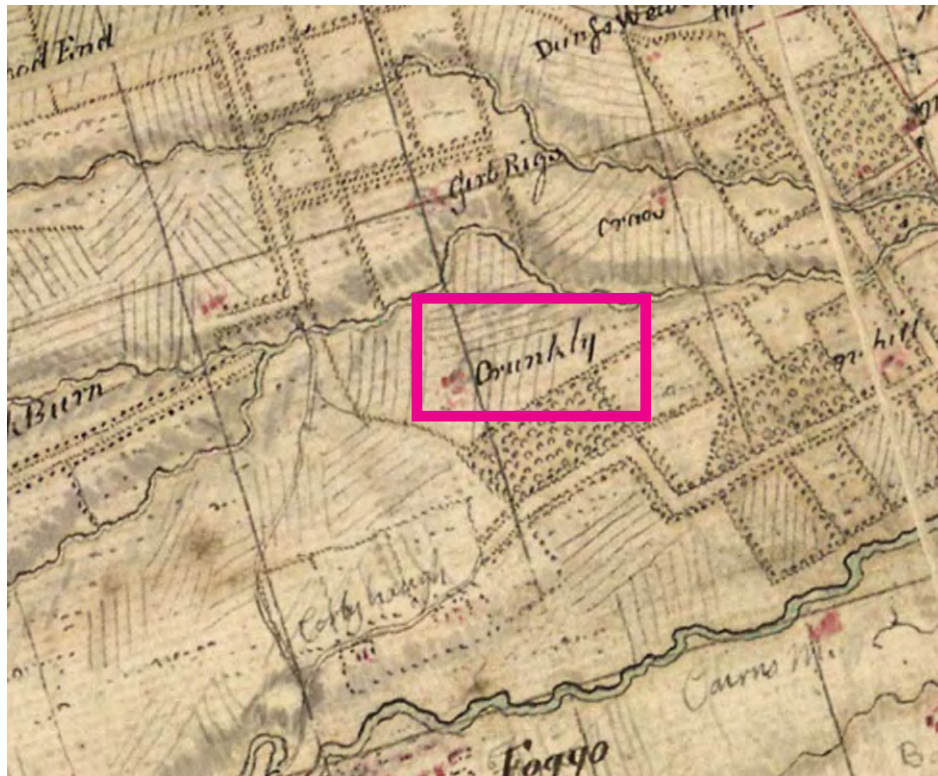
Fig. 2a Extract from map by Roy, 1752-1755

Crunklaw Steading first appears as a placename on General Roy's map of 1752-55 and is depicted as *Crunkle* (Fig 2a). The map shows a dispersed settlement pattern in an area that was had unenclosed rig and furrow. Armstrong's map of 1771 depicts Crunklaw as a single inverted L-shaped building (Fig 2b). Blackadder's map of 1797 depicts Crunklaw as three separate buildings (Fig 2c). Ainslie's map of 1821 depicts Crunklaw only as a placename only. Sharp's map of 1826 shows a U-shaped building arrangement situated close to a trackway with two more buildings on its south side (Fig 2d). The same building arrangement is shown on Forrest's map of 1843.

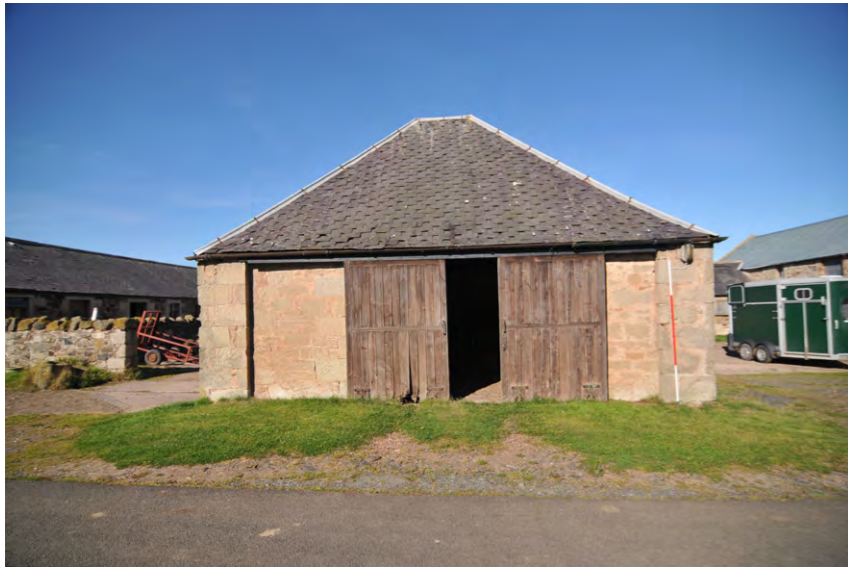
This single storey detached building measured 7.7m by 6.5m and was built of coursed sandstone and whinstone rubble framed by droved ashlar quoins. The roof was hipped and covered with slate with galvanized zinc flashings. The north-facing elevation contained two small rectangular blocked windows partially hidden by a metal container. The east and west-facing elevations were featureless. The south-facing elevation had a large single bay-opening with a large double-leaved sliding door.

Fig. 5 Exterior view of the Turnip Shed, Unit 1

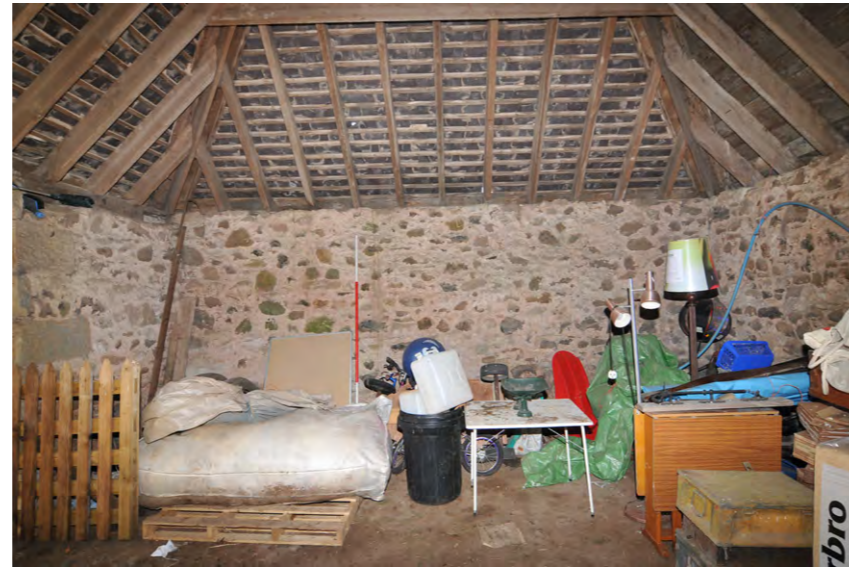
The south-facing elevation (Fig 6) contained the two aforementioned windows hidden behind stored materials. The east and west-facing elevations were featureless. The north-facing elevation had ashlar quoins around the bay opening and a large timber lintel had been inserted across the door. The softwood rafters were scarfe-jointed and nailed. Each rafter rested on the wall heads.

Fig. 6 Interior view of the Turnip Shed, Unit 1

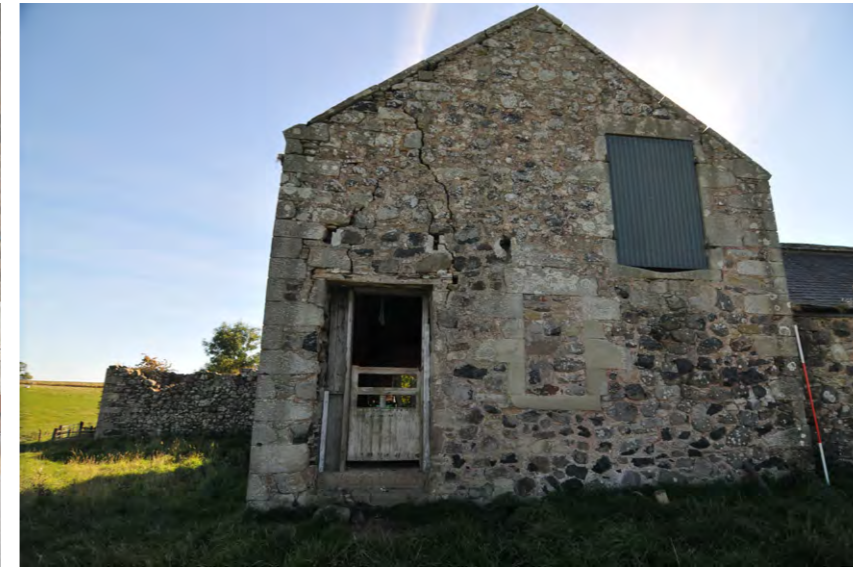
The pitched two-storey north-facing gable was constructed of random rubble (sub-rounded sandstone and whinstone) and framed with droved ashlar quoins. A doorway occupied the left-hand side of the doorway (facing). This had a single step and a timber lintel. To the right of the doorway was a blocked window with ashlar surrounds and internal rubble blocking. At first-floor level there was a boarded-up pitching door

framed by ashlar surrounds. The gable was advanced by 0.5m off the wall line of the North Range.

Fig. 7 East Range, north-facing gable

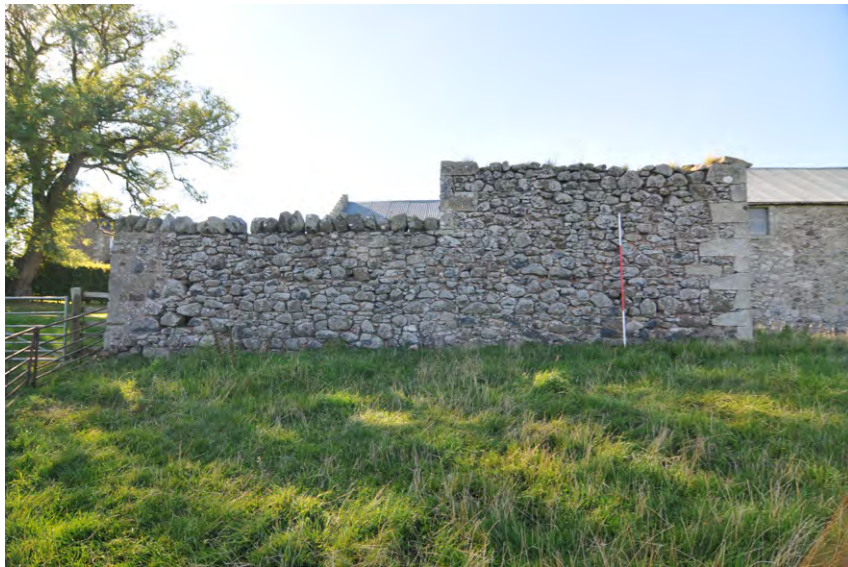
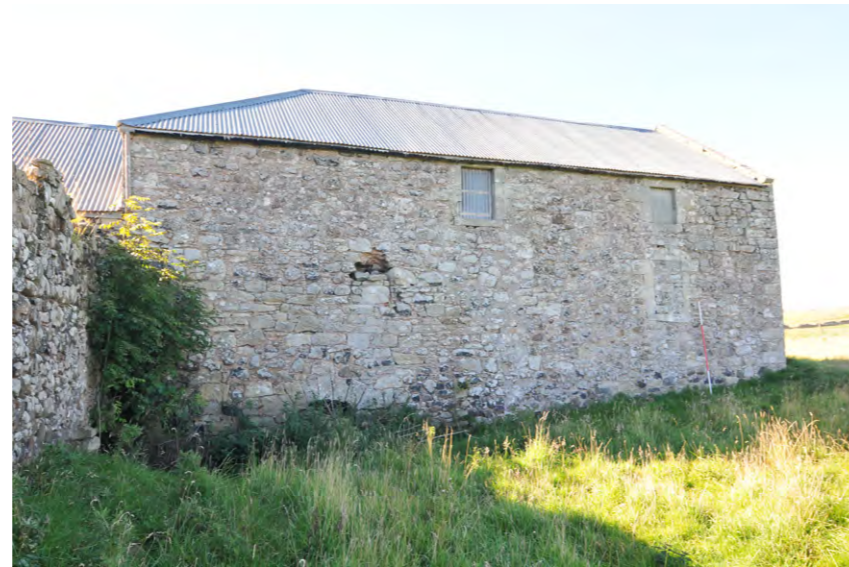
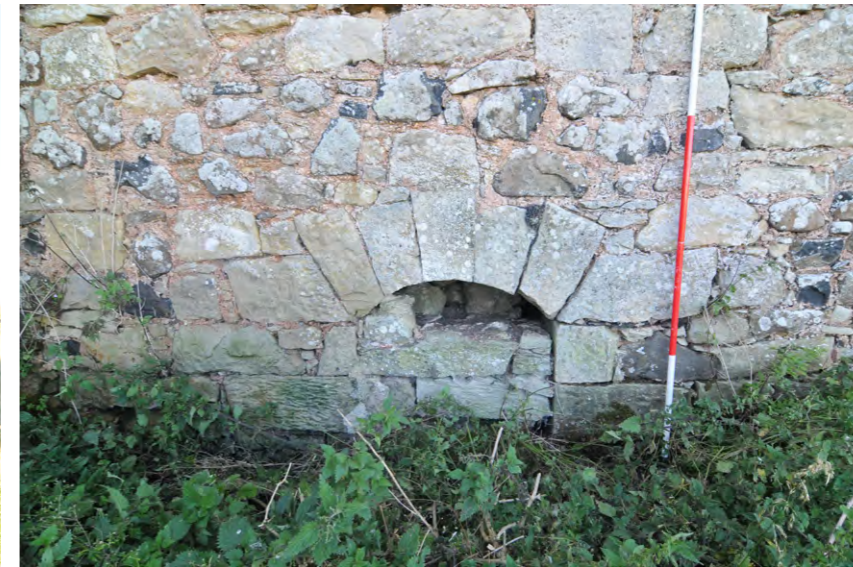
The two storey east-facing elevation was constructed of coursed rectangular and sub-angular stones with a greater proportion of whinstone at the foot of the wall. Ashlar quoins framed the elevation and three windows. A roofless ruin (Unit 3, Fig 8) ran at right-angles to the main elevation. The south end of the east-facing elevation was single storey and had a slit vent facing into Unit 3.

At the north end of the elevation at ground-floor level there was a blocked window. Also at the same level, but further south was a large void with collapsed blocking work. At the ground floor more or less in line with the void was a segmented arched opening that was partially blocked with stone (Fig 10). The arch has seven segments and the opening measured 0.7m wide by 0.7m high. The opening marks the position of an undershot low-breast water wheel and wheel pit. The section of wall within the interior of Unit 3 was masked by vegetation. At the south end of the elevation, towards the south gable, the wall contained a crude foundation layer of large projecting boulders surmounted by coursed random rubble.

Fig. 8 East Range, east-facing elevation, south end

Fig. 9 East Range, east-facing elevation, north end

Fig. 10 East Range, east-facing elevation, segmented arched opening

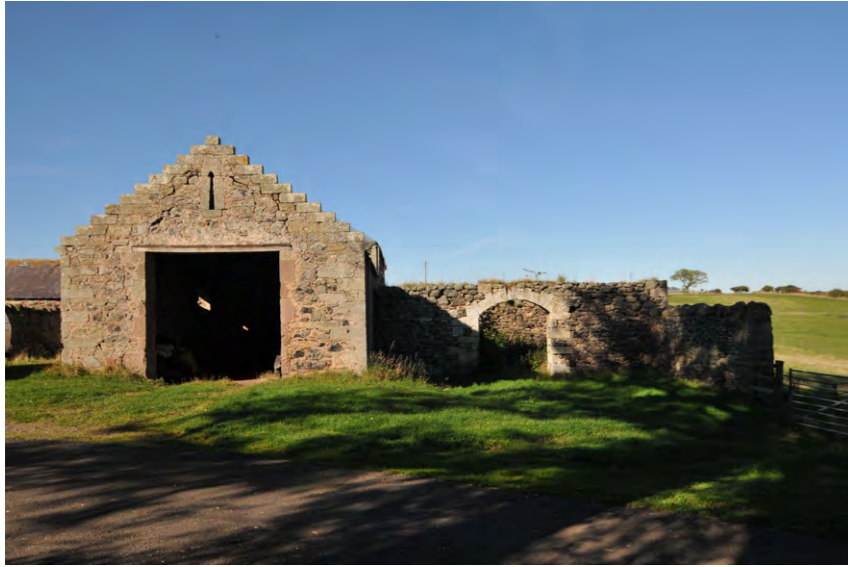
The south-facing crow-stepped gable was rubble built and was framed with droved ashlar quoins. A single bay-opening was surmounted by an arrow slit below the gable head.

Fig. 11 East Range, south-facing crow stepped gable

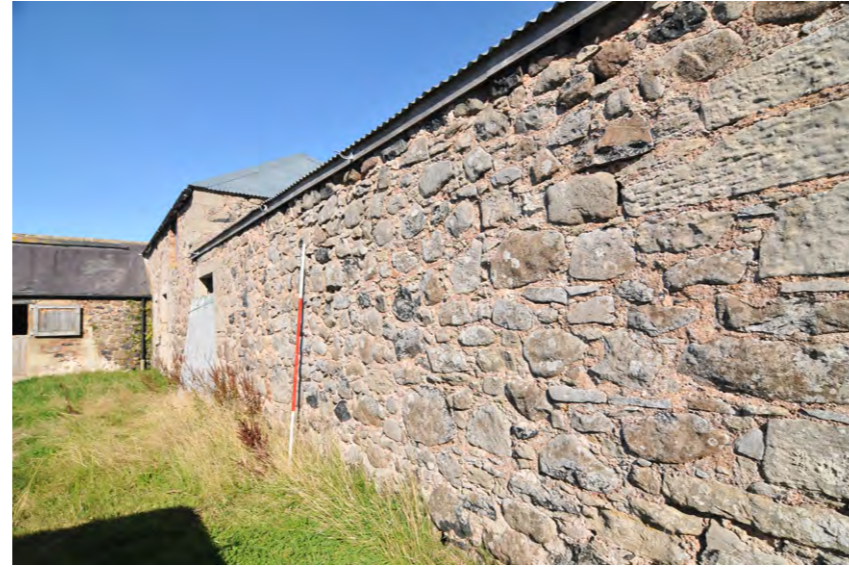
The single-storey west-facing elevation is comprised a featureless random rubble wall with a single doorway framed with droved ashlar surrounds. The door adjoins the two-storey block which contained an off-centre plank-built door within ashlar surrounds. A ground floor window opening was present on the left of the door (facing). At the first floor two windows were present. The larger was rectangular and had brick surrounds and was a later insert. The smaller window had stone surrounds. The north end of the elevation is hidden by the roof of the North Range.

Fig. 12 East Range, west-facing elevation

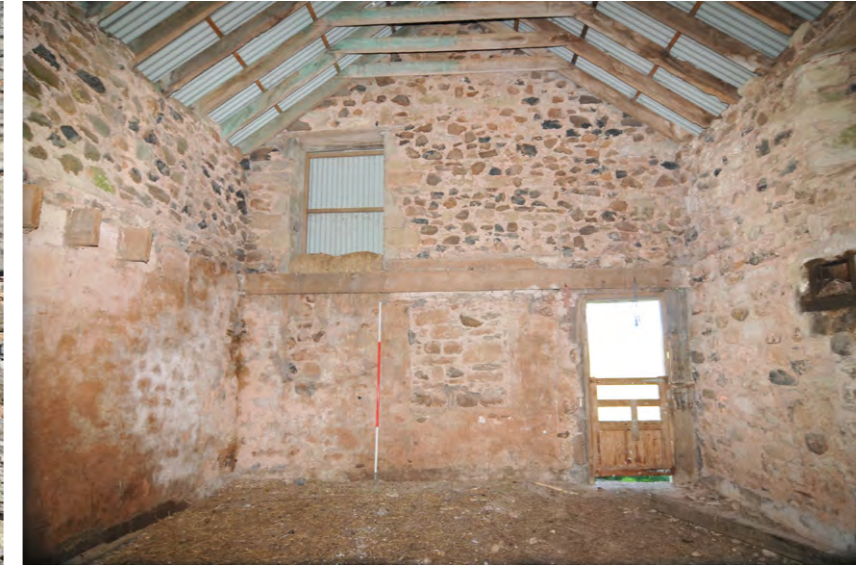
The interior south-facing elevation included a blocked ground floor window and a doorway in the right-hand corner (facing). A timber floor joist marked the position of the floor that had been removed. Immediately above the joist was a boarded pitching door. The A-frame collar rafters were clad with corrugated metal sheeting.

Fig. 13 East Range, interior south-facing elevation

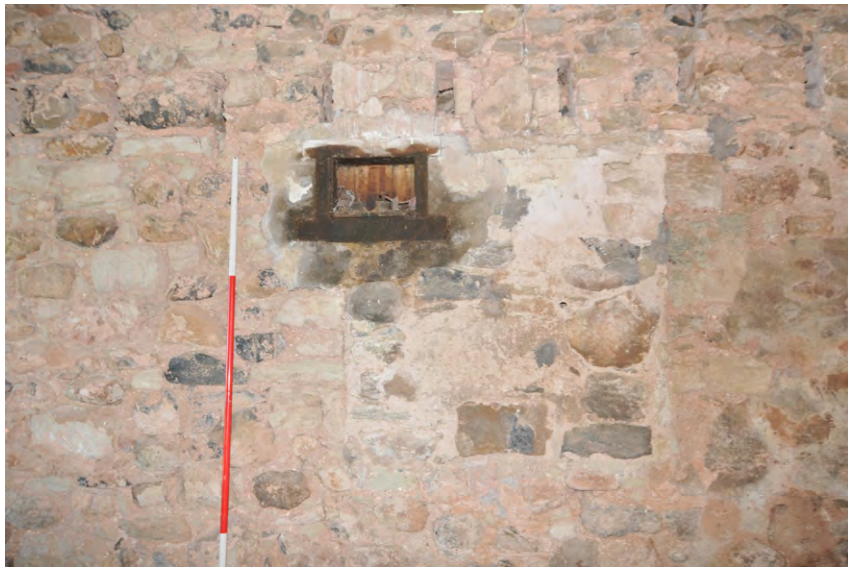
The north end of the west-facing elevation had a blocked ground floor window that had a later bearing box inserted into it (Fig 14). Above were two windows with

splayed reveals at first floor level. A line of sockets marked the position of the loft floor. Roughly at the centre of the elevation were two more blocked bearing boxes. The lowest was c.1.5m above the ground floor and the second one was c.3m high and set within the rubble wall. At the junction of what was the two-storey and single storey wall line was a raggle of a partition wall. Just above the ground floor and inserted into the raggle was another bearing box. A single slit vent facing into Unit 3 was the only opening on this end of the building.

Fig. 14 East range, west-facing elevation bearing box and first floor joist sockets

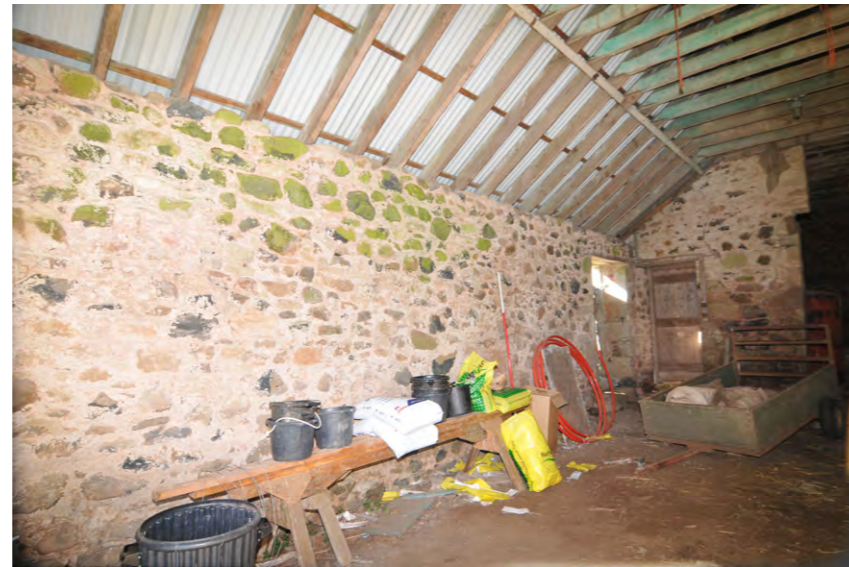
The east-facing wall of Unit 2 was featureless with a doorway at its north end. The remains of a partition wall survived to loft height and contained a doorway that once led into the northern half of the building. On the north side of the partition wall a window and door was present at ground floor level. Above these features was the line of timber floor joist stubs running the full length of the wall. These marked the position of the loft floor. Two windows of unequal size were present at loft level. The rest of the wall was featureless.

Fig. 15 East Range, east-facing elevation with surviving section of a partition wall

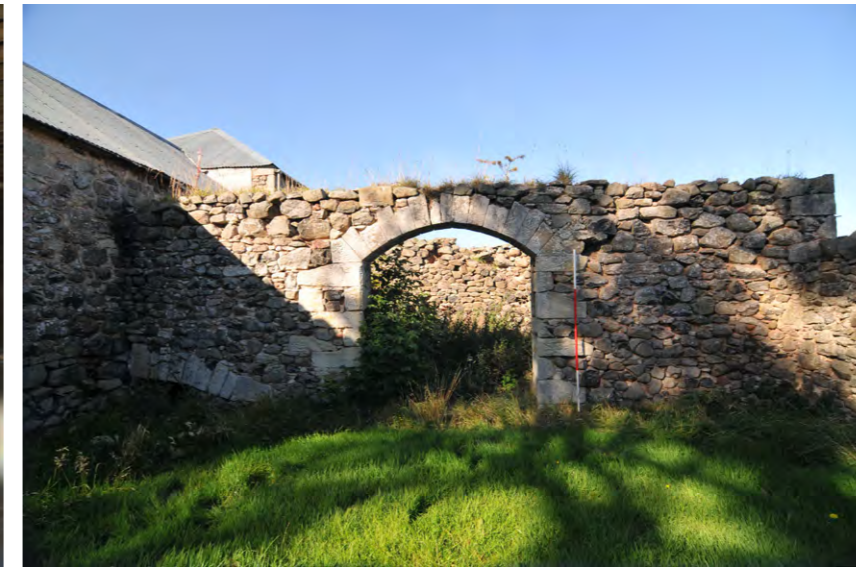
The south-facing elevation had a central segmented arched doorway framed by ashlar quoins. On the west side of the opening was a segmented arched mill lade that ran under the floor of the building. The arch had nine voussoirs. On the east side of the elevation a boundary wall had been incorporated into its construction. The boundary wall was 5.6m long, c.2m high and 0.45m wide.

Fig. 16 East range outshot building, south-facing elevation

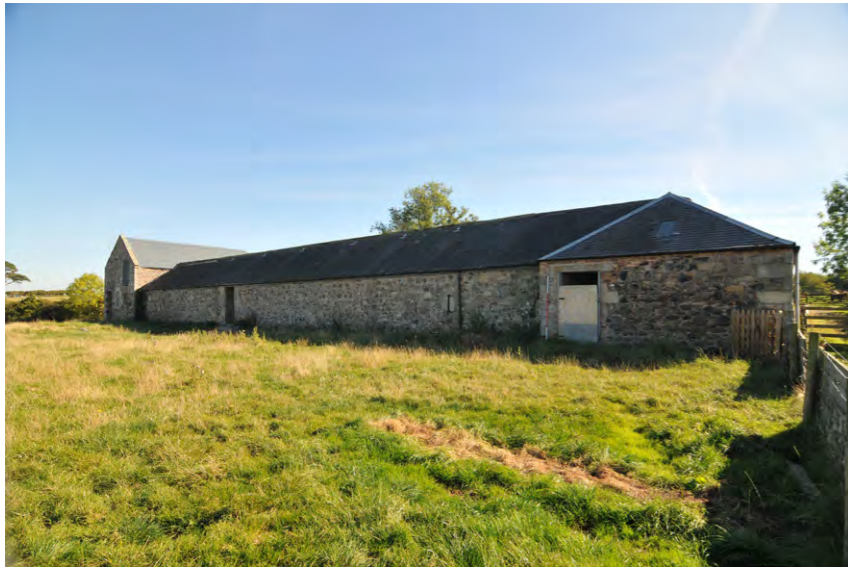
The north-facing elevation incorporated the two-storey gable of the East Range (Unit 2) and the West Range (Units 6-8). The elevation was set back by 0.5m from the two gable walls. It was constructed of coursed rubble throughout, the fenestration included a single off-centre doorway and two slit vents. All were framed by rough dressed and droved ashlar quoins.

Fig. 17 North Range, north-facing elevation

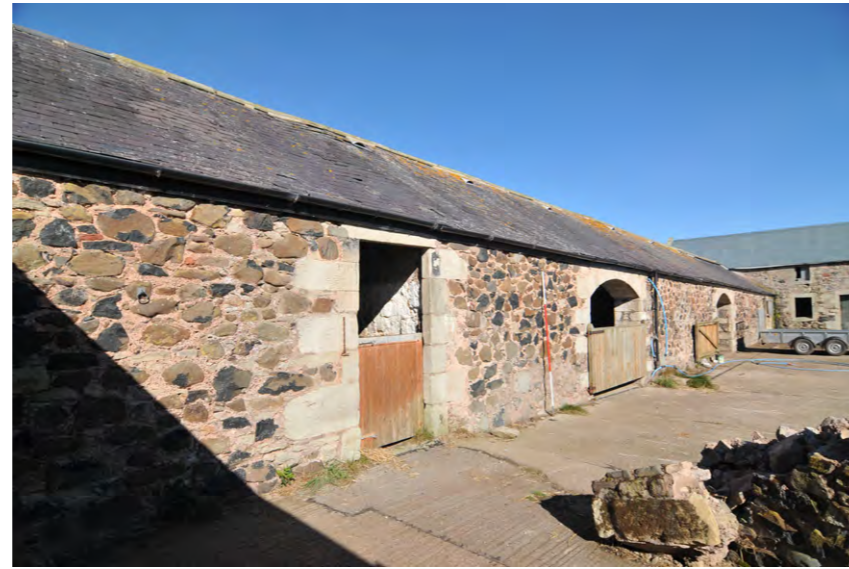
The south-facing elevation had symmetrical fenestration including two outer stable doors and two inner segmented arched openings. These were all framed with ashlar surrounds. The stonework used to create the segmented arches were recent inserts. The slate roof had a cat-slide vent at the east end.

Fig. 18 North Range, south-facing elevation

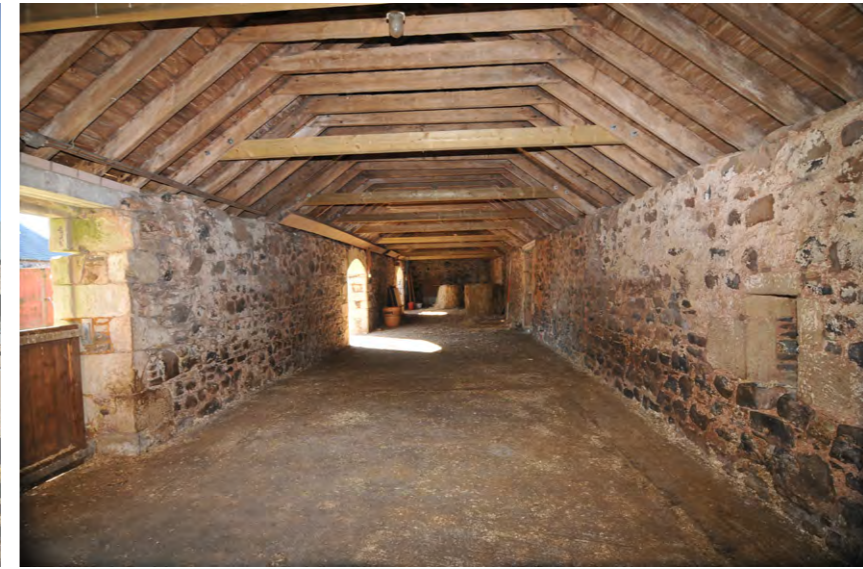
Unit 4 measured 27.4 m long and 4.7m wide and had featureless rubble walls throughout its length. The roof comprised A-frame collar rafters that rested on the wall heads.

Fig. 19 North Range, general view of the interior

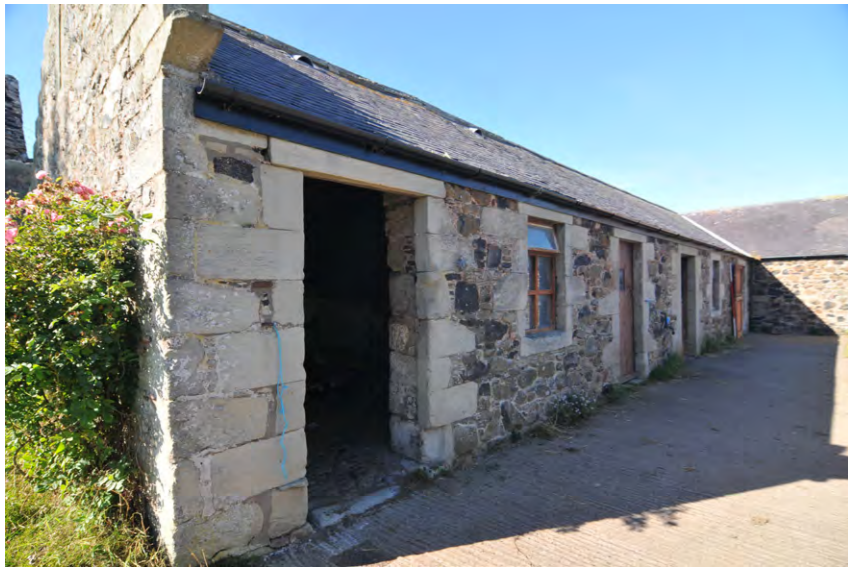
The east-facing elevation was rubble-built and contained 6 bays with two central doorways flanked by two windows. A doorway was situated at each end of the

elevation. The doors were all plank-built and the window frames were modern. All the openings were framed by droved ashlar sandstone and the lintels were modern inserts.

Fig. 20 West Range, east-facing elevation

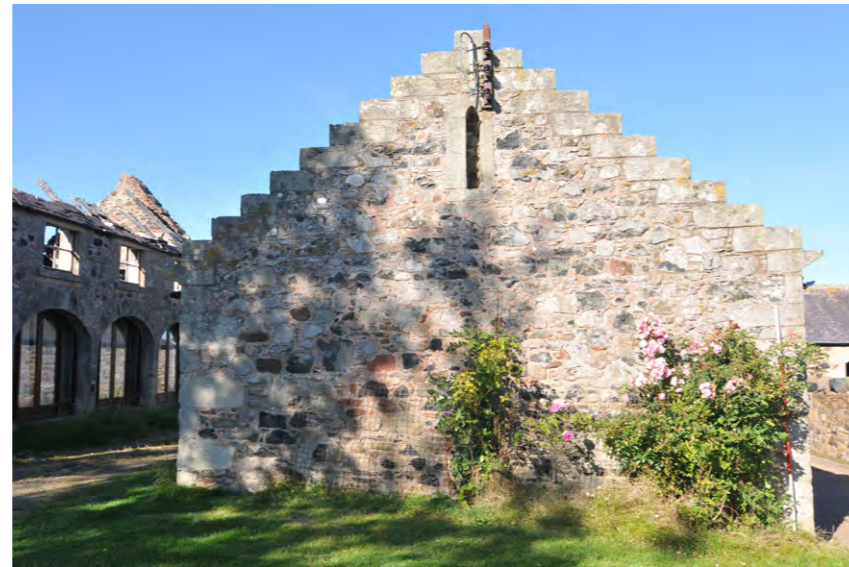
Fig. 21 West Range, south-facing gable

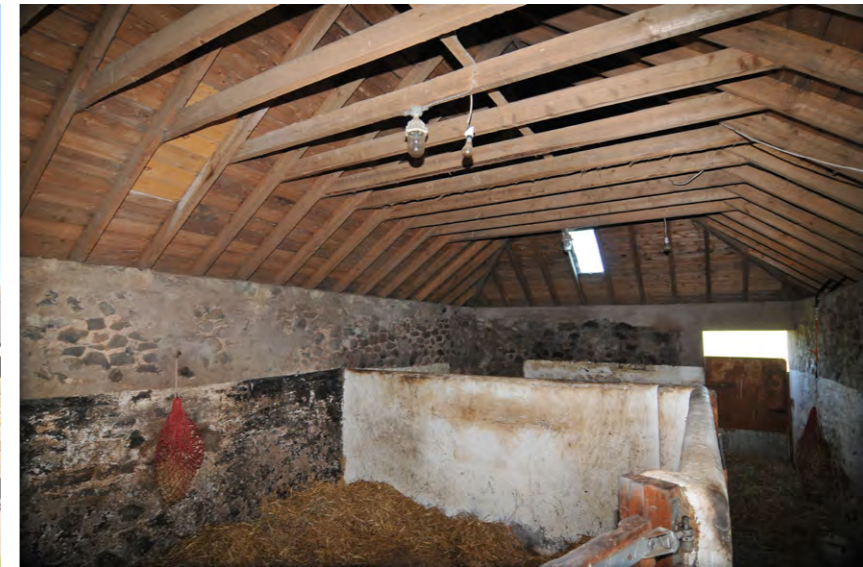
Fig. 22 West Range, interior view of the stable stalls

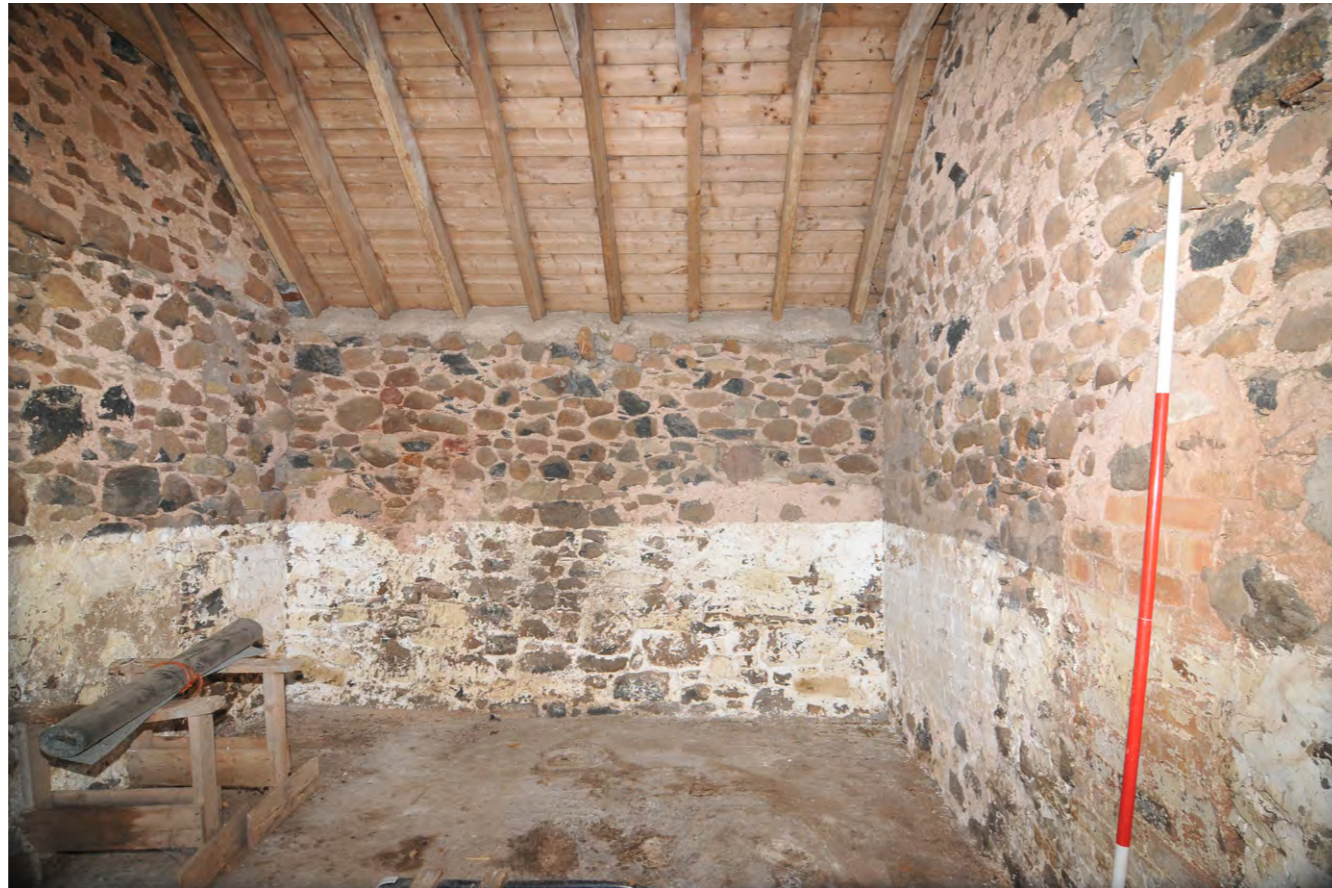
Fig. 23 West Range, interior of Unit 8, stable

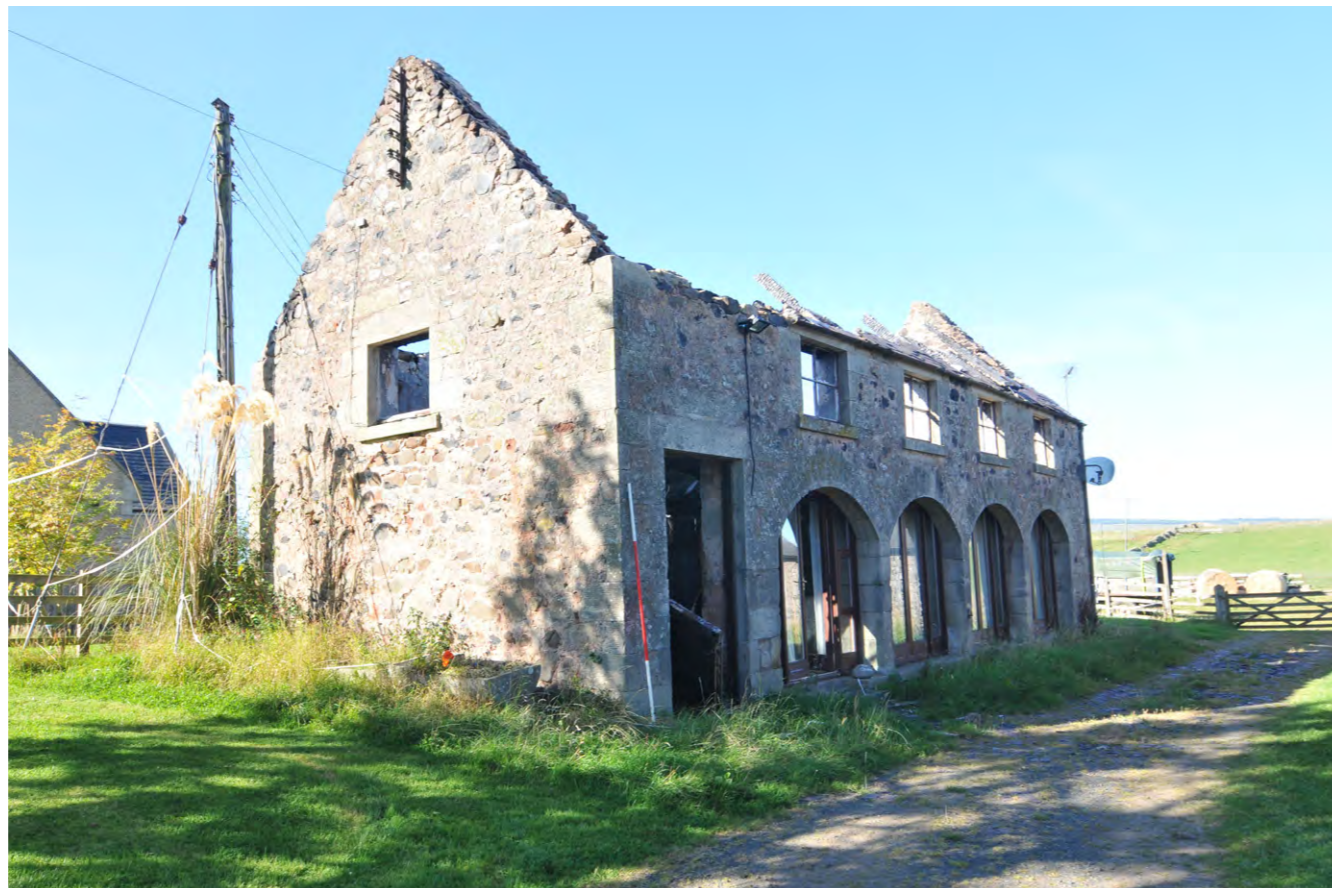
Fig. 24 General view of the fire-damaged former granary building and cart shed
