**Braid Church, 1 Nile Grove,  
Morningside, Edinburgh**

**Historic Building Report  
No 2033**

**Historic Building Survey**

**Report No 2033**

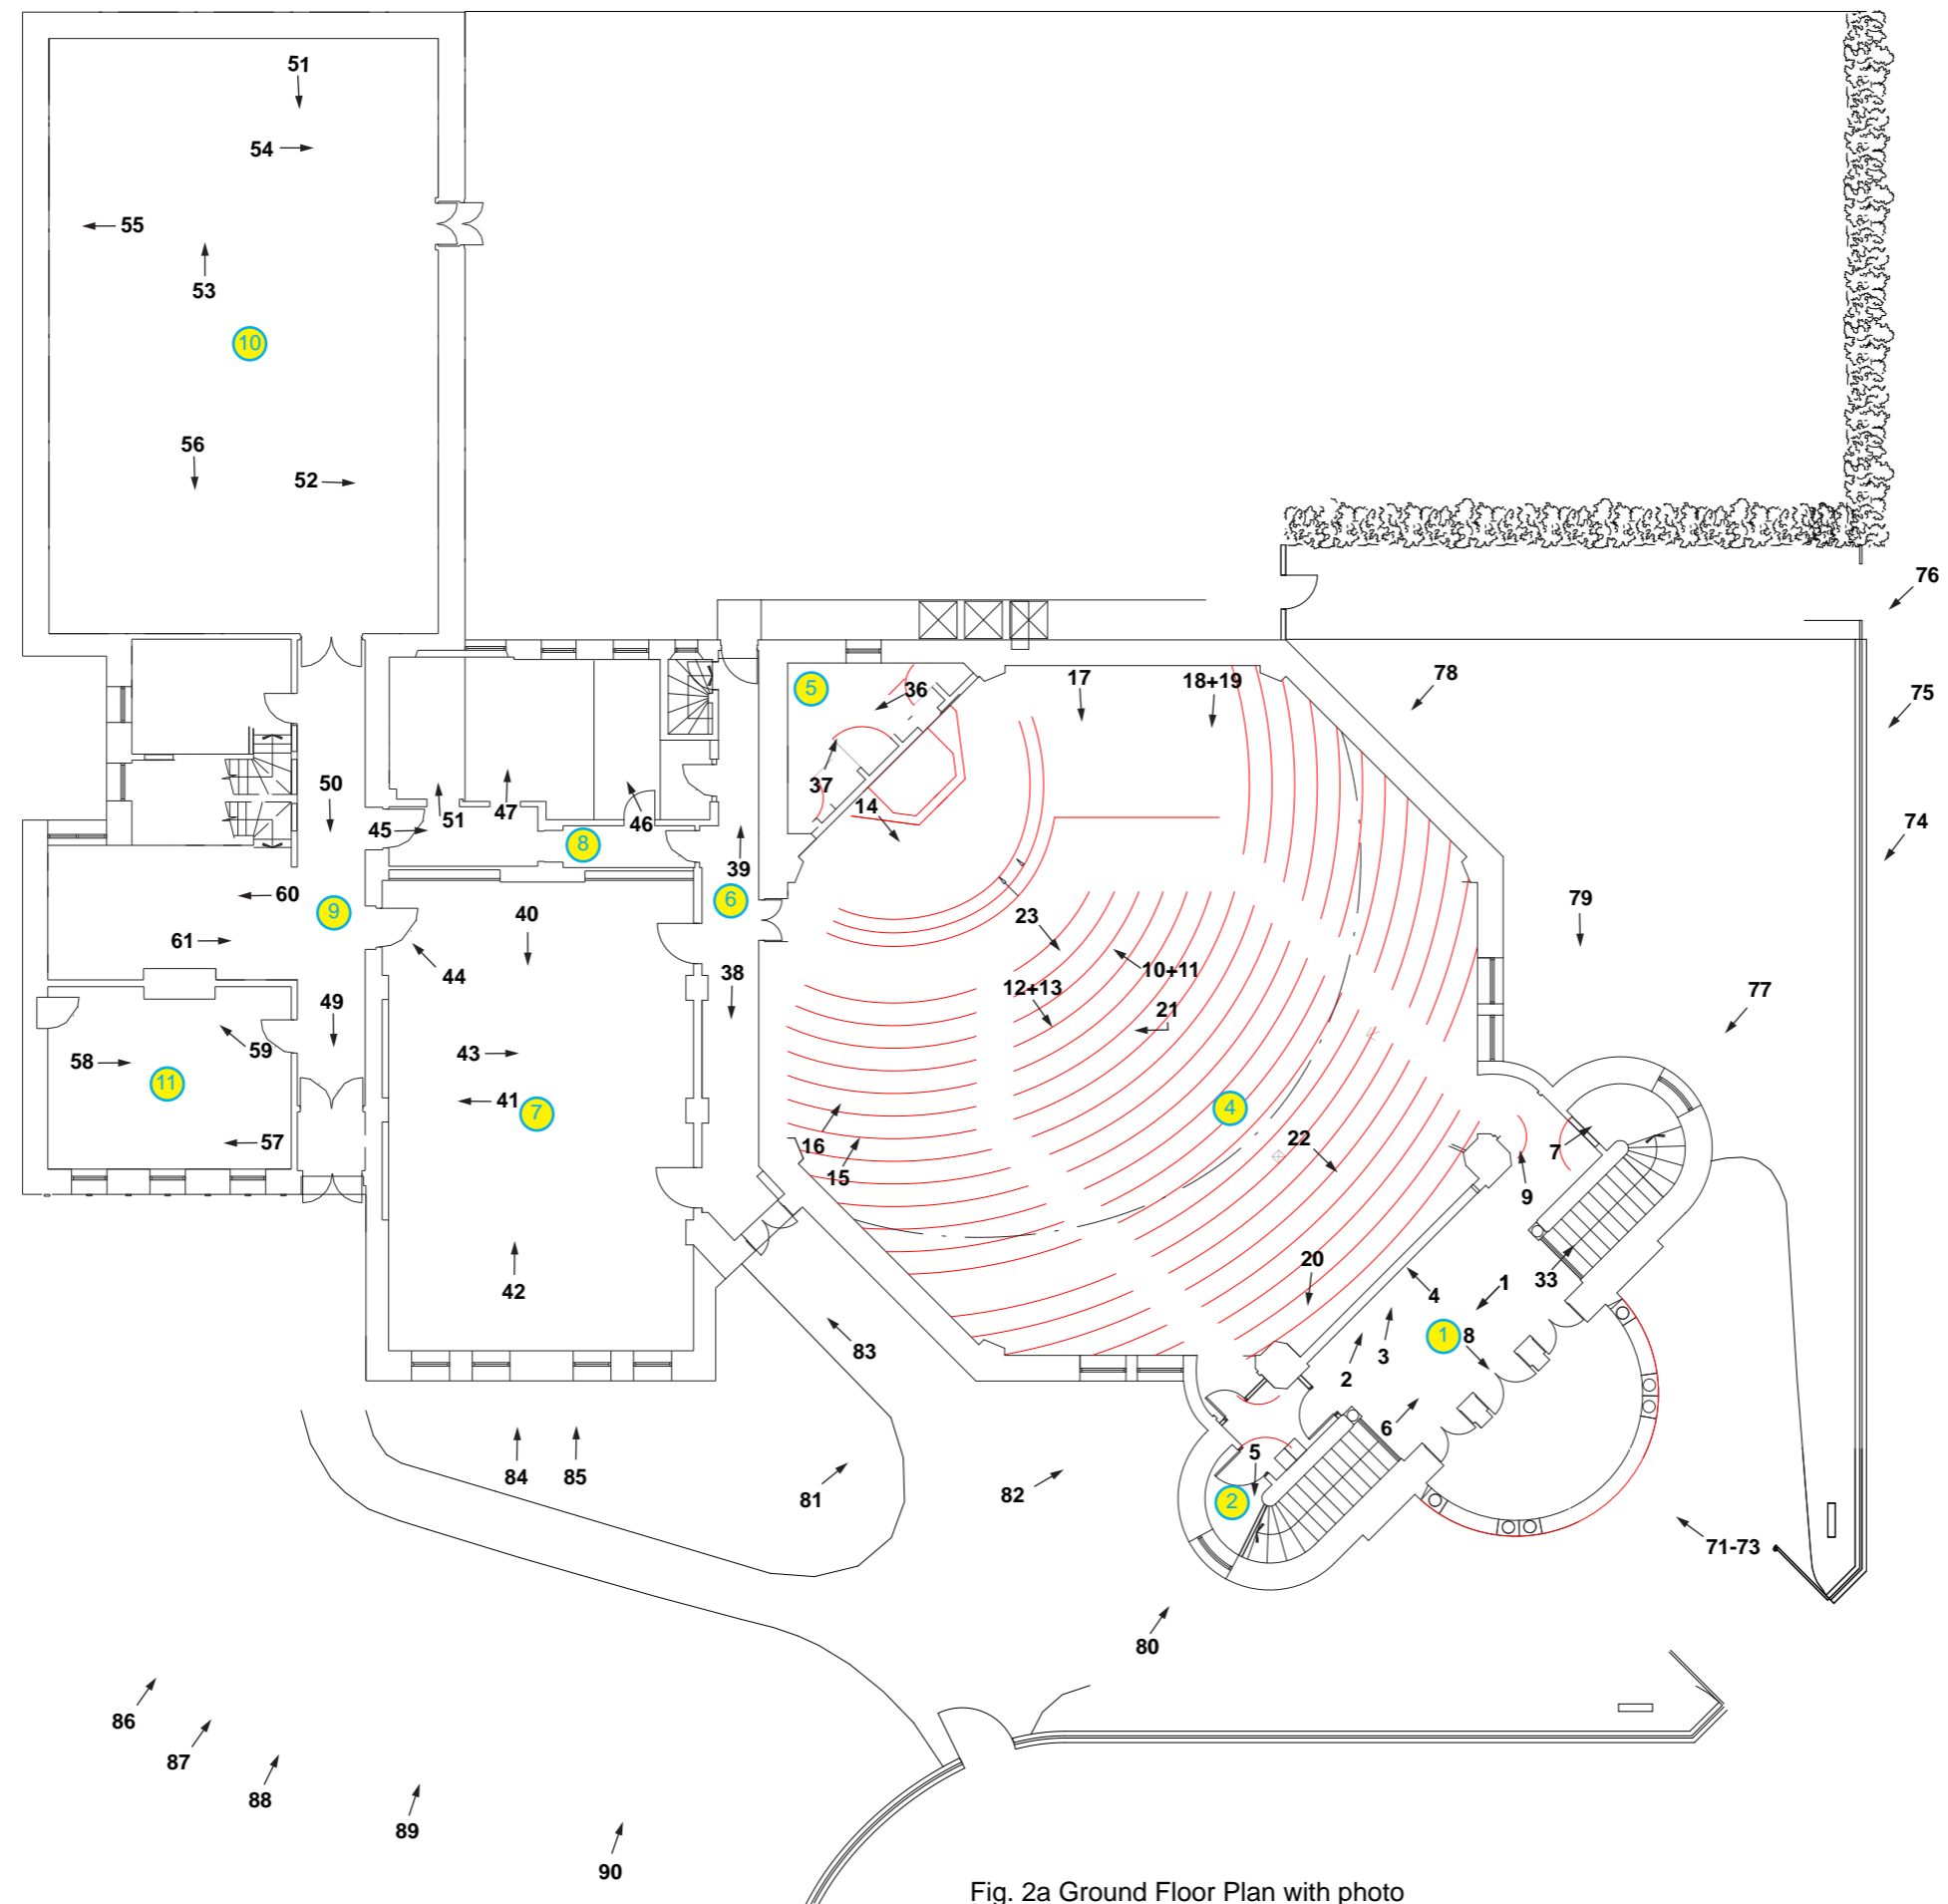
Fig. 2a Ground Floor Plan with photo locations

Figure 2a and 3b-c shows the ground and first floor plans of the church and the Large and Small Halls. These figures show the unit numbers ascribed to the rooms below. The dimensions of the individual rooms within each building are listed in Table 2. Summary descriptions of each unit are listed in Table 3.

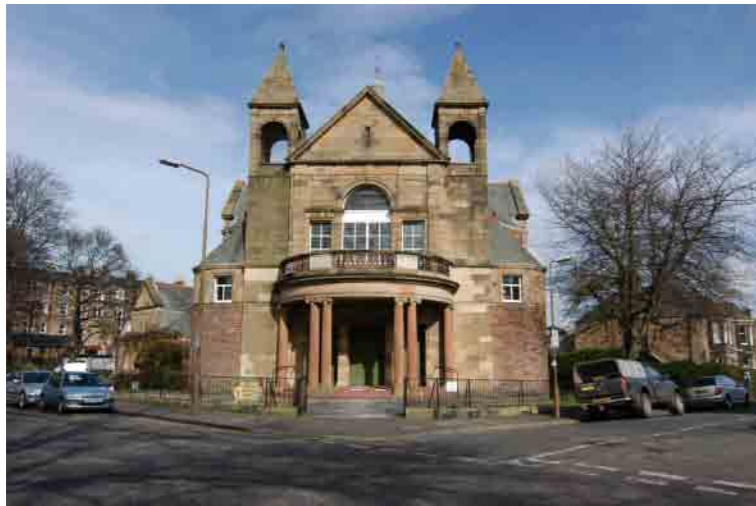
The architectural descriptions are adequately described in Historic Scotland's Statutory List and need not be repeated here. The principal south-west facing elevation is the most impressive with its column- flanked entrance with balustrade above (Fig 3). The Italianate windows have a pediment which is advanced. The columns and stair turrets break the strong angular footprint of the church. Set back are the two bellcotes with bird-cage openings (Fig 3). The side elevations (south-east and north-west) are broken by the large clerestory windows and the curve of the stair towers (Fig 4-5). The hall elevations are plain with the exception of the west-facing elevation of the Small Hall. The ashlar-built façade has four bays surmounted by pilasters below the pediment (Fig 6). The north-east facing elevation of the church includes the clerestory windows (Fig 7). The main entrance gate (Fig 8) has a dove and fish motif and is flanked by a low wall with chamfered coping stones.

Fig. 3 South-west-facing elevation of Braid Church

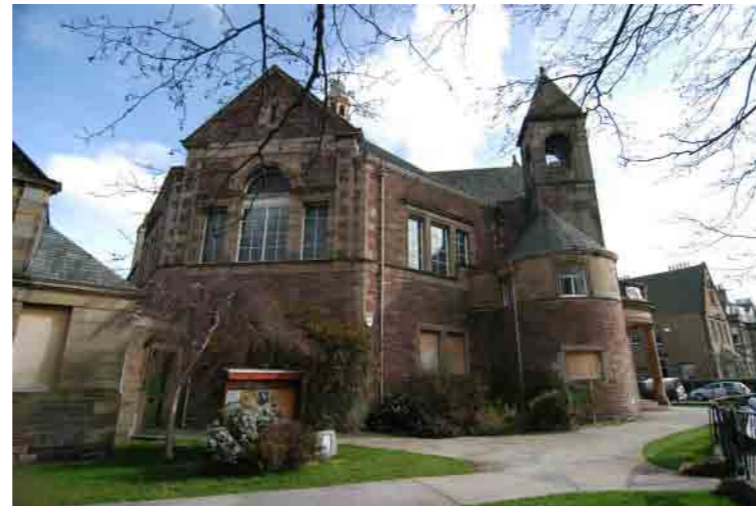
Fig. 4 Snecked-built sandstone stair turret, south-east elevation

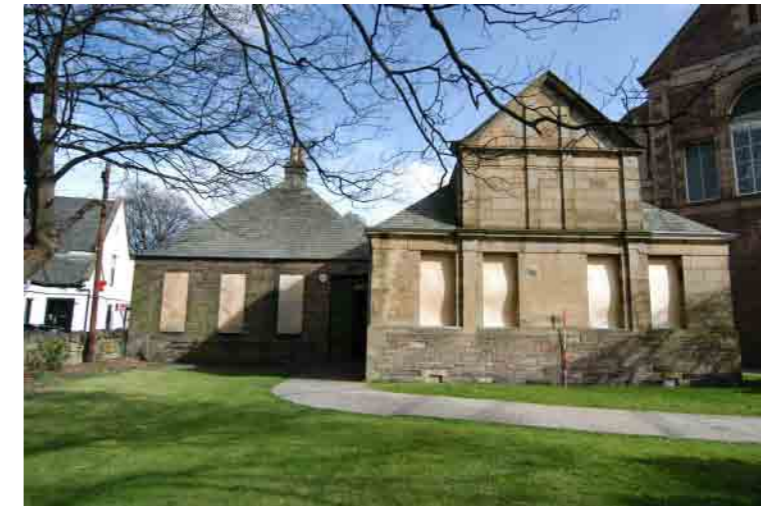
Two church halls are set obliquely on the north side of the church and are linked to the church through passages on their west sides. Both halls are single storey. The Small Hall has an ashlar gable with pediment and a piend roof. Two bipartite windows divided by flat pilasters and a tall pedimented centre bay has angled

pilasters. The roof ridge incorporates a decorative galleried ventilator with ogee cupola.

Fig. 5 South-west facing elevation of the Small Hall

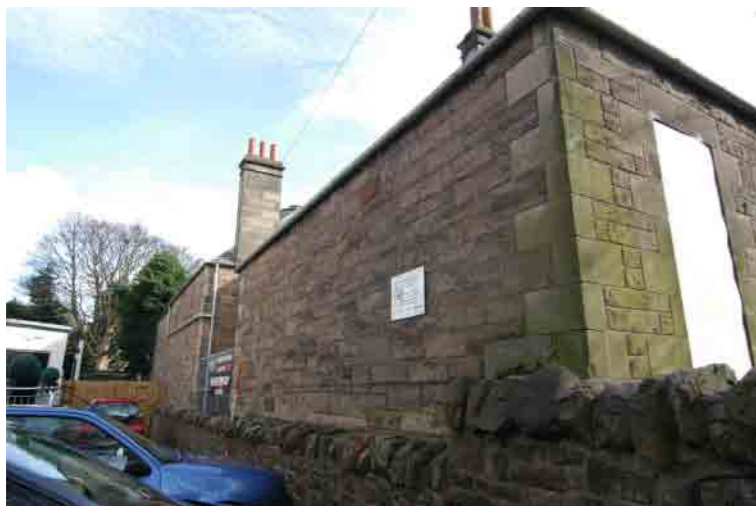
Fig. 6 West-facing elevation of the Small Hall

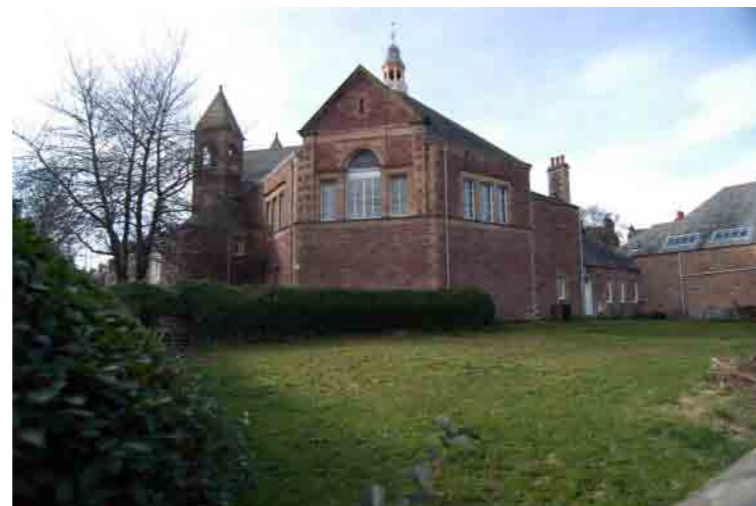
The north-east (rear) elevation is occupied by the organ chamber and is mainly featureless.

Fig. 7 North-east facing elevation of Braid Church

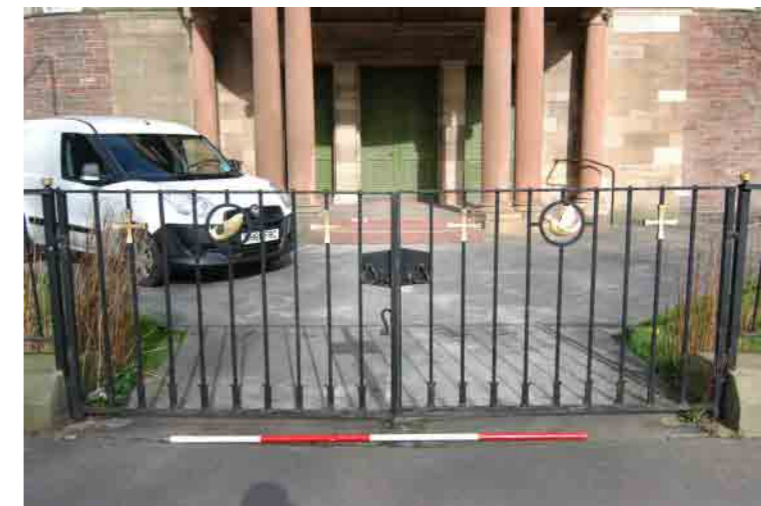
The Statutory List also includes the low rubble-built boundary walls that incorporate plain cast-iron railings and the gates inset with fish and dove motifs and small thistle finials on the main gate.

Fig. 8 Listed main gates with fish and dove motif

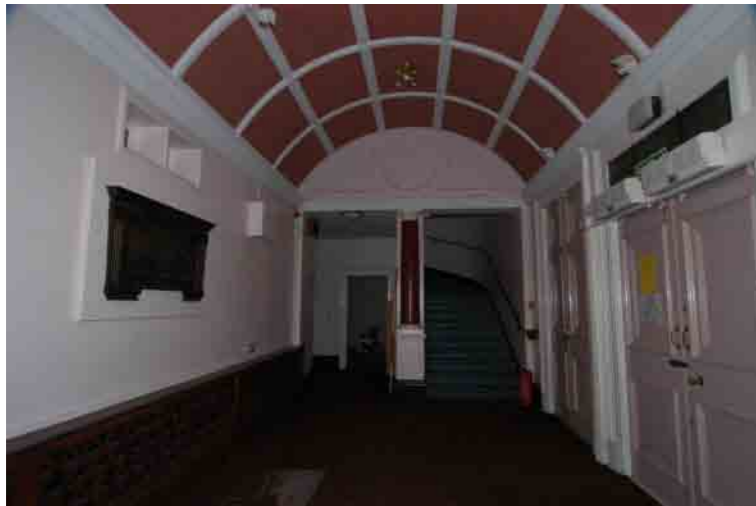
<b>Unit No.</b>	<b>Room/feature</b>	<b>Summary description</b>
1	Vestibule (Fig. 9)	The main entrance has three sets of double-leafed doors. The ceiling is barrel vaulted broken by regular inset panels. A below stairs cupboard and stairs to the first floor is present at each end. The stairs are flanked by columns resting on a rectangular base. A brass memorial plaque is present on rear (south-west facing wall) which is dedicated to the first minister of the church. Two leather clad doors lead into the auditorium.
2	Below stairs cupboard	A semi-circular shaped cupboard lit by a six paned blind window. Coat hooks on rear wall. The main door is six-panelled.
3	Below stairs cupboard	A semi-circular shaped cupboard lit by a six paned blind window. Coat hooks on rear wall. The main door is six-panelled.
4	Auditorium (nave) (Figs. 10-13)	The auditorium is lit on all sides by large Italianate windows with both square and round heads. The north-east facing elevation has a central round-headed window flanked by a pair of square headed windows. The floor of the nave is ramped as is the first floor. The wooden pews curve gently in order to conform to the floor layout. The central isle has 13 rows, with 9 and 11 rows on the north and south sides respectively. The rose-red painted octagonal ceiling is heavily moulded to emphasise the individual panels. The altar has a wooden classical facade with pediment and a large arched frieze exposing the rows of organ pipes. The organ console has been removed but it was located on the east side of the chancel. The balcony is broken by simple panels with a clock at its centre. The floor of the balcony has 10 rows of pews at its centre flanked on each side by four rows. Doors midway along the balcony floor lead out to the ground floor.

Fig. 9 Church vestibule with painted vaulted ceiling

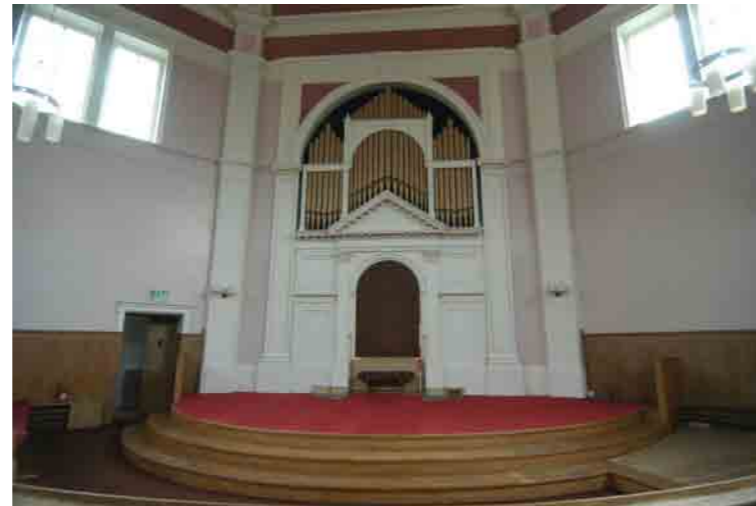
Fig. 10 Church chancel and altar

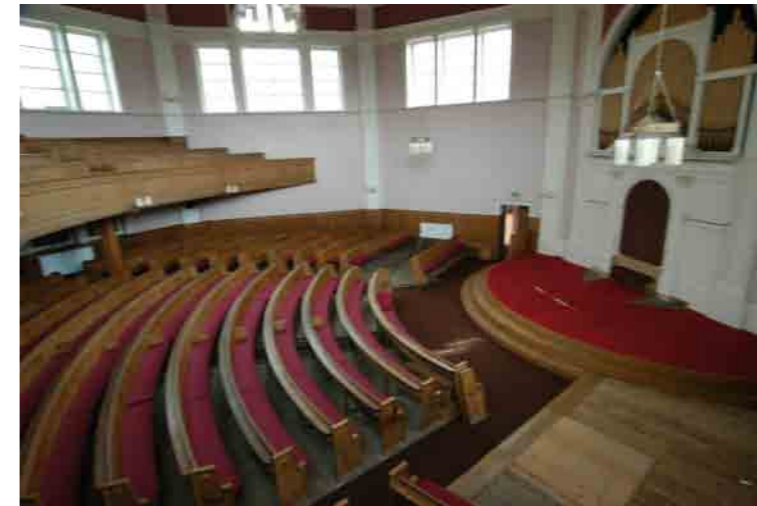
The interior of the church has a raked auditorium with a curving timber gallery on square wooden columns. Corniced angle pilasters lead up to the paneled ribs of a shallow octagonal dome with a central ornamental ventilation grille. The entablature clerestory windows are framed by plain cornices. The numbered church pews are plain timber and follow the curve of the church floor. The pulpet, lectern and communion had been removed at the time of the survey but they are described as being of plain timber. The vestibule has a compartmentalised barrel vault with short marbled wooden columns dividing the stair openings on each side.

Fig. 11 Church auditorium and balcony

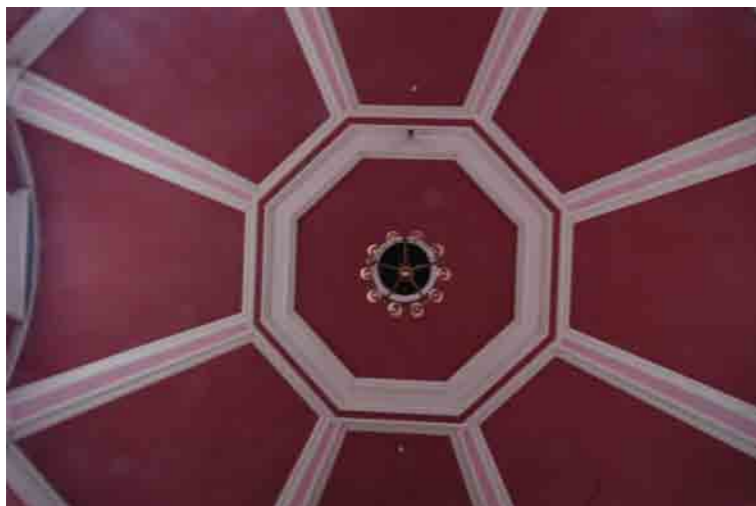
Fig. 12 Octagonal-shaped ceiling within the church

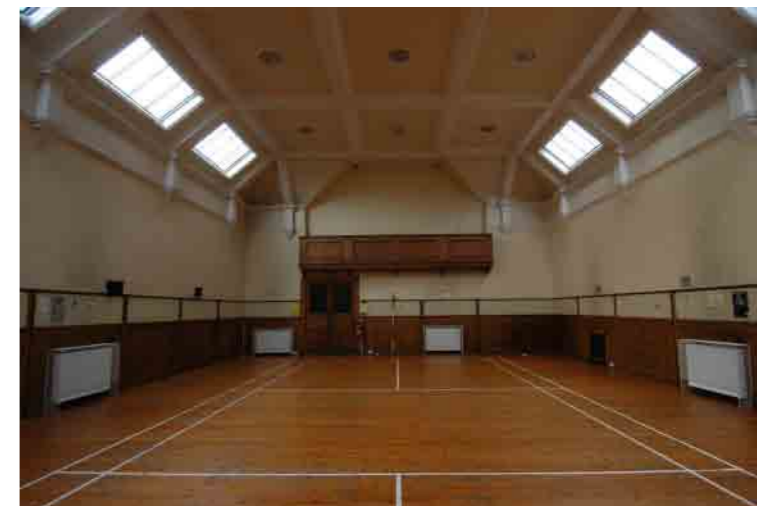
9	Hallway	A hallway between the Large and Small Halls with white painted walls and doors leading off the north wall to the Large Hall (Unit 10) Kitchen (Unit 11) and Session Room (Unit 12). On the south wall doors leads to the Small Hall (Unit 7 and the toilet block (Unit 8).
10	Large Hall (Fig. 15)	The walls are panelled on the lower half to a height of 1.2m. The hall is lit by four-paned roof lights within the mansard-shaped ceiling. Each plastered roof beam rests on a short pilaster with moulded scrolled corbel. A cornice and architrave run between the pilasters. At the west end of the hall there is a wooden panelled balcony accessed by an

Fig. 15 Small hall showing the beams and ceiling configuration

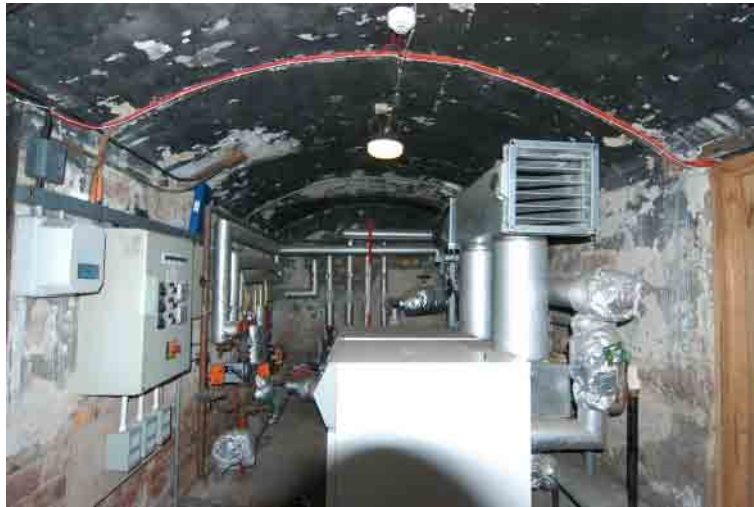
exterior staircase. The parquet floor is marked out for recreational games.
11	Session Room	The Session Room is lit on the west wall by three nine-over-two paned sash-and-case windows. A plain blocked fireplace occupied the opposite wall. The moulded cornice has an egg-and-dart motif.
12	Kitchen	The kitchen has pastel-green painted walls with an egg-and-dart cornice. A dado rail is present on the south wall. All fixtures and fittings are modern.
13	Basement entrance	The entrance to the church basement has plaster-lined walls. A blocked coal chute is present on the east wall. The entrance into the adjoining boiler room (Unit 14) is through a door in a brick partition wall.
14	Boiler Room (Fig. 16)	The boiler room has a barrel-vaulted roof with plaster over stone. The room has a blind window on the east wall. The room is fitted out with electrical boilers and the south wall is lined with electrical switches.

Fig. 16 Interior view of the basement boiler room with vaulted ceiling

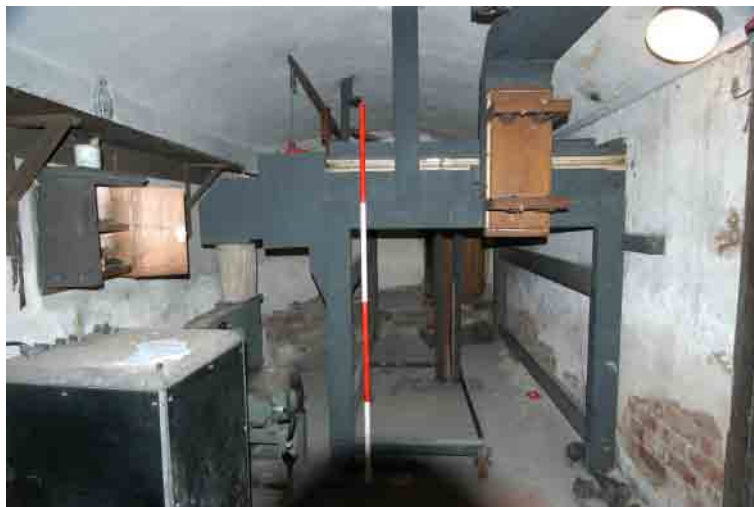
15	Organ pump room (Fig. 17)	The organ pump room has a barrel-vaulted ceiling with a blind window on the east wall. The floor is occupied by an electrical driven organ pump within a wooden framework.

Fig. 17 Interior view of the basement organ pump room with vaulted ceiling
