Excavate trenches and lay district heating  
mains between existing mains and multi-  
storey blocks, Seaton, Aberdeen

Cameron Archaeology  
29 March 2011

# **Excavate trenches and lay district heating mains between existing mains & multi-storey blocks Bayview Court, Northsea Court, Aulton Court, Beachview Court, Balgownie Court, St.Ninian Court, Inverdon Court and Lords Hays Court, Seaton, Aberdeen**

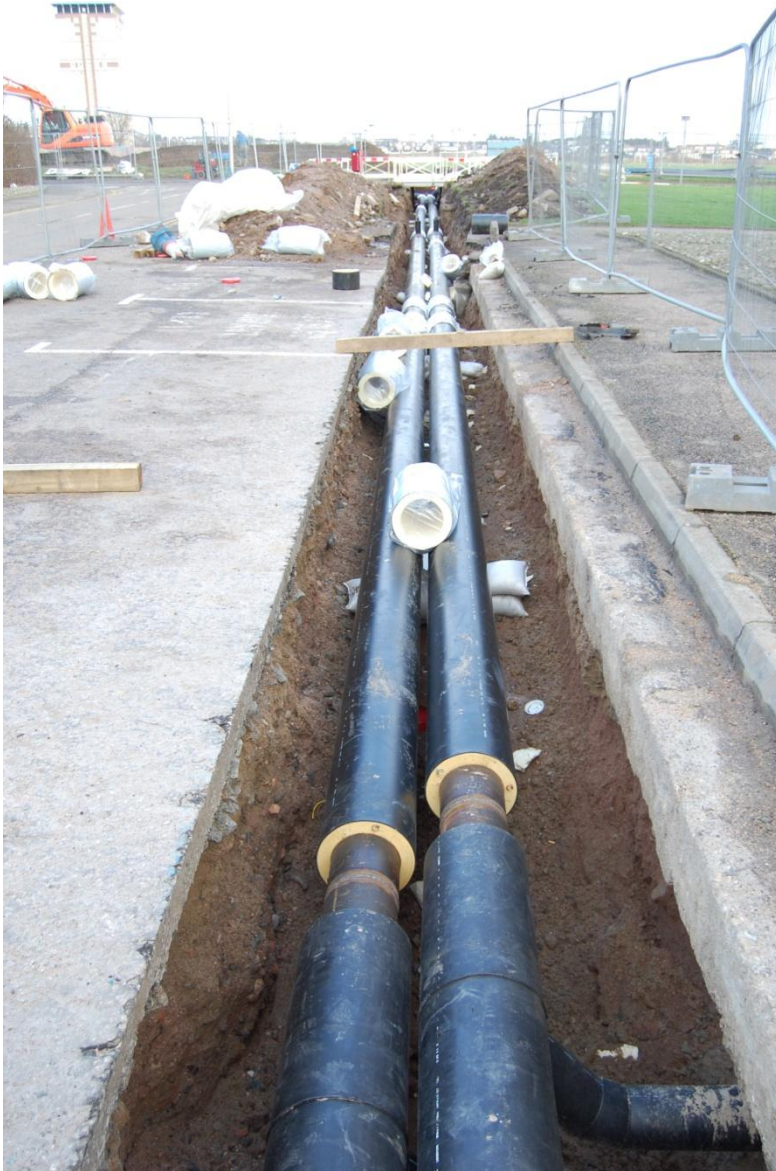
III 3 Trench excavated through Seaton Pottery site

A watching brief was carried out during excavation of trenches for laying heating pipes between Beachview Court and Balgownie Court. Unfortunately prior to an archaeologist being appointed trenches had been dug from Bayview Court to the north of Beachview Court, pipes laid and some trenches backfilled. This included a trench through the Seaton Pottery site which has been previously investigated (Cameron 2002, 2003).

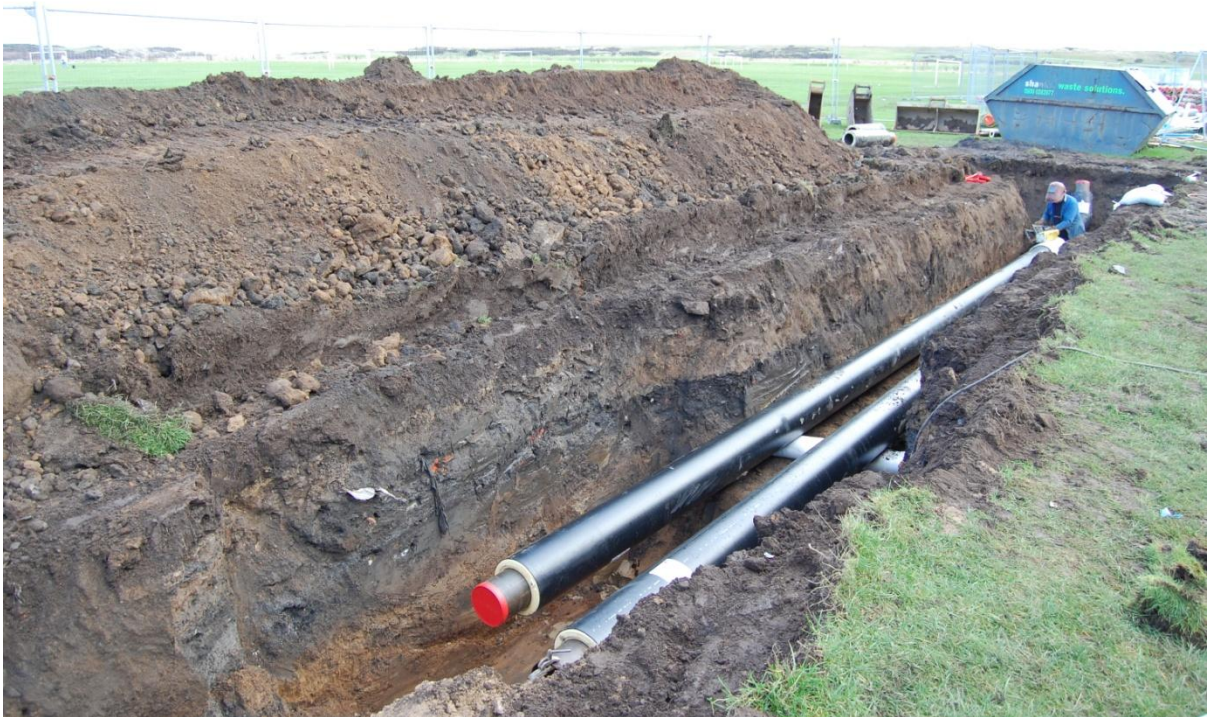
Ill 4 Trench 1 showing 1.5m domestic refuse

Trench 1 and the south part of Trench 2 were cut through 1.5m domestic rubbish dumped in the area in the early 20th century. The north of Trench 2 and Trench 3 were cut through dumps of sand and clay probably into old clay pits where clay was extracted for use by the nearby Pottery and Brick and Tile works.

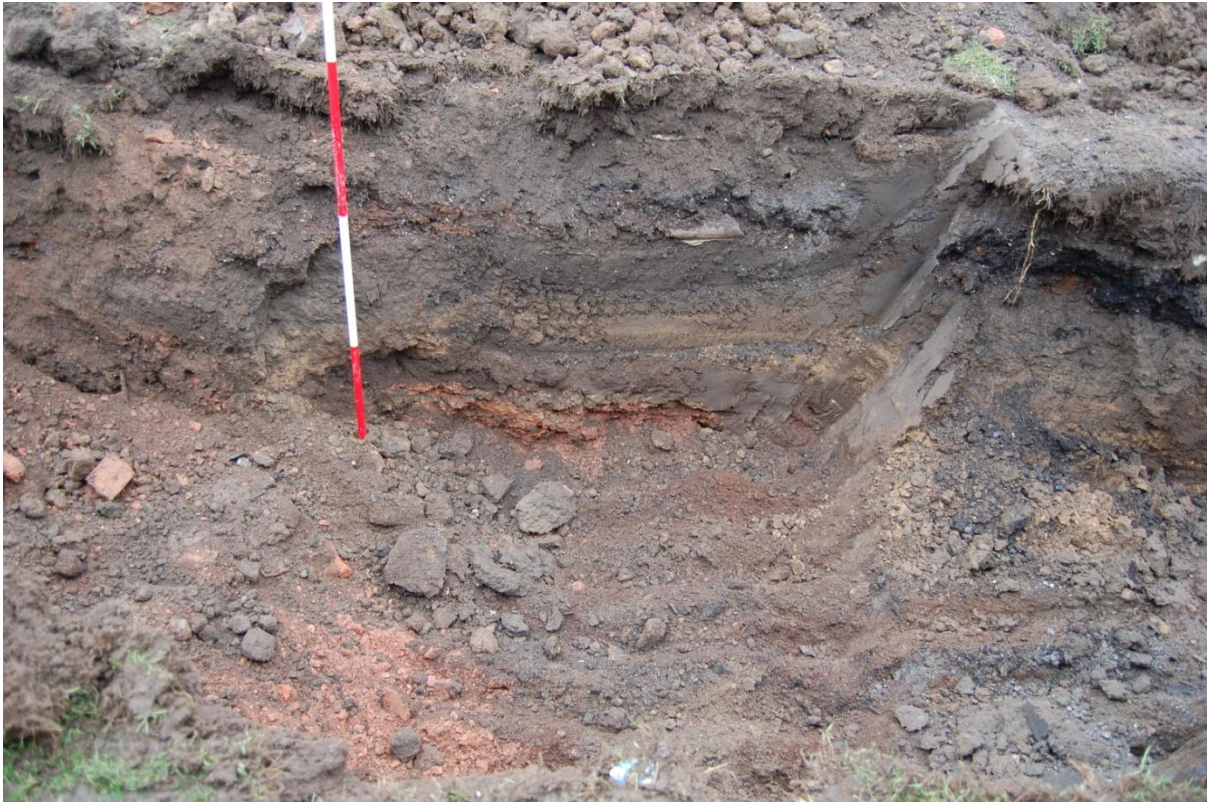
The trenches were dug to 1.5-2m deep and several areas of brick and tile waste were recorded. In the trench east of Seaton School a dump of brick and tile (F2) was found at a depth of 2m below the current ground level. It was recorded but left *in situ* as it did not have to be disturbed for the current development. North of Seaton School an area 6m long contained several pits and dumps of brick and tile waste (F8 and F9) which were sectioned by the trench for the current development. These deposits were sampled and recorded. At the junction of the trench north of the school and east of the Nursery, another dump of brick and tile was sectioned by the current trench.

Ill 6 Trench 2 F2 showing brick rubble 1.5m below current ground surface

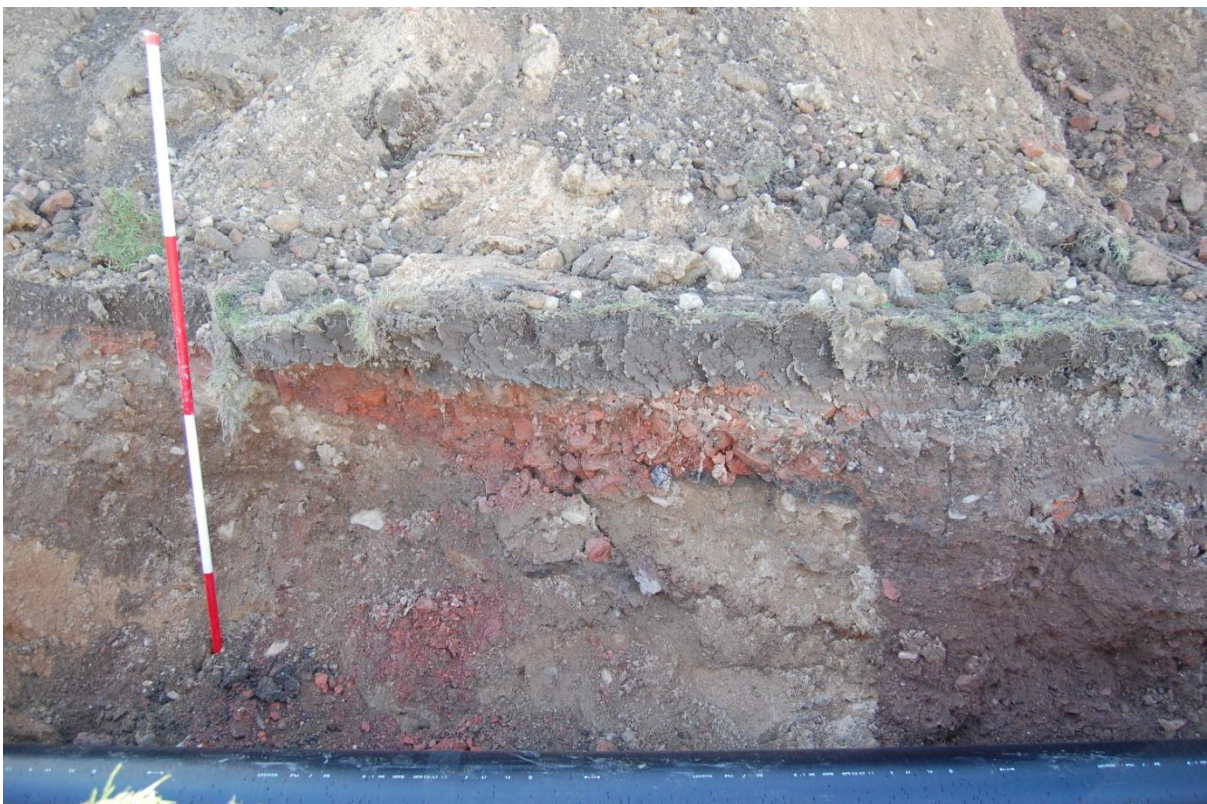
Ill 7 Trench 3 brick and tile wasters 3 (centre) and pit F9 (right)
