**Primark Store, 91-93 Princess Street
Edinburgh
Elevation Recording
Report No. 1869**

| Commissioned by | 3D Reid Architects' on behalf of Primark Stores Ltd |
| Date issued | March 2011 |

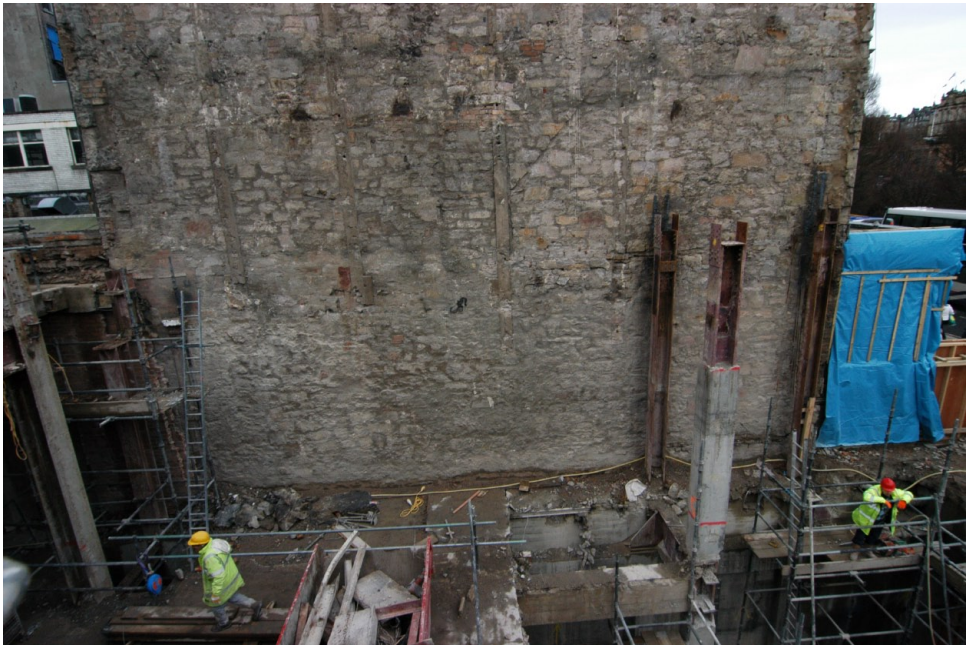
Plate 2 - General view of the west-facing elevation of 90 Princes Street at street level and basement level

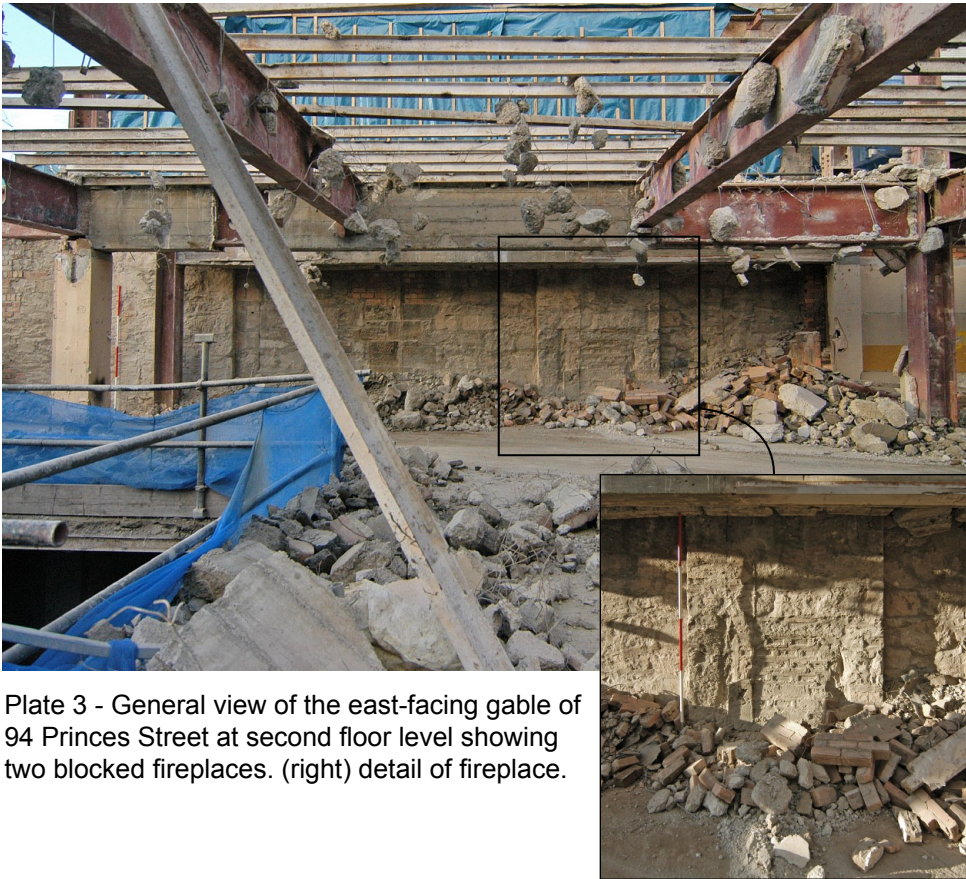
On the second floor of the former M&S building two features were exposed on the east-facing elevation of No. 94 Princess Street (Plate 3). These comprise two chimney breasts with blocked fireplaces. Each chimney breast was exposed to a height of 2m high and was 1.5m wide. Both were advanced by 0.20m. They were constructed of random rubble and the blocked work in the fireplaces was red-brick (1m x 1m) in stretcher bond.

Plate 3 - General view of the east-facing gable of 94 Princes Street at second floor level showing two blocked fireplaces. (right) detail of fireplace.

Two blocked fireplaces of probable 19th-century date were recorded on the east-facing gable of No. 91 Princess Street.
