Replacement Overhead Line (YX route) Ben Cruachan Hydro Power Station to Dalmally Substation

Walkover Survey

Report No: 3311

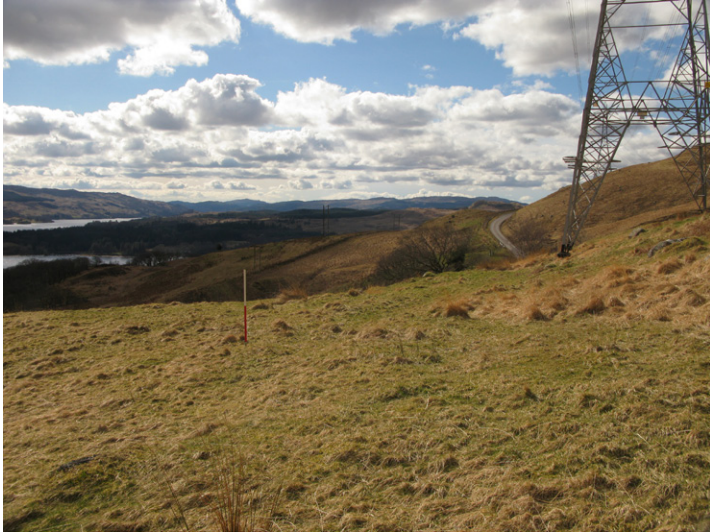
Site 3 (NGR: NN 10313 26427) (Fig. 2) to the north of Tower YX10 was identified to be an area of roughly WNW to ESE aligned rig-and-furrow, covering an area of 22m by 17m. The furrows survive to a maximum height of 0.15, and have a roughly 4m wavelength. The site was demarcated with canes and high visibility tape.

Fig. 2 - Site 3: rig-and-furrow east of Tower YX10

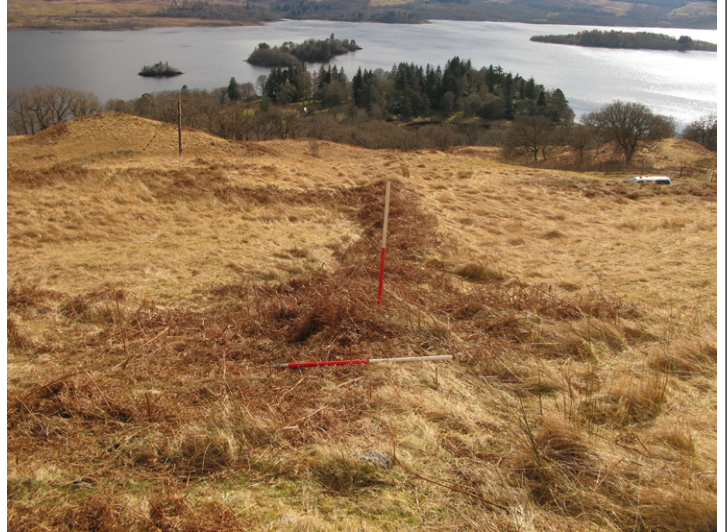
Site 5a (NGR: NN 10838 26466) (Fig. 3) to the east of Tower YX12 comprises a field bank 60m in length and a maximum of 1.5m in width. The bank survives to a maximum height of 0.3m, and was aligned north to south. This is adjoined on the west by Site 5b (NGR: NN 10828 26528) (Fig. 4) consisting of north to south aligned rig-and-furrow covering an area of 20m by 15m. The rigs survive to a maximum height of 0.1m and have a wavelength of roughly 4m, similar to Site 3. It is probable that Sites 5a and 5b form a field system with bank 5a once enclosing rig-and-furrow 5b.

Fig. 3 - Site 5a: field bank to the east of Tower YX12

related to the field system of Sites 5a and 5b to the east. Site 5 was demarcated in its entirety with canes and high visibility tape.

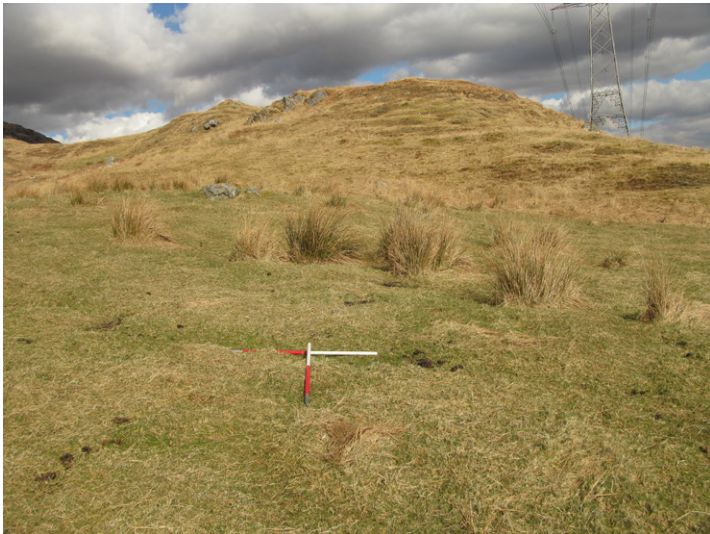
Fig. 4 - Site 5b: rig-and-furrow adjoining Site 5a on the east

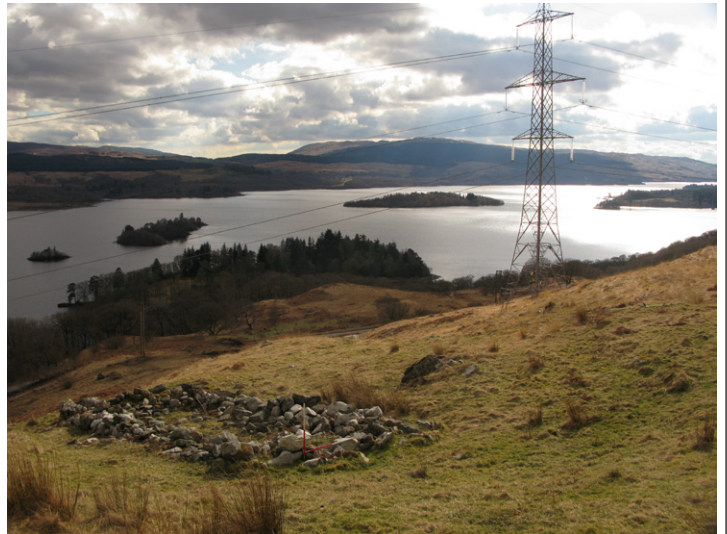
Site 5c (NGR: NN 10971 26613) (Fig. 5) comprises an 11m by 5m rectangular structure immediately west of Tower YX12. The walls are upstanding and consist of roughly coursed stone up to a maximum height of 0.6m, with considerable levels of inward and outward tumble to a total width of 1.5m. It is likely that this structure is

Fig. 5 - Site 5c: rectangular structure to the west of Tower YX12

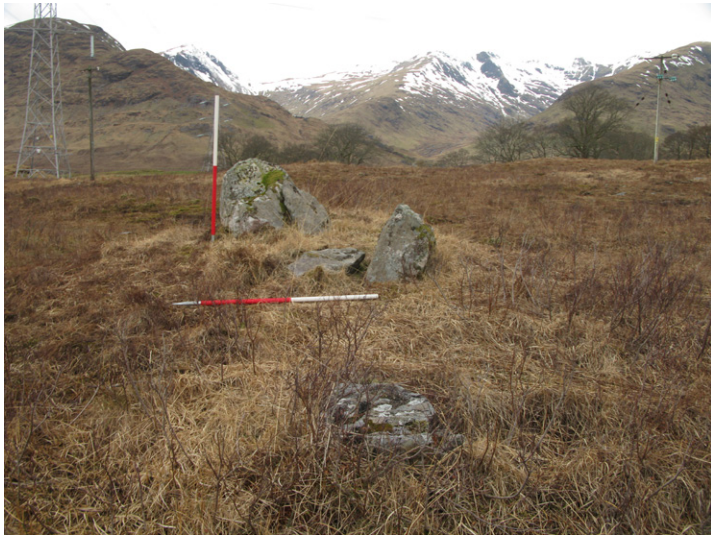
A possible clearance cairn, Site 14 (Fig. 6, NGR: NN 14180 29510). was identified as a grouping of stones c.3m in diameter and surviving to a height of 0.8m at maximum. Rocks up to 0.5m in diameter were seemingly intentionally piled, most likely in an attempt at field clearance.

Fig. 6 - Possible clearance cairn (Site 14)

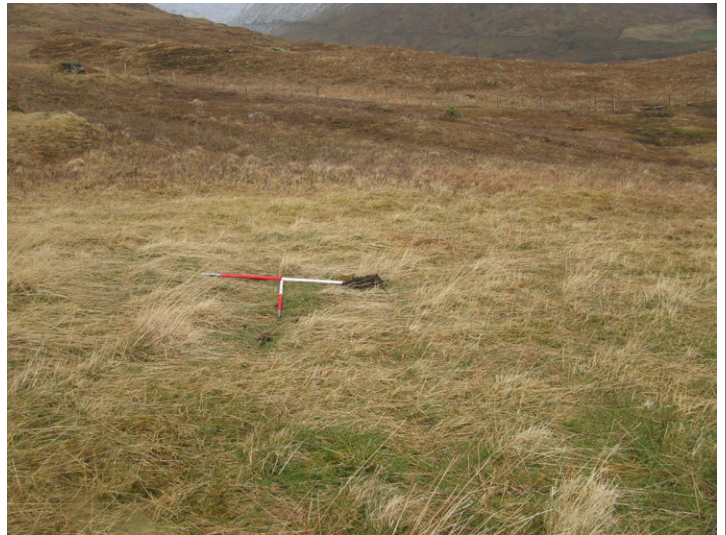
Site 15 (NGR: NN 12946 28380) (Fig. 7) was identified to be an area of east to west aligned rig-and-furrow along the proposed ATV track between Towers YX18 and YX20. The rig-and-furrow covers an area of roughly 30m by 18m and rigs survive to a height of 0.3m with a wavelength of roughly 3m. The site exists on an area of unimproved pasture which gently slopes to the south-east.

Fig. 7 - Site 15: rig-and-furrow between Towers YX18 and YX20

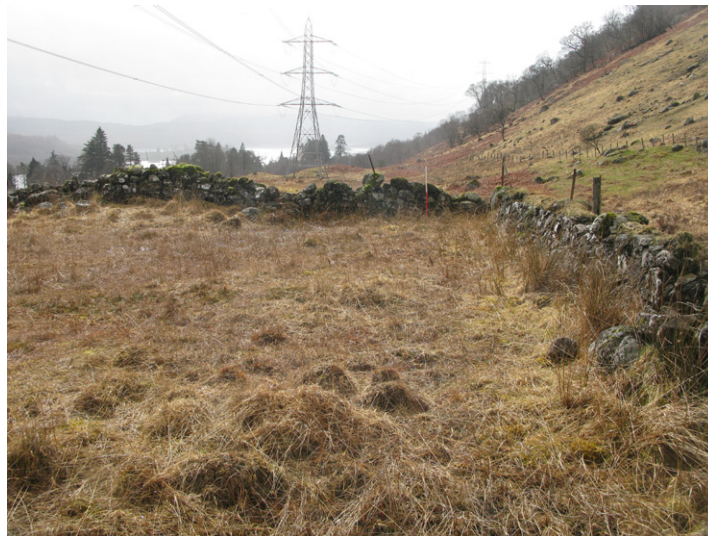
Site 16 (NGR: NN 12832 28110) (Fig. 8) was identified to be a drystone rectangular enclosure again lying on the proposed ATV track between Towers YX18 and YX20. The walls of the enclosure consist of roughly coursed stone up to a maximum of 1m in height. The structure has a total length of c.300m and a width of 200m. The enclosure is situated on an area of ground which slopes gently to the south-east. At the bottom of this slope, next to the existing public road, the walls terminate and meet with a multi-compartmented sheepfank structure. The north-east corner of the structure has a turf and stone bank extending a further 21m to the north-east, possibly representing an earlier phase of the structure. Where the proposed ATV route bisected this structure, through an existing gap in the wall, the area was demarcated with canes and high visibility tape.

Fig. 8 - Site 16: large drystone enclosure between Towers YX18 and YX20
