***Braevallich Farm, Loch Awe, Argyll
Proposed Hydroelectricity Scheme***

***Report on a rapid Archaeological Walk Over Survey
and
Method Statement for Archaeological Work***

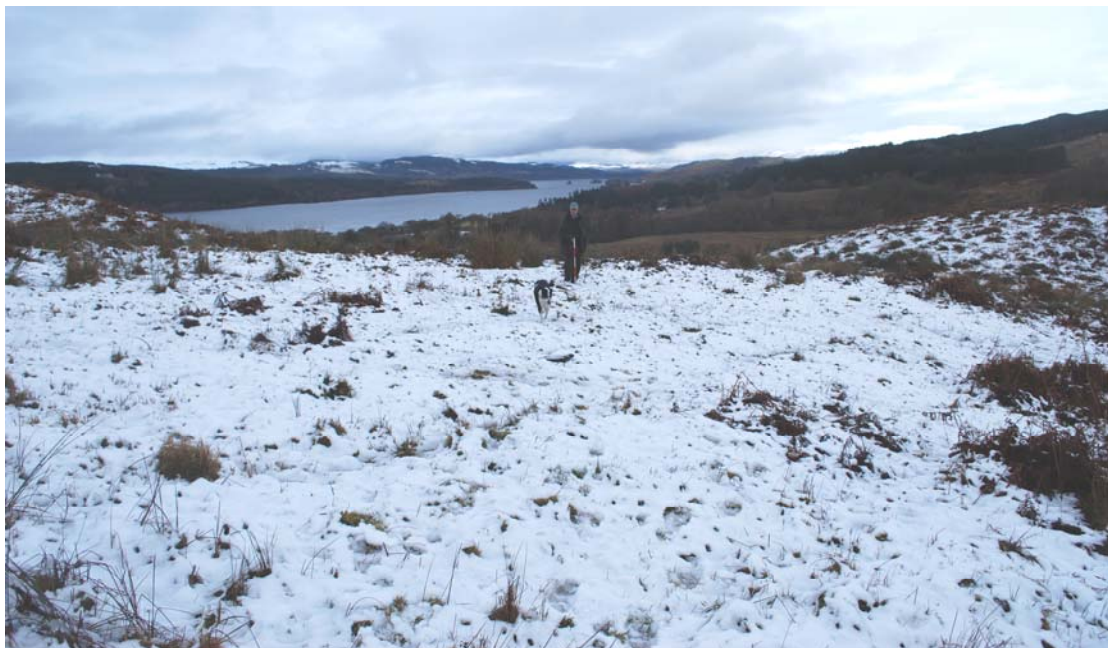
Survey conditions, general view N over Site 2, building and rig and furrow.

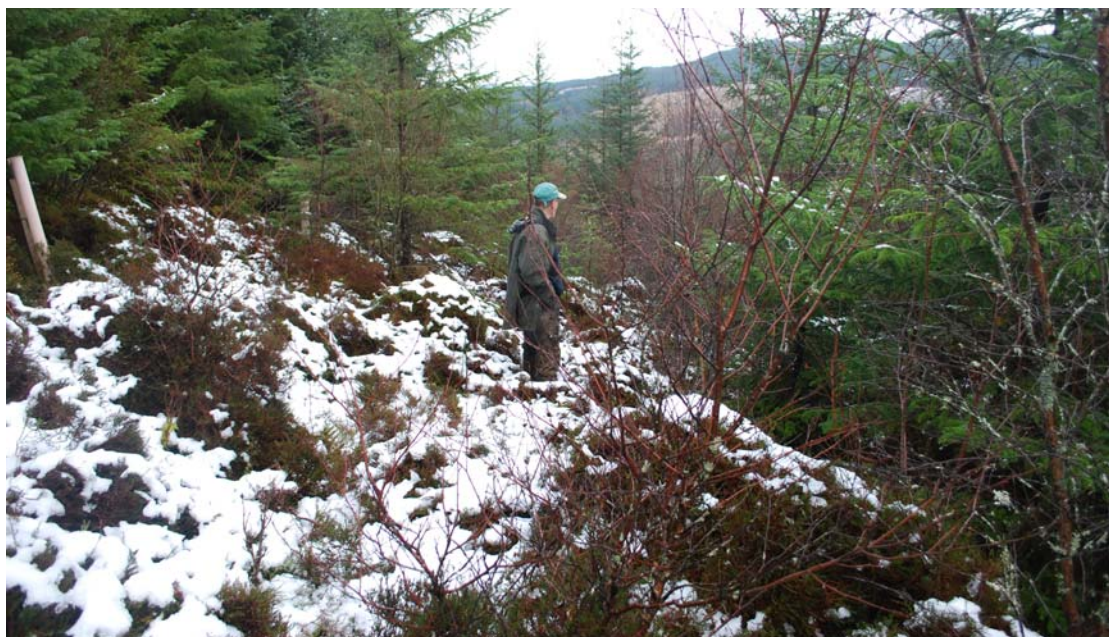
General view to NNE over the south part of the pipe route in forestry section.

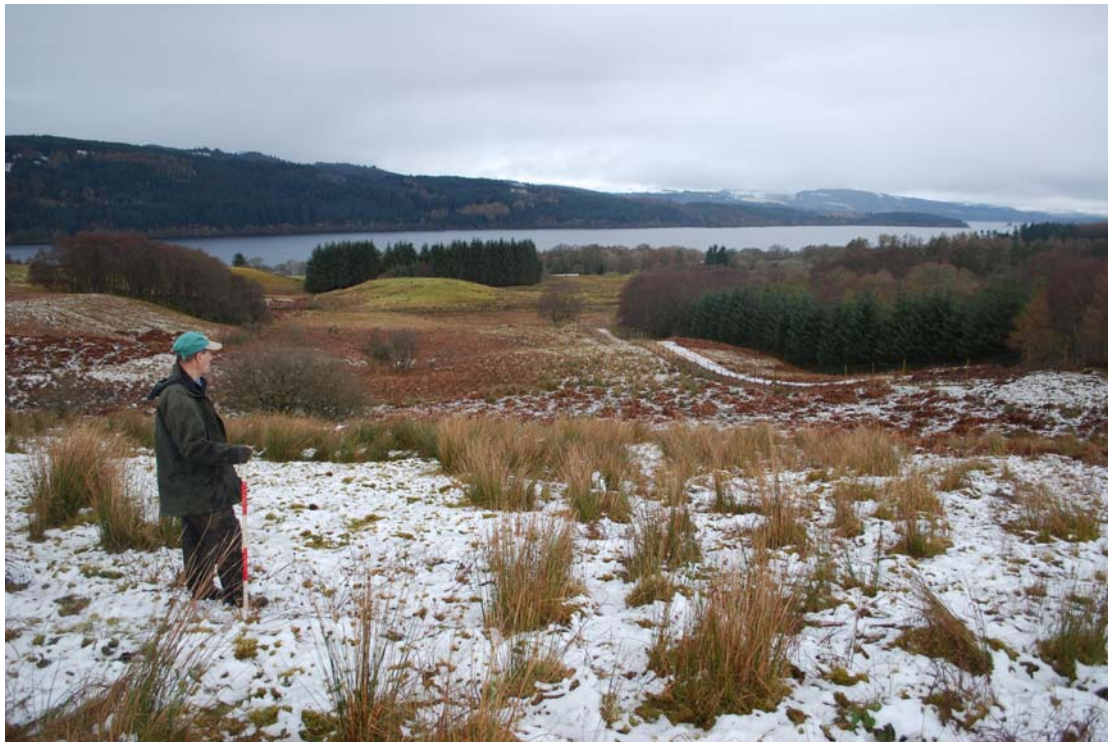
General view over the northern section of the pipe route from rig and furrow at Site 2 and showing dyke Site 3 at base of slope, rig and furrow Site 4 on undulating lower ground. Sites 5 and 7 and the crossing of the burn are beyond the single central tree in the distance and before the grass pasture.

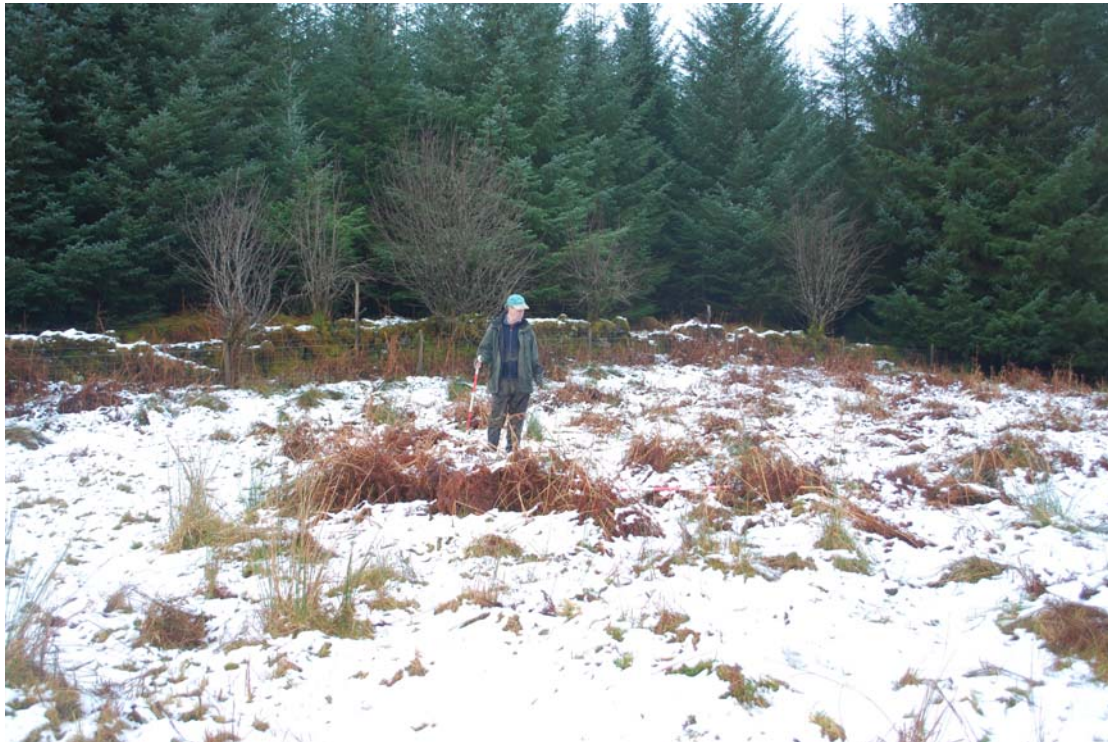
Immediately to the N of the boundary wall Site 1 is a pasture field which shows traces of rig and furrow agriculture. The rig runs in a NE-SW direction across the slope and the furrows are spaced c. 2m apart. There are several ‘humps and bumps’ in this area but the snow lying on the ground made prospection difficult. A possible rectangular structure defined by an intermittent line of boulders was located at the grid reference point given above and is pictured below. This structure was obscured by snow and bracken but appears to measure c. 6m x 4m and stand up to c. 0.40m high and is aligned NE-SW at 40°. There are several bedrock outcrops in this area that should be inspected for cup and ting markings and also a possible clearance cairn. The line of the pipe route will miss the possible building but a watching brief is required in this area and further prospection under better field conditions to determine if any other identifiable archaeological remains are present. The pipe route continues downslope from Site 2 and the rig and furrow is present on the hill slope.

Site 2 possible rectangular building, view to the SW.

There is no way that Site 1, the two drystone walls and possible track, can be avoided by the pipe and the walls will need to be cut through. In the area of Site 2 the possible building can be avoided. The pipe route will cross rig and furrow between Site 1 and Site 5. It is not considered necessary to monitor the excavations across all of the rig and furrow and the objective of a watching brief in this area would be to ensure that

the possible building Site 2 is avoided and that any other archaeological remains in the vicinity are avoided. The survey conditions of snow cover meant that recognition of sites was difficult but there are several knolls and bedrock outcrops in this area although it was impossible to determine if any of them were manmade or enhanced natural features. During the watching brief of the walls Site 1 and the area around building Site 2 any further archaeological sites in this area would be recorded.

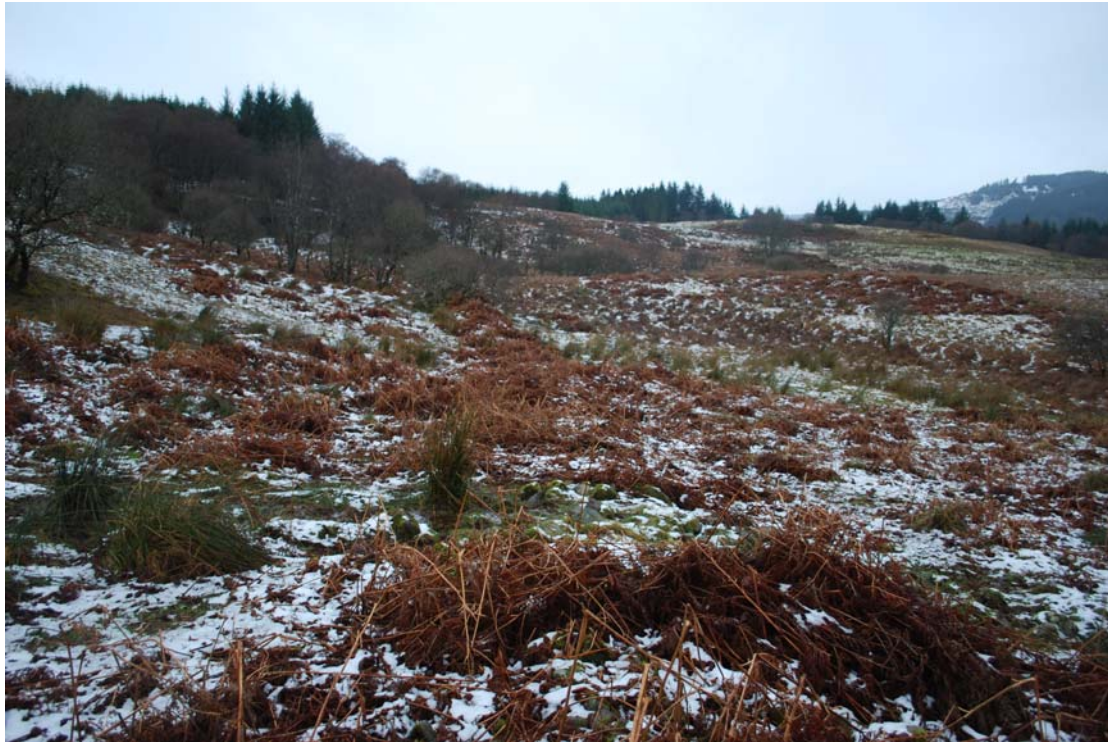
A collapsed dry stone dyke curving around the base of the hill in a roughly meandering E-W direction. This bracken covered dyke is a 1.5m wide spread of field stones measuring c. 0.25m x 0.20m on average and standing up to 0.50m high maximum. It may be built on an earth bank but in the areas examined appears more likely to have been a drystone wall. Rig and furrow (Site 2) is present to the south on the hill slope and rig and furrow (Site 4) is present on the level ground to the north. This suggests this dyke, which follows the base contour of the hill, is a field boundary. However, the land owner Mr Bowden Smith informed me that this dyke continues to the east and it may be a consumption dyke (i.e. clearance of field stones to improve cultivation as the primary reason rather than for construction of a land boundary). The dyke has already been cut through by a farm track and it is recommended the pipe route is laid through the existing cut and a watching brief is carried out.

Site 3 collapsed stone dyke, view along its length to the west.

The boundary dyke Site 3 has already been cut through by a farm track. This substantial linear feature extends beyond the survey area and a c.2m wide cutting through it will not substantially damage the monument. It would be preferable to put the pipe in the already disturbed area of the track but this might mean the farm traffic, although only occasional and light usage, might prove a damage risk for the pipe. The cutting of this wall would be monitored by a watching brief and the wall and its section recorded. The pipeline then crosses over quite boggy ground with remains of rig and furrow Site 4 running towards a small knoll with a large glacial erratic on it at NM 95484 07292. No archaeology was observed on this knoll and the boulder was inspected for cup and ring marks and none were found. However, topographically this knoll is a more attractive location for previous activity and a watching brief should be maintained over this section of the route. Immediately to the north of the knoll with the glacial erratic is an overgrown raised track way Site 7 which leads to the canalised burn Site 5. The pipe route can avoid the track line and run to the east of it. A watching brief in this area would ensure the track is avoided. There is no option but to cut across the canalised burn Site 5 but again a watching brief would record details of the feature and possibly also bridge footings where the track Site 7 crossed it but it is hoped the pipe route would be far enough from the track to avoid disturbance to the best preserved part of the canalised burn and also the point where the track crosses it.

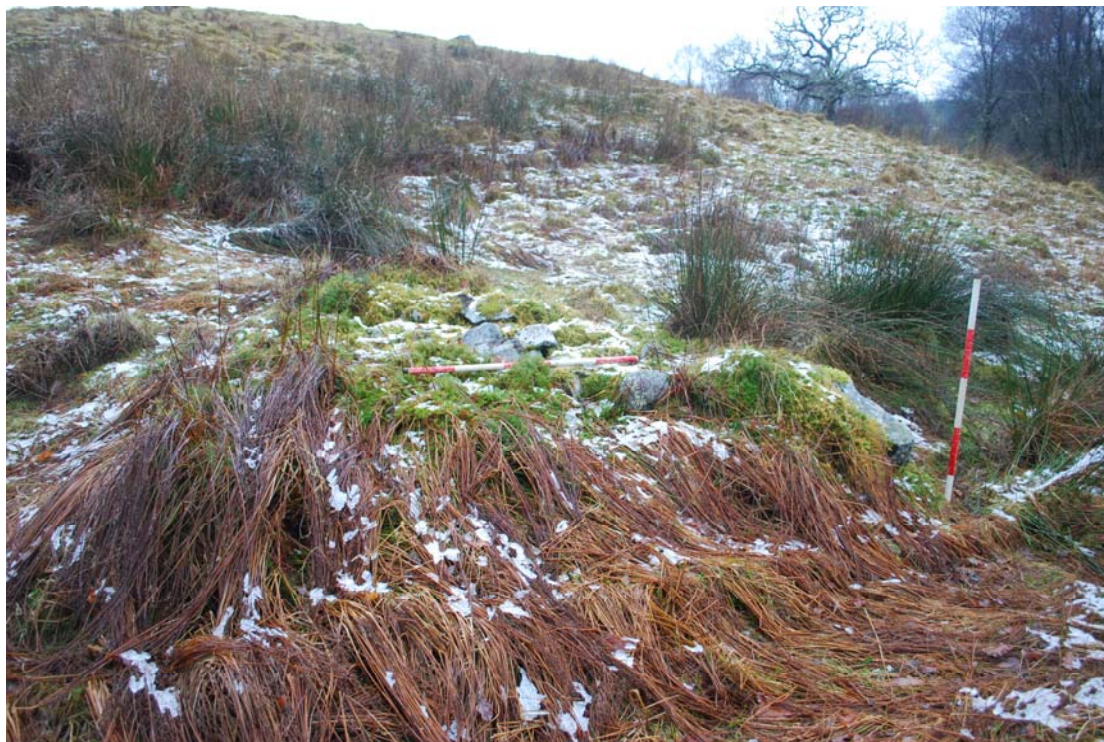
A possible corn drying kiln represented as a heap of stones measuring 3m diameter and standing to 0.60m high. Excavation would be required to determine if this is a corn drying kiln or a pile of clearance stones. This feature is located at the NW side at the base knoll on which the steading site (WoSAS PIN 51763) is located. This possible corn drying kiln is on the flat river bank and c. 10m from the river. The pipe route runs along the base of the knoll and avoids the steading but will run very close by this possible kiln. A watching brief is required in this area to ensure that the possible kiln is avoided. If it cannot be avoided it must be investigated by archaeological excavation and recorded. There are several boulders in the immediate vicinity at the base of the knoll on which the steading is located, which may represent tumbled stones that have rolled down the slope. However, only this sub-circular feature looks as if it might be a deliberate construction.

Site 6, possible corn drying kiln view to the south-east. The steading site is on the top of the knoll.

The watching brief would also be required at Site 6, a pile of stones, possibly a corn drying kiln, at the base of the slope below the steading site WOSAS PIN 51763. With careful excavation it may be possible to excavate the pipe trench here without disturbing Site 6 but it is a tight fit between the stone pile and the fence line. A watching brief here will ensure that the site is either avoided or recorded if it has to be disturbed.

The building at Site 2, the track Site 7 and the possible corn drying kiln Site 6 can all be avoided by the pipe route but it is essential that an archaeologist is on site at these locations to ensure the archaeological features are avoided. Site 6, the possible corn drying kiln will be the most difficult to avoid due to limitations of space. Site 6 should be fenced with temporary orange mesh fencing or similar before excavations begin to ensure it is not damaged during pipe installation or machinery.

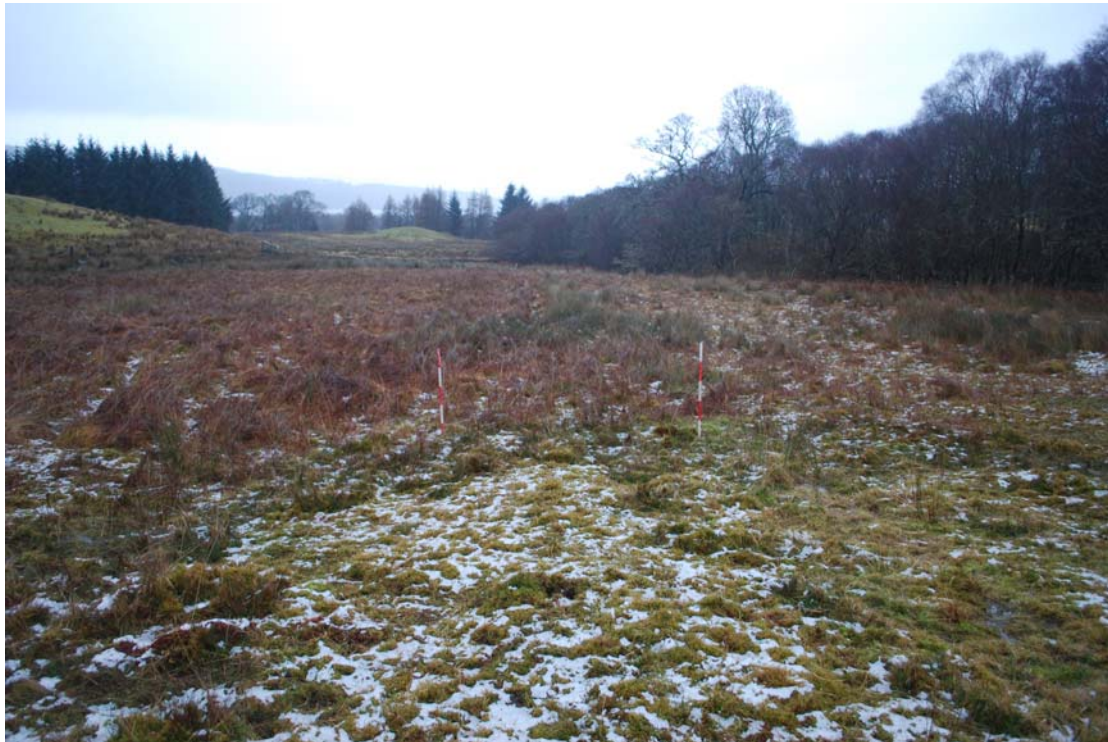
A disused track way leading from the glacial knoll noted above (Site 4) to the canalised burn Site 5. The track is covered with turf and Juncus grass and is c. 3m wide and stands up to 0.20m high above the surrounding ground surface. It is aligned N-S at 16°. There may be traces of rig and furrow to the west side of it but this was not entirely convincing under the survey conditions but further inspection will take place in this area during the watching brief. It is recommended that the track is avoided by the pipe route and a watching brief is maintained to ensure the track is avoided.

Site 7 the disused track way viewed to the north running towards the canalised burn Site 5 and the proposed pipe route crossing over the Allt Doire nan Sobhrachan.

The excavation of the pipe trench across the glacial mound at the S end of the track Site 7 will also be monitored as although no archaeological remains are visible on the surface it is an attractive topographic feature that may have been the focus of earlier activity.
