31 Barnton Avenue West:
Data Structure Report

20278

0.1 This report presents the results of an archaeological evaluation undertaken by AOC Archaeology Group prior to the proposed development of 31 Barnton Avenue West, Barnton, Edinburgh. The work was commissioned by Richard Hall Architecture Design on behalf of their clients Mr and Mrs Lam. The site is centred at NGR: NT 18867 75812 and is situated to the immediate east of Barnton Lodge, in the grounds of which stood the now demolished 17th century building of Barnton House (Cramond Regis).

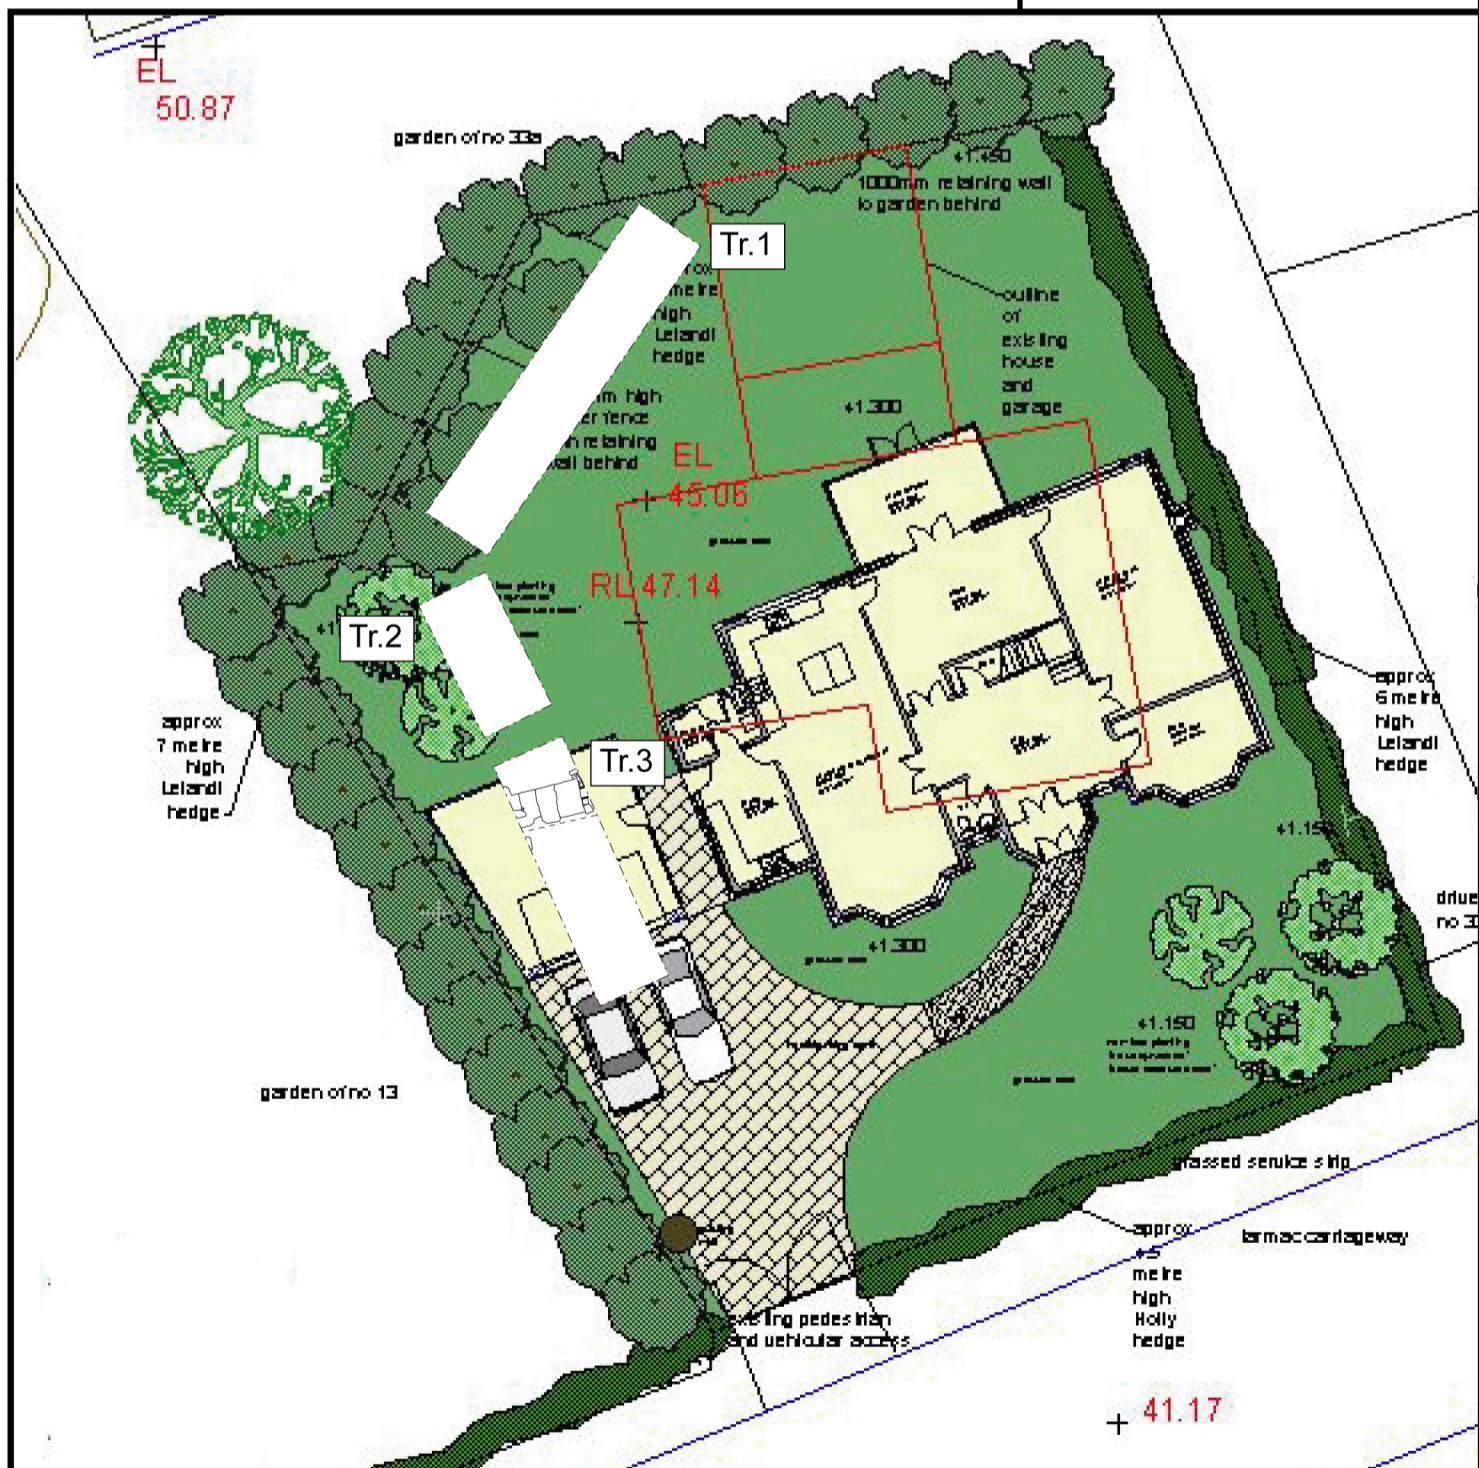
Figure 1: Site location location of evaluation trenches

3.1 Three trenches, comprising a 5% sample (34 m²), were opened. The trenches were 10 m, 7 m and 5 m in length. The trenches were located within the grounds of the present building occupying the site and as such their locations were dependent on the position of existing live services. (Figure 2).

4.1.2 The three trenches were located along the western boundary of the site all within the driveway of the existing property. All the deposits were therefore capped with 0.05 m of tarmac under which lay a layer of made ground which ranged in depth from 0.30 m in trenches 1 & 2 to 0.55 m in trench 3. The made ground [008] was a mixture of building rubble, garden soil and re-deposited natural. In the eastern end of trench 1 the made ground was contaminated by diesel. A layer of crushed sandstone [007], which appears to be a demolition layer, was visible underlying the made ground in all three trenches. This was 0.30 m in depth. The natural drift geology consisted of medium grey boulder clay [002].

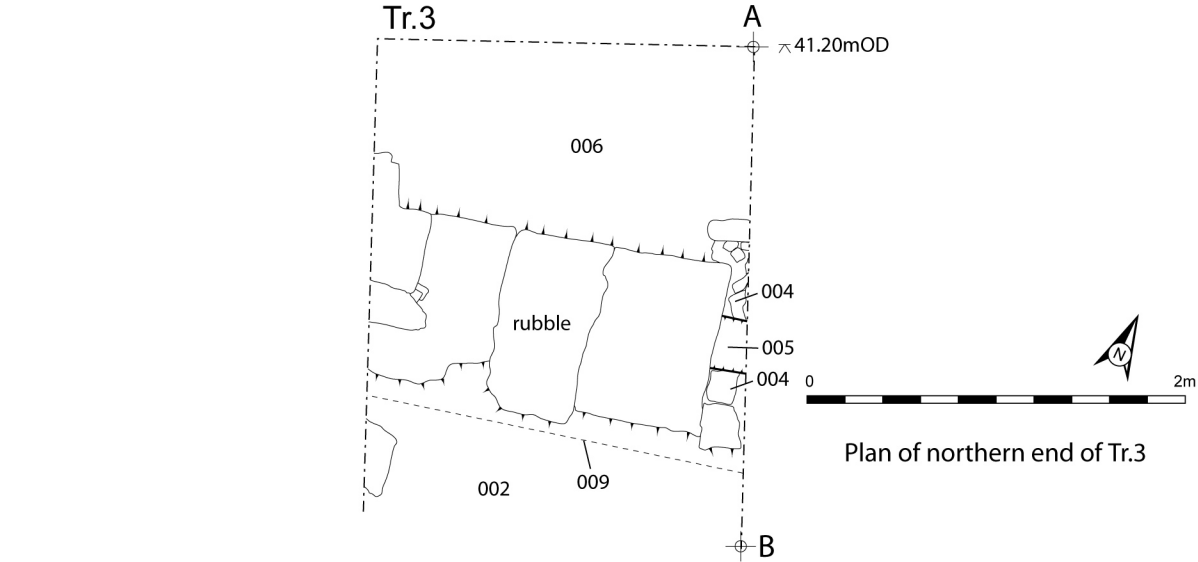
Figure 2: Plan and section of features in Tr.3

- 4.1.4 A section of sandstone flooring [006] (plates 1 & 2) was uncovered at the north end of trench 3. This feature was 1.20 m from the surface and filled the width of the trench. The feature was directly overlain by the layer of crushed sandstone [007]. At 0.90 m the flooring abutted the substantial sandstone wall [004] (plates 1 & 2). The wall was aligned east to west and was 1.30 m in width and double coursed. A 0.30 m void [005] ran along the central section of the wall this void was constructed of nine visible courses of faced stone on both sides and was approximately 1.10 deep. However rubble appeared to fill the void at this level and the void may be deeper. The wall survived to a height of 0.50 m and was again overlain by a probable demolition layer of crushed sandstone. The wall was 0.60 m wide to the north of the void and 0.40 m to the south. A 0.12 m wide cut [009] was also visible on this side. The wall was lime mortar bonded.

<i>Dimensions</i>	7.0 m by 2.0 m
<i>Total Area</i>	14.0 m ²
<i>Orientation</i>	N-S
<i>Depth of Tarmac</i>	0.05 m
<i>Depth of Excavation</i>	1.20 m
<i>Natural</i>	Medium grey boulder clay
<i>Drains</i>	Rubble at 4 m & 12.0 m orientated N-S & SW-NE
<i>Significant Features</i>	Sandstone flooring [007] 0.90 m x 2.0 m abutting wall [004] Sandstone wall at 0.90 m from north. Dimensions 1.30 m (width) x 2.0 m (length) x 1.10 m (max.).Lime mortar bonded, double coursed with central void 0.30 m in width, wall is 0.50 m in height overlain by crushed sandstone [005]
<i>Finds</i>	None

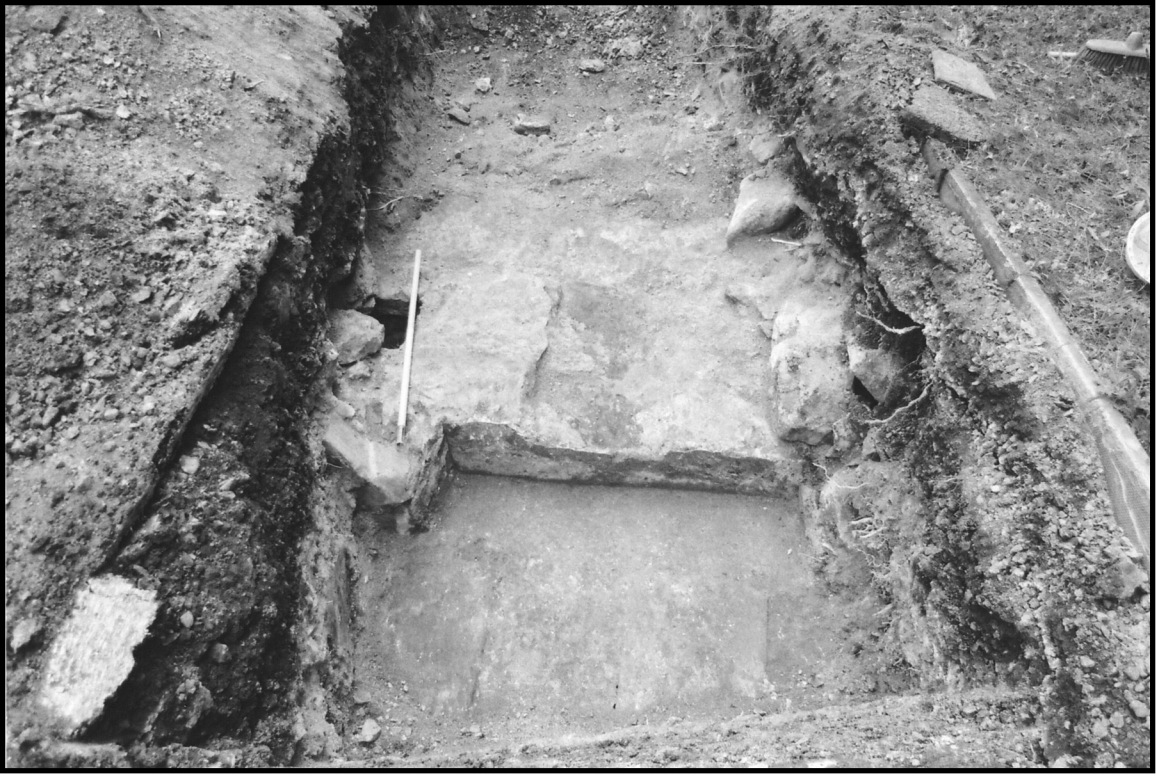
Plate 1: Sandstone floor [006] and wall [007] from north

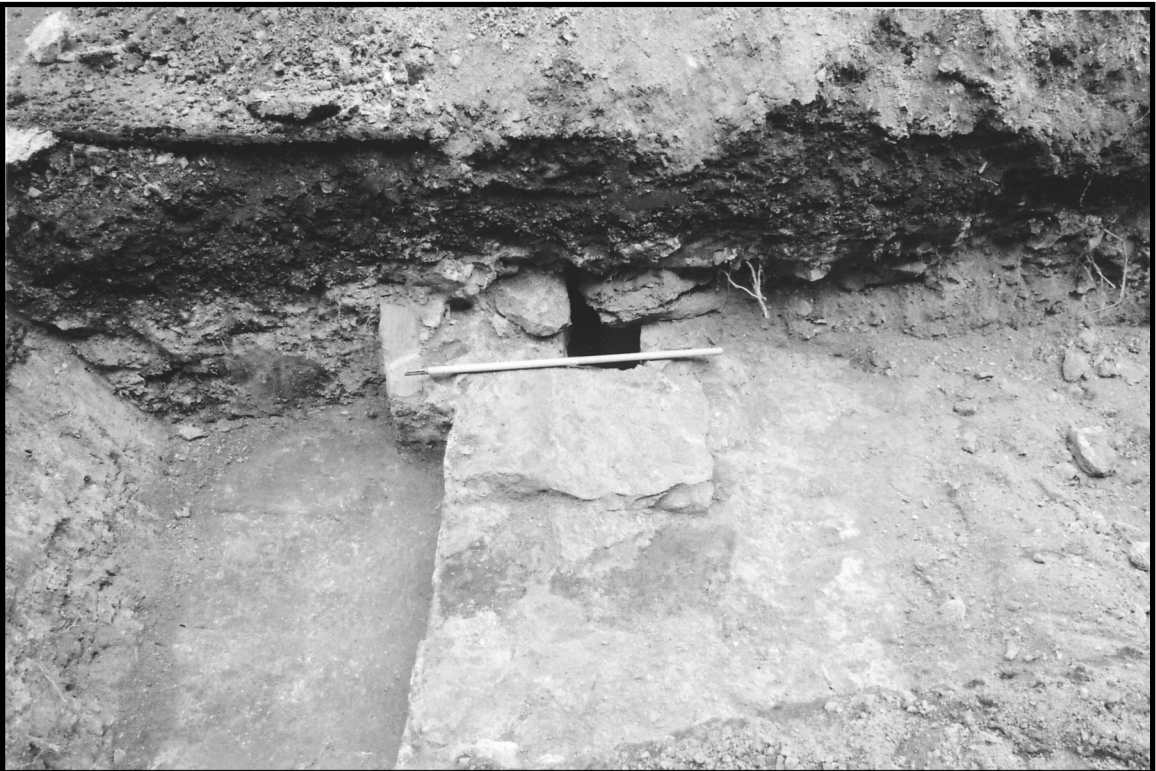
Plate 2: Sandstone floor [006] and wall [007] from west
