# Sound of Mull Remote Sensing Project Interim report for Historic Scotland

# Sound of Mull Remote Sensing Project

## Interim report for Historic Scotland

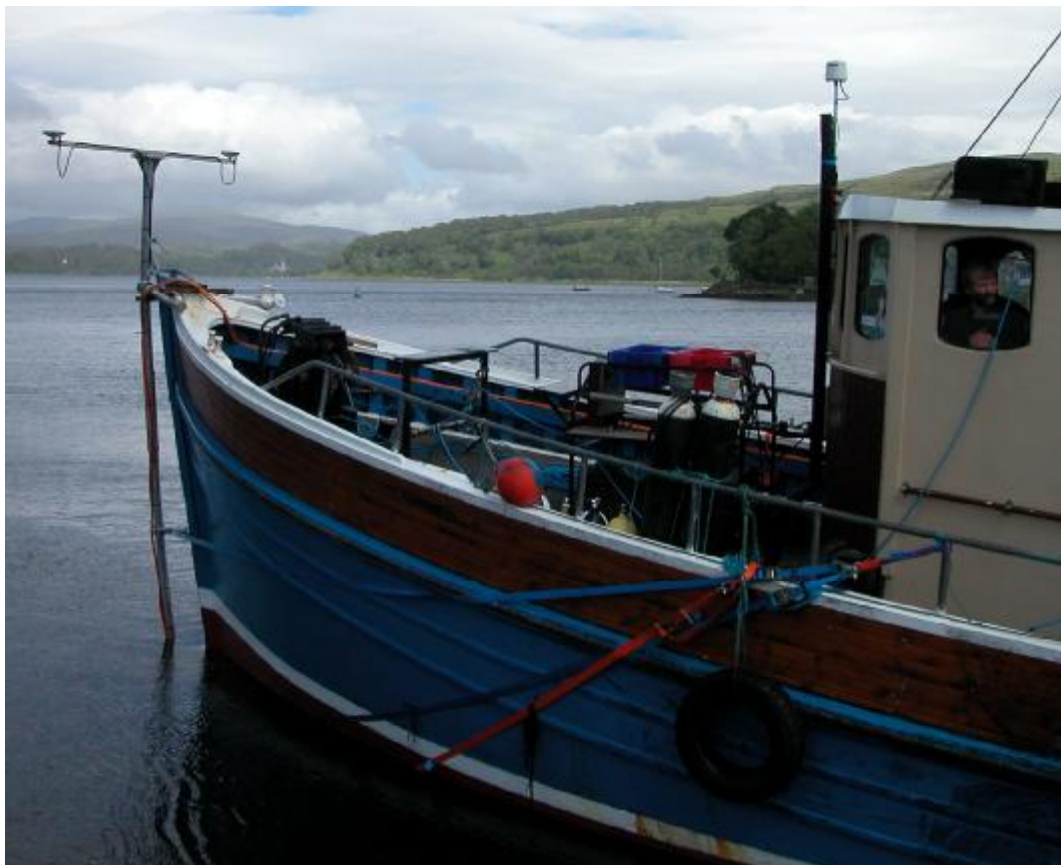
Fig.4: The MV Gaelic Rose at Lochaline. Note the purpose built, bow mounted pole for the multibeam sonar system, complete with position fixing antennae. The rig was welded to the hull and tensioned using webbing straps.

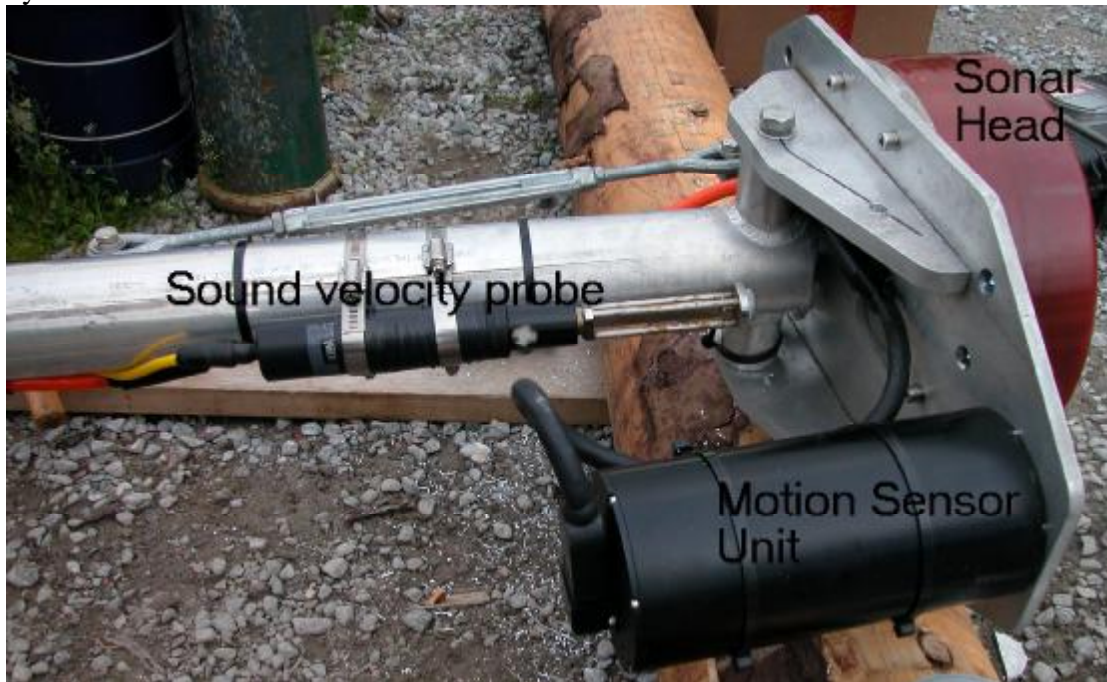
Fig.5 The EM3002 single sonar head and ancillary systems mounted onto a purpose built pole.

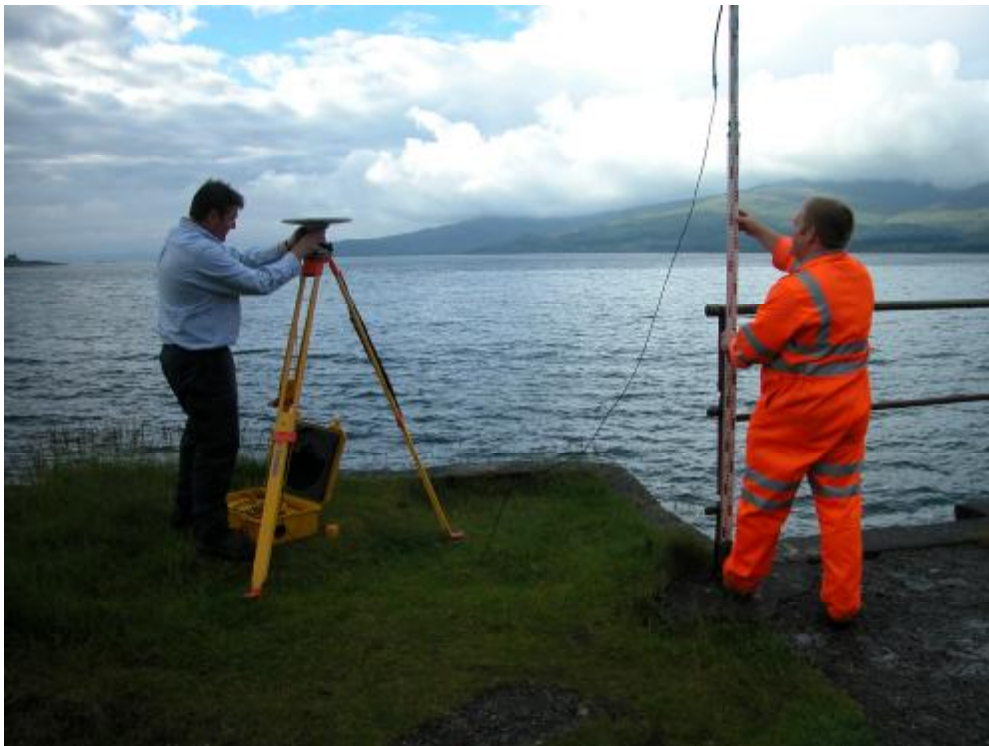
Fig.6 Setting up a Real Time Kinetic (RTK) shore station adjacent to the West Pier, Lochaline.

Base station coordinates were levelled from ordnance datum benchmarks adjusted to chart datum using Admiralty Tide tables (NP 2001-04) and real time tidal levels were provided using a Valeport 740 digital tide gauge mounted on the west pier at Lochaline, and accurate to +/- 10mm.

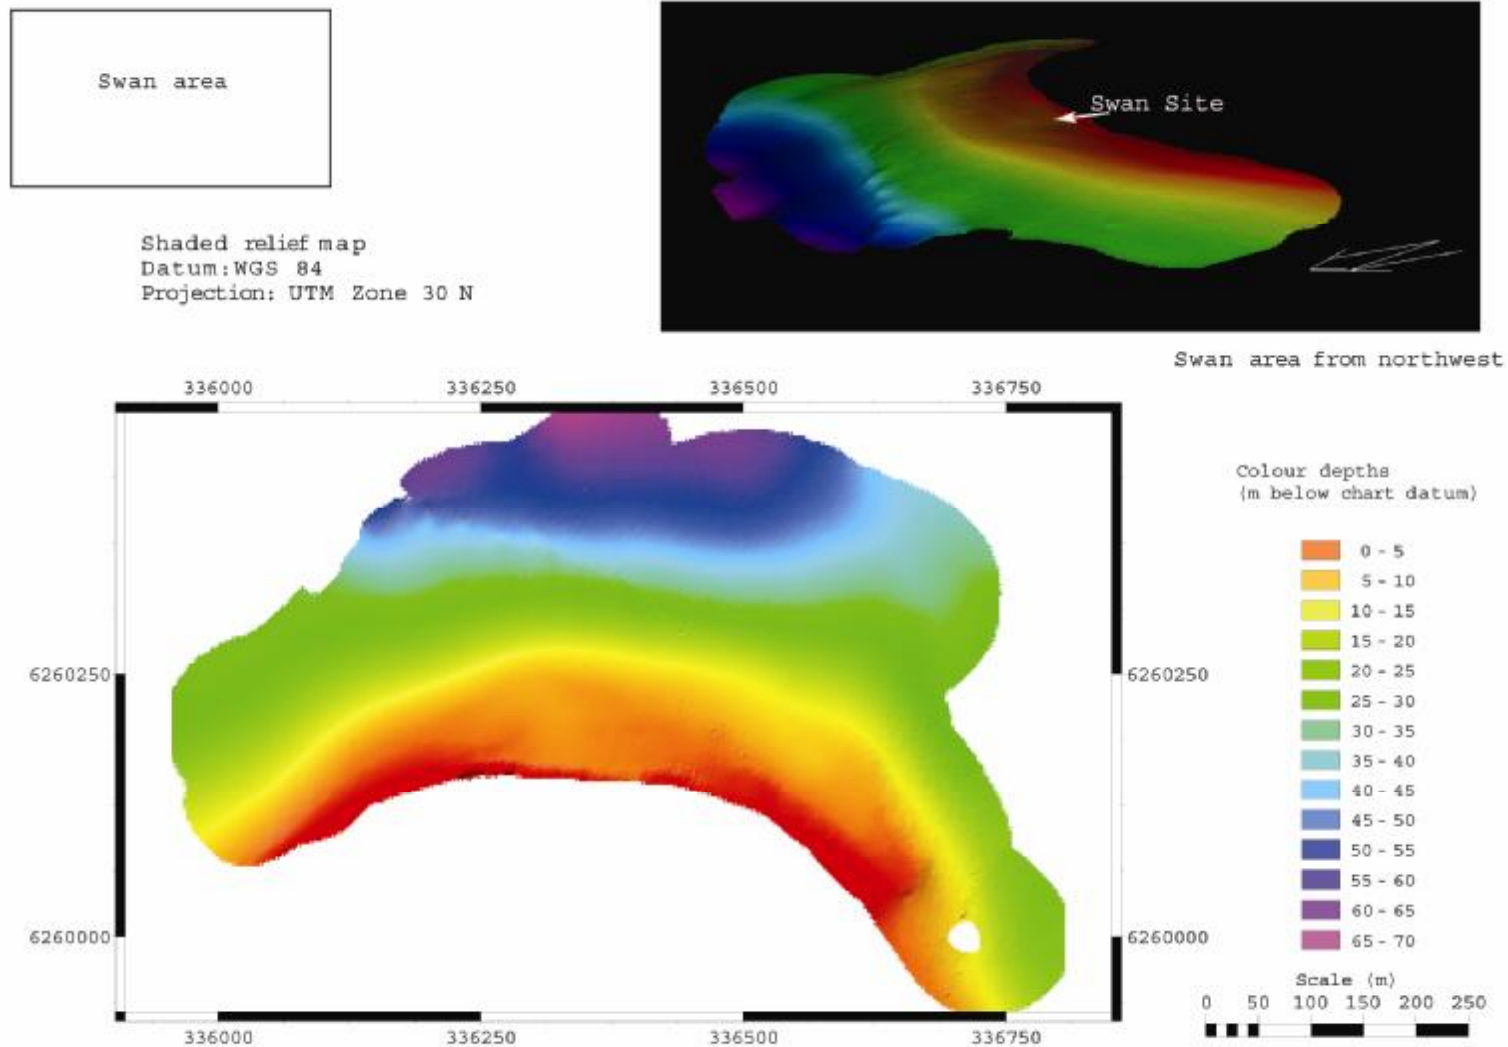
Fig 15: Multibeam plot of the Swan area survey, showing the shelf off Duart Point. Data processed at 0.5m point resolution

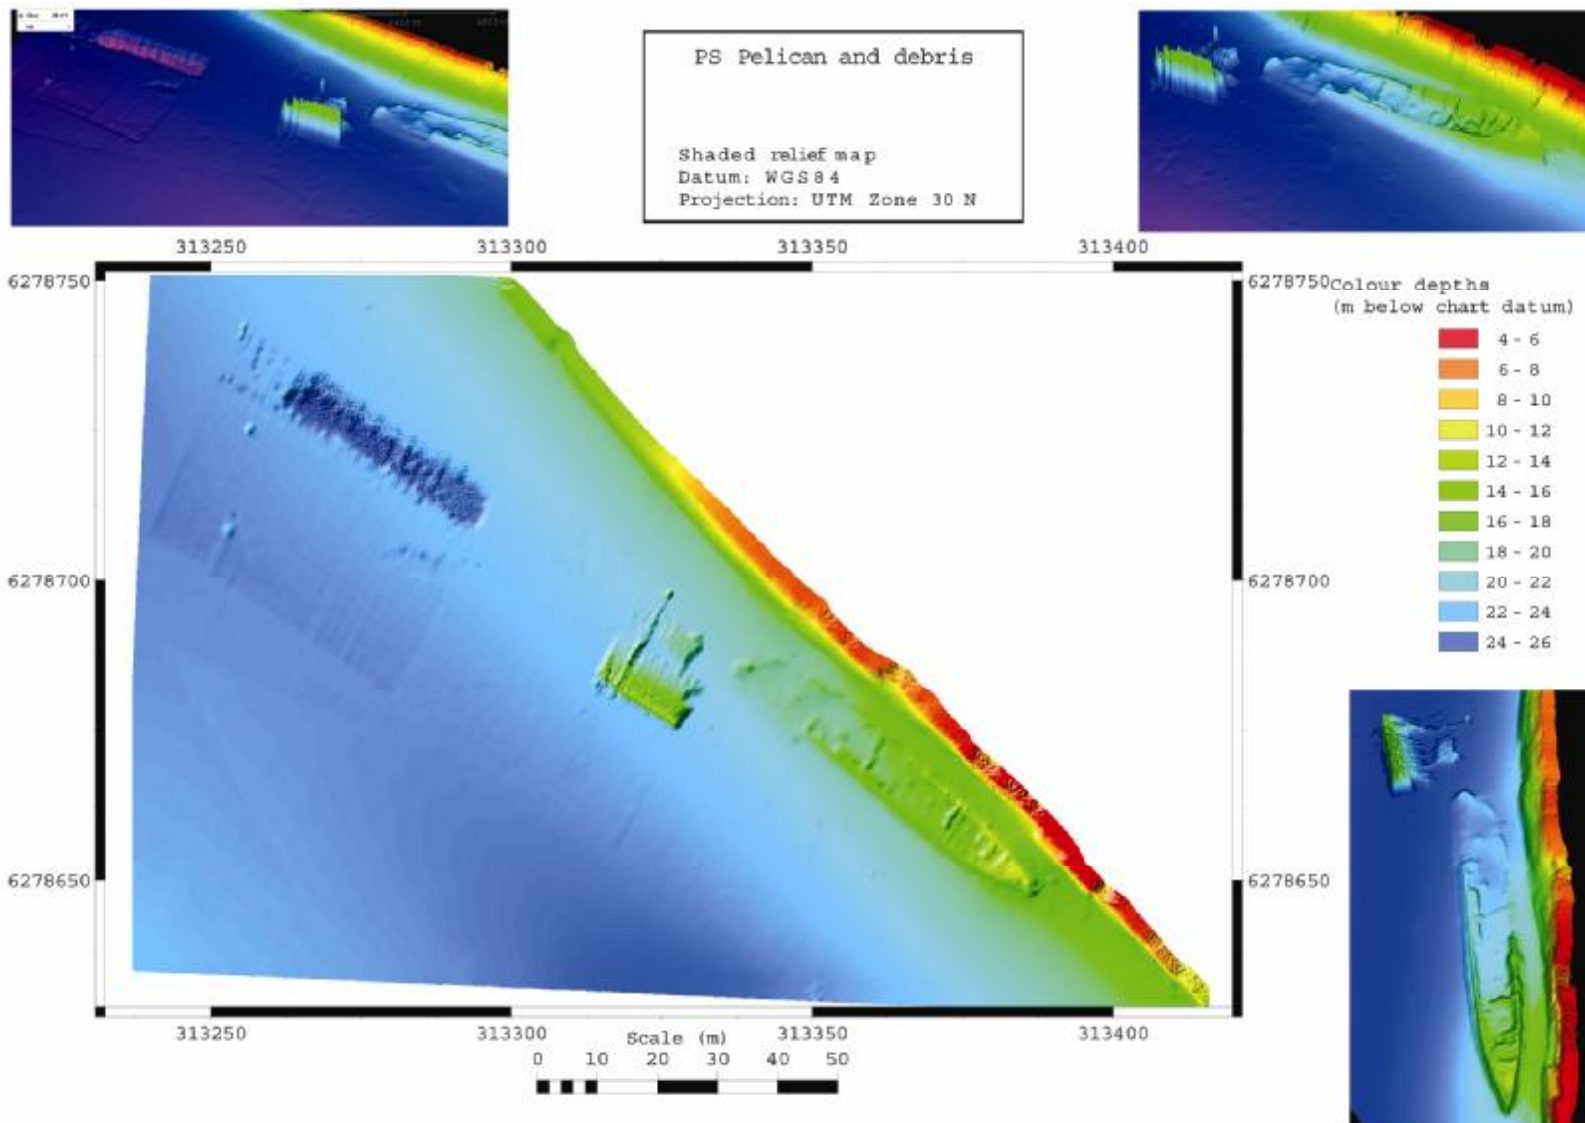
Fig.51: Multibeam map of the Pelican. Note anomalies to the stern that may be erroneous.
