**Newton Stewart  
Scottish Water Solutions Pipeline  
Archaeological Field Inspection Report**

**Prepared for:** Scottish Water Solutions  
Watermark  
Alba Campus  
Livingston  
West Lothian  
EH54 7HH

**AOC Archaeology Project No:** 20513

**Date:** June 2007

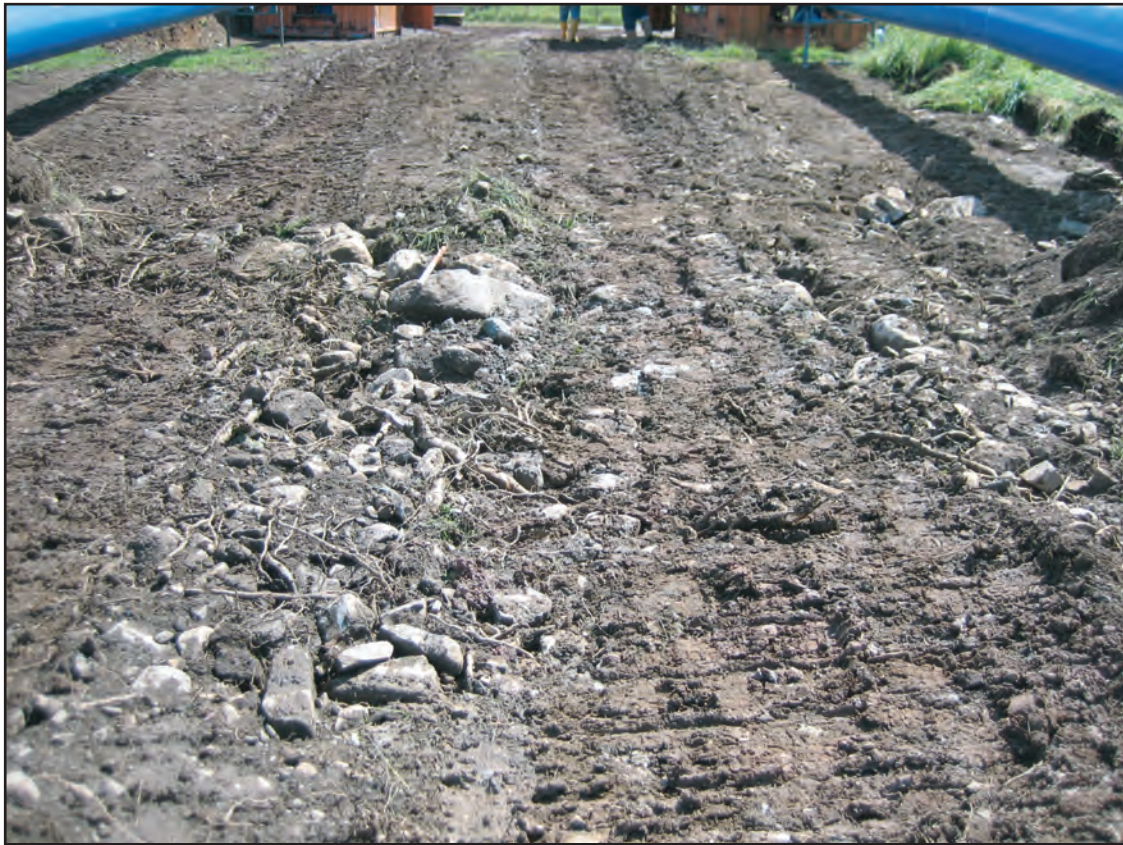
1.4.1 This part of the pipeline corridor had been subject to topsoil stripping without archaeological supervision. An area of rubble stone was visible at the western end of this area (Figure 2, Plate 1). This consisted of an amorphous spread of large and medium sized stones that had been partially

disturbed by tree root penetration and covered an area *circa* 8 m long by 6 m wide. The easement had been traversed repeatedly by tracked vehicles which made it impossible to tell whether more discreet features survived along this part of the pipeline corridor.

Plate 1: Rubble stone along the Shennanton to Ardachie pipeline corridor from the west

5.1 It is unclear what the rubble spread recorded along the Shennanton to Ardachie pipeline corridor represents. It may be a clearance cairn or the remnant of a demolished field boundary. Given the proximity of the cairn at Shennanton it cannot be discounted that this may be similar in nature. It is therefore recommended that further ground breaking works in this area, ie during cutting of the pipe trench, are monitored by a watching brief.

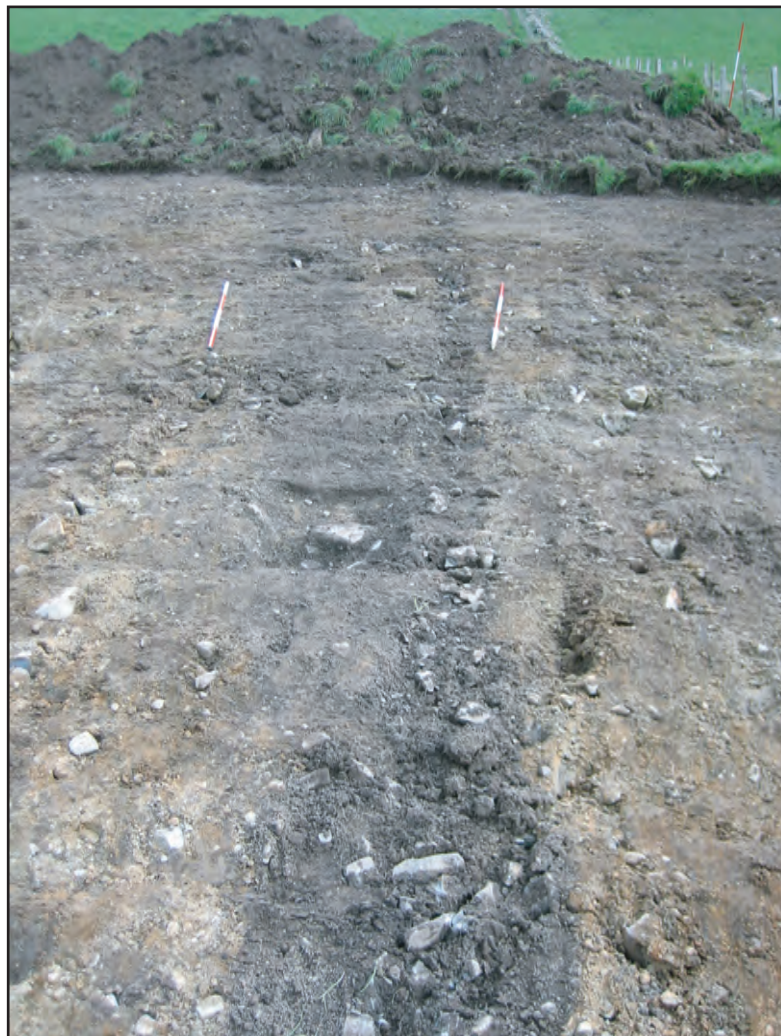
4.2.1 An area measuring 31.4 by 34.0 m was monitored during topsoil stripping of a compound along this part of the pipeline corridor. Here whinstone filled rubble drains, aligned north-west to south-east, were recorded along with a shallow gully drain, a plastic drain was also visible (Figure 3, Plate 2). No significant archaeological features were encountered.

Plate 2: Whinstone filled rubble and gully drain in area monitored during topsoil strip along Glenluce to Ladyburn stretch from the northwest
