# Cathcart Road, Govanhill, Glasgow: Evaluation Data Structure Report

# Cathcart Road Evaluation, Govanhill, Glasgow:

## Data Structure Report

**AOC Project No:** 21868

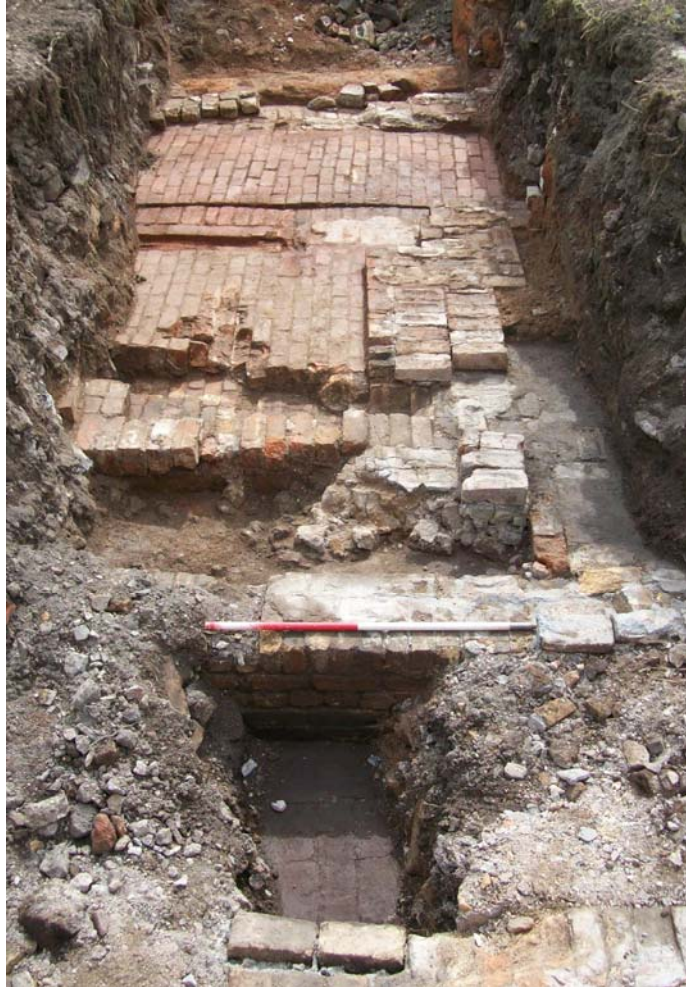
**Plate 1: General view of brick channel, surfaces and walls in Trench 48**

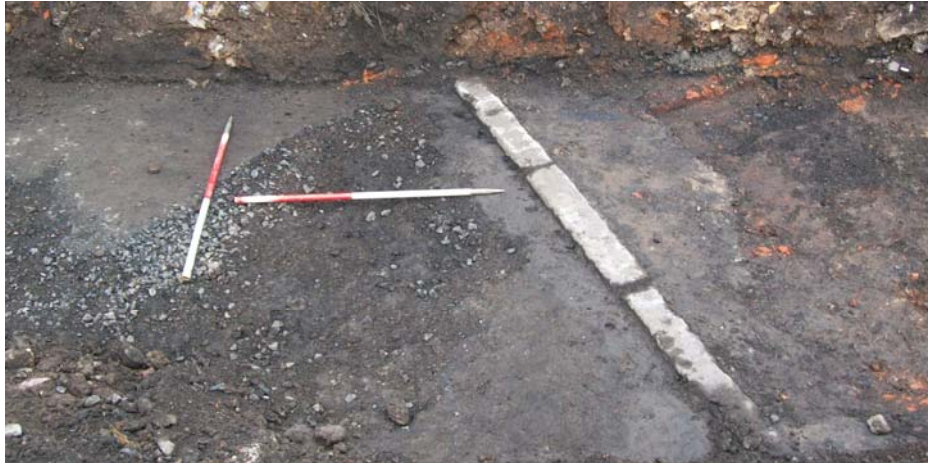
**Plate 2: View from eastern kerbing, [3823], of Naburn Street, Trench 38**

4.3.2 Trenches 37 and 38 both revealed the remains of Naburn Street itself covered by between 1.3 m and 2.0 m of mixed madeground deposits. In Trench 37, extending the entire length of the trench, was found the western kerbing of Naburn Street whilst in Trench 38 a complete section across Naburn Street was revealed with both the western and eastern kerbings exposed. The kerbing consisted of large, almost 1.0 m long setts (See Plate 2).

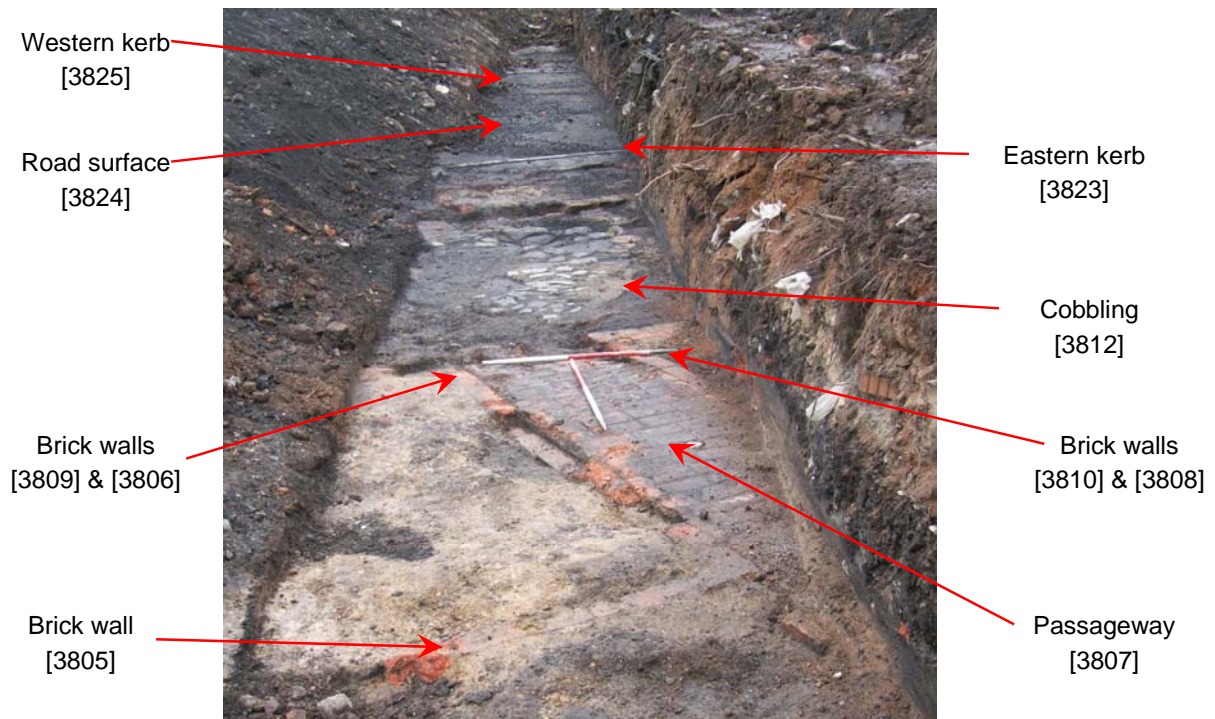
**Plate 3: View from south-east along Trench 38**

4.3.3 The kerbing edged a road surface some 14 m wide which had a distinct camber resulting in a concave profile orientated east to west. The road surface was a rough tarmac but it is possible that cobble setts may have survived below this upper surface.

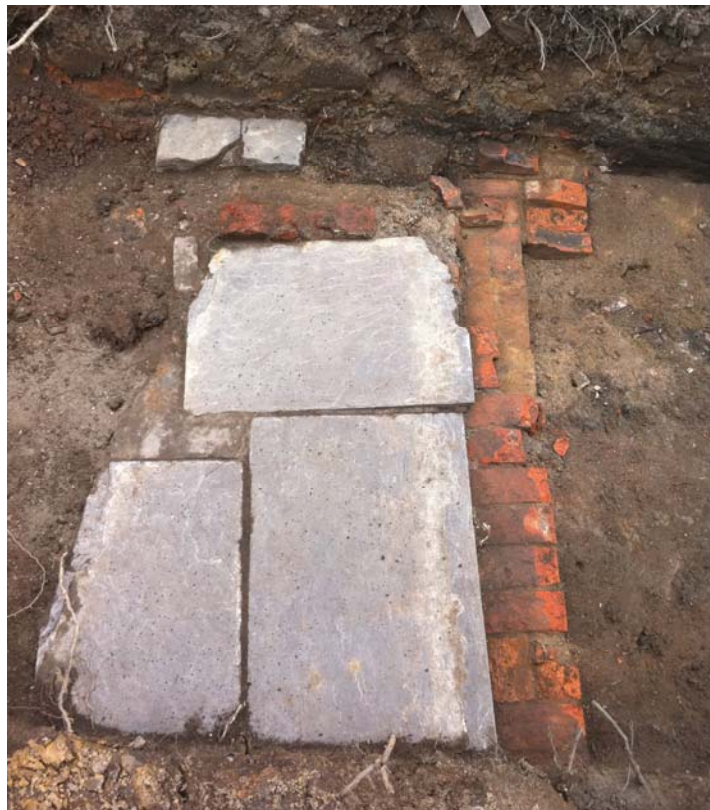
- 4.3.6 Trench 1 revealed a small selection of brick wall lines [104], [105], [106] and [107] underlying approximately 2.0 m of mixed madeground at its northern end. The wall lines were a single unfroged brick wide, 0.24 m, and aligned north-east to south-west and north-west to south-east. The southern end of Trench 1 revealed a further unfroged brick wall line [108] aligned north-west to south-east which edged a small remnant of stone paving, [109].

**Plate 4: View of paving [109] and brick wall [108], in Trench 1**

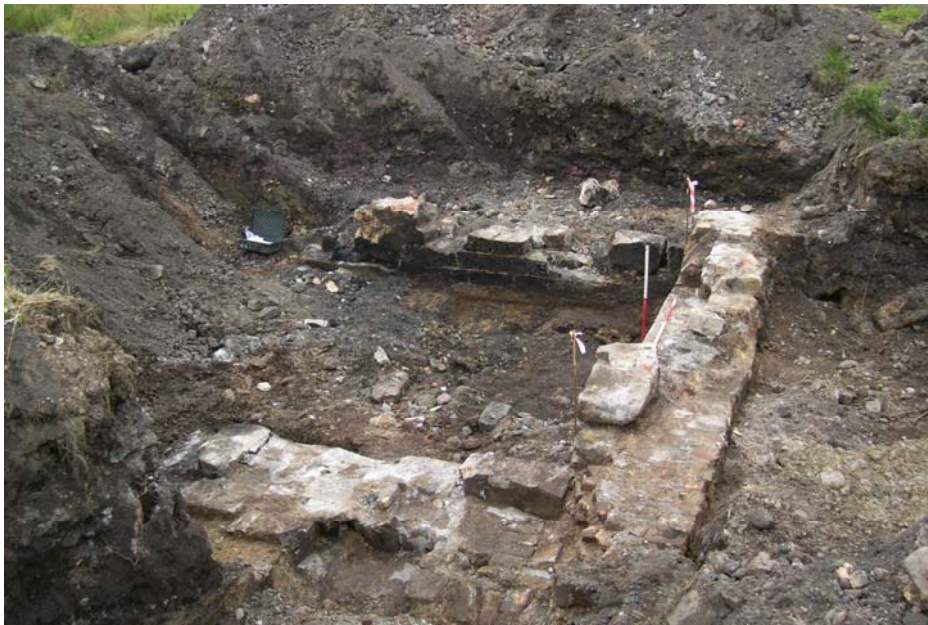
**Plate 5: View of structure [1201] from north-west in Trench 12**

- 4.5.1 At the western end of Trench 12 lay a large predominantly sandstone wall [1201] which had been augmented or repaired by the addition of unfrosted bricks. The wall survived in height to a maximum of five courses, some 0.65 m high. The foundation was cut into the natural clay [1203] and underlay c.1.6 m of made ground [1204]. The foundation consisted of a western end wall measuring c.5.4 m with a width of c.0.81 m and had considerable brickwork at the northern end. Extending east from

this wall were two other segments of sandstone wall. The northernmost section measured c.3.1 m long by c.1.2 m wide. The southernmost was longer at c.4.45 m and narrower c.0.72 m wide. Excavation within the structure revealed the possible remains of a mortar floor [1202]. Internally the structure would have measured 3.75 m wide by a minimum of at least c.4.45 m long. There was an indication that the western end of the structure extended north beyond the junction with the northernmost wall and there was a hint that the southernmost wall extended beyond the western end wall to the west. Together this suggests that the remaining walls record were not an isolated stand alone structure but rather part of a much larger more complex suite of rooms.

- 6.3 Given the paucity of survival indicated by the evaluation it is recommended that no further works are required across the site with the exception of the areas around Trench 12 and Trenches 48/49. In both instances further recording of the remains could be achieved through a limited watching brief on any ground breaking works in their vicinity. Such recommendations would require approval by WoSAS.

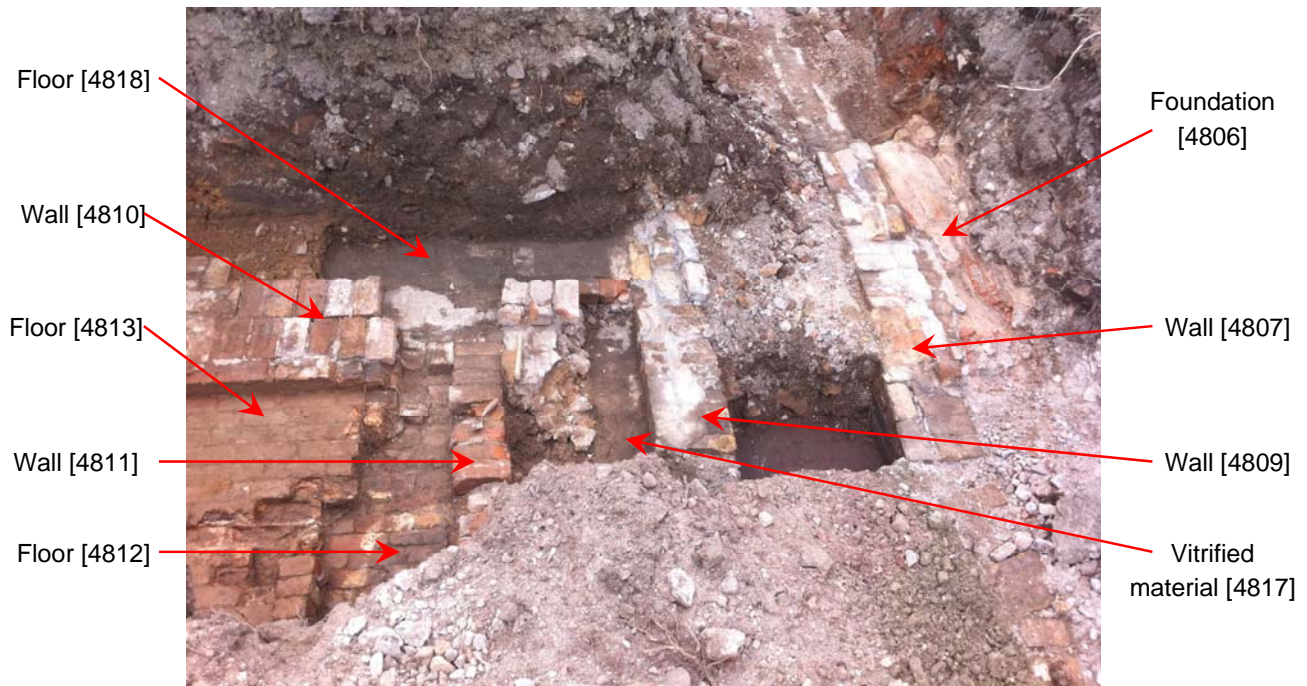
- 4.6.1 Trench 48 contained a number of brick-built elements that can be seen to relate to industrial usage. Firstly, running almost parallel to the trench was a large fire-brick built channel [4807] and [4809] which extended for c.25 m. The walls were two bricks wide and created a channel 0.90 m in width. The walls stood to a height of 0.35 m and the channel was floored with large flat cobbles [4808]. The channel was filled with crushed brick material [4816]. A large brick foundation [4806] abutted wall [4807].

**Plate 6: View of brick channel [4807] & [4809] and associated brick surfaces in Trench 48**

- 4.6.2 Wall [4811] was aligned east to west and paralleled the channel c.0.70 m to the south of [4809]. Between these two parallel walls was a hard compacted layer of vitrified, slag like material [4817]. Overlying [4817] was brick surface [4818] which abutted the channel and was in turn built over by a large wall base [4810]. Wall [4810] extended for c.2.7 m north to south and most likely up to wall [4809]. At its southern end wall [4810] turned west and continued in that direction beyond the limit of

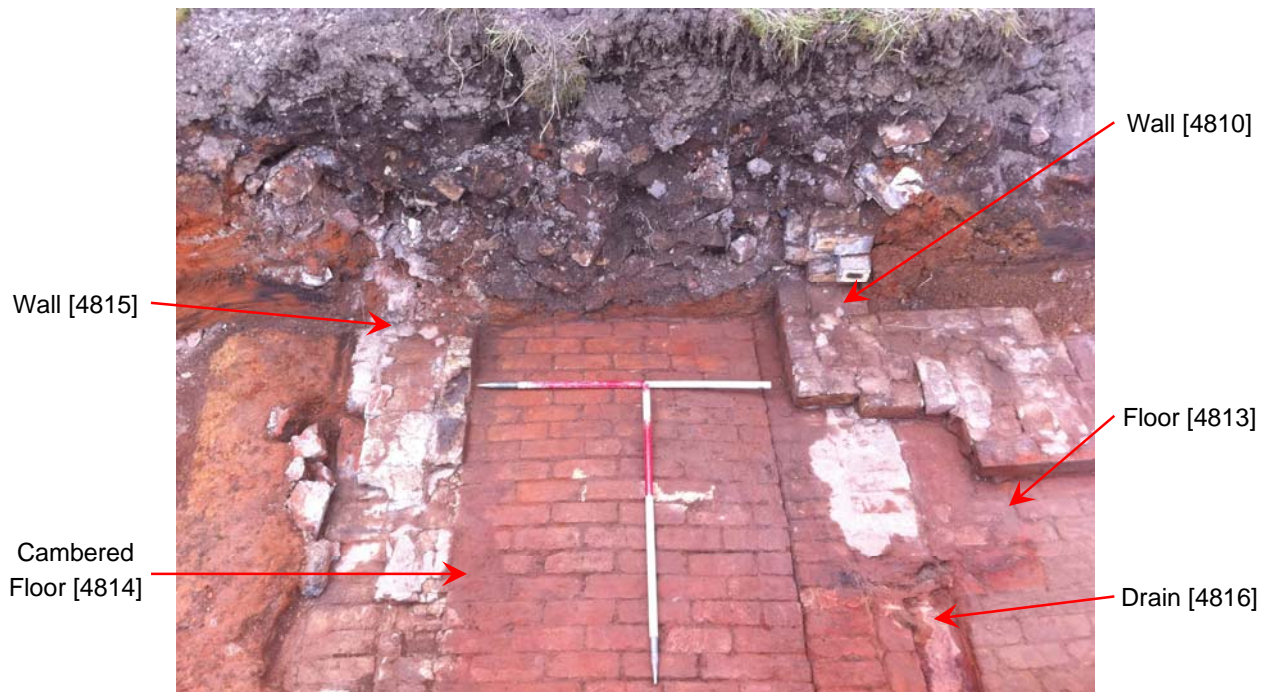
**Plate 7: View of brick walls [4810] & [4815], with floor [4814] in Trench 48**

- 4.6.3 Floor [4813] was contemporary with the well formed floor surface [4814] which comprises part of a larger east to west passageway. This surface has a distinct camber and with wall [4810] a drainage channel was formed along its northern edge. The passage is nearly 1.20 m wide and was defined to the south by a large wall, [4815].

- 4.6.4 The bricks appeared to be mostly unfrosted though a number in wall [4810] were marked 'GOVAN'. Where possible to determine the foundations were cut into natural subsoil and were covered by in excess of 1.4 m of modern made ground.

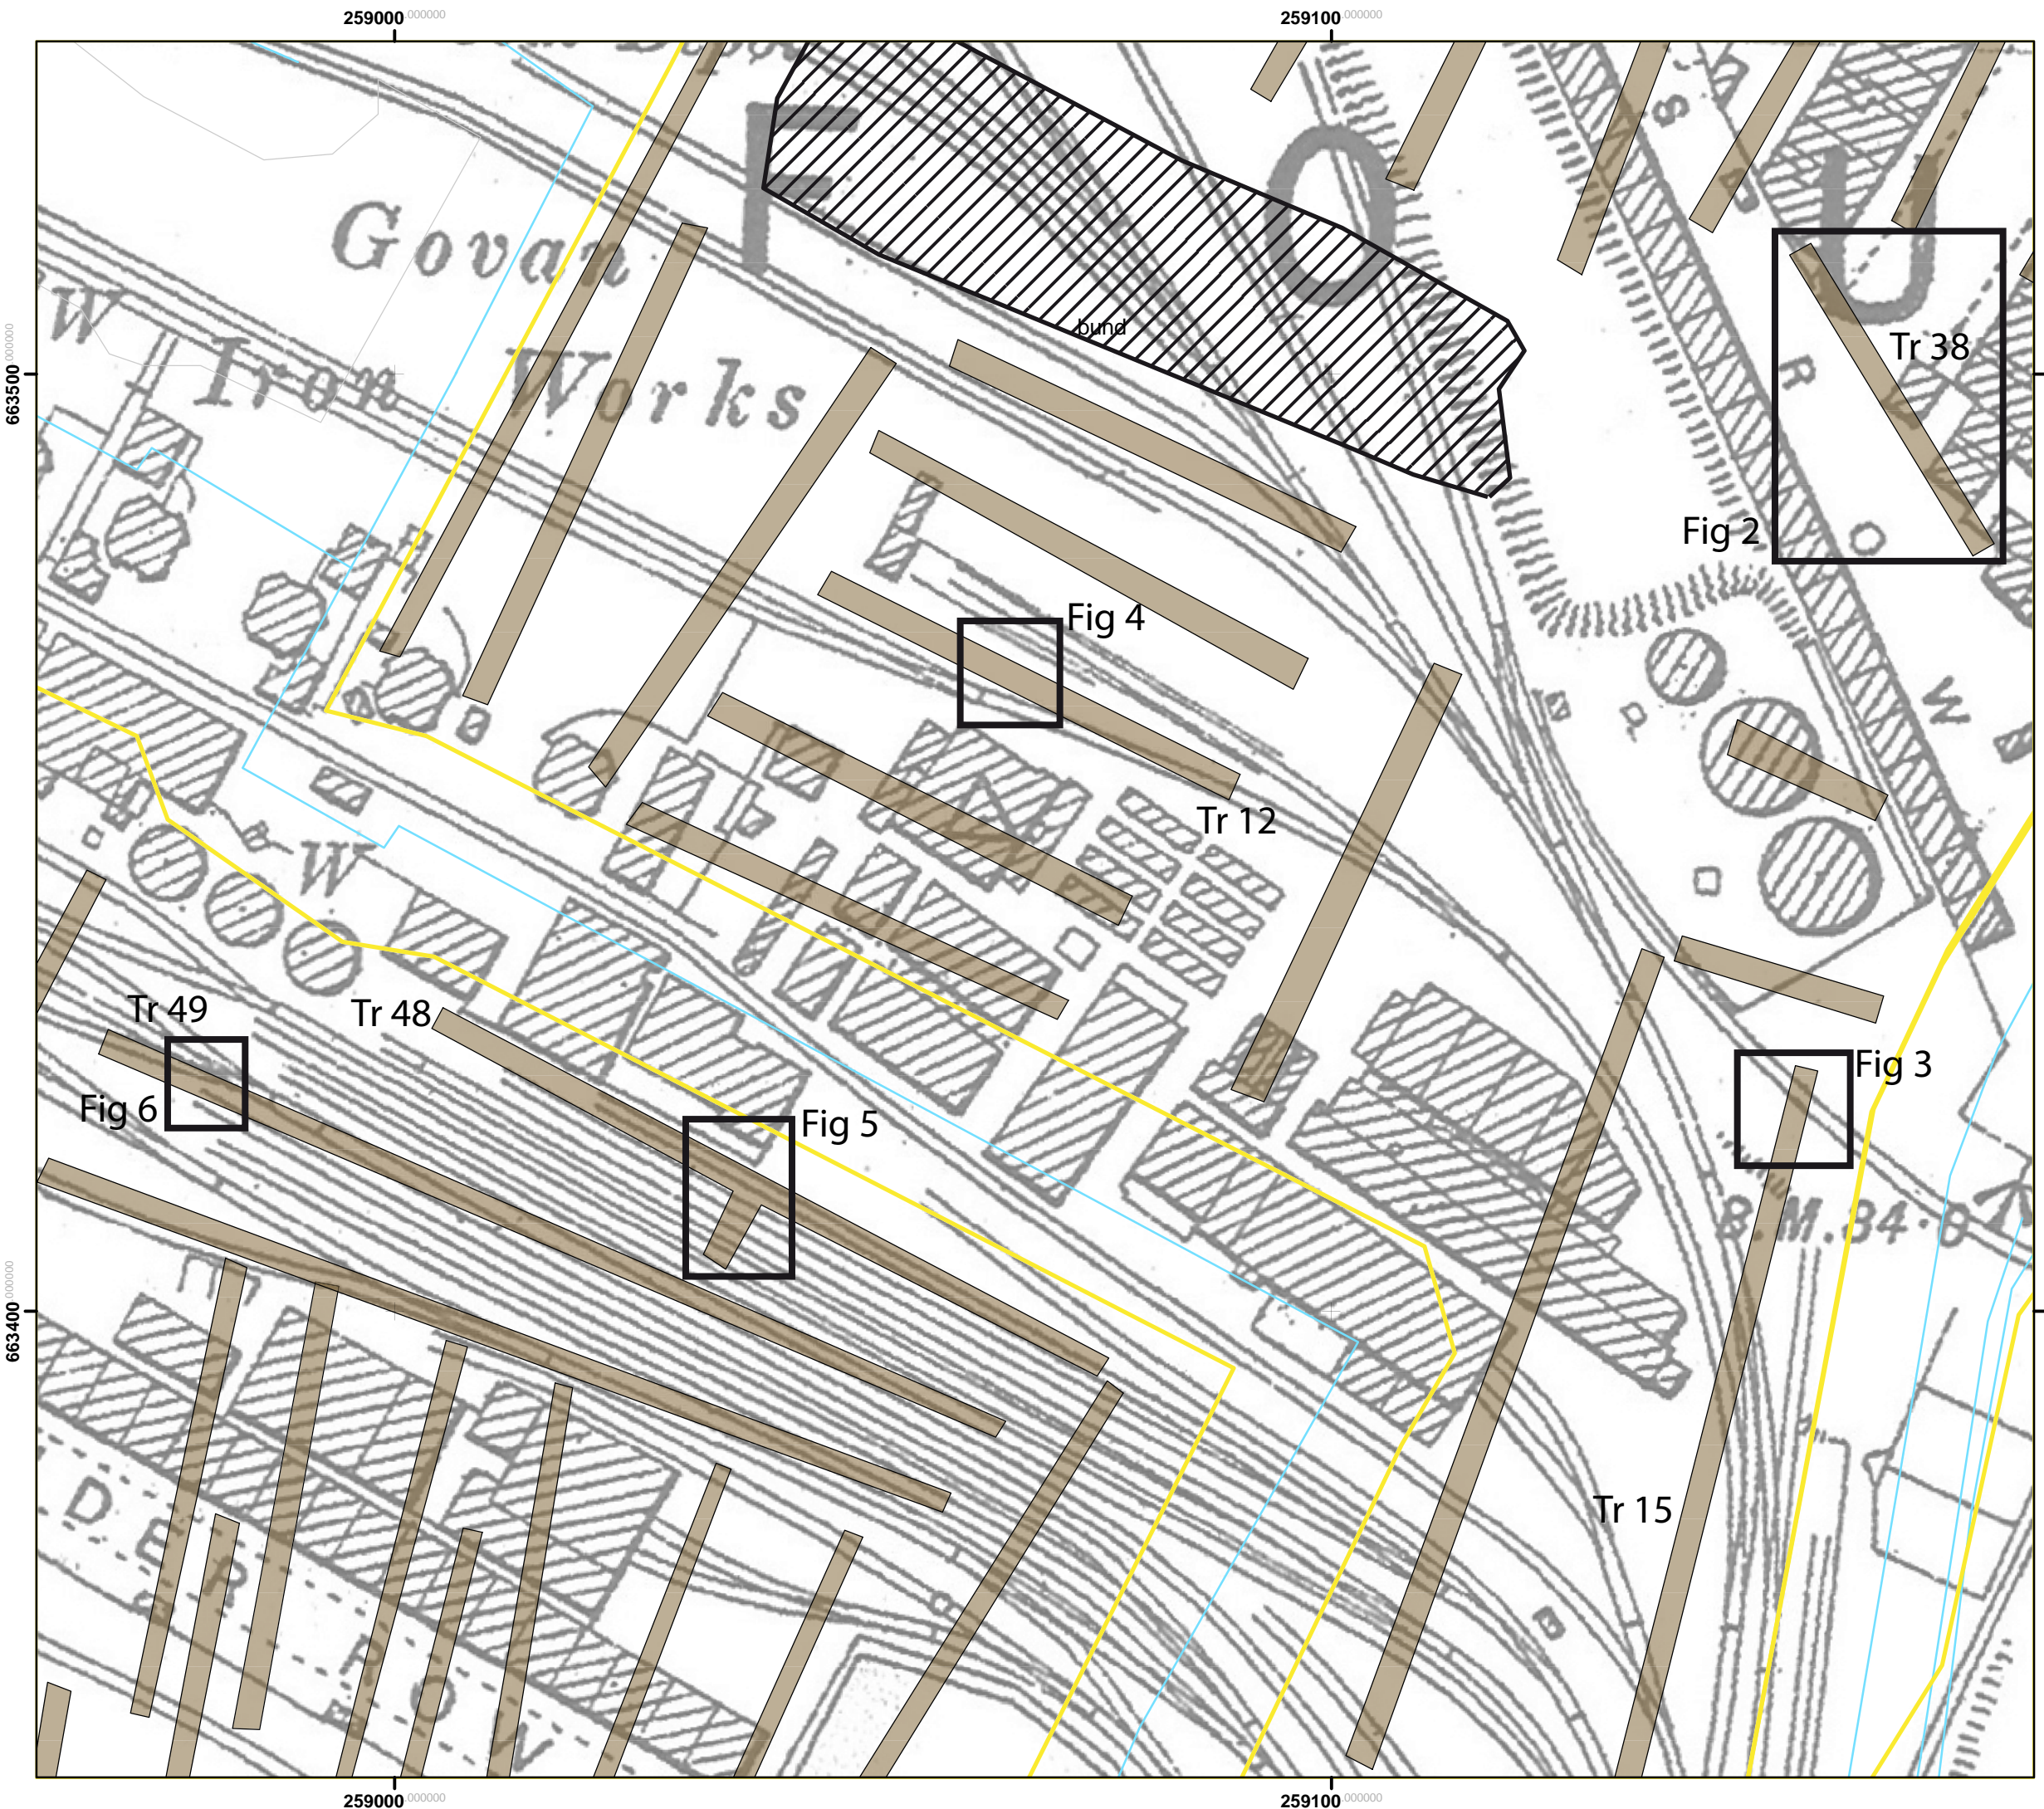
Figure 7: Evaluation trenches overlain on OS 1st Edition map
