Anne Crone and Diana Sproat

Revealing the History Behind the Facade: A Timber-framed Building at No. 302 Lawnmarket, Edinburgh

Architectural Heritage XXII (2011): 19–36

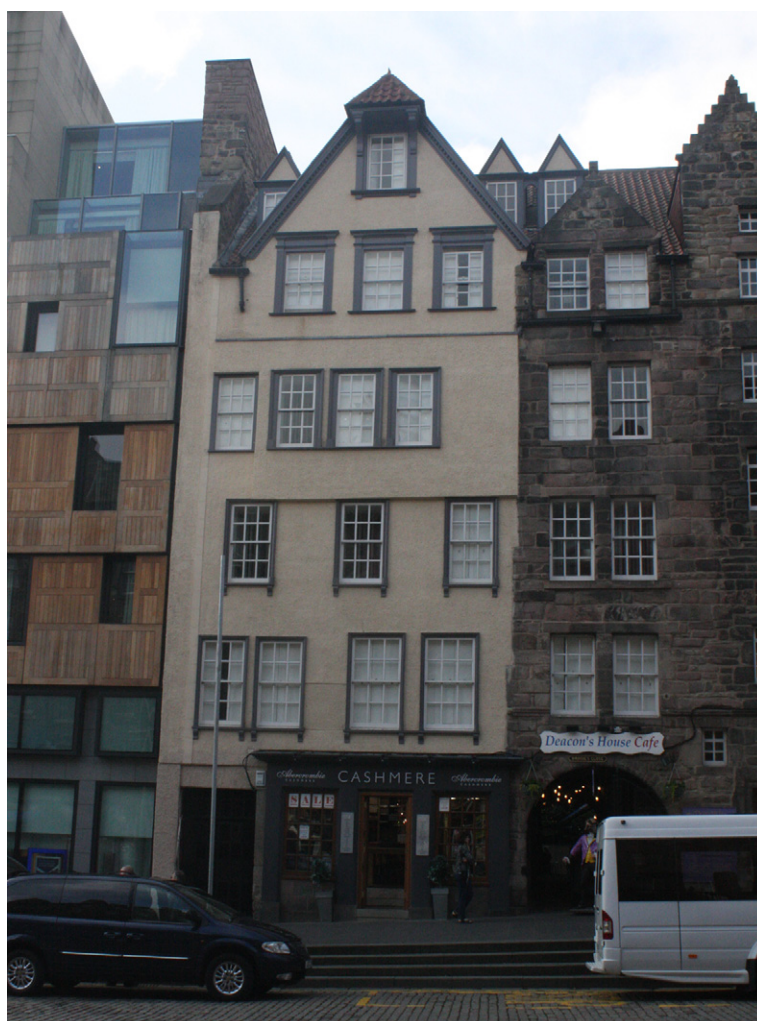
1. The frontage of No. 302 Lawnmarket after renovation. To its left is the renovated frontage of No. 304 while to its right is the new development of the Missoni Hotel. (Copyright: AOC Archaeology)

Between 2006 and 2008, AOC Archaeology Group undertook a detailed survey of Nos. 302–304 Lawnmarket, two Category A listed tenement buildings located within the Old Town of Edinburgh. The work was undertaken as part of a planning condition for the redevelopment of a large plot located at the junction between George IV Bridge and the Lawnmarket, now the Missoni Hotel. The buildings have now been incorporated into this development, with shops on the ground floor and hotel accommodation on the upper levels (Figure 1).

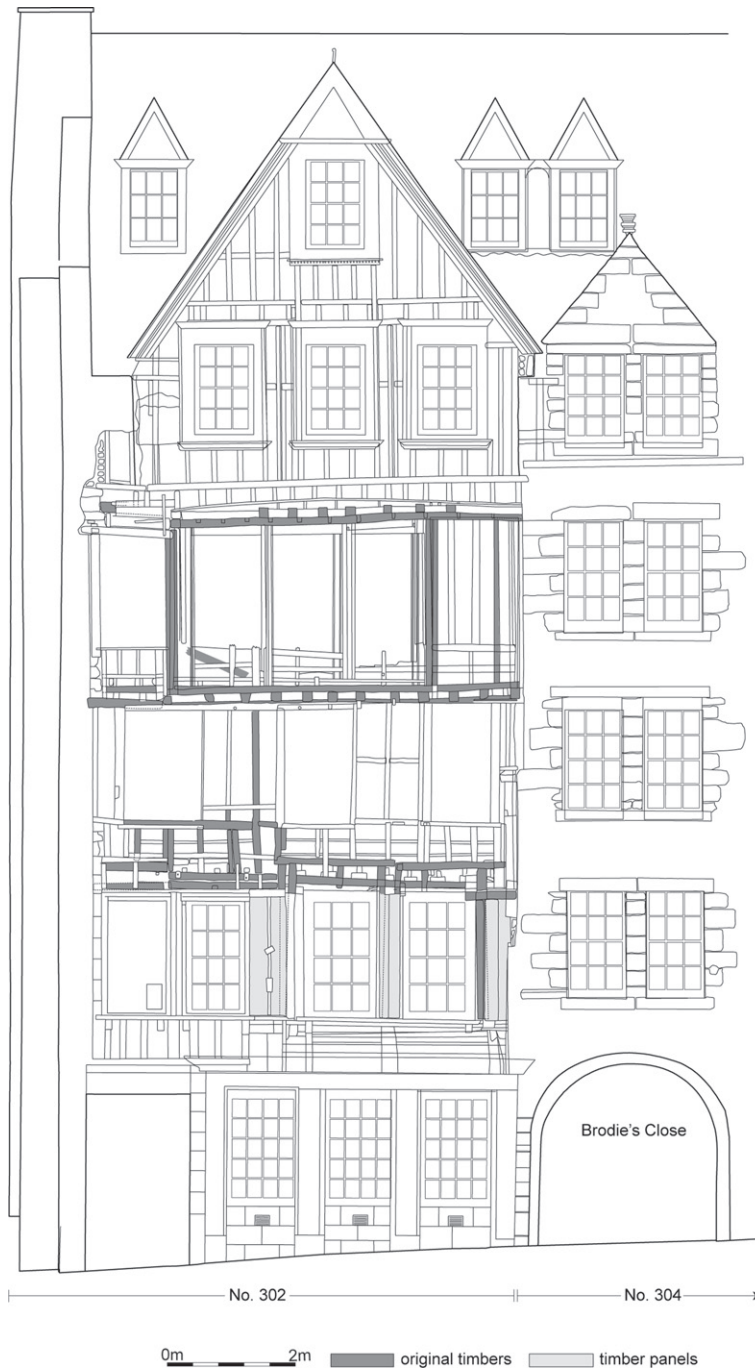
2. The street frontage with the remnants of the original timber framing on the first, second and third floors highlighted. (Copyright: AOC Archaeology)

During the recent development works, the removal of the wire mesh and render facade revealed a patchwork of timber features relating to the original late sixteenth century construction, late nineteenth century alterations and the 1960 development, all of which were recorded in detail (Figure 2). The vertical timber framing was confined to the Lawnmarket frontage; the rear and gable walls of the building were stone rubble-built, as was the ground floor frontage, and there was no evidence to suggest that these elevations had not always been stone-built. The fourth floor and attic of the building were added in the late nineteenth century (see below) and, whilst still retaining a timber facade, the timber used on these floors was machine-cut pine. The original timber framework on the first, second and third floors is vestigial, much confused by the later interventions, and was also rotten in places, so much so that it was often impossible to determine how individual components had been jointed together. Nonetheless, the facade retained enough features to allow something of the nature of the original construction to be determined.

Most of the main vertical framing has been removed on the second and third floors. On the second floor there were remnants of a mid-rail about 750mm above ceiling height with vertical studs below, each one approximately 250–350 mm apart (Figure 2). Where the joints survive, the horizontal members of the framework have been tenoned into the sides of the vertical members. However, there is no evidence that the joints were ever pegged together. One of the few surviving studs on the third floor is tenoned into the upper rail of the second floor ceiling. Like the studs on the first floor, the studs on the second floor had mortises cut at irregular intervals into their side faces, suggesting that there was also a lattice of transverse timbers.

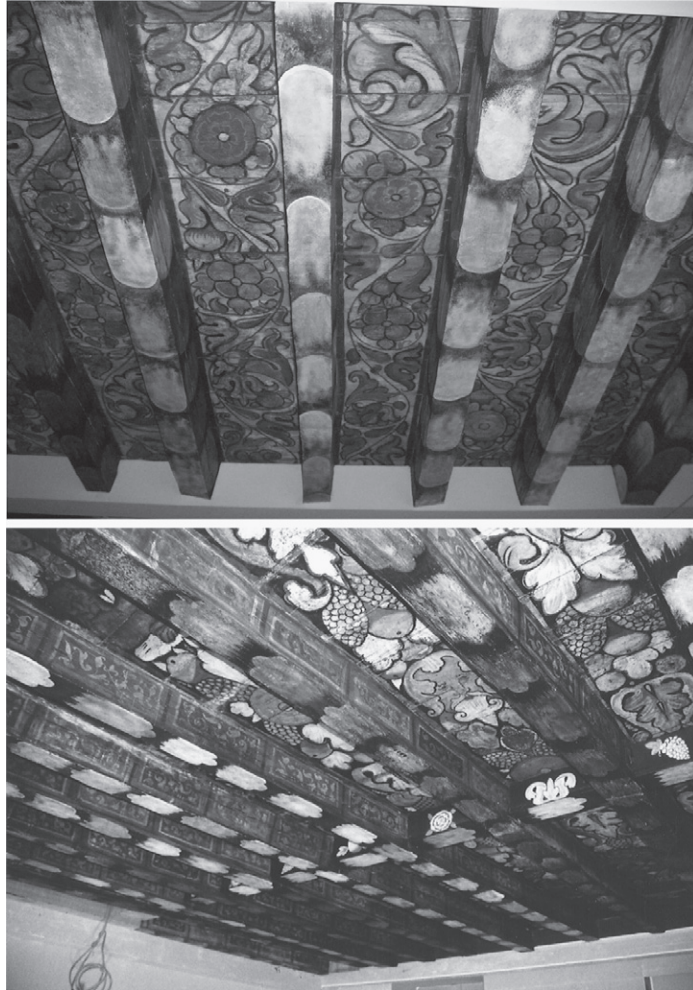
4. The board-and-beam ceilings from the second floor (upper) and third floor (lower). (Copyright: AOC Archaeology)

What remains of the second floor ceiling consists of ten boards, each approximately 300mm wide, supported over eleven north-south running beams, also painted. It seems clear from the designs on the boards now in storage at the Historic Scotland Conservation Centre, that the second floor ceiling probably spanned two rooms separated by a dividing wall.⁷ The third floor ceiling also comprises ten boards supported by eleven beams.

The decoration of the painted ceilings has already been described in detail by Bath,⁸ and so is only briefly summarised here. Both ceilings share decorative motifs in common, notably arabesque or trailing tassel decoration along the beams, with fruit and floral patterns including roses and acanthus leaves on the boards, all heavily outlined in black or brown (Figure 4). However, the third floor ceiling displays a greater variety of motifs, including a rabbit, a lion, a fox and several birds interspersed amongst the vegetation, as well as a male head resembling a Green Man. The overall colour scheme of both ceilings was warm and vibrant, with certain colours highlighted by varnishing.⁹

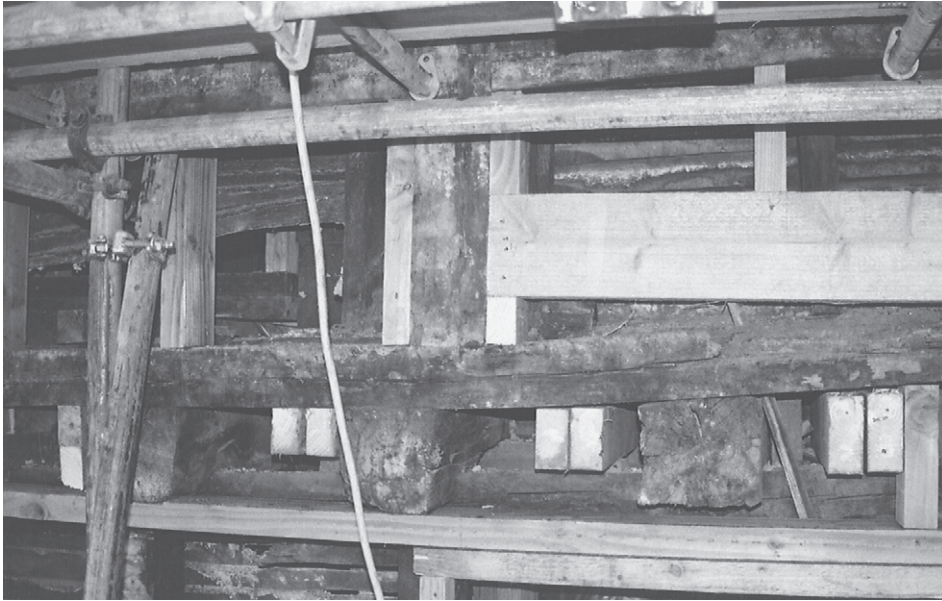
7. The jointing between the beams and rails of the second floor ceiling, on the western side of the building. The half-lap joints are visible some distance behind the ends of the beams, while the upper rail lies directly over them. (Copyright: AOC Archaeology)

The ceiling of the second floor is defined on the frontage by double rails, between which the beams of the ceiling are sandwiched with their ends projecting out beyond the frontage.²⁰ The beams were set between 320 mm and 520mm apart and were lap-jointed over the lower rail, while the upper rail lay directly on the beams with no apparent means of fixing (Figure 7). On the third floor, the ceiling beams were similarly spaced but appeared

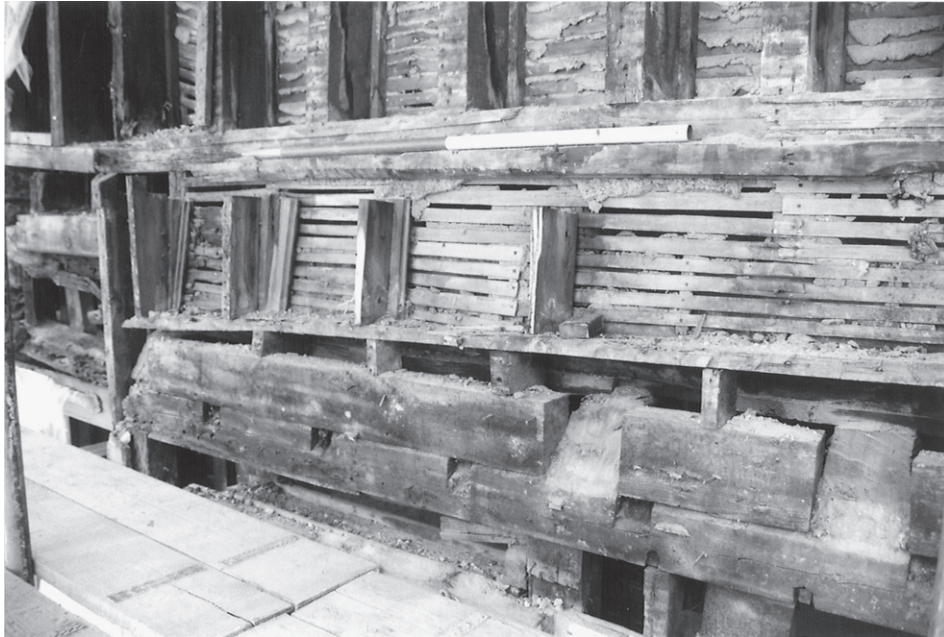
8. The lower rail and beams of the third floor ceiling, on the eastern side of the building. The chopped-off ends of two of the beams are visible on the right of the photograph, as are the notches cut into the lower rail. The timber lying over the rail and between the beams forms part of the 19th century renovations. (Copyright: AOC Archaeology)

to lie directly over the lower rail, although the beams had been cut back at an angle and later interventions made it difficult to see whether they had actually been jointed over the rail (Figure 8). A notch had been cut into the lower rail to one side of each beam; these features do not appear to have served any function in the later interventions so they may well relate to the original design of the framework. The upper rail was missing, if it had existed at all.

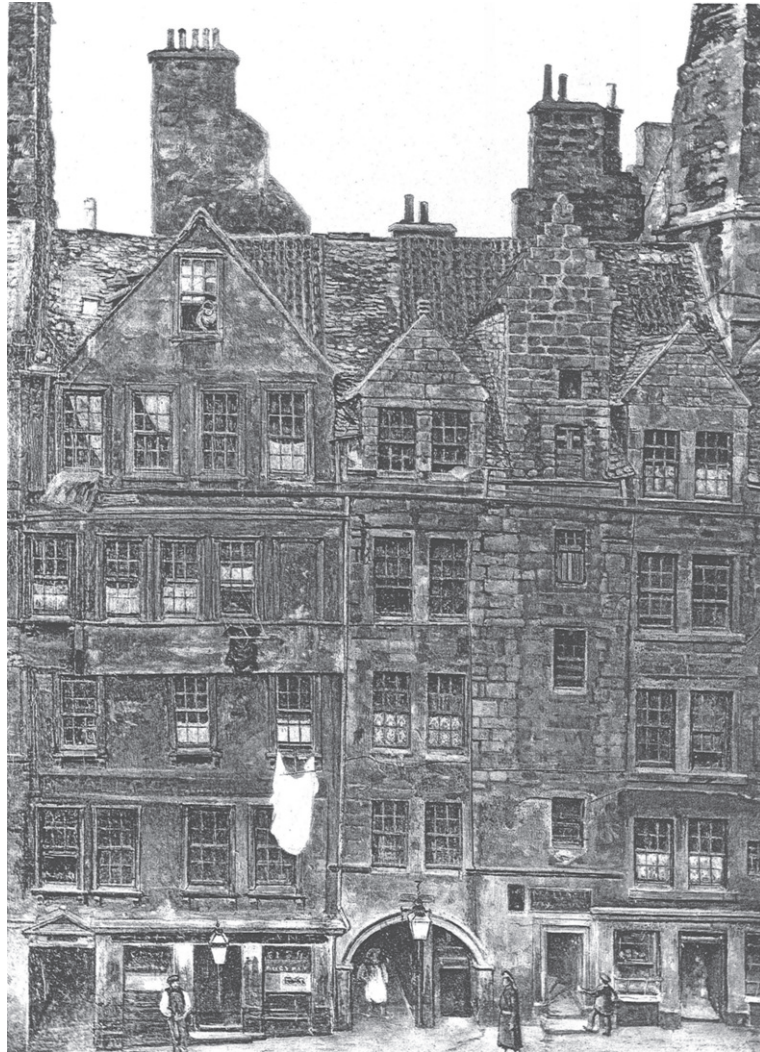
9. No. 302 Lawnmarket c. 1908 (from 'Map showing the old houses remaining in the High Street & the Canongate of Edinburgh, March, 1908' prepared by B. J. Home).

No. 302 was one of a small number of timber-framed buildings along the Lawnmarket which had survived into the late nineteenth century. Other examples include the house of Mary of Guise in Milne's Court²¹ and the two neighbouring buildings on the corner of the West Bow.²² In 1898 plans were drawn up to improve the building; these involved the removal of the projecting timber galleries so that the frontage of No. 302 was flush with its neighbours, and the addition of the fourth storey and attic, thus bringing it to the same height as its neighbours and creating a more harmonious elevation along the Lawnmarket (Figure 9).

The cut back frontage was harled to hide the mess of timberwork, but the timber rails of the second and third floor ceilings appear to have been left visibly defined.
