Commonwealth Games Village Remediation Archaeological Works: Data Structure Report

AOC 21370
January 2011

Commonwealth Games Village, Remediation Works: Excavation Data Structure Report

AOC Project No: 21370

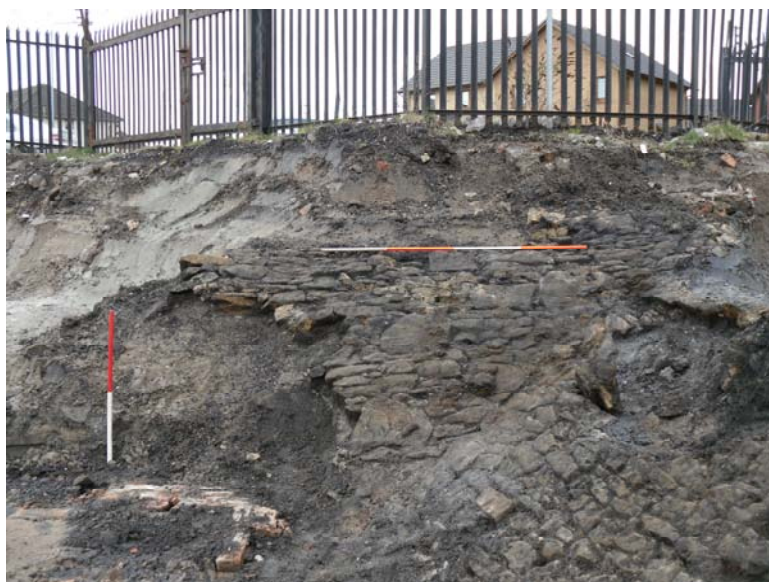
Plate 10: Detail of northern corner of Filtering Pond

6.2.6.1 Remediation Area 37 was partially excavated across the north-eastern corner of the Glasgow Waterworks filtering pond and the internal area. The pond was excavated to a depth 2 m through a fill of building rubble including sandstone, brick and concrete [345] deposited once the structure had gone out of use. Alluvial sand was identified at the base of the remediation excavation.

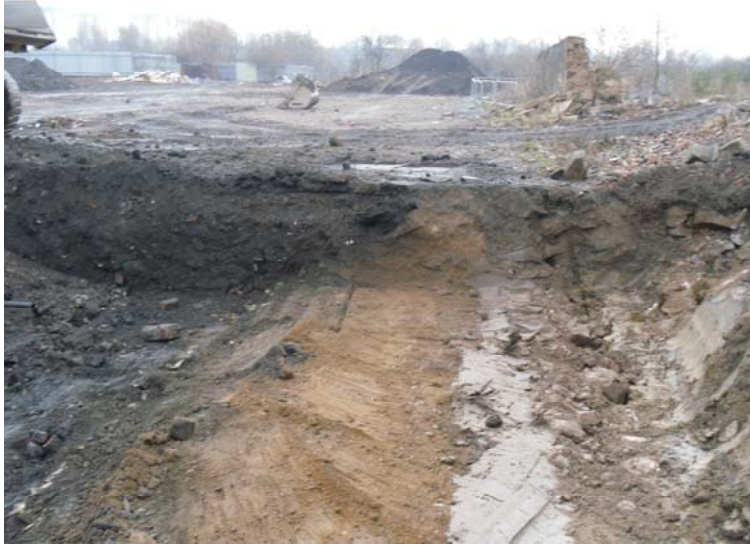
Plate 12: Detail of Filtering Pond clay bank [340]

6.2.7.2 The filtering pond's eastern wall [337] comprised a sandstone cladding [342] overlying a foundation of sand and clay [506], which itself was built against a clay bank [340] (Plate 12). A deposit of red bricks [338] and [339] within the wall indicates a secondary phase of repair. The origin of the repair is unclear, however as above in Area 37 wall section, it seems likely that either the wall was damaged or piping that once entered in to the tank at this point was removed.

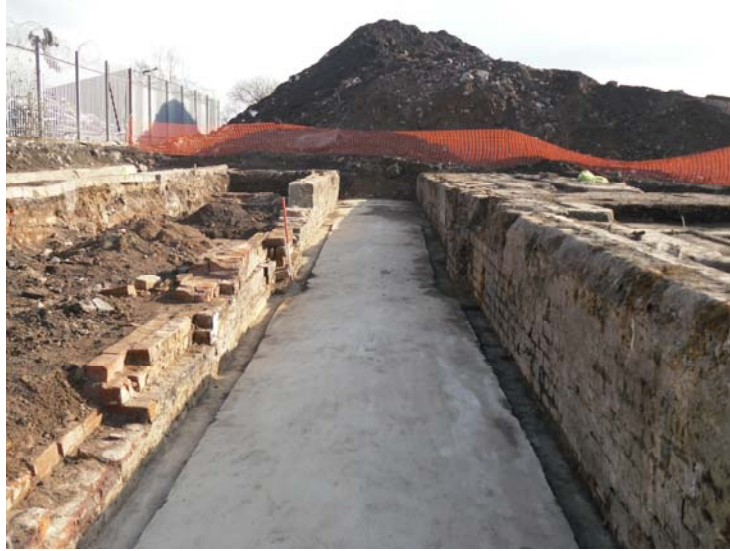
Plate 13: Detail of later machine base overlying earlier Glasgow Waterworks Boilerhouse

6.2.9.2 Initially, the excavation suggested that that very little of the actual boilerhouse had survived truncation by later development. Only those features which could be used as foundations for the later buildings survived. The external, load bearing walls of the building were identified to the east [032] (Plate 14), south ([087] and [109]) and possibly west [118]. The surviving building remains measured 29 m by 18 m in width, by up to 1.50 m in high. No other internal features such as doorways, windows or floor levels were identified during these works. These walls were well built using red sandstone. Additionally, a red sandstone culvert [088], constructed of well dressed blocks was identified to the immediate south of the boilerhouse. The drain is built from recycled stone rescued from the demolition of Georgian buildings in central Glasgow (Hugh McBrien pers.comm).

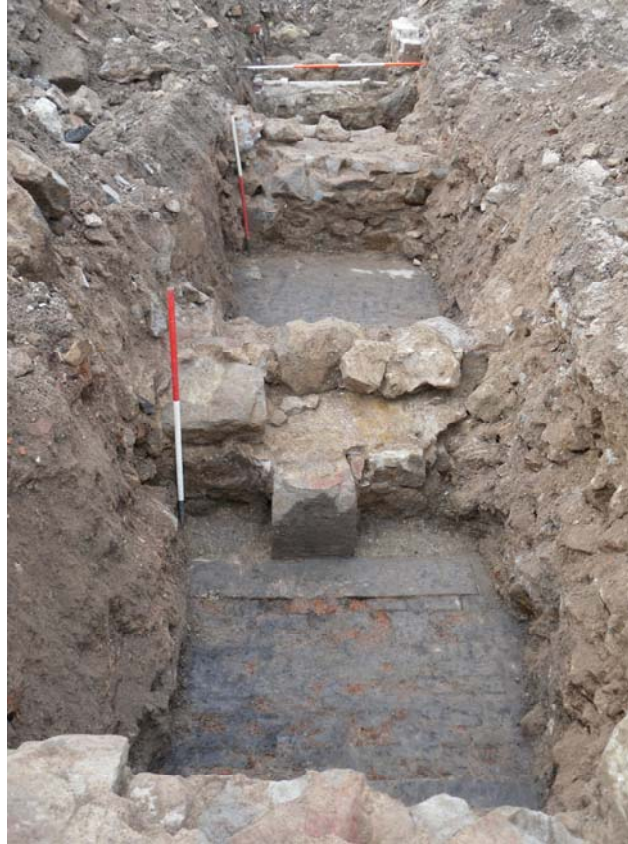
Plate 15: Detail of Cornish Boiler Pits within Glasgow Waterworks

6.2.9.3 A secondary trench was excavated below the level required by the remediation works, through the middle of the boilerhouse (Plate 15 and Figure 13). The trench measured 2 m in width by 6 m in length with excavation revealing three parallel north-east to south-west aligned sandstone-built machine pits, floored by handmade red bricks. In consultation with WoSAS, the excavation stopped at this point as the structures were under no immediate threat from the immediate development or remediation.

6.2.9.4 In total four large, load bearing sandstone wall were identified [154], [159], [161] and [163]. The walls were similar in size and function generally measuring 1.55 m in width and surviving to approximately 0.65 m high, and were constructed using roughly cut sandstone blocks (Figure 13). The foundation of each wall was 0.80 m wider than the overlying structure, protruding 0.40 m at either side. In addition each wall was abutted by at least one surviving sandstone buttress ([164], [105], [166] and [167]), which supported a now removed pipe. Each of the machine pits were floored by a concave base of handmade bricks, measuring 1.10 m in width (Plate 16). The pits existed across the entire building, as recorded on the 1st Edition OS Map (1861, Figure 6).

6.2.9.5 The shape and size of the pits suggest that they supported a series of parallel Cornish boilers. The boilers themselves would have been aligned north-east to south-west, and supported on the sandstone walls, allowing air to freely circulate in the curved brick course underneath. The 1st Edition OS Map records seven individual channels suggesting the existence of seven boilers (1861, Figure 6). These boilers would have been at the basement level of the building, with access to fire doors to the south-west. A flue system to the north-east of the basement would have been accessed by the circulation points under the boilers. Chronologically, the Cornish boilers would have been replaced by Lancashire boilers (Ian Miller pers.comm).

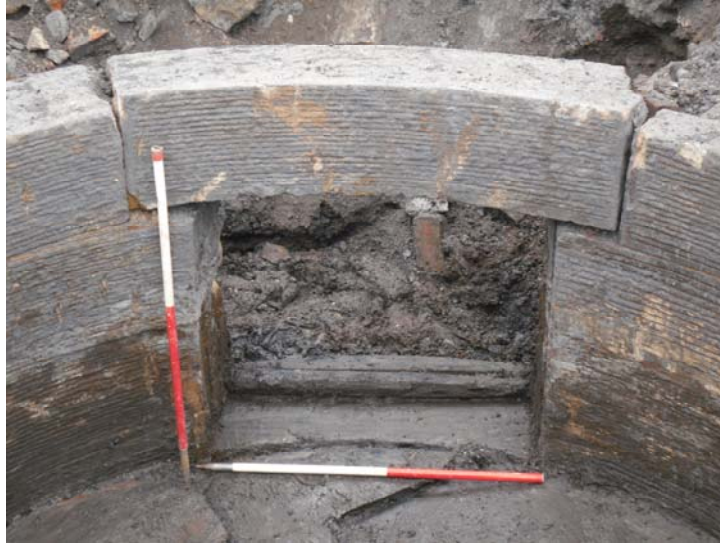
Plate 18: Detail of Glasgow Waterworks Filtering Tower gateway [1671]

6.2.10.2 The tower was built adjacent to the northern filtering pond wall, which shared all the characteristics of those examples excavated in Areas A35, A37, B9 and B10. A layer of sandstone cladding ([1636] and [1637]) was laid on to a foundation of alluvial material [1667], which itself was laid against a clay wall or bank [1634].

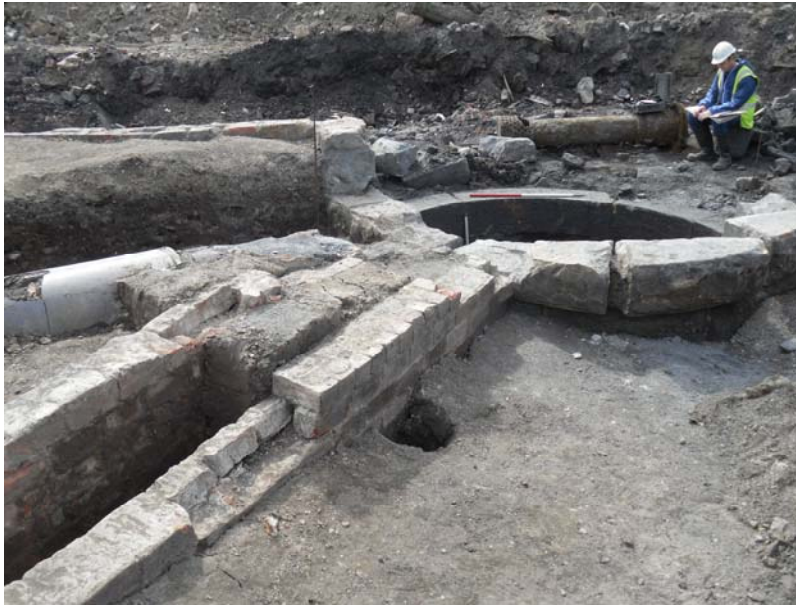
Plate 19: Detail of Glasgow Waterworks Filtering Tower pipe [1642]

6.2.10.5 The tower was accessed by two pipes located within the platform area (Figure 14). An earlier iron pipe [1660] was built over by the later wall [1648], on the same alignment between the wall [1636] and the tower [1651]. The pipe measured 0.25 m in diameter. A second, later ceramic pipe [1642] (Plate 19) and associated foundation cut [1662], overlay clay [1664], cutting through wall [1640] and the tower itself [1655]. A third pipe, the filtering instrument [1661] was identified at the base of the tower and measured 2.1 m by 0.50 m in depth (Plate 20). The pipe was found *in situ* where it would have been able to filter the water prior to it being pumped into the main supply. The dimensions of pipes, [1648] and [1661] are such that the former could have fitted in to the latter. Although the connecting piece of pipe is missing, it seems likely that this is the original system used by the filtering tower.

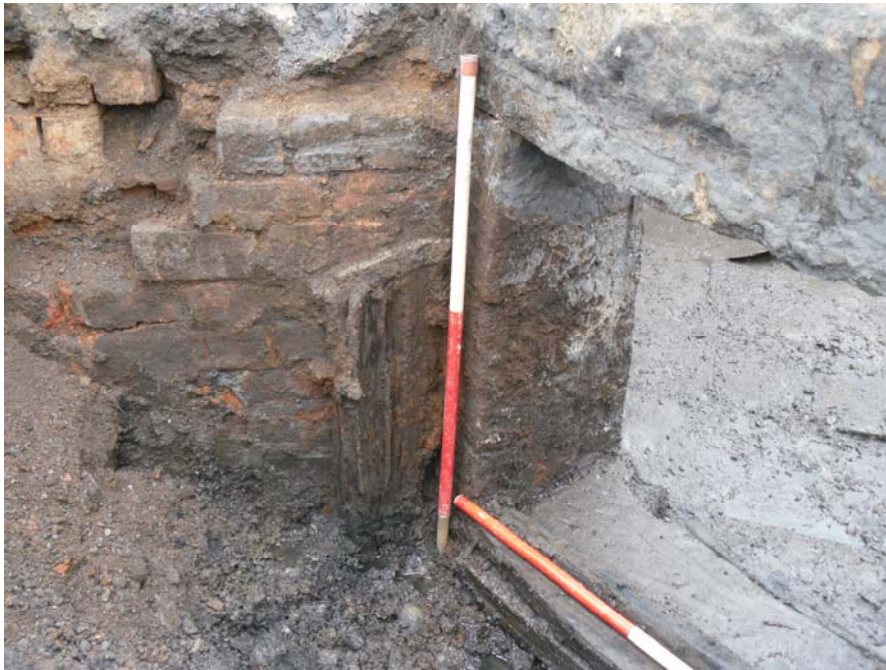
Plate 21: Detail of Glasgow Waterworks Filtering Tower gateway [1671] and wall [1653]

6.2.10.8 The filtering pond wall [1653] was identified on the southern edge of the tower (Figure 14). The wall was constructed using hand-made red bricks, placed within a 0.30 m by 0.20 m slot [1654], within the tower itself (Plate 21). The wall [1653] measured the same depth as the surviving tower, and was contemporary with it.

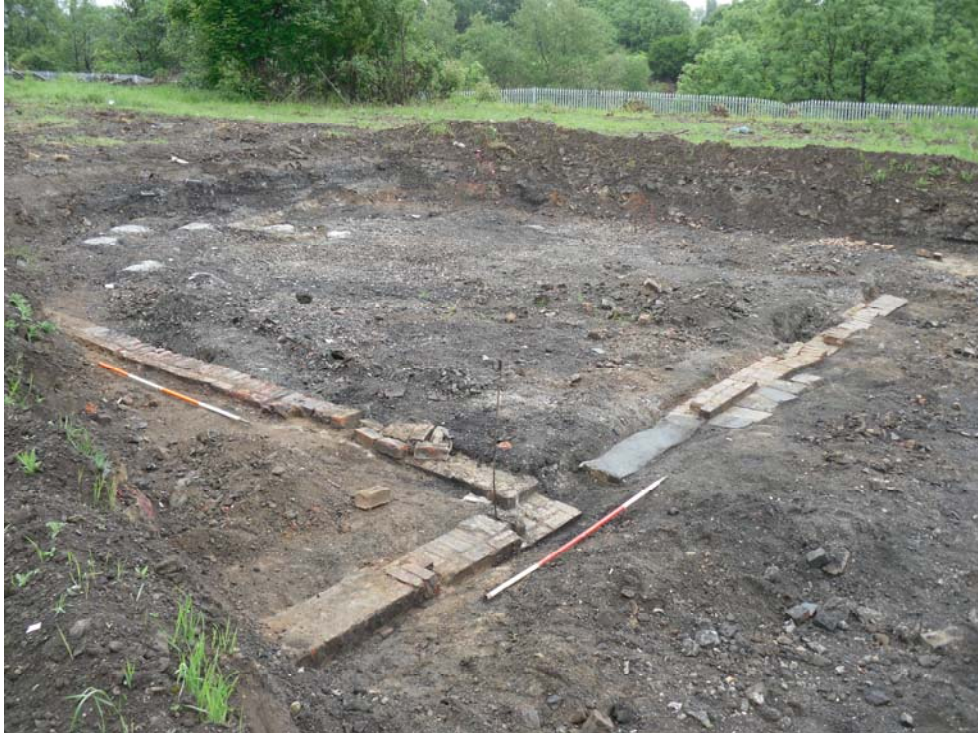
Plate 22: Detail of Building [1268], Area 26

was located to the immediate west of [1268]. The structure was represented by the south-east corner of a building defined by walls [1265] and [1266] (Plate 22). The surviving building measured 7.25 m by 2.5 m. Both buildings were built into the redeposited clay [865] found across the site. These buildings represent the remains of structures from the Springfield Print and Dye Works and are represented on the 1st Edition OS Map (1861; Figure 6).

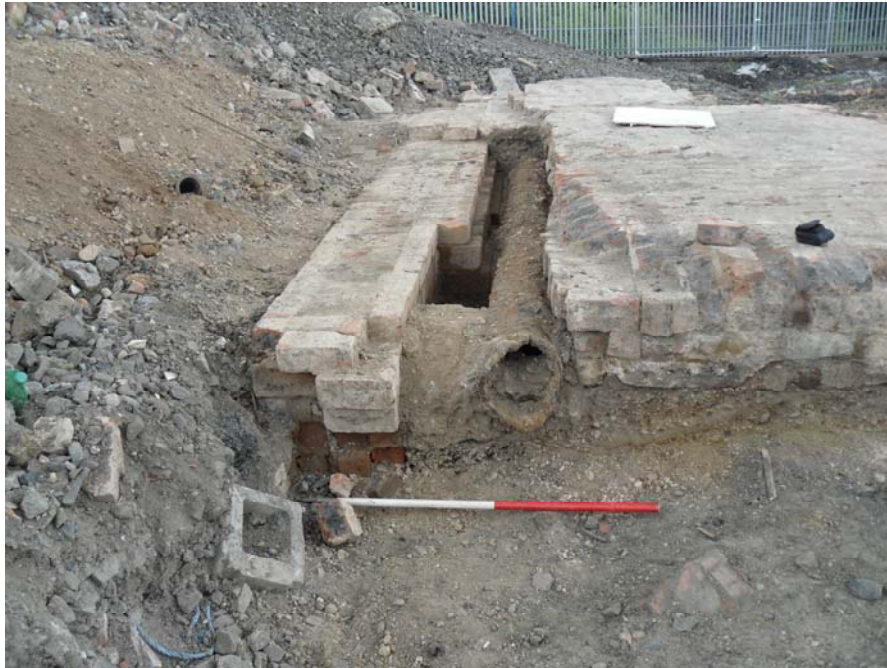
Plate 23: Detail of internal floor [1283] and water pipe [1274], Area 27

6.3.5.1 Area A27 was excavated through an existing embankment to a depth of 2.4 m through made ground including building debris and rubbish. The natural subsoil was not encountered. The red brick foundations of a building ([1270] to [2186]) were identified at the base of the area (Plate 23 and Figure 16). The building comprised an east to west aligned load bearing red brick wall, measuring 5.5 m by 0.74 m by 0.43 m in depth. The wall was abutted by an internal brick floor surface [1283] measuring 3.73 m by 2.2 m. Associated internal features include internal walls [1276], [1285] and [1277], a metal water pipe [1274] and isolated bricks [1281] and [1284]. These buildings represent the remains of structures from the Springfield Print and Dye Works that are represented on the 2nd Edition OS Map (1895; Plate 8).

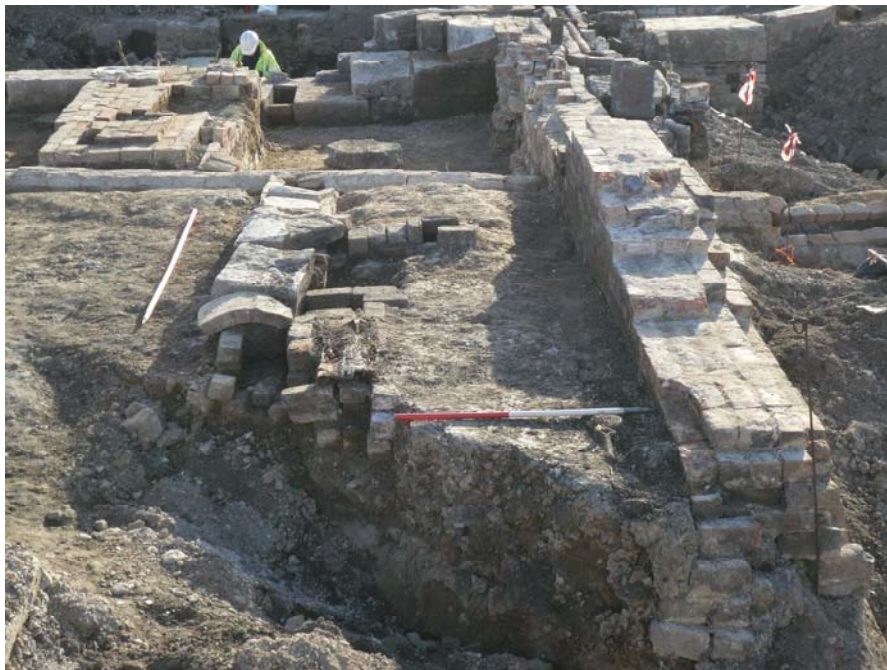
Plate 24: Detail of load bearing wall [1600], with adjacent drain [771] and re-used boiler fragment, Area 29

6.3.8.2 The external, load bearing southern wall consisted a combination of red brick ([1600] and [742]) (Plate 24) and sandstone ([800] and [526]) walls measuring in total at least 60 m in length (Figure 18). Internally, only walls ([616] [703], and [708]) were capable of load bearing, suggesting that the building comprised a single shell requiring few internal structural supports. There was no evidence in the form of stairs to suggest the building was anything but single floored with a lower basement /cellar area.

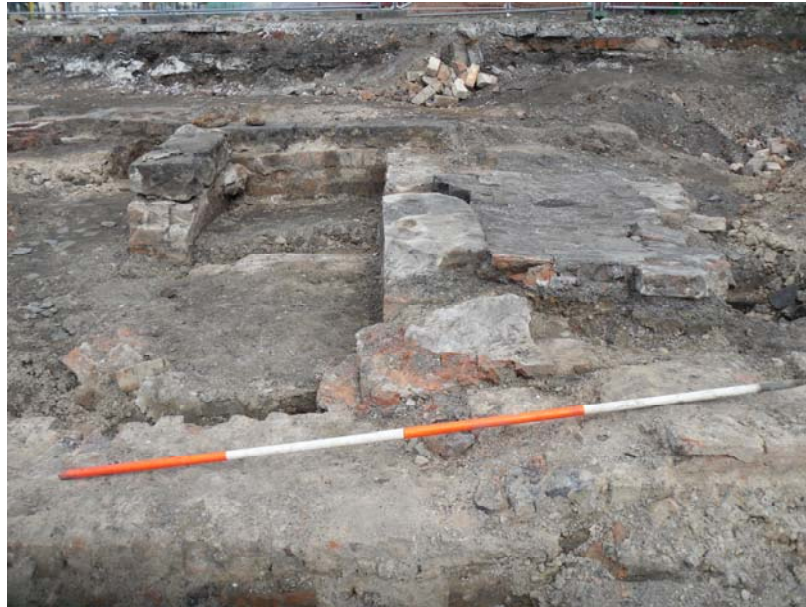
Plate 25: Detail of floor surface [618] with protruding drain [615], Area 29

6.3.8.3 The survival of floor levels was poor, the surfaces having been removed during its later use and/or subsequently by the partial demolition occurring by the 1950s (5th Edition OS Map 1955, Figure 10). Only two floor surfaces were identified ([618] and [670]/[671]). Floor [618] was constructed of concrete covered red brick (Figure 18) and contained a central drain protruding from its surface (Plate 24), which directly accessed the underlying red brick drain [615]. That the drain was identified here suggests a working shop floor, where the bleaches and dyes were being used. Floor surfaces [670] and [671] formed a working floor where a probable row of washing machines stood (Figure 18 and Plate 26; Ian Miller pers comm.). Despite existing at slightly different heights, both floors were built directly on to the underlying clay [864], and probably represent the original floor levels.

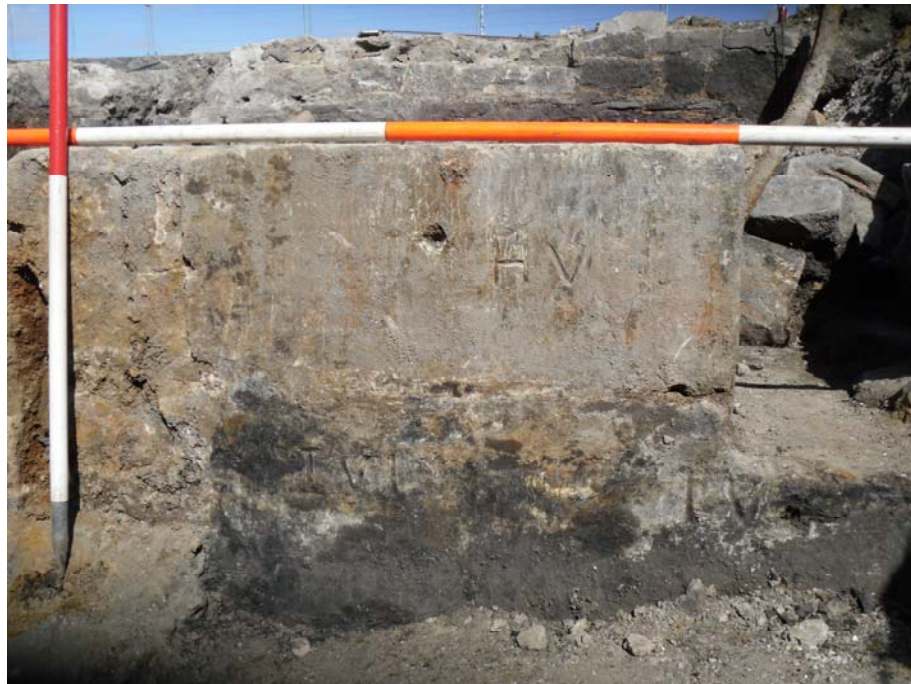
Plate 29: Detail of Roman numerals within Beam Engine [759], Area 29

6.3.8.5 The beam engine [759] (Figure 18 and Plate 28) was built through the underlying clay [864] into the underlying natural sand [865]. Measuring 9 m by 6 m and up to 2.5 m- 3 0 m in depth, the structure was constructed of large dressed sandstone blocks. The engine structure comprised a north [797], east [742], south [800] and west wall [757]/[799], and was divided in two by a central lower wall [727] aligned through the middle. A sandstone base [733] was identified in the northern fragment of the engine. Evidence for machine bases and supports were identified throughout the structure. The main 'beam' of the engine would have been pivoted on the central wall [727] and attached through machine bases [728, [729], [730], [731] and [863]. The beam would have been attached to the cylindrical piston which was connected to the base [733] and attached to the surrounding walls through machine slots [743], [744], [742], [747], [799], [802], [803] and [805] (Plate 27). Analogy with other examples suggests that a flywheel may have been located at the top of wall [799] and held in place by machine slots [748], [749] and [750]. At least five carved Roman numerals were identified on the southern face of wall [727] (Plate 29). Such numbers would have been carved into every stone so the building could be constructed from plan. The beam engine was laser scanned using a 3D laser scanner; the digital information is currently stored with AOC.

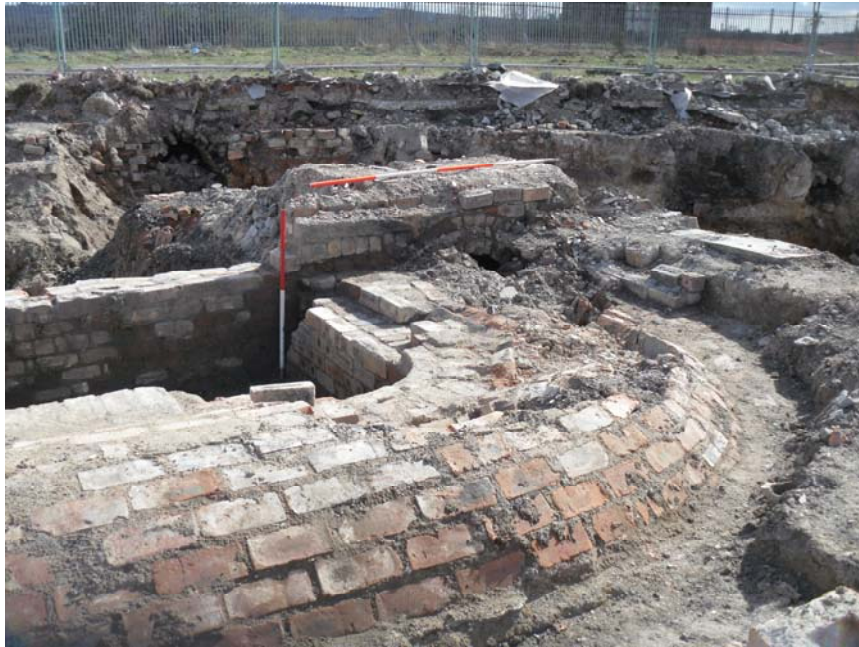
Plate 30: Detail of red brick flue [828], Area 29

6.3.8.6 A network of red brick built flues was identified underlying the existing floor levels and the clay foundation layer [864] (Figure 18). The main example [828], was identified to the immediate south of Building B, and comprised a curving tunnel, measuring 19 m in length by 1.20 m in width by 1.60 m in depth (Plate 30). The flue was aligned towards the large chimney [1288], excavated within Area A30 (Figure 20). Analogy with other parts of the site confirms that minor flues fed into a series of principal examples.

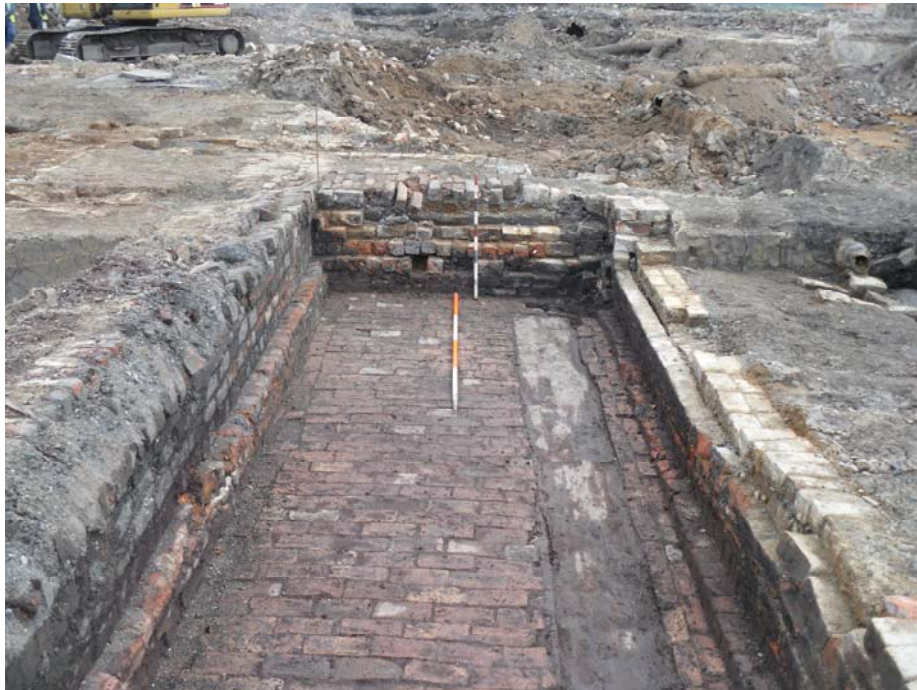
Plate 32: Detail of red brick tank [872], Area 29

6.3.8.8 The two rectangular structures ([872] and [1603]) were identified to the immediate south of Building B, abutting its southern edge [1600] (Figure 19). Structure [872], a tank, comprised a rectangular red brick structure built into the underlying clay [864]. Measuring 7.2 m by 2.9 m by 1 m in depth, it was floored by a red brick surface containing a wooden element [873] (Plate 32). Structure [1603] represent the basal remains of the toilet, measuring 5.2 m by 2.40 m. Built in to the underlying clay [864], the structure comprises a series of red brick foundations ([1604] and [1632]) associated with a drain [1601].

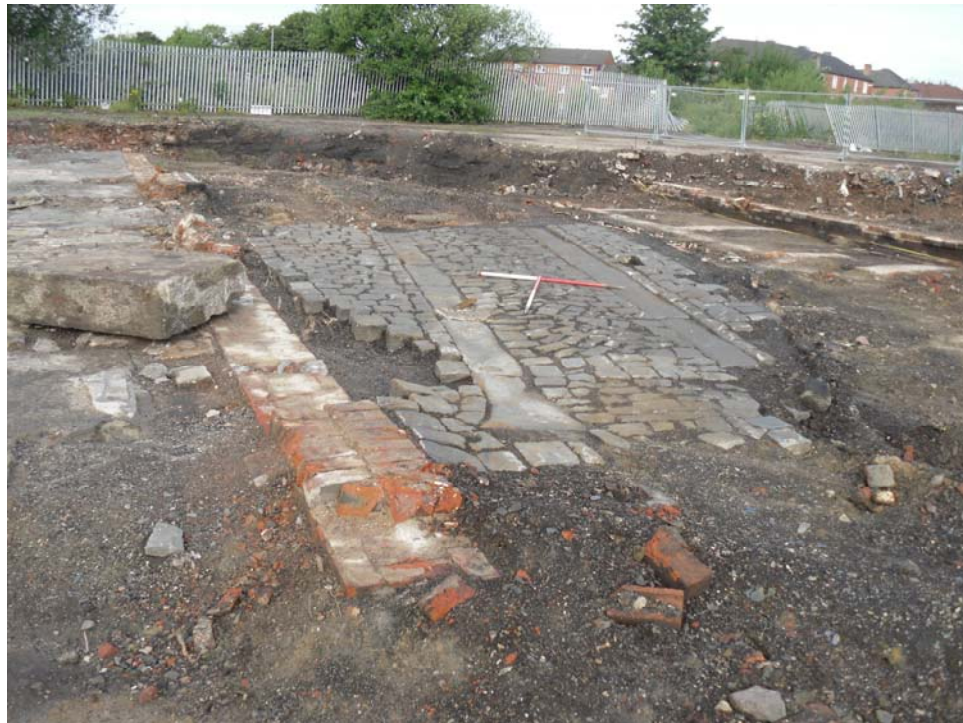
Plate 35: Detail of load bearing wall [1576] of Building O, and associated road [1596], Area 29

6.3.9.4 The northern fragment of Building O was identified within Area A29 (Figure 17). The features identified comprised elements relating to the northern edge of the building, including structural and internal walls, working floors, flues and drains. The surviving elements of Building O measured approximately 11 m in width by 30 m in length. The northern, external load bearing wall [1576], was constructed of red brick (Plate 35). The building was originally floored by a combination of sandstone slabs ([1558], [1584], [1590]) and granite cobbles [1550] with subsequent repairs by concrete slabbing [1579].

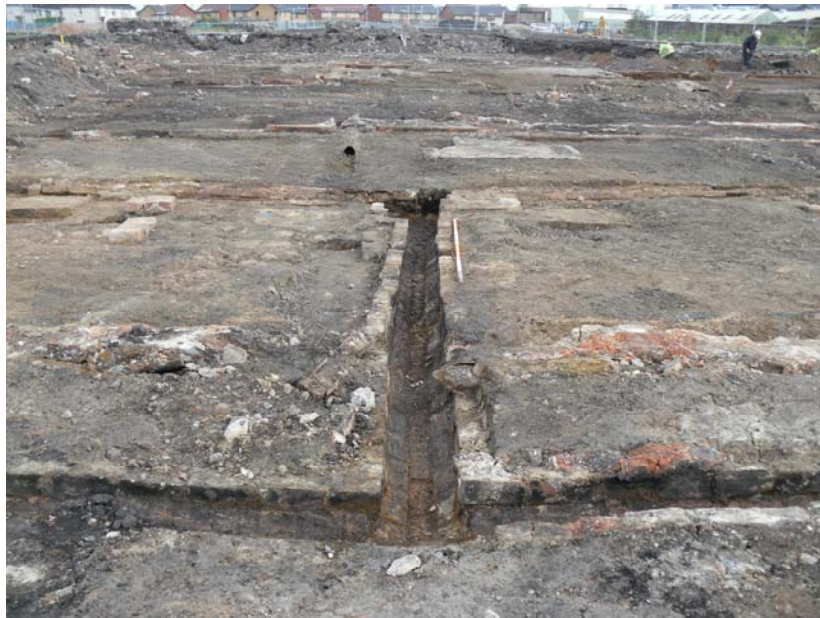
Plate 36: General shot of Building E, with Drain [1032], Area 29

6.3.10.1 Building E (Structure [1022]) is first recorded on the 1st Edition OS Map (1861; Figure 6) as a long rectangular building adjacent to the eastern end of Building D. Excavation revealed it measured approximately 10 m in width by at least 15 m in length (Figure 20). The building was identified in the south-eastern fragment of Area A29. The building comprises a series of red brick walls ([1020], [1024] and [1026]) and drains ([1029] and [1032]) excavated into the underlying clay [864] (Plate 36). By the publication of the 2nd Edition (1895, Figure 7), the building has undergone a series of changes; the most apparent being that it had been divided in to three separate elements. The north-eastern end of the (excavated) building had been divided by the insertion of a large load bearing wall [1025].

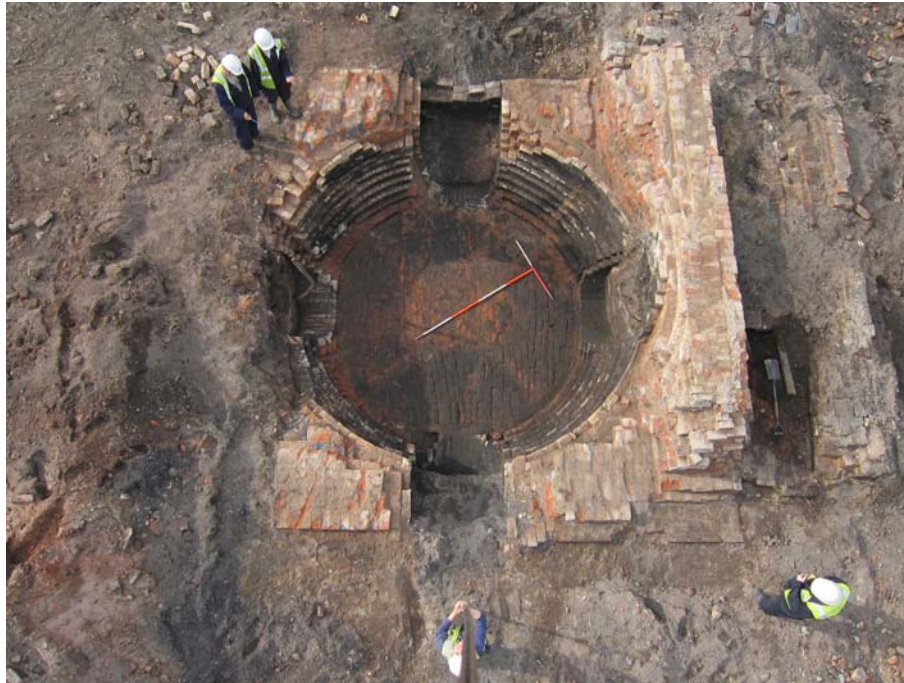
Plate 37: Detail of chimney [1288] within Building F

6.3.11.1 Building F is first recorded on the 1st Edition OS Map (1861; Figure 6) as a small square building adjacent to the southern end of Building G, measuring approximately 15 m by 20 m. The building appears on all the OS maps between 1861 and 5th Edition (1955; Figure 10). A square feature identified within the south-west corner of the building is recorded as a chimney (Plate 37), on the 3rd Edition (1912, Figure 8). This feature represent the large red brick chimney [1288] identified during the removal of the upper level of the Springfield Print and Dye Works (Figure 20). The chimney measured 6.15 m by 9.95 m and consisted of a square foundation with internal lining of fire bricks [1299], around a sub-circular red brick floor [1290]. The chimney is accessed by four brick flues [1291], [1293], [1295] and [1297], which are lined respectively by fire bricks [1292], [1294], [1296] and [1298].

6.3.11.2 General number assigned to all the features associated with the large red brick built chimney comprises numbers [1288] to [1298]. Square, red brick built base/foundation of chimney [1288], incorporating contexts [1289] to [1301]. Comprises a square built chimney, with an internal lining of fire brick [1299], with a sub-circular red brick floor [1290]. The large flue [828] excavated in Area 29 appeared to run in to the chimney.

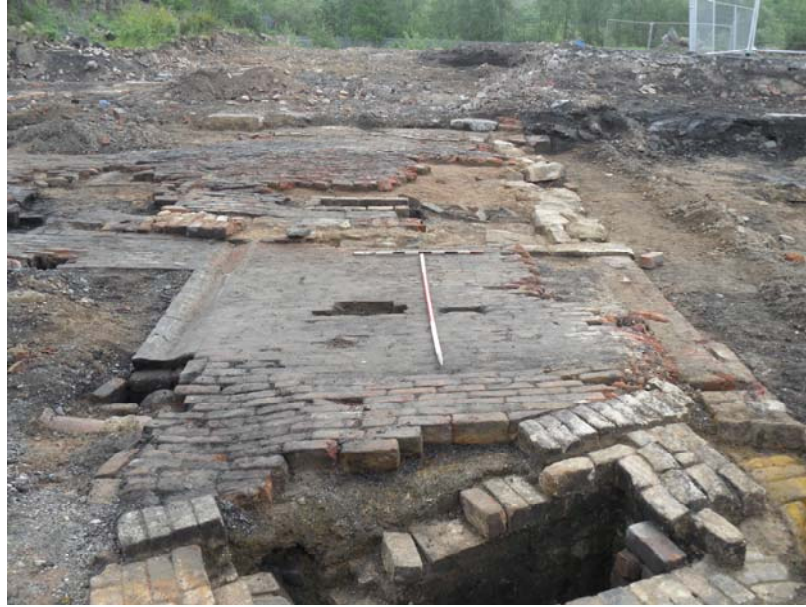
Plate 38: General shot of southern end of Building I, with red brick floor [473]

6.3.14.2 Although Building I remains unchanged in plan between the publication of the 1st and 2nd Edition Maps (1895, Figure 7), no evidence was found for the sandstone elements of the structure, that were identified in contemporary buildings such as Building J (Figure 21). Instead the structure as it survives was made entirely of brick. The surviving building measured 15 m in length by 5 m in width. An external structural wall was identified to the north [468] and to the east ([443] and [467]) and south [469] only (Plate 38).

6.3.14.3 Where the floor survived, there was clearly at least two phases of construction. The primary floor surface was constructed of hand made brick ([470], [473] (Small Find 433), [486] and [490]). The same floor surface (bricks and character) was identified in Buildings J and K. Secondary repairs had been made to the surface using bricks set at a different angle ([474] (Small Find 435) and [475]) and paving slabs [472]. The floor was built directly over a deposit of made ground [508], itself overlying redeposited clay [285].

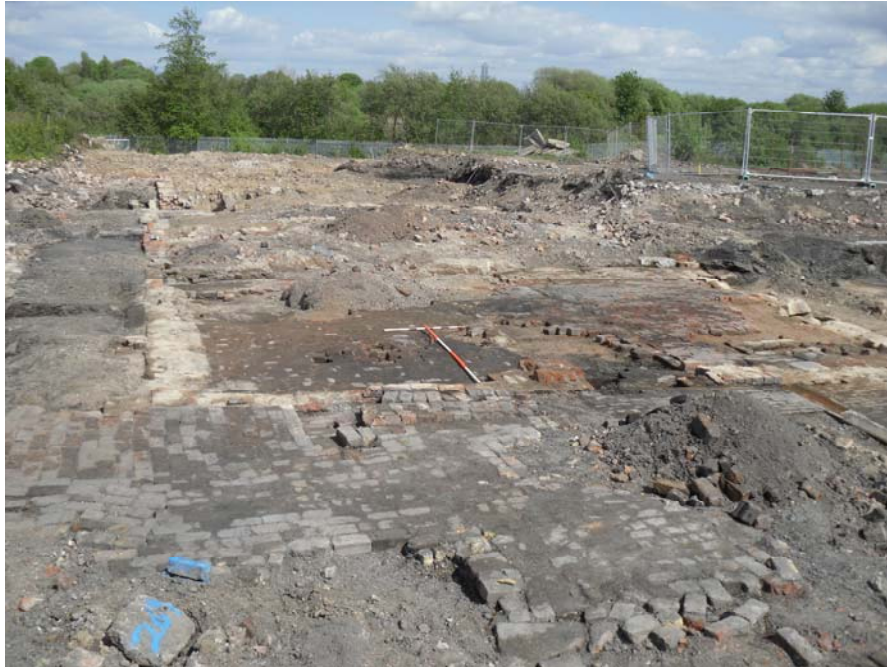
Plate 39: General shot of western end of Building J, abutted by floor [473]

6.3.15.2 Building J (Structure [418]) was originally constructed of sandstone and measured 18 m in length by 10 m in width (Figure 21). External load bearing walls survive to the east [396], to the south ([419] and [439]), to the west [414] and to the north ([331] and [442]; Plate 39). All four walls have been built in to the underlying clay foundation deposit [285].

6.3.15.3 Where the floor survived [448], it was constructed of hand made red bricks (Small Find 454), built directly over a deposit of made ground [508]. Generally, no internal features were identified within the building, although a rectangular tank [446] and a drain [425] were located within the floor [448]. Secondary phasing within the building was identified in the form of red brick repairs ([323], [443] and [445]) to the existing sandstone walls.

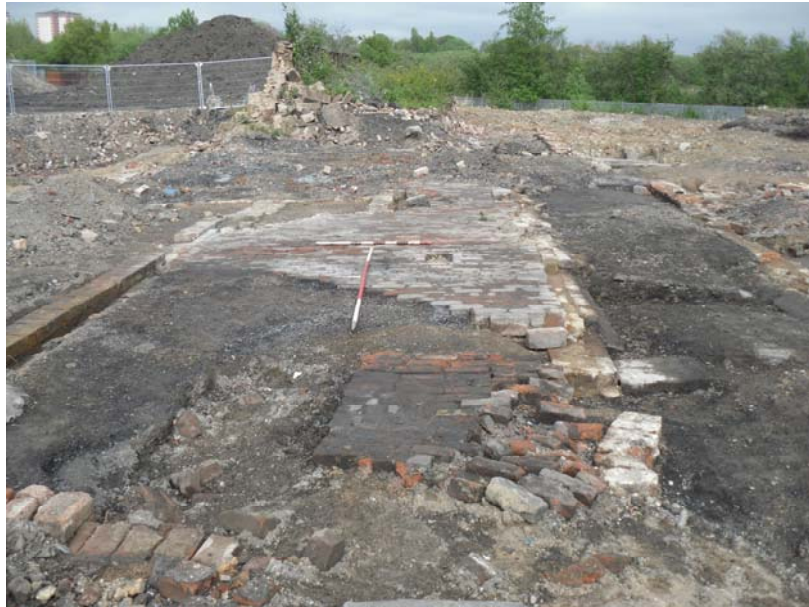
Plate 40: General shot of Building K, with red brick floor [461]

6.3.16.3 Although Building K remains unchanged between the publication of the 1st and 2nd Edition Maps (1861, Figure 6 and 1895, Figure 7), no evidence was found for sandstone construction within the structure. The building, as it survives, was made entirely of brick and measures 19 m in length by 7 m in width (Plate 40). External load bearing walls survive to the south [316] and to the west [471]. No structural wall was identified to the east; the building apparently incorporating the west wall of Building L. Internally, a floor surface of red brick [461] was identified. Internally, a red brick built drain [457] was aligned east to west through floor surface [461].

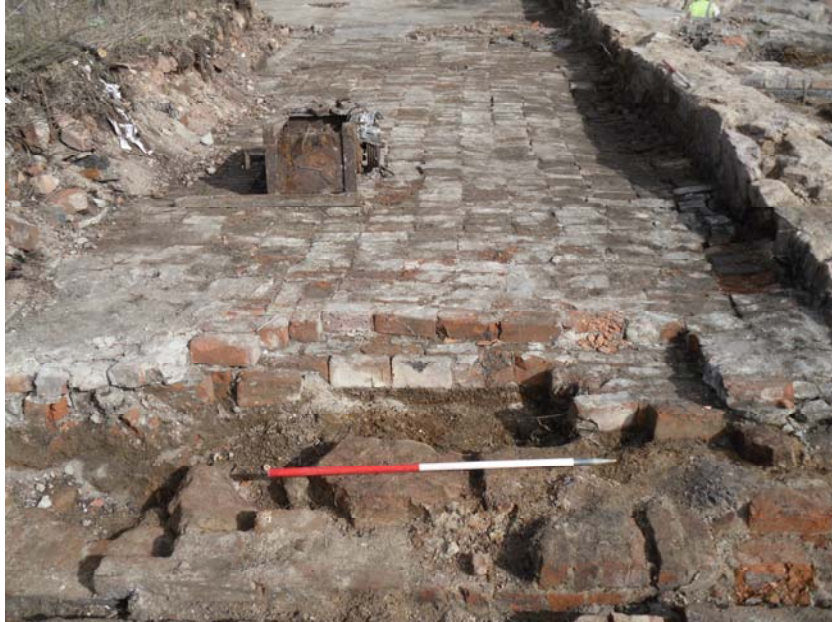
Plate 43: Detail of Building L, with later red sandstone wall [204] in foreground and red brick floor [256]

measuring 19 m in length by 8 m in width. Internally, the floor level comprised a red brick surface [256] which covered the whole building. A brick recovered from this layer was dated 1867. No other features relating to this phase were identified. Structure [328] comprised a 15 m long by 8 m wide building. Although elements of the original sandstone wall survived to the north [313] and west [310], the building had undergone substantial re-building in brick. External load bearing walls were identified to the north [313], to the east [205], to the south [306]/[413] and to the west [310].

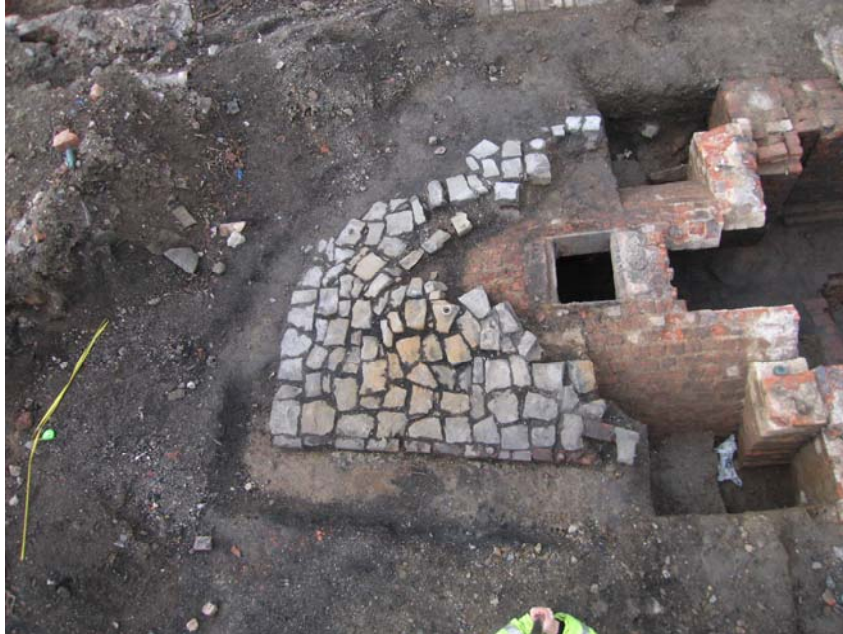
Plate 45: Detail of Coal Bunker [254], cobbles [312] and shaft [304]

6.3.17.4 The restructuring of the building was required because of a probable change in function or at least a change in the machines the building housed (Figure 22). A coal bunker [254] was built into the southern wall [306] (Plate 43). That the bunker was added suggests that a new furnace may have been added to the building at this point. Measuring 5 m in length by 3 m in width, the bunker was constructed of hand made bricks (Small Find 16; Plate 44). The bunker was accessed at ground level through an iron hatch [304], which was enclosed by granite cobbles [312], allowing vehicular access (Plate 45). The bunker was also accessed at floor level within the building, adjacent to furnace [395]. The furnace was severely truncated but survived as two adjacent walls ([432] and [433] and a curving wall [436], which had all been severely damaged by heat. A sloping brick chute [303] provided access to the structure (Figure 22).

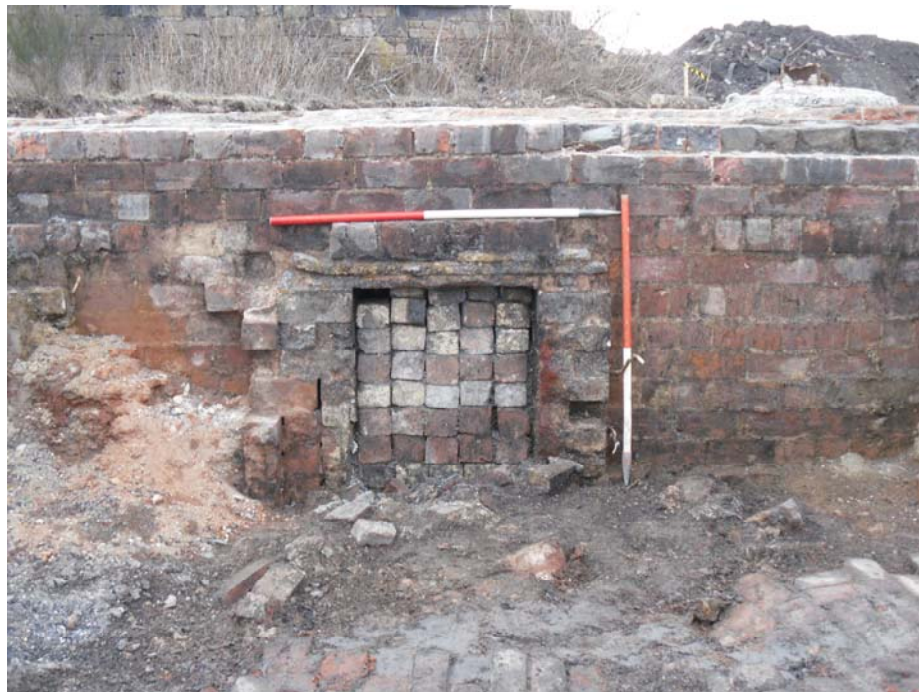
Plate 47: Detail of wall [231] of Building O, with flue entrance [232]

wall [237] (Plate 47), and evidence of burning was identified on its edges, confirming hot gases were required within this processing area.

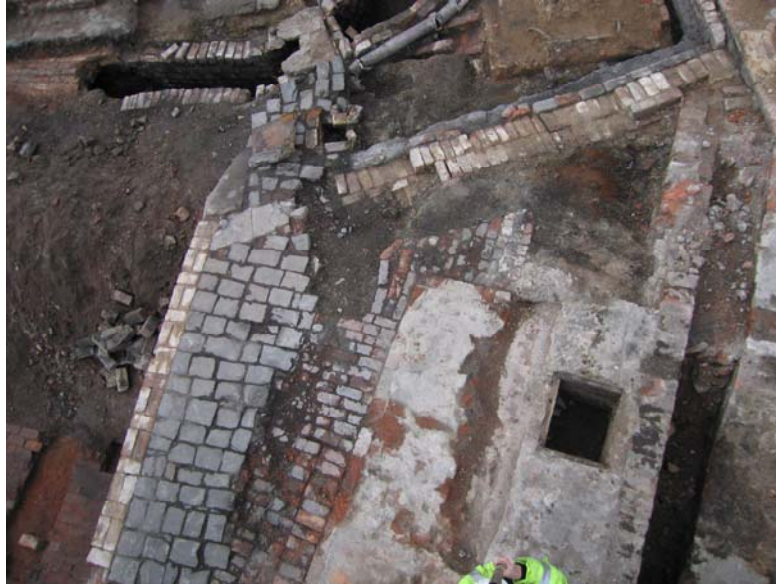
Plate 49: Detail of complex of features between Building N and O

6.3.19.1 By the time of the publication of the 3rd Edition OS Map, Buildings L and M had been superseded by the construction of a larger rectangular complex (1912, Figure 8). The new building complex roughly mirrors the original plan of Building L as recorded on the 1st Edition (1861; Figure 6). The building was restructured by extending Building M to the north, which connected it to the surviving elements of Building L (Plate 49). Although elements of wall [238] and Building N survive, Building O was at least partially demolished.

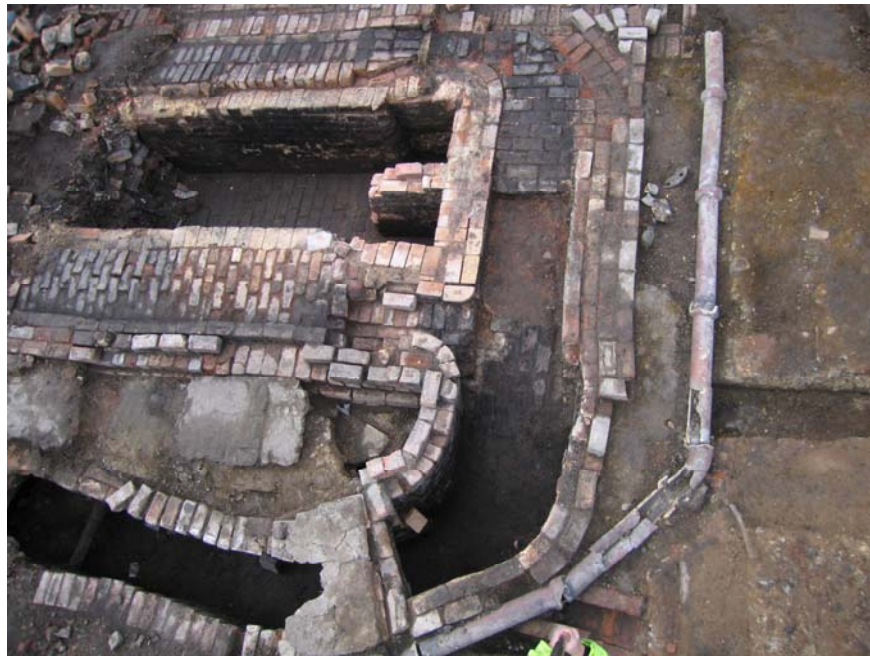
Plate 50: Detail of Boiler complex [272]

6.3.21.1 Boiler [272] is first identified on the 3rd Edition OS Map (1912, Figure 8 and Figure 23), as a long rectangular building (Plate 50). The structure was identified in Area B9, but was only the north end was excavated. The boiler was constructed of red brick and was built into the underlying clay [1003], at basement level. Measuring approximately 3.6 m by 1.5 m where excavated, the boiler was constructed of a single chamber, enclosed by walls [276] and [277], and floored by red brick [279]. The associated flue system [273], appears to have been connected to the west of the boiler, and enclosed the northern and eastern end of the structure. A metal pipe [355], contemporary with, and identified running through the flue [273], may have used the hot air generated by the boiler to heat the water it was using (Ian Miller pers.com).

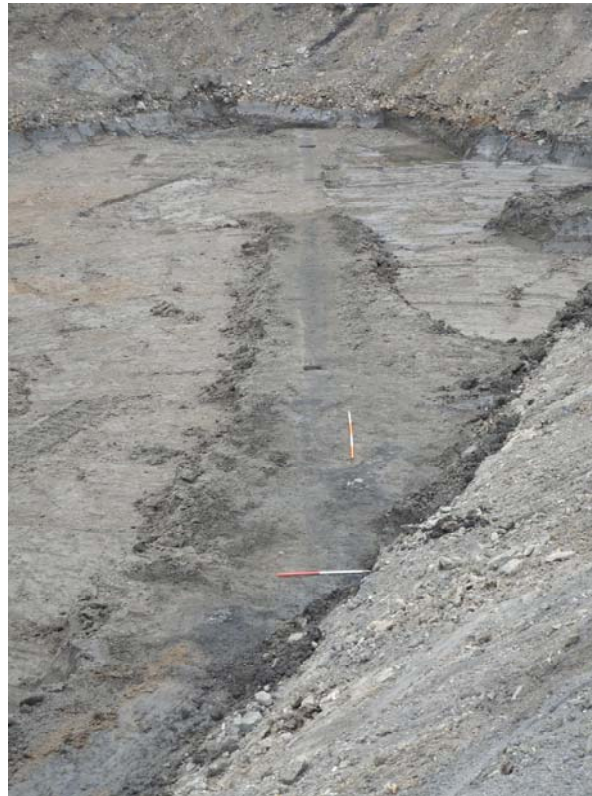
Plate 51: Detail of Ditches [2002] and [2006], Area A10

6.4.4.10 Remediation Area A10 was excavated across the southern fragment of the Dalmarnock House gardens. The pit, measuring 30 m by 10 m, was excavated through 6.5 m of made ground to the natural subsoil at approximately 6.30 m in depth. The stratigraphy of the pit consisted 0.20 m of rough topsoil, overlying 6 m of industrial waste including grey ash and clinker mixed in with isolated lumps of clay. Tip lines were apparent in this material. A series of features were excavated in to the natural subsoil at the base of A10, at a depth of approximately 6 m below the existing ground surface. The features comprised two linear ditches ([2002] and [2006]; Plate 51) separated by a 1 m gap and a series of isolated pits ([2007], [2009], [2017] and [2025]). Some of these features ([2007] and [2002]) contained modern white ceramic or fragments of brick and must have been open until relatively recently. Furthermore the linear features match the location of the northern boundary ditch to the meadow (1st Edition OS Map 1861, Figure 6) to the immediate south of Dalmarnock House, and it seems likely that they represent the same feature.

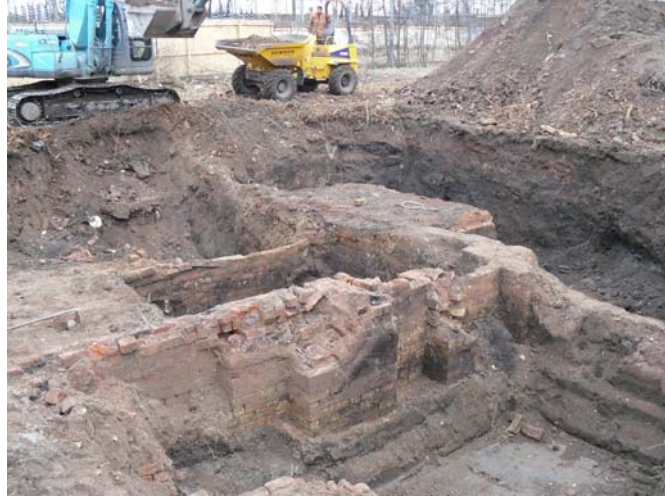
Plate 52: Detail of Woddrop Street tenements, Area B1a

6.4.4.27 Area B1a was excavated through the existing recreation ground to a depth of between 1.4 m and 2.6 m through made ground including hazardous material. Natural subsoil was encountered at 2.6 m. Evidence of the tenement buildings of Woddrop Street (NMRS: NS66SW596), that once occupied the area were identified in the form of red brick and sandstone buildings.
