Commonwealth Games Village Remediation Archaeological Works: Data Structure Report

AOC 21370
January 2011

Commonwealth Games Village, Remediation Works: Excavation Data Structure Report

AOC Project No: 21370

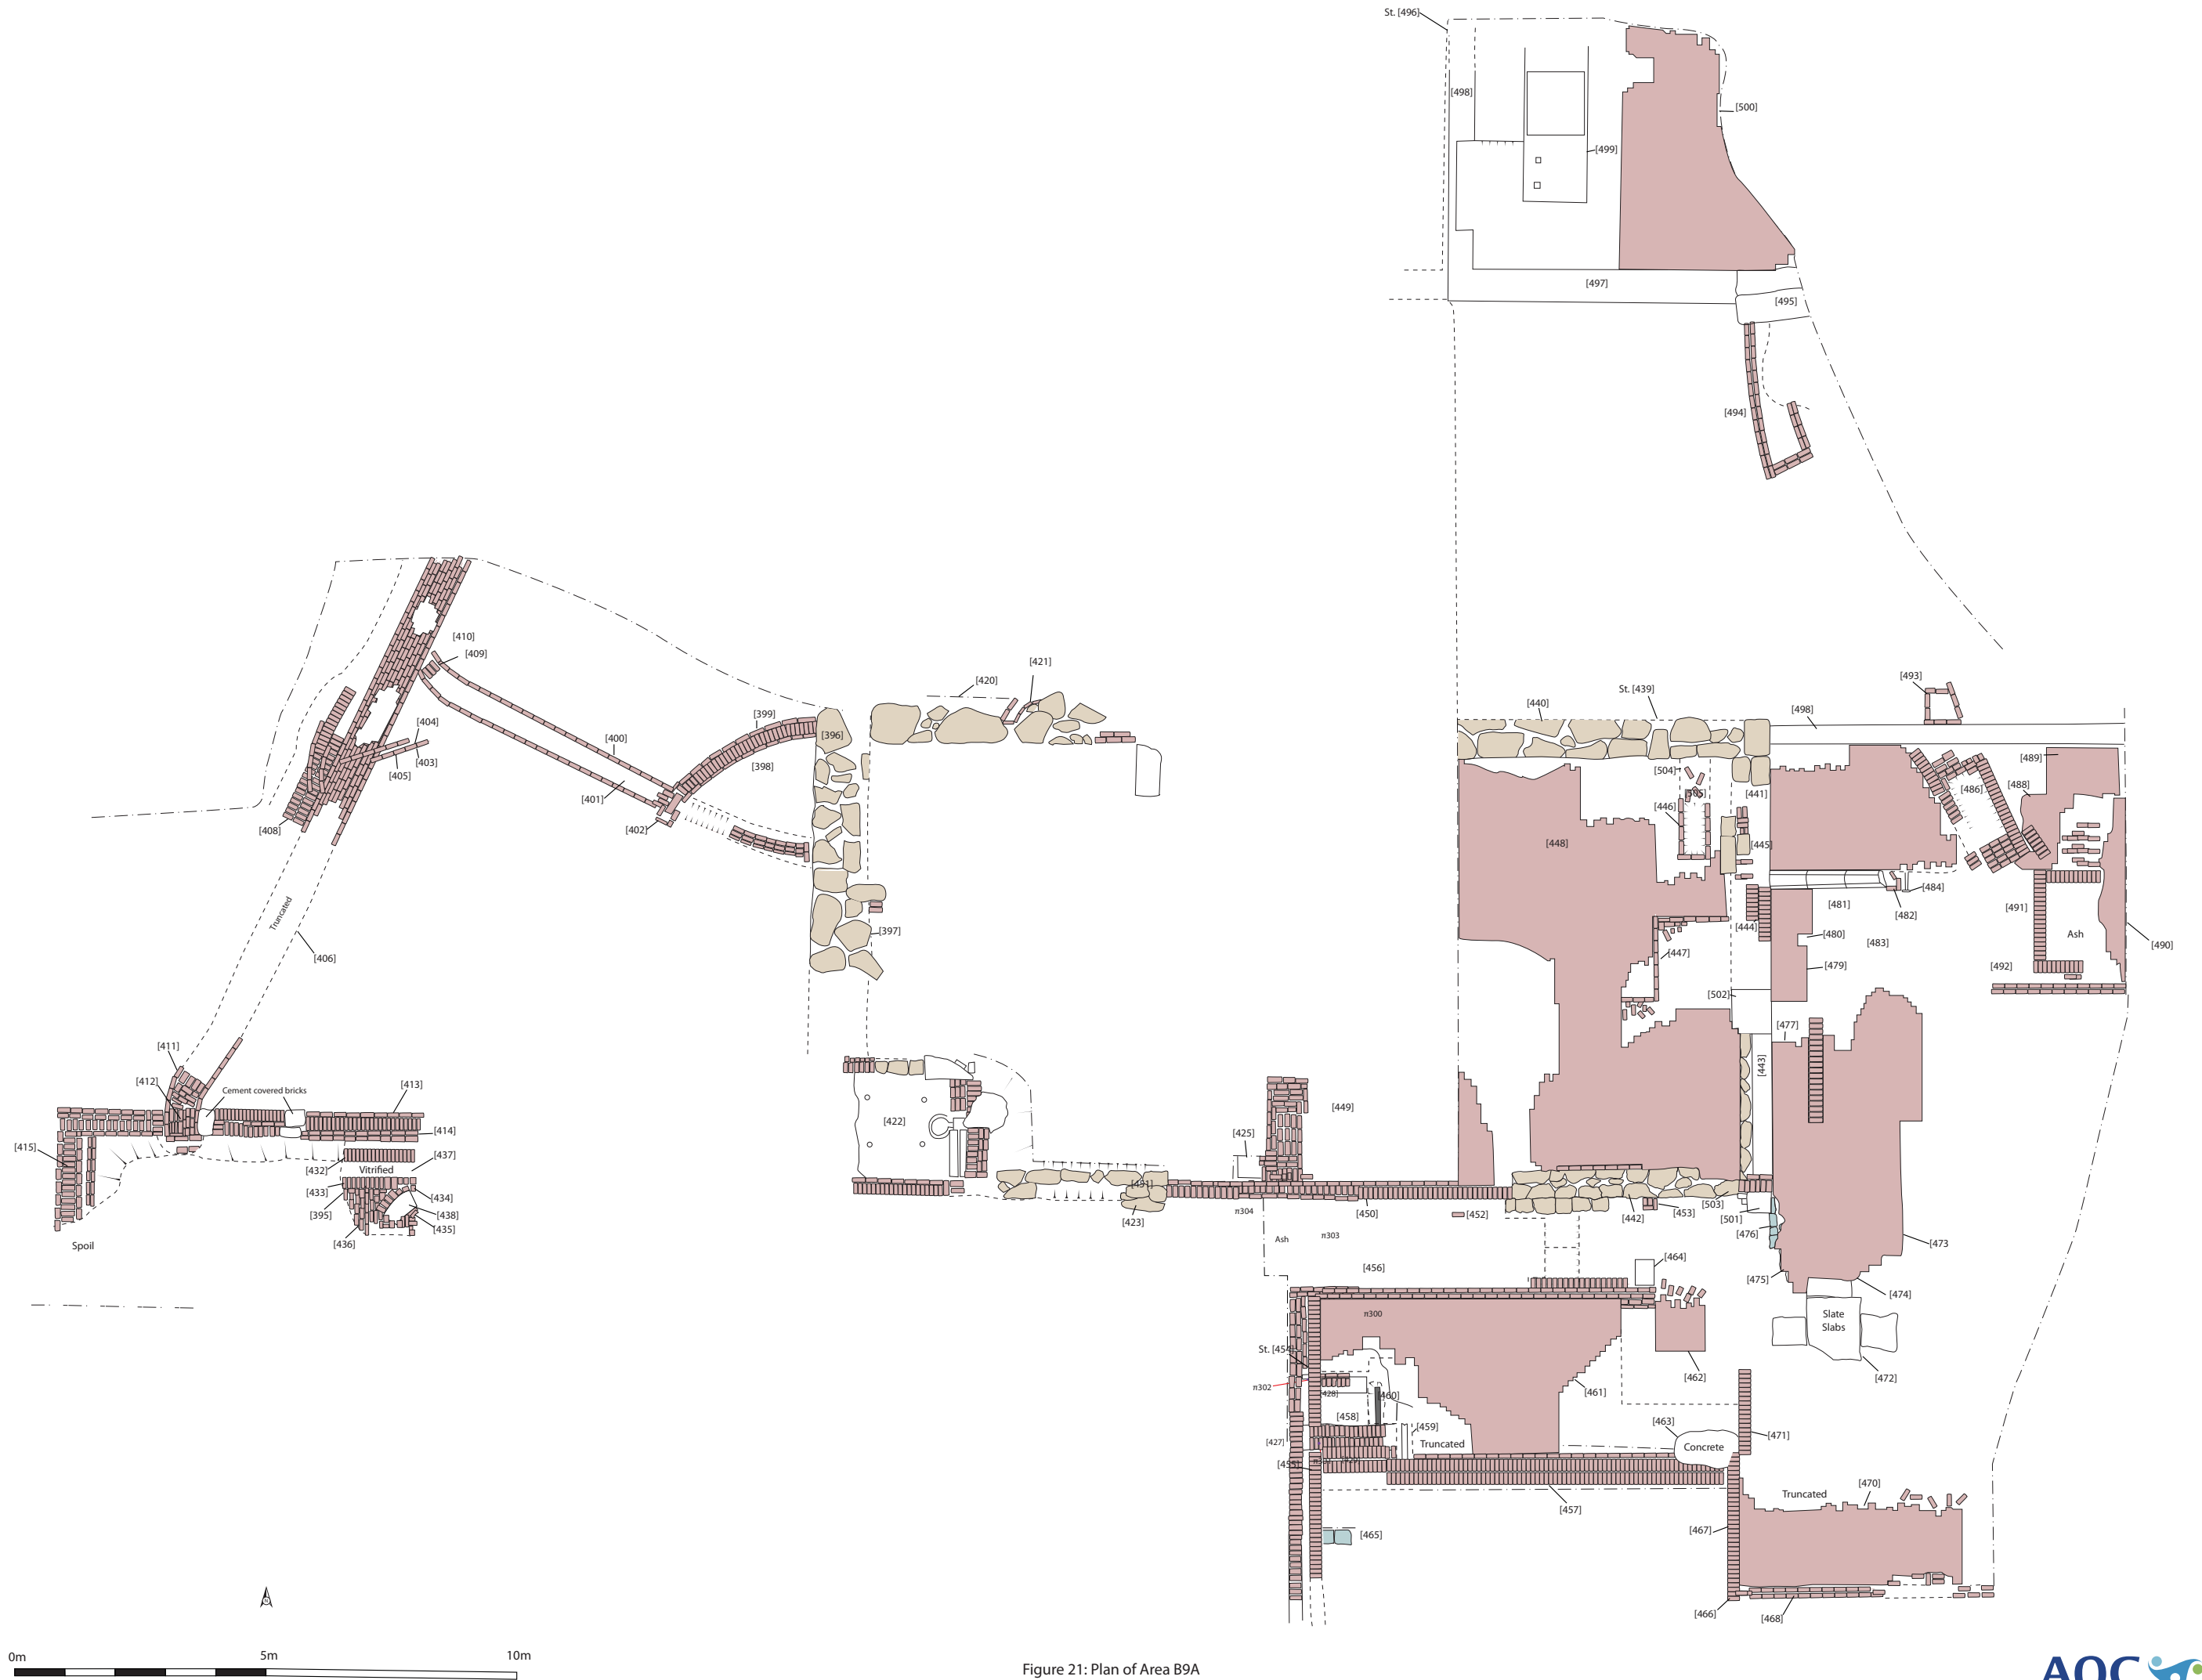
Figure 21: Plan of Area B9A

6.3.15.2 Building J (Structure [418]) was originally constructed of sandstone and measured 18 m in length by 10 m in width (Figure 21). External load bearing walls survive to the east [396], to the south ([419] and [439]), to the west [414] and to the north ([331] and [442]; Plate 39). All four walls have been built in to the underlying clay foundation deposit [285].

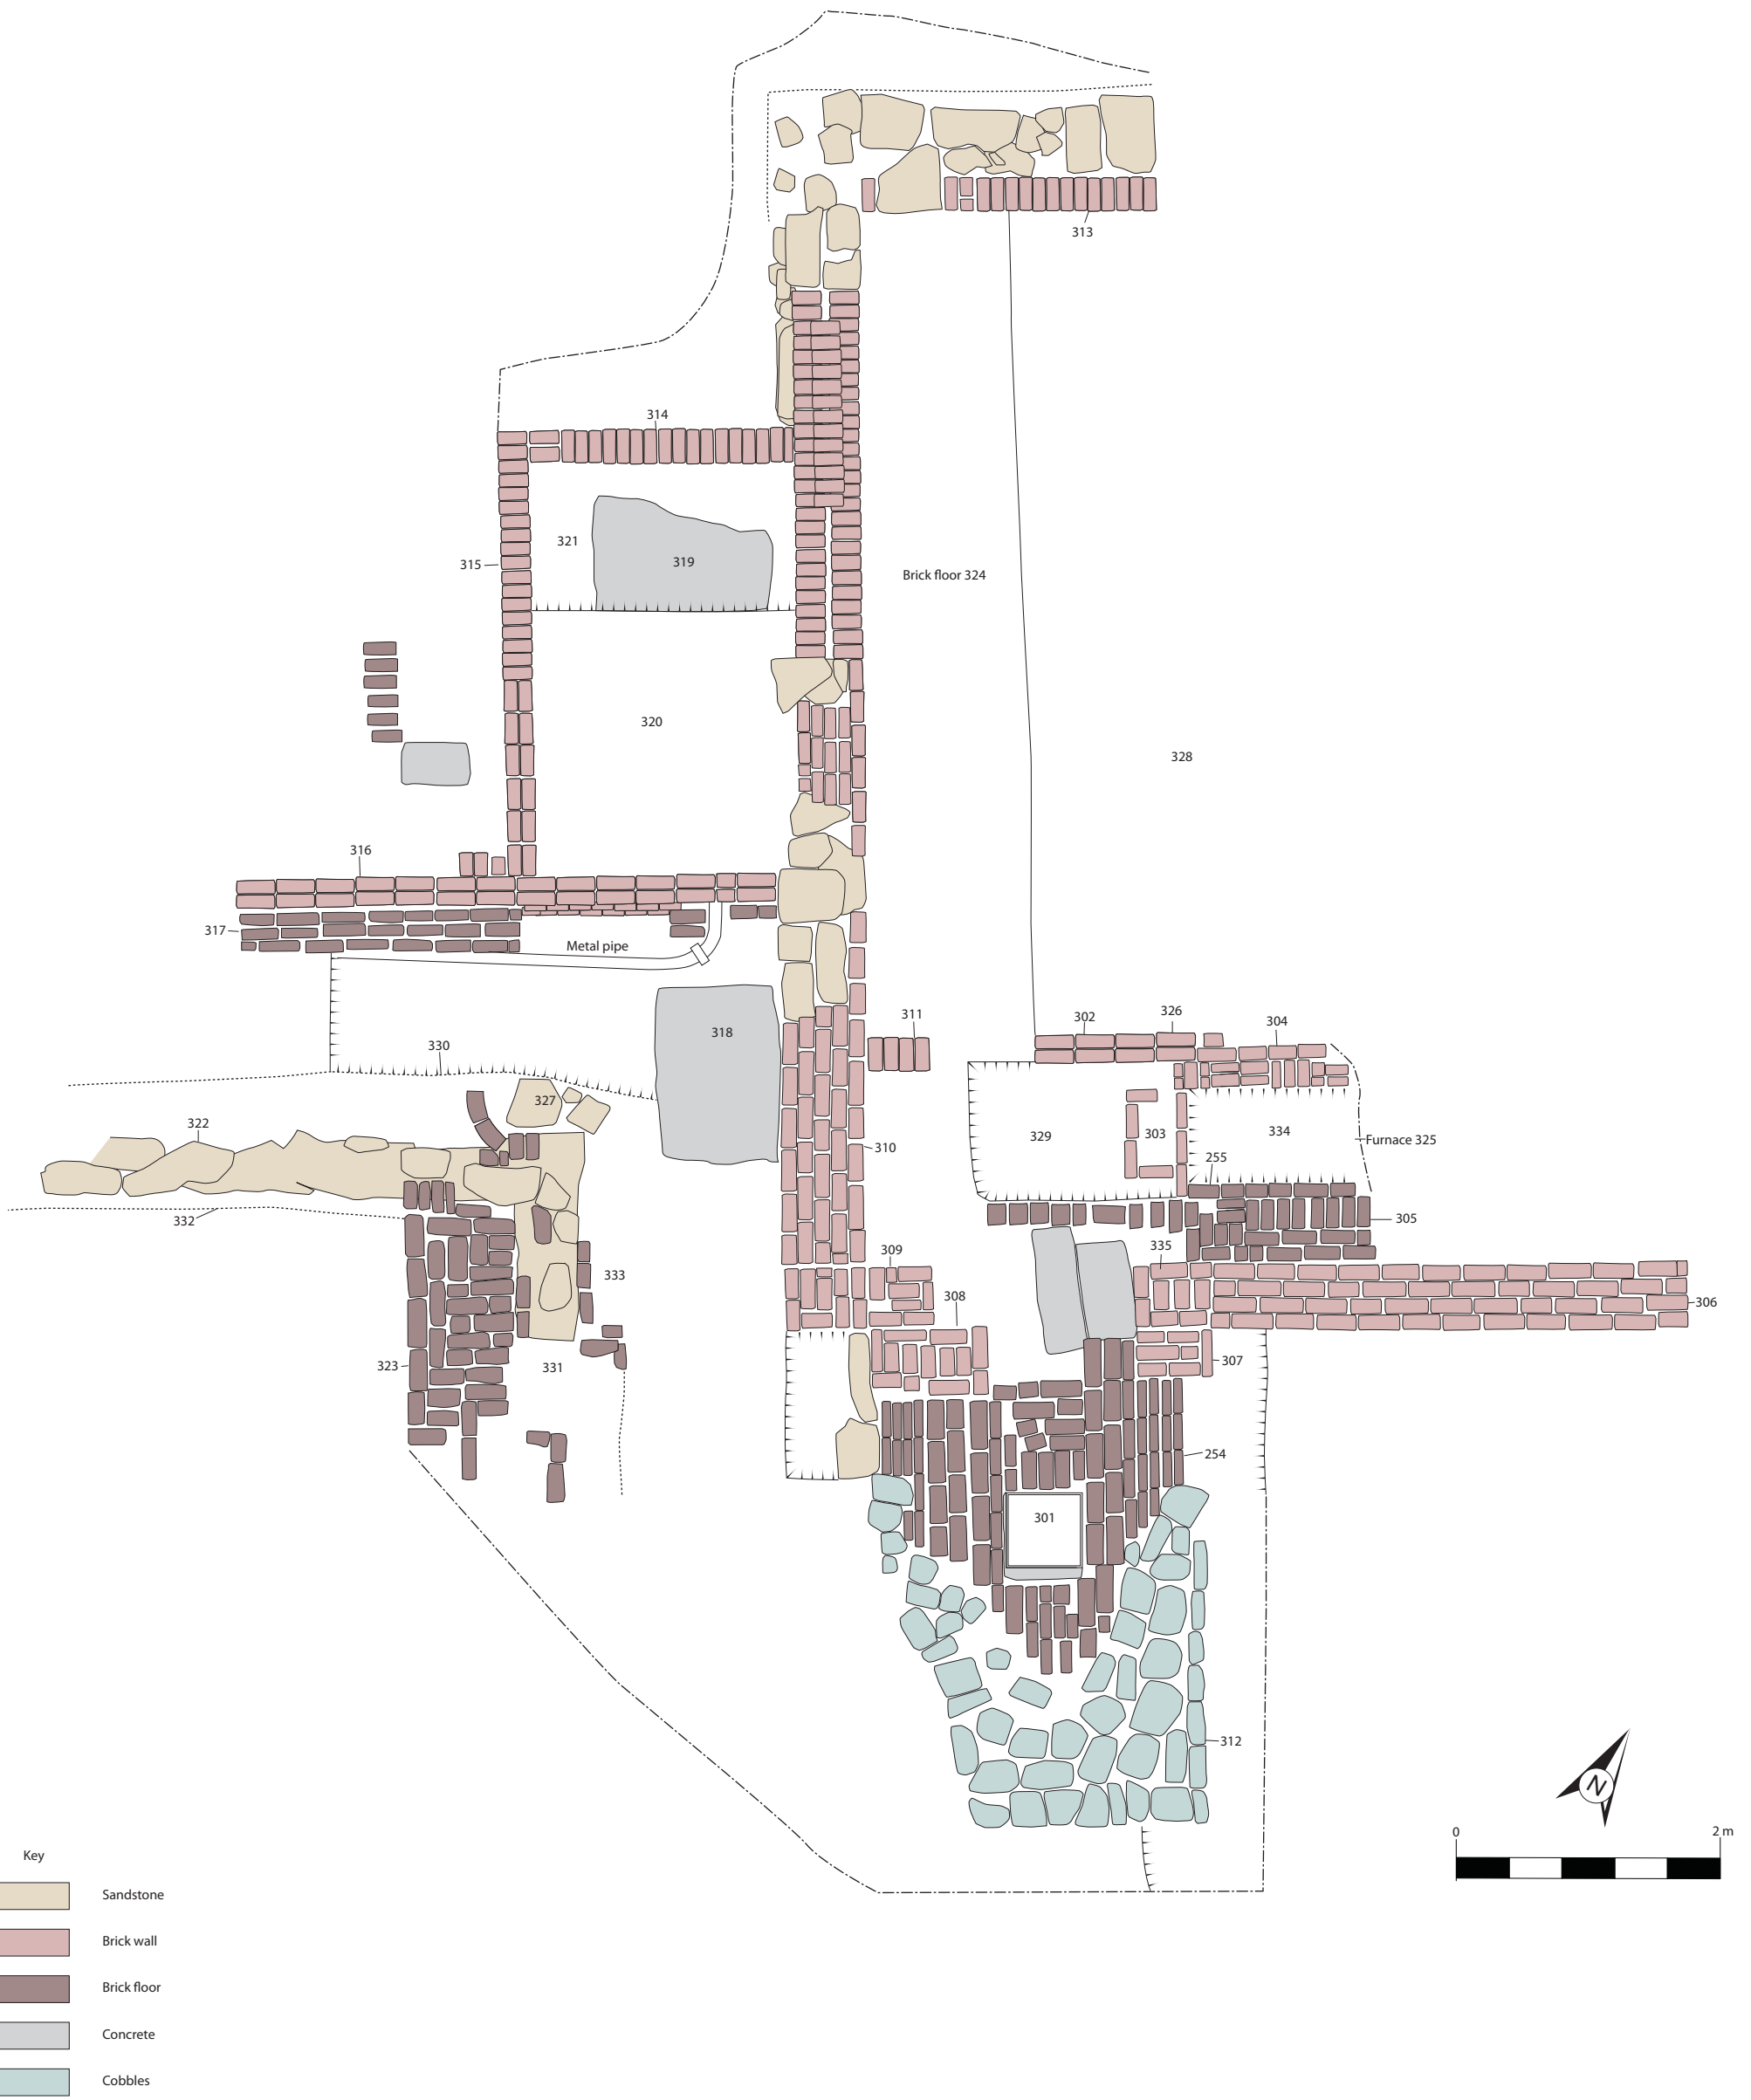
Figure 22: Plan of Area B9

6.3.17.4 The restructuring of the building was required because of a probable change in function or at least a change in the machines the building housed (Figure 22). A coal bunker [254] was built into the southern wall [306] (Plate 43). That the bunker was added suggests that a new furnace may have been added to the building at this point. Measuring 5 m in length by 3 m in width, the bunker was constructed of hand made bricks (Small Find 16; Plate 44). The bunker was accessed at ground level through an iron hatch [304], which was enclosed by granite cobbles [312], allowing vehicular access (Plate 45). The bunker was also accessed at floor level within the building, adjacent to furnace [395]. The furnace was severely truncated but survived as two adjacent walls ([432] and [433] and a curving wall [436], which had all been severely damaged by heat. A sloping brick chute [303] provided access to the structure (Figure 22).
