Greenholm Road, Cumnock: Evaluation Data Structure Report

(in respect to Planning App 09/0076/FL)

27th May 2010

On Behalf of:	Comprehensive Design Architects
National Grid Reference (NGR):	NS 5707 2000
AOC Project No:	AOC 21592
Prepared by:	Alan Hunter Blair
Illustration by:	Alan Hunter Blair
Date of Fieldwork:	17 th May to 24 th May 2010
Date of Report:	27 ^h May 2010

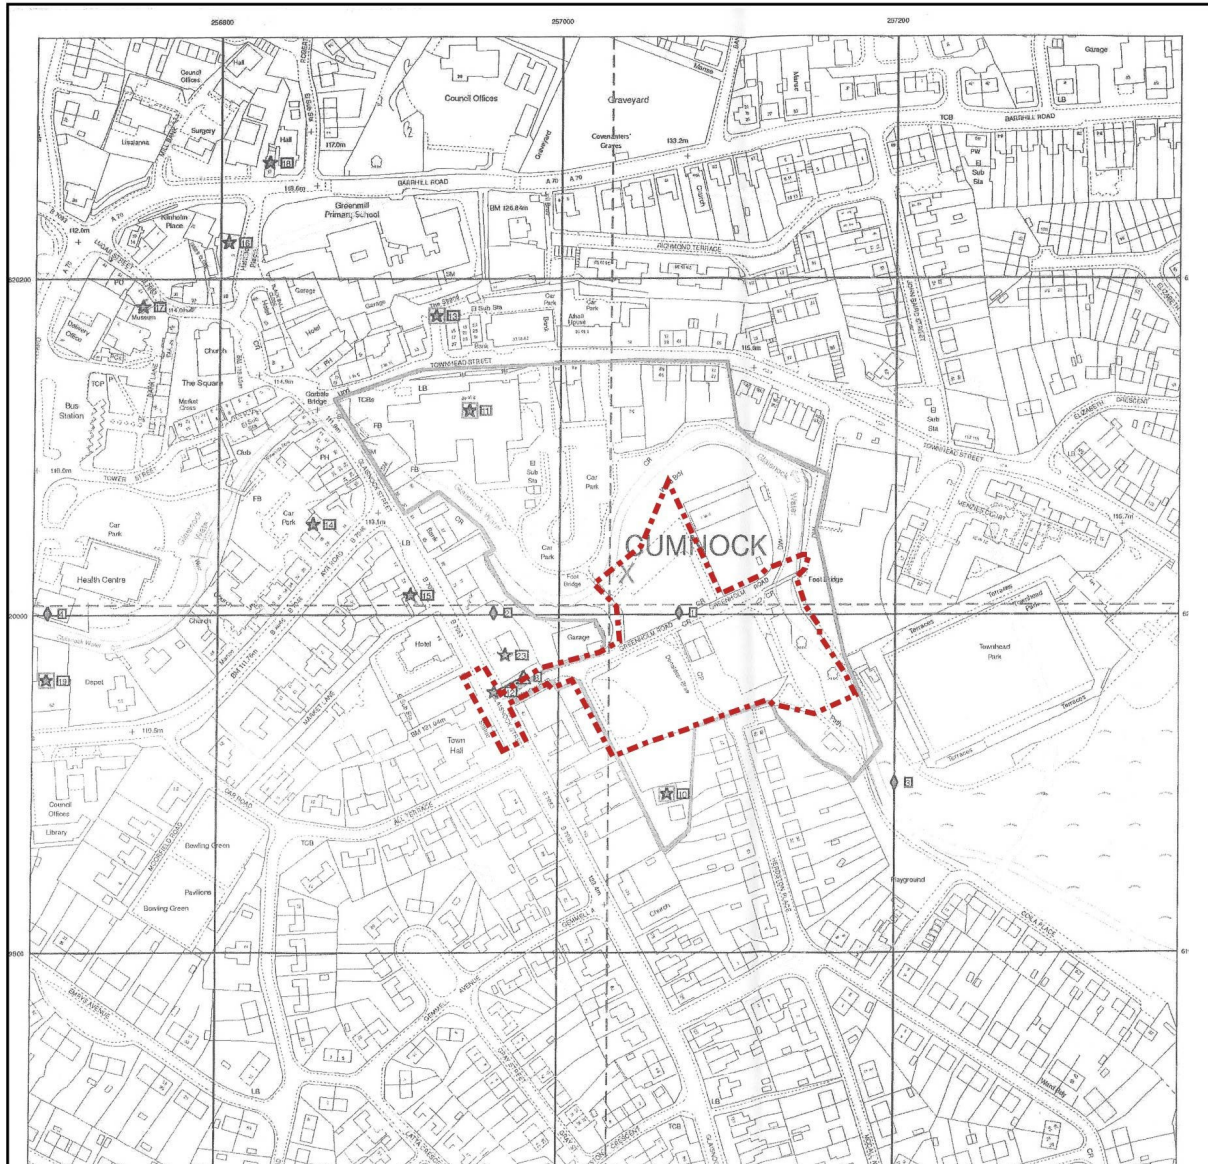
Figure 2: Trench location plan

- 4.1.1 The evaluation was conducted between 17th and 24th May 2010. The weather conditions during the evaluation were mostly dry and clear, overall archaeological visibility was good. Thirteen trenches with a combined basal area of 742 m² were excavated (Figure 2). The following should be read in conjunction with the data presented in Appendices 1 - 3, Figures 1 - 4 and Plates 1 - 13.
