St. Mary's Medical Centre, Edinburgh: Watching Brief Data Structure Report

AOC Project 21990

7th July 2013

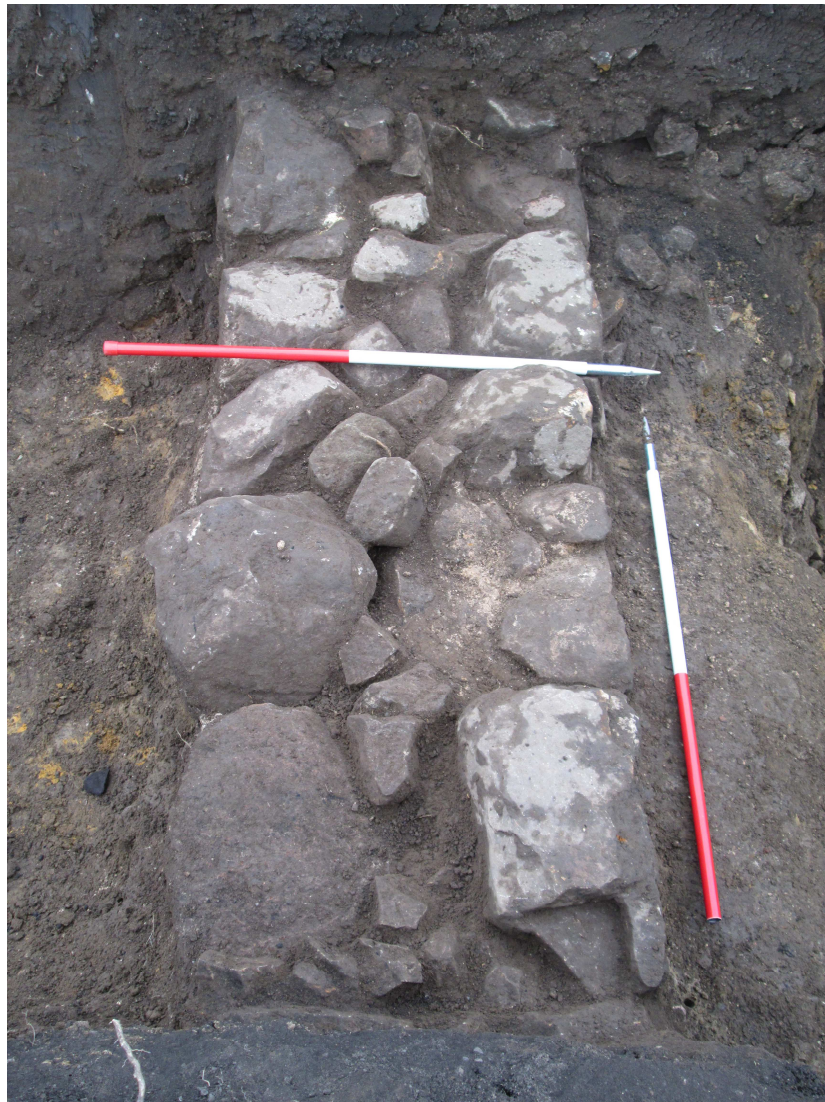
Plate 1 View of wall [1012] from the East

- 4.3 Close to Manor Place, immediately to the West of the site boundary a large service track encountered two east to west aligned walls. These were present at a depth of c.0.5 m and both survived for up at least two courses. By far the best preserved wall was [1012] which lay c.4.0 m north of wall [1008]. Wall [1012] measured 0.87 m wide with a surviving depth of 0.23 m. It was faced with roughly dressed blocks with a more rubble like core and coarse mortar. Wall [1008] was much more disturbed though careful cleaning of the section revealed a wall, mortared roughly dressed blocks with rubble core up to 0.62 m wide with depth up to 0.50 m. In subsequent trenches to the west of these walls no traces of either wall was encountered.

| Context No. | Description |
|---|--|
| [1012] | East to West aligned stone wall. Wall [1012] measured 0.87 m wide with a surviving depth of 0.23 m. It was faced with roughly dressed blocks with a more rubble like core and coarse mortar. |

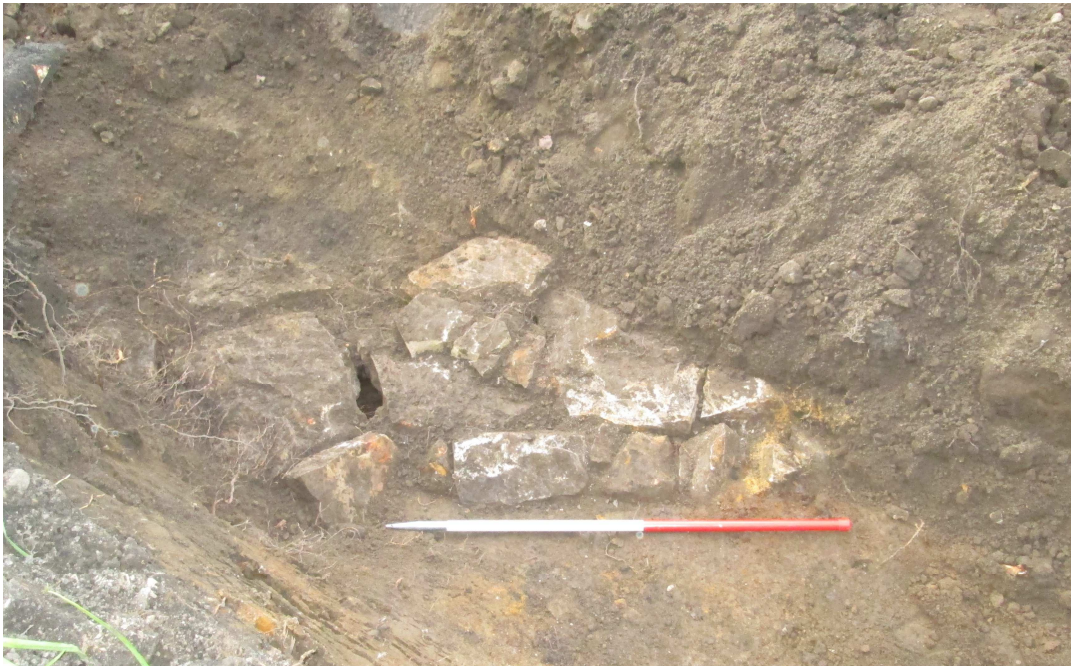
Plate 2 View of culvert [1016] from the southeast

- 4.4 In a trench some 11.0 m west of Manor Place revealed a stone culvert, [1016]. This feature consisted of edge set stones with capstones creating a voided culvert. It was aligned Northeast to Southwest and measured some 0.89 m wide with an exposed length of 1.61 m. This feature was approximately 1.0 m below ground surface and was able to be left *in situ*.

| Context No. | Description |
|---|--|
| [1016] | Drystone culvert. It was aligned Northeast to Southwest and measured some 0.89 m wide with an exposed length of 1.61 m. |
