ÀRAINNEACHD
EACHDRAIDHEIL
ALBA

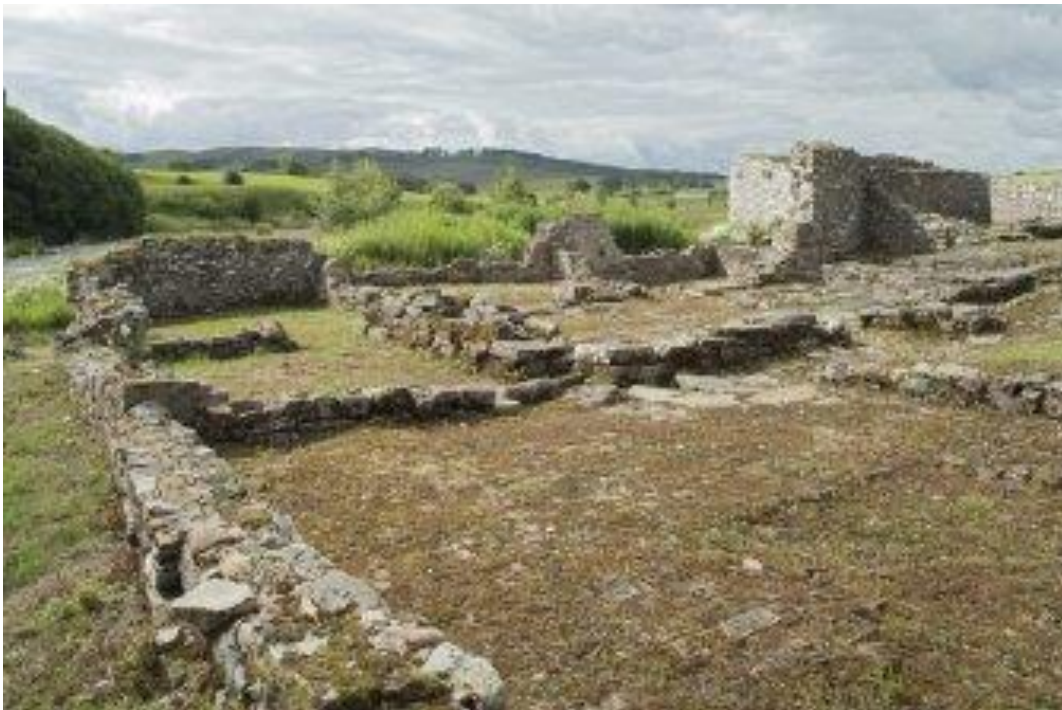
View from south east of North Mill foundations with the South Mill (top right) [DP 237917, HES]

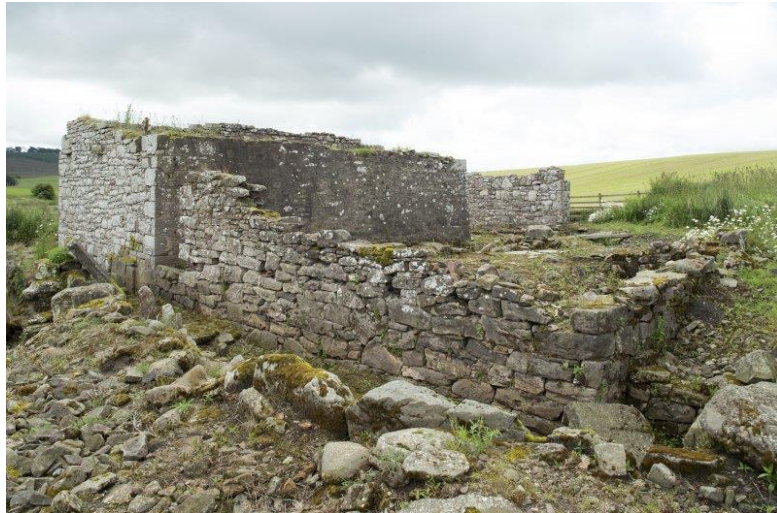
View of South Mill from south east, showing the lade on the left. [DP 237900, HES]

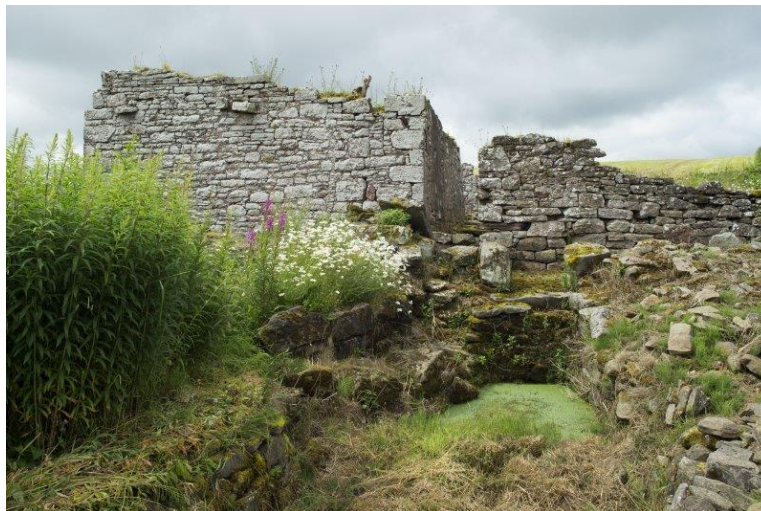
View of South Mill from west showing lade (right) and foundations of structures (right). The now silted up lade at this point has been part - concreted (date unknown). [DP 237897, HES]

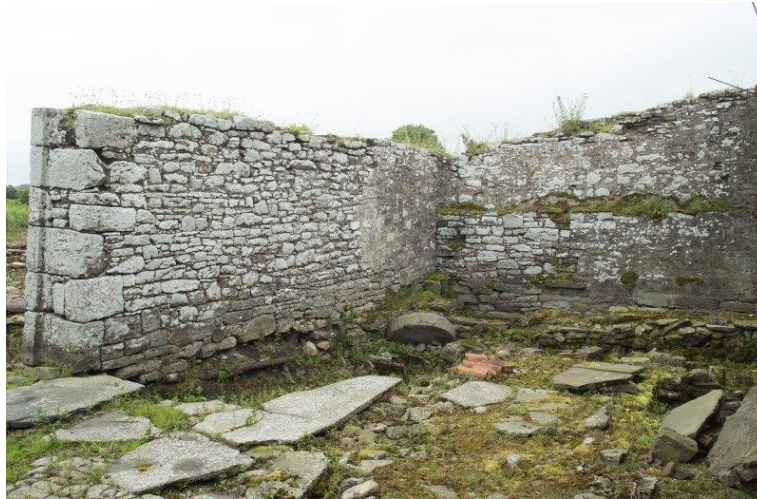
View of interior of remains of South Mill from north. The lade is beyond the wall on the right and the remnants of the double door entrance can be seen (left) [DP 237910, HES]

The excavation carried out by the Clydesdale Mill Society uncovered some internal features in the main mill building. This included the foundations for an electric water pump (probably post-grain mill period) which possibly fed a nearby cottage and outbuildings (now demolished) at NS 92856 42144. (16) The 'gear cupboard' area for the grain mill mechanism is also visible, although the rebuilding of the upper part of the south gable has removed details of the aperture for the waterwheel axle. The remnants of a wooden barrel were found (17) and this appears to have been fed from the lade by means of a later pipe. This water barrel or butt was possibly the feed for the cottage water pump.

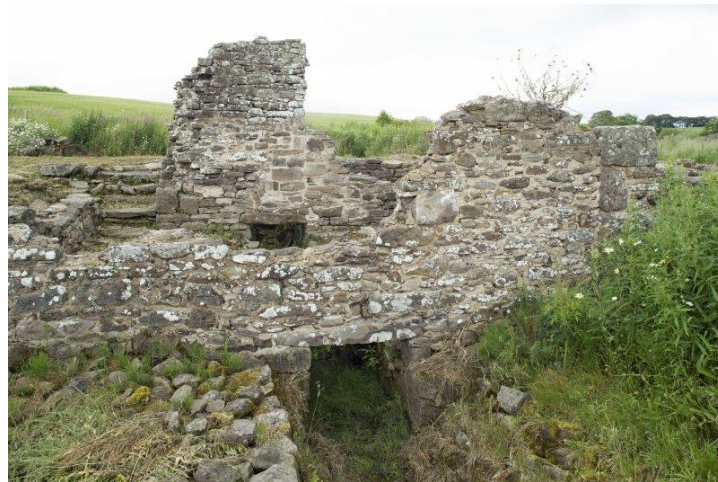
View of waterwheel house, west end of North Mill. [DP 237896, HES]

At the north west end of the North Mill (G), there are the remains of what was probably an undershot waterwheel (H). Stones in what would have been one of the lateral waterwheel axle bearing walls has been cut into to take the axle and the slots for two separate bearing blocks. This may suggest the wheel axle bearing has been relocated/moved, possibly as a result of replacement of the waterwheel or other building work. The corresponding evidence for the bearing block of the waterwheel shaft on the adjacent support wall no longer exists.

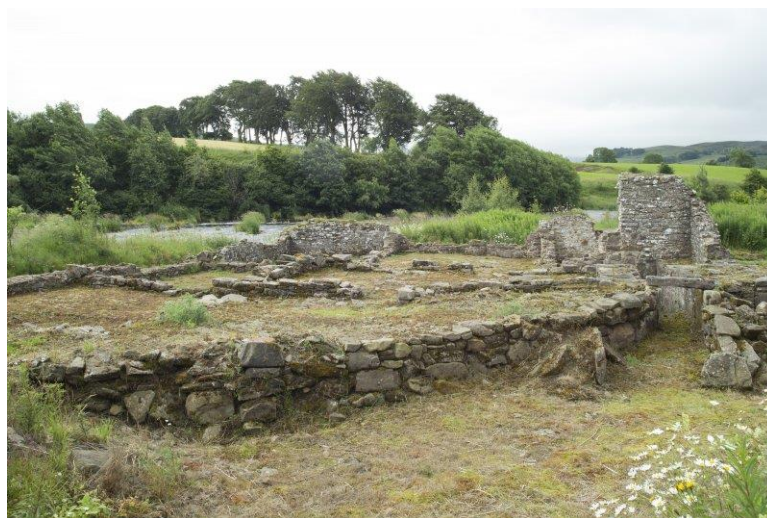
View from north east across North Mill foundations with the lade on the right [DP 237887, HES].

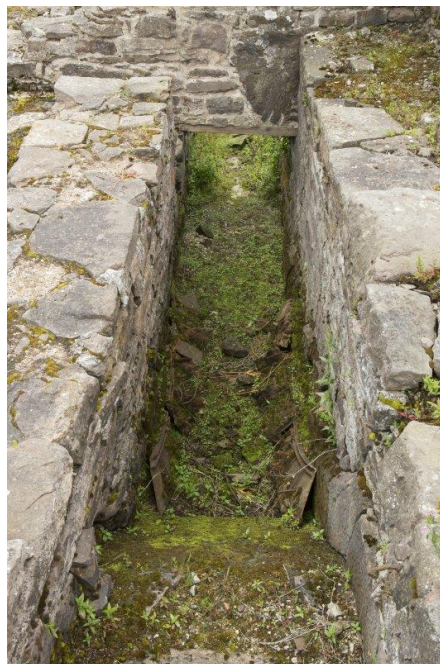
View from north of North Mill waterwheel pit. Here we see the remains of the metal 'shrouds' of the waterwheel. These 'shrouds' held the 'buckets' in place. [DP 237928, HES].

The lade is 1.0m (3ft 3 in.) in width and so the waterwheel would have been about 0.7m (2.5 ft) in width. This would have stopped and started by the opening and the closing of the sluice gate at the entrance to the lade. There is a possibility that the building has been extended west to enclose the waterwheel pit area.

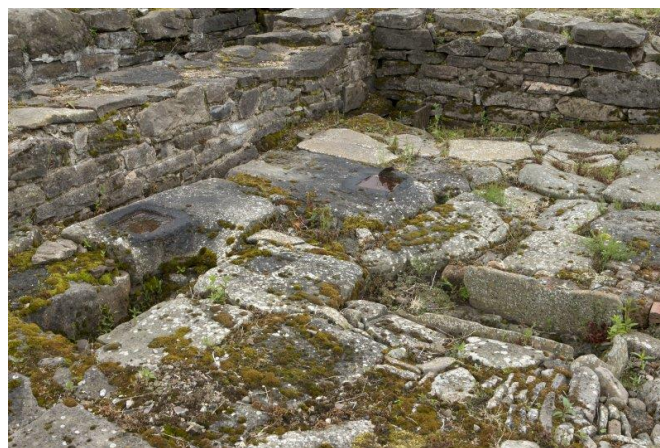
View of floor of 18th century lint mill with later features at the west end of the North Mill. The metal plates visible are the possible remains of the bone crushing machine with the waterwheel pit (extreme left) [DP 237893, HES]

It is known that artificial manure derived from crushed animal bone was produced at Hyndford by at least 1858 (34) and that the machinery was probably housed in the North Mill. Using crushed animal bones to increase agricultural yield in Scotland began in the late 18th century and was largely replaced by the introduction of chemical fertilisers in the late 19th century.

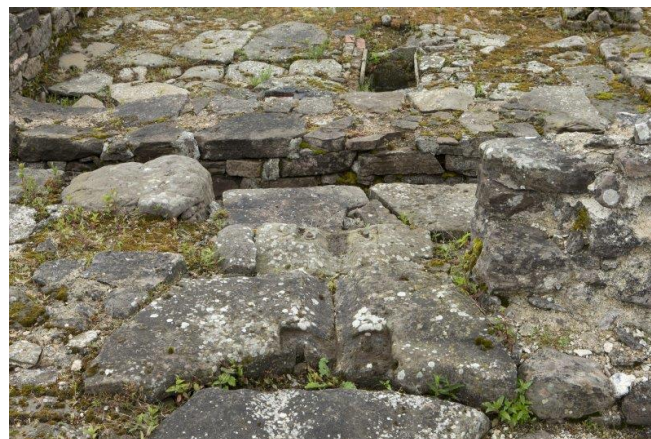
View of remnants of waterwheel shaft and bearing mount - the stones has been cut to take the metal bearing components, west end of North Mill [DP 237890, HES]
