Project Code: ATG07

**Old Athenaeum Theatre, 179 Buchanan Street, Glasgow
Recording of Raked Seating and hat-check**

PROJECT SUMMARY SHEET (ATG07)

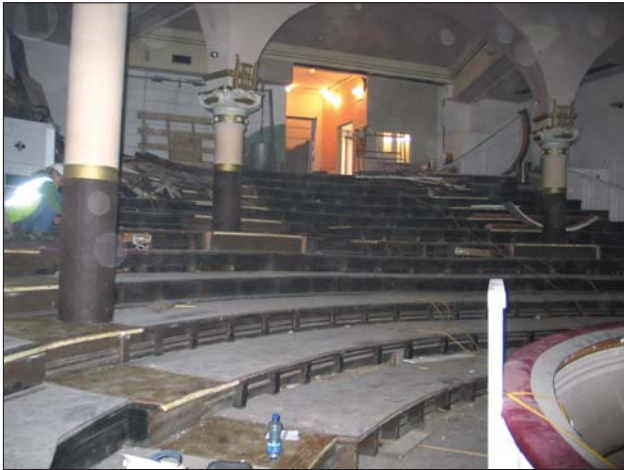
Plate 1: General view of later raked floor. Looking south.

The later raked floor was constructed from wooden planking and formed a 13-stepped floor area (Plates 1 & 2). The front two rows of seating located behind the balcony rail followed the curve of the horseshoe shaped balcony, terminating at each side with a door leading into a cupboard space (not fully accessed). The remainder of the raked seating behind the front two rows continued to follow the curve of the balcony, terminating at the walls of the theatre or the banister of the two stairwells.

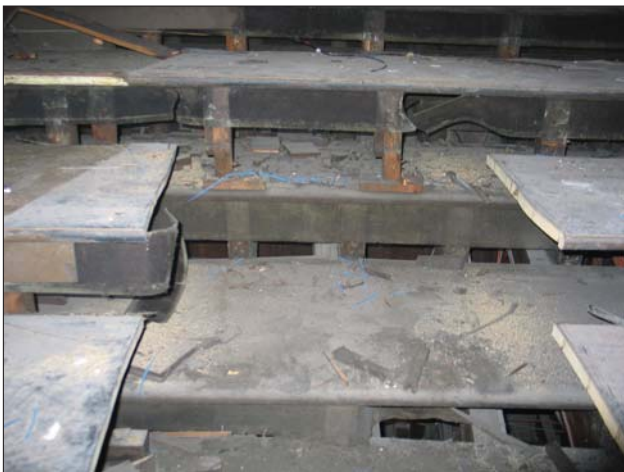
Plate 3: Detail of later raked floor with earlier floor seen below. Looking south-east.

The flooring was tiered so as to allow a view of the stage below from all areas of the balcony and had been constructed onto a softwood frame over the earlier floor below (Plate 3 & 5). It is probable that the later floor had been constructed to increase the seating capacity of the balcony area.

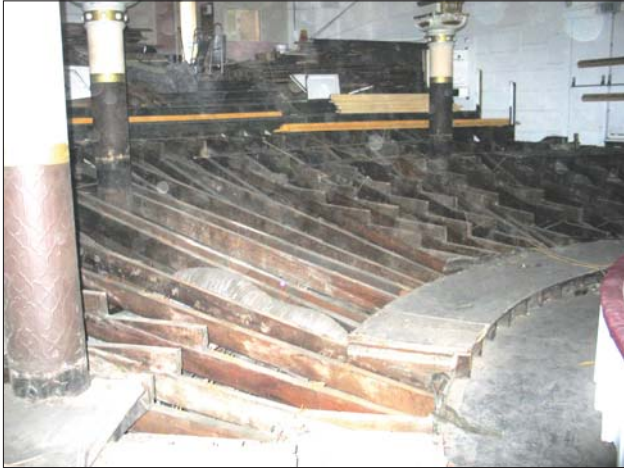
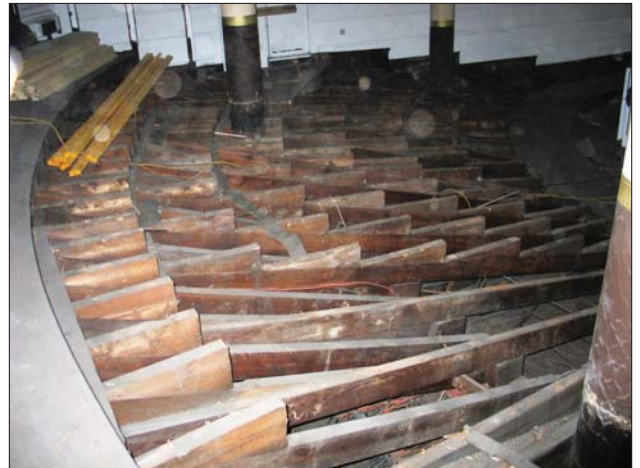
Plate 7 & 8: Timber floor beams after the removal of the early raked floor. Right - Looking south. Left - Looking west.

The earlier floor was tiered, constructed onto stepped and angled timber beams which ran from the rear wall to the front rail of the balcony (Plate 7 - 12). These sloping floor beams rested onto two semi-circular wooden beams located close to the rear and front of the balcony space. Each semi-

circular beam ran the width and length of the balcony area, following the curve of the seating above and tied into both the side walls of the theatre and a horizontal steel beam located on the underside edge of the horseshoe shaped balcony.
