Inchkeith Island, Firth of Forth, Fife: Results of an Archaeological Survey & Assessment

PROJECT SUMMARY SHEET (IKH07)

**INCHKEITH ISLAND, FIRTH OF FORTH, FIFE (IKH07)
RESULTS OF AN ARCHAEOLOGICAL SURVEY & ASSESSMENT**

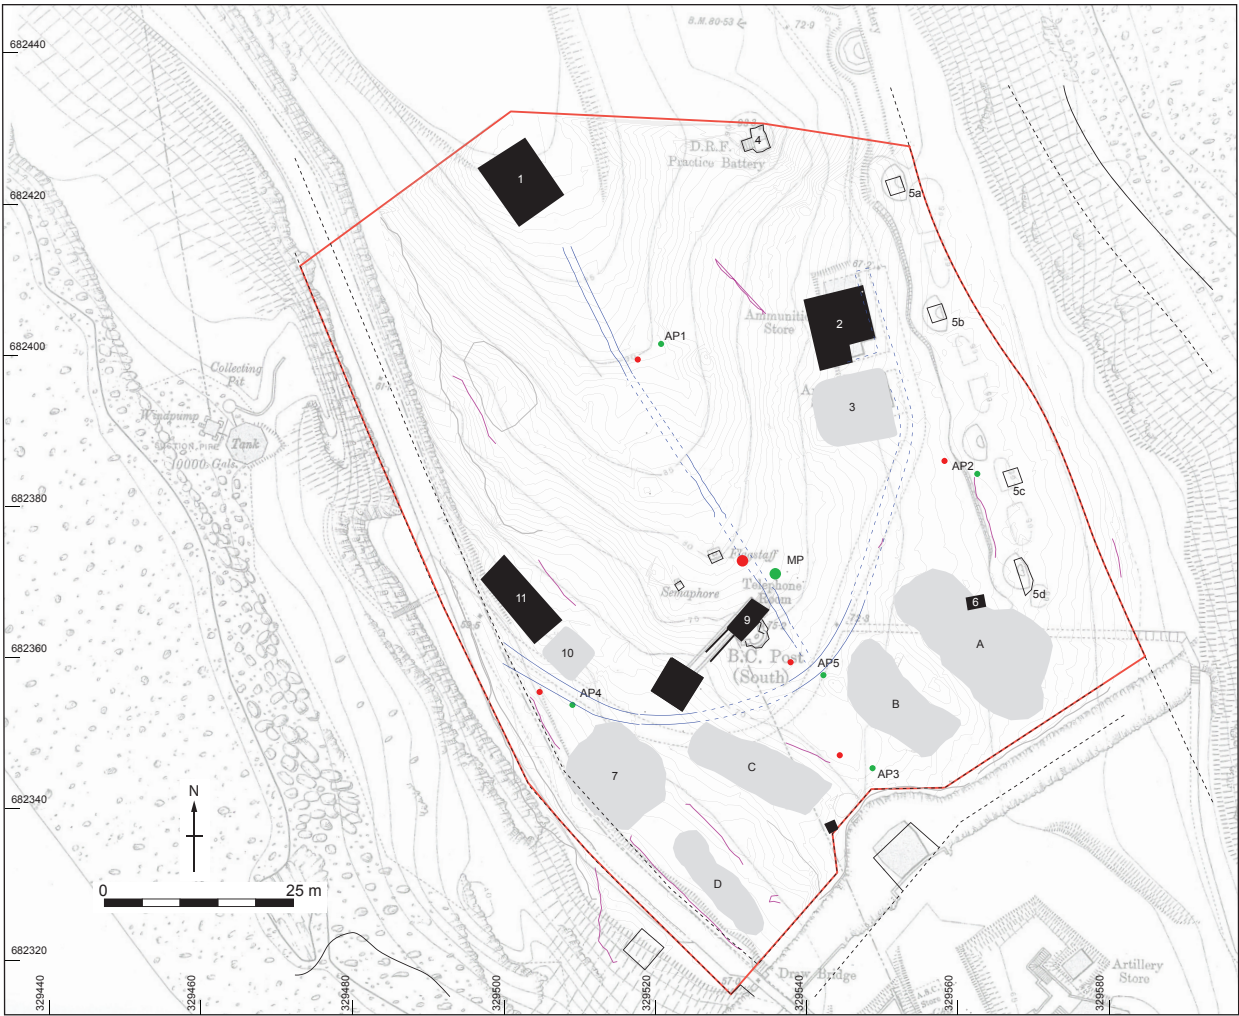
Figure 2 - IKH07: Inchkeith Island, Firth of Forth, Fife. 1911 OS showing details of site survey.

Figure 2: Assessment Area showing the main archaeological structures, features and areas superimposed onto the 1911 OS

Potential impact – The proposed locations of Anchor Points 4 & 5 are in close proximity to paths marked on the 1911 OS plan (Figure 2).

With regard to the proposed locations, Anchor Points 2, 4 and 5 were close to mapped paths or structures. In order to minimize any potential disturbance related to excavation for the anchor points it is proposed to adjust the position of the Mast Plate (which involves no ground disturbance) and the 5 Anchor Points by moving them to the northwest as shown in Figures 1 and 2.

- It is proposed that the anchor points be moved to the revised positions shown in Figures 1 and 2 to increase distance from mapped structures and paths.
- In order to safeguard against possible damage or loss to any unrecorded archaeological remains, a 'precautionary principle' should be adopted in connection with any further works and excavations for anchor points should be undertaken by hand in an archaeologically controlled manner.

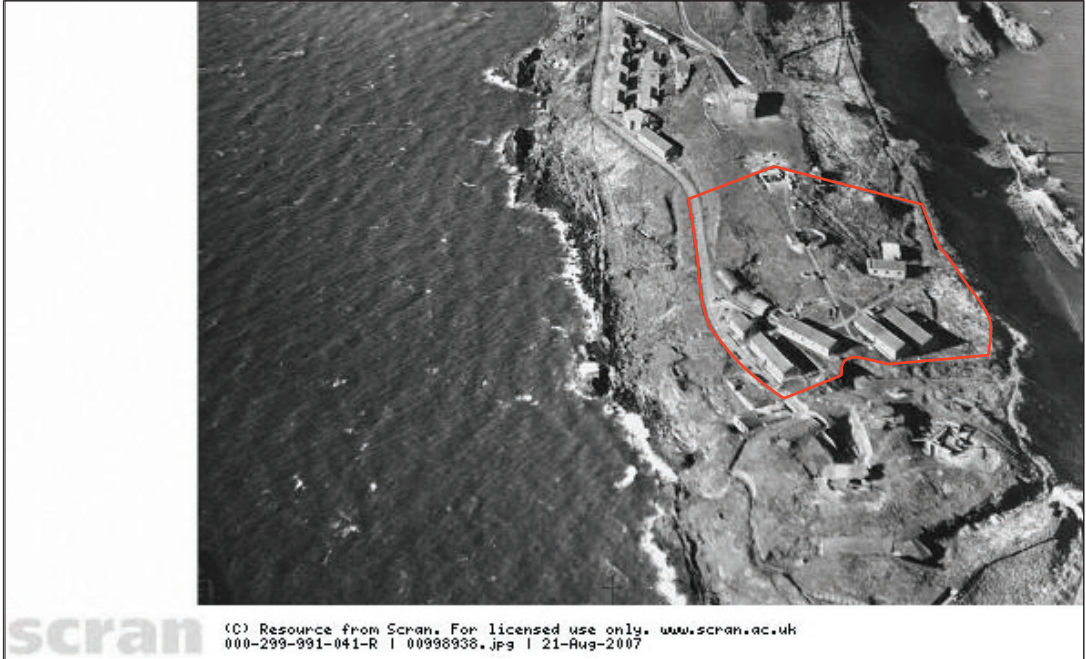
Figure 3 - IKH07: Inchkeith Island, Firth of Forth, Fife. Aerial photograph, 1941.

Figure 3: 1941 aerial photograph of the south end of Inchkeith showing the assessment area and associated features

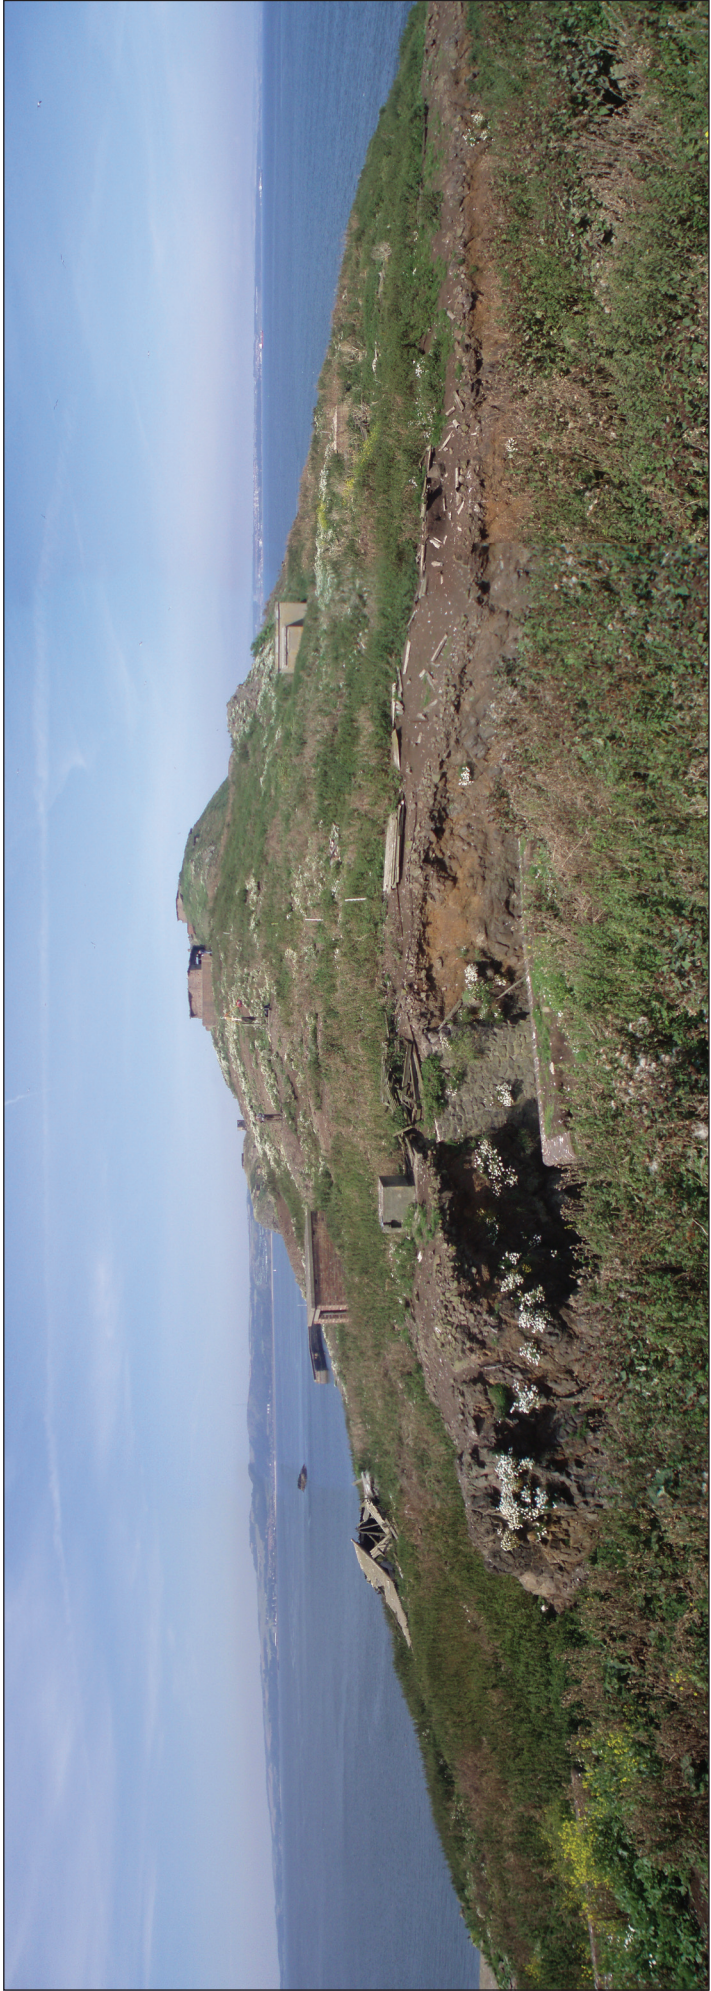
Plate 1: Panoramic view

Plate 1: Assessment area – looking north

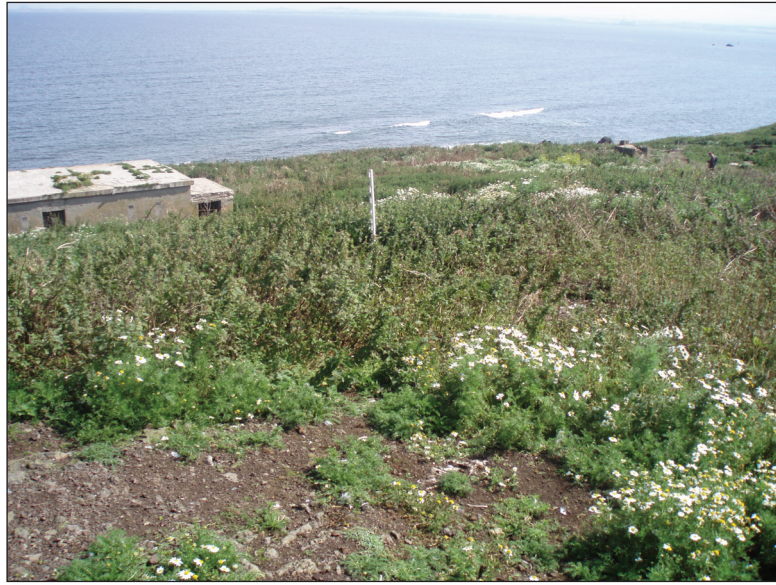
Plate 2

Plate 2: Anchor Point & Structure 2 – looking southeast

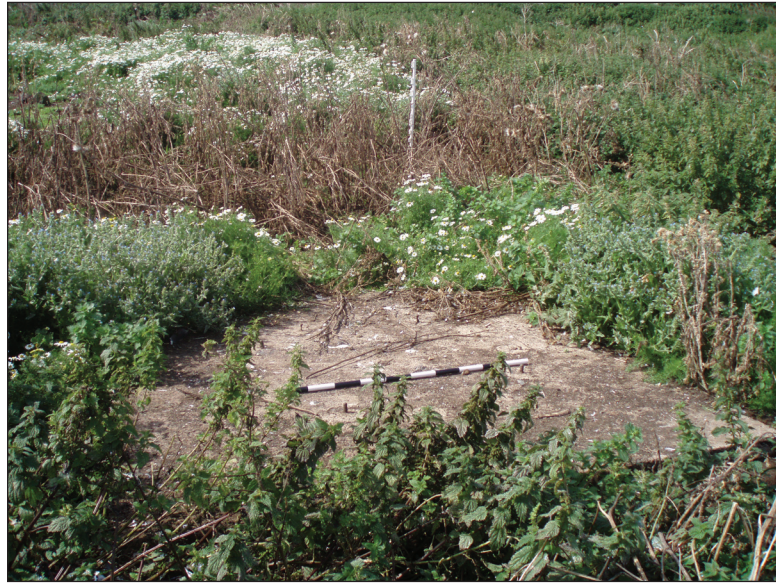
Plate 3

Plate 3: Gun platform 5c and Anchor Point 2 – looking northwest

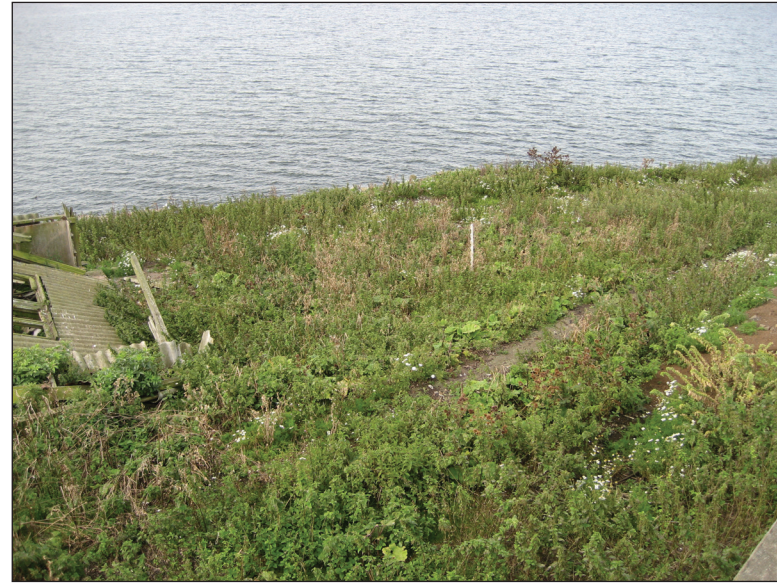
Plate 4

Plate 4: Anchor Point 4 and Structure 7 – looking northwest

Structure 7 represents the collapsed/demolished remains a roughly square timber framed building with asbestos sheet cladding (similar to Structure 3 and the remains in Area A – D) located on a flat area in the west of the assessment area adjacent to the relict access track. This building is noted on the 1941 aerial photograph (RAF309) and forms part of the Second World War developments.

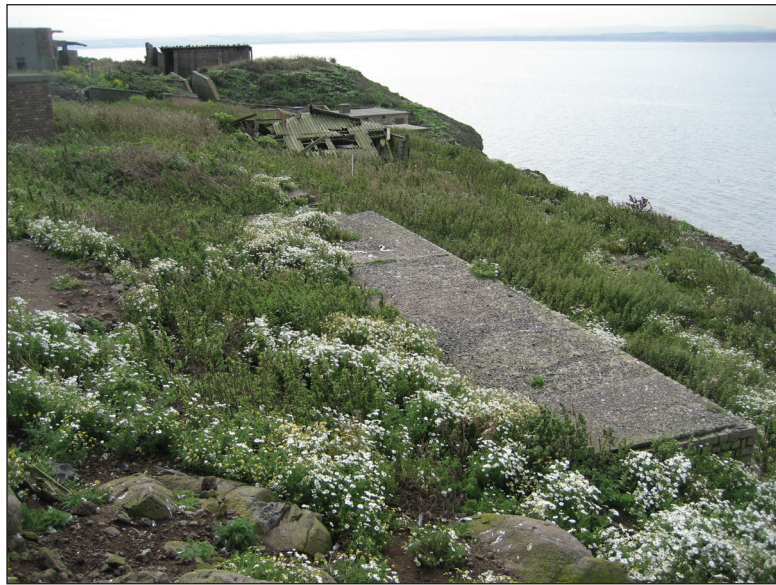
Plate 5

Plate 5: Structure 11 and 7 – looking south

These structures comprise the foundation rafts of two rectangular buildings, comprising a brick plinth with concrete floor above, both of which are partially scarped into the slope along the western margin of the assessment area. Structure 10 is orientated roughly north to south and Structure 11 roughly northwest to southeast. Both structures appear on the 1941 aerial photograph and represent possible Nissen huts introduced during the Second World War developments.

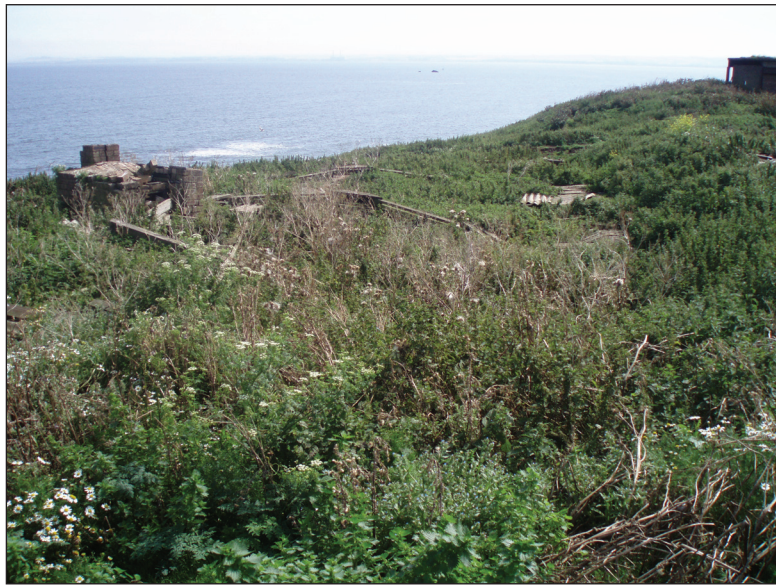
Plate 6

Plate 6: Area A and Structure 6 – looking southeast

This area comprises a rectangular depression terraced into the slope and orientated northwest to southeast. Although the area is particularly overgrown with vegetation, it is still possible to identify collapsed/demolished building debris from a timber framed asbestos sheet clad structure (similar to Structure 3 and 7). The timber floor joists for the former building appears to have comprised of brick plinths, some of which were visible through the thick vegetation. This building appears on the 1941 aerial photograph in association with the barracks-type buildings to the west. The connection of this building with the brick-built oven (Structure 6) suggests that it may have been a kitchen or canteen.

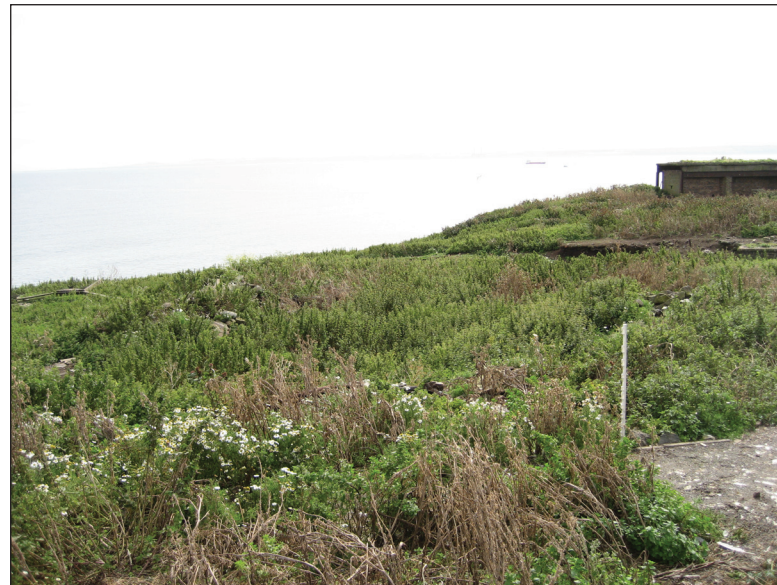
Plate 7

Plate 7: Anchor Point 5 and Area B – looking south

This area is similar in character to that of Area A and is located in a depression immediately to the west. Like Area A, evidence of building debris from a timber framed, asbestos clad building was noted across the area. This building appears on the 1941 aerial photograph in association with the barracks-type buildings to the east and west.

Potential impact – This area will not be impacted upon by the introduction of the proposed mast, although Anchor Point 5 is in close proximity (approximately 50cm) to building debris.

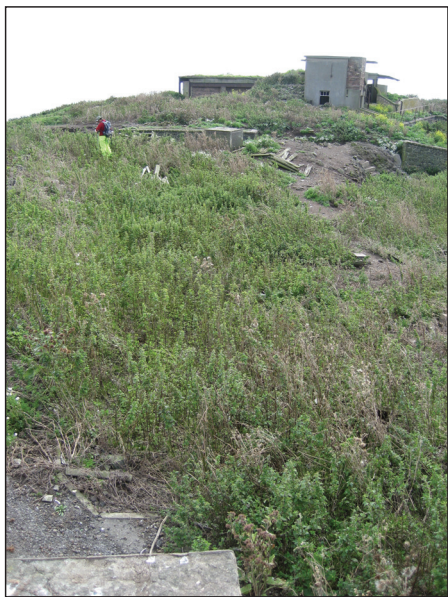
Plate 8

Plate 8: Area C – looking south

This area is similar in character to that of Area A and B and is located on a flat terrace, scarped into the bedrock to the east. Some evidence of building debris from a timber framed, asbestos clad building was noted, as were a number of brick plinth foundations, similar to those noted in Areas A. This building appears on the 1941 aerial photograph in association with the barracks-type buildings to the east and west.

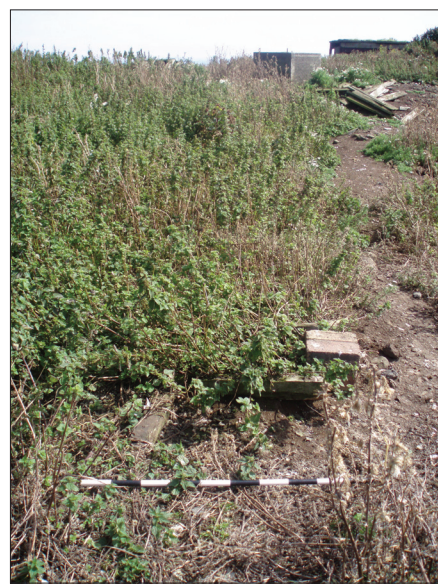
Plate 9

Plate 9: Area C and detail of brick plinth and timber floor joists – looking south

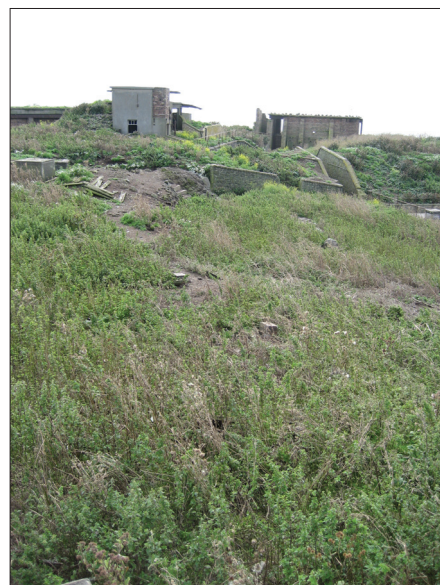
Plate 10

Plate 10: Area D – looking south

This area is similar in character to that of Area A, B and C and is located on a terraced area to the west of Area C. Despite the lack of evidence for building debris, brick plinths were noted similar to those in Area A, B and C. This building appears on the 1941 aerial photograph in association with the barracks-type buildings to the east.
