Historic Buildings Survey :  
walls to the rear of  
**John Muir'S Birthplace**  
Dunbar, East Lothian

Historic Buildings Survey:  
Walls to the rear of  
**John Muir's Birthplace**,  
Dunbar, East Lothian.

By Andrew Dutton

November 4<sup>th</sup> 2002

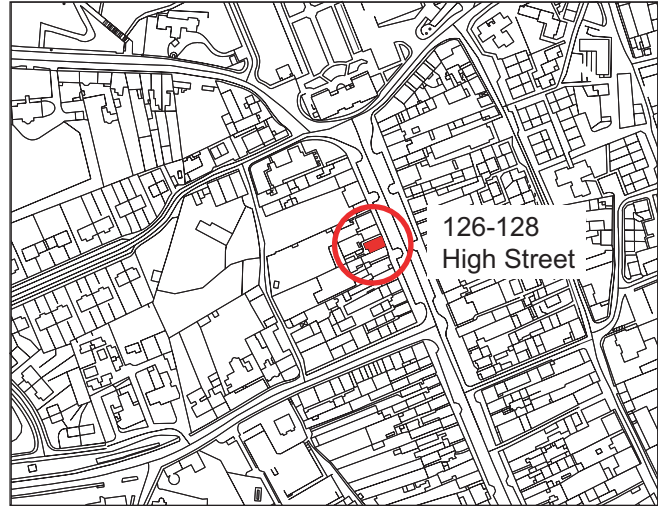
Figure 1. John Muir's Birthplace: Site location and map progression.

Reproduced from 1995 Ordnance Survey 1:10,000 Series with the permission of the Controller of HMSO. © Crown copyright. Headland Archaeology Ltd licence no AL51514A0001

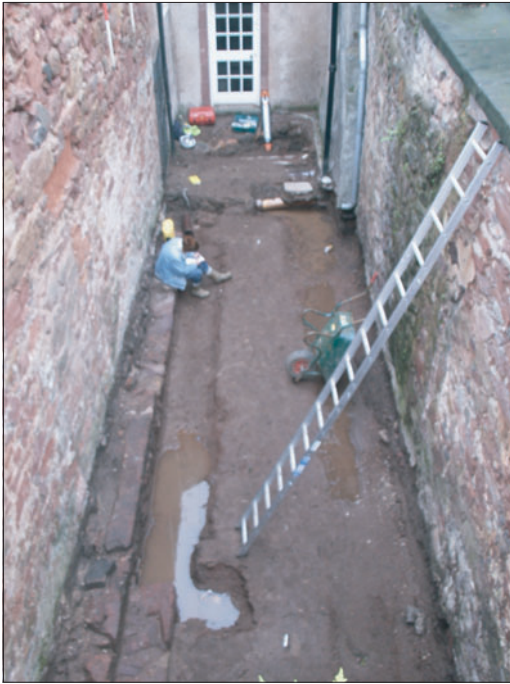
Plate 1. (left)  
 General view of yard looking east.  
 The extent of the clay bonded walls (20,21) and the location of the blocked doorway (14) can be seen.

The clay-bonded wall (21) terminates immediately west of the blocked doorway (13) and is considered to be deliberate rather than the result of robbing out of the feature further east (Morrison 2002).

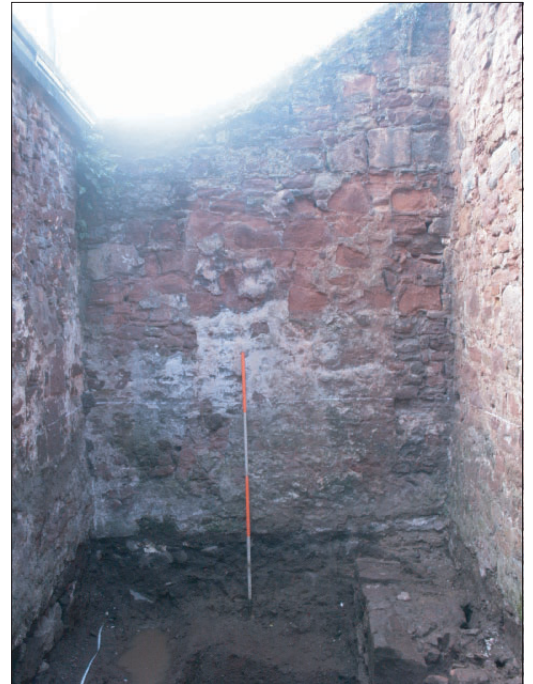
Plate 2. (right)  
 The west wall - The clay bonded walls (20,21) scarring (22) and upper coursing are visible.

Both the north wall and the south wall were seen to cut the earliest cobbled surface seen in the excavation, yet the west wall was constructed from a higher level and overlay the cobbling. This west wall was assumed to be an insertion. There was however, evidence of scarring (22) adjacent to its interface with the north wall where an east-west aligned wall, essentially the vertical extension of the clay-bonded wall below (20) butted, or was at least partially bonded with it. The curving profile along the top of the west wall may be later again, a simple case of reconciling the different height of north and south walls.

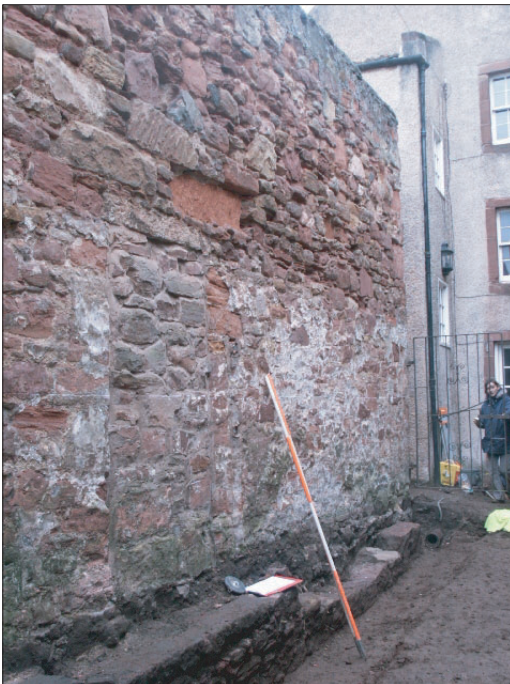
Plate 3. (below)  
 The north wall - Detail of the blocked doorway head and lintel (15).  
 Pantiles are visible just above the lintel on the left.

Above the level of the doorway header (15) the coursing appears to be different (16) and this difference is continued into the shorter west wall. The quoins (19) at the corner of the south-east corner of the bakery building appear to bear this out and are smaller above this line, suggesting that the walls were raised.

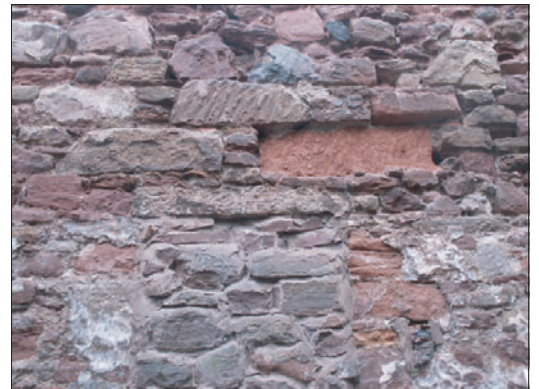
Plate 4. (left)  
 The north wall - The blocked doorway and step (12,13) above the reduced clay bonded walls (20,21) with the raised walls above.

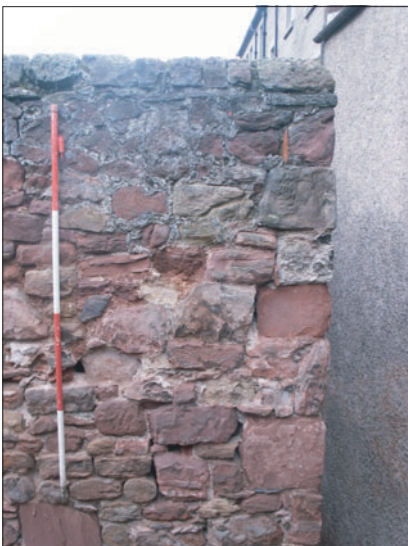
Plate 5. (left)  
 The north wall - Detail of the upper coursing and quoins (19).

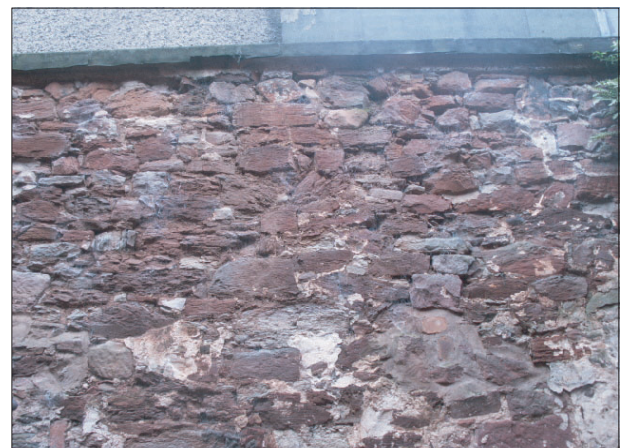
Plate 6. (below)  
 The south wall - Line of possible gable (3) and blocked opening (2).

The south wall did not show any evidence that the line of upper coursed work (16) seen in the north and west wall continued. Immediately adjacent to the west wall and partly obscured by it was a blocked opening (2), defined on two sides by rubble rybats. Below this more blocking was revealed (1), a possible lintel and rubble rybats just visible under an area of harling. The true extent of these features was not revealed but both are presumed to have been window openings. Both these features occurred within an area of wall comprised of fairly large coursed blocks, defined at the top edge by a diagonal line of roughly dressed, stepped blocks (3). This may indicate the line of a gable since subsumed in later stonework. Above and to the east of the stepped blocks the masonry was comprised of smaller stone rubble, in which a further blocked opening (4) was observed. This was defined by squared rubble rybats and immediately east of this was scarring indicating the former presence of a semi-bonded north-south aligned brick wall (6).
