Date: July 2005

Project Code: MNB03

**Marine Hotel, 18 Cromwell Road, North Berwick, East
Lothian: Data Structure Report of Archaeological
Monitoring and Evaluation**

**MARINE HOTEL, NORTH BERWICK
DATA STRUCTURE REPORT OF ARCHAEOLOGICAL MONITORING AND EVALUATION**

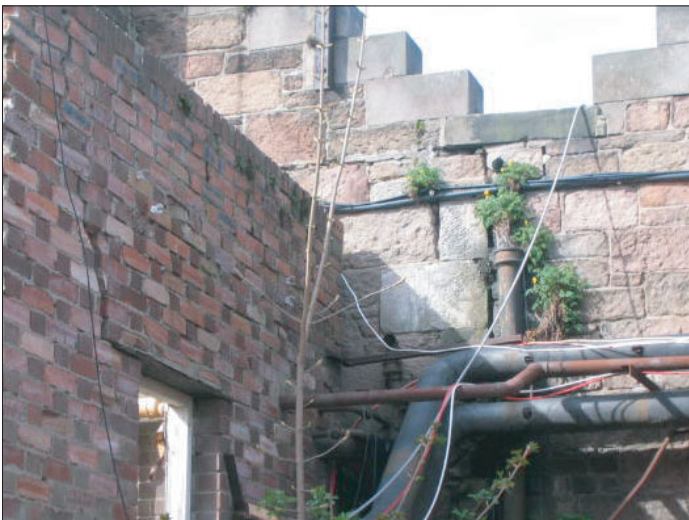
Plate 3: Eastern end of Buildings B & C facing west

It was also possible to see that Building C abutted the rear of Building B. The crow-stepped skewers that extend across the eastern end of both buildings could be seen to be integral to the construction of Building C, but an addition to Building B, which was an earlier structure (see Plate 3, note in particular the sandstone quoins on Building B).

Building C was a later addition to the Carriage House complex. The window at the eastern end of the building suggests that the chimney-stack at this end is ornamental. Building C seems to have been built with a function similar to that of Building B in mind, but lacked the features connected with stabling which were present in Building B, such as floor drains and ‘scratch marks’ from harnesses. Although these features could have been obliterated by the modern alterations, it is possible that Building C was used more for vehicle storage rather than animal stabling.
